## **Lester Park Golf Course- Clubhouse**

Lester Golf Course Clubhouse

Accessibility Review

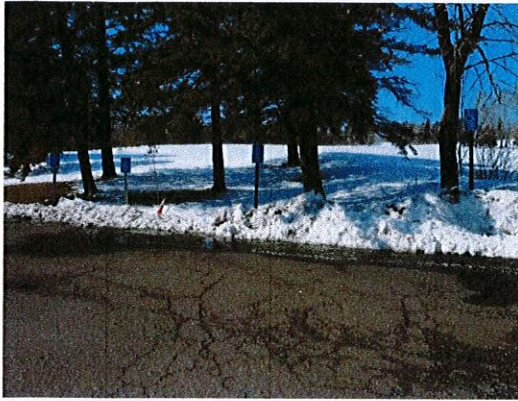
**Photo 1:** View of parking. Restripe the accessible parking to provide 8' wide space with an 8' wide aisle (can be shared between 2 spaces).

Location JQP # / Item #	Solution / Comments	Qty	Unit Cost	Total Cost	Priority	Estimated Compl. Date	Person Responsible	Actual Compl. Date	Actual Cost
<b>Parking</b>									
05H 16595	Stripe to provide an accessible parking stall that is 8' wide with an adjacent 8' access aisle. It is preferred that the access aisle be located on the passenger side of the vehicle. MN 1341 502.4.2 <i>There are currently signs designating 4 spaces as accessible, the spaces and aisles are not striped. Photo 1.</i>	1	\$150	\$150	3				
<b>Patio</b>									
12H 16583	Bevel / replace / reset threshold so there is no abrupt rise greater than 1/2" or slope greater than 1:2. ICC / ANSI 404.2.4 <i>There is currently at 3" rise at the threshold to the patio. Photo 3.</i>	1	\$200	\$200	3				
<b>Pro Shop</b>									
21A1 16581	Lower a minimum 36" wide section of counter to a maximum height of 36" above the floor. ICC ANSI 904.3 <i>Currently at 38 1/2".</i>	1	\$1,000	\$1,000	3

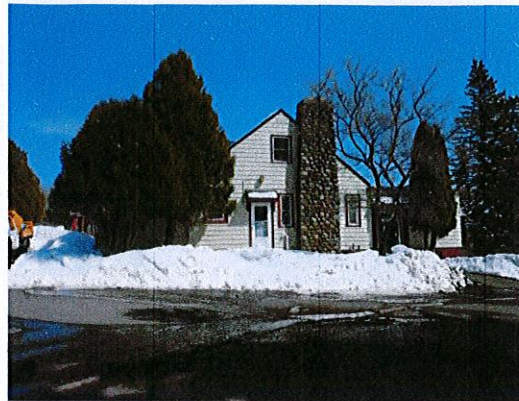
**Photo 2:** Post a sign at the main entry directing to the accessible side entry. (The main entry leads directly to stairs.)

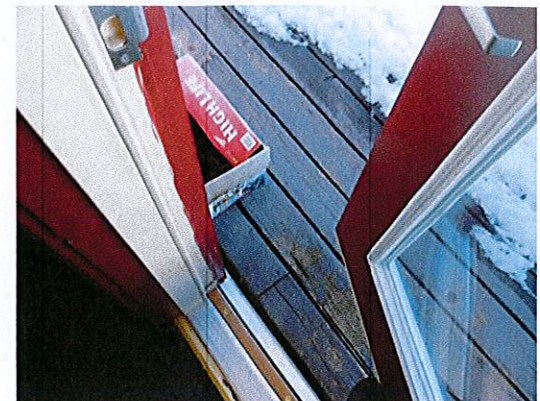
**Photo 3:** Modify the threshold to eliminate the 3" rise at the patio.

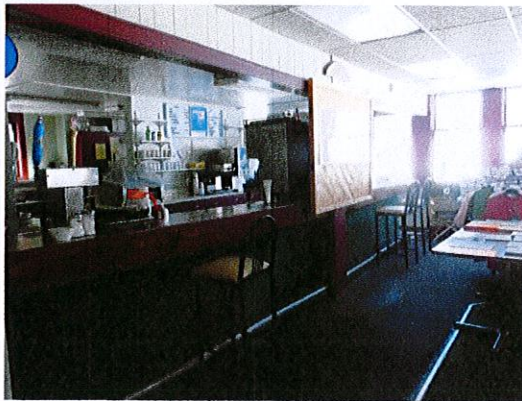
**Photo 4:** Lower a section of the counter to 36" maximum (currently at 43").

Location	Solution / Comments	Qty	Unit Cost	Total Cost	Priority	Estimated Compl. Date	Person Responsible	Actual Compl. Date	Actual Cost
JQP # / Item #									
<b>Snack Bar</b>									
21A1	16580	Lower a minimum 36" wide section of counter to a maximum height of 36" above the floor. ICC ANSI 904.3 Currently at 43". Photo 4.	1	\$1,000	\$1,000	3			
<b>Women's Toilet Room</b>									
22B	16585	Install signage with appropriate raised and Braille lettering. MN 1341 1110.2	1	\$40	\$40	3			
				<b>Priority # 3 Total</b>		<b>\$22,000</b>

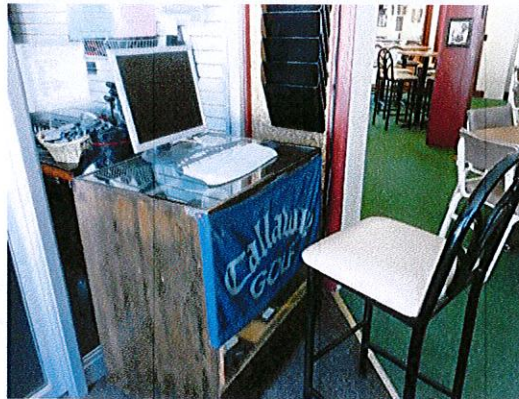
**Photo 5:** Relocate the computer used to register league and handicap to an accessible location. Currently at 37 1/2".

Location JQP # / Item #	Solution / Comments	Qty	Unit Cost	Total Cost	Priority	Estimated Compl. Date	Person Responsible	Actual Compl. Date	Actual Cost
<b>Building Wide</b>									
20D 16577	Provide door hardware that does not require grasping, pinching or twisting to operate, such as lever. ICC / ANSI 404.2.6	4	\$250	\$1,000	3				
40B 16578	Provide compliant raised and Braille permanent room identification signage. MN 1341 1110.2	4	\$40	\$160	3				
				<i>Location Subtotal:</i>					\$1,160
<b>Computer Station</b>									
29A 16582	Provide a minimum of one computer lab on an accessible permanent or movable table / counter. The top height of the surface is to be 28"-34" above the floor, with knee clearance a minimum 27" high by 30" wide x 19" deep. ICC / ANSI 902.2 <i>The computer for registering league and handicap is currently at 37 1/2". Photo 5.</i>	1	\$200	\$200	3				
<b>Lower Level</b>

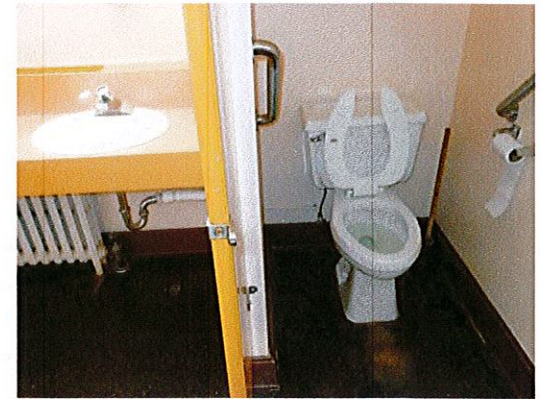
**Photo 6:** There is 1 toilet room designated as 'accessible'. Remodel to provide a compliant single user accessible toilet room.

Location	Solution / Comments	Qty	Unit Cost	Total Cost	Priority	Estimated Compl. Date	Person Responsible	Actual Compl. Date	Actual Cost
<b>'Accessible' Toilet Room</b>									
22.1	16589 Upgrade toilet room to be fully accessible. IBC 1109.2 <i>There is a single user toilet room (1 toilet, 2 sinks) that has been designated as accessible. Currently no features of accessibility have been provided. (This location is on an accessible route, there is not a route to the men's toilet room in the lower level.) Photo 6.</i>	1	\$10,000	\$10,000	2				
<b>Main Entry</b>									
11B	16576 Provide signage directing persons to and identifying the accessible entrance. IBC 1110.6 <i>The main entry enters at a mid-point stair landing. There is an on-grade entry on the north side of the clubhouse. Photo 2.</i>	1	\$30	\$30	2				
				<b>Priority # 2 Total</b>	<b>\$10,030</b>
