## **Central Hillside Community Center**

Accessibility Review

*Transition Plan - (location/priority)*

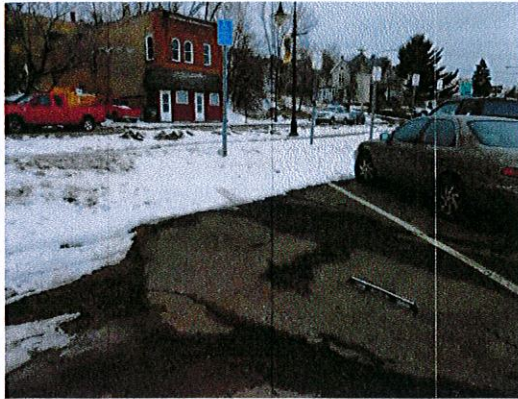
05N1	16532	Relocate accessible parking to a location where the slope / cross slope of the parking area is no greater than 1:48 (2%) in any direction. ICC / ANSI 502.5 <i>The slope is currently 9% within the accessible parking space. Relocating to the opposite side of the parking lot would reduce the slope to 4.3% (still greater than the maximum 2% allowed) and would align the aisle with the new curb cut and shallower route into the building. Photo 1.</i>	1	\$250	\$250	2			
				<i>Location Subtotal:</i>					\$400
				<b>Priority # 2 Total</b>					<b>\$1,650</b>

**Photo 1:** View of existing upper lot accessible parking space. There is currently a slope of 9% in the parking space.

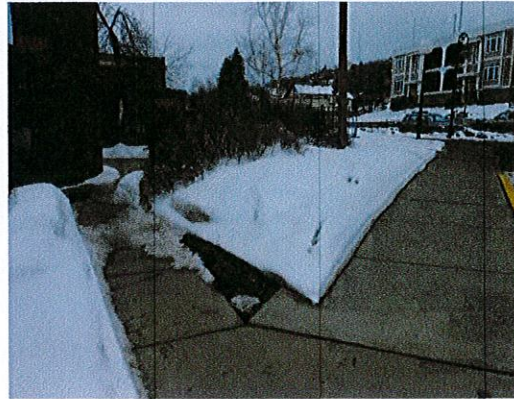
Location	Solution / Comments	Qty	Unit Cost	Total Cost	Priority	Estimated Compl. Date	Person Responsible	Actual Compl. Date	Actual Cost
JQP # / Item #									
<b>Exterior Route- Upper</b>									
09A	16533	Provide fully compliant handrails on both sides of the sloped surface. ANSI 405.8 <i>The east route to the upper level entry currently has a slope of up to 6.4%. Photo 2.</i>	50	\$25	\$1,250	2			
<b>Parking- Rear</b>									
	16491	<i>There is 1 parking space designated as accessible. Currently the dumpster and snow pile are in the access aisle. Photo 4.</i>	1	\$0	\$0	2			
<b>Parking- Upper</b>									
05H	16531	Stripe to provide an accessible parking stall that is 8' wide with an adjacent 8' access aisle. It is preferred that the access aisle be located on the passenger side of the vehicle. MN 1341 502.4.2 <i>There is currently 1 parking space designated as accessible, there is not an aisle. Photo 1.</i>	1	\$150	\$150	2

**Photo 2:** Add handrails to the east route to the upper level entry. (The slope is 6.4%.)

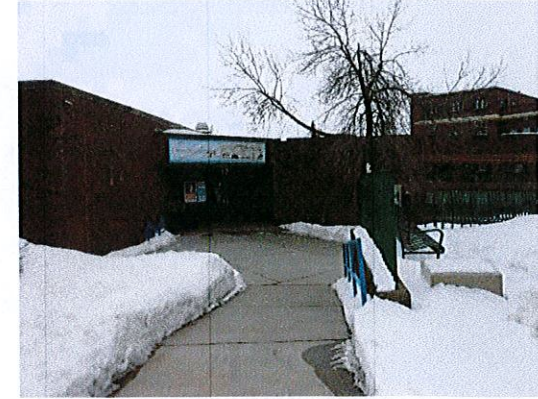
Location JQP # / Item #	Solution / Comments	Qty	Unit Cost	Total Cost	Priority	Estimated Compl. Date	Person Responsible	Actual Compl. Date	Actual Cost
<b>Boxing Gym Exterior Entry</b>									
08D1 16535	Modify / replace existing surface material to eliminate changes in level greater than 1/2". ANSI 303.2, Figure 303.2		\$500	\$500	3				
<b>Building Wide</b>									
20D 16492	Provide door hardware that does not require grasping, pinching or twisting to operate, such as lever. ICC / ANSI 404.2.6	30	\$250	\$7,500	3				
40B 16493	Provide compliant raised and Braille permanent room identification signage. MN 1341 1110.2	30	\$40	\$1,200	3				
				<i>Location Subtotal:</i>					\$8,700
<b>Exterior Route- Upper</b>									
09K 16534	Reconstruct ramp to provide an maximum 1:12 (8.33%) slope. ADA 405.2 <i>The west route to the upper level entry is approximately 15' long and has a slope of 15.5%. A handrail is provided on 1 side. Photo 3.</i>	1	\$5,000	\$5,000	3

**Photo 3:** Reconstruct (or remove) the west route to the upper level entry. The slope is currently 15.5% for a distance of approximately 15'.

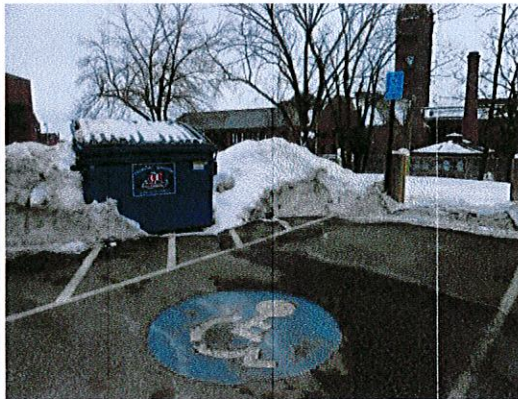
**Photo 4:** Relocate the dumpster so it is not located within the aisle of the accessible parking space at the lower level lot.

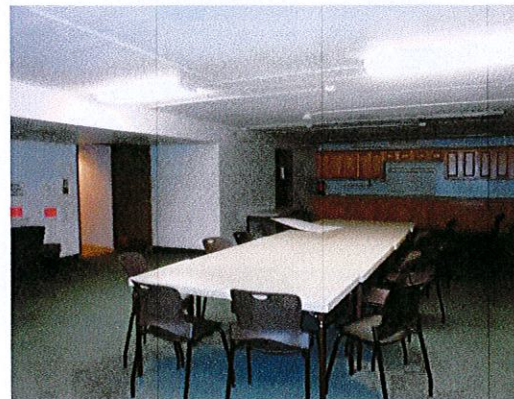
Location	Solution / Comments	Qty	Unit Cost	Total Cost	Priority	Estimated Compl. Date	Person Responsible	Actual Compl. Date	Actual Cost
JQP # / Item #									
<b>Mezzanine- Conference / Meeting</b>									
14D2 16505	Relocate program as necessary to an accessible location to provide program access. MN 1341 1104.4 <i>The mezzanine storage area was converted to a conference/meeting room. There is not currently an accessible route to this level. Photo 5.</i>	1	\$0	\$0	1				
				<b>Priority # 1 Total</b>	<b>\$0</b>

**Photo 5:** View of mezzanine conference/meeting room. There is not currently an accessible route to this location.

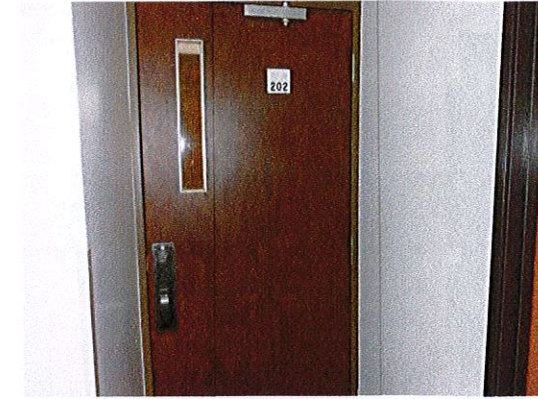
<b>Community Room- Upper Level (202)</b>									
20B 16527	Re-hinge / relocate door to provide needed maneuvering clearance on the latch pull side of the door. ICC / ANSI 404.2.3, Table 404.2.3.1 <i>Currently provides 2". Photo 6.</i>	2	\$400	\$800	4

**Photo 6:** Maneuvering clearance is not currently provided into the community room.

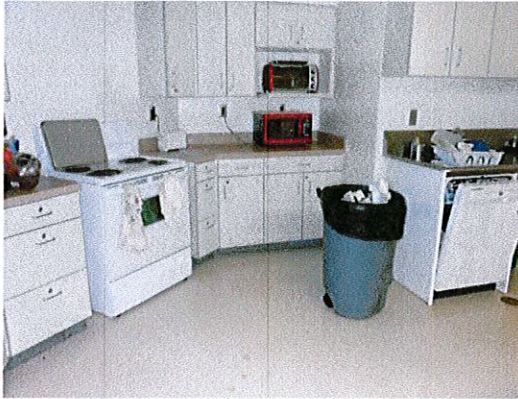
**Photo 7:** View of kitchen. Currently no features of accessibility have been provided.

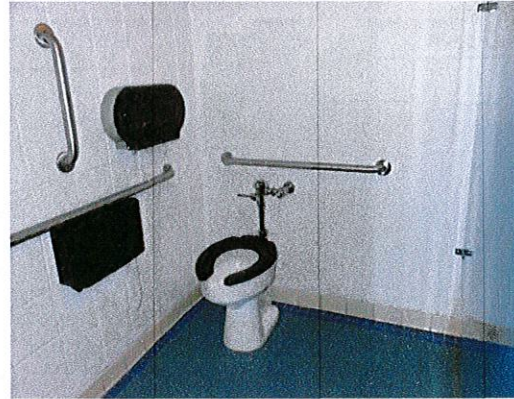
Location	Solution / Comments	Qty	Unit Cost	Total Cost	Priority	Estimated Compl. Date	Person Responsible	Actual Compl. Date	Actual Cost
JQP # / Item #									
<b>Men's Toilet Room- Lower Level</b>									
22A	16494	1	\$50	\$50	3				
	Install a sign displaying the International Symbol of Accessibility at such time toilet room is fully accessible. MN 1341 1110.2								
22H1	16496	1	\$50	\$50	3				
	Provide staple style pulls on both sides of the accessible stall door near the latch. ANSI 604.8.3								
22L (MN)	16495	1	\$50	\$50	3				
	Reposition the toilet paper dispenser so it is located below the horizontal grab bar. Operable parts should be located within an area 12" - 40" from the rear wall, and 18" minimum above the floor and 1 1/2" minimum below the horizontal grab bar. MN 1341 604.7 <i>Remove the extra toilet paper dispenser positioned above the grab bar. Photo 8.</i>								
22Z	16497	1	\$50	\$50	3

**Photo 8:** Remodeling has occurred to provide features of accessibility in the lower level toilet rooms. *This is a good example of accessibility.* Remove the 2nd toilet paper dispenser currently mounted above the grab bar.

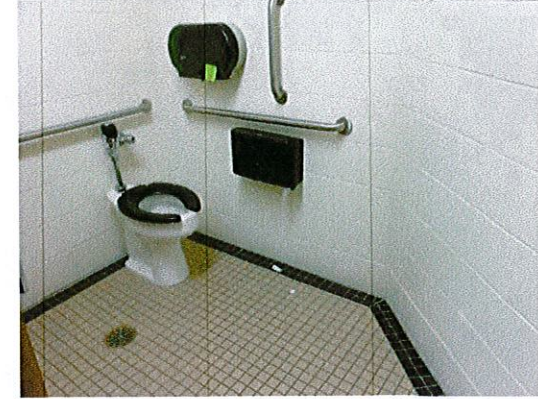
Location JQP # / Item #	Solution / Comments	Qty	Unit Cost	Total Cost	Priority	Estimated Compl. Date	Person Responsible	Actual Compl. Date	Actual Cost
<b>Women's Toilet Room- Upper Level</b>									
22-20B0 16514	Install an automatic door opener to address non-compliant maneuvering clearance at the door. (Note: Automatic door opener is not required) ICC / ANSI 404.2.3, Table 404.2.3.1 <i>Currently provides 40" (vs. 54" minimum). Photo 10.</i>	1	\$1,500	\$1,500	3				
22B 16513	Install signage with appropriate raised and Braille lettering. MN 1341 1110.2	1	\$40	\$40	3				
22H1 16516	Provide staple style pulls on both sides of the accessible stall door near the latch. ANSI 604.8.3	1	\$50	\$50	3				
22L (MN) 16515	Reposition the toilet paper dispenser so it is located below the horizontal grab bar. Operable parts should be located within an area 12" - 40" from the rear wall, and 18" minimum above the floor and 1 1/2" minimum below the horizontal grab bar. MN 1341 604.7 <i>Remove the extra toilet paper dispenser positioned above the grab bar. Photo 9.</i>	1	\$50	\$50	3

<b>Single User Toilet Rooms- Basement</b>									
22 16508	Enlarge and upgrade the toilet room to be fully accessible. IBC 1109.2 <i>There are 2 small (5'x5') toilet rooms in the basement storage area.</i>	2	\$10,000	\$20,000	4				
<b>Women's Toilet Room- Upper Level</b>									
22G (MN) 16518	Modify to provide a minimum clearance of 48" in front of the water closet. MN 1341 604.3.1 <i>Currently provides 36" because of the angle of the exterior wall. Photo 9.</i>	1	\$1,000	\$1,000	4

**Photo 9:** View of upper level women's toilet room. Remove the 2nd toilet paper dispenser currently mounted above the grab bar. This location does not currently provide 48" in front of the toilet due to the angle of the exterior wall.

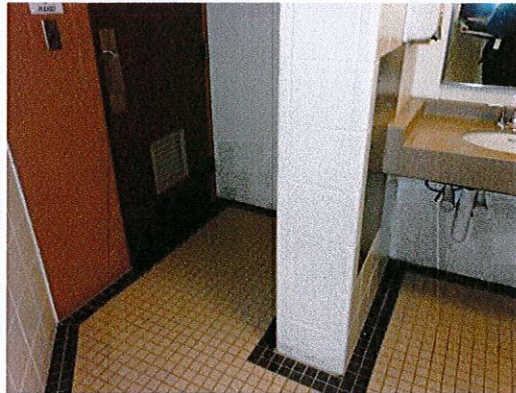
**Photo 10:** Maneuvering clearance is not currently provided at the entry to the upper level toilet rooms.

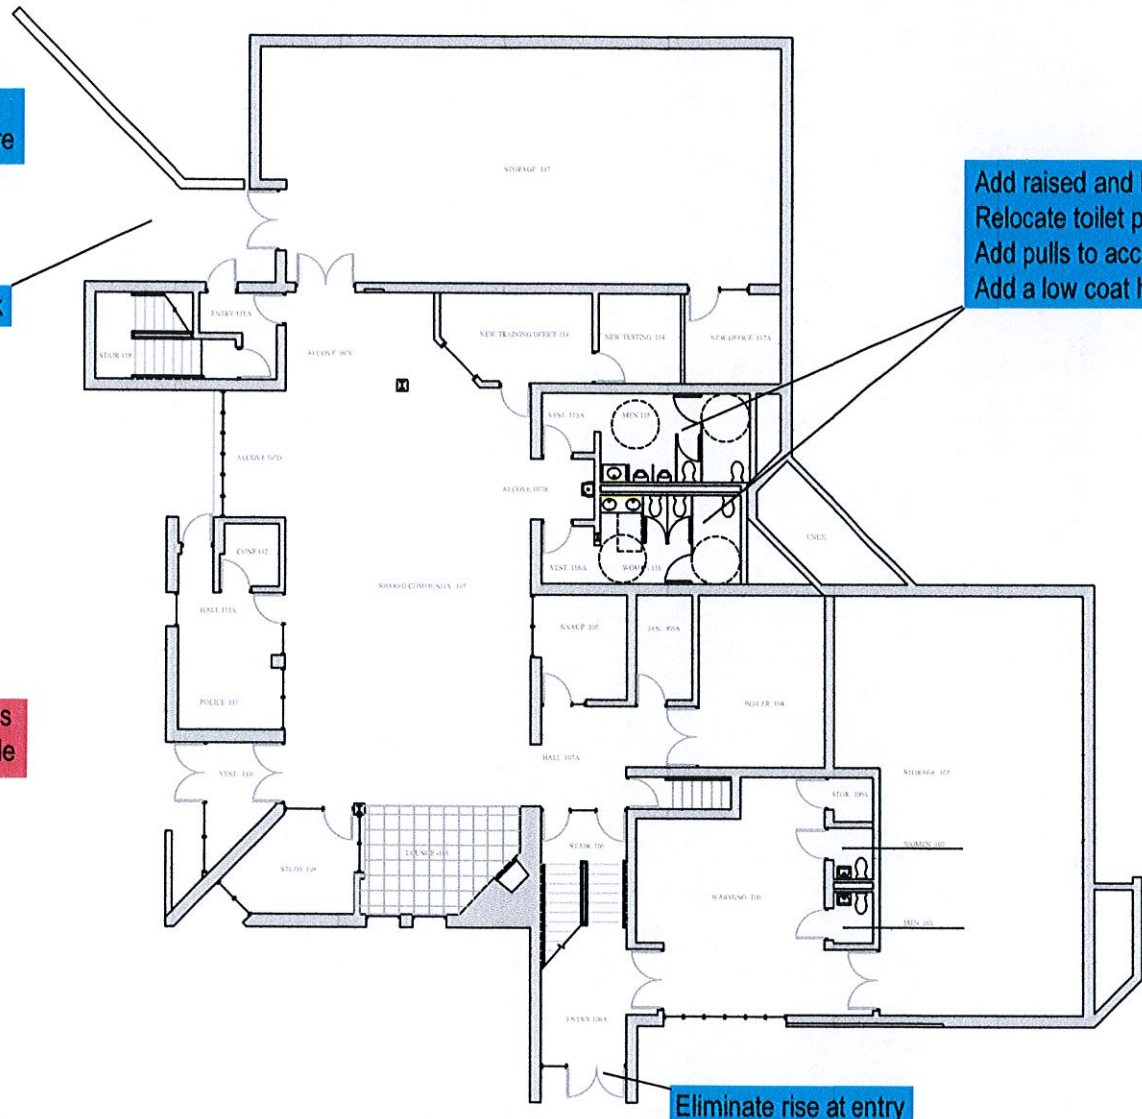
Central Hillside Community Center  
 Lower Level  
 City of Duluth, MN

Eliminate rise in sidewalk

- Add raised and braille sign
- Relocate toilet paper dispenser
- Add pulls to accessible stall door
- Add a low coat hook

- Relocate the dumpster so it is not located in the access aisle

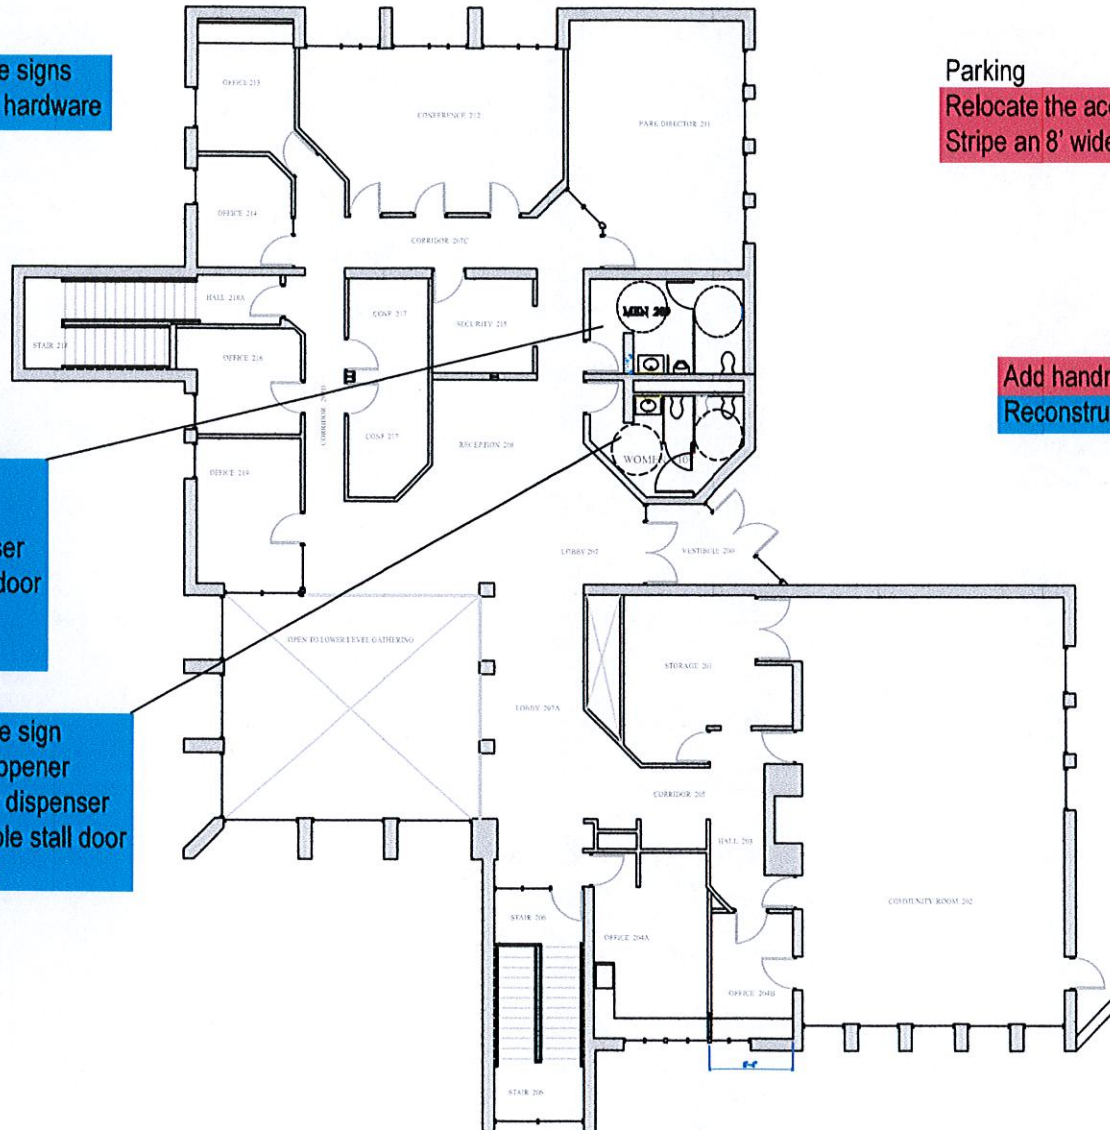
Central Hillside Community Center  
Upper Level  
City of Duluth, MN

Relocate the accessible parking space  
Stripe an 8' wide access aisle

Add raised and braille sign  
Install a power door opener  
Relocate toilet paper dispenser  
Add pulls to accessible stall door  
Add a low coat hook  
Lower 1 urinal

Add raised and braille sign  
Install a power door opener  
Relocate toilet paper dispenser  
Add pulls to accessible stall door  
Add a low coat hook

Add handrails to the east ramp  
Reconstruct the west route to reduce slope

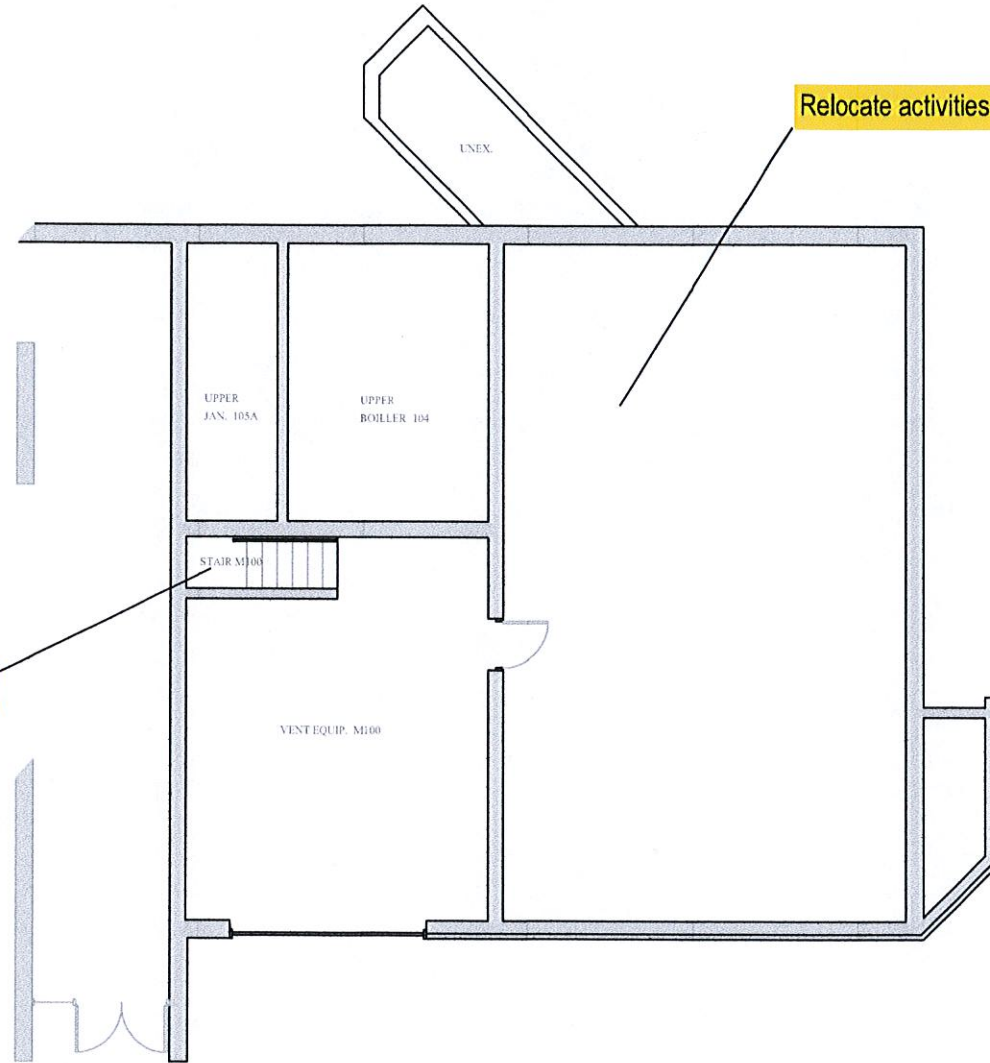
Central Hillside Community Center  
Mezzanine  
City of Duluth, MN

Relocate activities to an accessible location

Create an accessible route between levels
