## **Harrison Community Club**

Accessibility Review

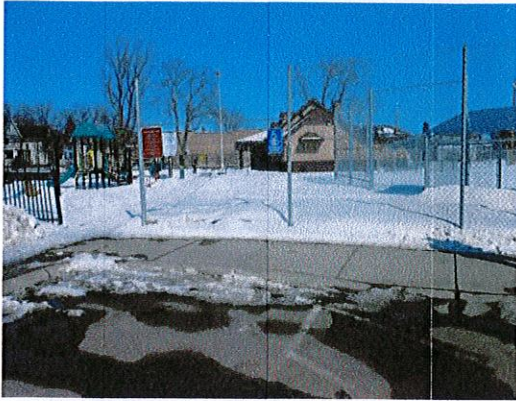
**Photo 1:** There is 1 parking space designated as accessible. *This is a good example of accessibility.*

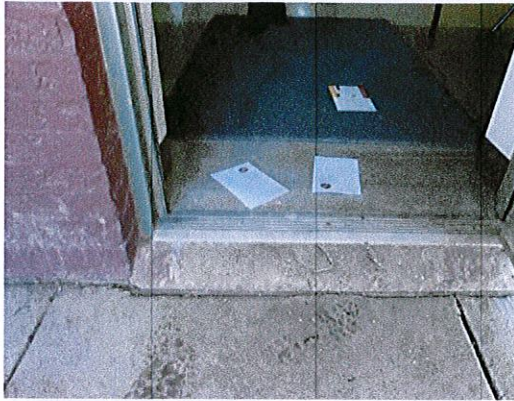
Location JQP # / Item #	Solution / Comments	Qty	Unit Cost	Total Cost	Priority	Estimated Compl. Date	Person Responsible	Actual Compl. Date	Actual Cost
<b>Coat Rack</b>									
14F4 16135	Provide a closet rod mounted no higher than 48" above the floor. ICC / ANSI 308 <i>Currently at 56".</i>	1	\$100	\$100	4				
<b>Corridor (to Women's Toilet Room and stairs to lower level)</b>									
20B 16136	Re-hinge / relocate door to provide needed maneuvering clearance on the latch pull side of the door. ICC / ANSI 404.2.3, Table 404.2.3.1 <i>Currently provides 2".</i>	1	\$400	\$400	4				
<b>Exterior Route</b>									
07H 16131	Modify to provide a level landing at the top of the curb ramp that is 36" minimum in length. MN1341 406.7	1	\$1,000	\$1,000	4				
<b>Main Entry</b>									
12H 16132	Bevel / replace / reset threshold so there is no abrupt rise greater than 1/2" or slope greater than 1:2. ICC / ANSI 404.2.4 <i>There is currently a 3" rise at the entry closest to the parking lot. A 2nd entry is accessible. Photo 2.</i>	1	\$200	\$200	4

**Photo 2:** Patch the concrete to eliminate the rise at the main entry.

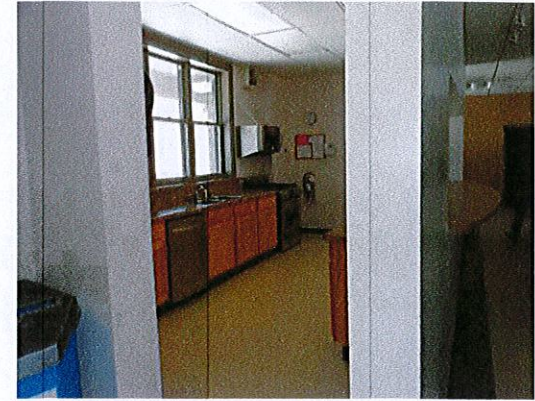
**Photo 3:** View of kitchen. The kitchen was recently (within the last 5 years) remodeled and did not include features of accessibility.

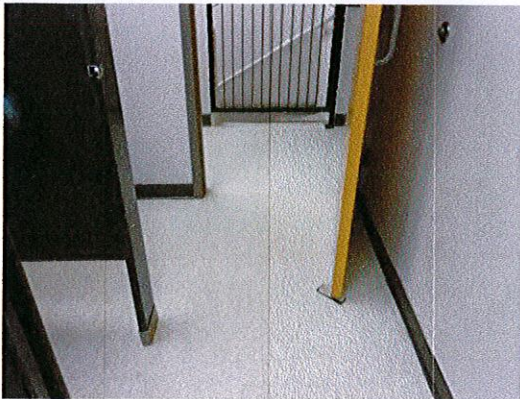
**Photo 4:** The stall partition currently obstructs the maneuvering clearance at the entry door to the women's toilet room.

Location JQP # / Item #	Solution / Comments	Qty	Unit Cost	Total Cost	Priority	Estimated Compl. Date	Person Responsible	Actual Compl. Date	Actual Cost
<b>Women's Toilet Room</b>									
22-20B2 16146	Rehinge / relocate door or alter permanent obstruction to provide needed maneuvering clearance at the door. ICC / ANSI 404.2.3, Table 404.2.3.1 <i>The stall partition is currently within the clearance on the pull (interior) side of the toilet room door to the corridor. Photo 4.</i>	1	\$1,500	\$1,500	4				
22E 16142	Enlarge to provide a fully compliant 60" minimum wide toilet stall. MN 1341 604.3.1 <i>Currently 51" wide (providing a 60" wide stall would require removing the 2nd fixture in the toilet room). Photo 5.</i>	1	\$1,350	\$1,350	4				
22N1 16143	Relocate the water closet flush valve so it is located on the open side of the water closet or provide an automatic flush system. MN1341 604.6	1	\$400	\$400	4

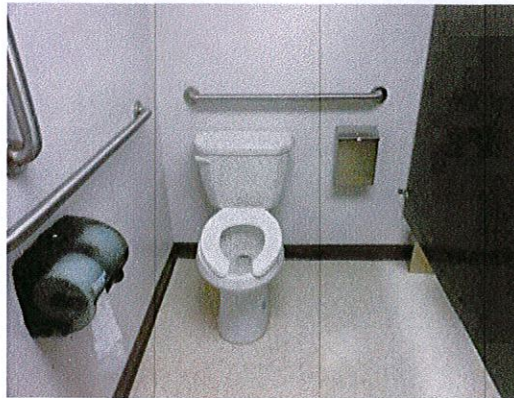
**Photo 5:** The toilet room has been remodeled to increase accessibility. Relocate the sanitary waste receptacle to below the horizontal grab bar. Note: the stall is only 51" wide (vs. 60" due to fixture count).

Location JQP # / Item #	Solution / Comments	Qty	Unit Cost	Total Cost	Priority	Estimated Compl. Date	Person Responsible	Actual Compl. Date	Actual Cost
<b>Women's Toilet Room</b>									
22B 16137	Install signage with appropriate raised and Braille lettering. MN 1341 1110.2	1	\$40	\$40	3				
22H1 16140	Provide staple style pulls on both sides of the accessible stall door near the latch. ANSI 604.8.3	1	\$50	\$50	3				
22K5 (MN) 16138	Relocate the existing grab bar(s) to be mounted 33" to 36" above the floor. MN 1341 604.5.1 <i>The horizontal grab bar is currently at 37 1/2". Photo 5.</i>	1	\$200	\$200	3				
22T 16145	Lower the towel dispenser/dryer so the highest operable part is no higher than 48" (44" maximum if located above lavatory or counter). ANSI 308 <i>Currently at 52".</i>	1	\$50	\$50	3				
22W2 16139	Relocate the sanitary product receptacle in the accessible stall. The sanitary product receptacle should be located 1 1/2" minimum below the horizontal grab bar and 18" minimum above the floor and 12"- 40" from the rear wall. MN 1341 604.7 <i>Photo 5.</i>	1	\$50	\$50	3

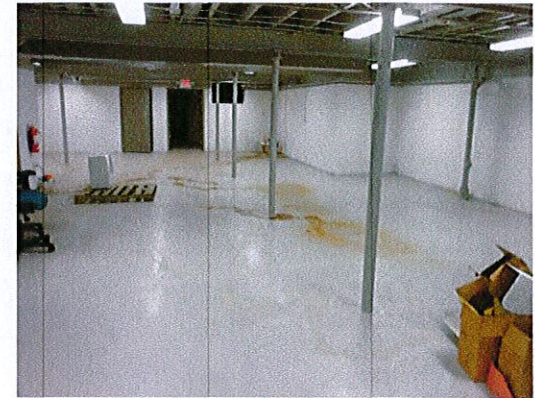
**Photo 6:** View of lower level. The lower level is currently abandoned and used only for storage. There is not an accessible route to the lower level.

Location JQP # / Item #	Solution / Comments	Qty	Unit Cost	Total Cost	Priority	Estimated Compl. Date	Person Responsible	Actual Compl. Date	Actual Cost
<b>Lower Level</b>									
14D2 16155	Relocate program as necessary to an accessible location to provide program access. MN 1341 1104.4 <i>There is not currently an accessible route to the lower level (interior and exterior stairs). The lower level appears to be abandoned at this time and used only for storage. Photo 6.</i>	1	\$0	\$0	1				
				<b>Priority # 1 Total</b>	<b>\$0</b>
