Lincoln Park Community Club

Transition Plan - (location/priority)

City of Duluth, MN

2013

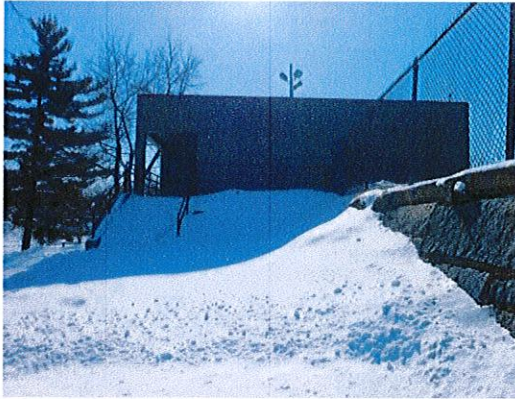
Lincoln Park Community Club is located at the top of the hill near N. 25th Avenue W. and W. 5th Street overlooking the play area, river and amphitheater/pavilion. The primary route from the street is currently stairs, however the driveway apron and basketball court create an accessible route to the main entry. The community club includes an open room with toilet rooms, office and a kitchen. There are currently no features of accessibility provided within the building.

Photo 1: View of the route from the street. There are currently steps to the main entry.

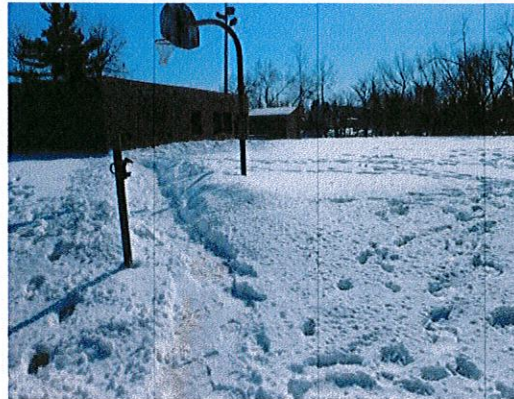
Photo 2: There is a potential accessible route via the driveway apron. Ensure the gate/barricade provides a 32" clear opening (if closed).

Location JQP # / Item #	Solution / Comments	Qty	Unit Cost	Total Cost	Priority	Estimated Compl. Date	Person Responsible	Actual Compl. Date	Actual Cost
Exterior Route 16178	<i>The accessible route from the street requires using the driveway (there are steps between the sidewalk and entry). Ensure that if the gate/barricade at the driveway is closed, a 32" wide clear opening is still provided. Photo 2.</i>	1	\$0	\$0	1				
				Priority # 1 Total					\$0

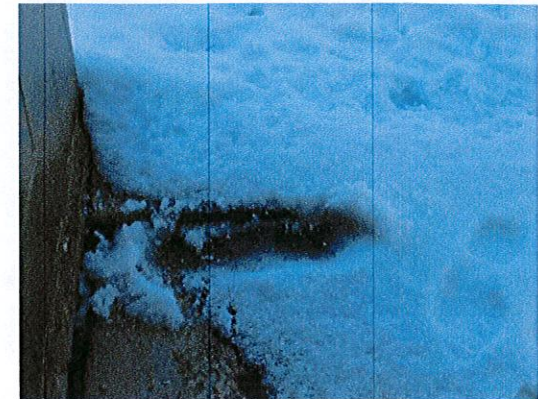
Photo 3: Patch the sidewalk to eliminate the rise in front of the building.

Location	Solution / Comments	Qty	Unit Cost	Total Cost	Priority	Estimated Compl. Date	Person Responsible	Actual Compl. Date	Actual Cost
JQP # / Item #									
Exterior Route									
08D1	16177	1	\$7	\$7	3				
	Modify / replace existing surface material to eliminate changes in level greater than 1/2". ANSI 303.2, Figure 303.2 <i>Photo 3.</i>								
Interior Doors									
20D	16156	3	\$250	\$750	3				
	Provide door hardware that does not require grasping, pinching or twisting to operate, such as lever. ICC / ANSI 404.2.6 <i>Photo 4.</i>

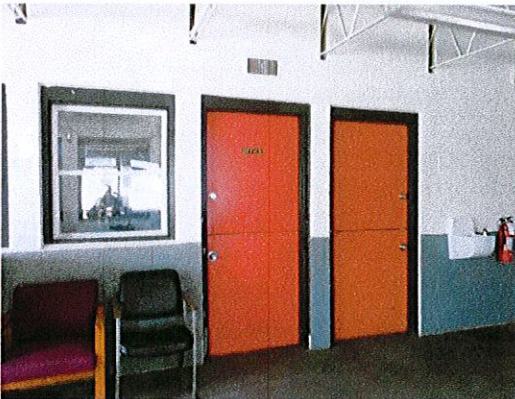
Photo 4: Typical door hardware throughout the building is a knob style. Replace the knobs with a style that does not require grasping, pinching or twisting to operate.

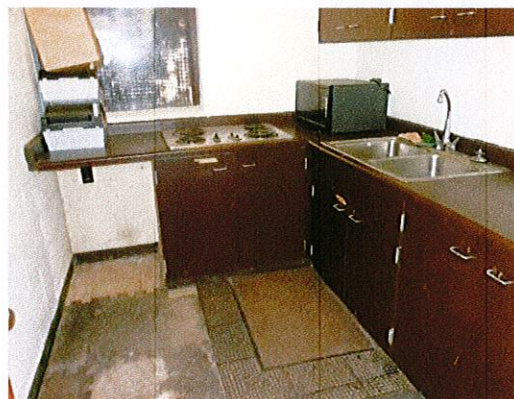
Photo 5: View of kitchen. There are no features of accessibility provided.

Location	Solution / Comments	Qty	Unit Cost	Total Cost	Priority	Estimated Compl. Date	Person Responsible	Actual Compl. Date	Actual Cost
JQP # / Item #									
Kitchen									
25J9	16157	1	\$7,000	\$7,000	4				
	Create an accessible kitchen, including: roll under work surface, roll under sink, range with front or side controls, and compliant clearances. ANSI 804 <i>There is a full kitchen (including a range) that currently provides no features of accessibility. Photo 5.</i>								
Men's Toilet Room									
22-20B	16168	1	\$750	\$750	4				
	Re-hinge / relocate door to provide needed maneuvering clearance on the latch pull side of the door. ICC / ANSI 404.2.3, Table 404.2.3.1 <i>Currently provides 2". The door is propped in the 'open' position.</i>								
22E1	16169	1	\$1,350	\$1,350	4				
	Enlarge to provide a fully compliant 60" minimum wide toilet stall. (Currently an alternate stall is provided). MN 1341 604.3.1 <i>Creating an accessible toilet room would require removing the other fixture.</i>

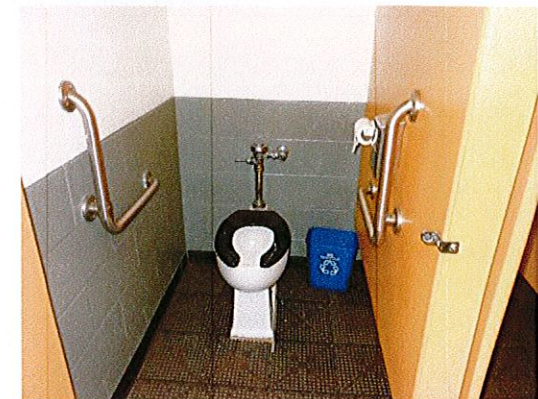
Photo 6: The toilet rooms provide an ambulatory accessible stall, but not a 5' accessible stall.

<i>Location Subtotal:</i>					\$2,100
Women's Toilet Room									
22-20B	16159	1	\$750	\$750	4				
	Re-hinge / relocate door to provide needed maneuvering clearance on the latch pull side of the door. ICC / ANSI 404.2.3, Table 404.2.3.1 <i>Currently provides 2". The door is propped in the 'open' position.</i>								
22E1	16160	1	\$1,350	\$1,350	4				
	Enlarge to provide a fully compliant 60" minimum wide toilet stall. (Currently an alternate stall is provided). MN 1341 604.3.1 <i>Creating an accessible toilet room would require removing the other fixture. Photo 6.</i>								
				<i>Location Subtotal:</i>					\$2,100
				Priority # 4 Total	\$11,200
