## **Fairmont Park- Bathroom Building**

*Transition Plan - (location/priority)*

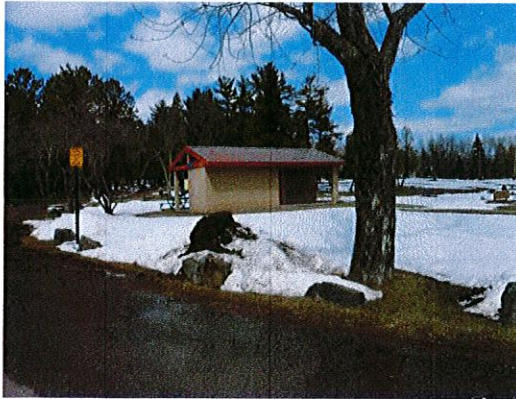
Fairmont Park is located adjacent to the Lake Superior Zoo. There is not currently an accessible route to the bathroom building and limited features of accessibility are provided within the building. An ambulatory accessible stall is provided in the men's and women's toilet rooms, but there is not currently a fully accessible 5' wide stall.

**Photo 1:** Create an accessible route to the toilet room building.

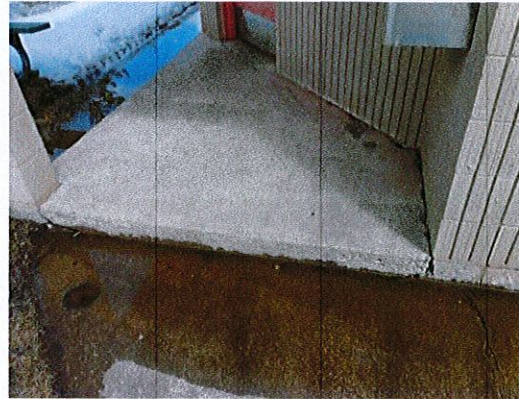
**Photo 2:** Eliminate the 4" rise at the concrete stoop to the men's toilet room.

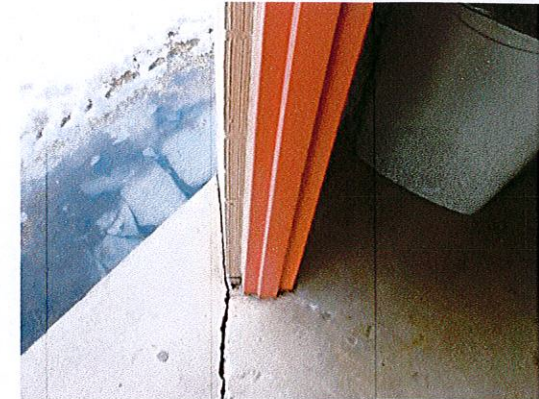
**Photo 3:** Enlarge the concrete landing to provide maneuvering clearance on the exterior side of the men's toilet room door.

Location JQP # / Item #	Solution / Comments	Qty	Unit Cost	Total Cost	Priority	Estimated Compl. Date	Person Responsible	Actual Compl. Date	Actual Cost
<b>Men's Toilet Room</b>									
12B1	16691	Extend sidewalk to provide appropriate maneuvering clearance on the latch side of the door. ICC / ANSI 404.2.3.1 <i>Photo 3.</i>	1	\$500	\$500	3			
22-20B	16689	Re-hinge / relocate door to provide needed maneuvering clearance on the latch pull side of the door. ICC / ANSI 404.2.3, Table 404.2.3.1	1	\$750	\$750	3			
22B	16684	Install signage with appropriate raised and Braille lettering. MN 1341 1110.2	1	\$40	\$40	3			
22K6 (MN)	16704	Remove the existing grab bar configuration and replace with a compliant grab bar configuration. MN 1341 604.5.1 ANSI 604.5.2	1	\$400	\$400	3			
22L (MN)	16705	Reposition the toilet paper dispenser so it is located below the horizontal grab bar. Operable parts should be located within an area 12" - 40" from the rear wall, and 18" minimum above the floor and 1 1/2" minimum below the horizontal grab bar. MN 1341 604.7	1	\$50	\$50	3

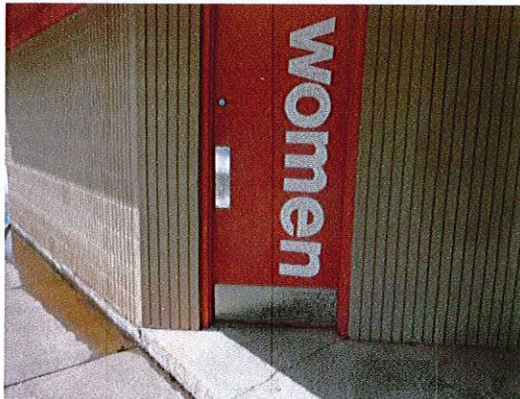
**Photo 4:** Eliminate the 4" rise at the concrete stoop to the women's toilet room and enlarge the concrete to provide maneuvering clearance on the exterior side of the door.

Location JQP # / Item #	Solution / Comments	Qty	Unit Cost	Total Cost	Priority	Estimated Compl. Date	Person Responsible	Actual Compl. Date	Actual Cost
<b>Men's Toilet Room</b>									
08D1 16683	Modify / replace existing surface material to eliminate changes in level greater than 1/2". ANSI 303.2, Figure 303.2 <i>There is currently a 4" rise at the concrete stoop. Photo 2.</i>	1	\$300	\$300	2				
<b>Route</b>									
08A 16682	Provide an accessible route. IBC 1104 <i>Photo 1.</i>	1	\$3,000	\$3,000	2				
<b>Women's Toilet Room</b>									
08D1 16693	Modify / replace existing surface material to eliminate changes in level greater than 1/2". ANSI 303.2, Figure 303.2 <i>There is currently a 4" rise at the concrete stoop. Photo 4.</i>	1	\$300	\$300	2				
				<b>Priority # 2 Total</b>	<b>\$3,600</b>

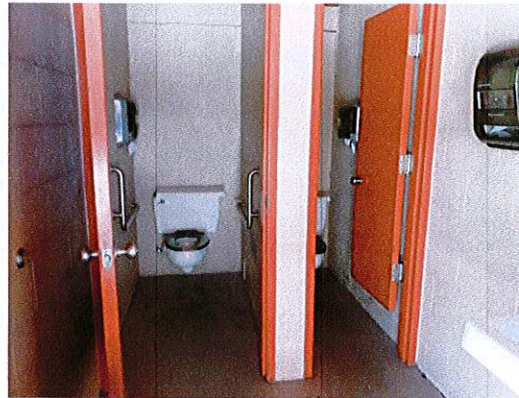
**Photo 5:** An ambulatory accessible stall has been provided, but not a 5' wide stall.

22E3	16692	Create a fully compliant 60" minimum wide toilet stall by combining two existing stalls and removing one toilet. Ensure that the new stall provides 48" minimum in front of the toilet, side and rear grab bars, toilet paper dispenser located below the horizontal grab bar, a low coat hook, easily operable stall locking hardware and staple style pulls on both sides of the stall door. MN 1341 604.3.1 <i>Creating an accessible 5' wide stall would require removing 1 of the 2 fixtures. Photo 5.</i>	1	\$1,350	\$1,350	4			
------	-------	---	---	---------	---------	---	--	--	--
