Tree Farm- East Toolhouse

Accessibility Review

City of Duluth, MN

2013

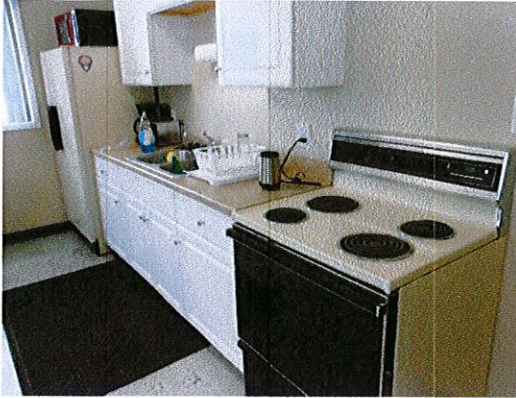
Photo 1: View of break room. The kitchen does not currently provide any features of accessibility.

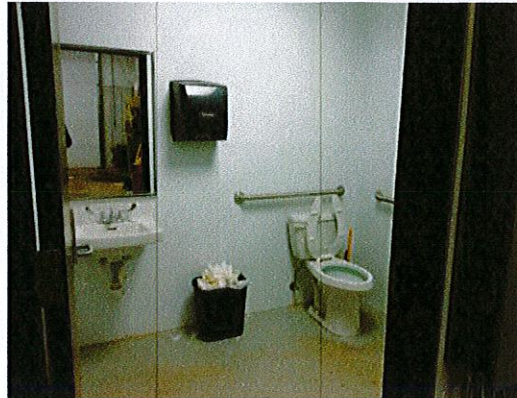
Photo 2: View of toilet room. Features of accessibility are provided. *This is a good example of accessibility.*

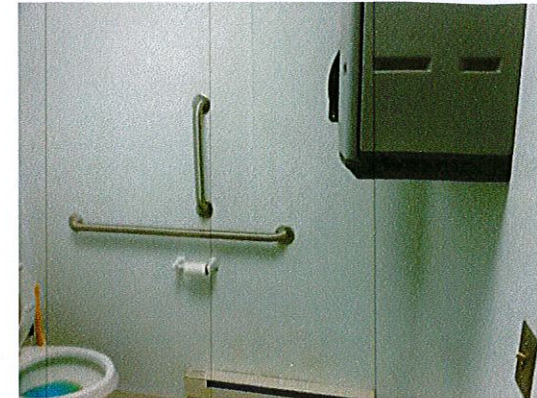
Photo 3: Remove the wall mounted storage cabinet from the toilet room that is currently within the clearance for the toilet.
