Lester Park- Bathroom Building

Accessibility Review

Transition Plan - (location/priority)

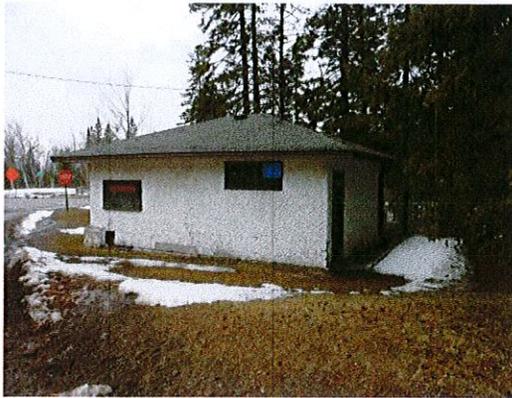
Photo 1: The toilet rooms are on the right side of the photo; the storage room is on the left. There is not currently an accessible route.

Location JQP # / Item #	Solution / Comments	Qty	Unit Cost	Total Cost	Priority	Estimated Compl. Date	Person Responsible	Actual Compl. Date	Actual Cost
Route									
08A 16623	Provide an accessible route. IBC 1104 <i>There is not currently an accessible route to the building. Photo 1.</i>	1	\$3,000	\$3,000	2				
				Priority # 2 Total	\$3,000

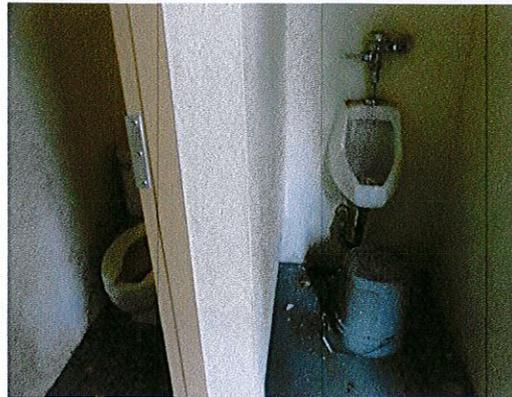
Photo 2: View of men's bathroom. There are currently no features of accessibility provided.

22.1	16626 Upgrade toilet room to be fully accessible. IBC 1109.2 <i>There are currently no features of accessibility provided. Photo 2.</i>	1	\$10,000	\$10,000	3				
22-20A	16625 Widen door opening to provide a minimum 32" clear opening. ICC / ANSI 404.2.2 <i>Currently provides a 29" clear opening.</i>	1	\$1,500	\$1,500	3				
22B	16624 Install signage with appropriate raised and Braille lettering. MN 1341 1110.2	1	\$40	\$40	3				
				<i>Location Subtotal:</i>					\$11,540
Women's Toilet Room

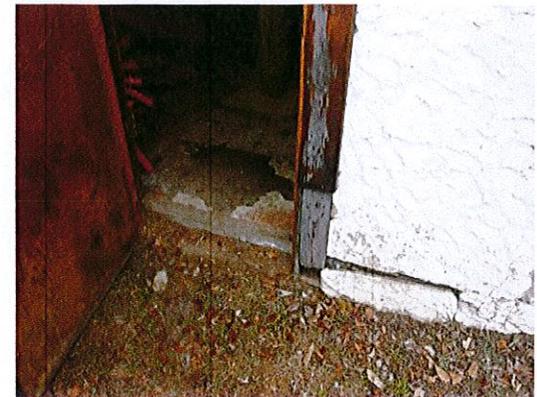
Photo 3: Modify the entry to the storage room, there is currently a 4" rise and the door provides a 27" clear opening.

Location JQP # / Item #	Solution / Comments	Qty	Unit Cost	Total Cost	Priority	Estimated Compl. Date	Person Responsible	Actual Compl. Date	Actual Cost
Storage									
12H	16631 Bevel / replace / reset threshold so there is no abrupt rise greater than 1/2" or slope greater than 1:2. ICC / ANSI 404.2.4 <i>There is currently a 4" rise at the entry. Photo 3.</i>	1	\$200	\$200	4				
20A	16630 Widen door opening to provide a minimum 32" clear opening. ICC / ANSI 404.2.2 <i>Currently provides a 27" clear opening. Photo 3.</i>	1	\$1,500	\$1,500	4				
				<i>Location Subtotal:</i>					\$1,700
									Priority # 4 Total \$1,700
