Superior Street Ramp

Parking- Superior Street

Accessibility Review

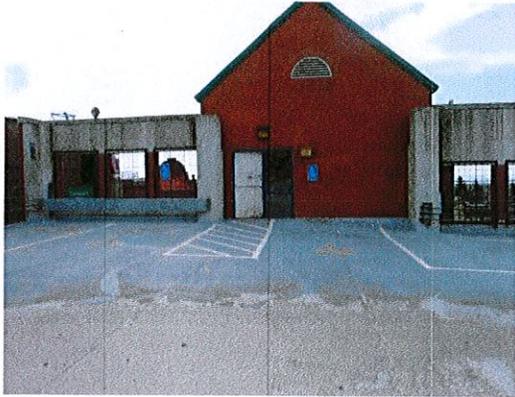
Photo 1: There is currently slope within the space and aisle that exceeds 2%.

Location JQP # / Item #	Solution / Comments	Qty	Unit Cost	Total Cost	Priority	Estimated Compl. Date	Person Responsible	Actual Compl. Date	Actual Cost
Parking- Surface									
05N 16727	Alter the slope of the accessible parking stall and / or access aisle to be no greater than 1:48 (2%) in any direction. ICC / ANSI 502.5 <i>All of the parking spaces and/or aisles currently have slopes and cross slopes exceeding 2% (4.3%-7.3%). Photos 1 and 2.</i>	1	\$500	\$500	3				
Route- Level 3									
08C 16728	Modify walkway to provide a maximum 1:48 (2%) cross-slope. ANSI 403.3 <i>The cross slope at the route to the elevator lobby (also the aisle between 2 accessible parking spaces) is currently 5.7%. Photo 3.</i>	1	\$10,000	\$10,000	3				
12B1.1 16729	Modify the slope of the area necessary for maneuvering clearance to ensure there is no slope greater than 2% (1:48) in any direction. ICC / ANSI 304.2 <i>The slope at the route to the elevator lobby and at the approach to the door (also the aisle between 2 accessible parking spaces) is currently 7.3%. Photo 3.</i>	1	\$10,000	\$10,000	3

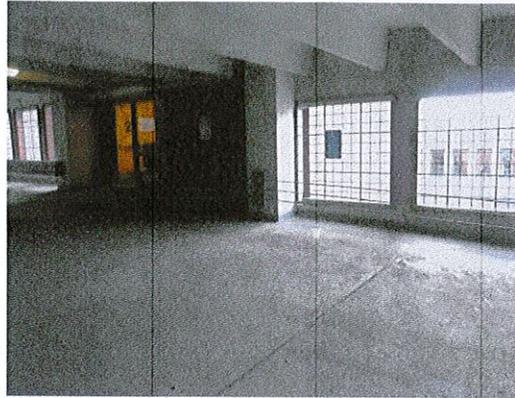
Photo 2: There is currently slope within the space and aisle that exceeds 2%.

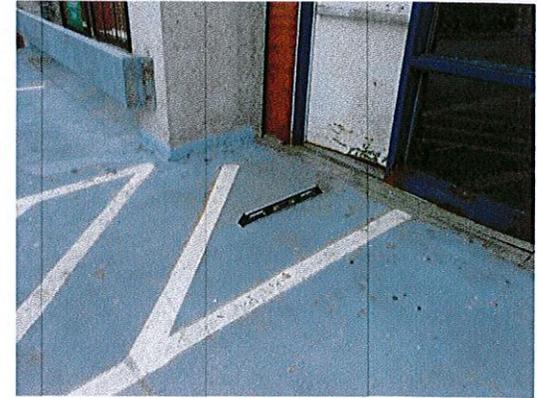
Photo 3: Modify to provide level (2%) maneuvering space at the entry to the elevator lobby.

<i>Location Subtotal:</i>					\$20,000
Route- Levels 1 and 2									
12B1.1 16730	Modify the slope of the area necessary for maneuvering clearance to ensure there is no slope greater than 2% (1:48) in any direction. ICC / ANSI 304.2 <i>The slope at the route to the elevator lobby and at the approach to the door (also the aisle between 2 accessible parking spaces) is currently 5.2%. Photo 3.</i>	1	\$10,000	\$10,000	3				
				Priority # 3 Total					\$30,500
