Roof Replacement – Snow Removal Equipment Bldg & Hangar 103

ROOF INVESTIGATION

Roof Investigation

Insured:	City of Duluth, MN	Claim #:	
Locations:	Building 1: 4875 Malstrom Street, Building 2: 4960 Airport Approach Road (Hanger 103)	459333 459332	
Contact:	Ryan Welch, 218-625-7761	D. O. L.:	July 21, 2016
		Loss:	Wind Damage

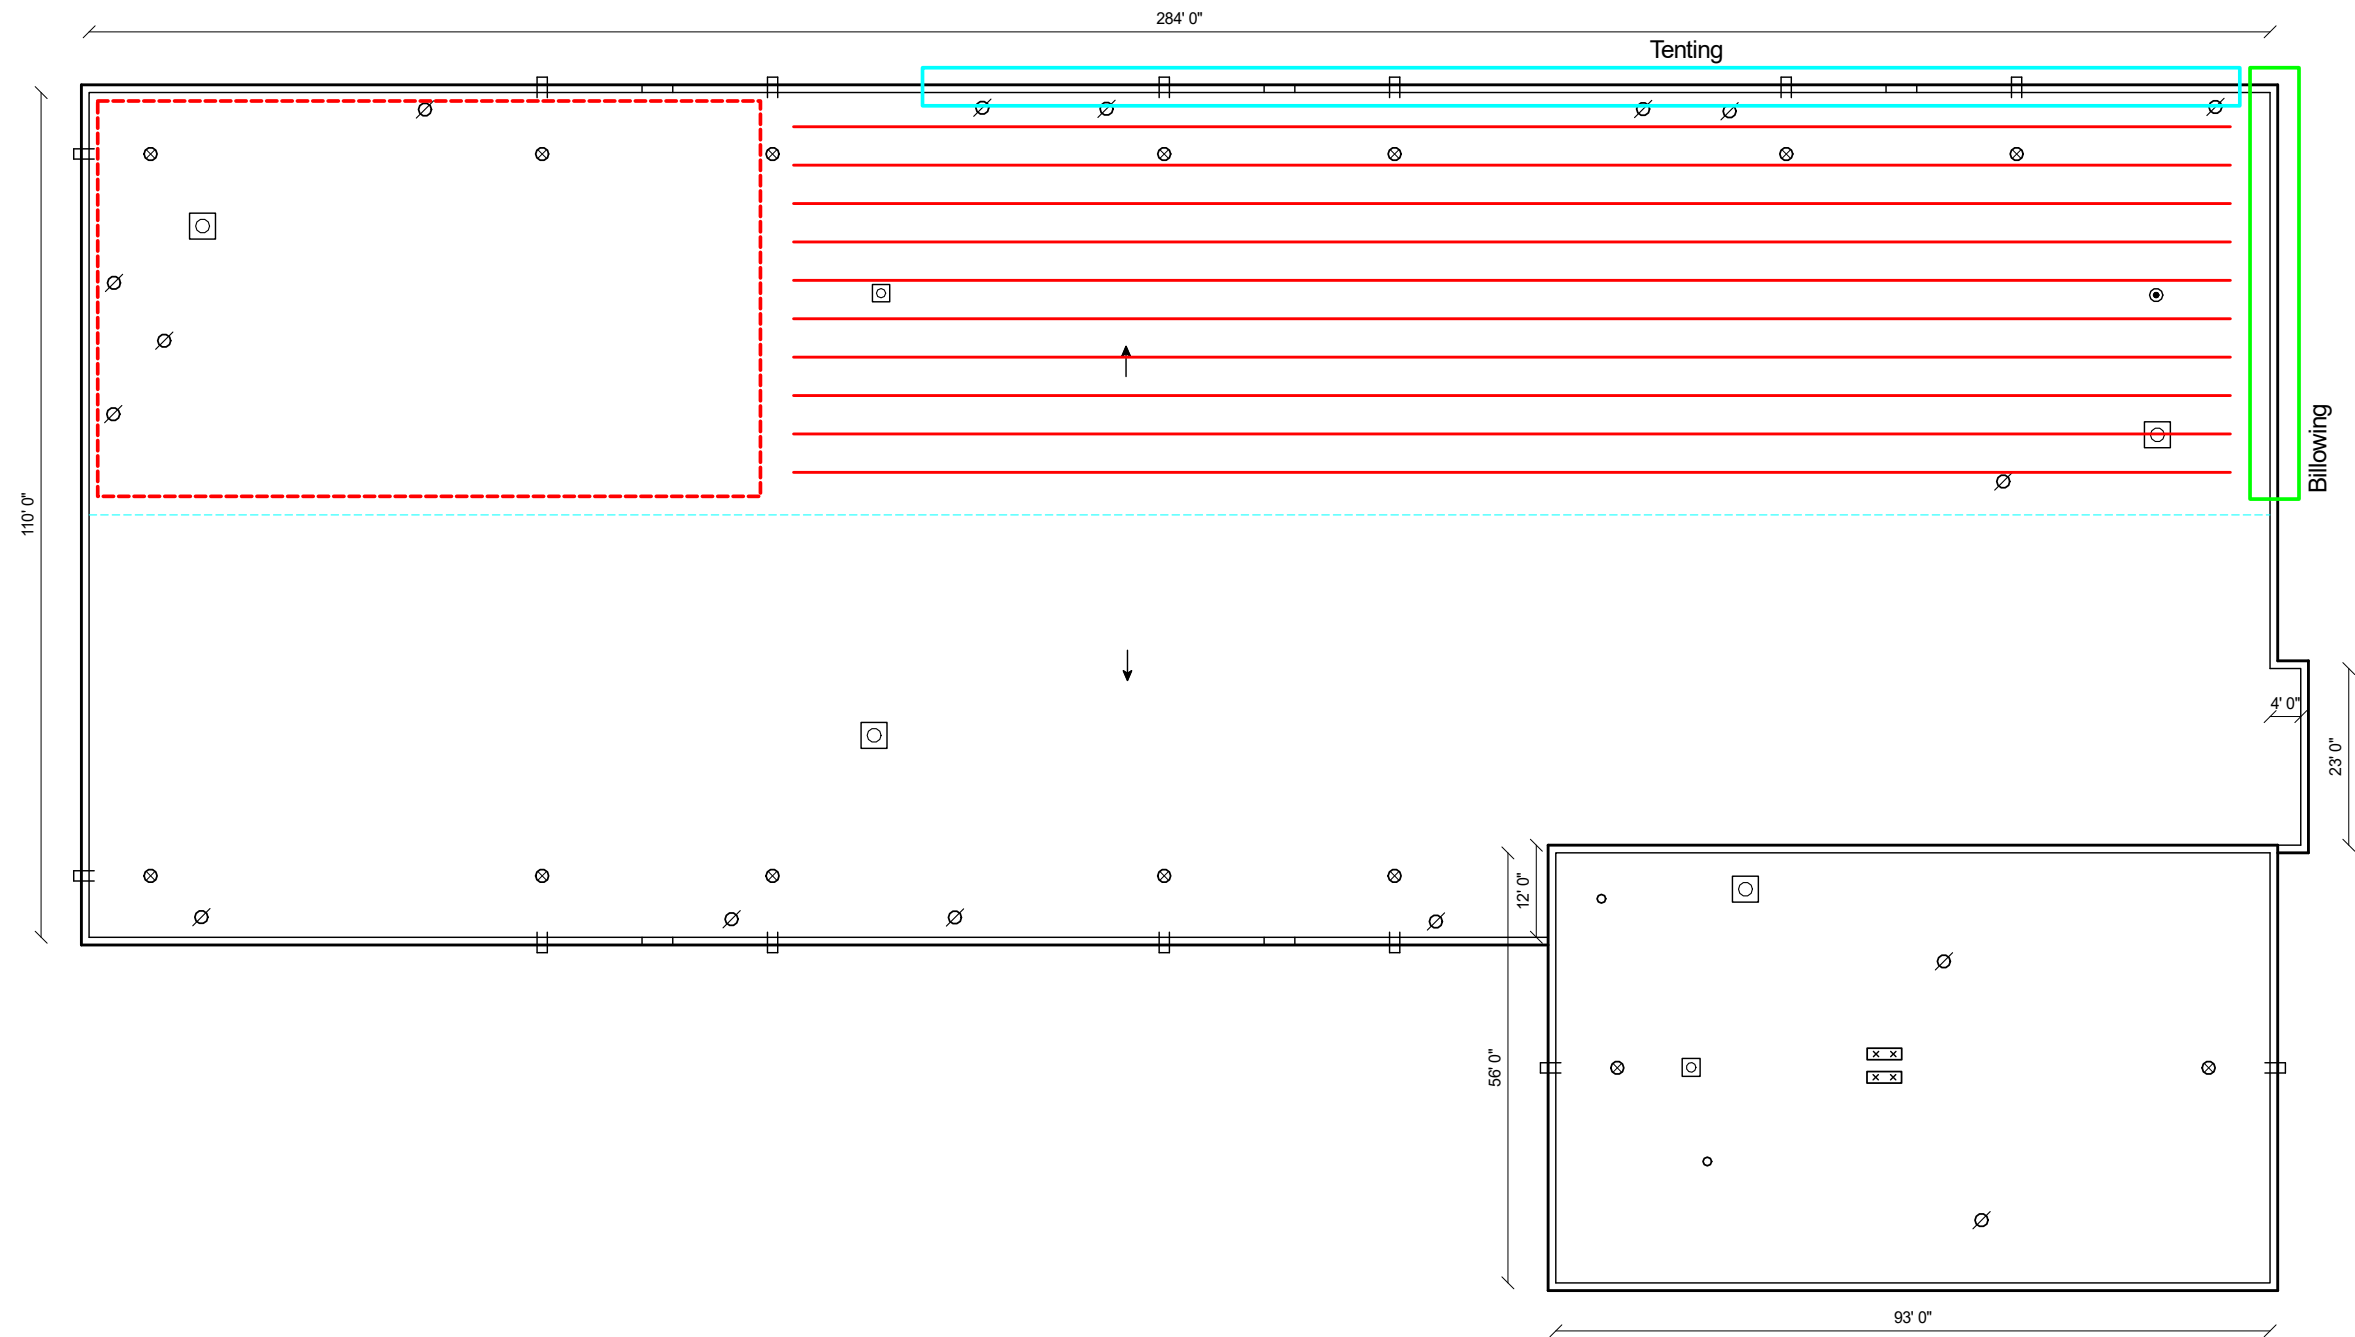
**Duluth Airport
Maintenance Garage**
4875 Maistrom St
Duluth, MN 55811

At the time of the inspection the wind speed was approximately 15 mph out of the west. No perceptible billowing of the membrane was noted during our inspection; however, it should be noted that significant repairs have been made to the roof to prevent further billowing of the membrane. These repairs included the mechanical attachment of a continuous batten strip, which was covered with seam tape flashing. These strips were placed in rows perpendicular to the west roof edge, approximately every five (5) feet. In addition, plates have been screwed through the membrane into the metal deck at numerous locations on the remainder of the west slope roof area. The west slope area that has suffered adhesion loss and had repairs made includes approximately 15,675 square feet. Refer to roof drawing for affected roof areas.

A test cut was made at the edge of the affected area. The test cut confirmed that the membrane was no longer adhered at this location. See roof drawing for test cut location. It was noted that the adhesive application was poor with approximately 35% of the membrane surface area appearing to have actually bonded to the wood fiber cover board at the time of its installation. At this location, manual inspection revealed that the membrane could easily be lifted away from the wood fiber board. It is clear that the installation of the EPDM roof system would generally be classified as poor.

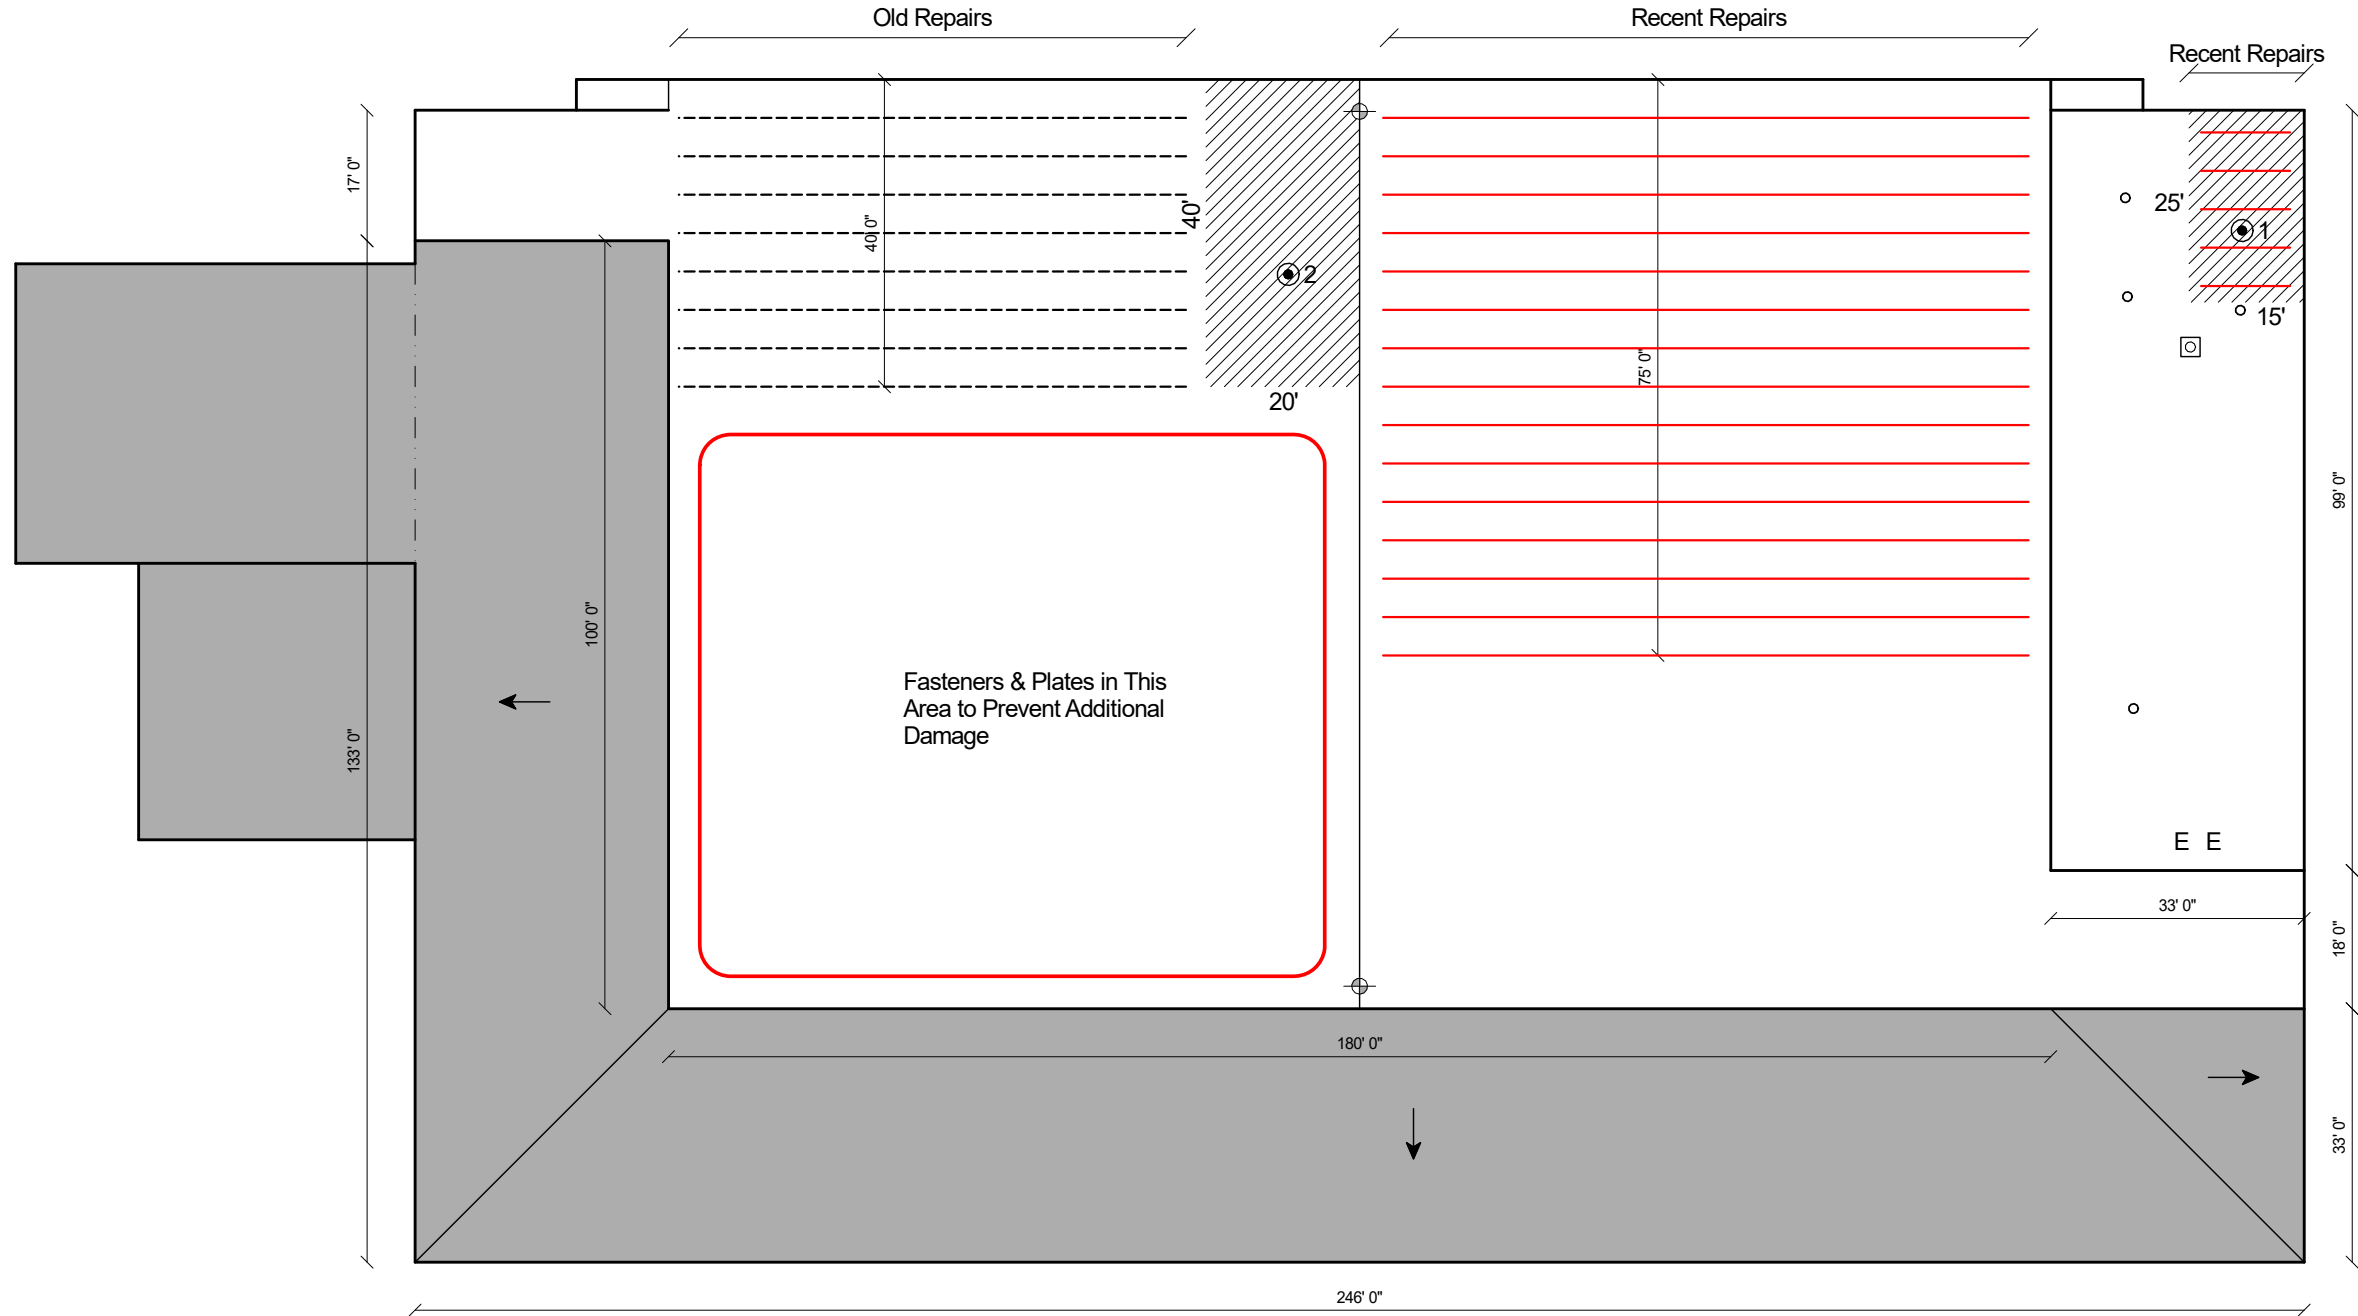
Duluth Airport
4960 Airport Rd.
Duluth, MN 55811

These recent repairs included the mechanical attachment of continuous batten strips which were covered with flashing tape. On the east facing upper slope, these strips were placed in rows which run perpendicular to the north roof edge, approximately 5' o.c. in an area approximately 100' x 75'. In addition, individual plates have recently been screwed through the membrane into the plywood deck and covered with flashing tape at numerous locations on the west facing slope. These repairs were made in two (2) separate areas; the first area measured approximately 40' x 20' and the second area measured approximately 80 x 100. In addition, a small area, measuring approximately 15' x 25', located at the north end of the lower east facing roof slope has also had batten strips with flashing tape installed over the membrane. These have been installed in rows which are 5' o.c. running parallel to the north roof edge. The total roof area which has had recent repairs made totals approximately 16,675 SF.

It should be noted that a significant area of the west facing slope has had previous repairs made to it as well. These repairs again consisted of batten strip installation, 5' o.c. with flashing tape covering them. This area includes approximately 3,200 square feet.

Two test cuts were made in the affected areas; one (1) on the upper roof - west slope and one (1) on the lower east facing slope. The test cuts indicated that the membrane was no longer adhered at either of these locations. No evidence of moisture intrusion was noted at either of the test cut locations. See roof drawing for test cut locations. At both test cut locations, it was noted that the adhesive application was very poor with approximately 25% of the membrane surface area appearing to have actually bonded to the plywood substrate at the time of its installation. At these locations, the manual inspection revealed that the membrane was loose and completely detached from the plywood substrate. It is clear that the installation of the EPDM roof system would generally be classified as very poor.

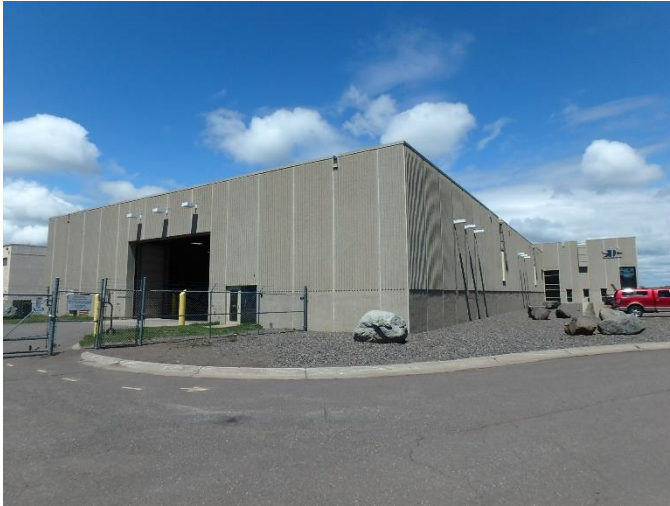
1. General site photo-Building 1
4875 Malstrom St.

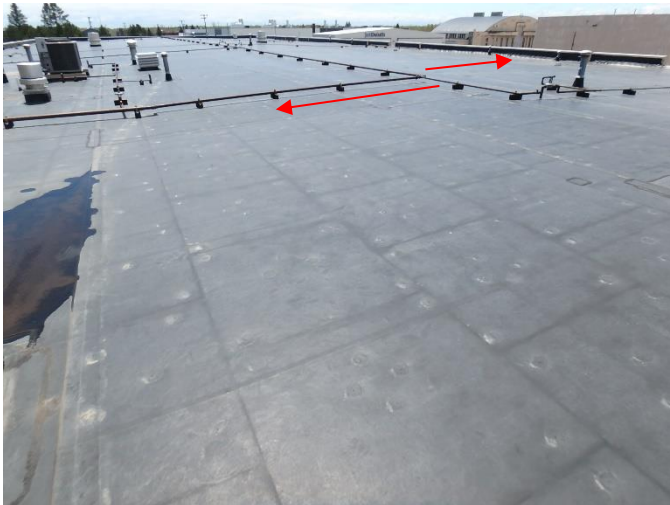
2. General roof photo facing
SW. Roof slope directions
noted.

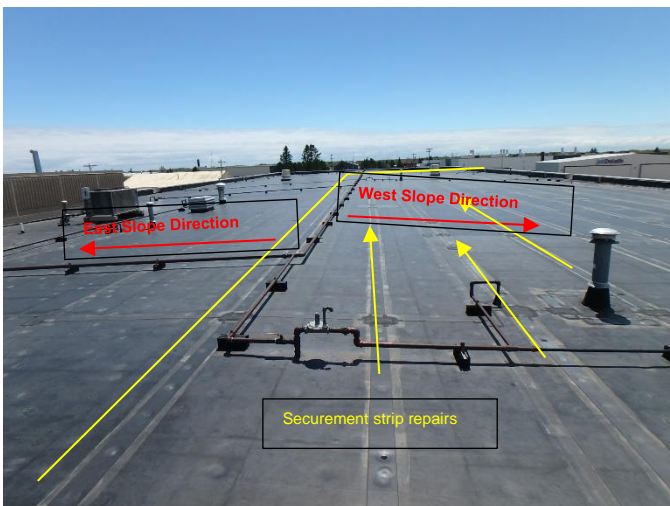
3. Additional general roof photo
facing south. The membrane
was found unadhered to the
wood fiber cover board
throughout the west slope.

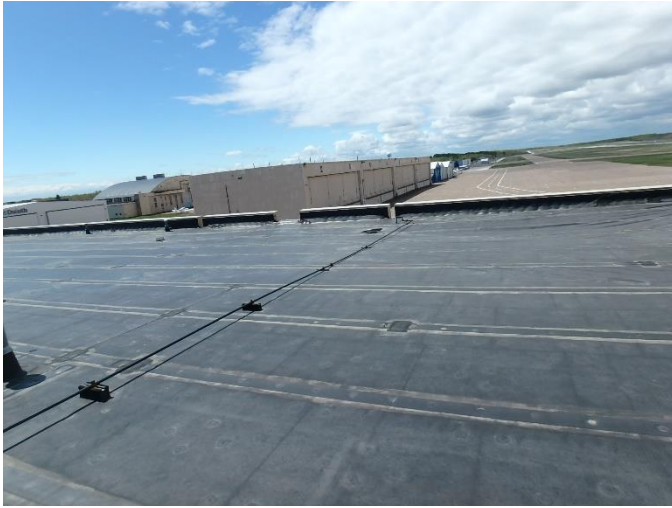
4. Additional photo documenting recent securement strip repairs.

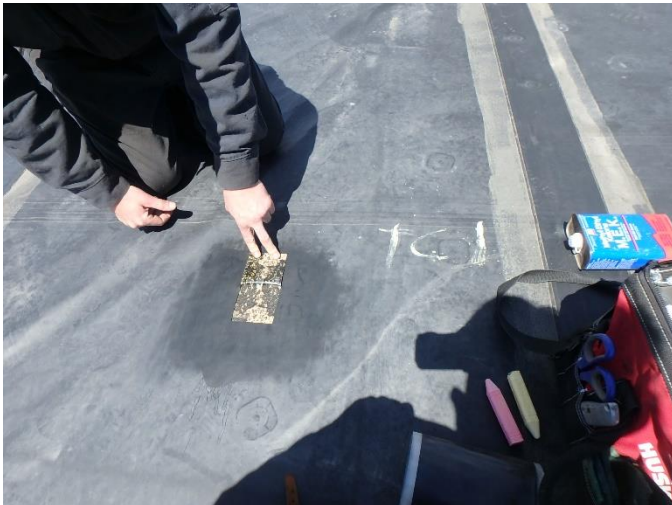
5. A test cut was performed – The membrane was not adhered at this location; no evidence of moisture was identified.

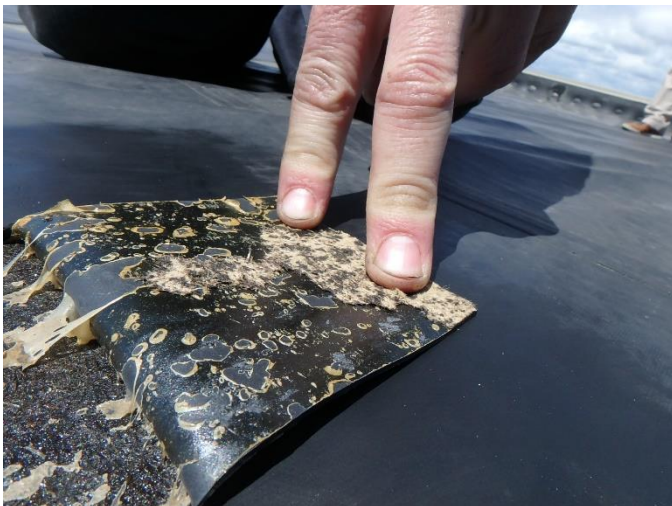
6. Close up of back side of membrane- note approximately 35% of the adhesive appears to have bonded to the wood fiber cover board.

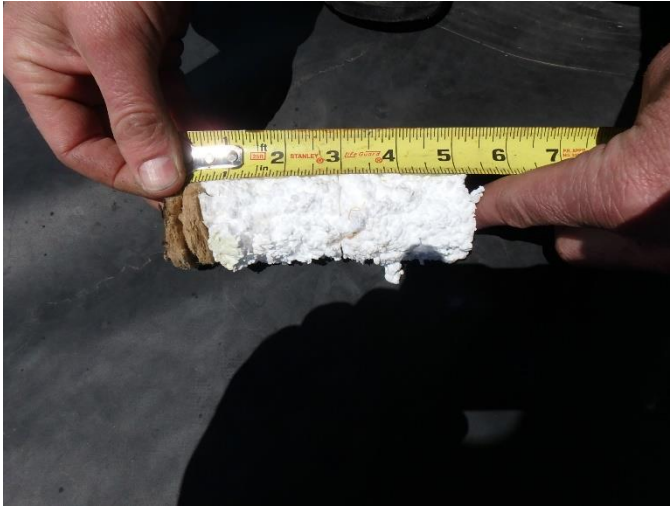
7. A core sample reveals EPS and wood fiber layers – no moisture was identified within the substrates.

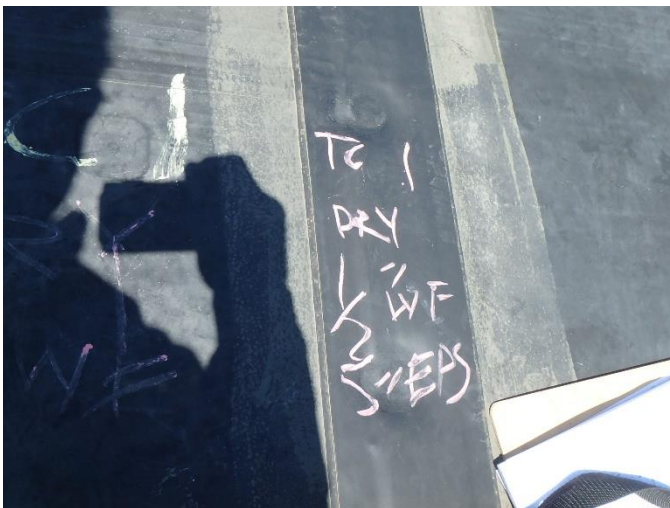
8. Additional photo documenting conditions at test cut 1.

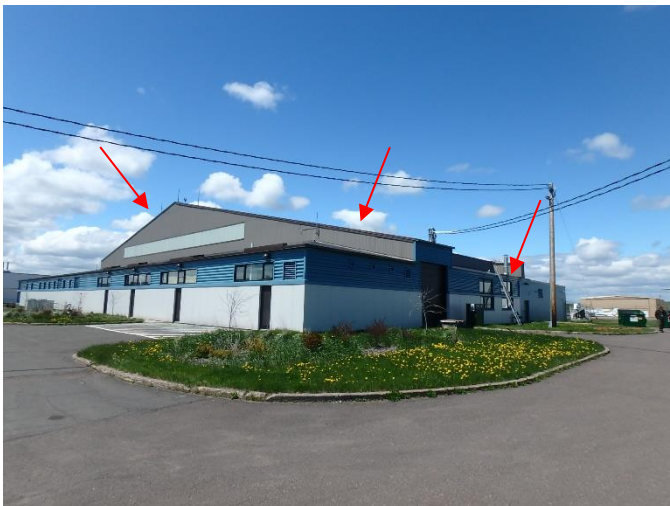
9. General site photo Building 2 4960 Airport Approach Rd. Roof areas included in our investigation noted.

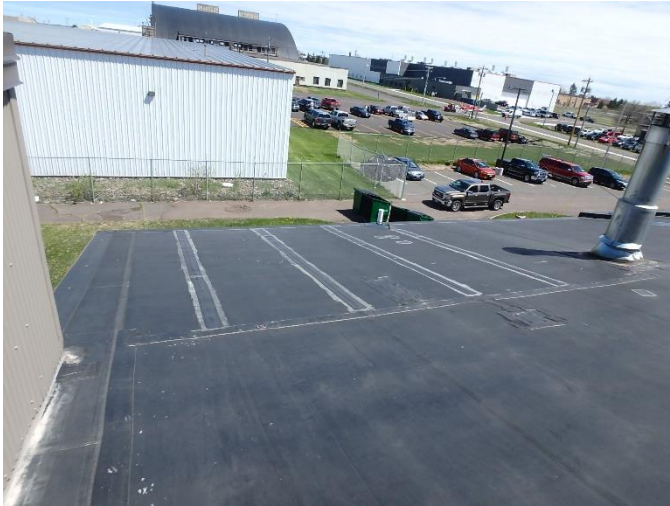
10. Repairs to lower roof slope noted.

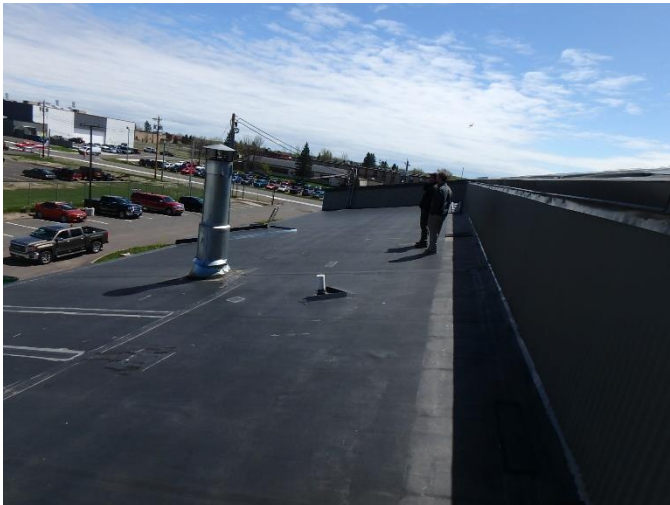
11. Additional photo of lower roof area facing south.

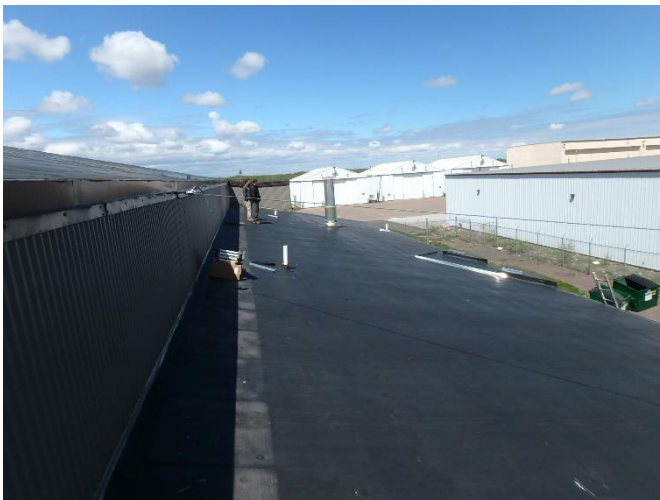
12. Additional photo of lower roof area facing north.

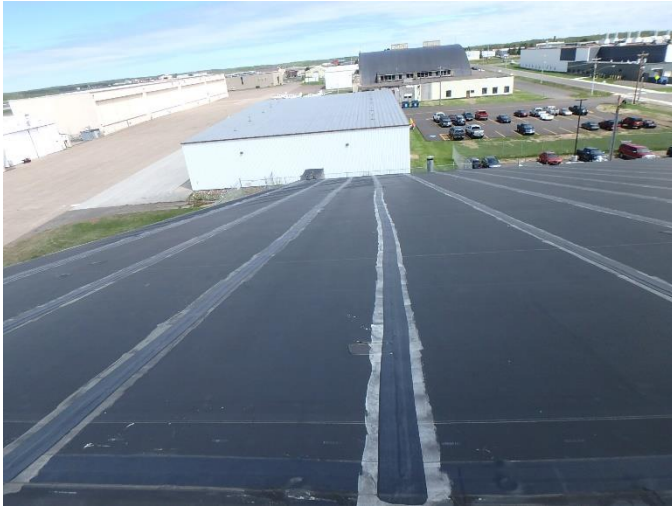
13. East slope. Securement strips have been installed on top of the membrane with flashing tape over the top.

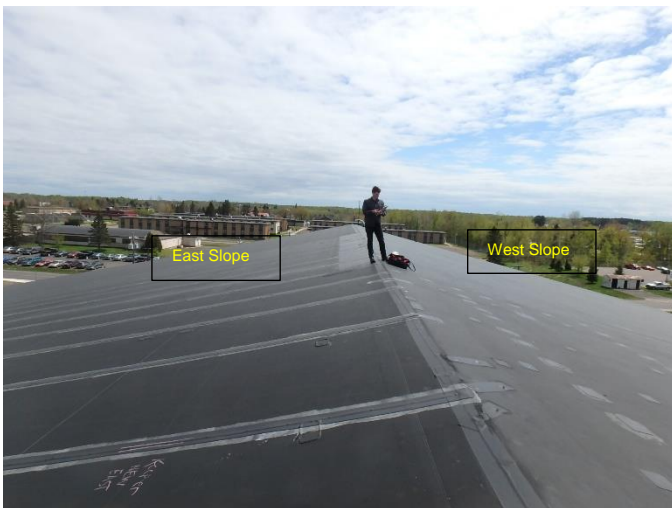
14. Additional photo of roof facing south. Note numerous plates installed on the west slope and batten strips on the east slope.

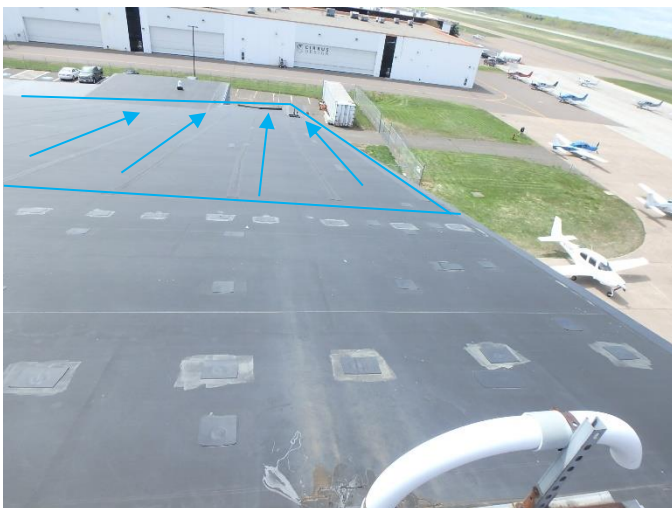
15. West slope – north end. Note new plates installed to keep roof membrane from billowing. Repairs from previous wind events noted in blue area below.

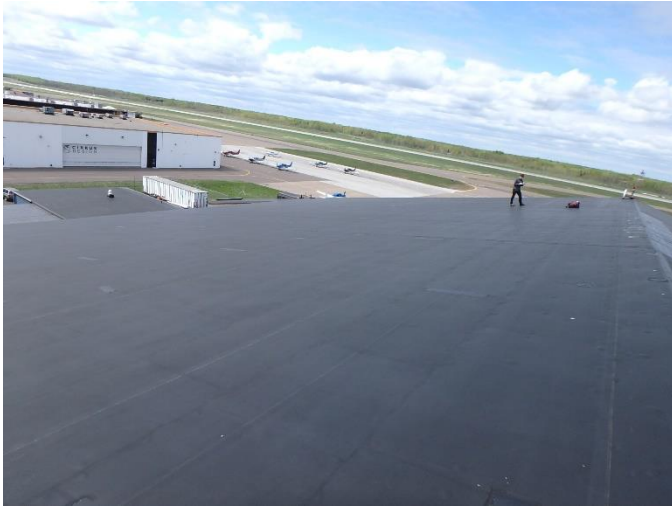
16. Photo documenting east slope south end reveals no evidence of adhesion loss.

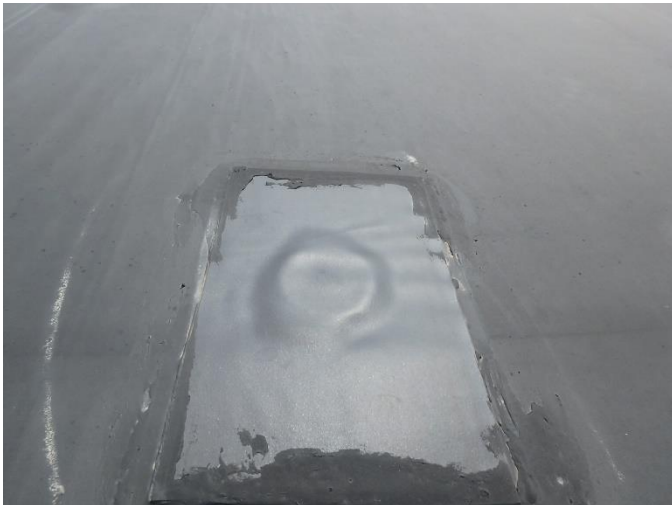
17. Photo documenting typical repair made with plate screwed over the membrane and flashing tape covering.

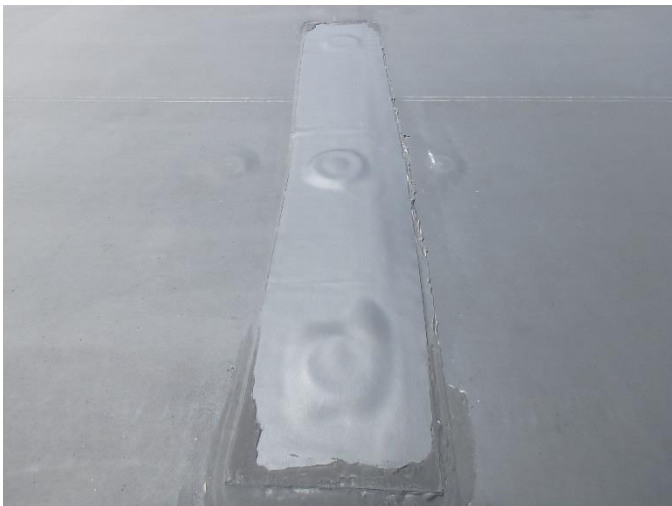
18. Additional photo documenting typical repair made with plates screwed over the membrane and flashing tape covering.

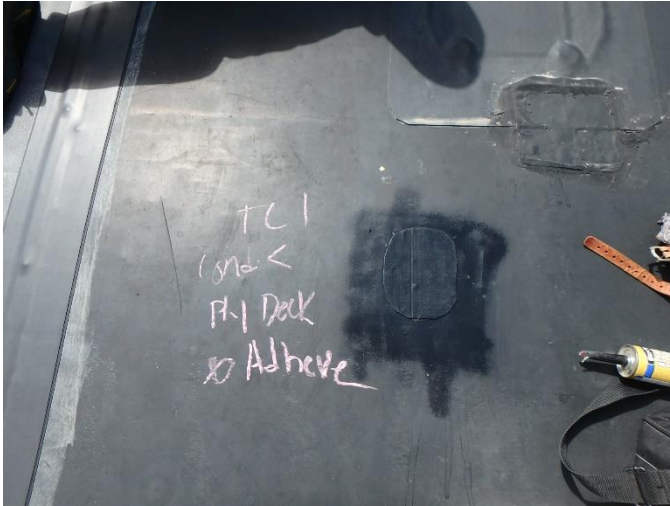
19. Test cut 1 location revealed no adhesion between membrane and plywood substrate. No evidence of moisture intrusion noted.

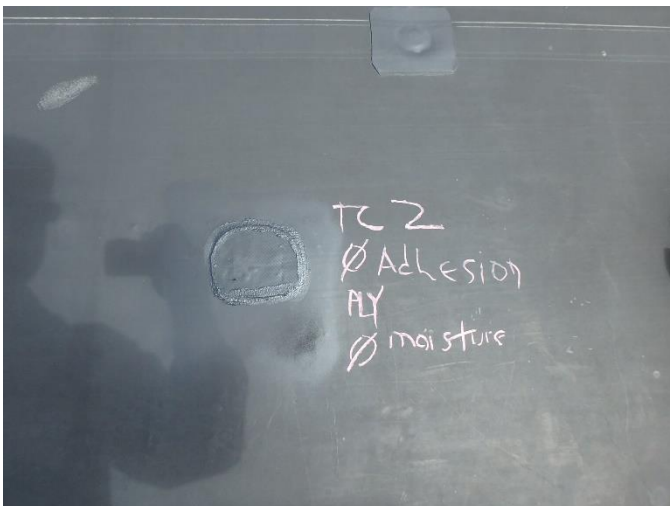
20. Test cut 2 revealed no adhesion between membrane and plywood substrate. No evidence of moisture intrusion noted.

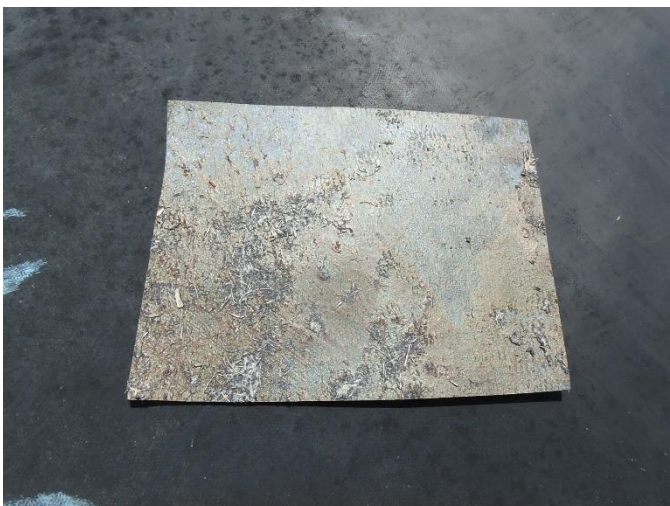
21. Photo documenting back of membrane – little adhesion was ever accomplished between the membrane and plywood. The membrane was completely loose at both test cut locations on Building 2.
