Case No. C-8884  
Condition Survey

June 12, 2018

### **Museum S.S. William A. Irvin**

REPORT OF INSPECTION made by the undersigned surveyor of North American Marine, Inc., on June 6 & 7, 2018, at the request of the, City of Duluth, Duluth, Minnesota, on the Museum Steamship William A. Irvin, 8,240 gross registered tons, 237395 Official Number, 6,072 net tons, the City of Duluth, Duluth, Minnesota, Owners, while lying afloat port side to the dock at the Minnesota Slip, Duluth, Minnesota, in order to ascertain the general condition of the vessel.

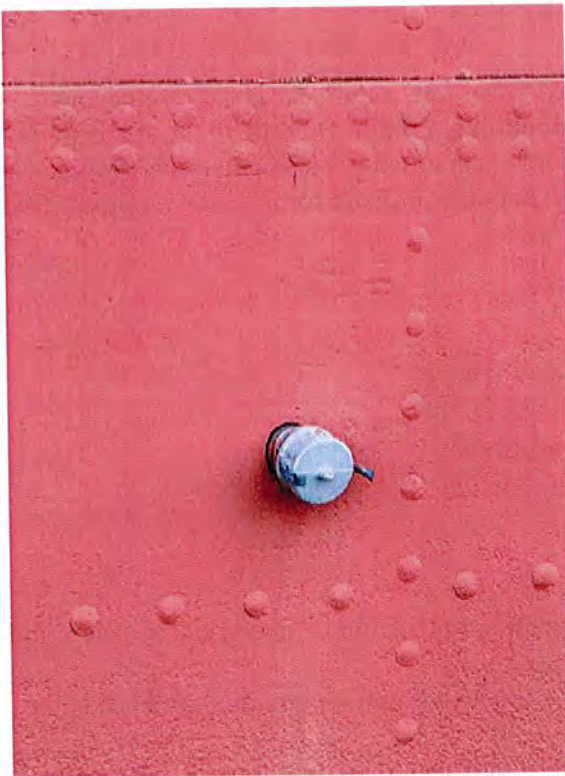
Number 5 Port – Sewage overboard

1. Above lightship water line hull penetrations to be sealed.
2. Ballast tank tween tank bulkheads and cargo slopes to be made watertight and or sealed.
3. Mooring winches to be overhauled and made serviceable.
4. Steel cable mooring lines to be replaced where found parted and establish an annual documented examination schedule.
5. Tailshaft to be drawn out and stern tube to be blanked off.
6. Detailed fire plan to be developed for "Haunted House" cargo hold.
7. Vessel to be dry-docked in order to sandblast hull down to white metal from lightship waterline to lightship water line and painted with marine grade two-part epoxy paint.

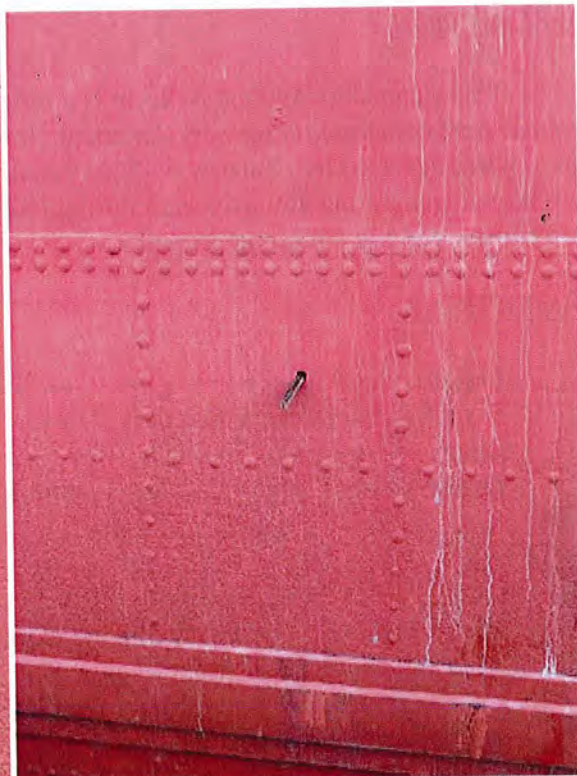
Number 6 Port – Through hull penetration

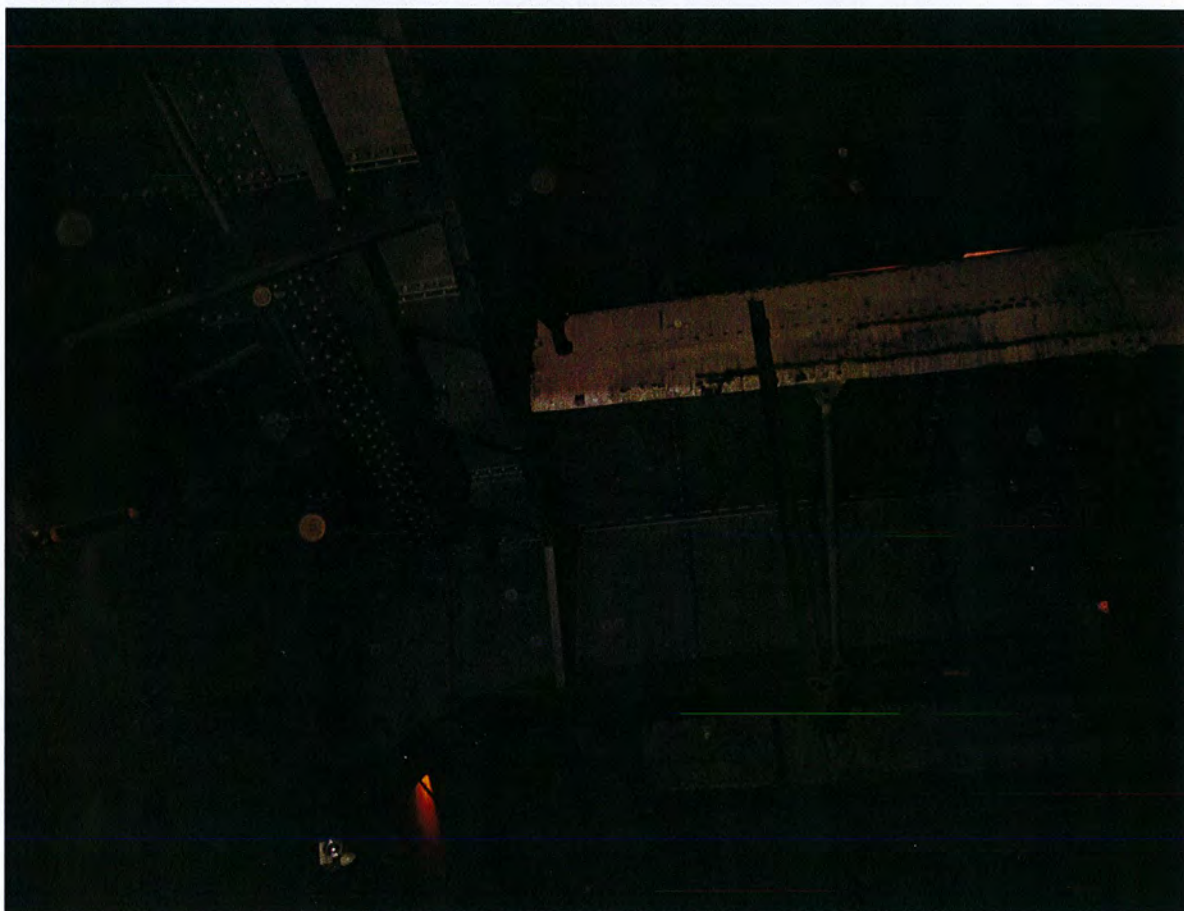
The arches which span the cargohold and support the spar deck were found well coated and in satisfactory condition.

Cargohold arch and underside of spar deck.

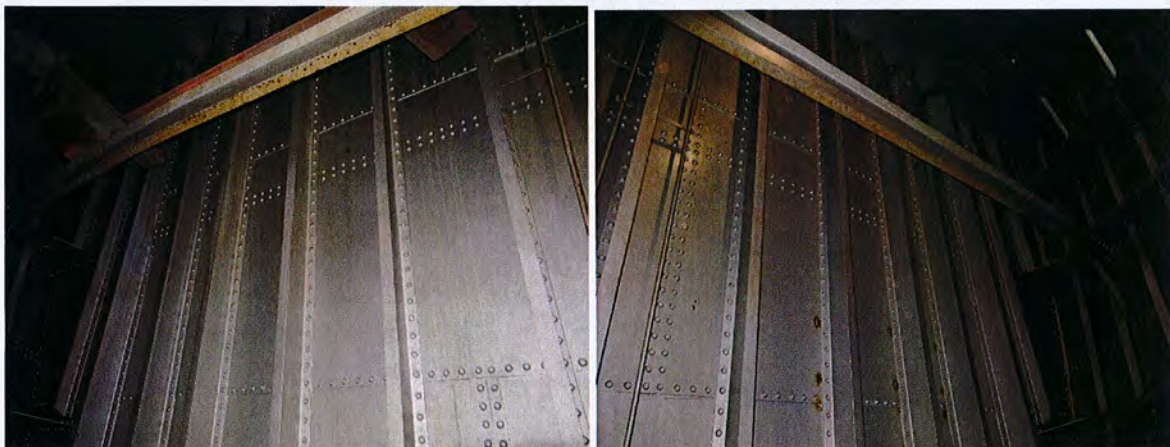
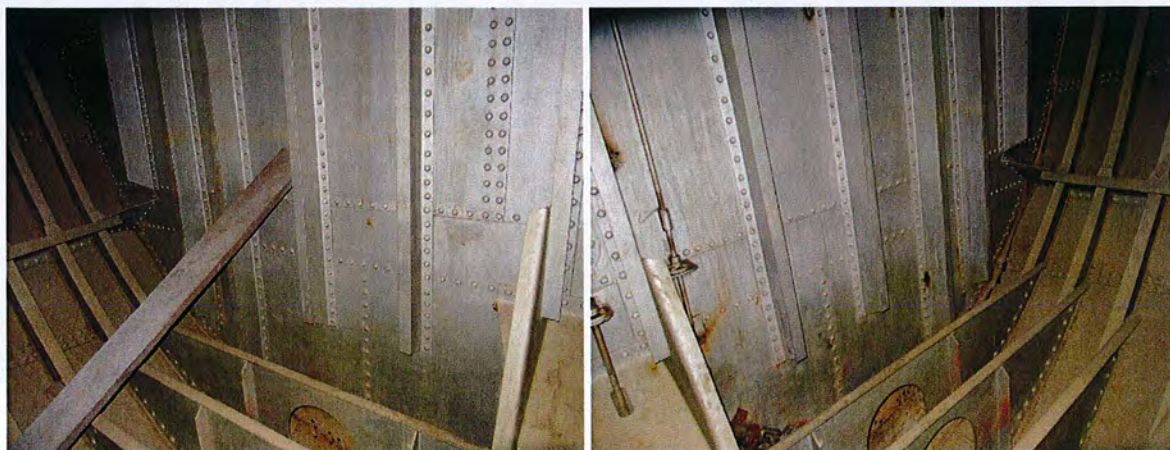
Forepeak stiffened with cant channel shell frames. Shell plate framing found in satisfactory condition. All structure very well coated with the exception of the lower 12" of the collision bulkhead.

Looking aft – Collision Bulkhead

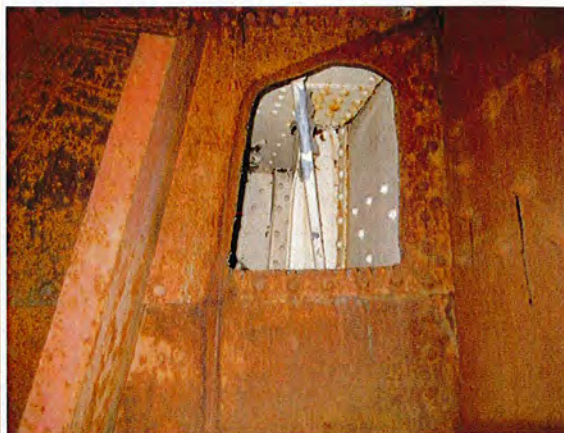
Access was gained from a man hole at the top of the tank from the main deck storm tunnel. Number one starboard ballast tank was found with two web frames and ten intermediate channel frames on 3'0" centers all of which were connected to the shell plate with rivets. Web frames were spaced every 12'00". There was no damage sighted to the frames. There is 8" x 3" x 21.4 lbs. channel stringers extending from the side shell framing to the cargo slope stiffeners. The channel stringers were found in fair condition. The side shell frames were connected to 5'06" high floors. The floors were attached to the bottom shell plating with rivets. The floors have either 22" diameter round or 20" x 30" oblong lightning holes. The lightning holes were found with square edges. Main deck beam flanges found square. Forward bulkhead found in satisfactory condition with the exception of a rough cut 24" x 24" access hole approximately 8" below the main deck. Aft bulkhead found in satisfactory condition with the exception of a rough cut 16" x 16" access hole just below approximately 8" below the main deck. The tank is not considered watertight.

Access hole in forward bulkhead

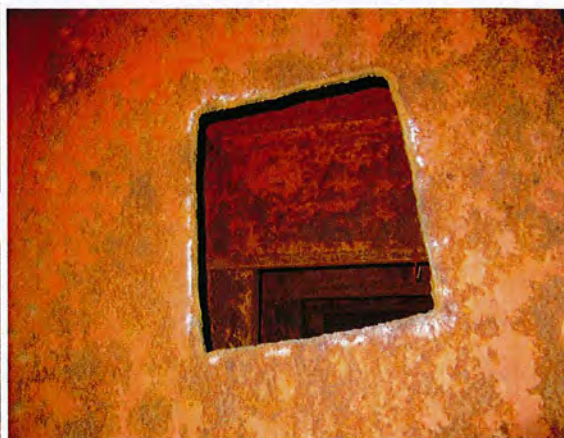
Access hole in aft bulkhead

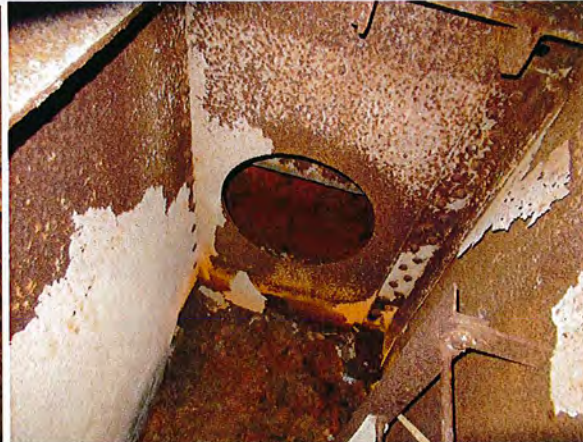
Access was gained from a man hole at the top of the tank from the main deck storm tunnel. Number four starboard ballast tank was found with five web frames and eighteen intermediate channel frames on 3'0" centers all of which were connected to the shell plate with rivets. Web frames were spaced every 12'00". There was no damage sighted to the frames. There is 8" x 3" x 21.4 lbs. channel stringers extending from the side shell framing to the cargo slope stiffeners. The channel stringers were found in fair condition. The side shell frames were connected to 5'06" high floors. The floors were attached to the bottom shell plating with rivets. The floors have either 22" diameter round or 20" x 30" oblong lightning holes. The lightning holes were found with square edges. Main deck beam flanges found lightly square. Forward bulkhead found in satisfactory condition with the exception of a rough cut 24" x 24" access hole just below approximately 8" below the main deck. Aft bulkhead found in satisfactory condition with the exception of a rough cut 10" x 10" access hole just below approximately 8" below the main deck. It should be noted that the main deck storm tunnel has been converted to men/women's restrooms for the gift shop that is located at midship. That being said there is water supply and sewage piping penetrating the main deck and flowing aft into number 5 ballast tank. There was 0-1" of accumulated water in the aft end of number four ballast tank. It is unknown whether the water is from the restroom plumbing or a shell plate leak. Tank considered non-water tight.

Lightning hole and water accumulation

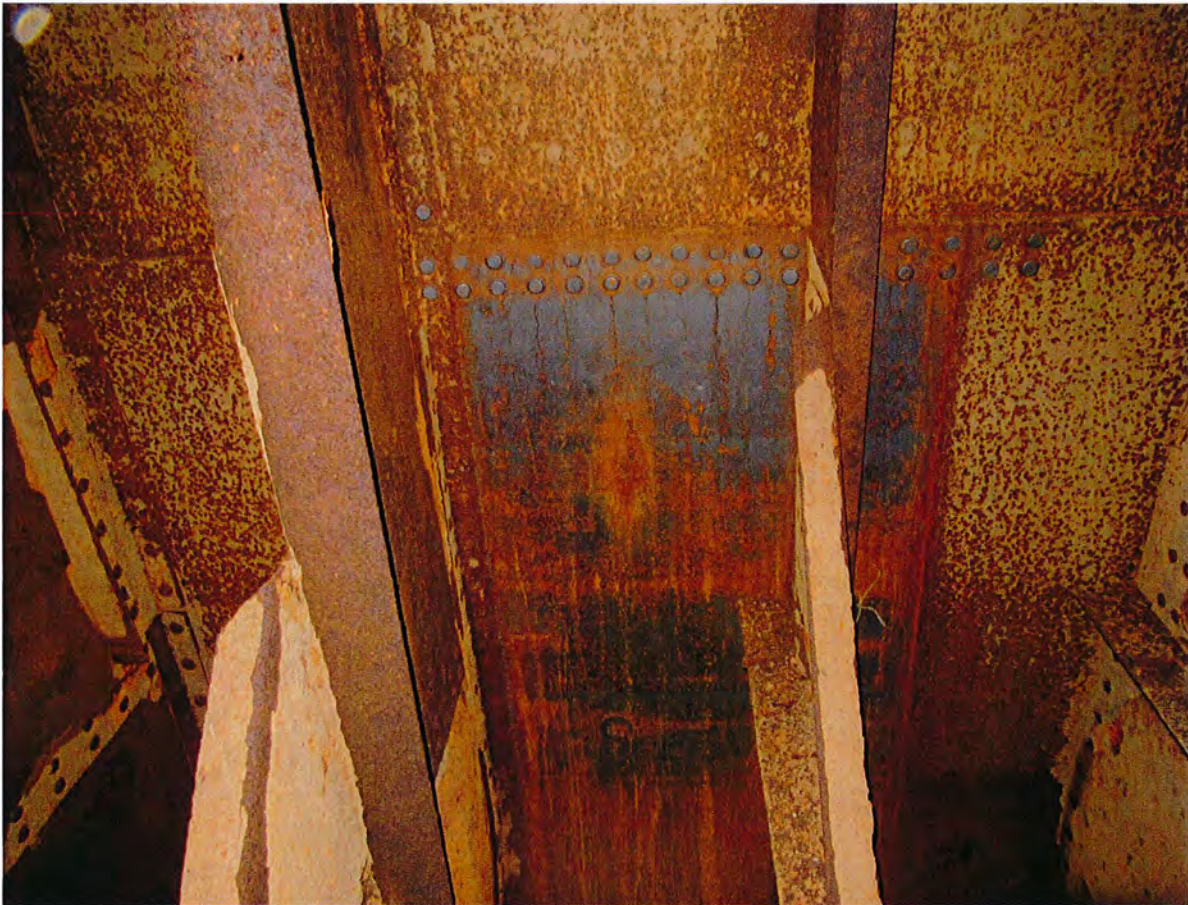
Commencing at frame 143 (ninth frame from forward) continuing aft through the bulkhead there is a bilge repair. This repair appears to have been made just prior to the end of the sailing career of the vessel. The repair is partially welded repair.

Please note that the steel is still mill blue, which is indicative of very little deterioration since the vessel has been out of service.

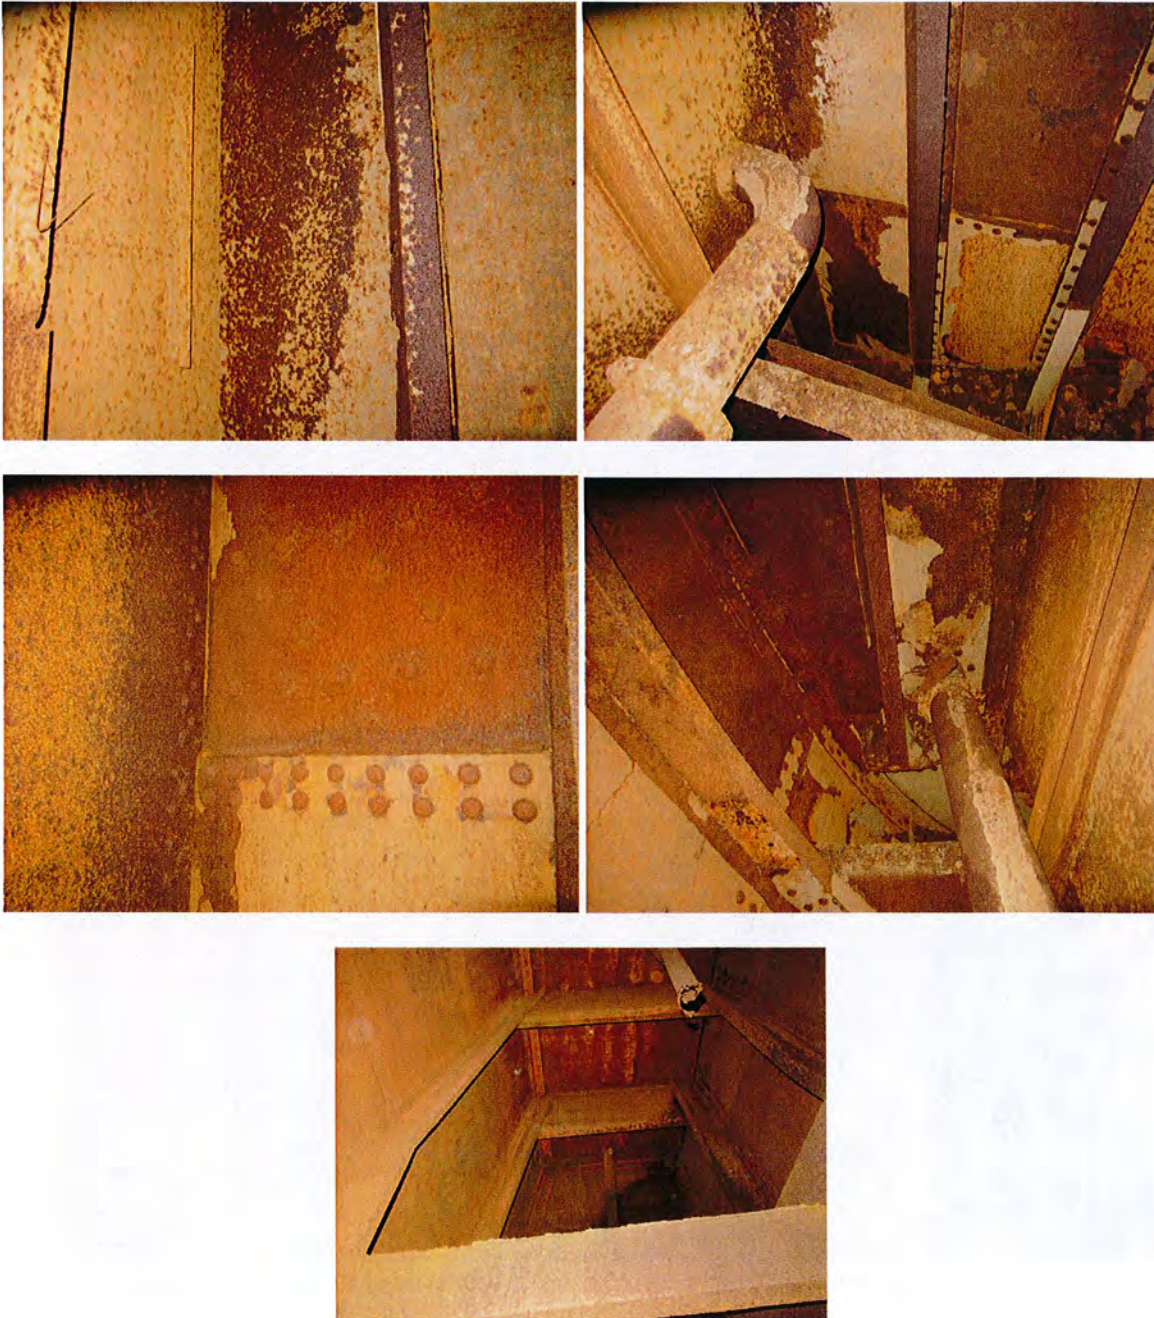
Access was gained from a man hole at the top of the tank from the main deck in the boiler room compartment. Number eight starboard ballast tank was found with six intermediate channel frames on 3'0" centers all of which were connected to the shell plate with rivets. Web frames were spaced every 12'00". There was no damage sighted to the frames. The intermediate channel frames were connected to floors. The floors are attached to the bottom shell plating with rivets. The floors have either 22" diameter round or 20" x 30" oblong lightning holes. The lightning holes were found with tapered edges. Main deck beam flanges found square. Forward bulkhead found in heavily pitted. Aft bulkhead found in fair condition. Sounding pipes completely deteriorated.

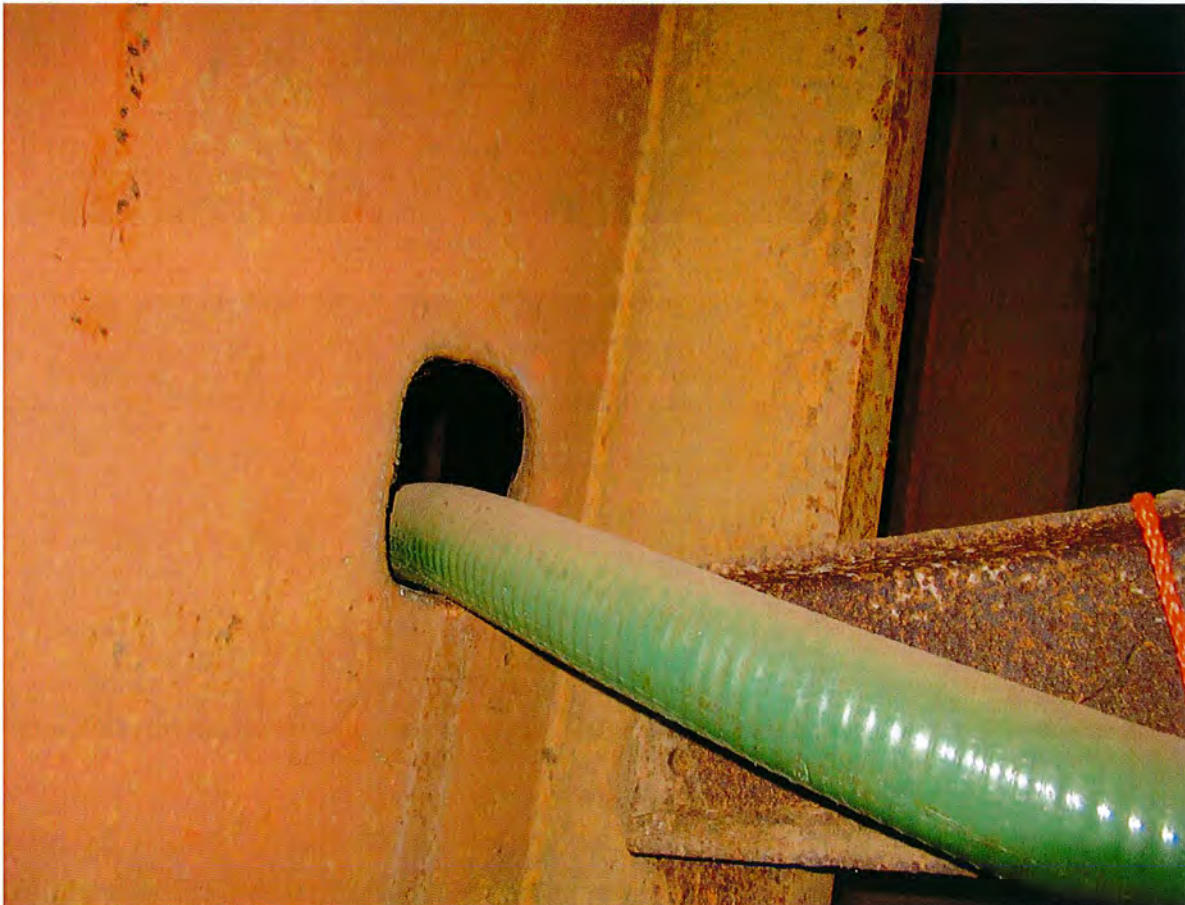
One 8" x 4" access hole cut into the cargo slope plating for pass through of flexible 3" green sewage line. That same line traveled through a another hole 4" in diameter cut into the "H" strake between frames 127 and 128. The sewage line shell plate hole is at approximately 13'00" waterline. A second cargo hold access hole had been cut into the slope plating 7" x 7" for a wiring pass through. The wiring cables penetrated the side shell plating through a piping nipple, 2" in diameter at frame 111. Tank considered non-water tight.

Cargo hold access hole

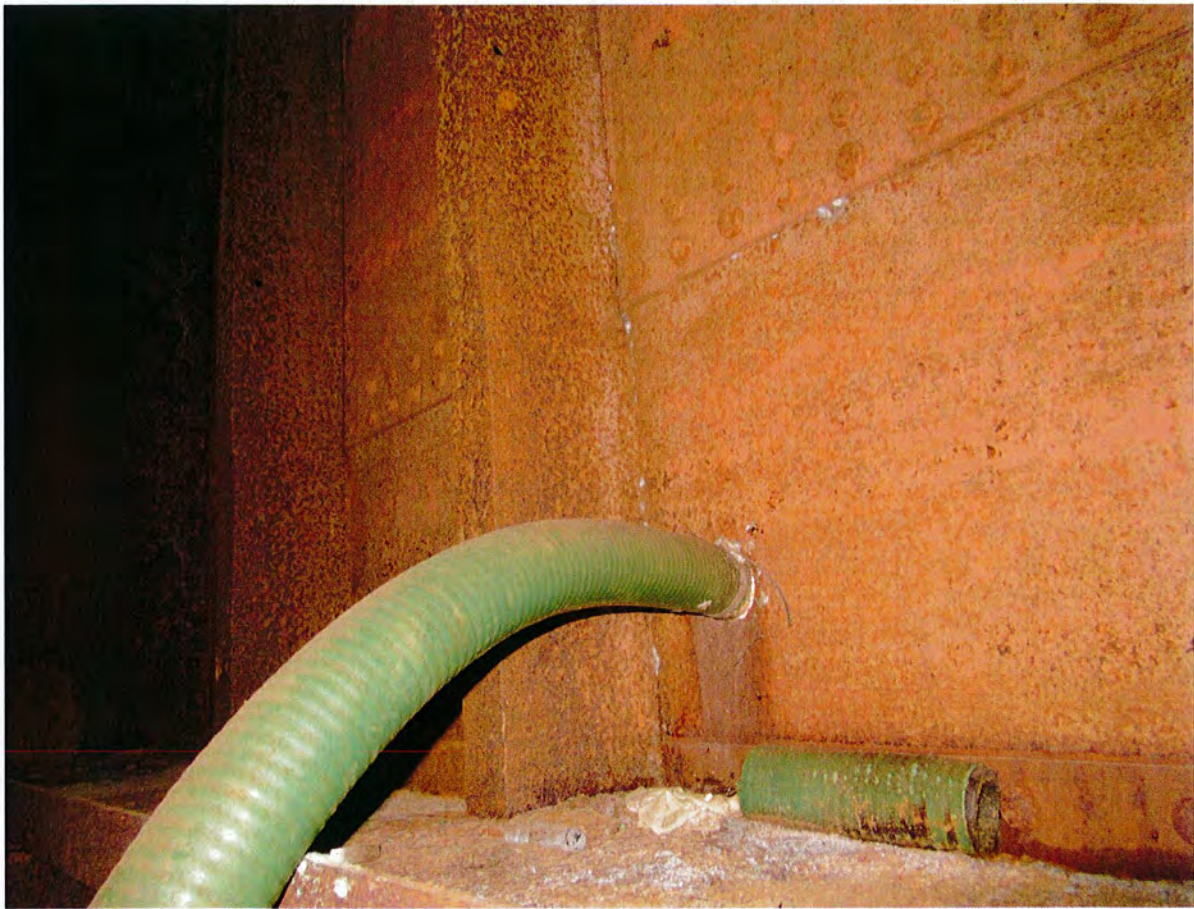
Shell plate access hole

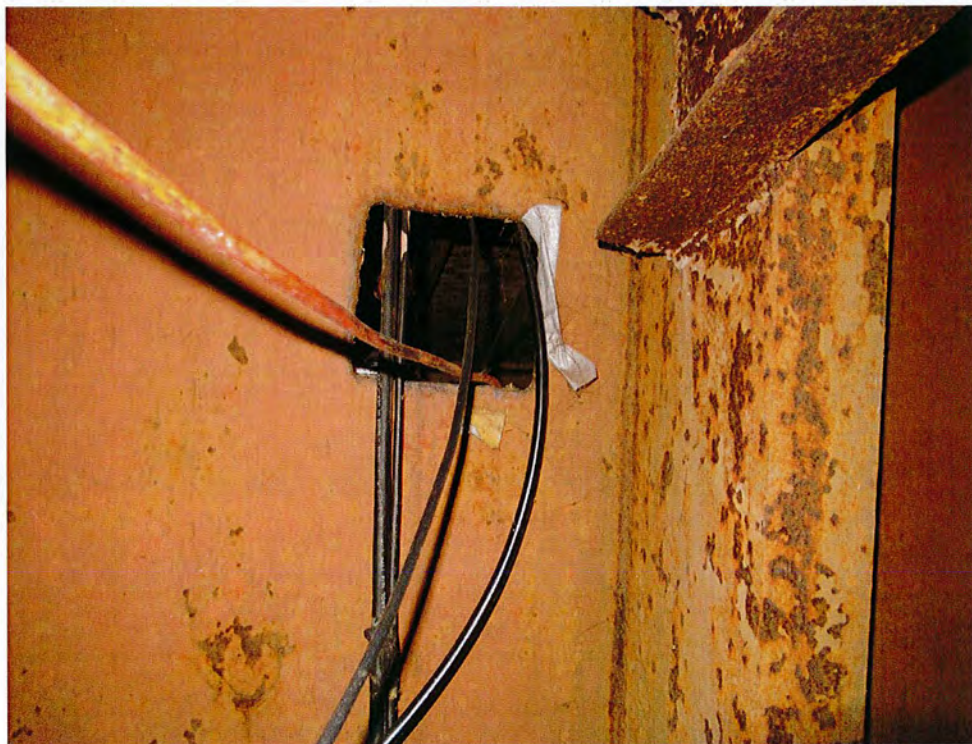
Cargo hold access hole

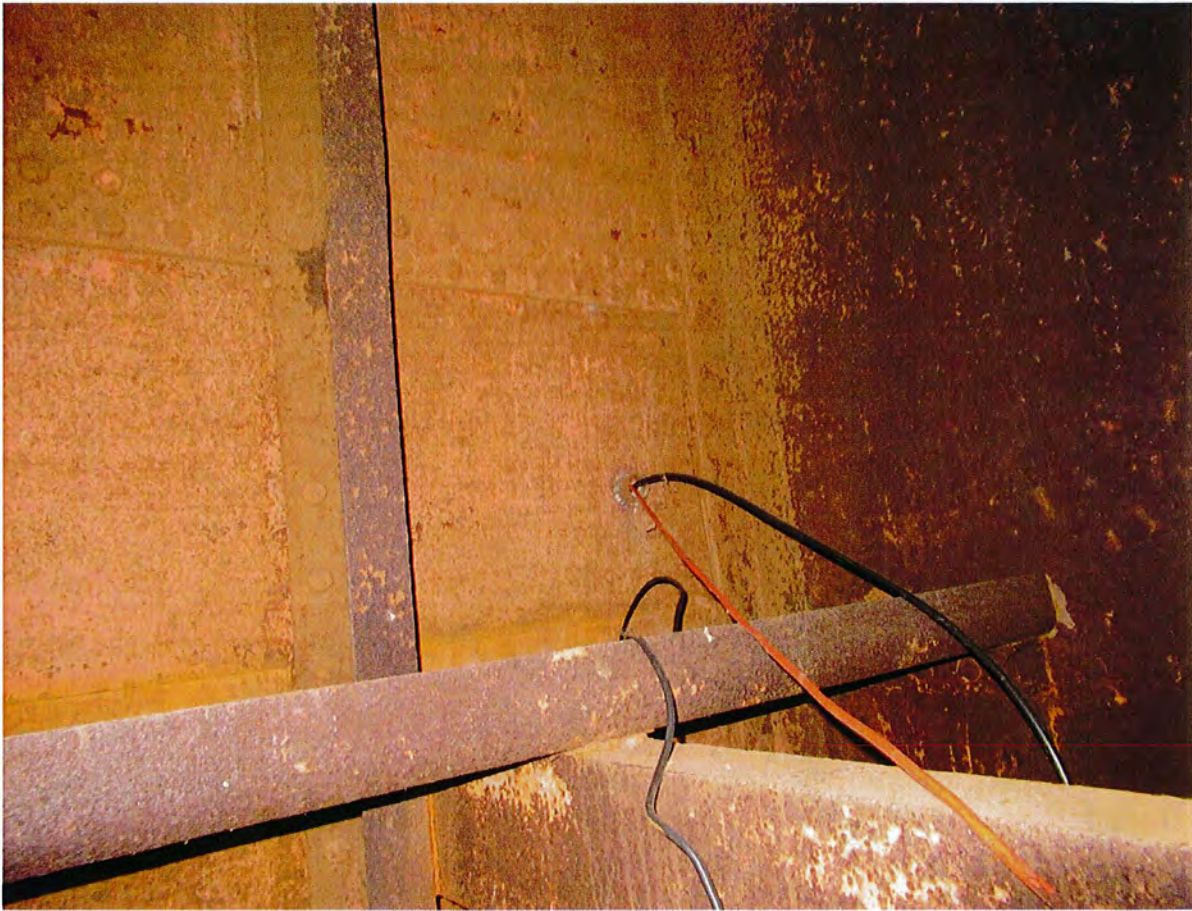
Wiring side shell penetration.

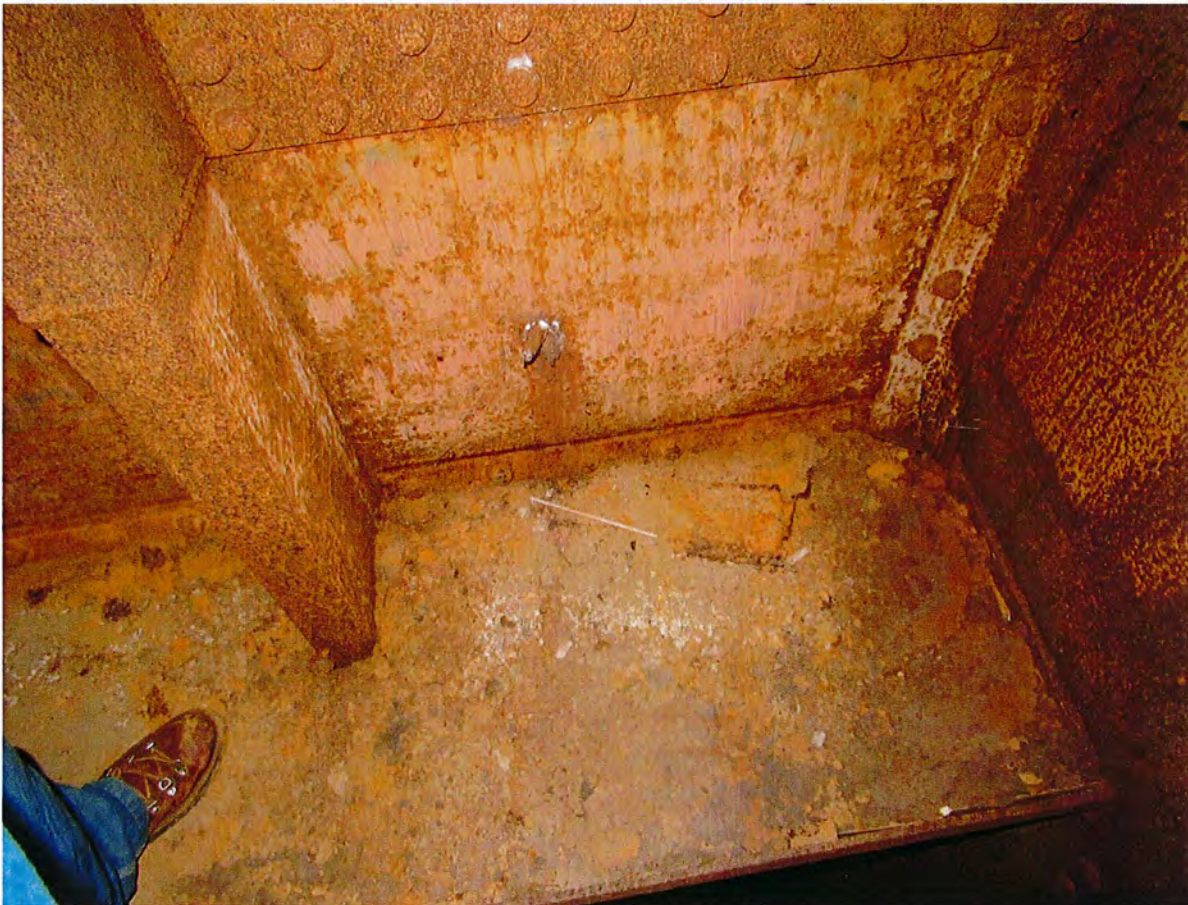
Access was gained from a man hole at the top of the tank from the main deck storm tunnel. Number six port ballast tank was found with five web frames and eighteen intermediate channel frames on 3'0" centers all of which were connected to the shell plate with rivets. Web frames were spaced every 12'00". There was no damage sighted to the frames. There is 8" x 3" x 21.4 lbs. channel stringers extending from the side shell framing to the cargo slope stiffeners. The channel stringers were found in fair condition. The side shell frames were connected to 5'06" high floors. The floors were attached to the bottom shell plating with rivets. The floors have either 22" diameter round or 20" x 30" oblong lightning holes. The lightning holes were found with square edges. Main deck beam flanges found square. Forward bulkhead found in satisfactory condition. Aft bulkhead found in satisfactory condition. Tank considered non-water tight.

Hole burned in side shell

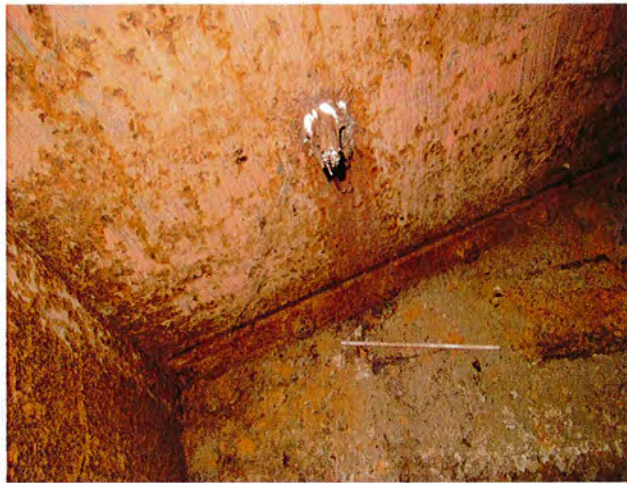
Hole cut through side shell with stick as plug

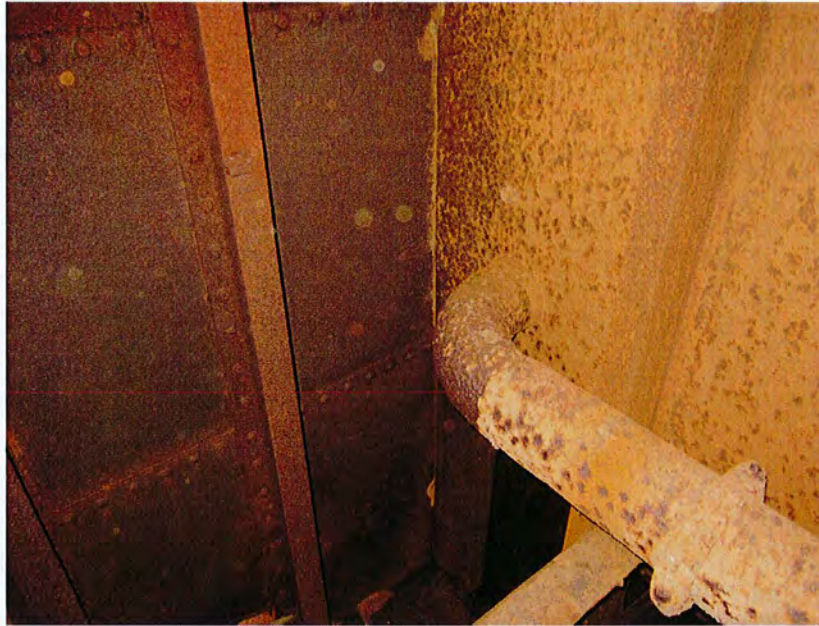
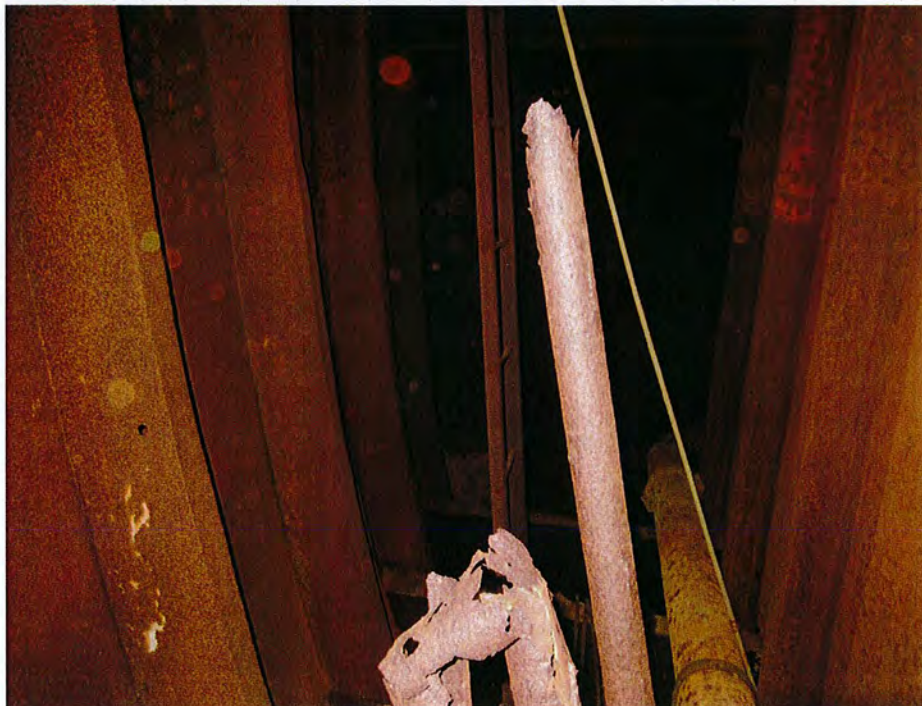
Access was gained from a man hole at the top of the tank from the main deck in the boiler room compartment. Number eight port ballast tank was found with six intermediate channel frames on 3'0" centers all of which were connected to the shell plate with rivets. Web frames were spaced every 12'00". There was no damage sighted to the frames. The intermediate channel frames were connected to floors. The floors are attached to the bottom shell plating with rivets. The floors have either 22" diameter round or 20" x 30" oblong lightning holes. The lightning holes were found with tapered edges. Main deck beam flanges found square. Forward bulkhead found in heavily pitted. Aft bulkhead found in fair condition. Completely deteriorated sounding pipes.

Completely deteriorated sounding pipes

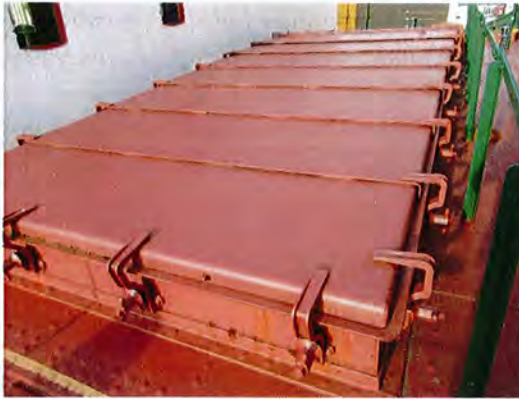
Hatch covers 1 & 2 constructed in leaf style. Remaining hatches constructed with riveted steel plate with I-beam strongbacks. Hatch covers in fair condition.

Leaf hatch covers

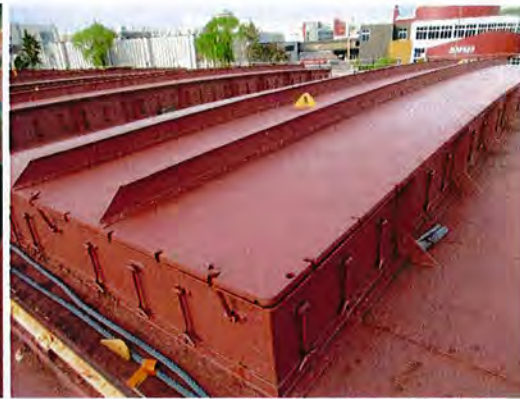
Plate hatch covers with dogs
