Addendum 1

Project: Dead Ship Two – Temporary Relocation of the William A. Irvin

Re: SS William A Irvin Underwater Hull Inspection

AMI Project # 171295

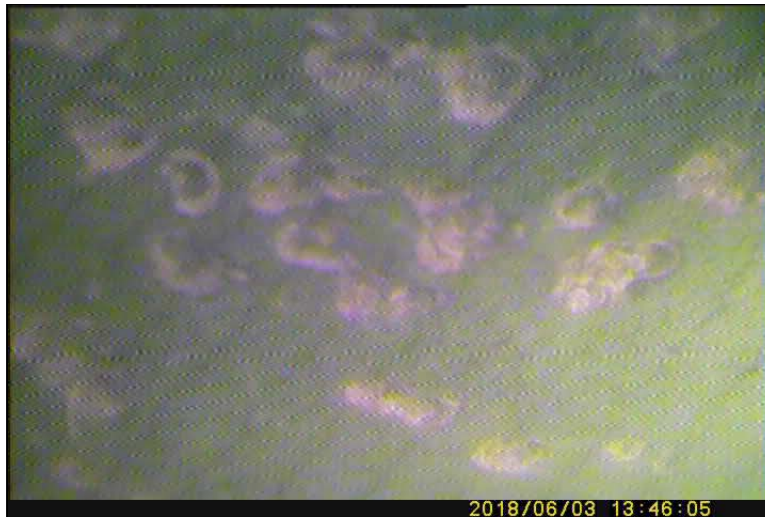
Below the rust tubercles, steel corrosion of the hull was documented in the form of overlapping pits. The highest concentration of pitting was documented from the waterline to 4'-0" below the waterline with a coverage of 70% to 80%. The concentration of the pits dropped off below 4'-0" and no pits were documented below the 8'-0" as described with the rust tubercles above.

The penetration of the pits documented between the waterline and 4'-0" below the waterline ranged from approximately 3/16" to 9/32". The size or diameter of the pits also ranged from 5/16" to 1" along the

same water depth range. The corrosion transitioned to a light etching below 4'-0" and no corrosion was documented below 8'-0". The average pit penetration of all the corrosion assessments was approximately 0.222". A typical condition of the corrosion on the hull can be seen in Picture 1.

Picture 1: Typical Condition of the Corrosion

The highest concentration of the corrosion was documented between the waterline and 4'-0" below the waterline with an average pit depth of 0.222". Based on the historical construction drawings of the Irvin, the hull plating near the waterline was constructed of $\frac{3}{4}$ " or $\frac{5}{8}$ " thick steel plates. However, at the overlaps or seams in the hull, the hull plating tapers down to approximately $\frac{1}{2}$ ". The sea chests were also sealed up with approximately $\frac{3}{8}$ " thick steel plate. The effects of the corrosion and the different estimated times to perforations in steel plating are summarized in Table 1 for the different steel thicknesses below the waterline.

After reviewing all of the data and assessing the existing site conditions, AMI Consulting Engineers, makes the following recommendations. Due to the condition of the hull and AMI's knowledge of the Duluth-Superior Harbor, AMI recommends that the hull of the vessel be coated with a corrosion resistant epoxy coating. AMI based its recommendation of the following items:
