Appendix B
Property Inspection Photographs
700-1000 West Railroad Street Property
Duluth, MN
March 5 and 9, 2010

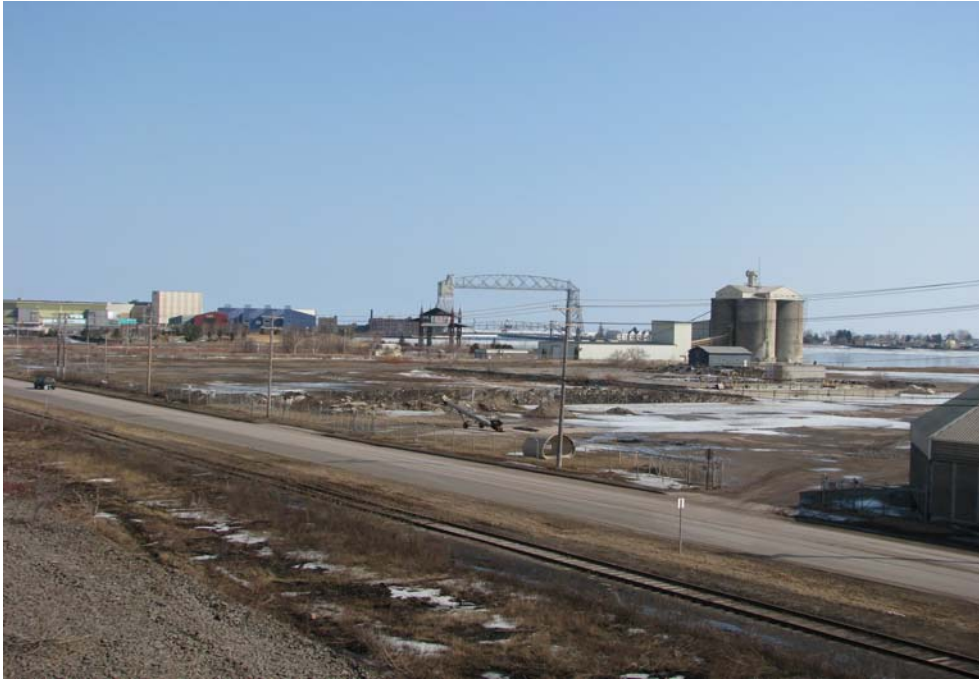
Photo 1 View eastward overlooking Property from pedestrian bridge. Railroad Street in foreground.

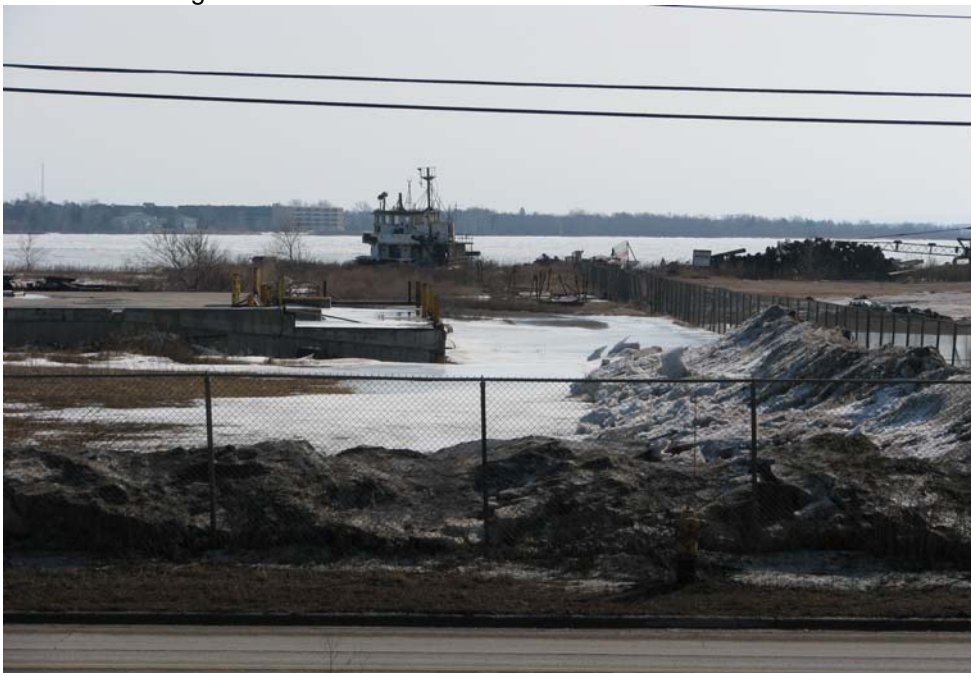
Photo 2 View southeastward along southern side of Property (Lot D). Snow stockpiles in foreground. Duluth harbor of St. Louis Bay in background.

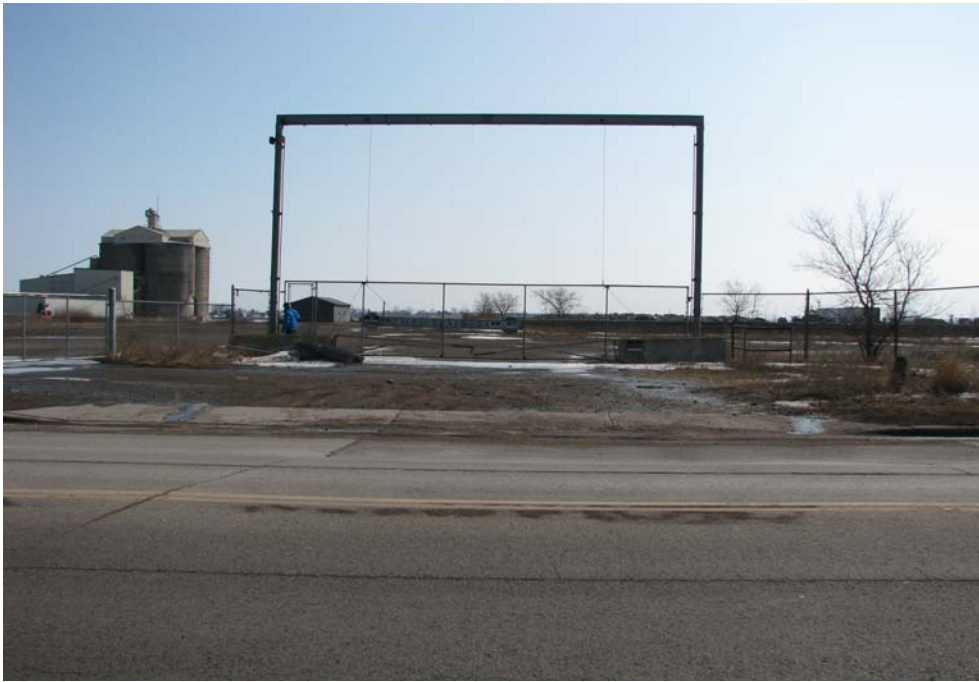
Photo 3 Property (Lot D) entry gate and perimeter fence on Railroad Street.

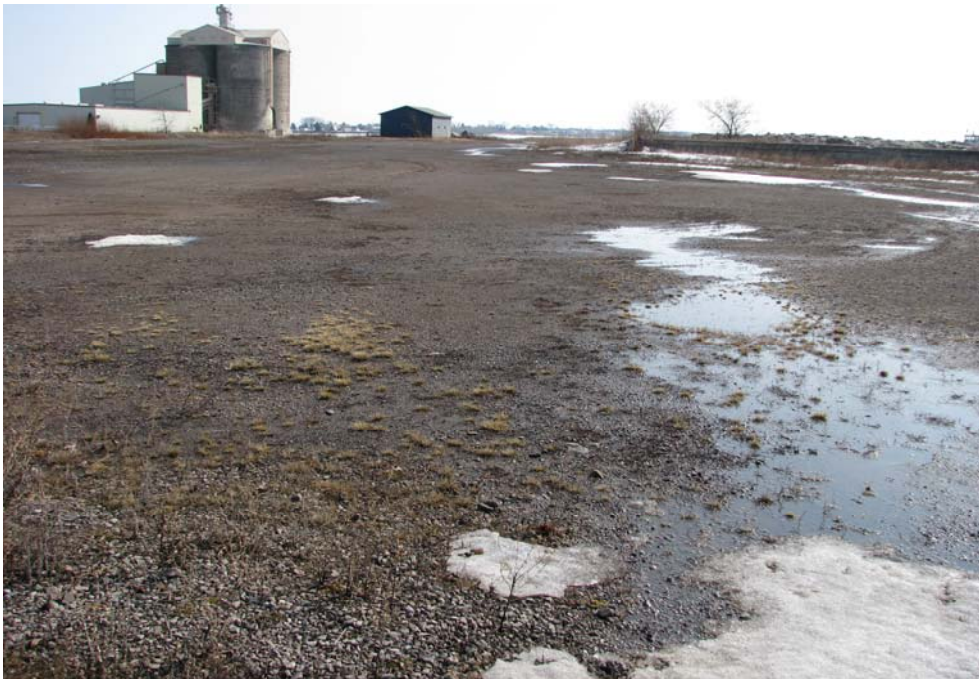
Photo 4 Central gravel-covered portion of Lot D area of Property. Small garage building in background. Adjoining former LaFarge property cement silos in left background.

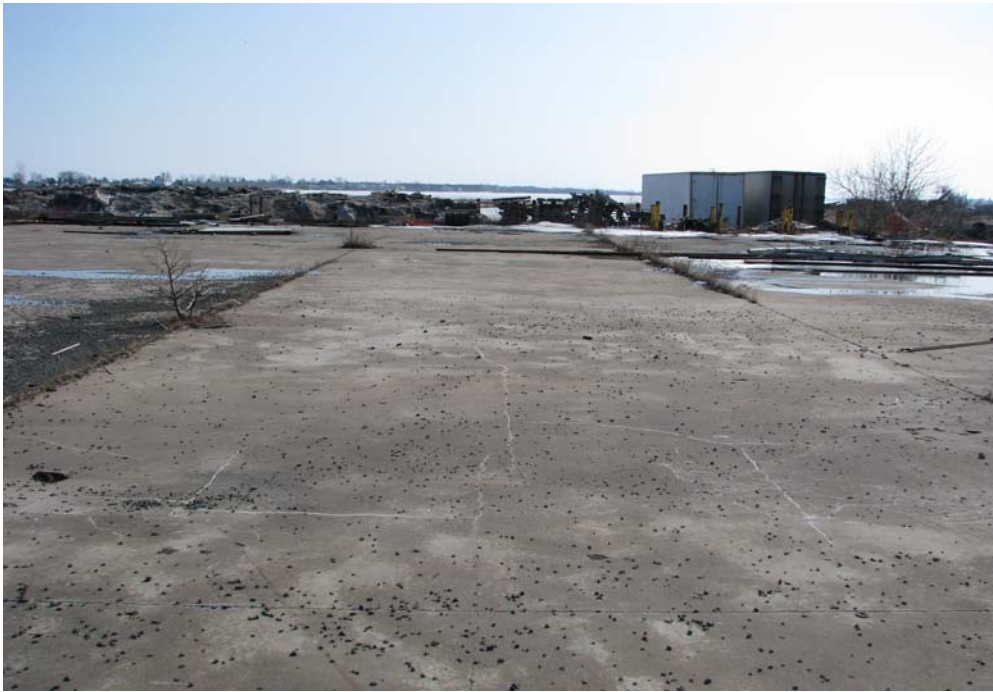
Photo 5 Former refrigerated warehouse building slab on south-central Lot D area. Semi trailers in background.

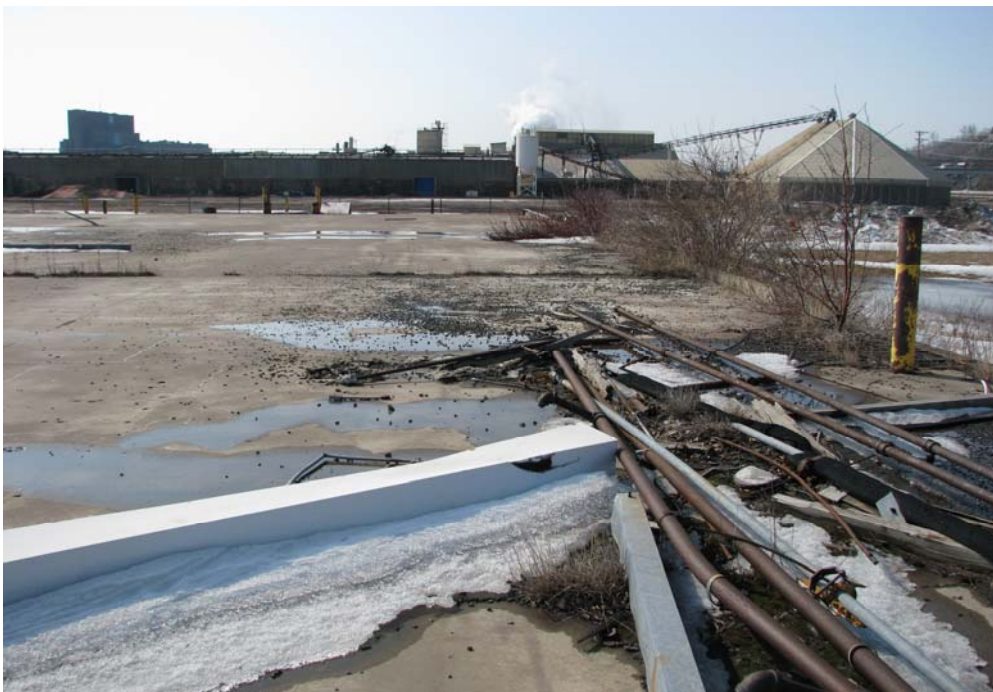
Photo 6 View southward of former refrigerated warehouse building slab with minor pipe and sheet metal scrap material on slab.

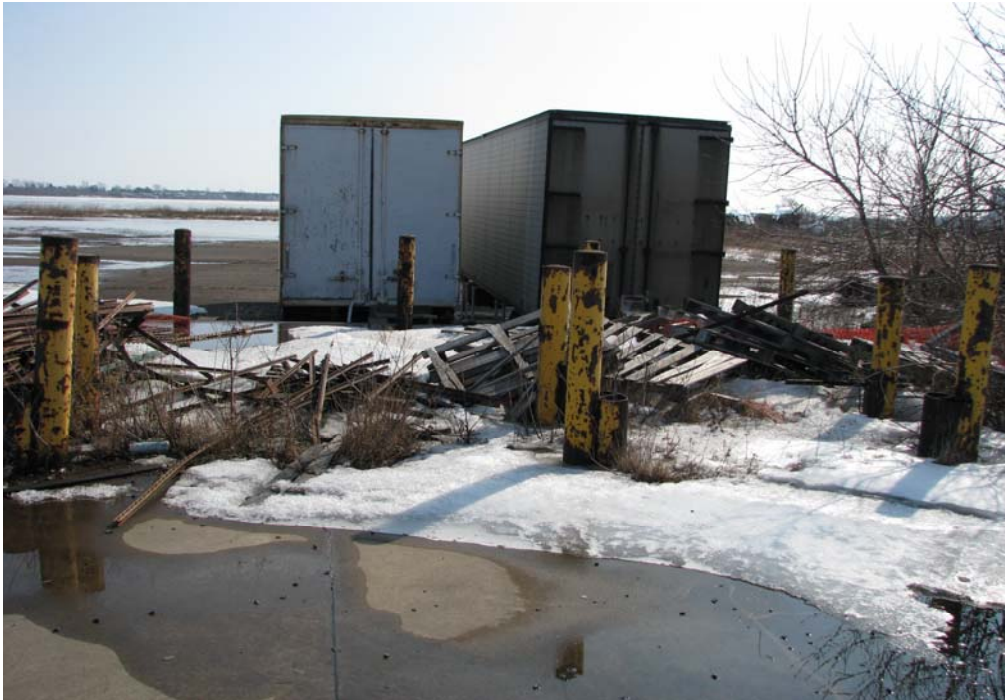
Photo 7 Eastern side of former refrigerated warehouse building slab- apparent former loading dock area with two semi trailers and minor piles of wooden pallets.

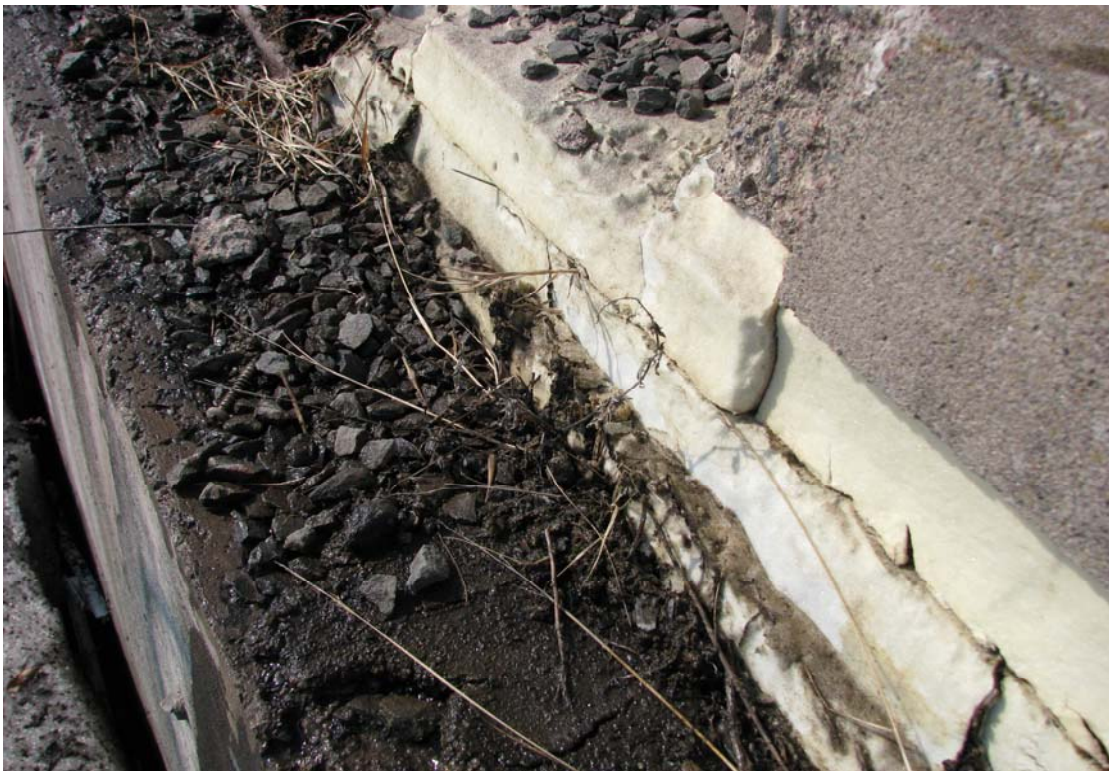
Photo 8 Close-up of foam insulation between former floor slab and foundation slab of former refrigerated warehouse building.

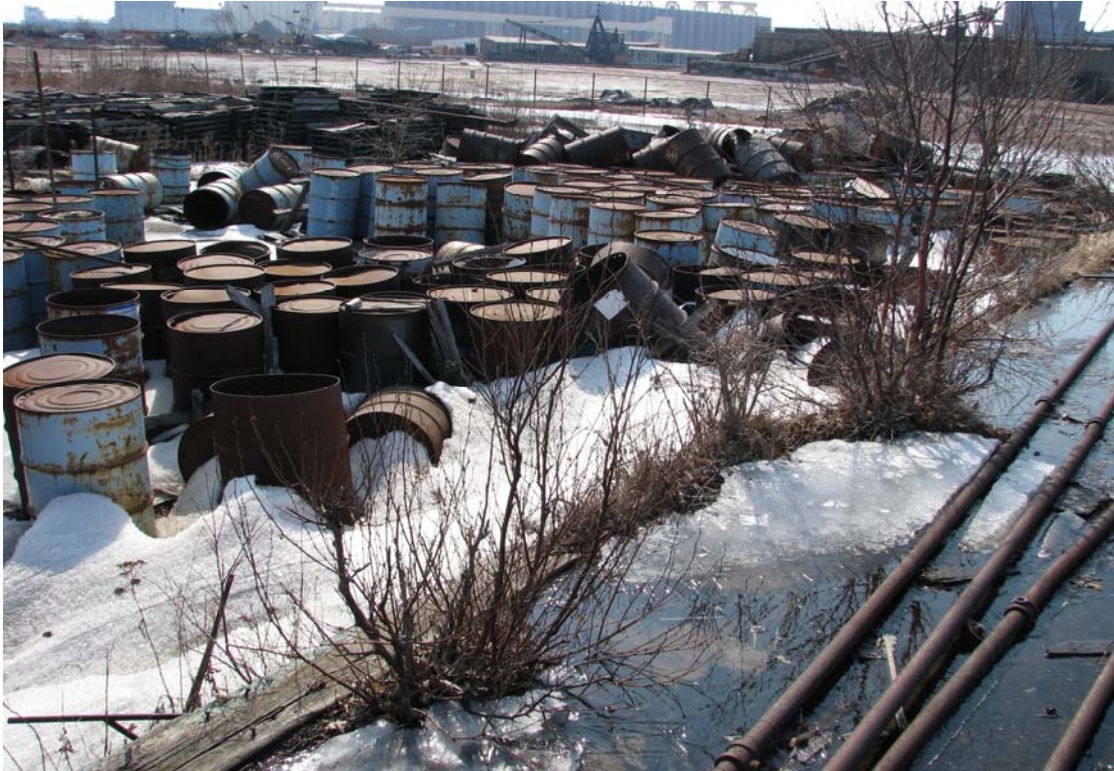
Photo 9 Stored - apparently empty- metal 55-gallon drums on southeastern side of former warehouse building slab (apparent former loading dock area).

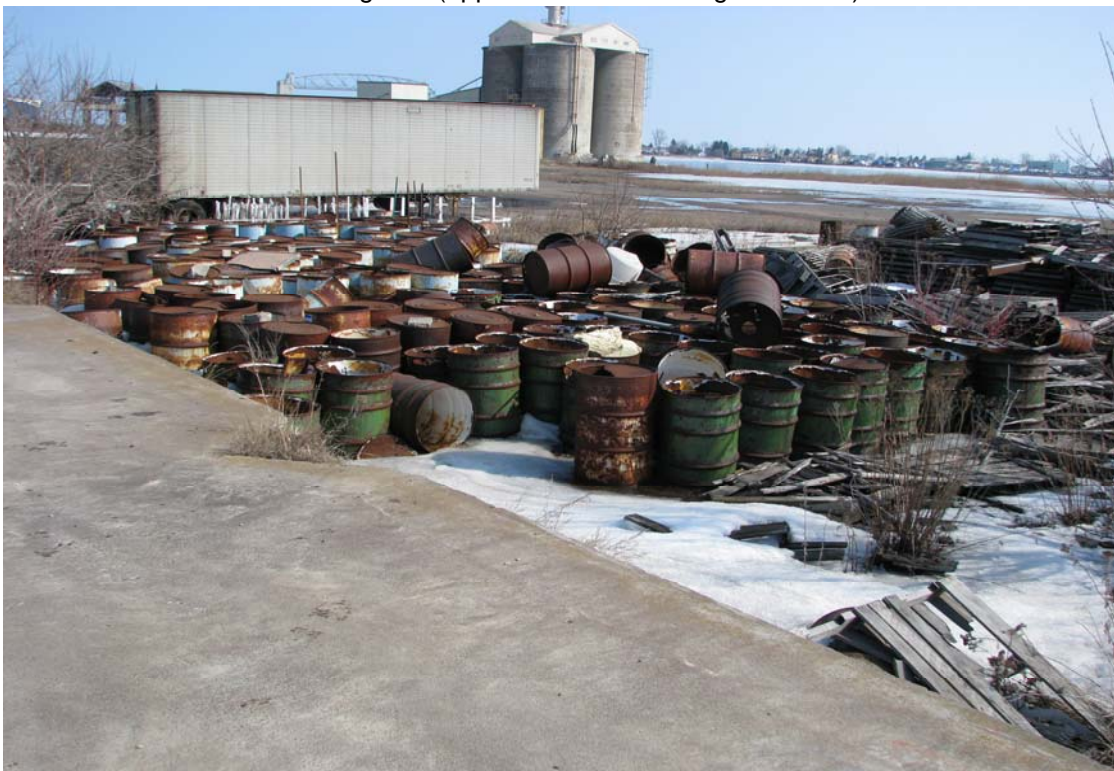
Photo 10 View eastward of stored drums. Some contain wood or metal. Majority are empty. Most drums are stored open side down.

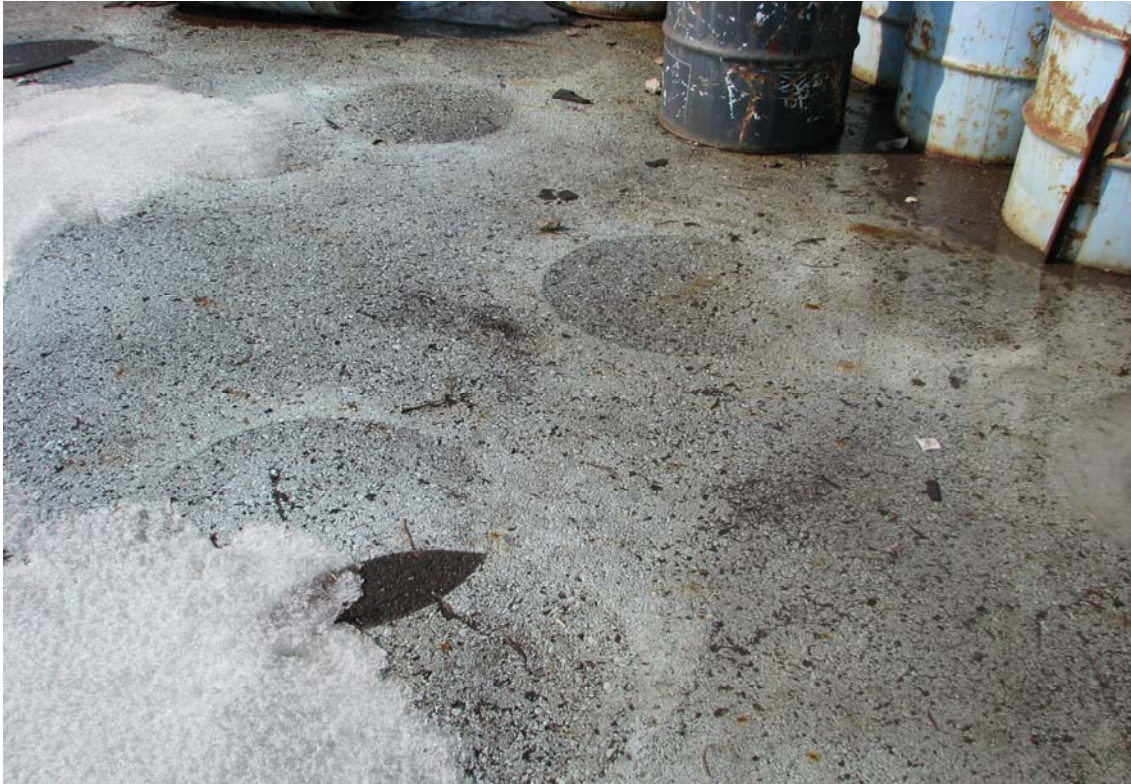
Photo 11 Asphalt paved drum storage area with evidence of drum painting- overspray on pavement. Drums apparently for use as trash cans by City.

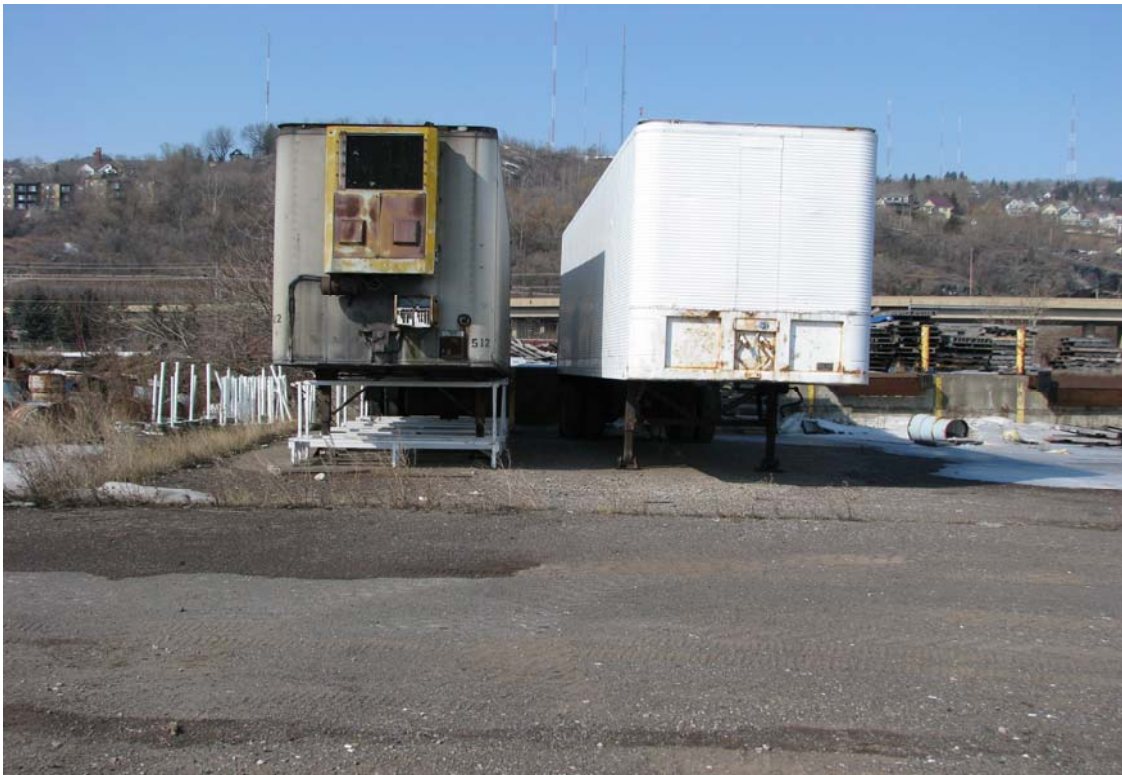
Photo 12 Two semi trailers parked in former apparent loading dock area. Trailer interiors not observable. Left trailer has batteries mounted on end- in poor condition.

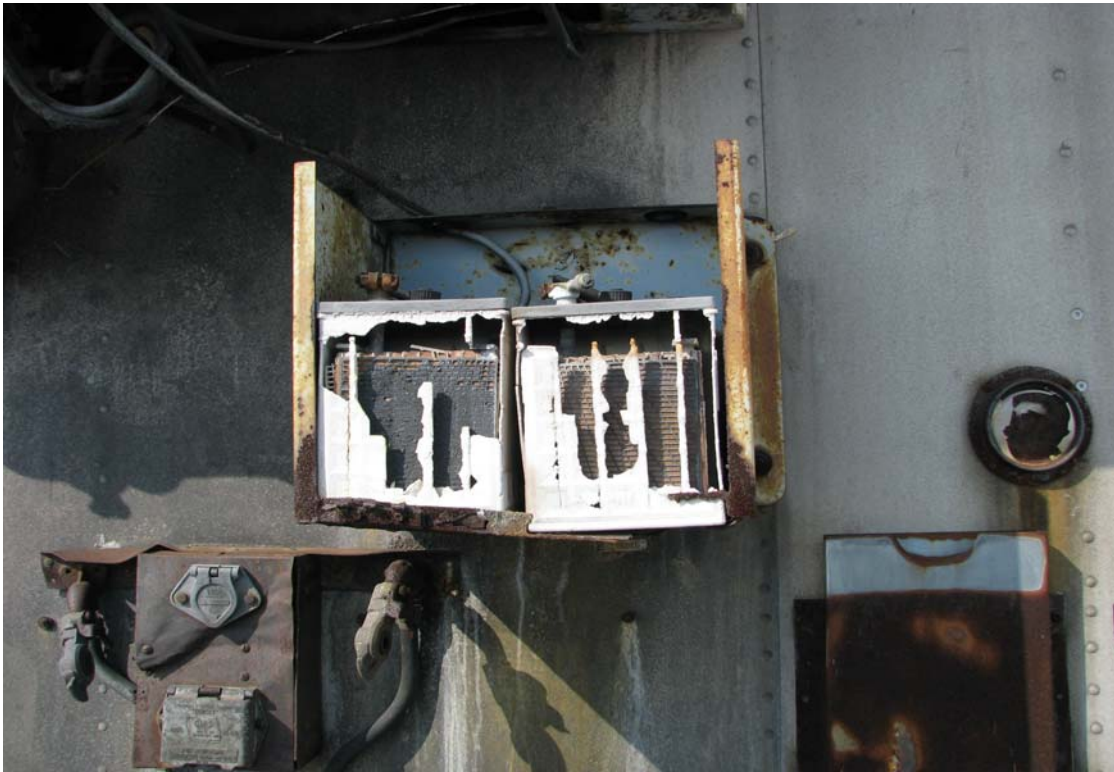
Photo 13 Close-up of deteriorating batteries on end of left semi trailer.

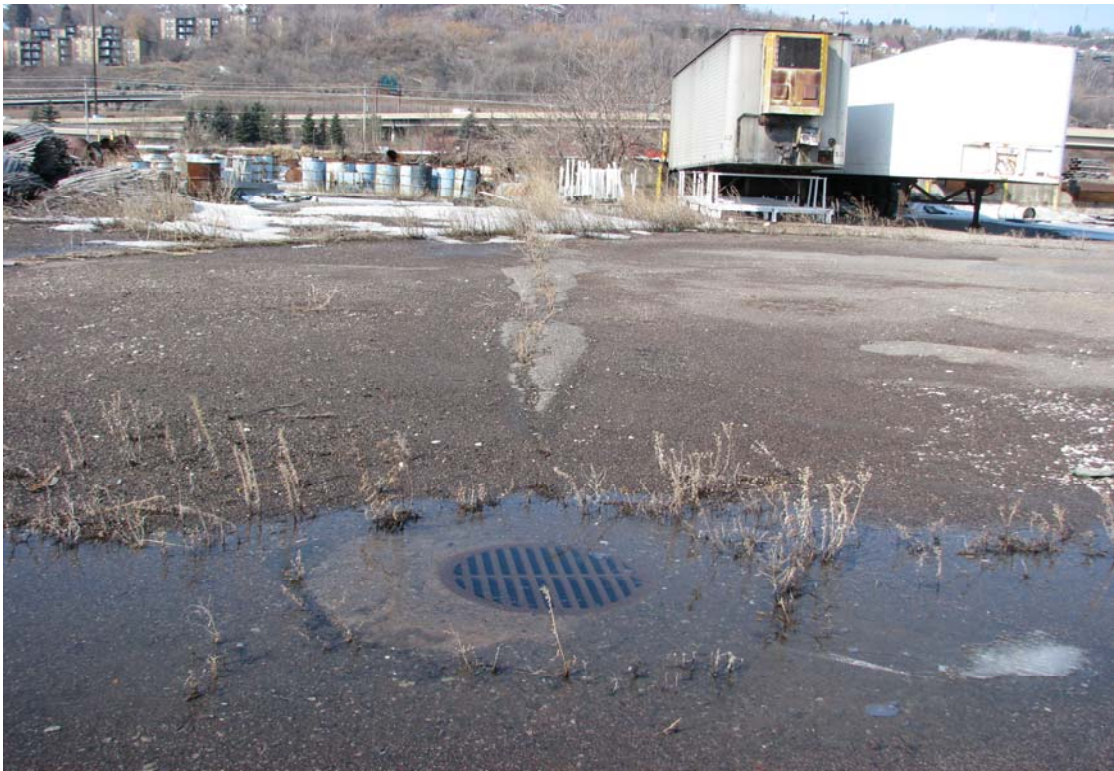
Photo 14 Storm grate inlet in asphalt paved lot area east of former warehouse building.

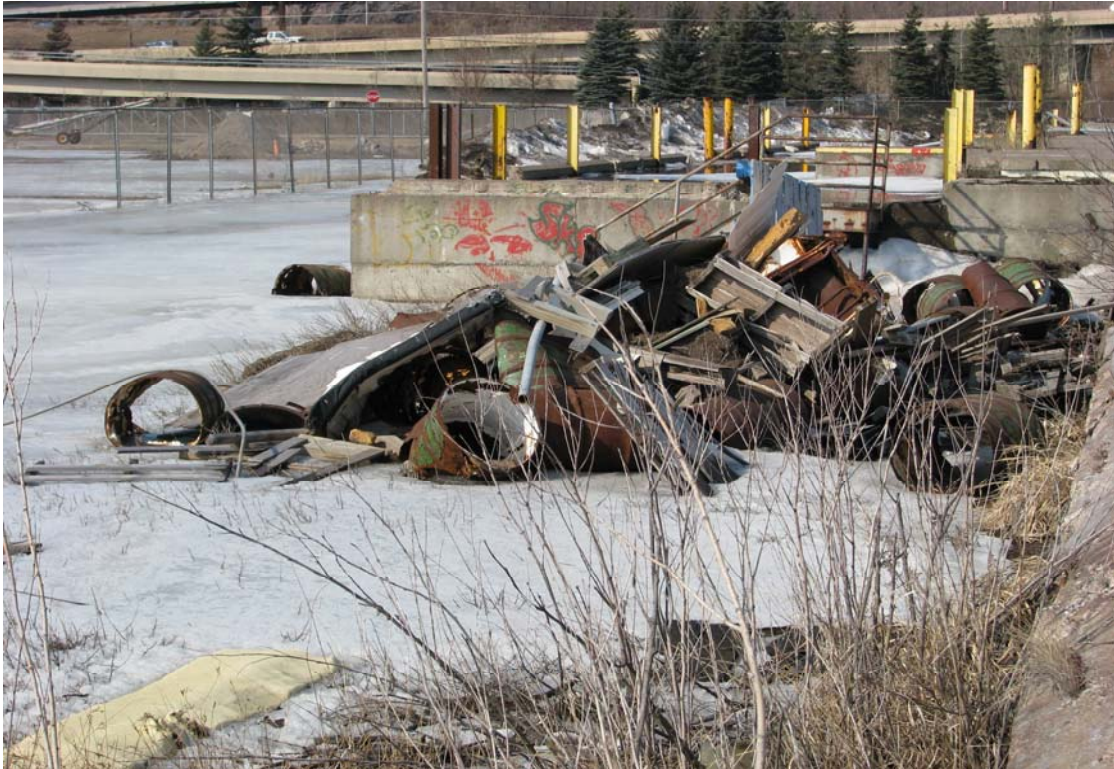
Photo 15 Debris pile at southeastern side of former warehouse building slab- drum carcasses, wood, metal, pipes, parts of apparent insulated garage doors.

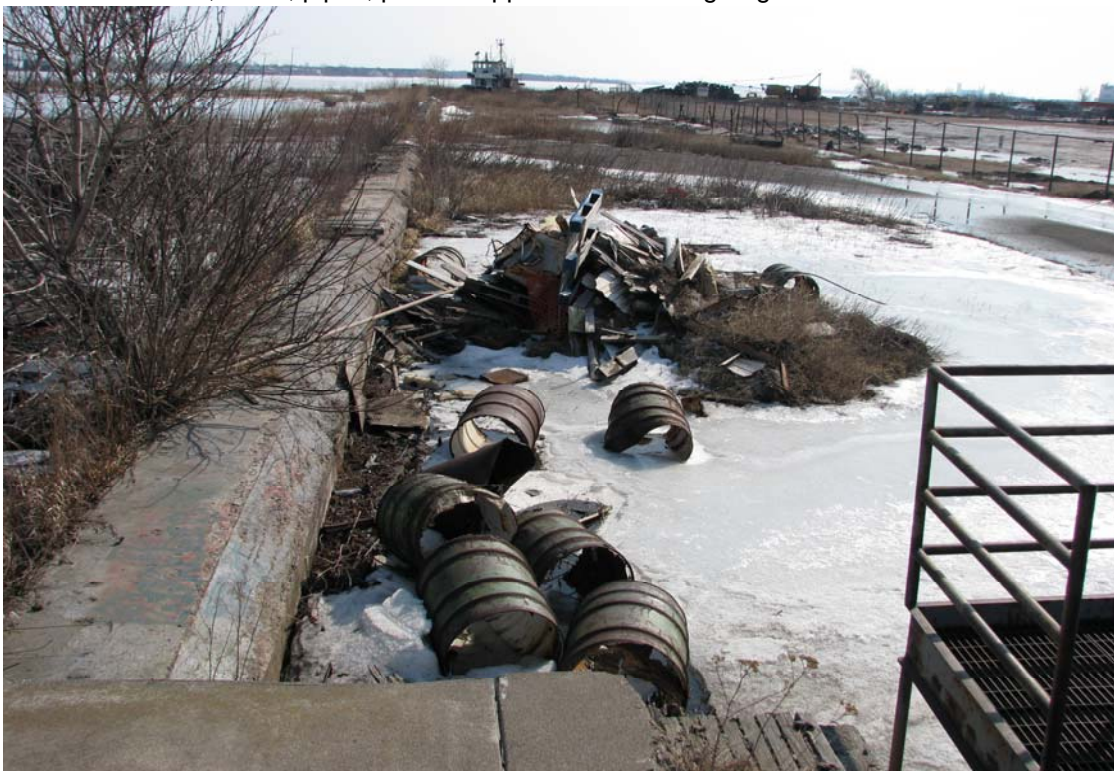
Photo 16 Second view eastward of same debris pile beside former warehouse (SE side). Former Slip 4 dock wall (concrete) extends eastward toward the harbor.

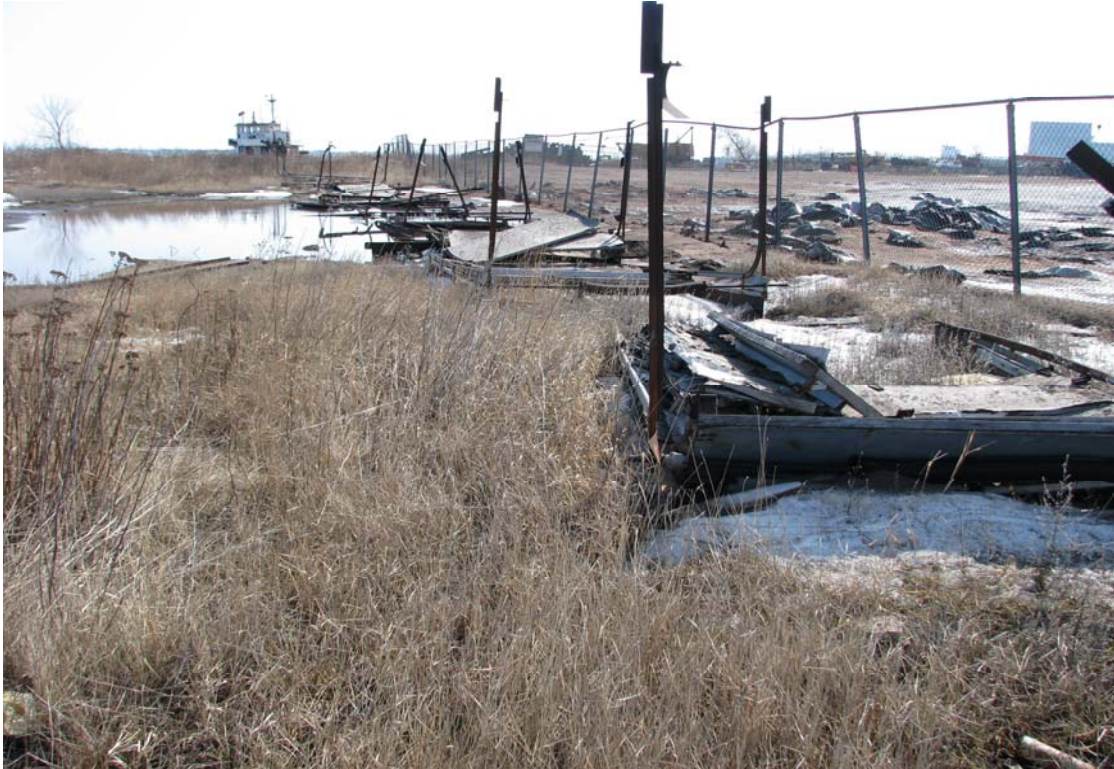
Photo 17 View along southern side of Lot D Property with approximately four or more former warehouse overhead door assemblies. Door panels insulated with foam material.

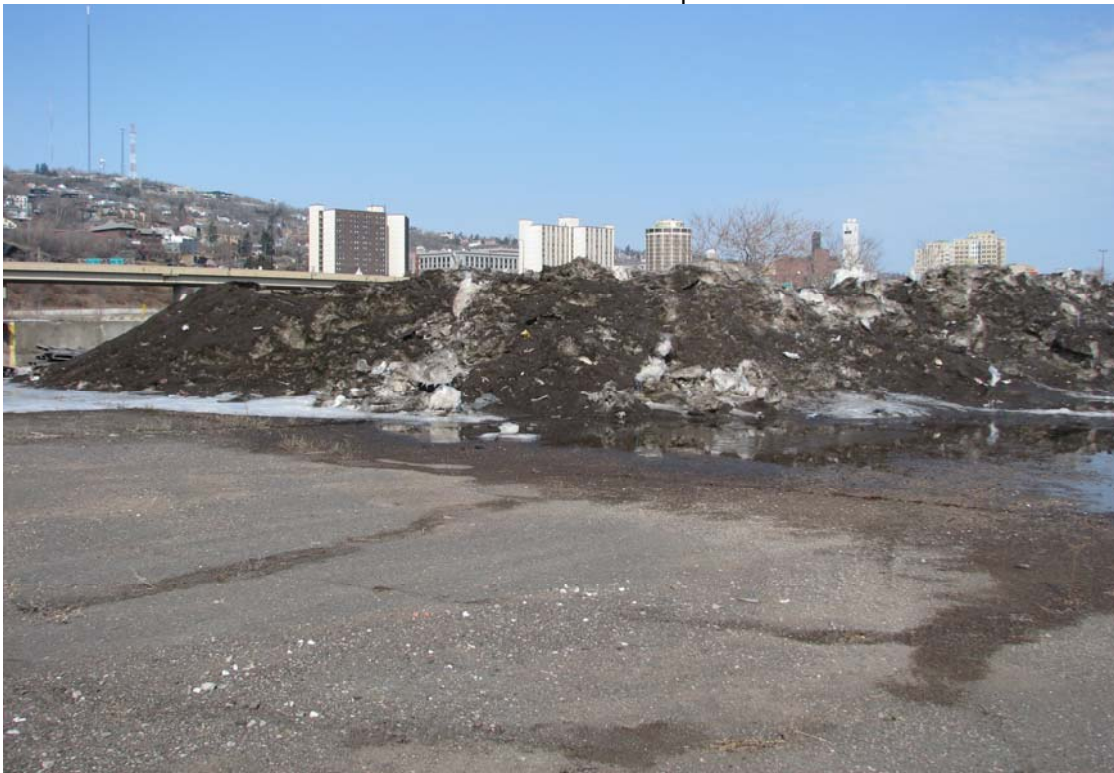
Photo 18 Snow stockpile beside northeastern corner of former warehouse foundation on asphalt paved lot area.

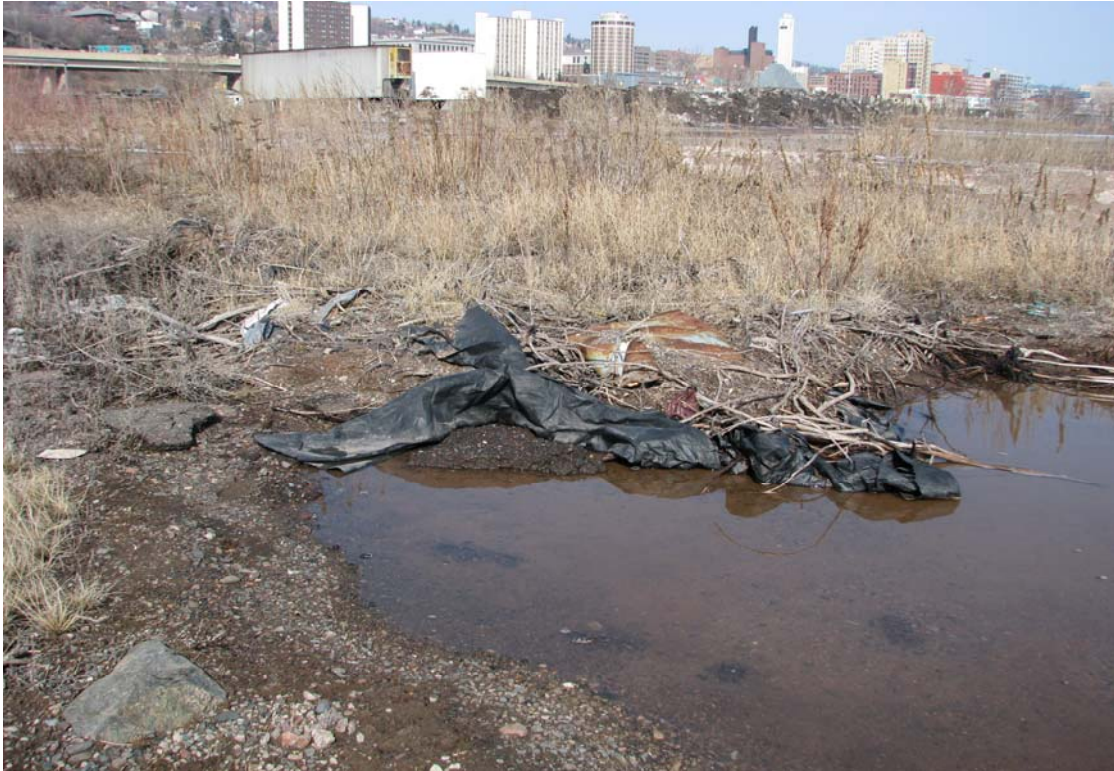
Photo 19 Apparent recently filled area with landscape fabric (black sheeting), metal drum carcass, glass, clothes, plastic, bricks, concrete in soil.

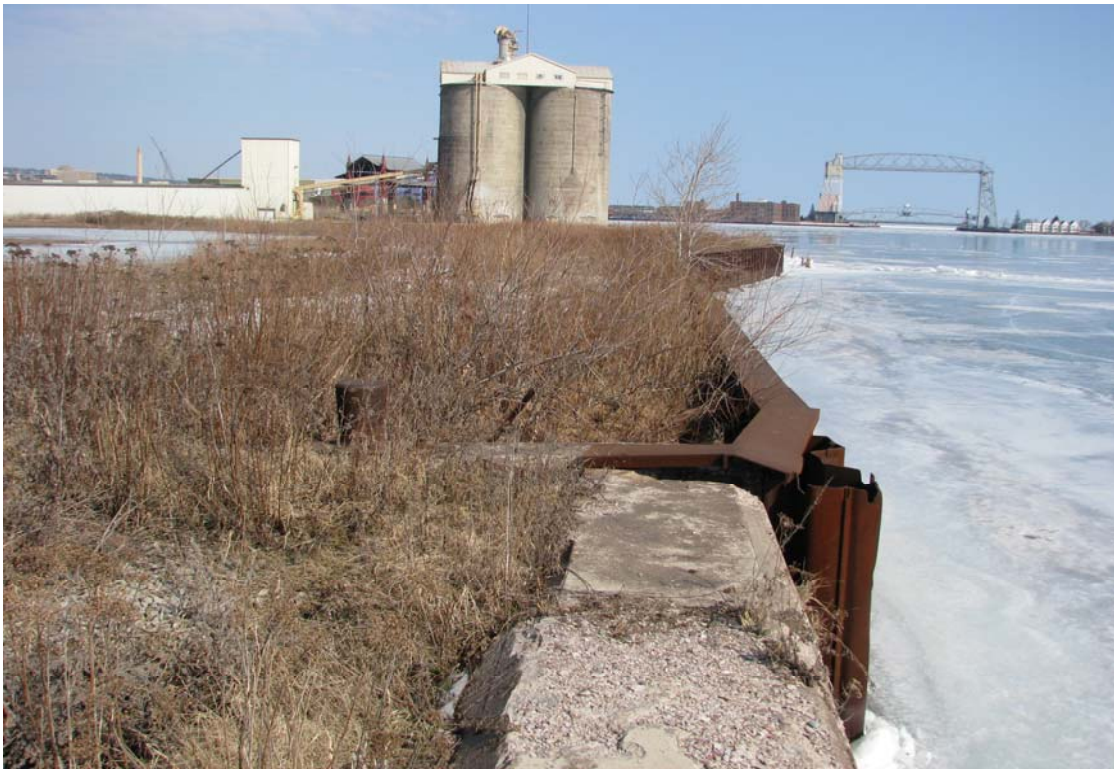
Photo 20 Southeastern side of Lot D area. View northeastward along concrete and steel sheet pile dock wall. LaFarge cement silos in background. Harbor on right.

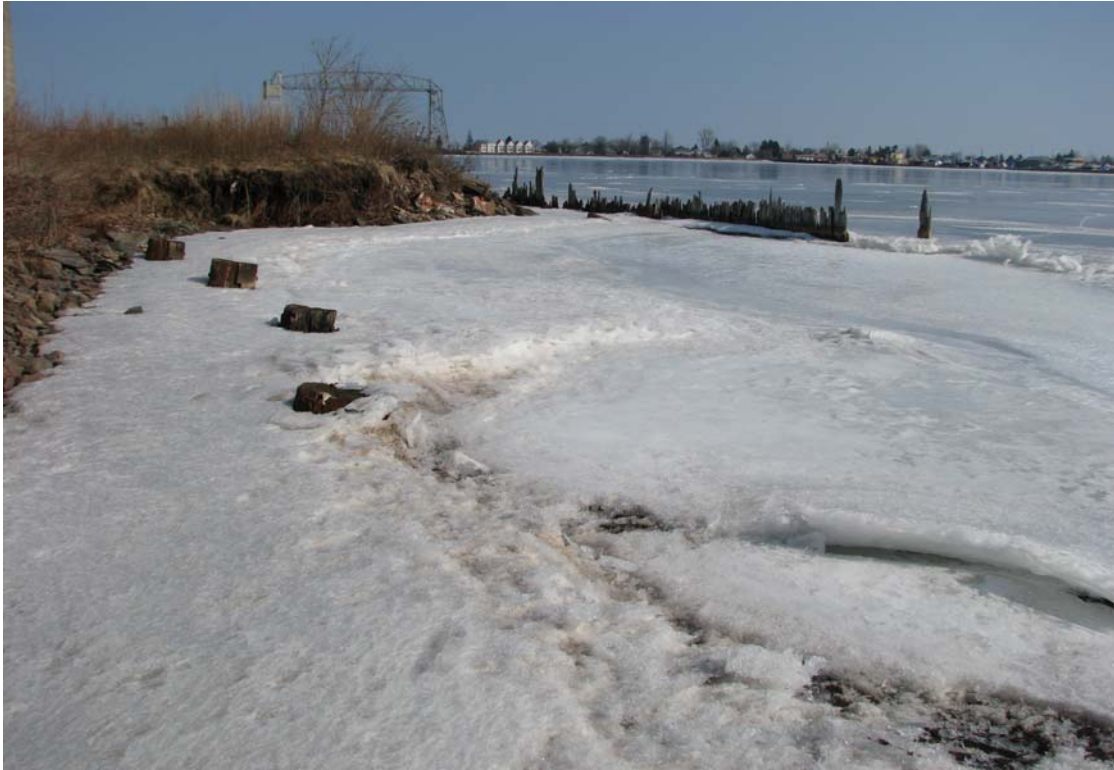
Photo 21 Southeastern side of Lot D area near Slip 3. Portion of filled pier now eroded away. Vertical wood boards mark approximate former dock wall. Fill with debris visible on eroded embankment.

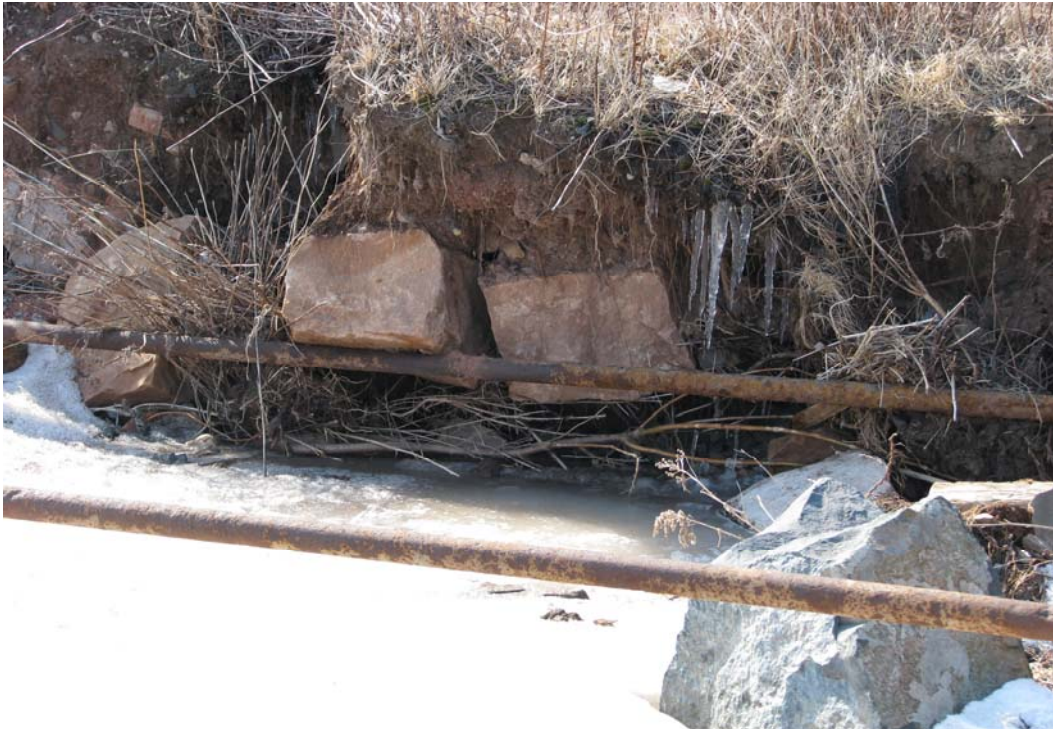
Photo 22 Close-up of steel tie rods, with dimension stone and fill soil displaying filled nature of constructed pier - Lot D area. Photo taken at eroded southeastern side Lot D area.

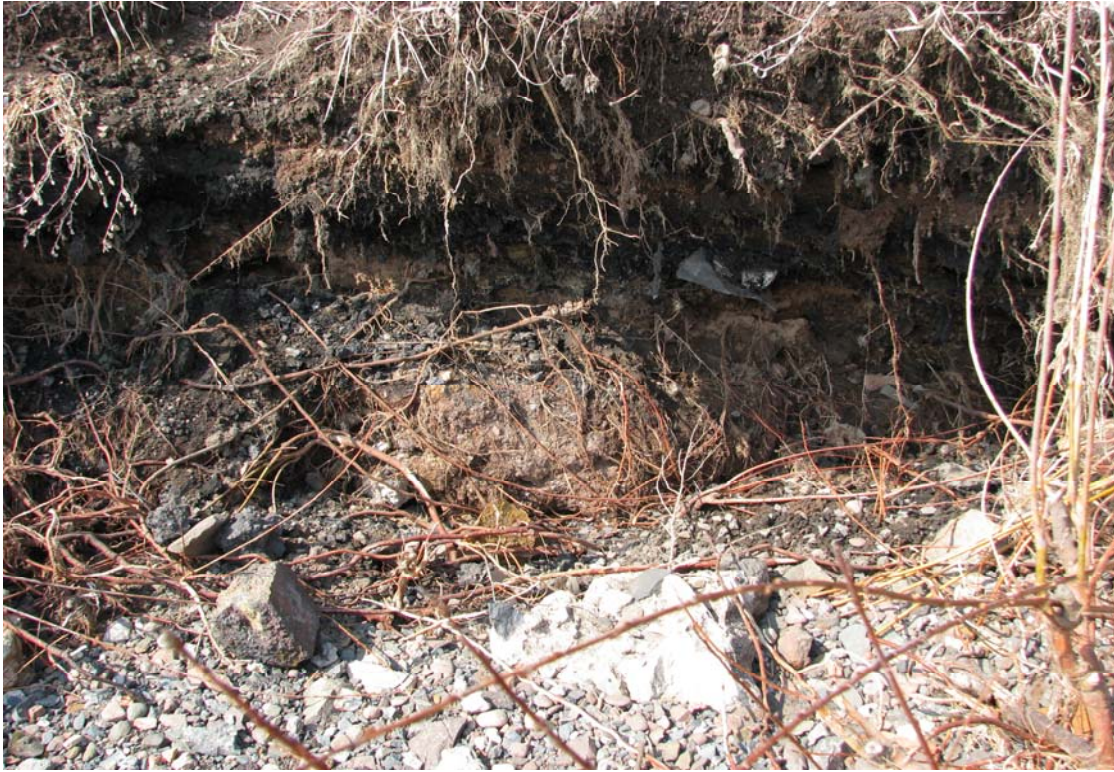
Photo 23 Close-up of eroded fill of Lot D area at southeastern side of Lot beside harbor.

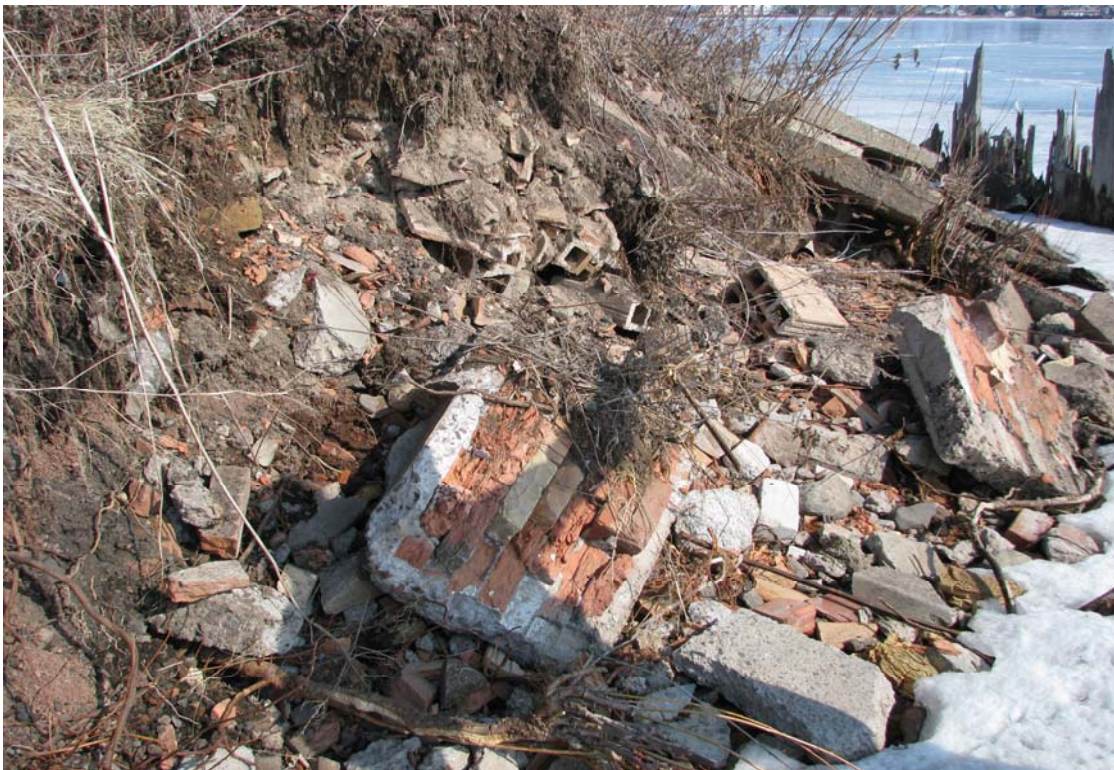
Photo 24 Close-up of fill with abundant bricks, mortar, cement and soil at eroded southeastern side of Lot D area. Harbor in background.

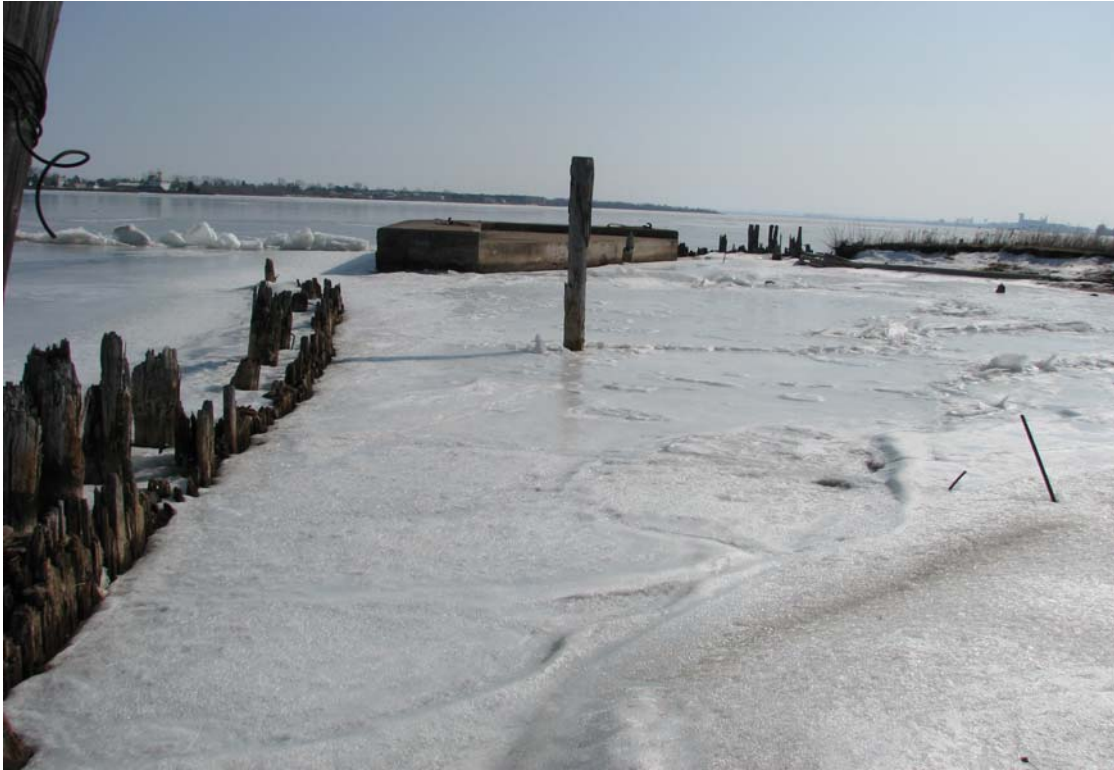
Photo 25 View southeastward toward mouth of Slip 3 (on left). Second eroded area with concrete dock wall moorage element at corner beside mouth of Slip 3.

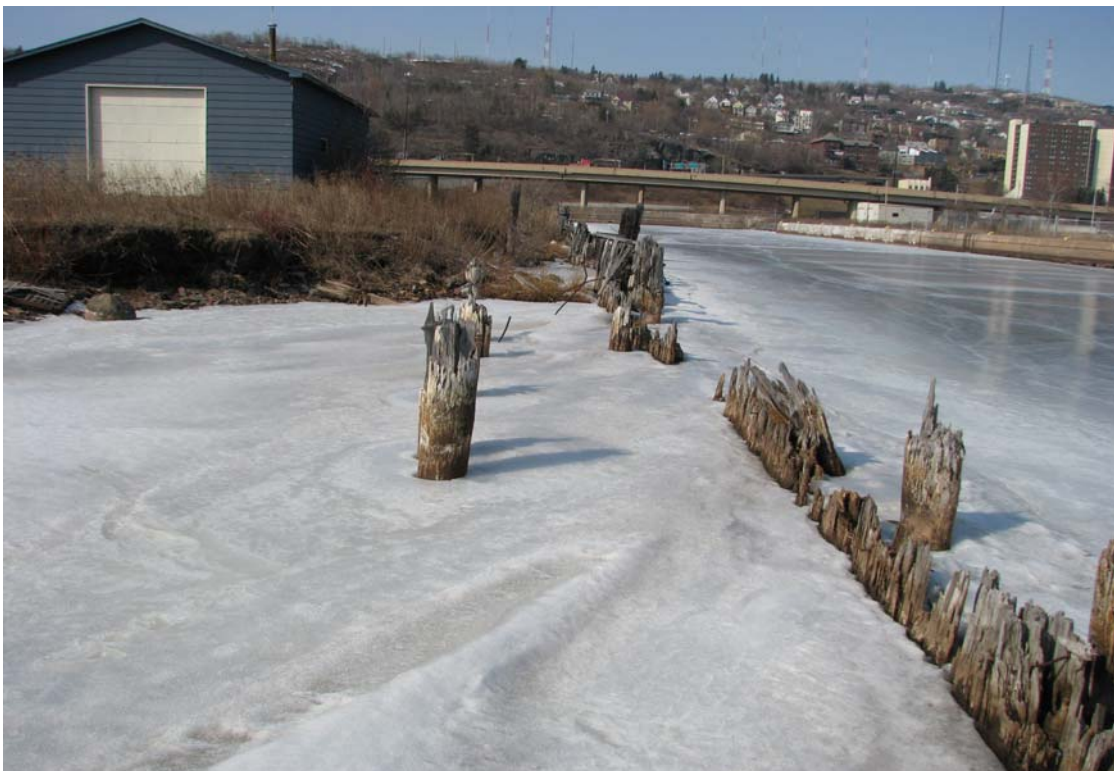
Photo 26 View northwestward along Slip 3 with eroded portion of Lot D in foreground. Garage building on left.

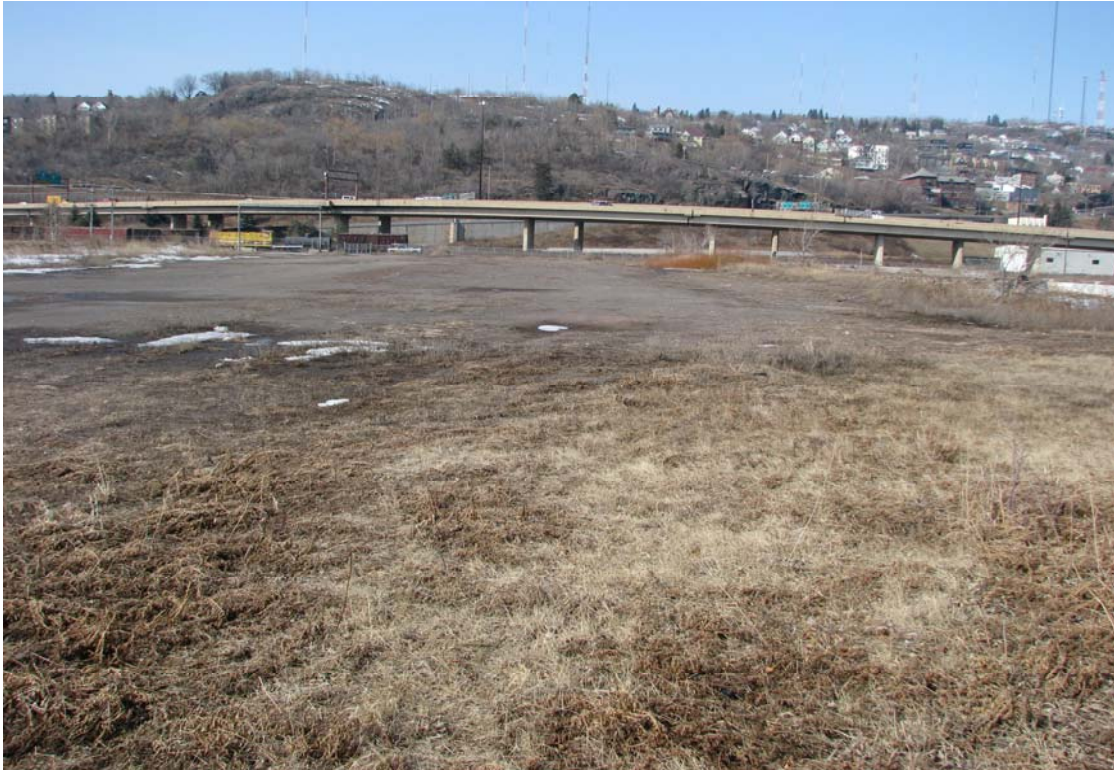
Photo 27 View northwestward across central Lot D area. Grass, asphalt and gravel surfaces. I-35 highway in background.
