Appendix B
Property Inspection Photographs
700-1000 West Railroad Street Property
Duluth, MN
March 5 and 9, 2010

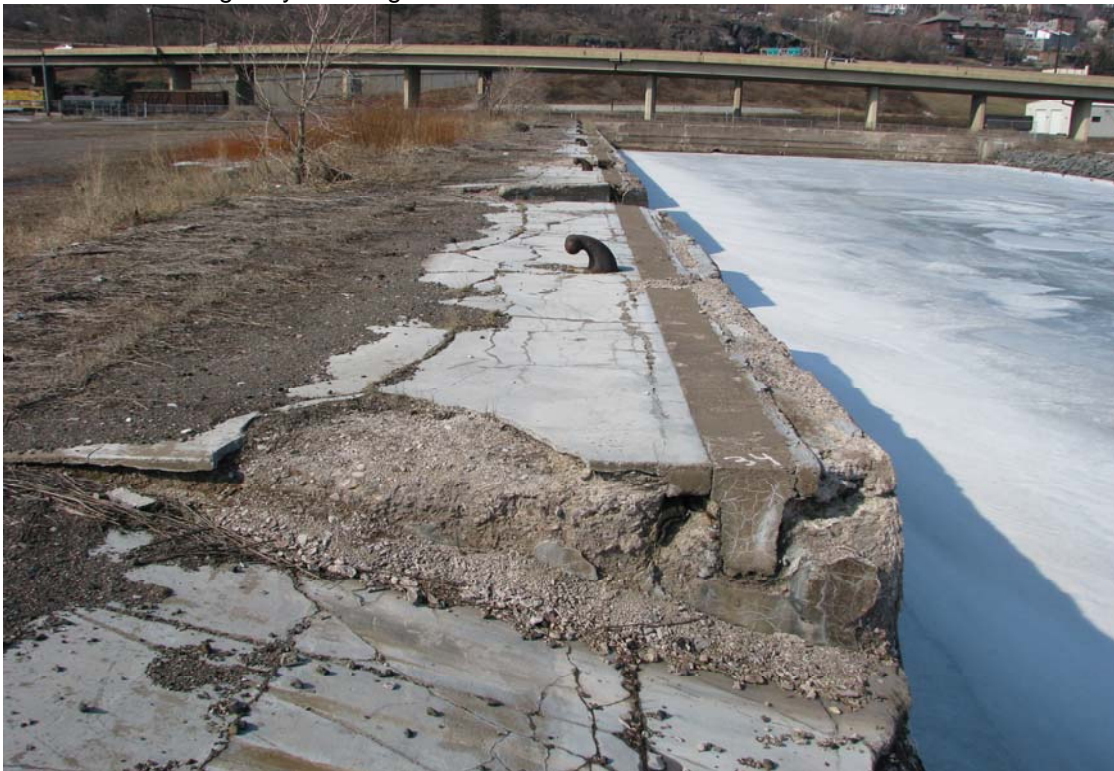
Photo 28 View northwestward along Slip 3. Lot D area on left.

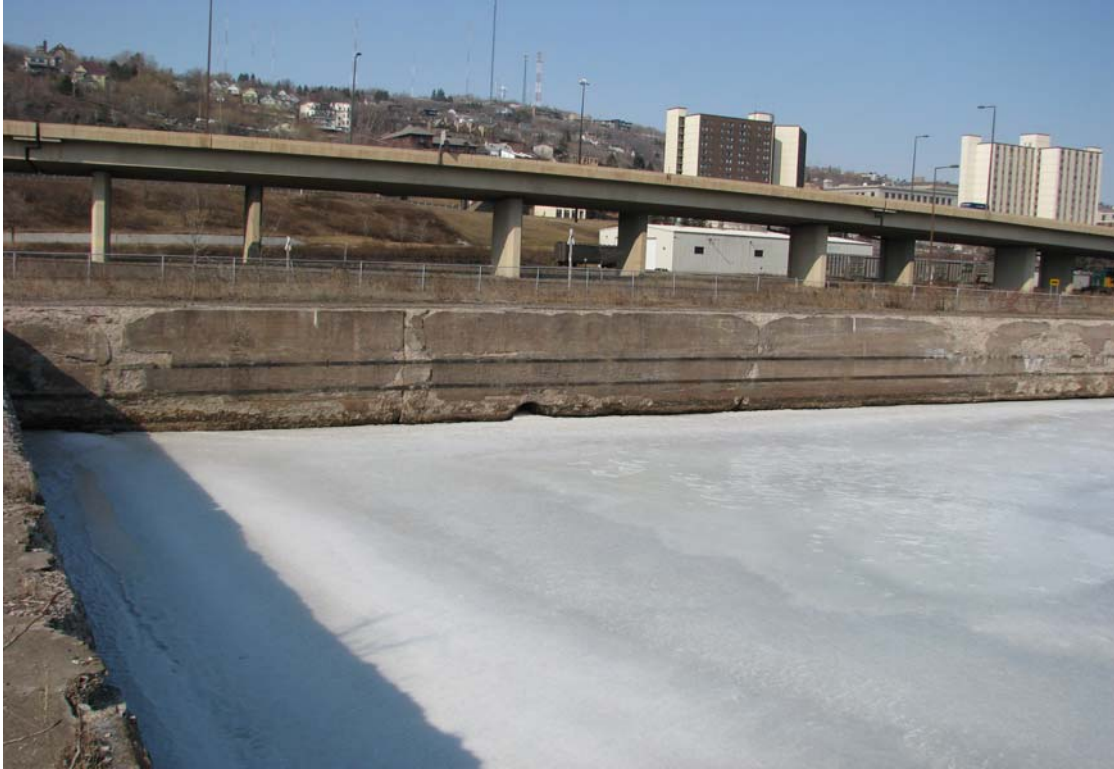
Photo 29 Western- head of Slip 3. Apparent storm sewer outlet at base of concrete dock wall.

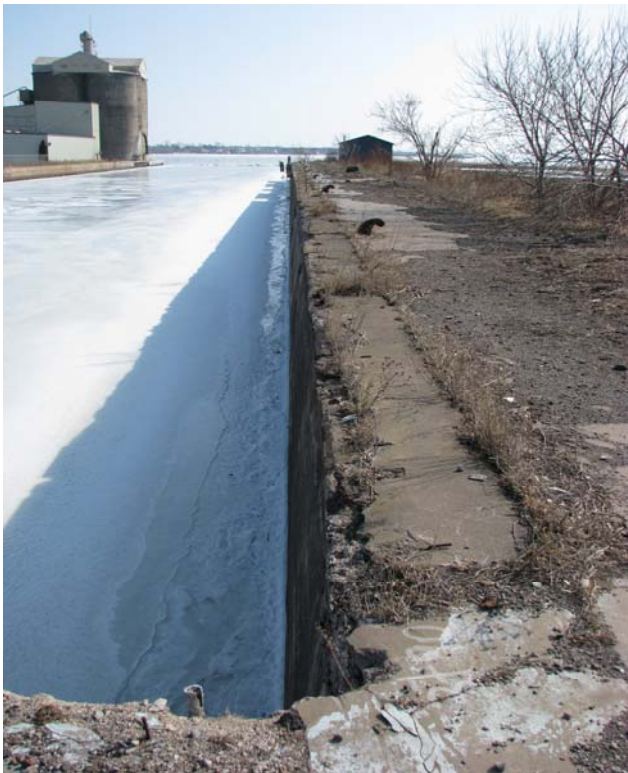
Photo 30 View southward along south dock wall of Slip 3. Garage in background.

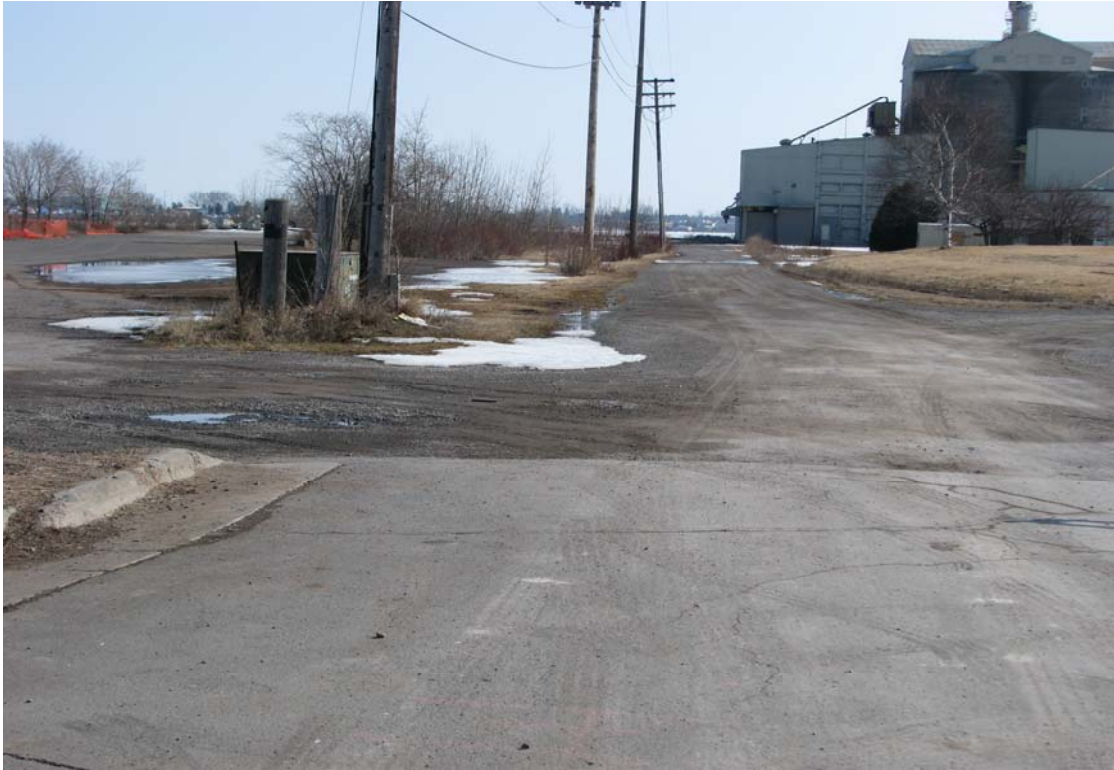
Photo 31 View eastward along alleyway (8th Avenue west). Lot C on left. Adjoining former LaFarge cement facility on right.

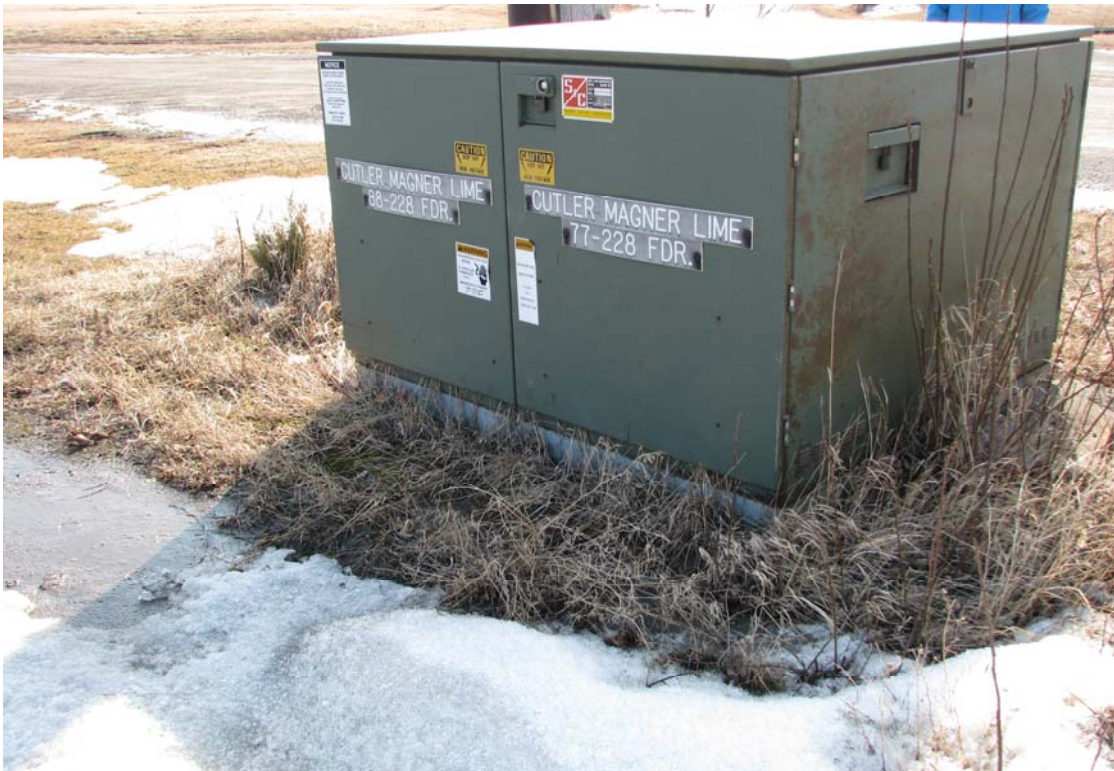
Photo 32 View of pad mounted transformer at 8th Avenue West and Railroad Street. Southwestern corner of Lot C.

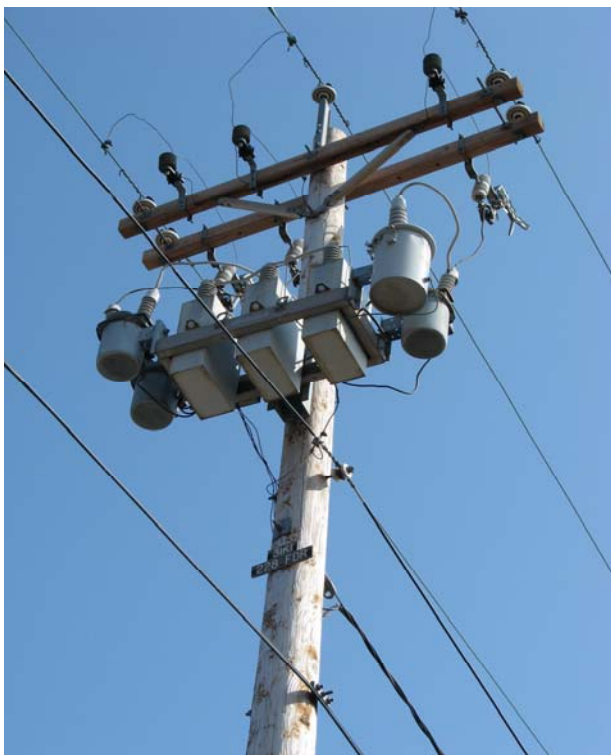
Photo 33 Pole-mounted transformers on southern side of Lot C area. Beside 8th Ave. West alleyway.

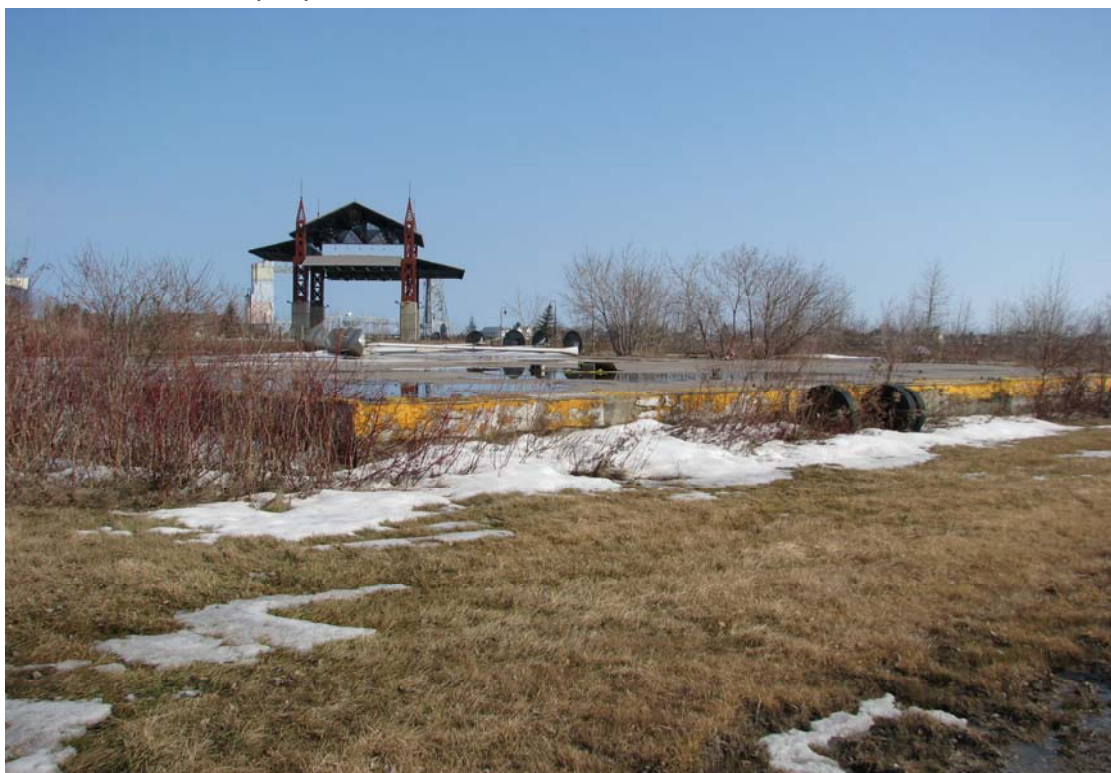
Photo 34 View of central Lot C area- former warehouse building foundation slab.

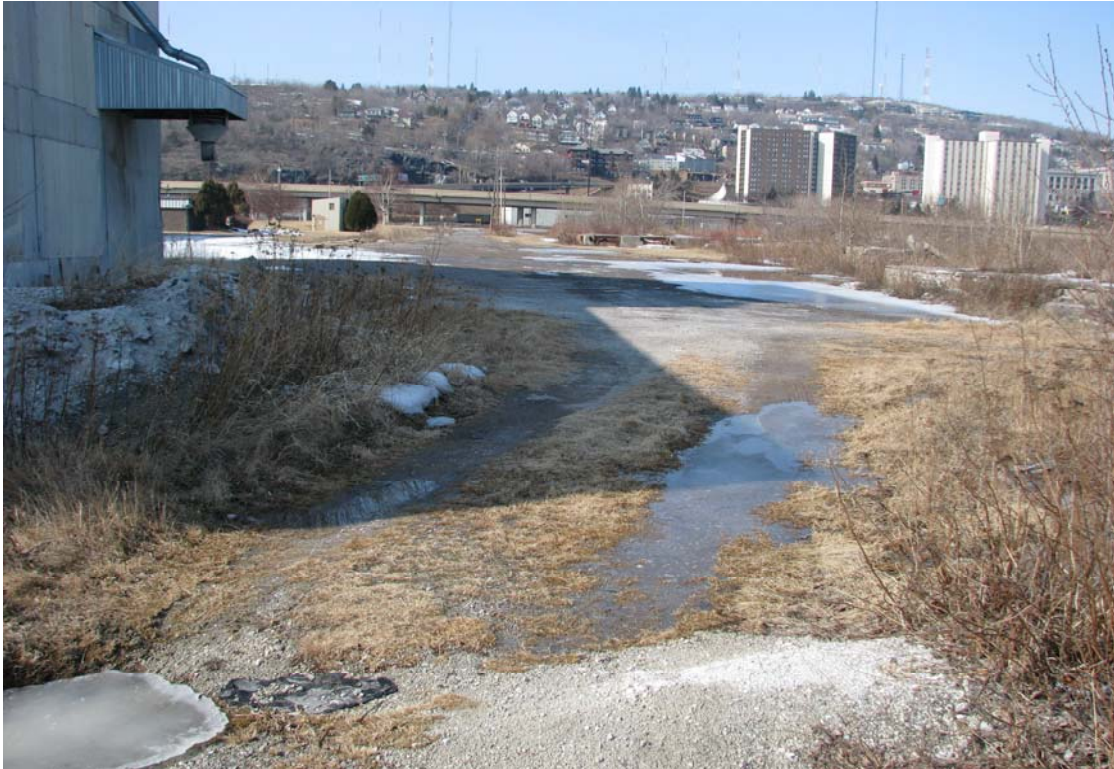
Photo 35 View northwestward along 8th Avenue West alley way. Lot C area on right. Former LaFarge cement facility on left. Taken at head of pier.

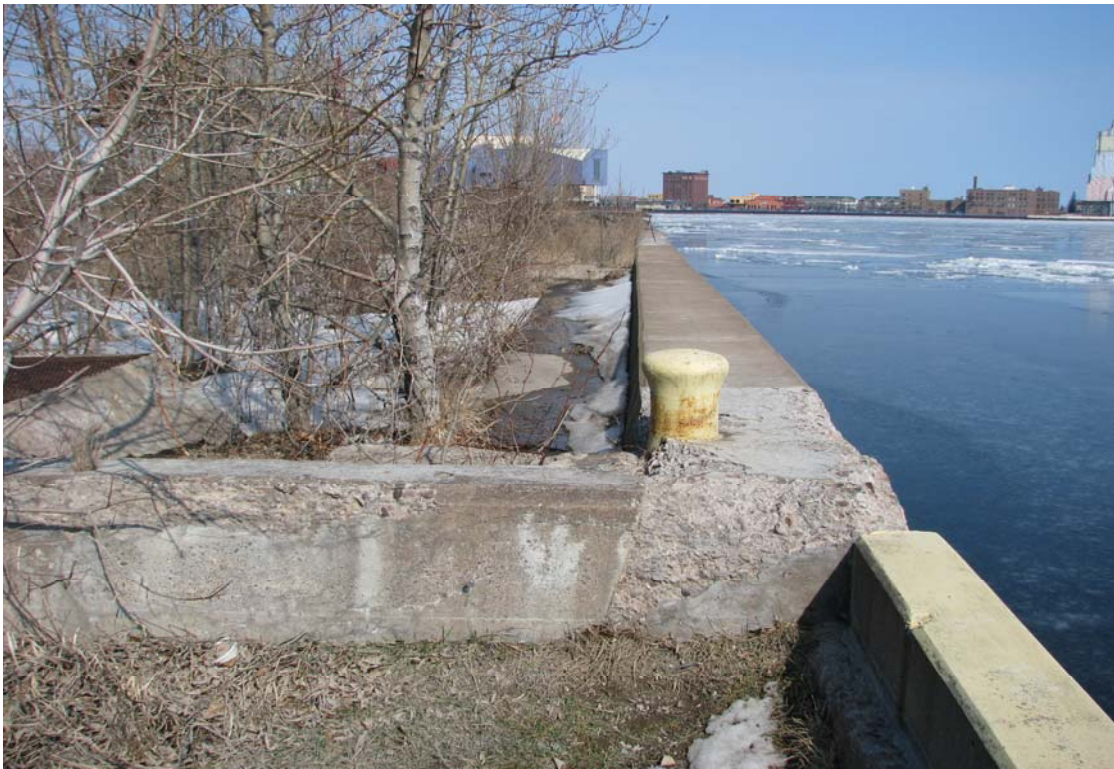
Photo 36 View northeastward along head of pier - Lot C. Great Lakes Aquarium in background.

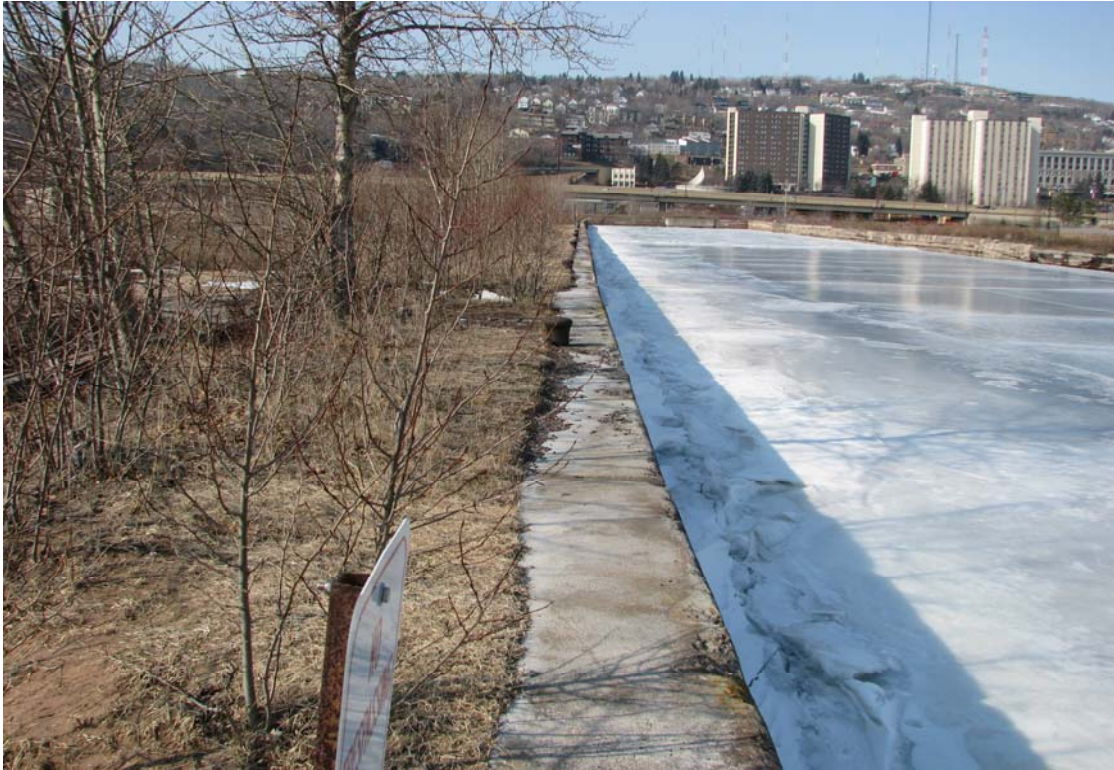
Photo 37 View northwestward along Slip 2. Lot C area on left. Bayfront Park to right.

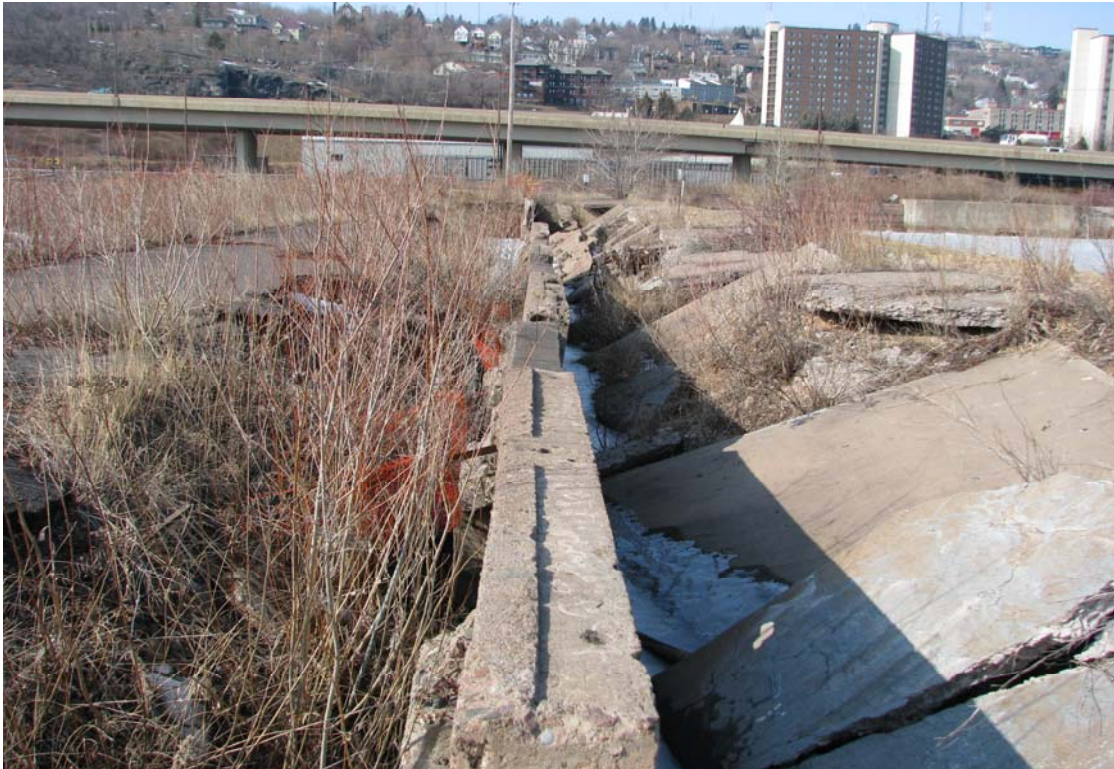
Photo 38 View northwestward of eroded and collapsing dock wall structures near western end of Slip 2. Lot C area to left.

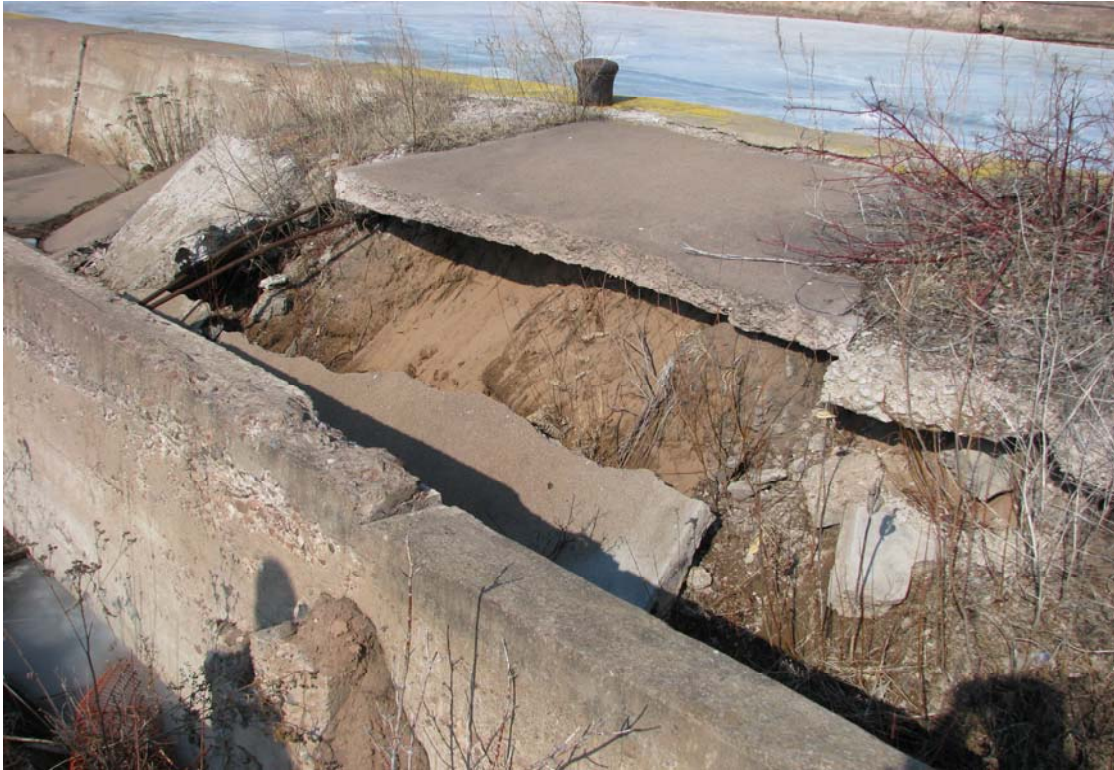
Photo 39 Collapsing section of Slip 2 dock wall structure on Lot C. Sand fill visible beneath cement slabs.

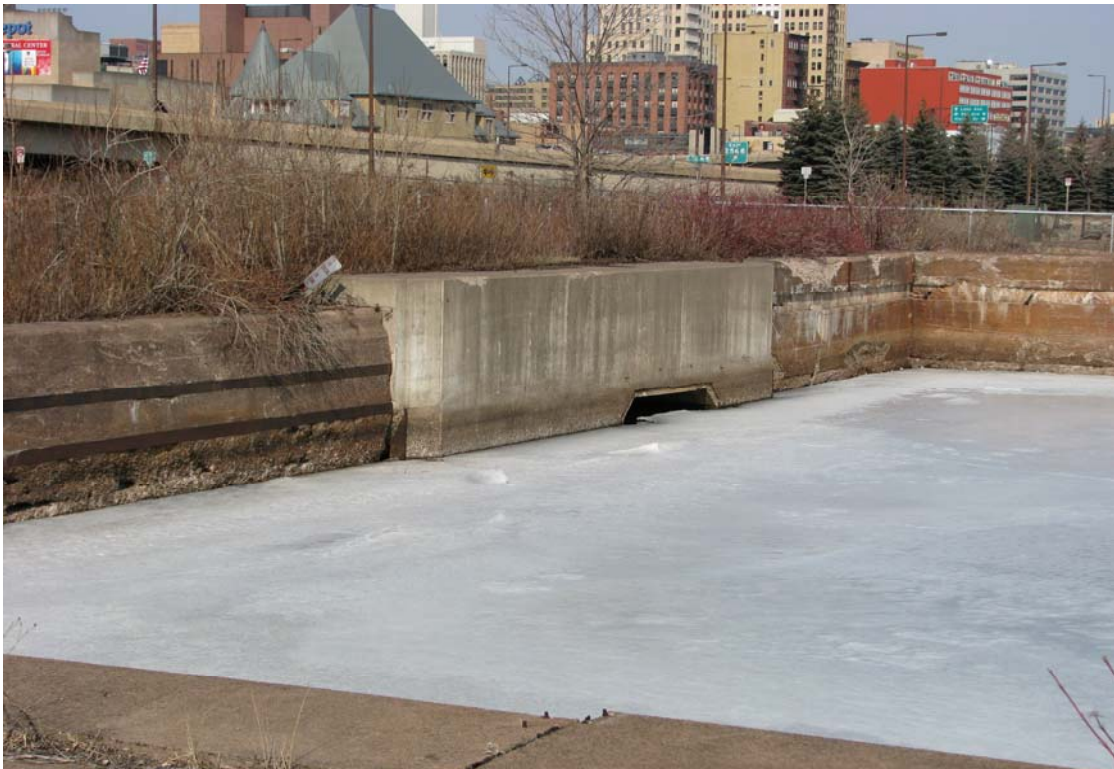
Photo 40 Storm sewer outfall structure at head of Slip 2. Downtown Duluth in background.

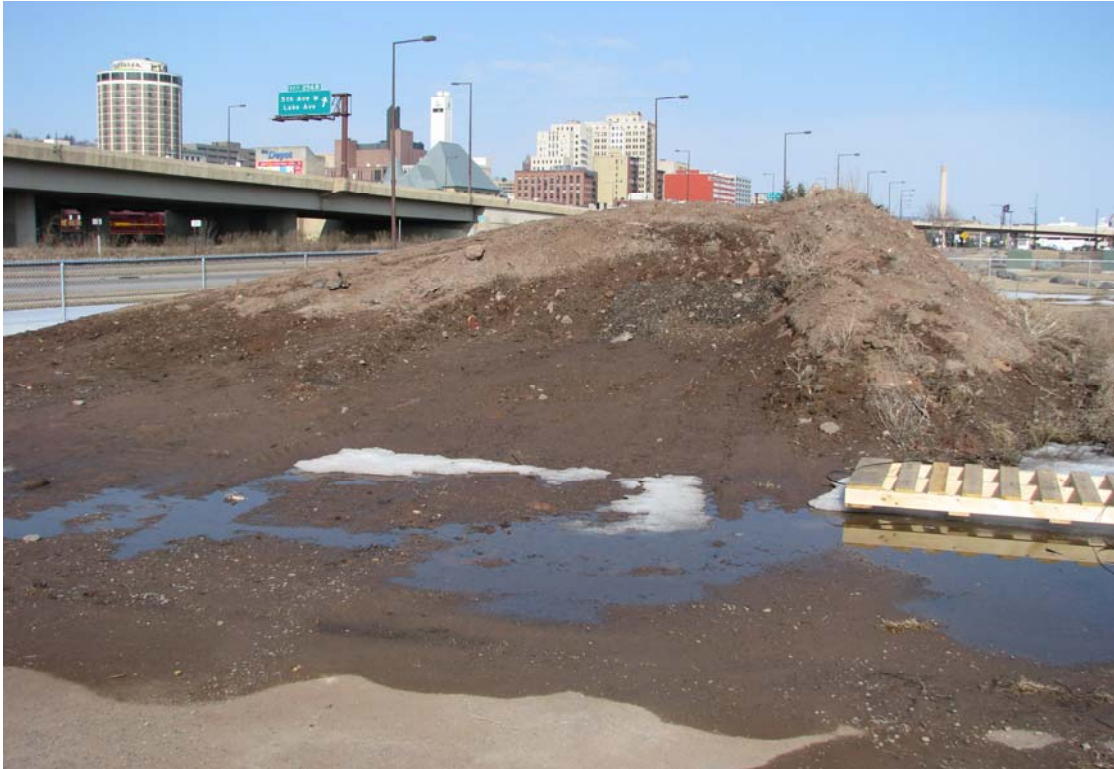
Photo 41 Soil stockpile at head of Slip 2. Railroad Street on left. Soil pile contains minor amounts of brick, concrete, metal in soil.

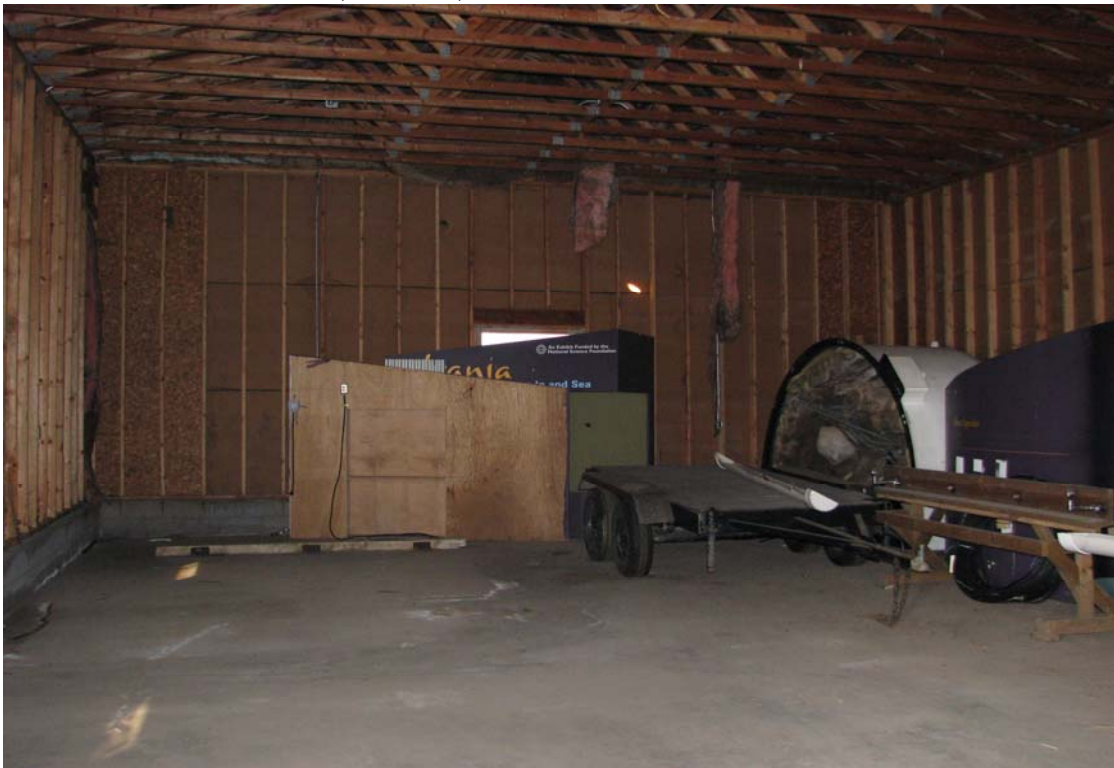
Photo 42 Interior view of garage building. Trailer, wood, and water equipment stored within. (garage interior viewed 3/9/2010)

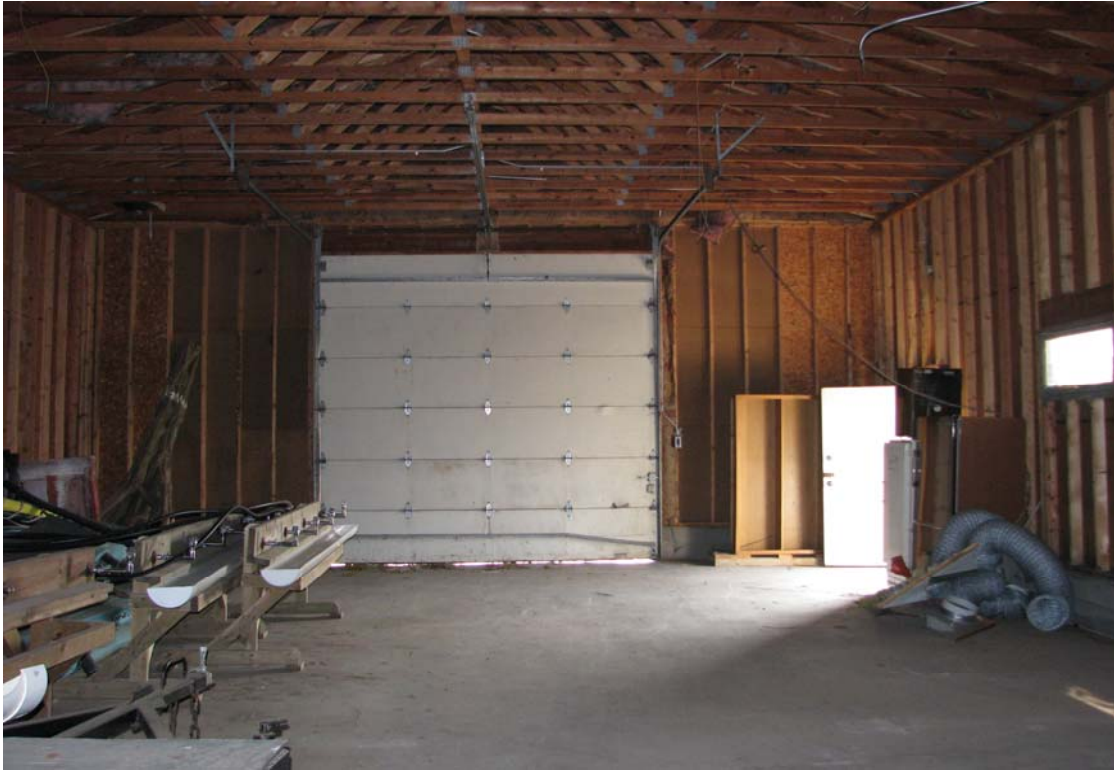
Photo 43 Second view within garage building. Garage interior viewed 3/9/2010.
