*Appendix D*

*MPCA File Review Information and  
Previous Investigation Reports*

*Leak # 2094 MPCA File Excerpts*

Re: Limited Phase I Site Assessment  
(Historical Records Review)  
Bayfront Property  
Duluth, Minnesota

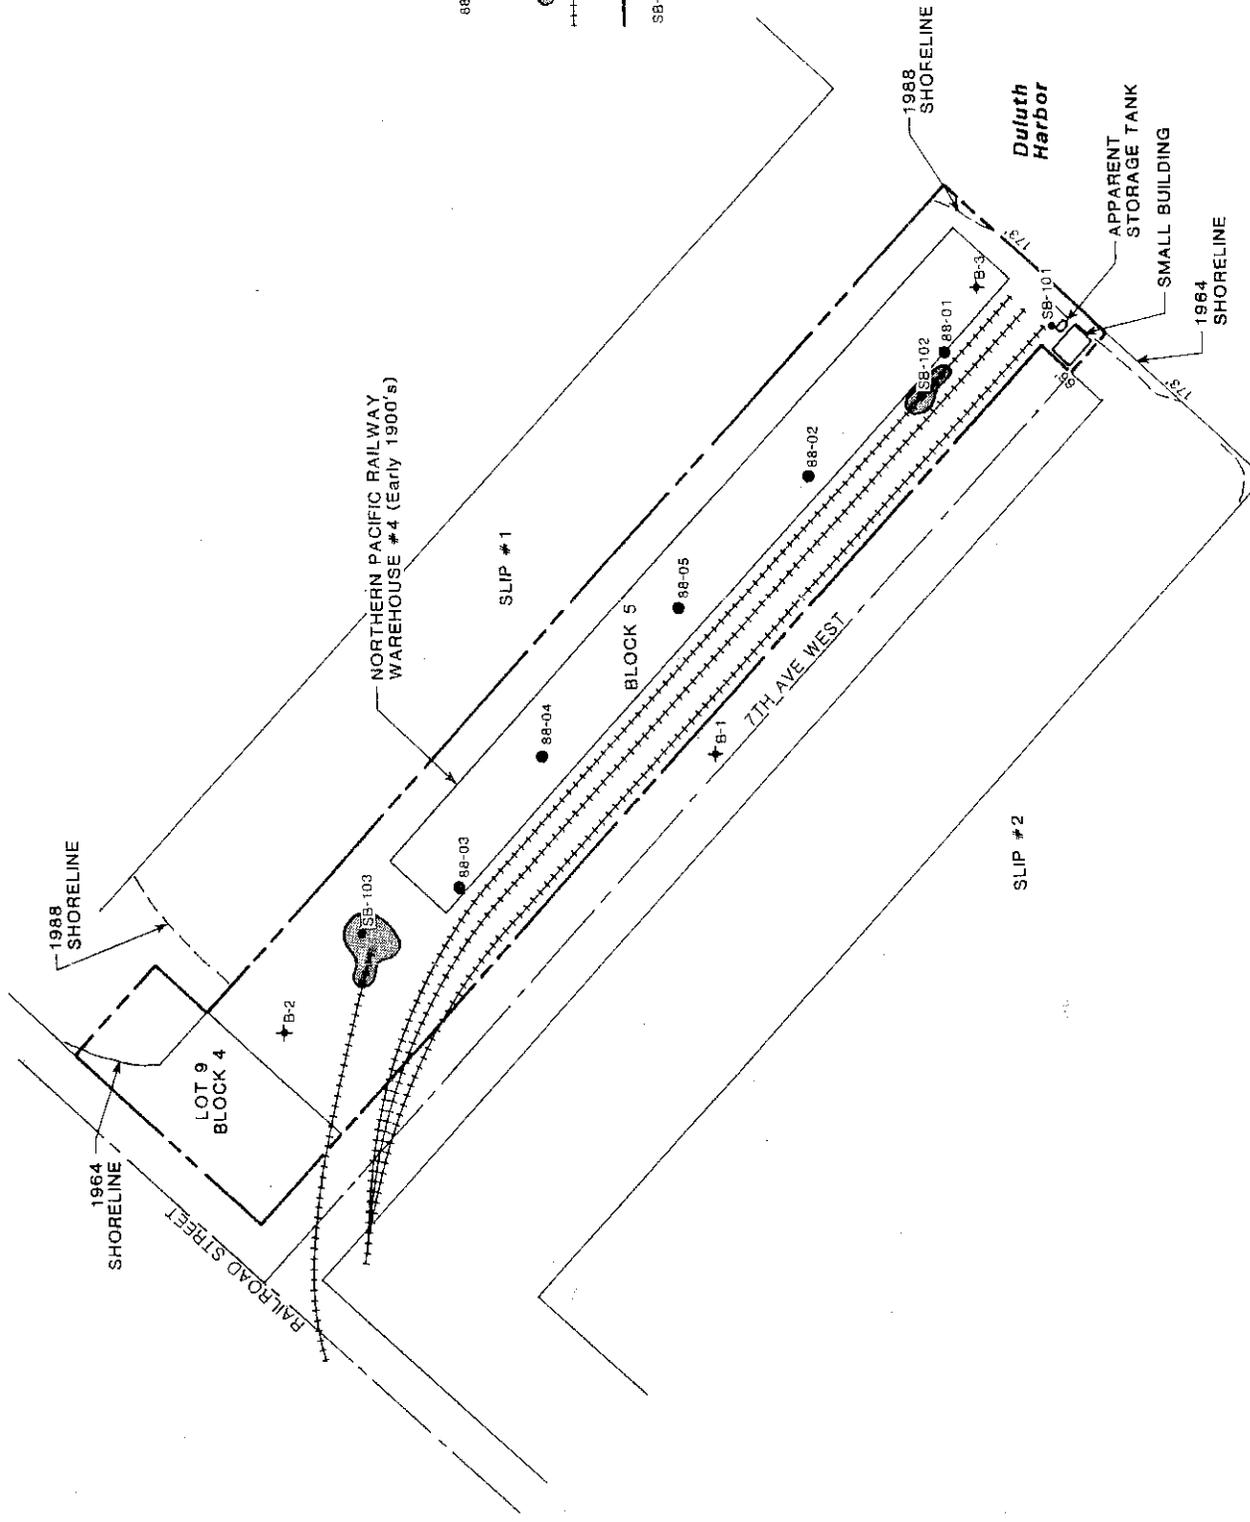
Figure 1  
 SITE MAP WITH  
 PROPOSED SOIL BORING LOCATIONS

Changes to the property observed on the 1964 aerial photograph were two areas of what appear to be soil staining. One of the areas was located northwest of the warehouse building, and the second area of staining was located near the end of the pier under a set of railroad tracks. An object which may be an aboveground storage tank was also observed in the northeast part of the Property. The presence of soil staining may indicate that a chemical release had occurred. The areas of soil staining are shown on Figure 1.

- Soil staining was visible on several aerial photographs at several locations on the Property. Although the aerial extent of staining was relatively limited, a likelihood exists that these stains are indicative of a chemical release.

Barr recommends placement of soil borings at locations identified as potential sources of chemical release (soil-stained areas and petroleum storage tank). Information collected will establish if a release requiring cleanup has occurred at those locations.

The proposed boring locations are shown on Figure 1. We recommend advancing the soil borings to the surface of the water table and collection of soil samples continuously throughout the depth of the boring. The soil samples should be screened in the field for the presence of volatile organic compounds, odor, oil sheen, and staining. Soil samples collected from the vicinity of the former petroleum storage tank (Boring SB-101) should be analyzed for total petroleum hydrocarbons, benzene, ethyl benzene, toluene, and xylenes. Soil samples collected from the vicinity of the stained soil areas (Borings SB-102 and SB-103) should only be submitted for laboratory analyses if evidence of contamination is observed.

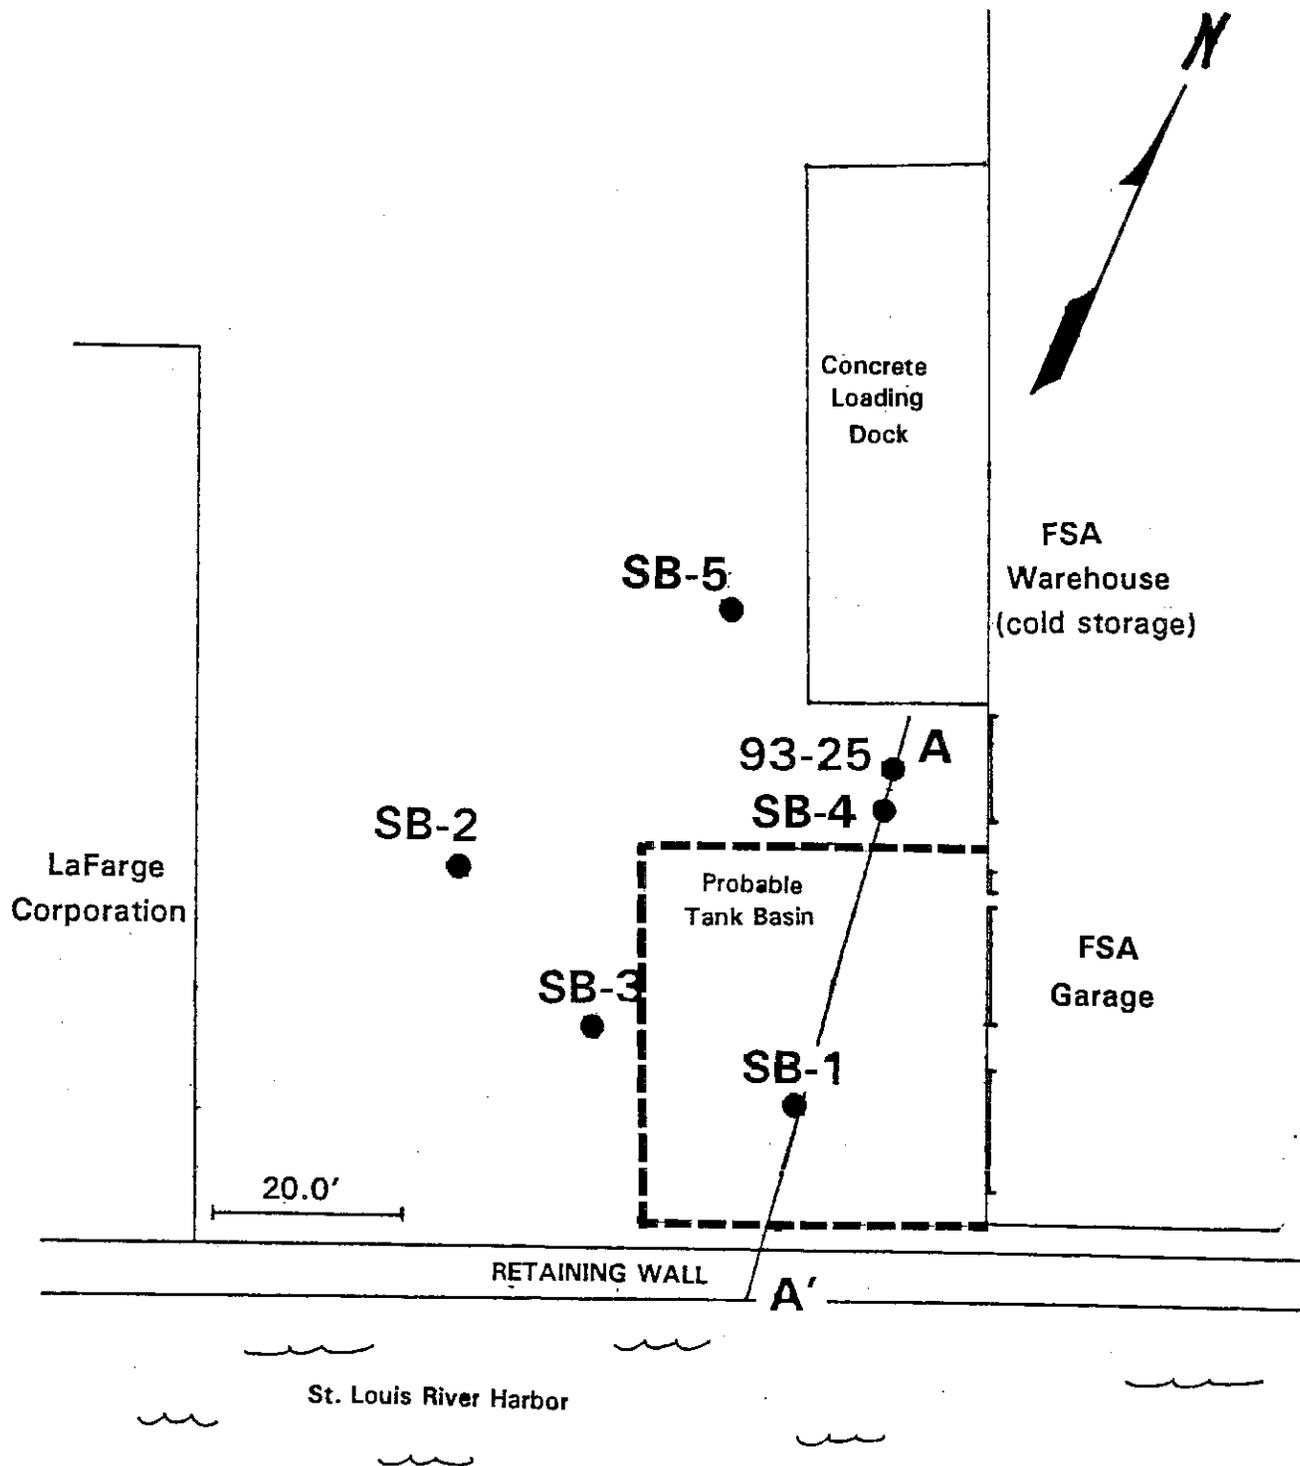
AMERICAN ENGINEERING TESTING, INC. DULUTH & ST. PAUL, MN	PROJECT REMEDIAL INVESTIGATION - CITY OF DULUTH		AET JOB # 93-7
	SUBJECT Figure 3. Soil Boring and X-Section Locations		DATE 10/18/93
SCALE 1:20	DRAWN BY DER	CHECKED BY TGK	PAGE

The fieldwork for the remedial investigation on the site was completed August 30, 1993 and January 7, 1994. Soil borings SB-1 through SB-3 were drilled by a CME-550C and soil borings SB-4 and SB-5 were drilled by a truck mounted CME-55. The soil boring locations can be found in Figure 3. The environmental soil borings, designated SB-1 through SB-5, were drilled

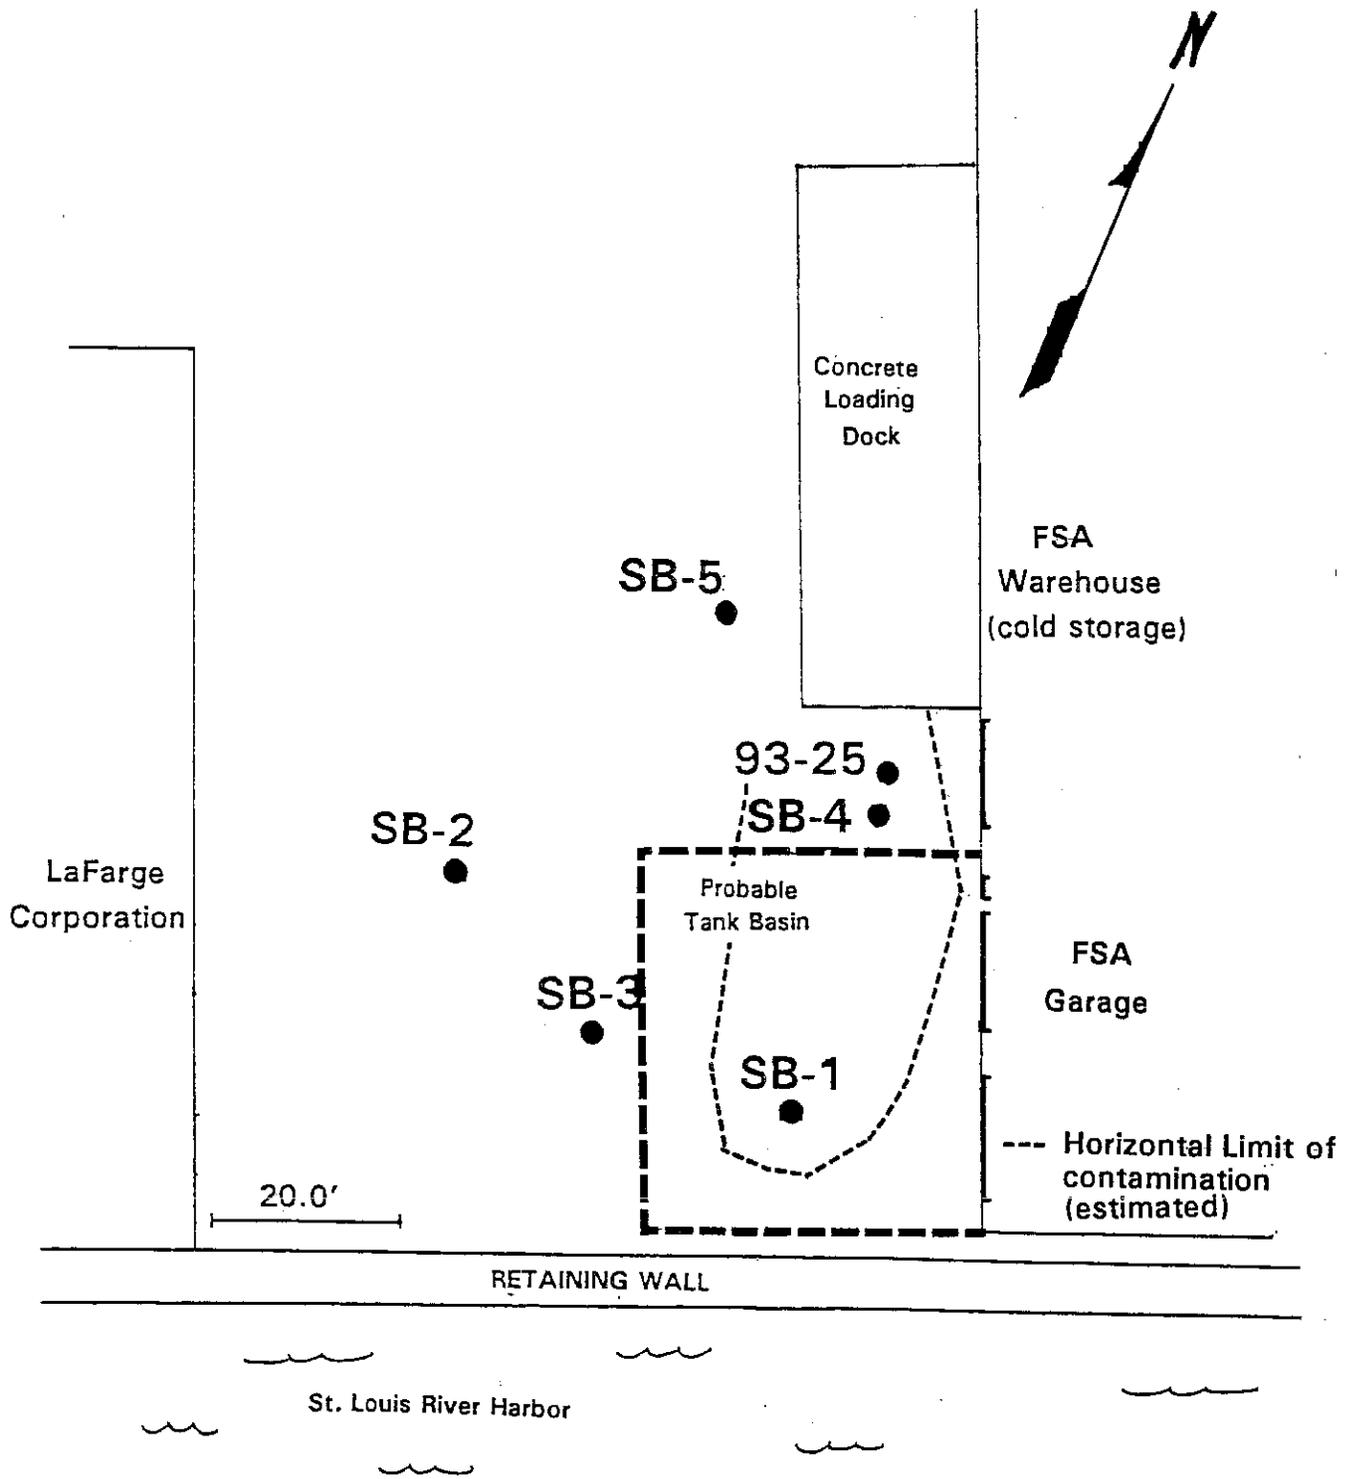
of the lighter components typical of gasoline, like the BTEX components. GRO was detected in the sample collected from the center of the excavation (SB-4, 11.0 feet) in a concentration of 19 parts per million (ppm), which is below the MPCA recommended action limit of 50 ppm for sandy soil. Contamination (toluene) was also detected in boring SB-5 at the 9.0 foot sample

The limit of the contamination was defined by data collected from field observations, headspace readings and chemical results. The horizontal and vertical limits represent limits of contamination that are below the MPCA Recommended Action Limit of 50 ppm of contamination in sandy soil (from headspace data and chemical analyses). Contamination was not detected in this investigation in concentrations above the MPCA limit of 50 ppm.

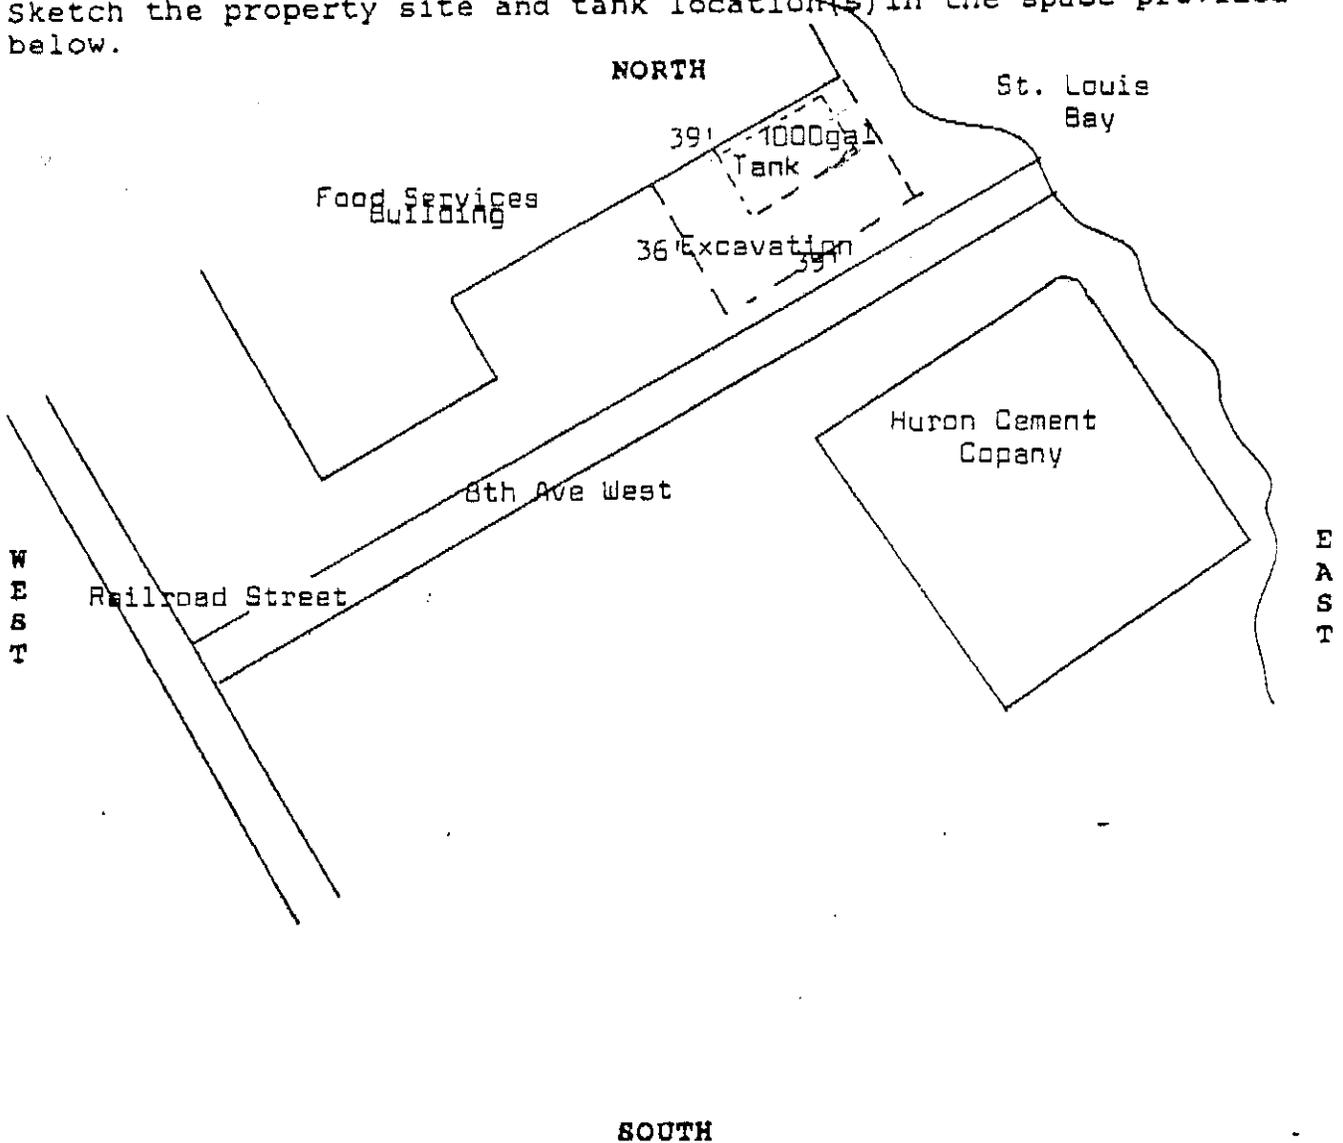
Sketch the property site and tank location(s) in the space provided below.

**ADDITIONAL COMMENTS, DETAILS AND DESCRIPTIONS:** The tank itself appeared to be in pretty good shape, all contaminated soil was removed to the best of the ability without destroying the standing structures. Because of high water table they were going to skim product off top of the water, then sponge off the rest before filling in with clean sand
