Engineering Company

April 14, 1992

Re: Limited Phase I Site Assessment
(Historical Records Review)
Bayfront Property
Duluth, Minnesota

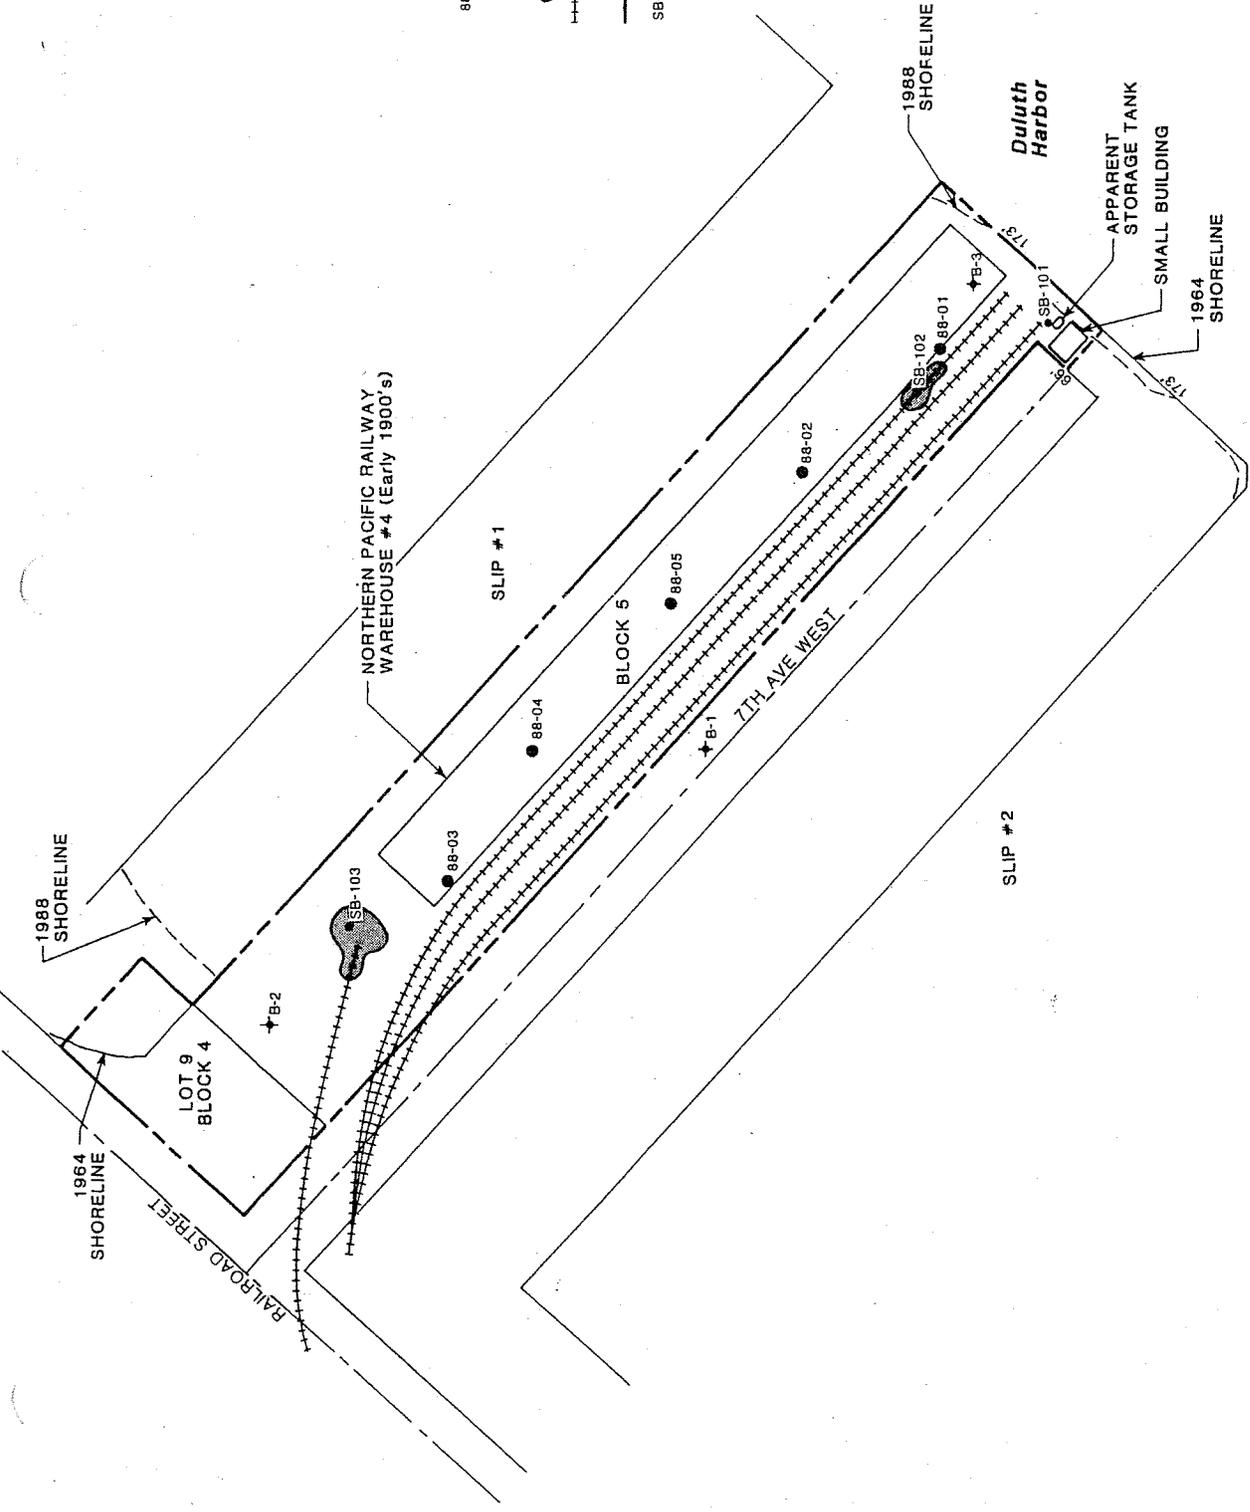
Figure 1
SITE MAP WITH
PROPOSED SOIL BORING LOCATIONS

Changes to the property observed on the 1964 aerial photograph were two areas of what appear to be soil staining. One of the areas was located northwest of the warehouse building, and the second area of staining was located near the end of the pier under a set of railroad tracks. An object which may be an aboveground storage tank was also observed in the northeast part of the Property. The presence of soil staining may indicate that a chemical release had occurred. The areas of soil staining are shown on Figure 1.

The previous investigations also reported the presence of petroleum product soil contamination near the southeastern end of the pier. This contamination was attributed to a surface spill. The historical data review suggests that the contaminated soil was located approximately 50 feet from the location of the suspected petroleum storage tank (1958 aerial photograph). This suggests that the presence of contaminated soil could have been the result of a tank release. The locations of the borings placed during the previous investigations are shown on Figure 1.

- Soil staining was visible on several aerial photographs at several locations on the Property. Although the aerial extent of staining was relatively limited, a likelihood exists that these stains are indicative of a chemical release.

Barr recommends placement of soil borings at locations identified as potential sources of chemical release (soil-stained areas and petroleum storage tank). Information collected will establish if a release requiring cleanup has occurred at those locations.

The proposed boring locations are shown on Figure 1. We recommend advancing the soil borings to the surface of the water table and collection of soil samples continuously throughout the depth of the boring. The soil samples should be screened in the field for the presence of volatile organic compounds, odor, oil sheen, and staining. Soil samples collected from the vicinity of the former petroleum storage tank (Boring SB-101) should be analyzed for total petroleum hydrocarbons, benzene, ethyl benzene, toluene, and xylenes. Soil samples collected from the vicinity of the stained soil areas (Borings SB-102 and SB-103) should only be submitted for laboratory analyses if evidence of contamination is observed.
