Addendum #1
File # 19-08AA
Final Design Services
Lake Superior Zoo Polar Shores/Bear Country Project

Subject: Structural Assessment of the Polar Shores Exhibit for Flood Damage
KO Job No: 121146

Polar Shores Exhibit at Lake Superior Zoo Structural Assessment of Flood Damage

Re: Bear Exhibit Condition Review
NCE Job No.: 19-020

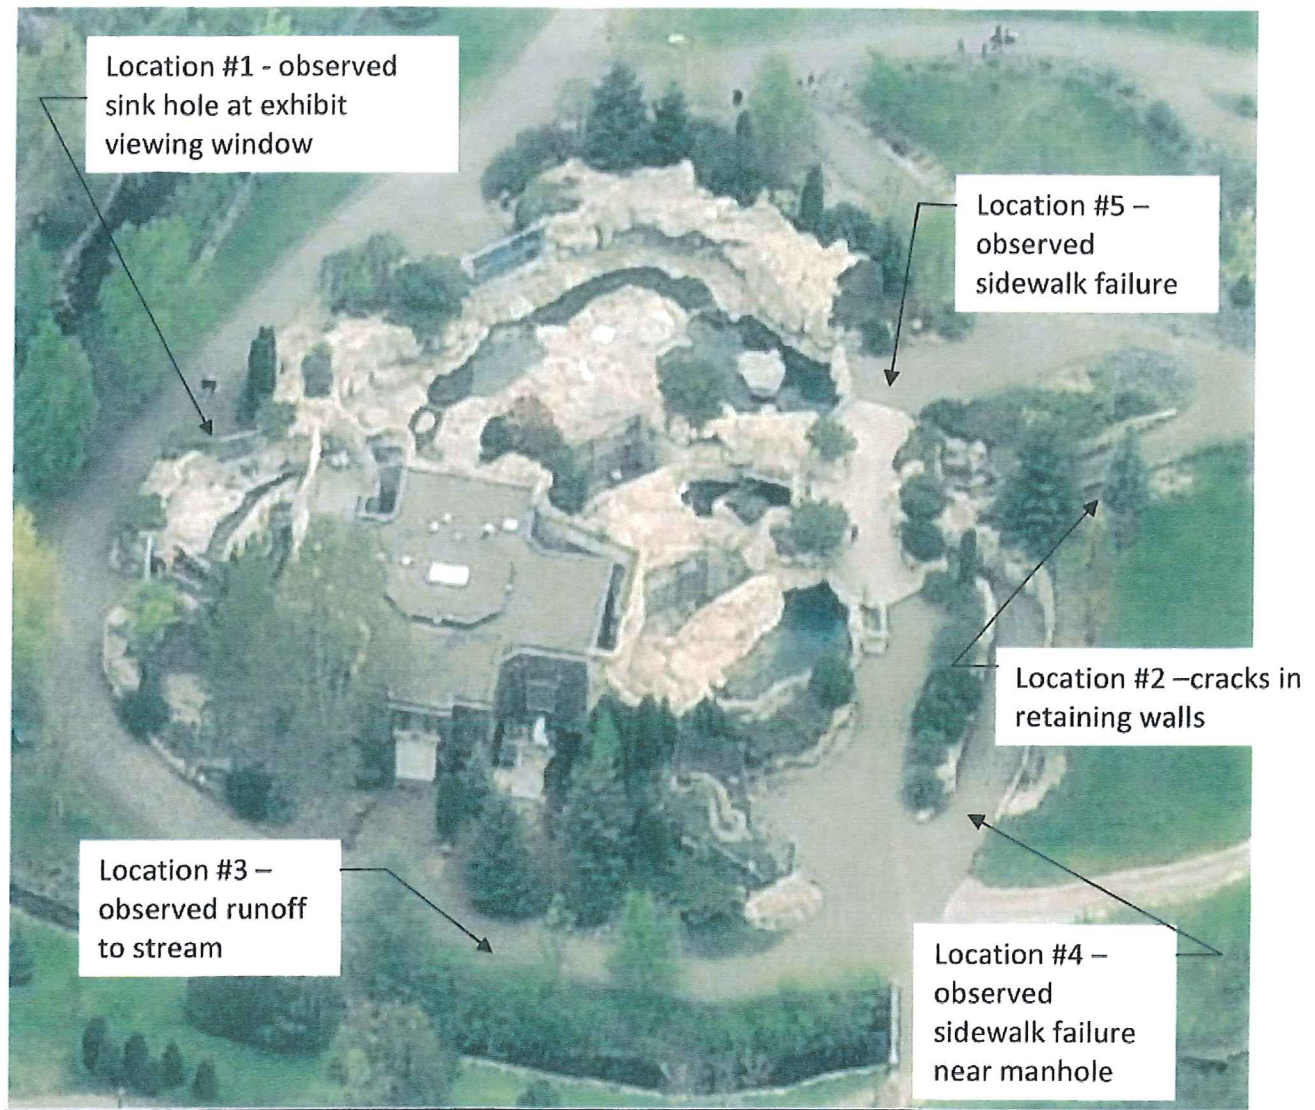
Figure 1 – Isometric Photo of the Polar Shore Exhibit at the Lake Superior Zoo

Figure 1 is an isometric aerial photo of the Polar Shore Exhibit at the Lake Superior Zoo. It is included for an overall reference to show the locations of witnessed sidewalk failures and sinkholes and to note locations of excavation. Please note that the photo is slightly outdated, since the cold-formed steel addition on the south west corner of the building is not shown, however it is a clear view of the exhibit for general reference and discussion.

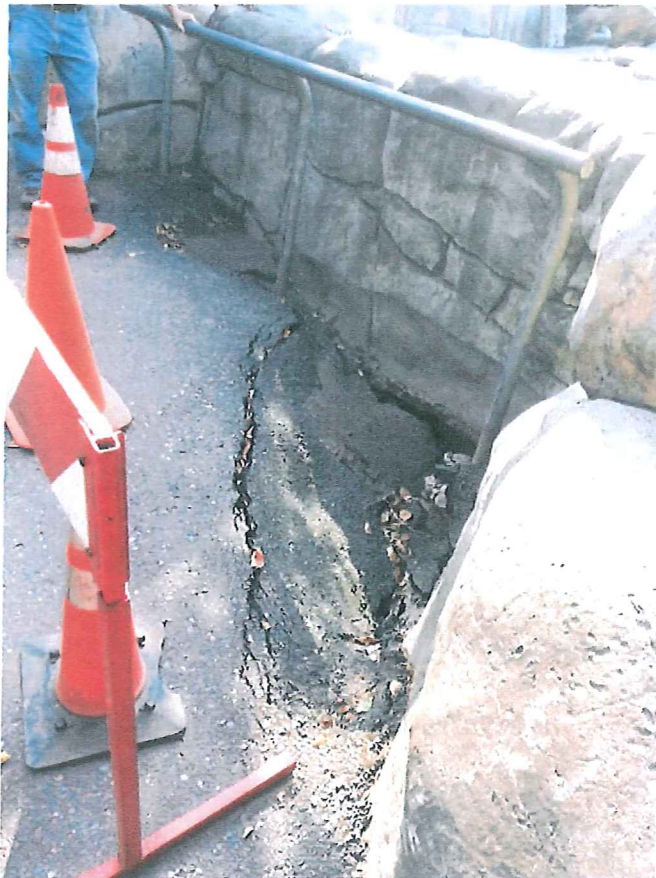
Figure 2: Sidewalk Failure

At Location #1 in Figure 1, a sink hole of the asphalt sidewalk was visible after the flood waters receded. Figure 2 shows the sidewalk after the flood. The visible rock work walls in the photo consist of shotcrete applied to a surface created by a welded-wire type mesh. The rock work was designed to considerably overhang the structural foundation by varying distances. It was not designed to be ground-supported.

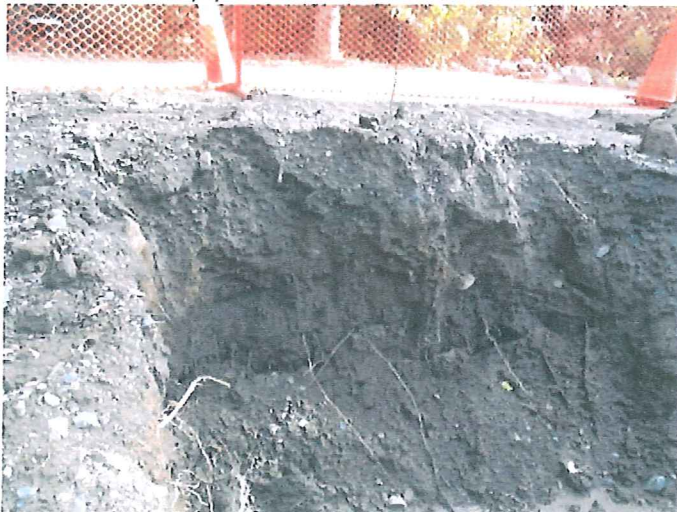
Figure 6 – Excavation near stream

Zoo personnel had shared witnessing water coming out the stream bank into the stream. We excavated a small section behind the stream bank to see if there was a broken water pipe in this area. No pipe was observed and the soil was well compacted. See Figure 6.

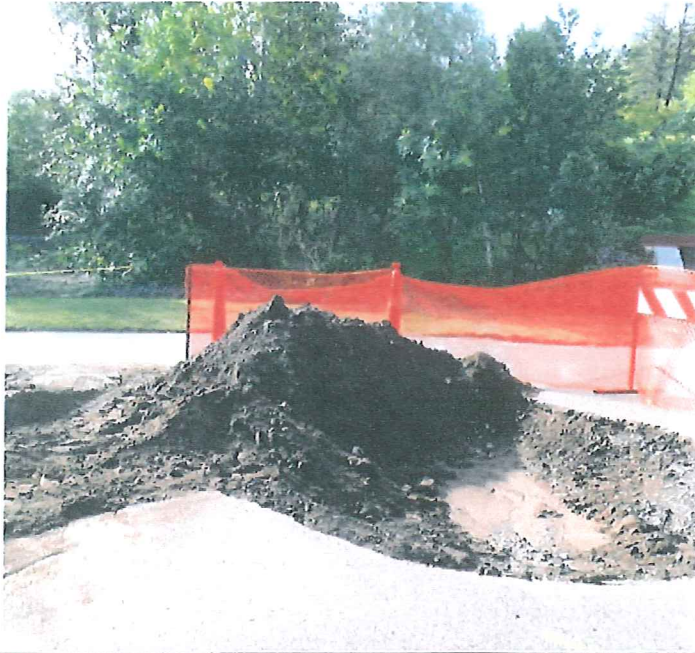
Figure 7 – Location #4 excavation near manhole

The asphalt sidewalk settled in these areas. Excavations were done to see the extent of the soil erosion. Location #4 was chosen since it was near a manhole. Location #5 was chosen because it was near the edge of the structural concrete supporting the upper exhibit viewing area. Figures 7 and 8 show these areas. In neither of the areas did the extent of soil erosion continue to adjacent structures causing structural concern.

After all the areas were observed, the fill was replaced and compacted to create a level walking surface. Any broken asphalt sidewalk pieces were removed. However, the sidewalk was not replaced.
