Arlington Soccer

Activities / Amenities

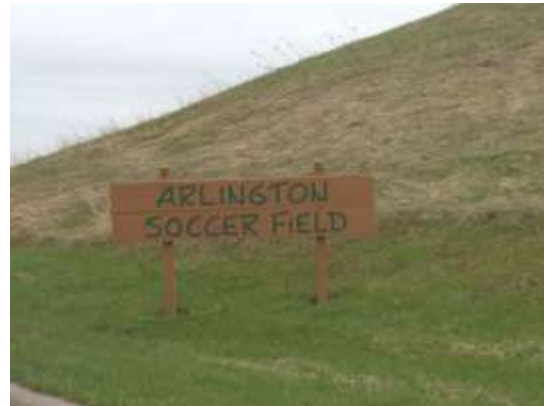
Route- Field 1

There is not currently an accessible route to the border of Field 1 or to the player seating (movable benches) on the far side of the field.

Priority 3- Create an accessible route to the boundary of the soccer field. (Approximately 60' from the driveway apron.) *ADA 206.2.2*

Priority 3- Create an accessible route to the player seating or relocate the player seating to an accessible location. *ADA 221.2.1.4*

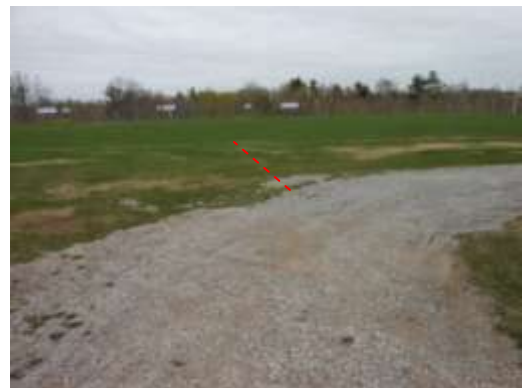
Route- Fields 2 and 3

There is not currently an accessible route to fields 2 and 3, which are located at the top of a hill.

Priority 1- Relocate games scheduled on fields 2 and 3 to an accessible location to accommodate participants and/or spectators as needed.

Priority 3- Create an accessible route to the boundary of the soccer field. *ADA 206.2.2*

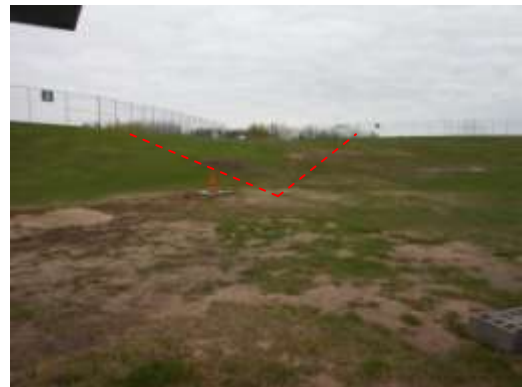
Route- Paul Antonich Field

There is not currently an accessible route to the boundary of Paul Antonich Field.

Priority 3- Create an accessible route to the boundary of the soccer field. (Approximately 160' from the driveway apron; a shorter route may be created directly from the parking lot.) *ADA 206.2.2*

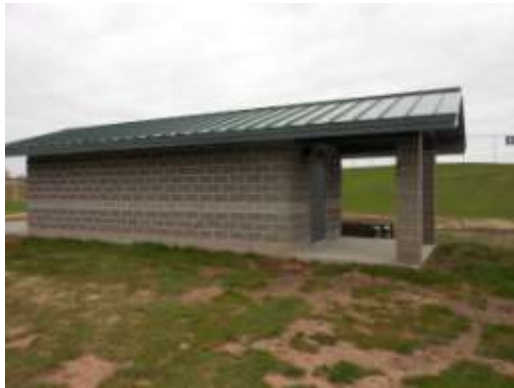
Route

There is not currently an accessible route provided to the building used for storage (and electrical) by the soccer association. (Note: the building provides adequate door width and lever style hardware.)

Priority 3- Create an accessible route to the storage building. *ADA 206.2.2*

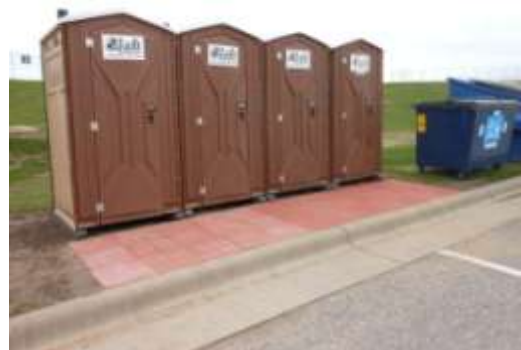
Portable Toilets

There are currently 4 portable toilets located on a paver pad near the parking lot. Currently none of the portable toilets is a larger/accessible style and there is not an accessible route. (In addition to the curb, the route to the portable toilets can be blocked by parked vehicles.)

Priority 2- Provide a minimum of 1 larger/accessible style portable toilet at an accessible location. *ADA 206.2.2, 213.2 Exception 3*

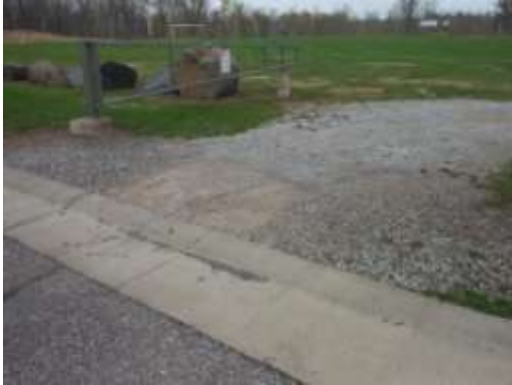
Driveway Apron

There is a driveway apron for the gravel service road at the curb. The surface is currently rough, with changes in level exceeding 1/2".

Priority 2- Patch and repair in order to use the driveway apron as part of an accessible route to the soccer fields and storage building. *ADA 403.2, 406.1*

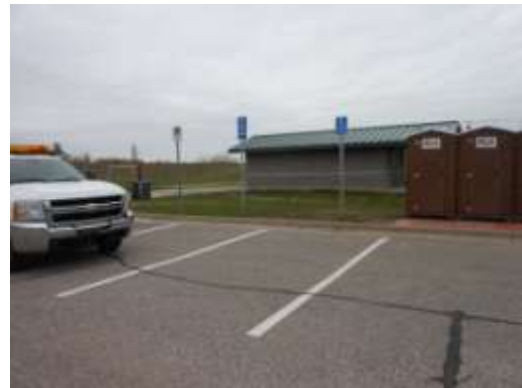
Parking

The designated accessible spaces are currently 9' wide and do not provide an aisle.

The signs designating the accessible parking spaces are currently at 90" AFF.

Priority 2- Restripe the accessible parking spaces to provide an 8' wide minimum space with an 8' wide minimum aisle. (Note: 2 spaces can share an aisle.) *MN1341 502.4.2*

Priority 3- Lower the parking signs so the bottom edge is 60"-66" above the surface of the parking space. *MN1341 502.7*
