# Enger Tower

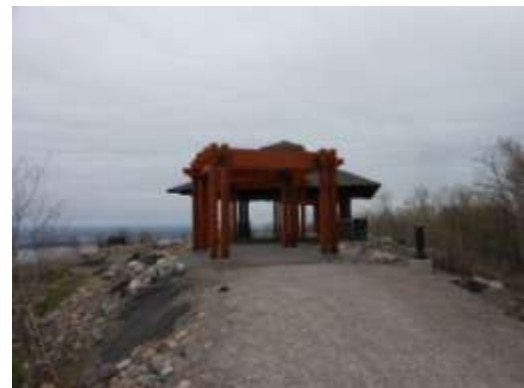
There are 2 routes provided from the parking lot to the pavilion- steps and a switch back route with a soil surface. The surface of the switch back route does not currently comply with the requirements for an accessible route.

**Priority 2-** Provide a firm and stable surface and remove any roots and rocks along the switch back route. *Recommended based on Draft Accessibility Guidelines for Outdoor Developed Areas 1016.2, 1016.5.2*

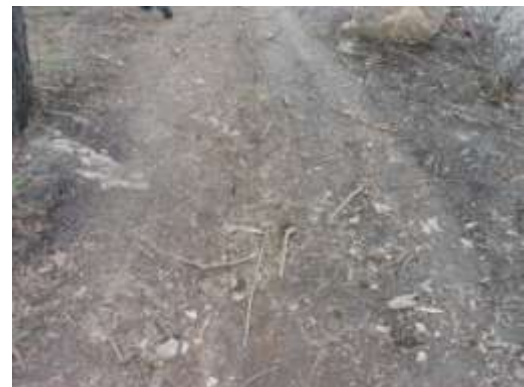
There are approximately 20 picnic tables scattered throughout the park, located in the grass. There is not currently an accessible route provided to the picnic tables or to any of the grills. Four tables with knee and toe clearance have been provided.

**Priority 2-** Provide a table with knee and toe clearance at an accessible location. *Recommended based on Draft Accessibility Guidelines for Outdoor Developed Areas 1011.4*

**Priority 3-** Create an accessible route to the grill.

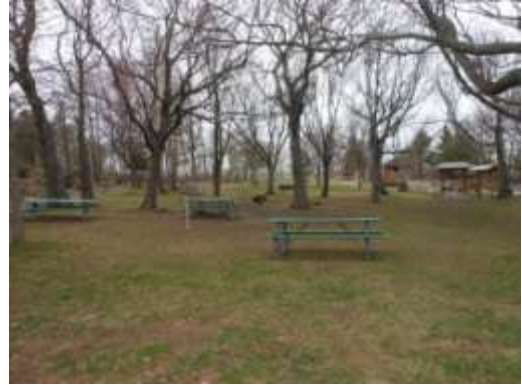
There is a picnic shelter associated with the toilet room building. At the time of site visit there were 3 tables, including 1 with knee and toe clearance. This picnic area will be eliminated as part of the planned expansion and remodel of the toilet rooms.

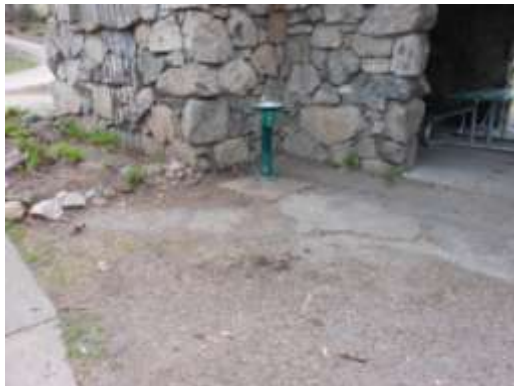
There is a single drinking located adjacent to the toilet room building. The drinking fountain provides a single spout at 38".

**Priority 3-** Add an additional drinking fountain with a spout at 38"-43". *ADA 211.2, 602.7*

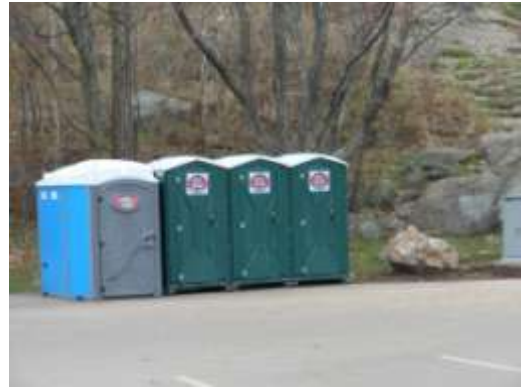
There are currently 4 portable toilets located in the parking lot, including 1 larger/accessible unit. *This is a good example of accessibility.*

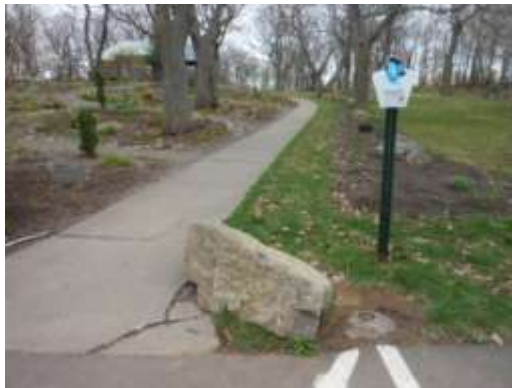
There is an informational sign located near the parking lot, approximately 3' from the accessible route. The sign provides information on how to access audio descriptions via cell phone.

**Priority 3-** Relocate the interpretive signs so they are positioned on the accessible route and provide a larger font size. *Recommended based on National Park Service Interpretive Media Guide.*

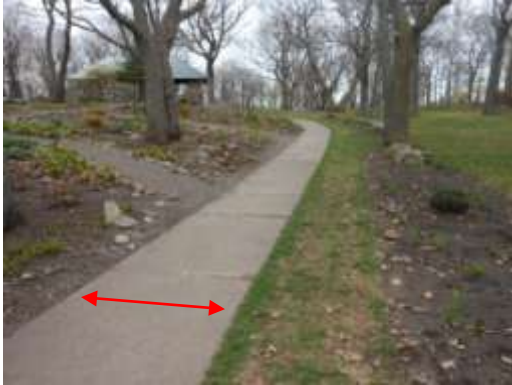
The slope of the route leading from the parking lot to the toilet building is currently as steep as 5.6%.

(Slopes between 5% and 8.33% are considered a ramp and require handrails.)

The width of the route is currently 4'-6" and does not provide passing space.

**Priority 3-** At such time the sidewalk/path is replaced, re-route to reduce the slope. *ADA 403.3, 405.2*

**Priority 3-** At such time the sidewalk/path is replaced, widen to 60" minimum or add passing spaces every 200'. *ADA 403.5.3*

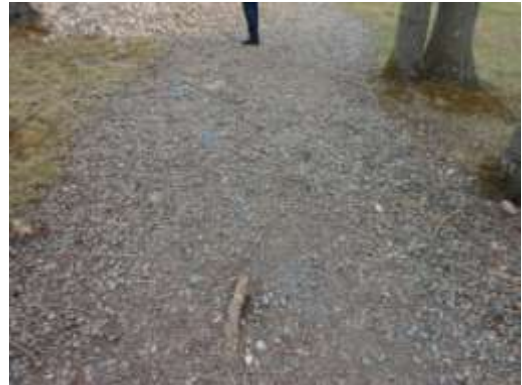
There is not currently an accessible route to the Asian Pavilion at the north end of the park. The existing surface is crushed rock.

**Priority 3-** Create an accessible route to the Asian Pavilion. *ADA 206.2.2*

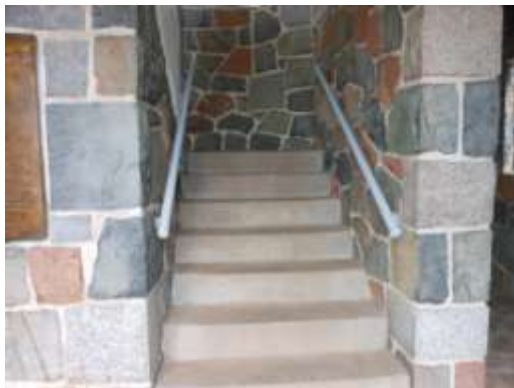
The tower is located on the top of a hill, located to the west of the parking lot. The route from the bathroom building to the entry to the tower is currently as steep as 15.8%.

**Priority 1-** Modify the policy to allow an individual to drive to the top of the hill, near the entry to the tower.

**Priority 2-** Reconstruct the route to the entry to the tower so the slope does not exceed 5% (without handrails) or a ramp with a slope as steep as 8.33% (with handrails).

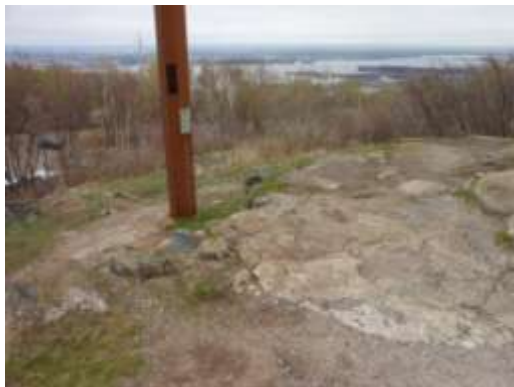
There are 85 steps from the entry of the tower to the top observation level. An accessible route is not currently provided. (It is not technically feasible to add an elevator to the tower.)

**Priority 2-** Utilize alternate methods (such as webcam) to provide users who choose not to reach the top of the tower a virtual experience.

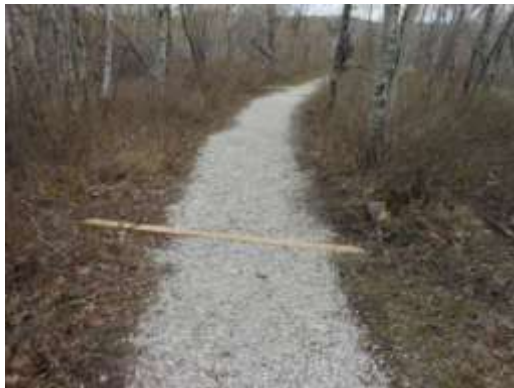
The Superior Hiking Trail passes through the park. This segment of the trail is not currently accessible.

**Priority 3-** At such time the trail is altered or rerouted, provide accessibility to the maximum extent feasible. *Recommended based on Draft Accessibility Guidelines for Outdoor Developed Areas F247.1, 1017*

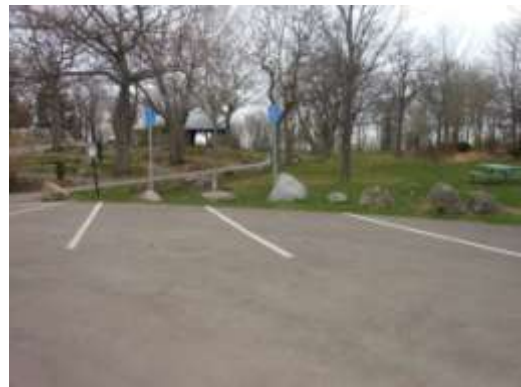
There are currently 2 parking spaces designated as accessible. The spaces are currently 9'-6" wide and do not provide an aisle.

The signs designating the accessible parking spaces are currently at 88" AFF.

**Priority 2-** Restripe the accessible parking spaces to provide an 8' wide minimum space with an 8' wide minimum aisle. (Note: the 2 spaces can share an aisle.) *MN1341 502.4.2*

**Priority 3-** Lower the parking signs so the bottom edge is 60"-66" above the surface of the parking space. *MN1341 502.7*
