Lester Golf Course

Activities / Amenities

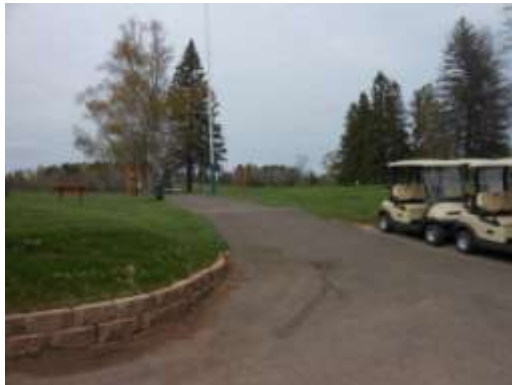
View of Golf Course

A hard surface route is provided throughout the golf course. There are no curbs that obstruct the route of golf cars. *This is a good example of accessibility.*

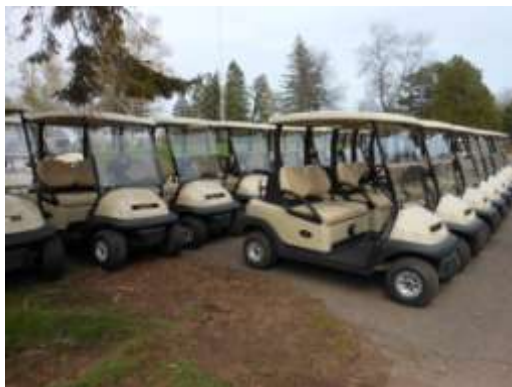
Golf Cars

There are currently golf cars available for rent. Currently none of the cars can be operated by hand controls.

Priority 2- Acquire a golf car that can be operated with hand controls.

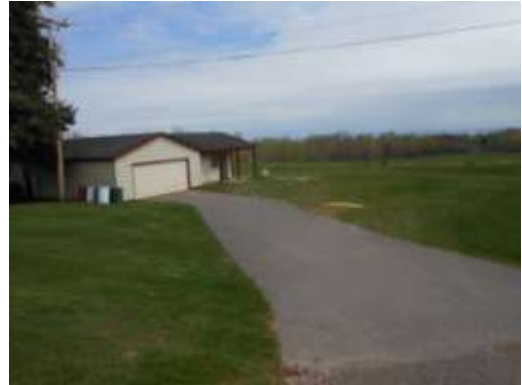
Route

An accessible route is not currently provided from the parking lot to the driving range building and the tee boxes of the driving range.

Priority 2- Create an accessible route to the driving range building and the tee boxes. *ADA 206.2.2, 206.2.15*

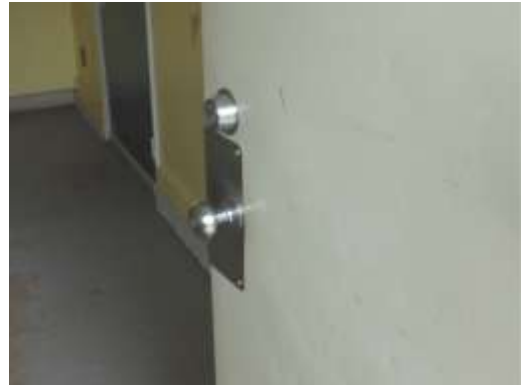
Building

There are currently knobs used at 2 locations in the driving range building.

Priority 3- Replace the knob style hardware with a style that does not require any grasping, pinching or twisting of the wrist to operate (such as a lever). *ADA 309*

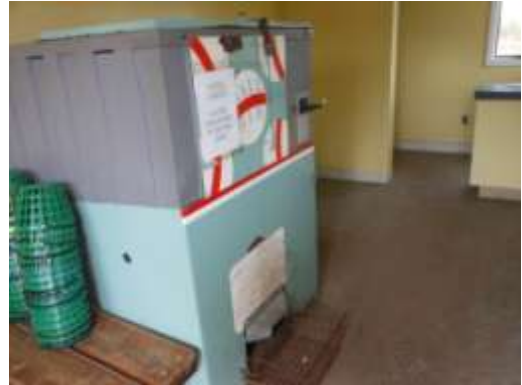
Ball Machine

There is a self-service machine for range golf balls. The collection area is currently on the floor, below the reach range (15"-48").

Priority 3- At such time the machine is replaced, ensure that all operable parts (money slot and collection point) are located within reach range. *ADA 308*

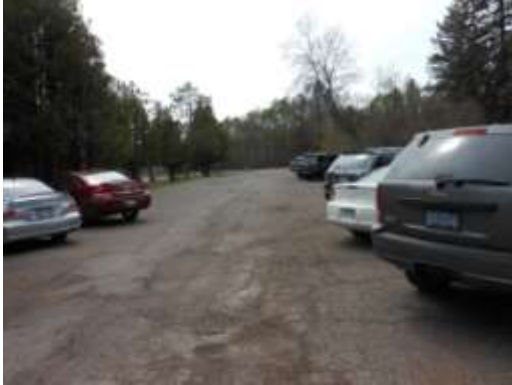
Quantity

There is room for approximately 120 vehicles in the parking lot, including 4 spaces designated as accessible. Based on the total number of parking spaces, a minimum of 5 accessible parking spaces are required.

Priority 2- Designate 1 additional accessible parking space. *ADA 208.2*

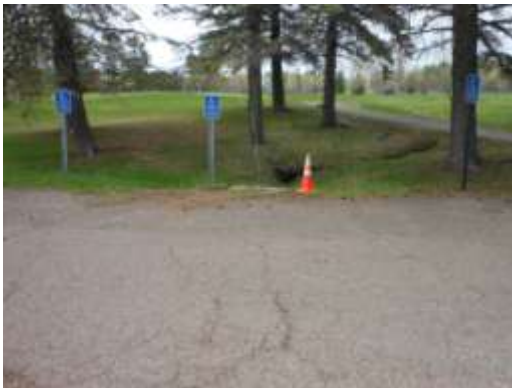
Parking

The designated accessible spaces are not currently striped and do not provide an aisle.

Three of the signs designating the accessible parking spaces are currently too low.

Priority 2- Restripe the accessible parking spaces to provide an 8' wide minimum space with an 8' wide minimum aisle. (Note: 2 spaces can share an aisle.) *MN1341 502.4.2*

Priority 3- Raise the parking signs so the bottom edge is 60"-66" above the surface of the parking space. *MN1341 502.7*
