Park Point

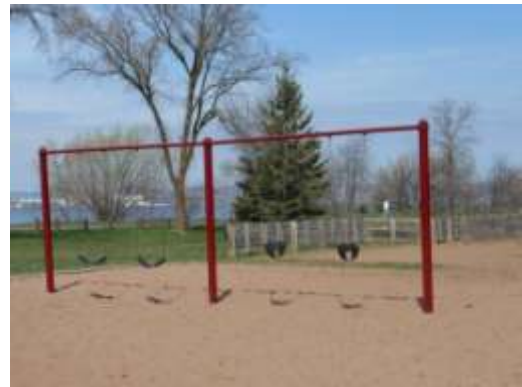
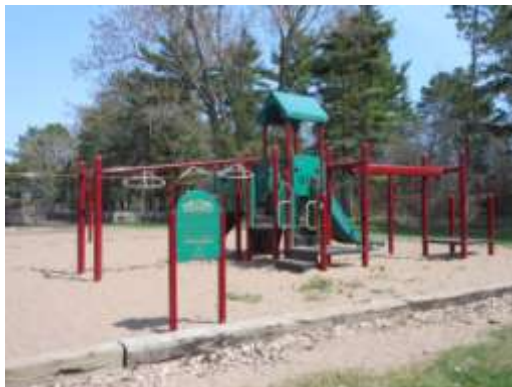
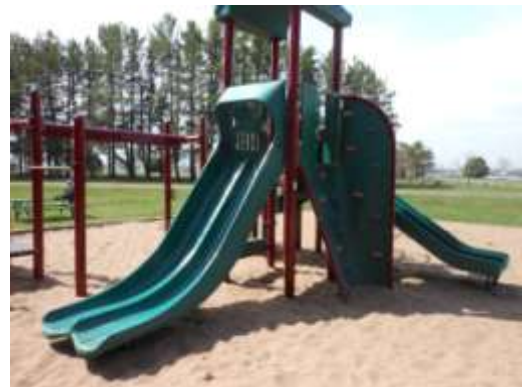
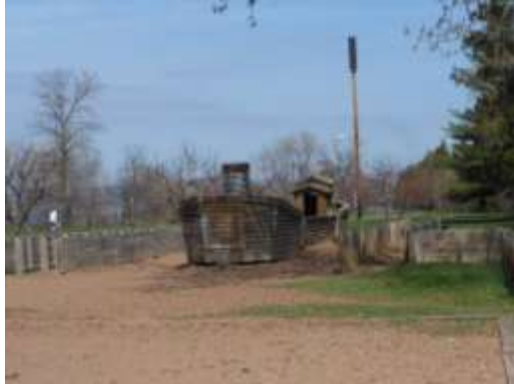
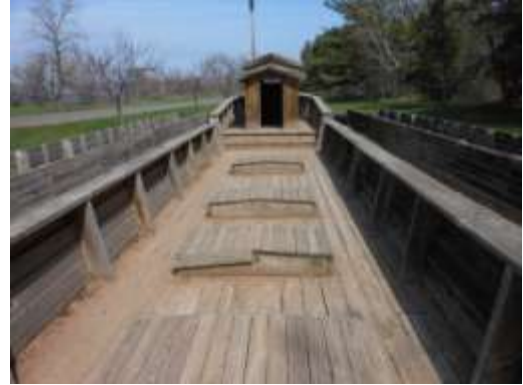
Defined Play Area

The defined play area includes 1 composite play structure, to-fro swings (2 strap style, 2 bucket style) and a 'ship' play structure. An adequate quantity of ground level components have been provided. *This is a good example of accessibility.*

Loose fill sand is used throughout the defined play area.

Priority 2- Replace the loose fill sand with a surface material with a type that complies with ASTM 1292 for impact attenuation and ASTM 1951 for accessibility. *ADA 206.2.17*

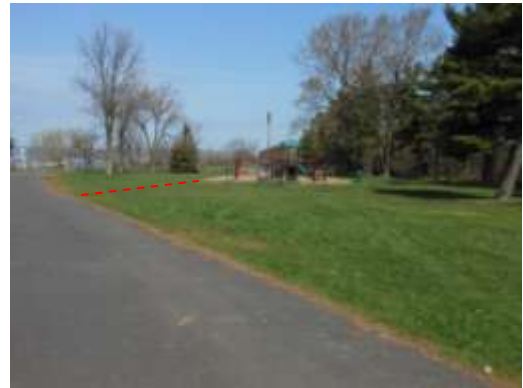
Defined Play Area- Route

There is not currently an accessible route to the defined play area.

Priority 1- Create an accessible route to the defined play area. (Approximately 45'.) ADA 206.2.2

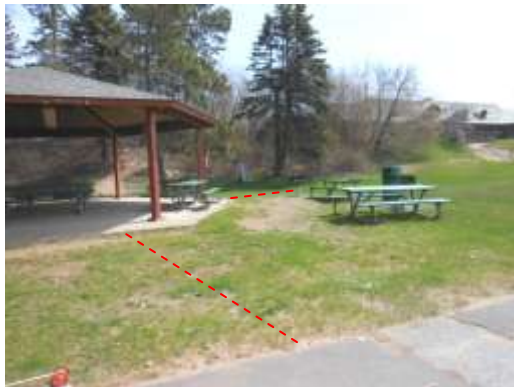
Picnic Pavilions

There are 2 covered picnic pavilions located near the north end of the park. There is not currently an accessible route to the pavilion or the nearby grill. There are 4 tables under 1 pavilion and 5 tables under the other; currently none of the tables provide knee and toe clearance.

Priority 2- Create an accessible route to the picnic pavilion to the east (approximately 17').

Recommended based on Draft Accessibility Guidelines for Outdoor Developed Areas F245.2

Priority 3- Provide a picnic table that provides knee and toe clearance. *Recommended based on Draft Accessibility Guidelines for Outdoor Developed Areas 1011.4*

Priority 3- Add an accessible route to the grill or relocate the grill to an accessible location.

Recommended based on Draft Accessibility Guidelines for Outdoor Developed Areas 1011.1

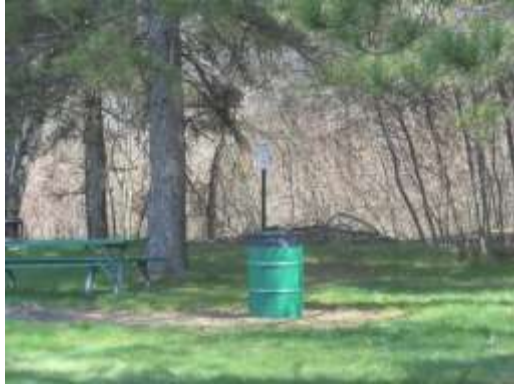
Picnic Tables- Scattered

There are approximately 20 picnic tables scattered throughout the park, located in the grass. There is not currently an accessible route provided to the picnic tables or to any of the grills. Four tables with knee and toe clearance have been provided.

Priority 2- Provide a table with knee and toe clearance at an accessible location. *Recommended based on Draft Accessibility Guidelines for Outdoor Developed Areas 1011.4*

Priority 3- Create an accessible route to the grill.

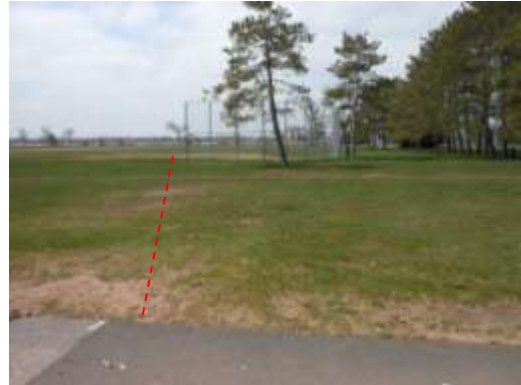
Route

There is a backstop for a baseball field near the parking lot. An accessible route is not currently provided.

Priority 3- Create an accessible route to the boundary of the baseball field. (Approximately 100')
ADA 206.2.2

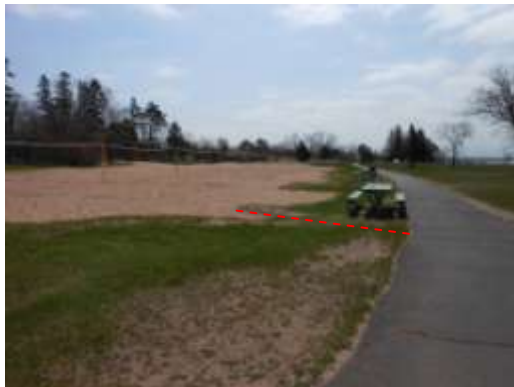
Route

There are 6 sand volleyball courts located in front of the beach house. An accessible route is not currently provided.

Priority 3- Create an accessible route to the boundary of the volleyball courts. (Approximately 18')
ADA 206.2.2

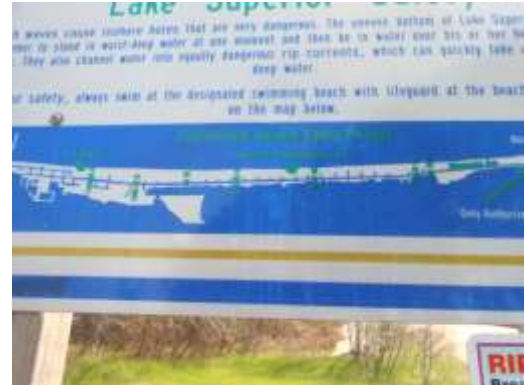
Beach House

The main beach (with lifeguard stands) is located at the beach house. An accessible route has been provided to the beach house, but does not continue from the back of the beach house to the water.

Priority 1- Create an accessible route to the water from the beach house. (Approximately 150').

Recommended based on Draft Accessibility Guidelines for Outdoor Developed Areas F248.1, 1018

Priority 3- Create an accessible route to the water from the other 3 authorized beach access points.

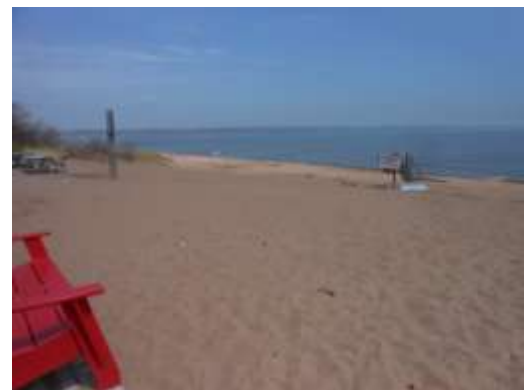
Dune Crossing

The authorized beach access points require crossing dunes; boardwalks have been installed to protect the dunes. The spacing between the boards currently exceeds 1/2".

Priority 3- As the boardwalks are replaced and/or maintained, ensure the spacing between the boards does not exceed 1/2". *ADA 1018.6*

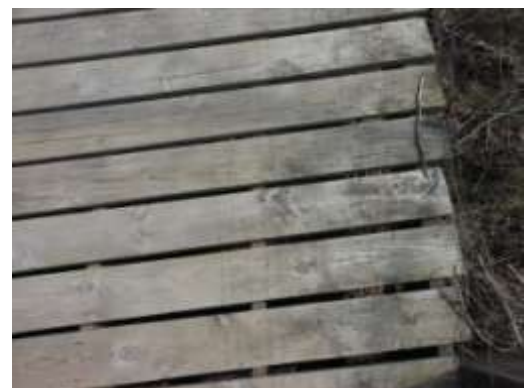
Dune Crossing

The boardwalk at the Barrens access point currently has a slope as steep as 9.5% and does not provide handrails.

Priority 2- Add handrails where the slope exceeds 5%. *Recommended based on Draft Accessibility Guidelines for Outdoor Developed Areas 1018.10, 505*

Priority 3- Reconstruct the boardwalk so the slope does not exceed 8.33%. *Recommended based on Draft Accessibility Guidelines for Outdoor Developed Areas 1018.7*

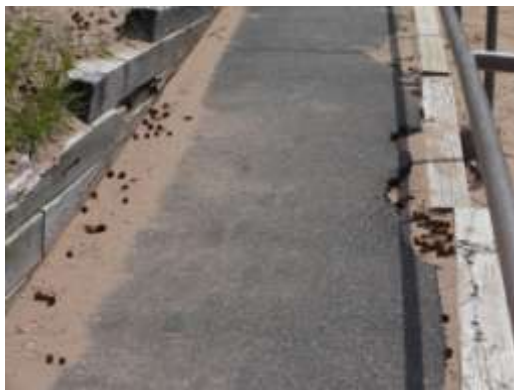
Exterior Route

The ramp that leads to the main entry of the Beach House is currently washed out at multiple locations.

Priority 2- Repair the sections of the ramp that have washed out. *ADA 403*

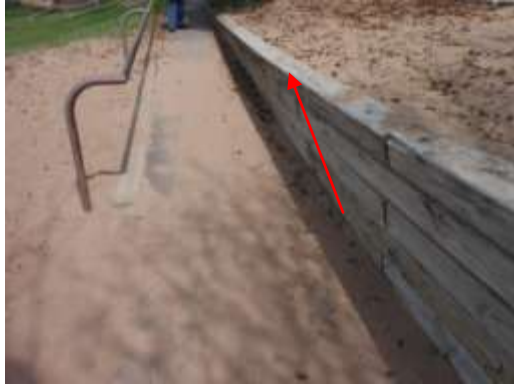
Exterior Route

The retaining wall along the ramp is beginning to tip, reducing the clear width of the ramp.

There is currently a handrail on 1 side of the ramp.

Priority 3- Repair or reinforce the retaining wall so it is not tipping.

Priority 2- Add a handrail to the retaining wall side of the ramp. *ADA 405.8*

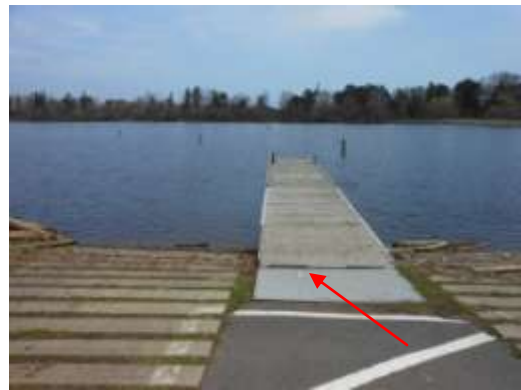
Boat Launch

There is currently a vertical rise greater than 1/2" at the entry to the boarding pier.

Priority 3- Replace the transition plate or bevel so the vertical rise does not exceed 1/2". *ADA 303*

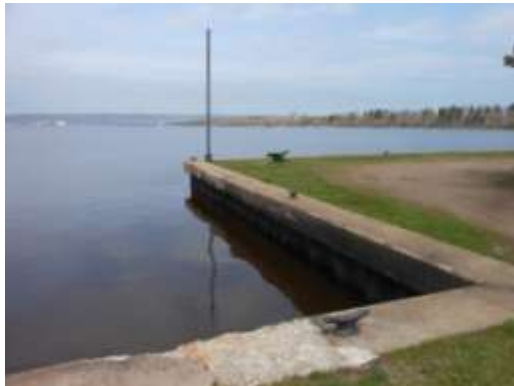
Dock

A traditional dock is not provided at this location, however cleats have been provided to tie-up boats along the perimeter of the peninsula. There is not currently an accessible route to any of the cleats.

Priority 3- Create an accessible route to 1 tie-up location. *ADA 235.2, 1003.2*

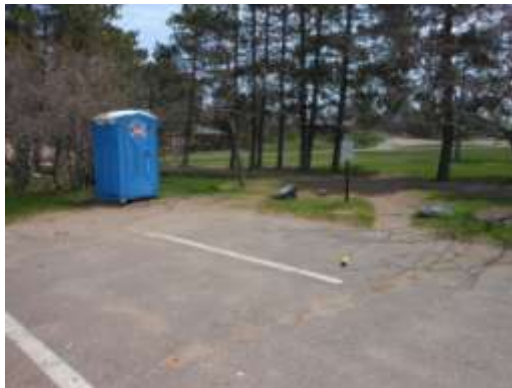
Portable Toilets

Portable toilets are provided at 3 locations in the park- the main parking lot, the south parking lot (Barrens access point) and near the boat launch. Currently none of the portable toilets provide features of accessibility.

Priority 2- Provide a minimum of 1 portable toilet that is a larger/accessible style and located on an accessible route. (JQP, Inc. recommends it be located near the main parking lot.)

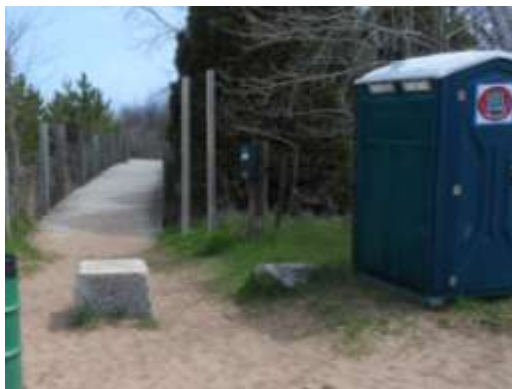
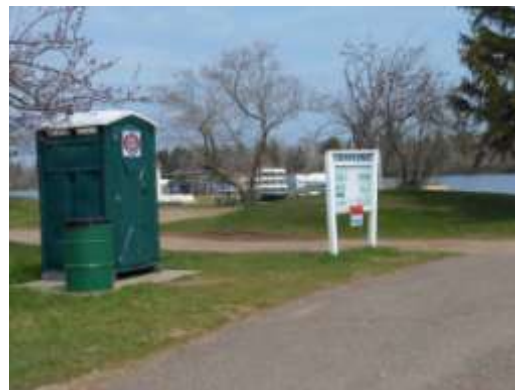
Accessible Route

Asphalt paths have been provided through the main areas of the park. The asphalt path does not currently connect to the north or south parking lots.

Priority 2- Create an accessible link between the parking lot and the asphalt route/path. *ADA 206.2.2*

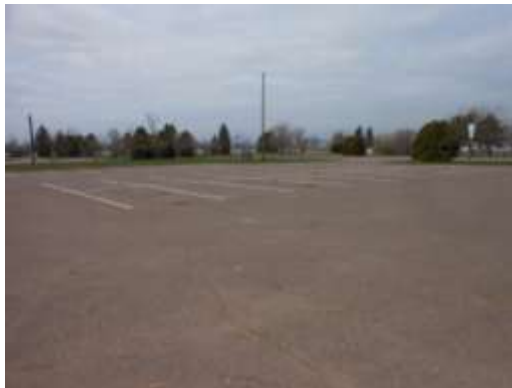
Parking- Pullout

There is room for approximately 77 vehicles along the road in designated pull-outs. Currently no parking spaces have been designated as accessible. Based on the total number of parking spaces, a minimum of 4 accessible parking spaces are required.

Priority 2- Designate 4 accessible parking space.

ADA 208.2

Note: These 4 spaces can be located in the north or south lot.
