GOLF COURSE ARCHITECTURAL ASSESSMENT

EXECUTIVE SUMMARY

The City of Duluth, Minnesota owns two (2) twenty-seven hole golf courses – Lester Park and Enger Park. The following is a summary of an on-site assessment conducted on July 25 and 26, 2018 by Kevin Norby of Herfort Norby Golf Course Architects.

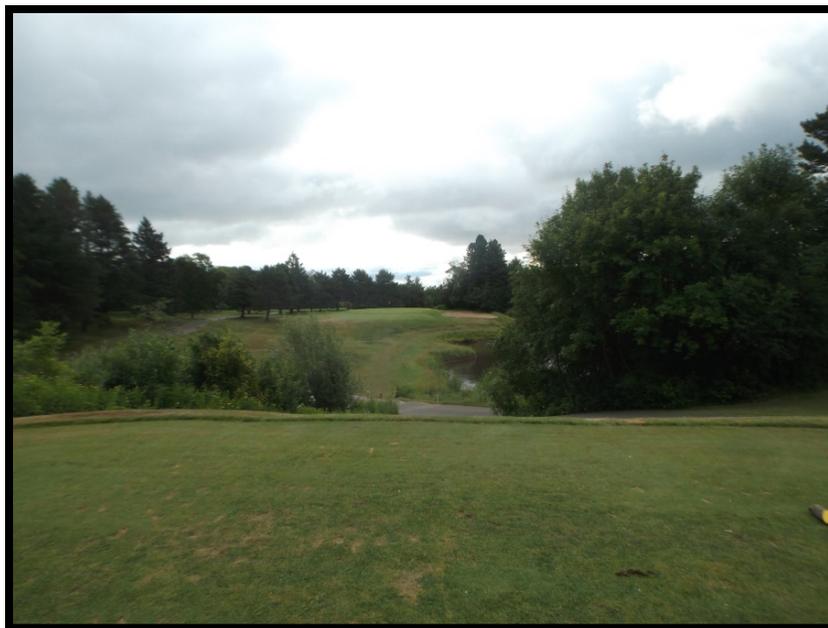
Historically, water from five wells and water from two creeks supplied water for irrigation to two irrigation ponds located on hole 8 on the Middle Nine (hole 17) and hole 5 on the Front Nine. Prior to 2012, Coffee Creek supplied runoff to a pond on hole 5 but this pond was abandoned after the dike failed during a large storm. The pond was never rebuilt. Prior to 2016, Buckingham Creek supplied water to the pond on the right side of hole 17. However, in recent years, the Minnesota Department of Natural Resources (DNR) has placed restrictions on the water supplied via Buckingham Creek and has diverted water from the creek around the irrigation pond thereby significantly reducing the City's availability for irrigation water. According to Director of Agronomy Dale Wesselman, the DNR has asked that the City excavate a new pond for irrigation and permanently cease irrigating with water from the designated trout stream.

Photo 3: The course has historically used natural runoff and well water to irrigate the golf course. Only two wells are working, and stream runoff is no longer available. Hole 8 on the Middle Nine.

Immediate improvements should include excavation of a new irrigation pond and installation of a new irrigation system including replacement of the pump station, central control, and field satellites. In addition, the water supply needs to be increased to provide for a minimum of 1,200 gallons per minute. This can be done by a combination of drilling new wells and increasing the use of City water. A new irrigation system will provide improved coverage and control so that water can be placed more efficiently where it is needed. It is estimated that a new 18-hole double-row system will cost between \$1.2 million and \$1.4 million depending on soil conditions, pipe sizing and the total number of heads. A complete 27-hole system will likely cost \$2.1 million.

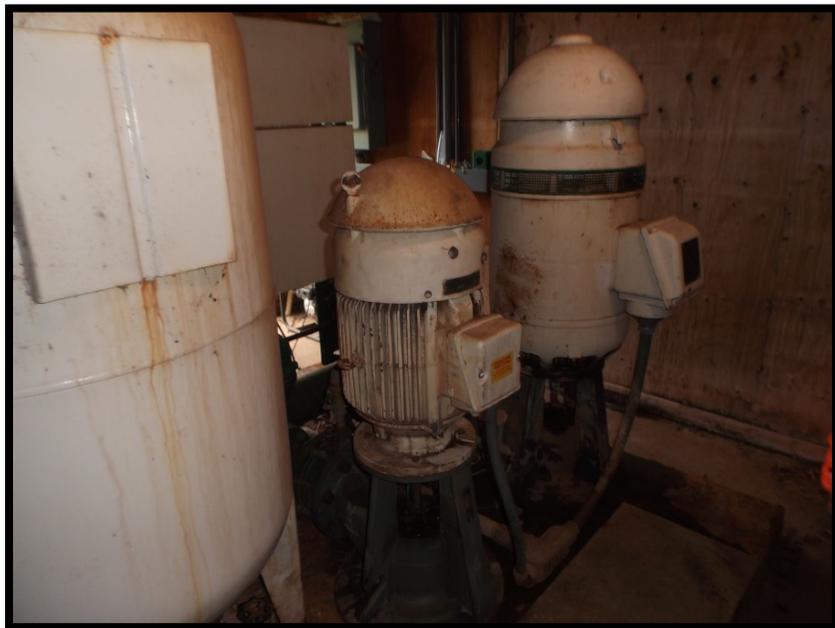
Historically, the course had two irrigation pumping stations. The pump station which was located on hole 5 near Coffee Creek, which was capable of pumping approximately 500 gallons per minute, was abandoned when the pond levee failed in 2012. The remaining pump station

located on hole 8 near Buckingham Creek, consists of a 60-horse vertical turbine with a variable frequency drive (VFD) and a smaller 25 horse pump which together are capable of pumping approximately to 850 gallons per minute. Typically, an 18-hole course in the upper mid-west would require 1,000 gpm while a 27-hole course would require 1,300 to 1,500 gpm. The remaining pump station is in very poor condition with excessive rust and leaks. As noted in the May 2015 Irrigation Water Use and Storage Study by Irrigation Technologies, the irrigation pump station is “well past its useful life cycle and catastrophic failure could occur at any time. Pump station replacement is the only option and should be considered a top priority”.

Although the system was at one time quite good, the system is not being utilized to its capacity because the course has a severe shortage of water and because of the poor condition of the piping and control system. In fact, during dry periods, the golf course staff can only irrigate critical areas such as putting greens and, as a result, fairways, and roughs are allowed to decline.

Photo 2: The irrigation pumps at Enger Golf Course are only capable of pumping 850 gpm.

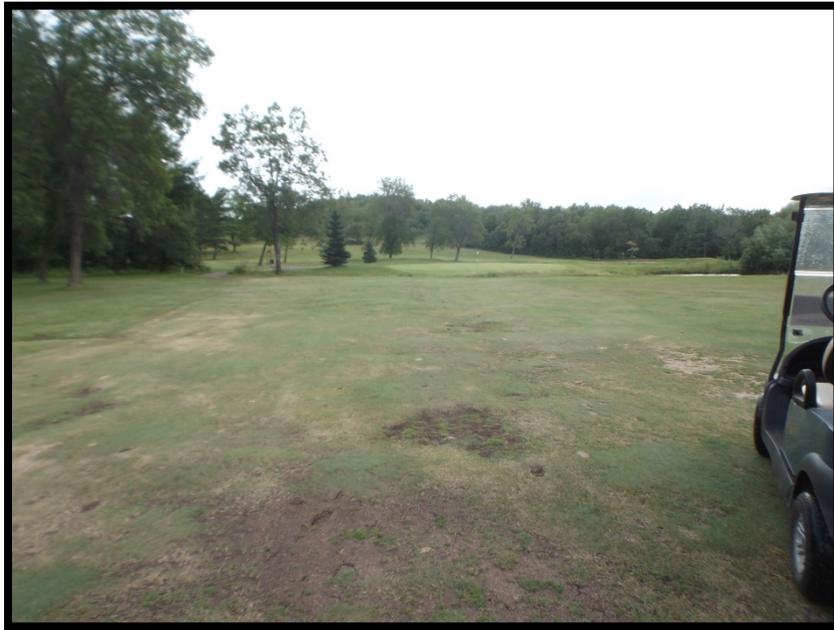
Photo 4: Poor turf conditions due to lack of water, poor drainage & compaction.

Overall, the fairways and rough turf conditions at Enger Park would be considered quite poor. On the Front and Middle Nines, fairways are dry and turf conditions suffer due to lack of irrigation. On the Back Nine, portions of the holes are dry and under irrigated while other low-lying areas are un-even and extremely bumpy due to poor soil conditions and lack of drainage. These “washboard” fairways and pockets of standing water lead to persistent issues with ice damage and poor turf quality.

Our recommendation would be to correct drainage and to re-grass the fairways in order to improve turf conditions, playability, and on-going maintenance. Because the Front Nine is better drained and in slightly better condition than the Middle and Back Nines, we have listed the regrassing of the Front Nine as “Competitive” rather than “Critical”. However, it should be noted that, ideally, all of this work would be done at the same time to create consistent playing conditions throughout all 27-holes. This work would be done by using a specialized piece of equipment such as a Blecovator or a Rotodarian to till and loosen the top few inches of soil. The affected areas would then be regraded to increase surface drainage followed by the installation of sub-surface drainage pipe and re-grassing. It should be noted that, although it is possible to regrade and re-grass the fairways without replacing the irrigation system, ideally this would all be done at the same time.

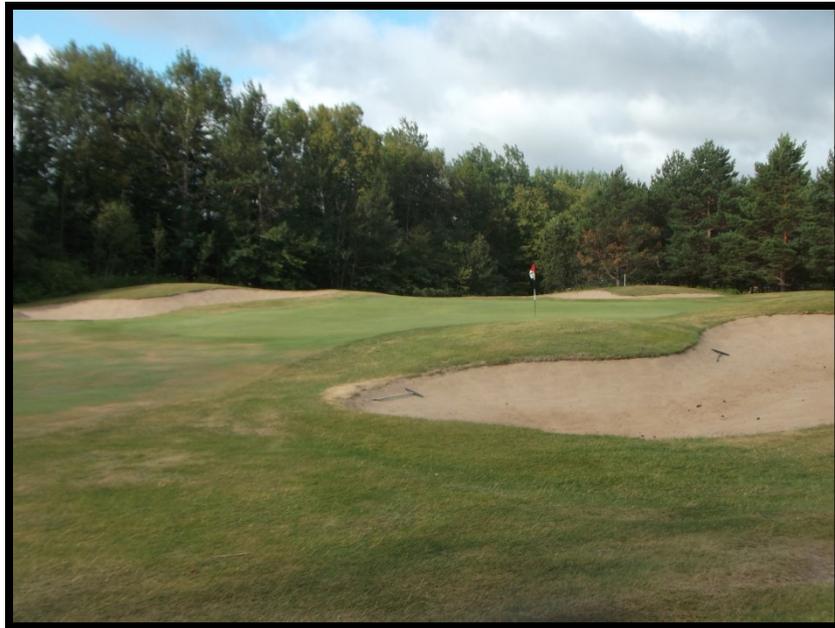
The greenside bunkers on the Front and Middle Nines at Enger Park Golf Course were renovated in 2011. No work was done to the fairway bunkers or any bunkers on the Back Nine. The bunkers that were renovated had new sand and bunker liners installed in an attempt to minimize future contamination. Unfortunately, the underlying problem of erosion into the

bunkers was not addressed so the edges continue to collapse, and the new sand is becoming contaminated. The bunkers are quite large and require a significant amount of time and expense to maintain. In addition, many of the bunkers are poorly located so as to unfairly impact the entry-level or high handicap golfer.

Photo 5: Large bunkers require excessive maintenance due to size and erosion.

It is our recommendation that the fairway bunkers and the bunkers on the Back Nine be renovated to reduce their size and to reduce regular maintenance and repair. In addition, a significant number of bunkers on the Front and Middle Nines should be removed or relocated to improve pace of play and playability.

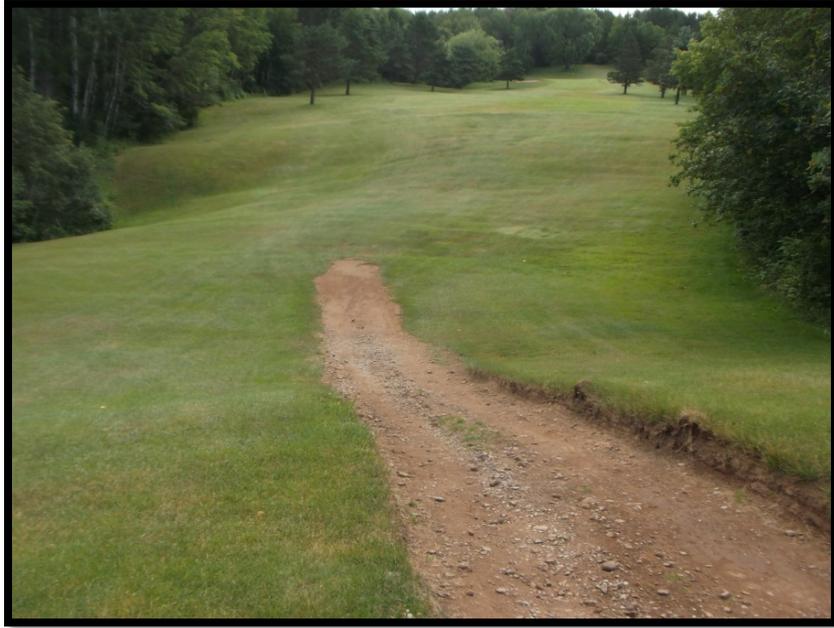
Cart paths at Enger Park generally run from green to tee and are constructed of gravel or asphalt. Many of the cart paths, particularly on the Back Nine, are in very poor condition due to poor subgrade preparation, damage from tree roots and frost heaving. Damaged cart paths should be removed and reconstructed with a granular base and a minimum of 2.5 inches of bituminous wear course. Given the sandy soils on the front and Middle Nines, it may prove cost effective to construct concrete cart paths with wire mesh and without a granular base in lieu of asphalt. Prior to paving cart paths, it is important that any drainage issues or fairway regrading be completed.

Photo 6: Existing cart paths are in poor shape. Many paths are not paved.

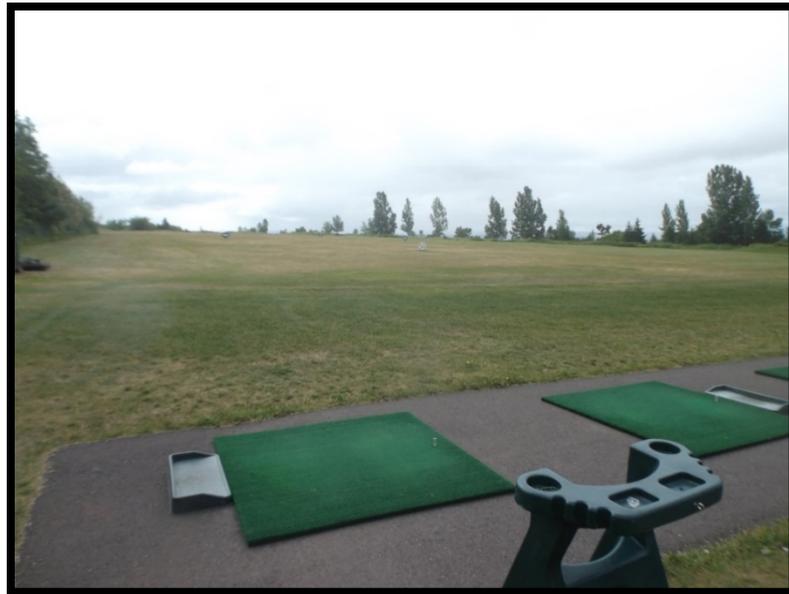
The driving range at Enger is located across the road from the clubhouse and golf course. This leads to some concern over safety as golfers try to cross the busy road. Although the width of the range tee is adequate, the length of the range and width of the landing area is too short. This is compounded by the fact that the driving range is not irrigated and, as a result, this leads to increased labor by golf staff to pick balls from the surrounding wooded areas.

Photo 7: Driving range has no irrigation and small tee resulting in poor turf and lost balls.

Our recommendation would be to improve turf quality by improving irrigation on the tee and in the landing area. This will also allow for contour mowing of fairway landing areas and target greens and provide for a more visually appealing experience. In addition, a 10-20' chain link fence should be erected at the east and south ends to minimize the expense of lost balls and hand picking. Long term improvements should include renovation of the existing practice green and short-game area and the expansion of the driving range tee.

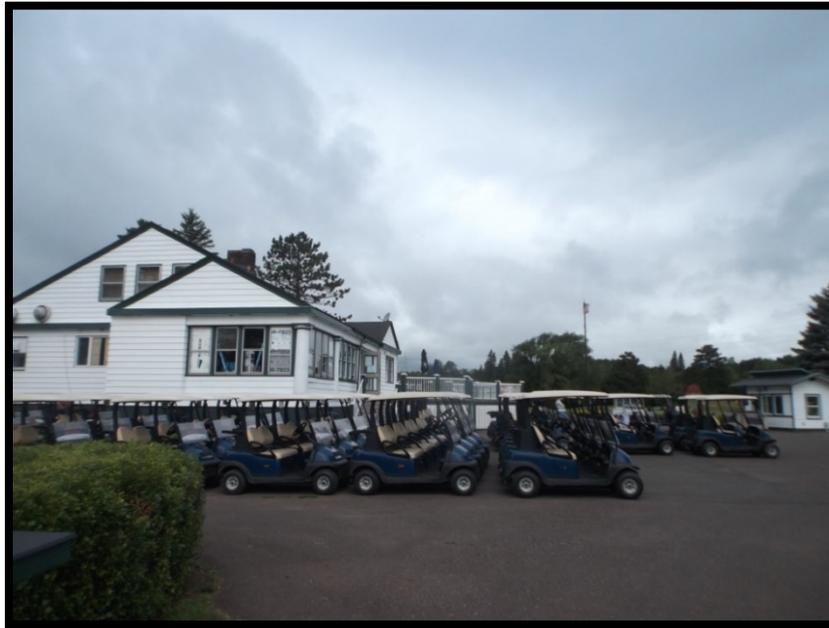
The clubhouse at Enger Park is one story, a wood-framed structure which was constructed in the 1930s shortly after the course opened. It has been added on to on several occasions. Without a more in-depth assessment, it is difficult to determine the condition of the structure including plumbing, electrical, insulation, etc. Any significant remodeling of the structure, however, will likely require updates to meet current codes for American Disabilities Act (ADA), fire safety and health department. Immediate improvements should include improvements to food service, plumbing & bathroom facilities, electrical, flooring, and HVAC. Those code upgrades will likely cost in excess of \$500,000.

Photo 8: Enger Clubhouse and asphalt cart staging area.

Future improvements should include a major remodel or the construction of a new clubhouse. It is estimated that a new clubhouse of similar size would likely cost at least \$2.5 to \$3.0 million depending on utility infrastructure costs and desired finishes. If expanded to allow for large events or underground cart storage, a new clubhouse could cost in excess of \$5 million.

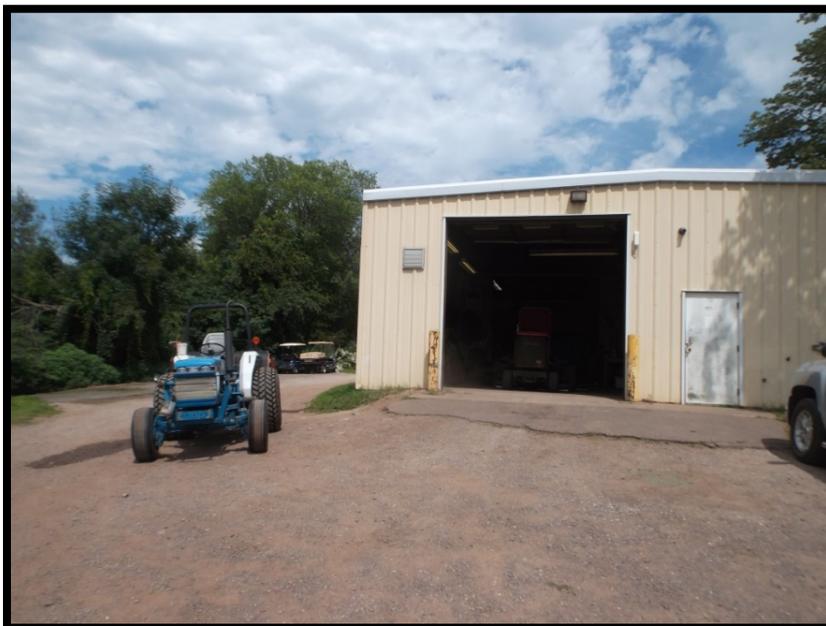
The maintenance facility at Enger Park consists of a pole barn structure with a concrete floor. The building is small and barely adequate to meet storage and operational needs for an eighteen-hole golf course. Short term improvements should include updates to the wash pad, storage bins, and fuel containment traps. Additional long-range improvements should include the construction of a new building capable of providing heated office, bathrooms and shop space as well as sufficient storage space to protect the City's investment in mowers, fertilizer, and equipment.

Photo 9: Enger Golf Course maintenance facility.

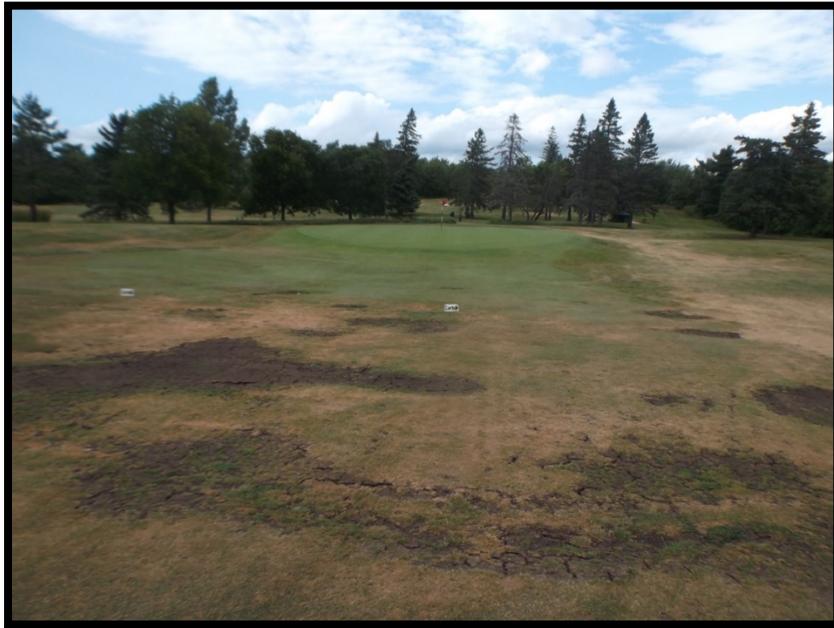
Overall, the course is in quite a poor condition. Some of this can be attributed to a short growing season. However, most of the poor conditioning is a result of an irrigation system that does not function properly and a lack of inadequate surface drainage which has resulted in numerous areas of poor turf quality, winter ice damage, golf cart, and mower ruts and compaction. At the time of this review, the greens appeared to be in good condition.

Photo 2: Poor conditions throughout the course from lack of irrigation.

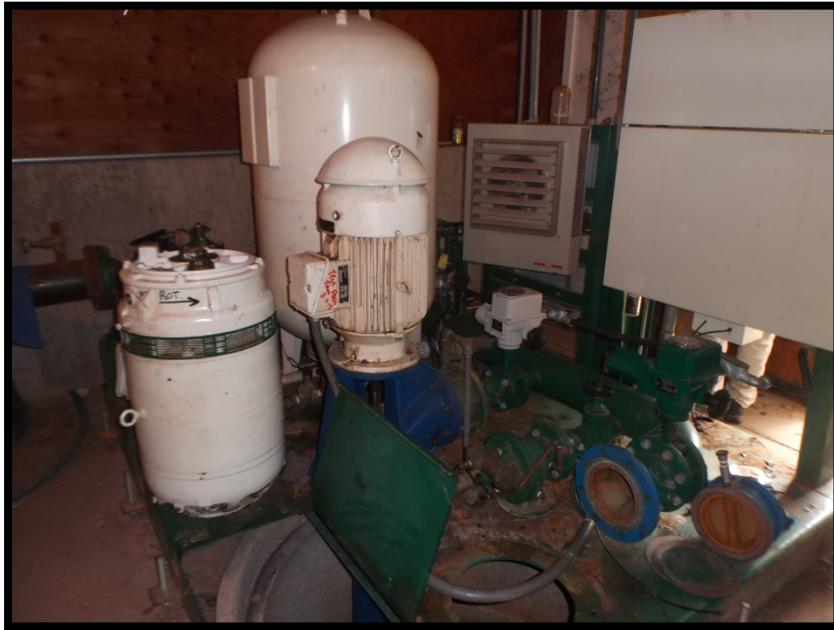
The existing irrigation system was installed in 1990 and consists of a series of pipes, satellites controllers, sprinkler heads, valves and a pumping system that delivers water to the golf course from a pond located on the right side of hole 17. The existing irrigation pond is shallow and only about 30,000 square feet in size and incapable of meeting the needs of even an 18-hole golf course. Originally, the irrigation system utilized five (5) wells that provided water to the irrigation pond but those wells have dried up and the pond is now filled with treated City water. The golf course budgets \$4,600 annually for City water. The irrigation pump consists of a 50 horse vertical turbine and a smaller 25 horse vertical turbine pump which together are capable of pumping approximately 750 gallons per minute. Neither pump has a variable frequency drive (VFD). Although the larger 50 hp pump was rebuilt in 2018, the pump system should be updated with new larger pumps and variable frequency drives to provide 1,200 to 1,500 gpm for the 27-hole course.

The life expectancy of a PVC pipe irrigation system is 25-30 years. The system at Lester Golf Course is now 28 years old so the golf course staff is beginning to experience a high number of leaks which requires a significant time commitment to repair and maintain. More importantly, the system lacks a sufficient supply of water so, most of the time, the maintenance staff can only irrigate critical areas. In the heat of the summer, only the greens are watered.

Photo 3: Pump station is undersized and lacks adequate water supply.

Immediate improvements should include replacement of the irrigation central control and field satellites. In addition, the irrigation pump station should be improved or replaced and the pond should be expanded and tied into the other ponds to increase storage capacity. The supply of water should be increased by drilling new wells, increasing the capture of natural run-off and/or increasing the use of City water. More long-range improvements should include replacement of the entire irrigation system including piping, valves and irrigation heads. A new irrigation system will provide improved coverage and control so that water can be placed more precisely where it is needed. It is estimated that a new 18-hole double-row system will cost between \$1.3 million and \$1.4 million depending on soil conditions, pipe sizing and the total number of heads. A complete 27-hole system will likely cost \$2.0 million.

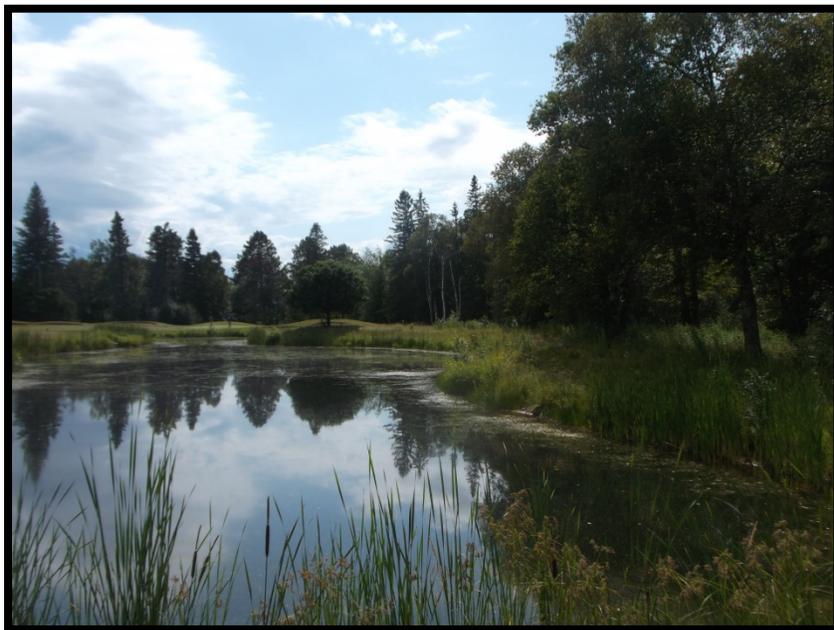
Photo 4: Irrigation pond on hole 17 should be enlarged and tied together With ponds on holes 11 and 12 to increase storage capacity.

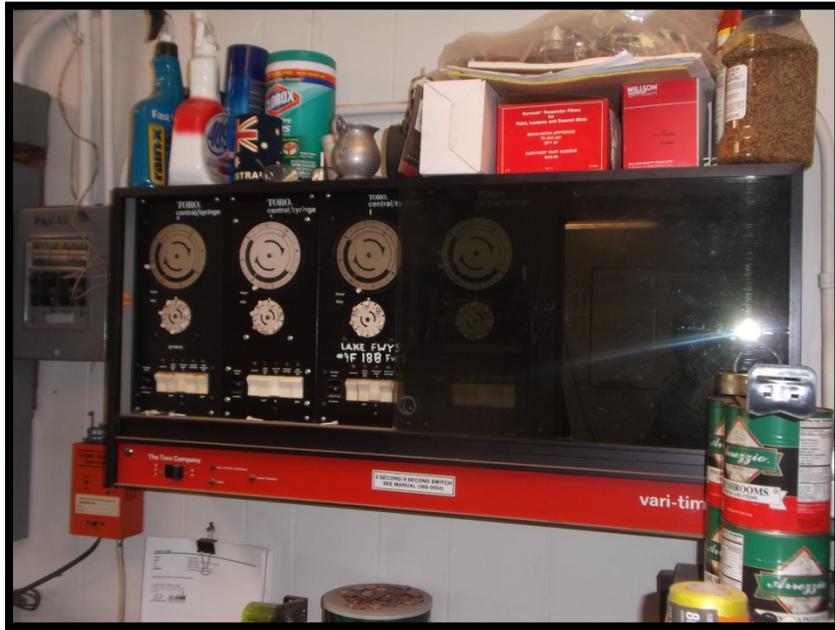
The control system consists of a 30 year old Toro Vari-time II central control panel. New parts for this equipment are no longer available and used replacement parts are nearly impossible to locate. The existing central control along with the field satellite controllers should be replaced immediately to avoid interruptions in the operation of the irrigation system. A new Toro Osmac or Rainbird Stratus computerized central control would allow for the more efficient use of water and should result in a noticeable improvement in turf quality.

Photo 5: Outdated and obsolete Toro Vari-time II irrigation controller

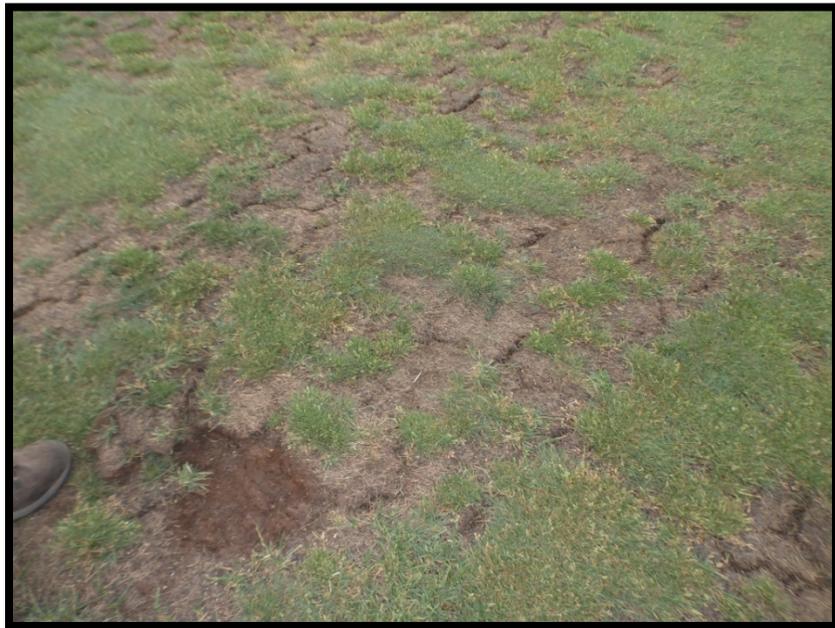
Photo 6: Sunbaked dead turf and cracked ground in fairways from lack of water.

Overall, the fairway and rough turf conditions at Lester Park might be described as “fair”. Fairways are, in many areas, very flat and the heavy clay soils do not allow for drainage. In addition, numerous fairways, such as those on holes 1,2,5,9 and 10) are extremely bumpy which makes mowing and operating a golf cart challenging and unpleasant.

Our recommendation would be to correct drainage in the fairways and roughs and to re-grass those areas in order to improve turf quality, playability, and on-going maintenance. This should be done by using a specialized piece of equipment such as a Blecovator or a Rotodarian to till and loosen the top few inches of soil and then regrade, install sub-surface drainage pipe and re-grass.

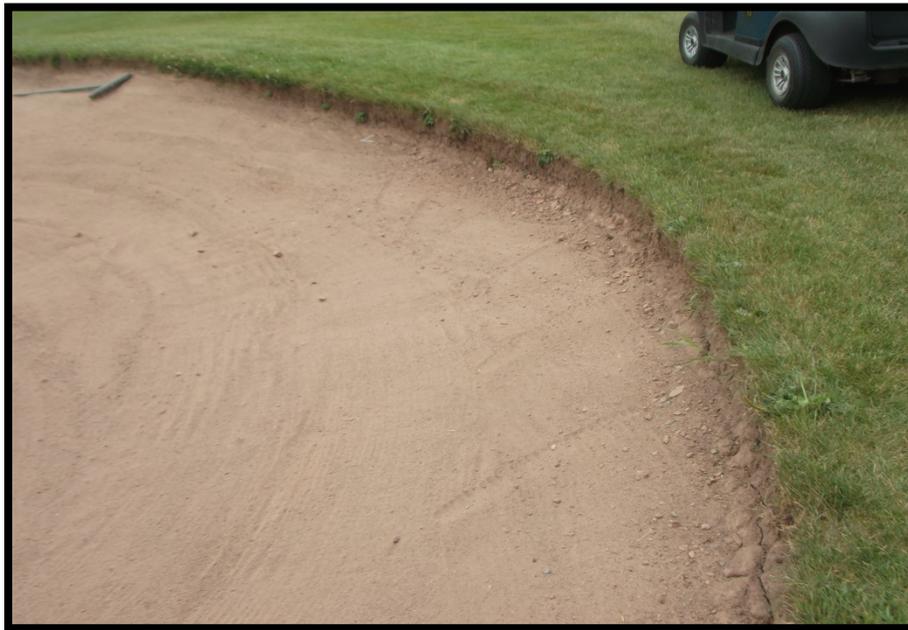
Bunkers are often one of the highest maintenance issues on a golf course. Over the past 20-30 years, the bunkers at Lester Park have become so large that the capes or edges have nearly vertical faces on which it is difficult to maintain sand. As they grow, the native soils and rock erode into the bunker and the sand becomes contaminated so that it can no longer drain properly.

In addition, because of the effect which technology has had on golf equipment, many of the bunkers at Lester Park are no longer properly positioned to challenge the low handicap golfer. Instead, they now un-necessarily penalize the high-handicap and shorter hitter.

Photo 7: Excessively large bunkers with eroded edges, contaminated sand, and poor drainage.

It is our recommendation that a comprehensive bunker renovation is undertaken to 1.) reduce regular maintenance and repair, 2.) provide visual framing and interest and 3.) define the holes strategically. This will involve removing some bunkers, rebuilding some bunkers and potentially relocating or building some new bunkers. By redesigning and reconstructing the existing bunkers, it is our belief that the City of Duluth can provide a more enjoyable golfing experience for golfers of all ages and all abilities while, at the same time, minimizing the time and expense of repairing unexpected washouts. The reconstruction of the bunkers should not simply include removal and replacement of the sand but instead, include completely reshaping the bunkers to reduce their size and control erosion.

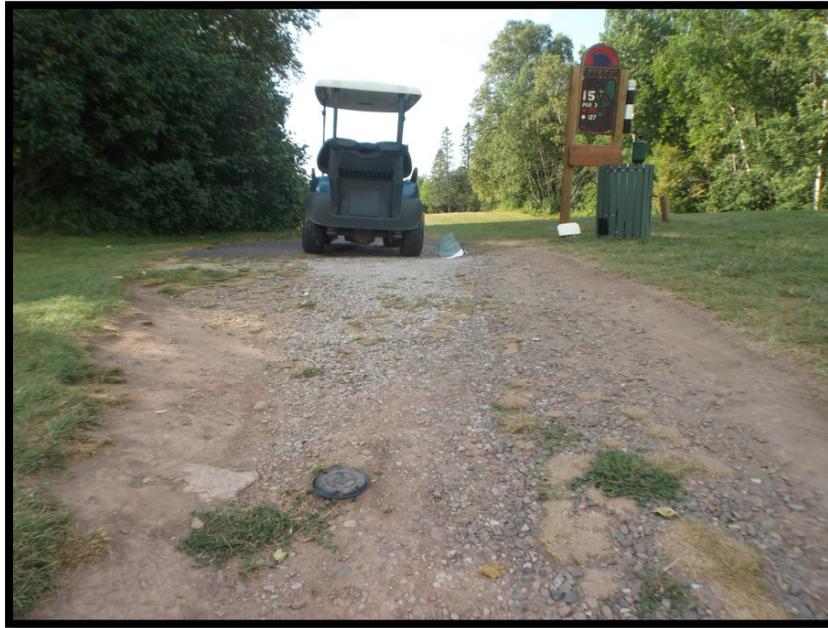
Cart paths at Lester Park generally run from green to tee and are constructed of gravel or asphalt with a granular base. Many of the cart paths are in poor condition due to damage from tree roots, frost damage, and normal deterioration. Damaged cart paths should be removed and reconstructed with a minimum of 5 inches of gravel base and 2.5 inches of pavement. Priority can be given to repaving cart paths in low lying areas and poorly-drained areas in an effort to minimize damage to the golf course and loss of revenue from course closures.

Photo 8: Deteriorated cart paths should be repaired and repaved.

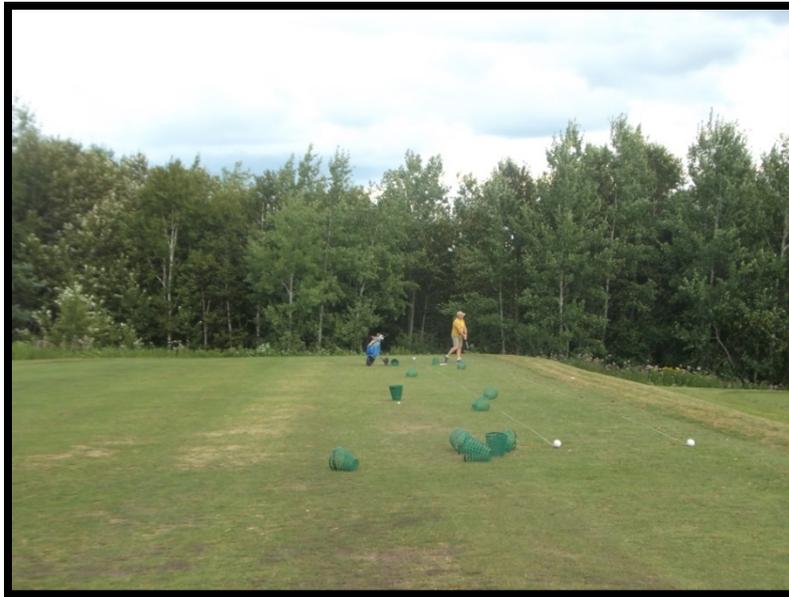
The driving range at Lester Park Golf Course is ideally located just south of the clubhouse and parking lot. The length and width are adequate and the teeing area appears sufficient to handle large events or a significant increase in daily use. The driving range tee is irrigated but the landing area and rough are not irrigated. This results in some lost balls into the surrounding trees.

Photo 9: Tee on the driving range is large but lacks adequate irrigation.

Our recommendation would be to improve irrigation on the tee and in the landing areas. This will improve turf quality and allow for contour mowing of fairway landing areas and target greens. Since the range faces south, a unique opportunity exists to construct a heated year-round practice facility which could provide for a significant increase in revenue.

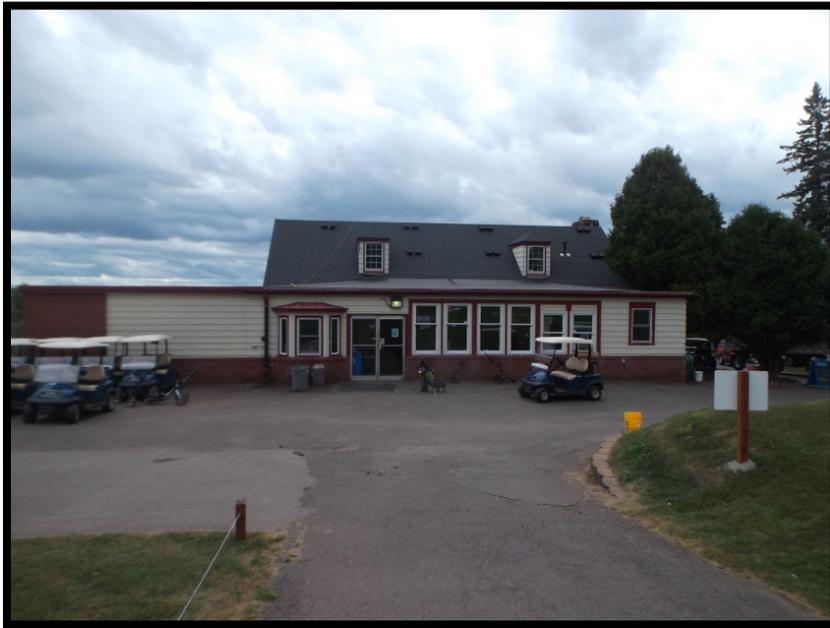
The clubhouse at Lester Park is one story, a wood-framed structure which was constructed in the 1930s shortly after the course opened. It has been added on to on a number of occasions and has significant issues with plumbing and functionality. Any significant remodeling of the structure to improve operations or services will likely trigger updates to meet current codes for American Disabilities Act (ADA), fire safety and health department. Immediate improvements should include improvements to food service, plumbing & bathroom facilities, electrical, flooring, and HVAC. Those code upgrades will likely cost in excess of \$500,000.

Photo 10: Clubhouse is small and in need of code updates.

Future improvements should include a major remodel or the construction of a new clubhouse with underground storage for golf carts. It is estimated that a new clubhouse of similar size would likely cost in excess of \$2M to \$2.5 million depending on utility infrastructure costs and desired finishes. If the clubhouse were expanded to allow for large events or underground cart storage, a new clubhouse could cost in excess of \$5 million.

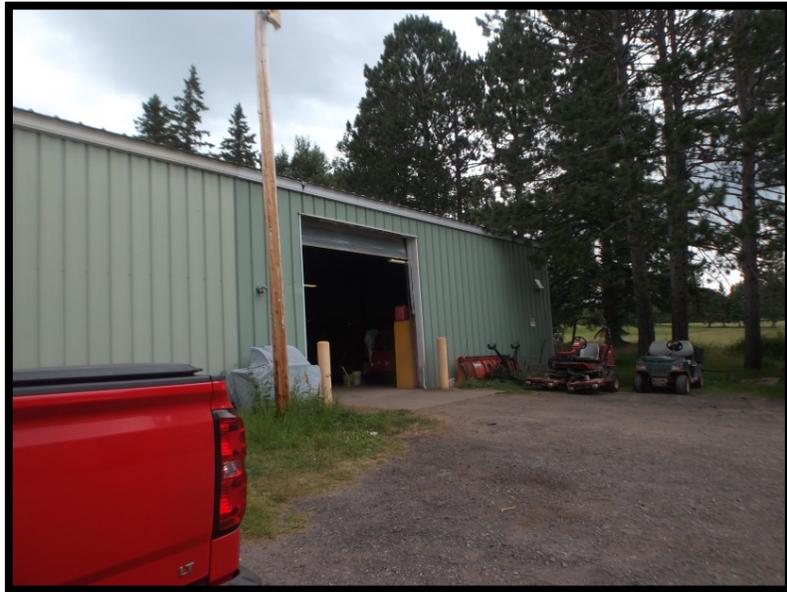
The maintenance facility at Lester Park is a pole barn structure of approximately 4,000 sf. It has a concrete floor and a heated office and shop. It has no running water in the winter. The building is small but barely adequate to meet the storage and operational needs of a 27-hole golf course. Long range improvements should include the construction of a new building or an additional building which will provide for additional equipment and fertilizer storage. A year round supply of potable water should be provided to allow golf course staff to work throughout the year. Improvements should be made to the fuel containment area and wash pad so meet current environmental and best management practices. New storage bins for materials should be constructed to allow a supply of bunker sand, topsoil, and topdressing sand to be purchased in bulk and stored on site.

Photo 11: Maintenance facility at Lester Park Golf Course.

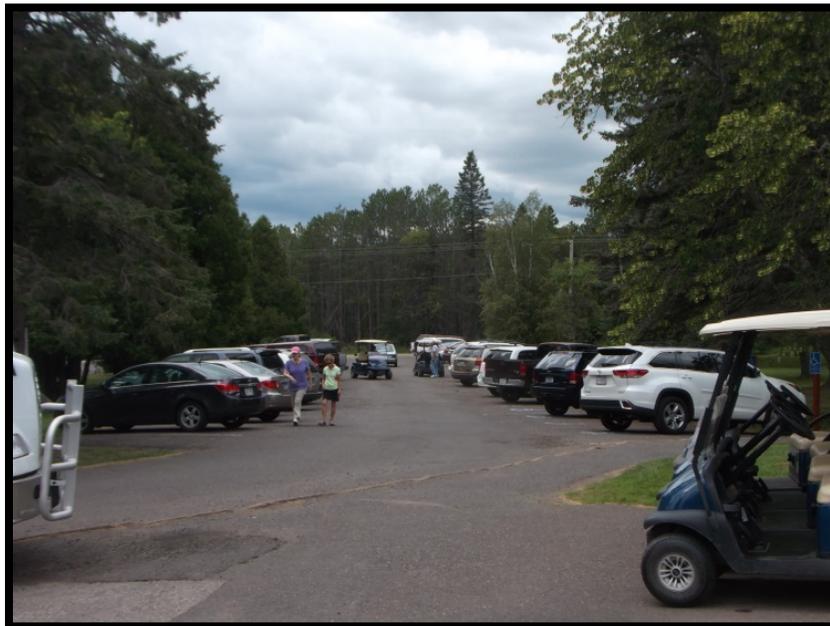
The asphalt parking lot is in poor condition and should have the old bituminous surfacing removed and be repaved. Best management practices will likely require the construction of a new storm water detention pond to address State and local storm water management requirements.

Photo 12: Parking lot has deteriorated and is in need of repaving.
