Purchasing Division
Finance Department
Room 120
411 West First Street
Duluth, Minnesota 55802

218-730-5340
purchasing@duluthmn.gov

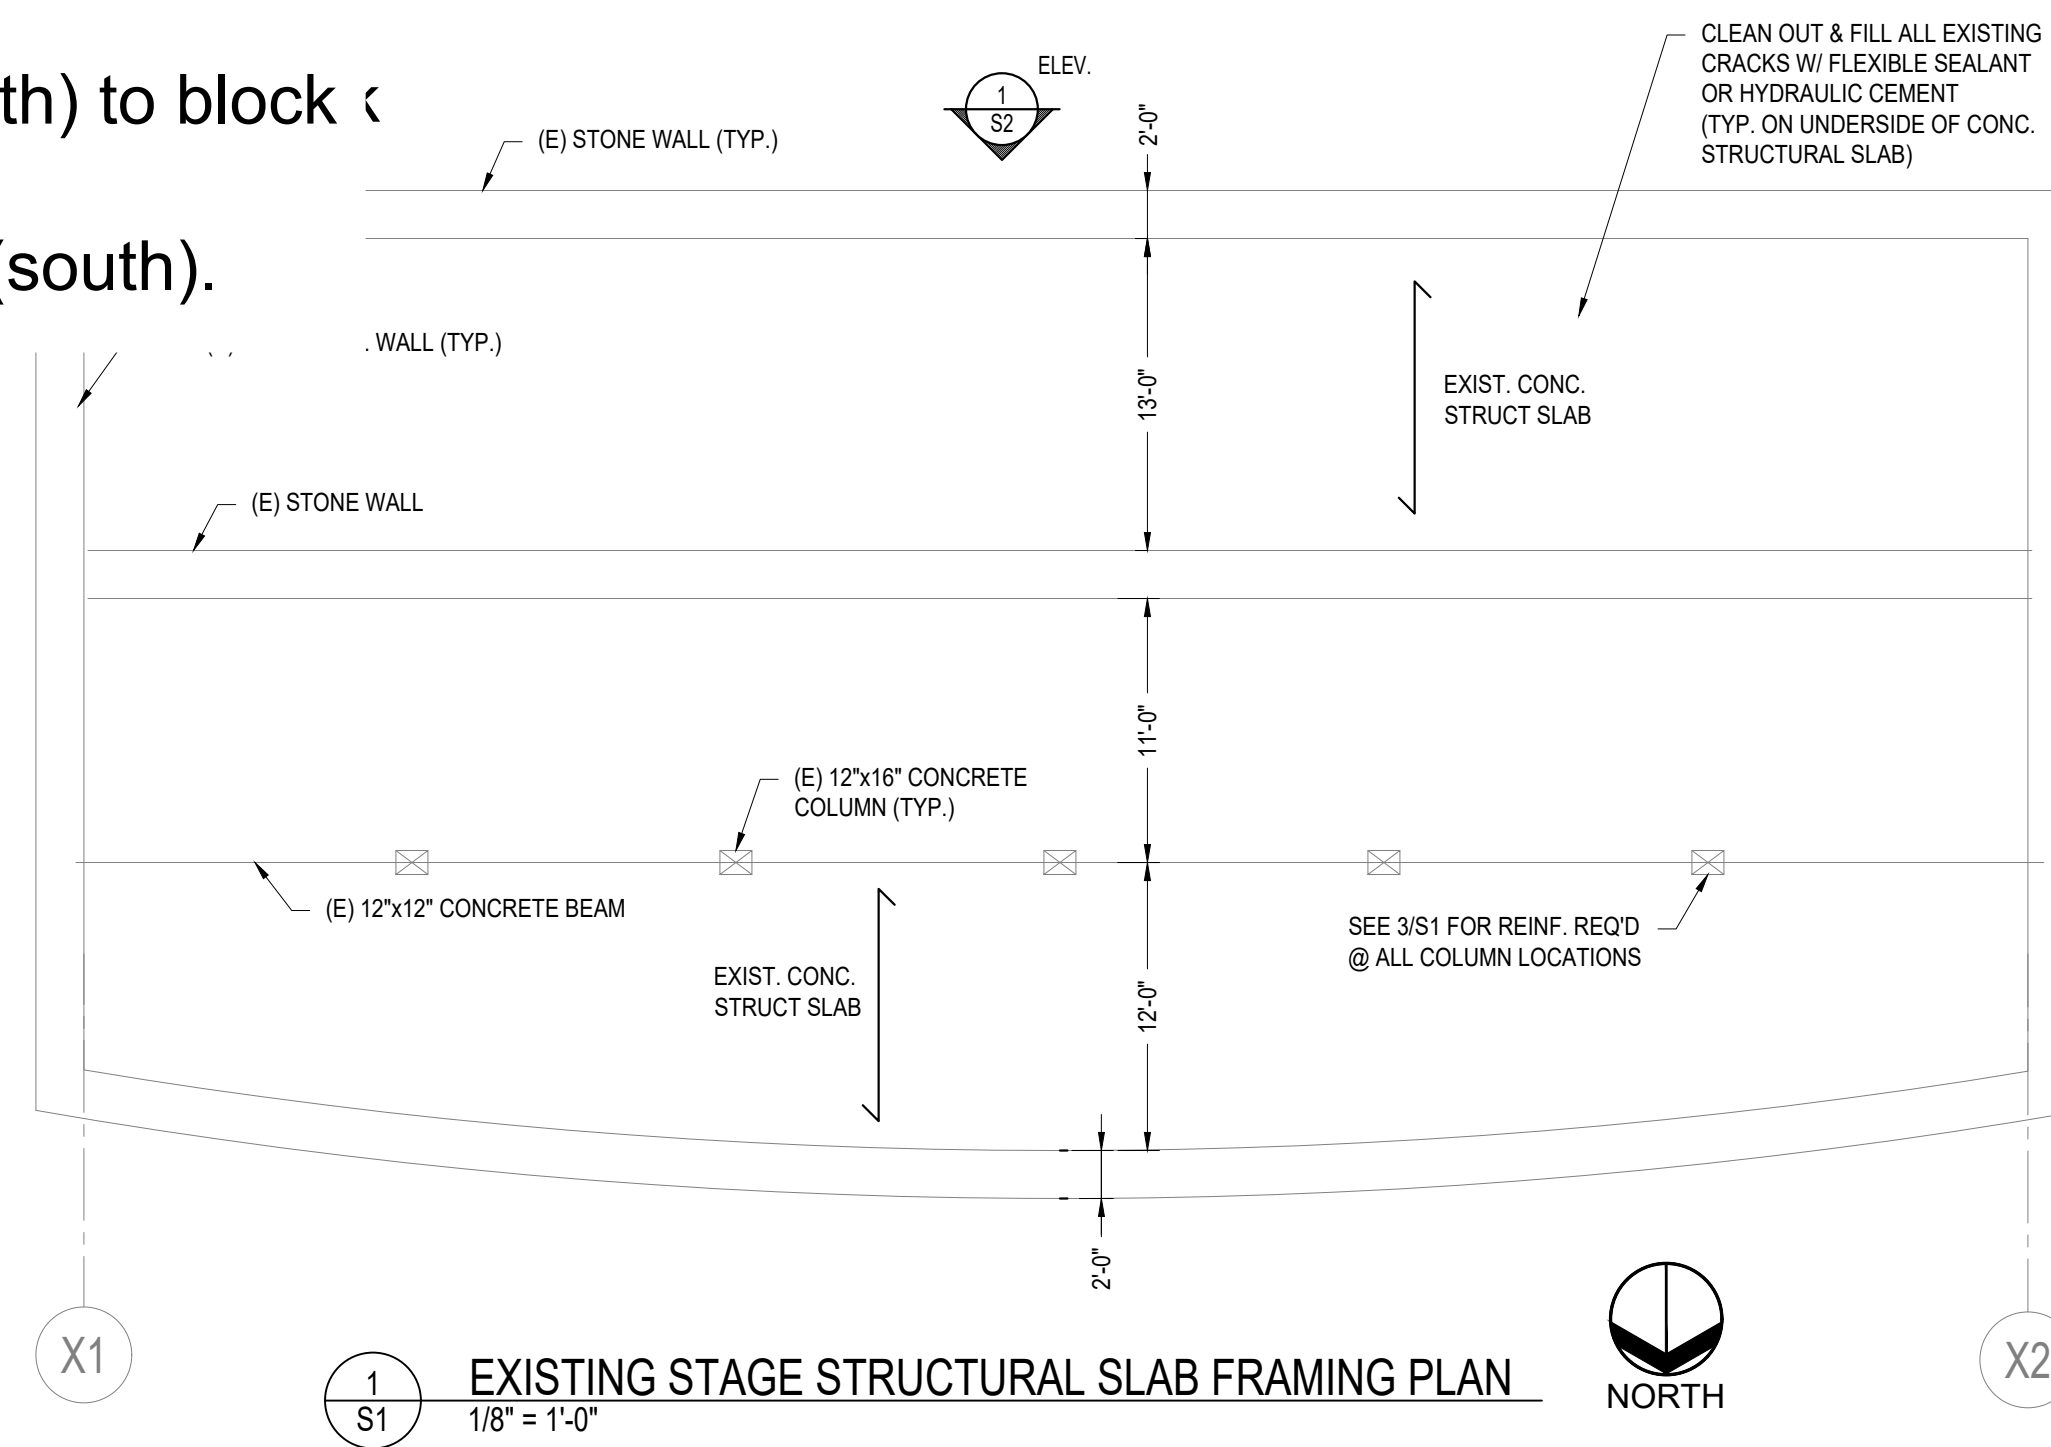
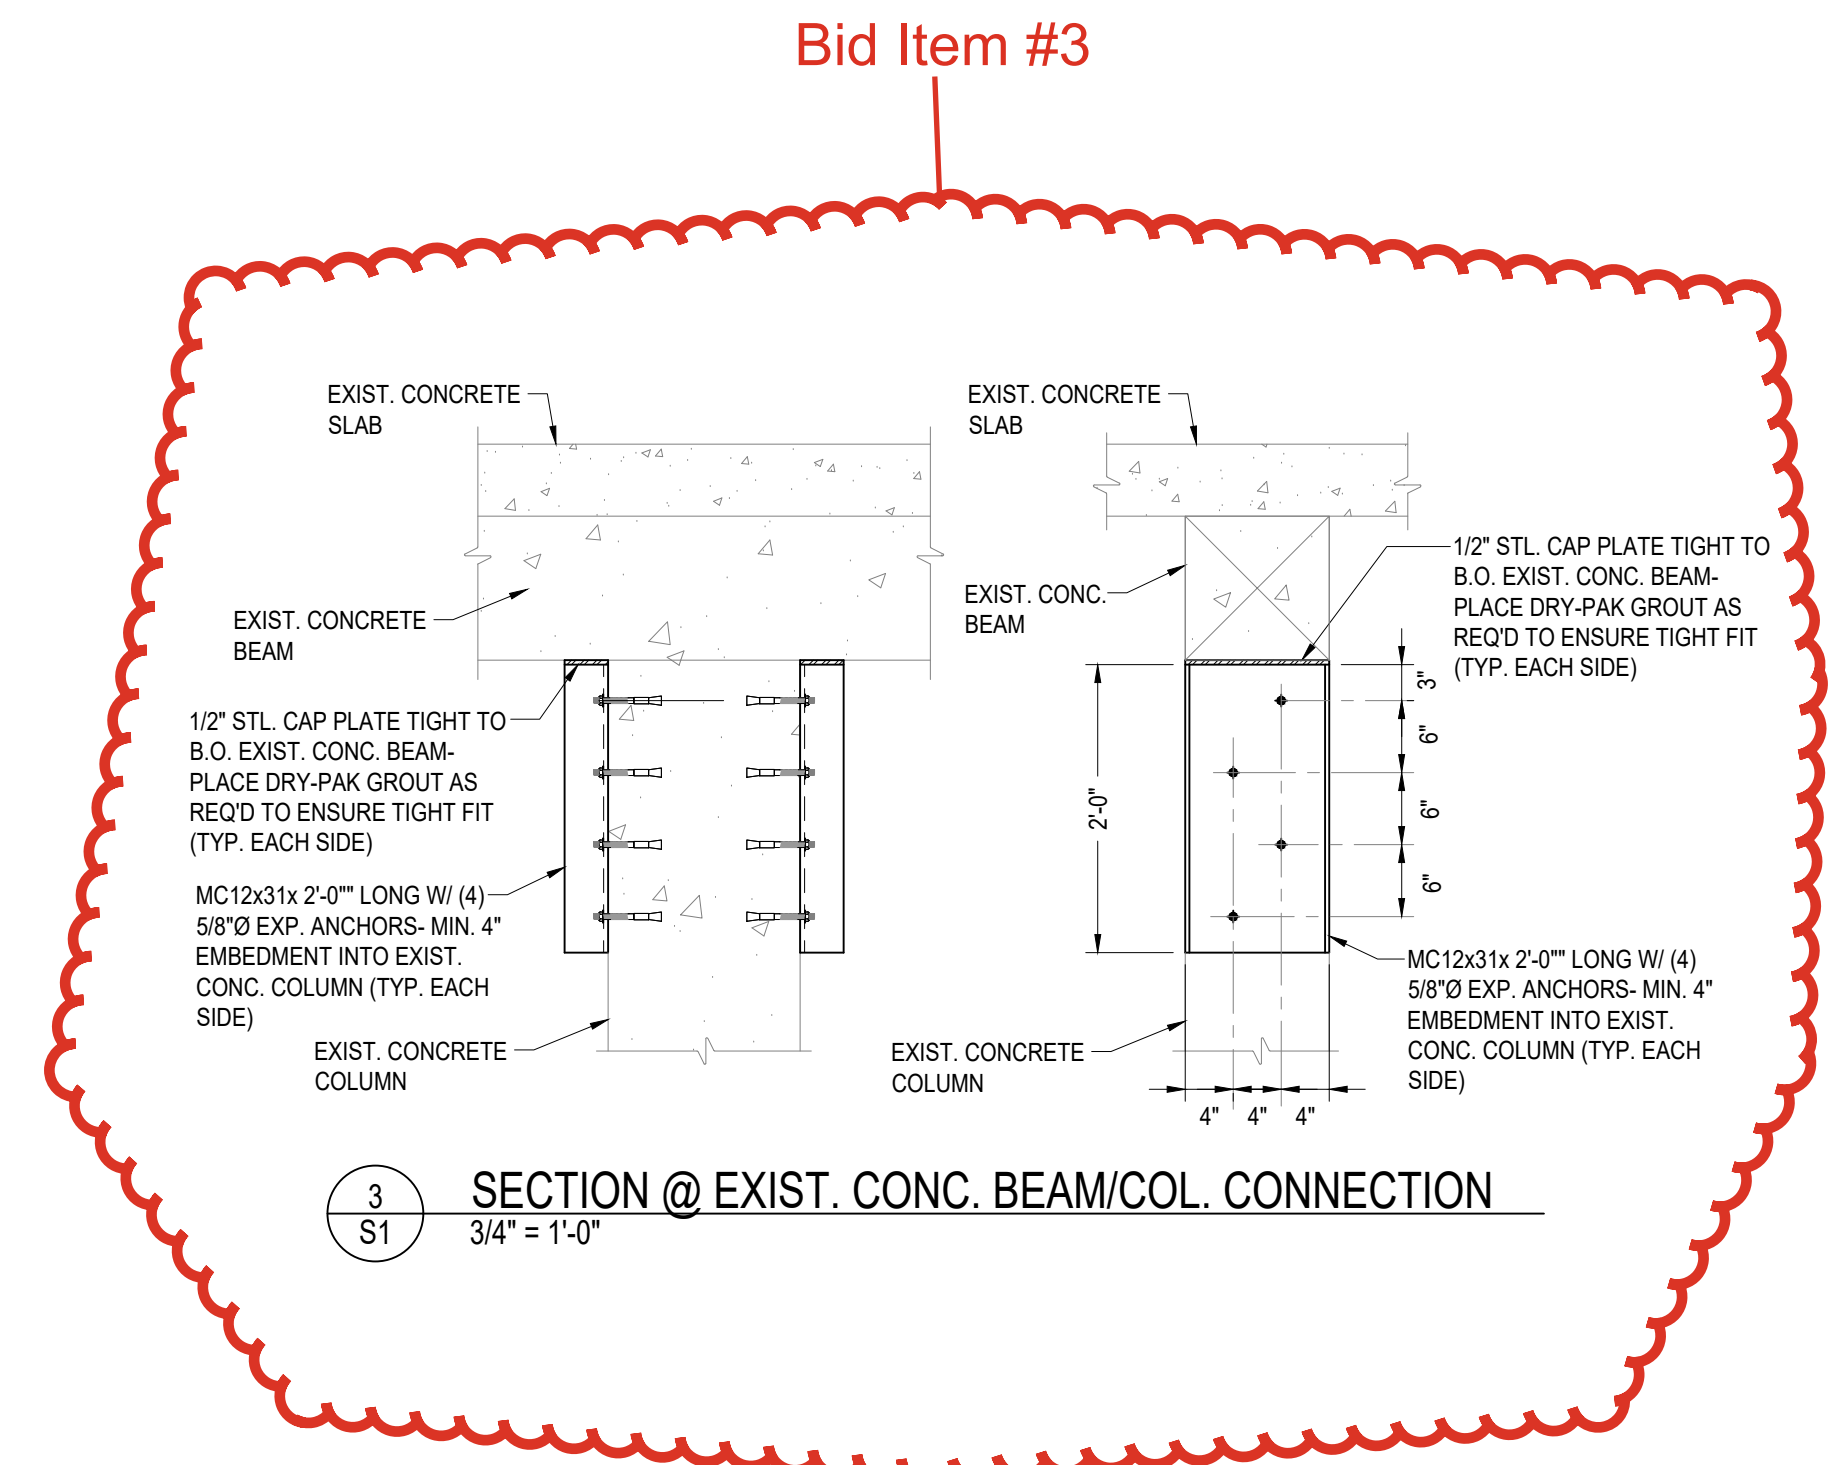
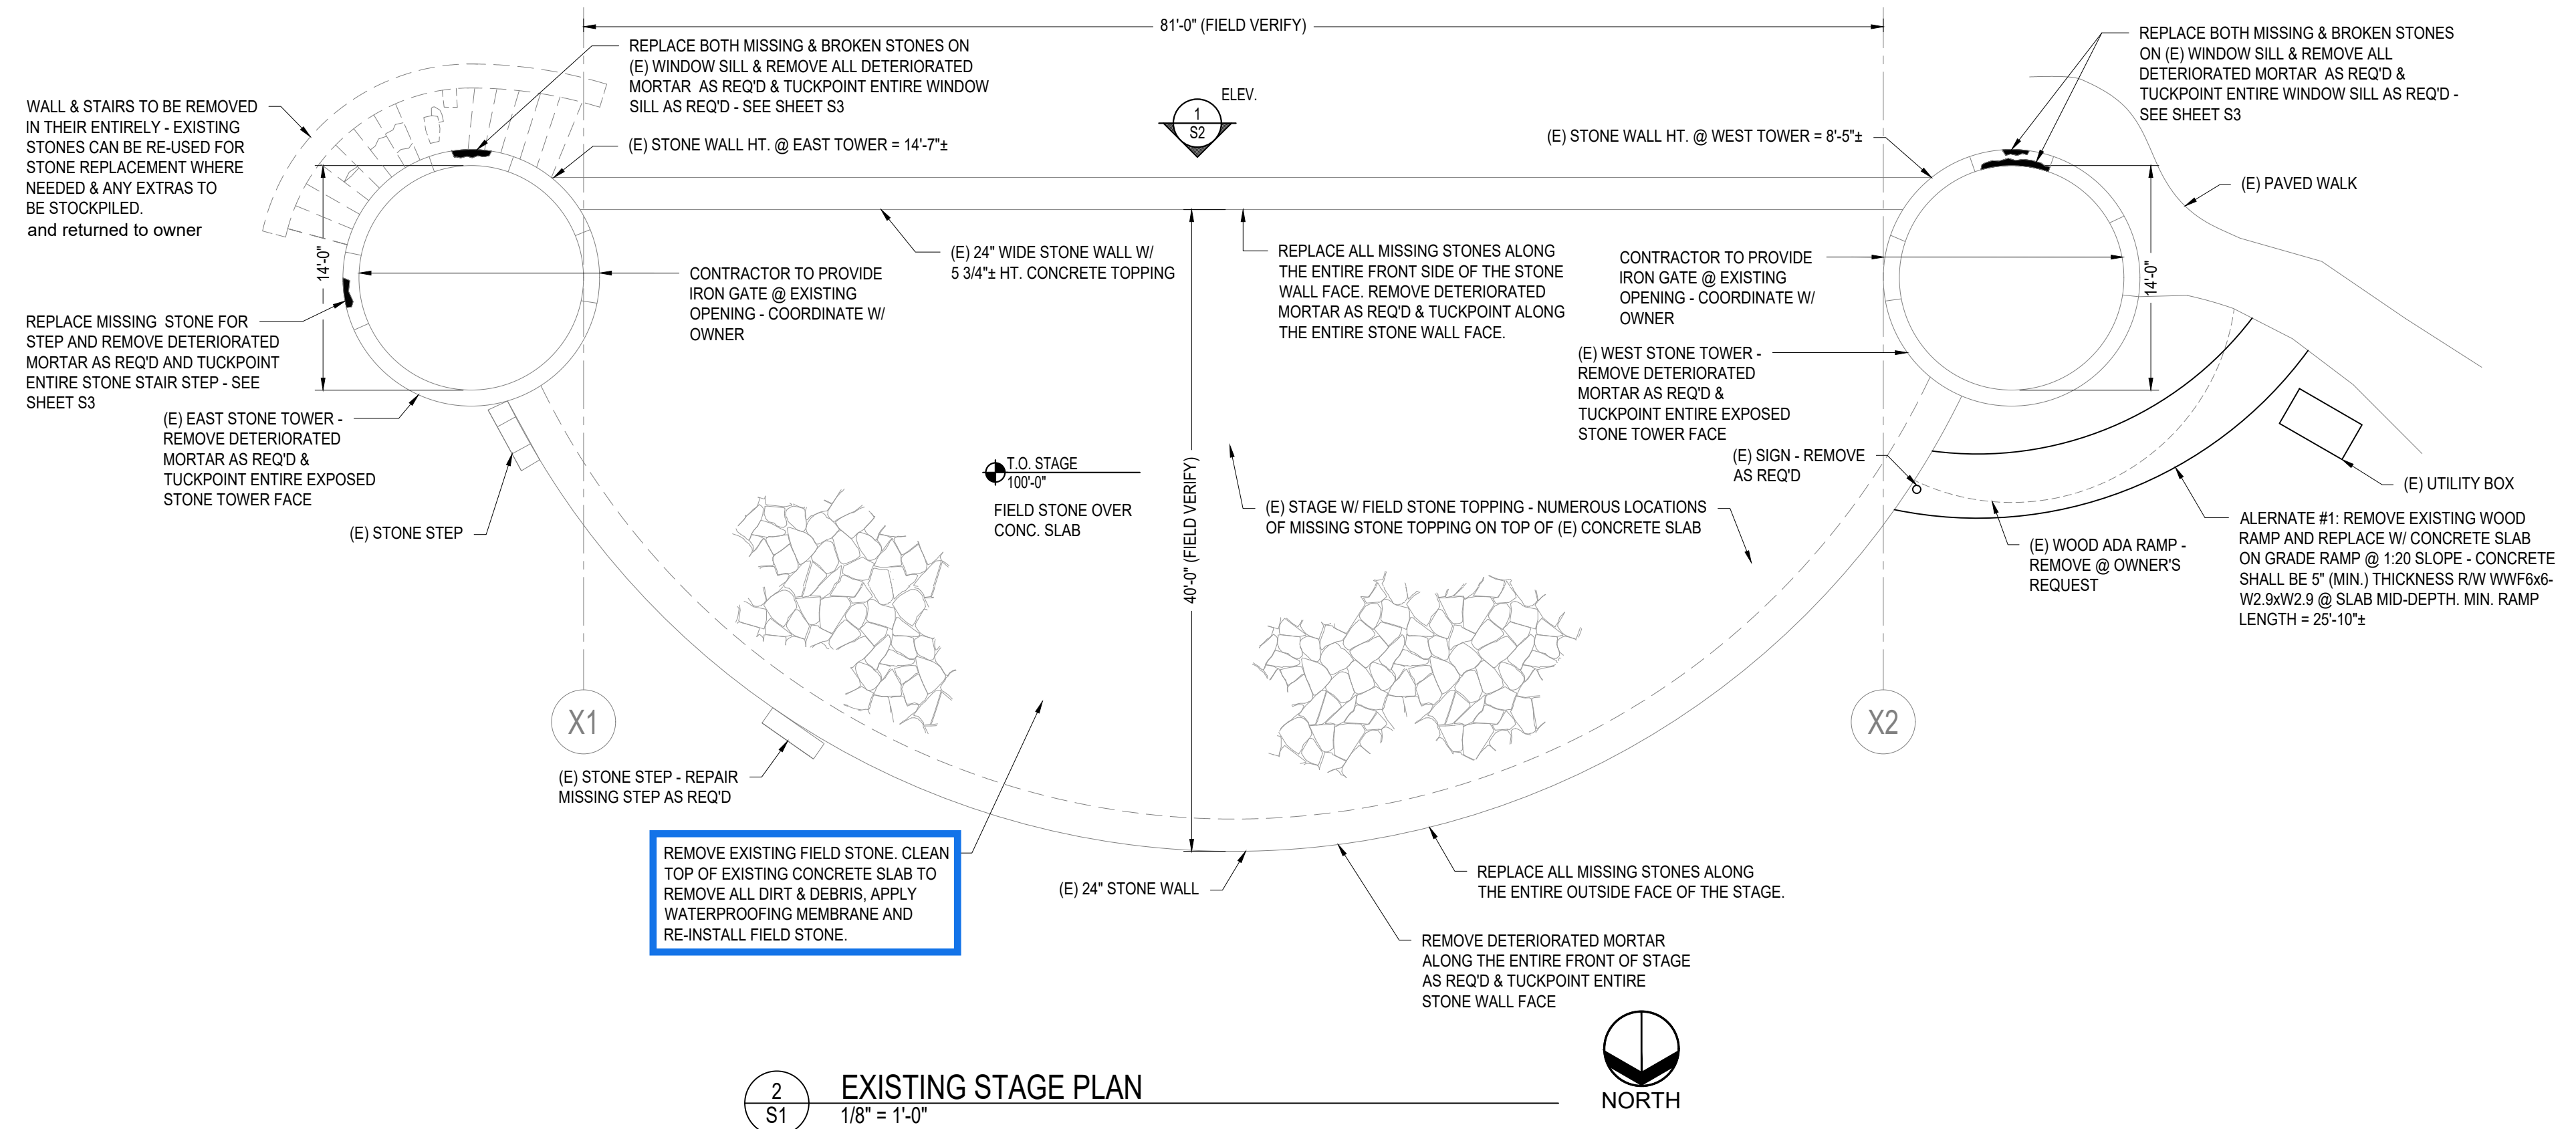
- STONE MASONRY**
1. ALL MORTAR SHALL BE TYPE M AS PER ASTM C-91 GUIDELINES.
 2. ALL GROUT SHALL HAVE A MINIMUM COMPRESSIVE STRENGTH AT 28 DAYS GREATER THAN OR EQUAL TO 2500 PSI. AIR-ENTRAINMENT LEVEL SHALL BE 10 TO 12 PERCENT FOR RESISTANCE TO FREEZE-THAW CYCLES.

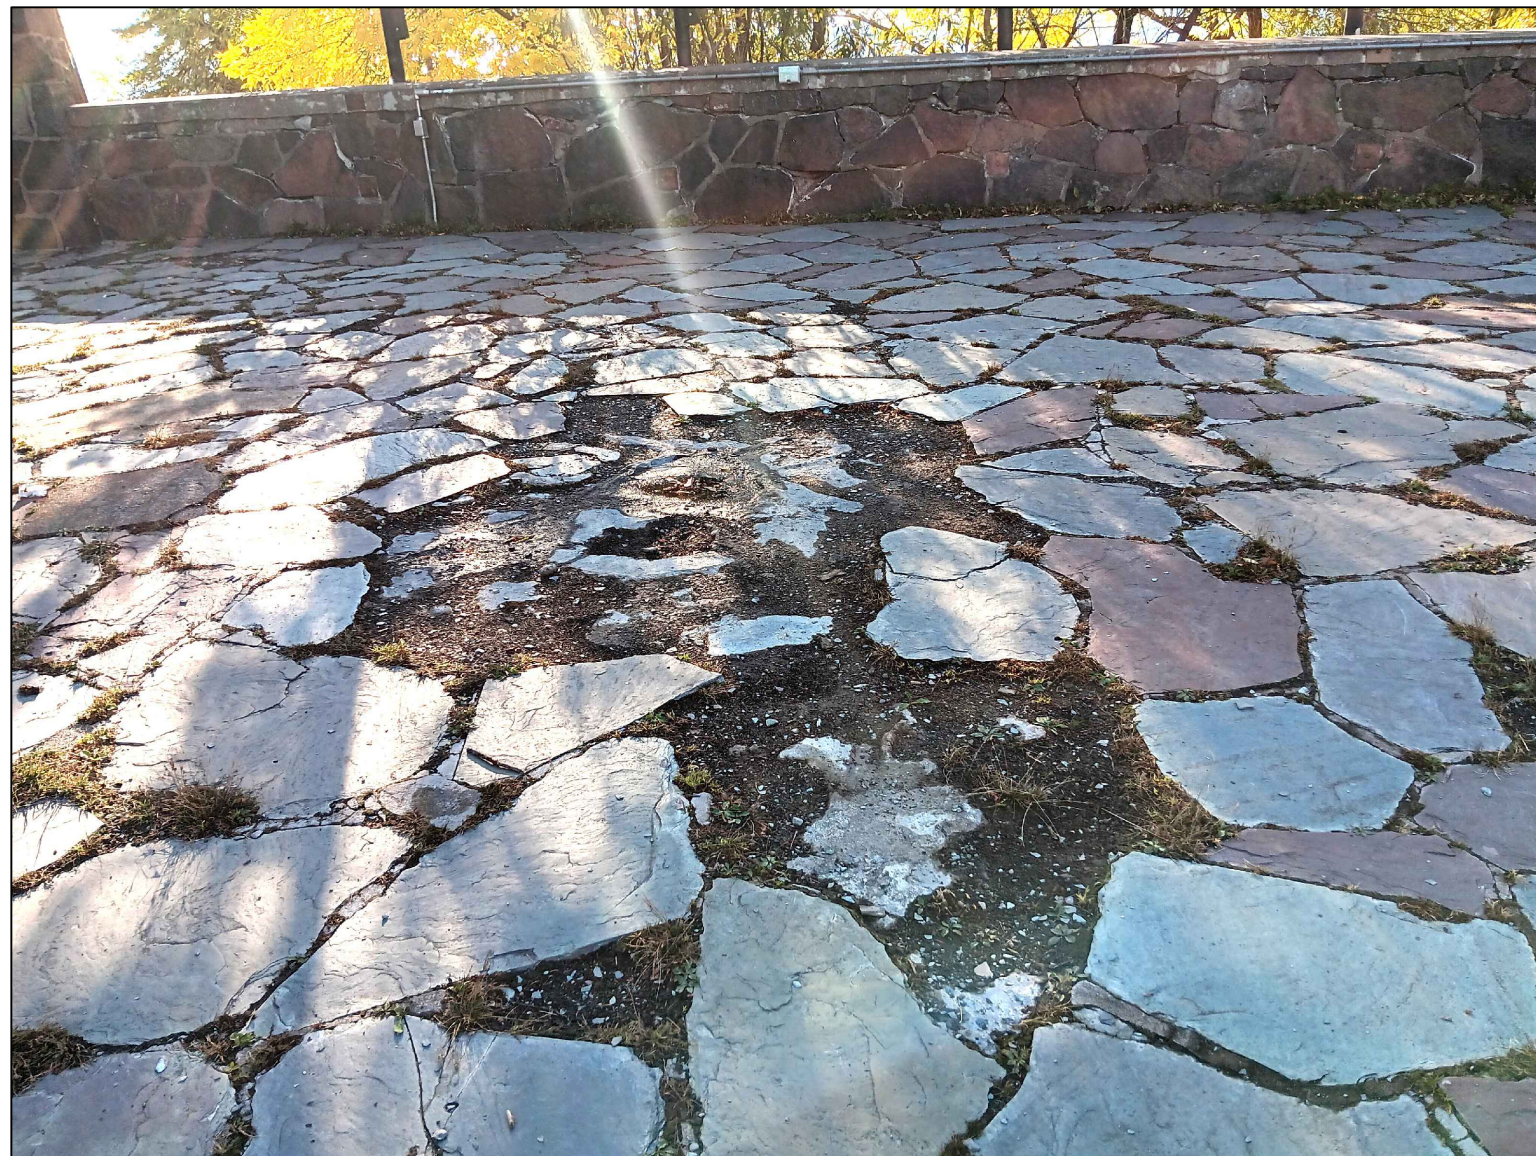
TYPICAL PHOTO OF DETERIORATED STAGE FIELD STONE

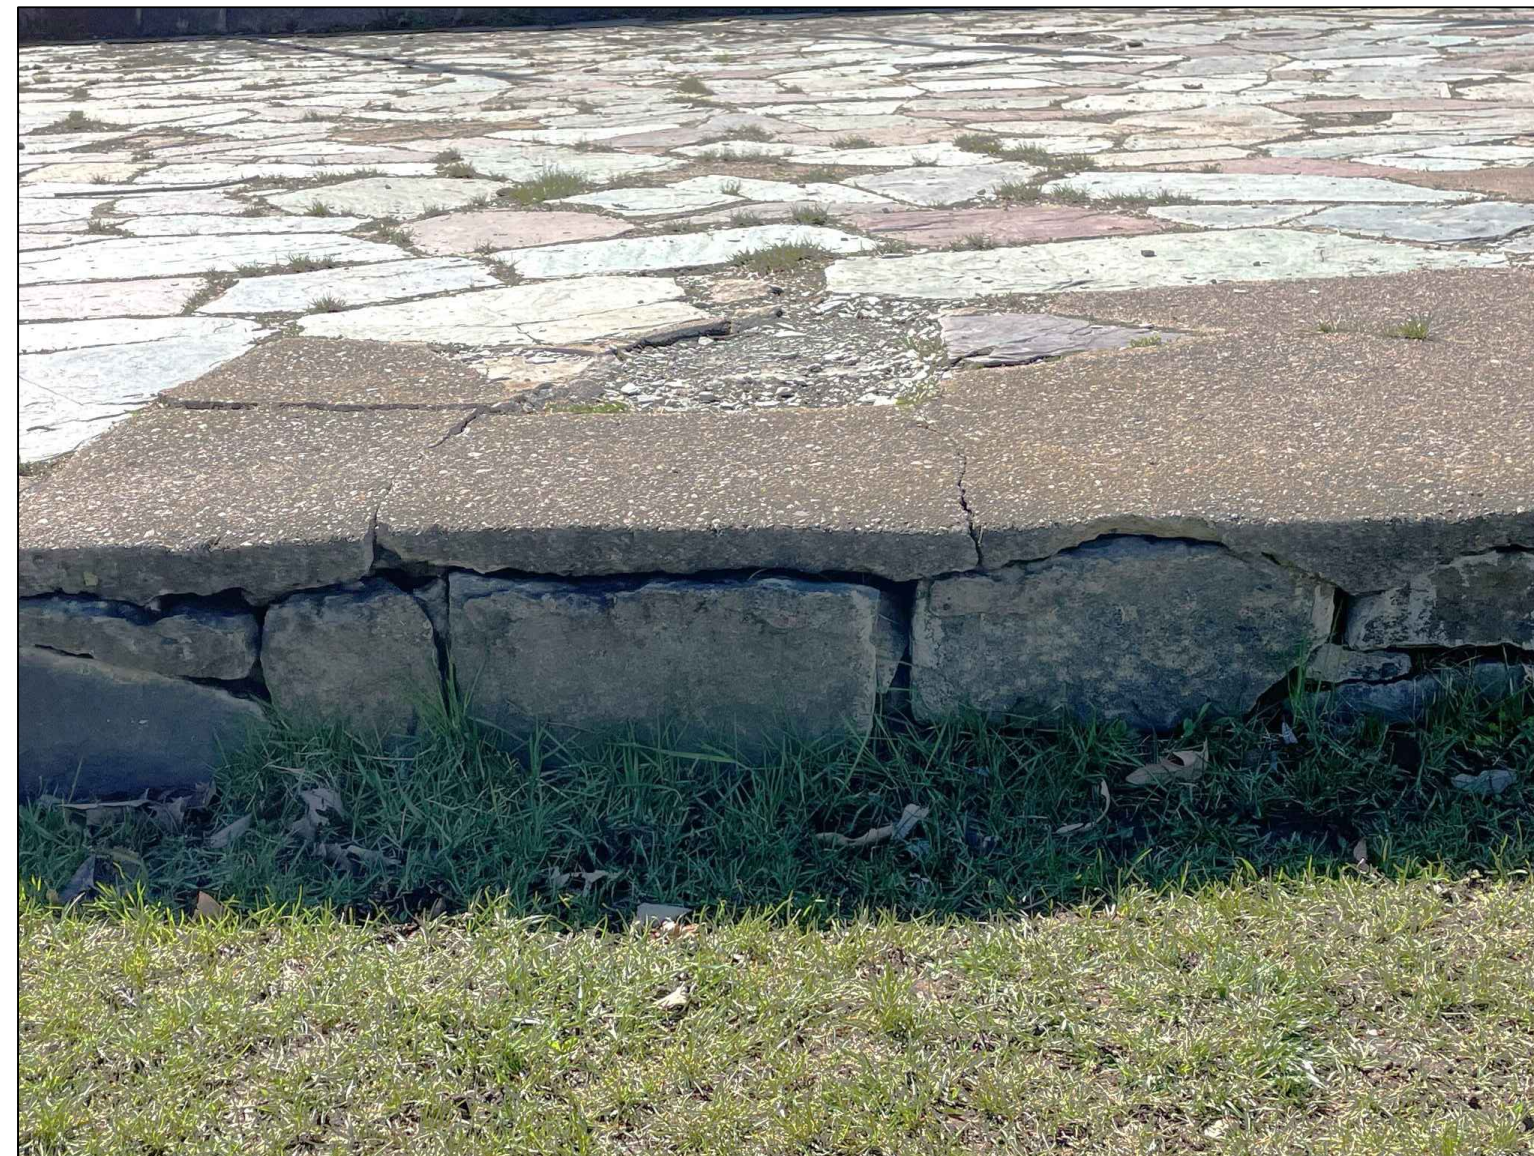
TYPICAL STAGE FRONT WALL DETERIORATED MORTAR JOINTS

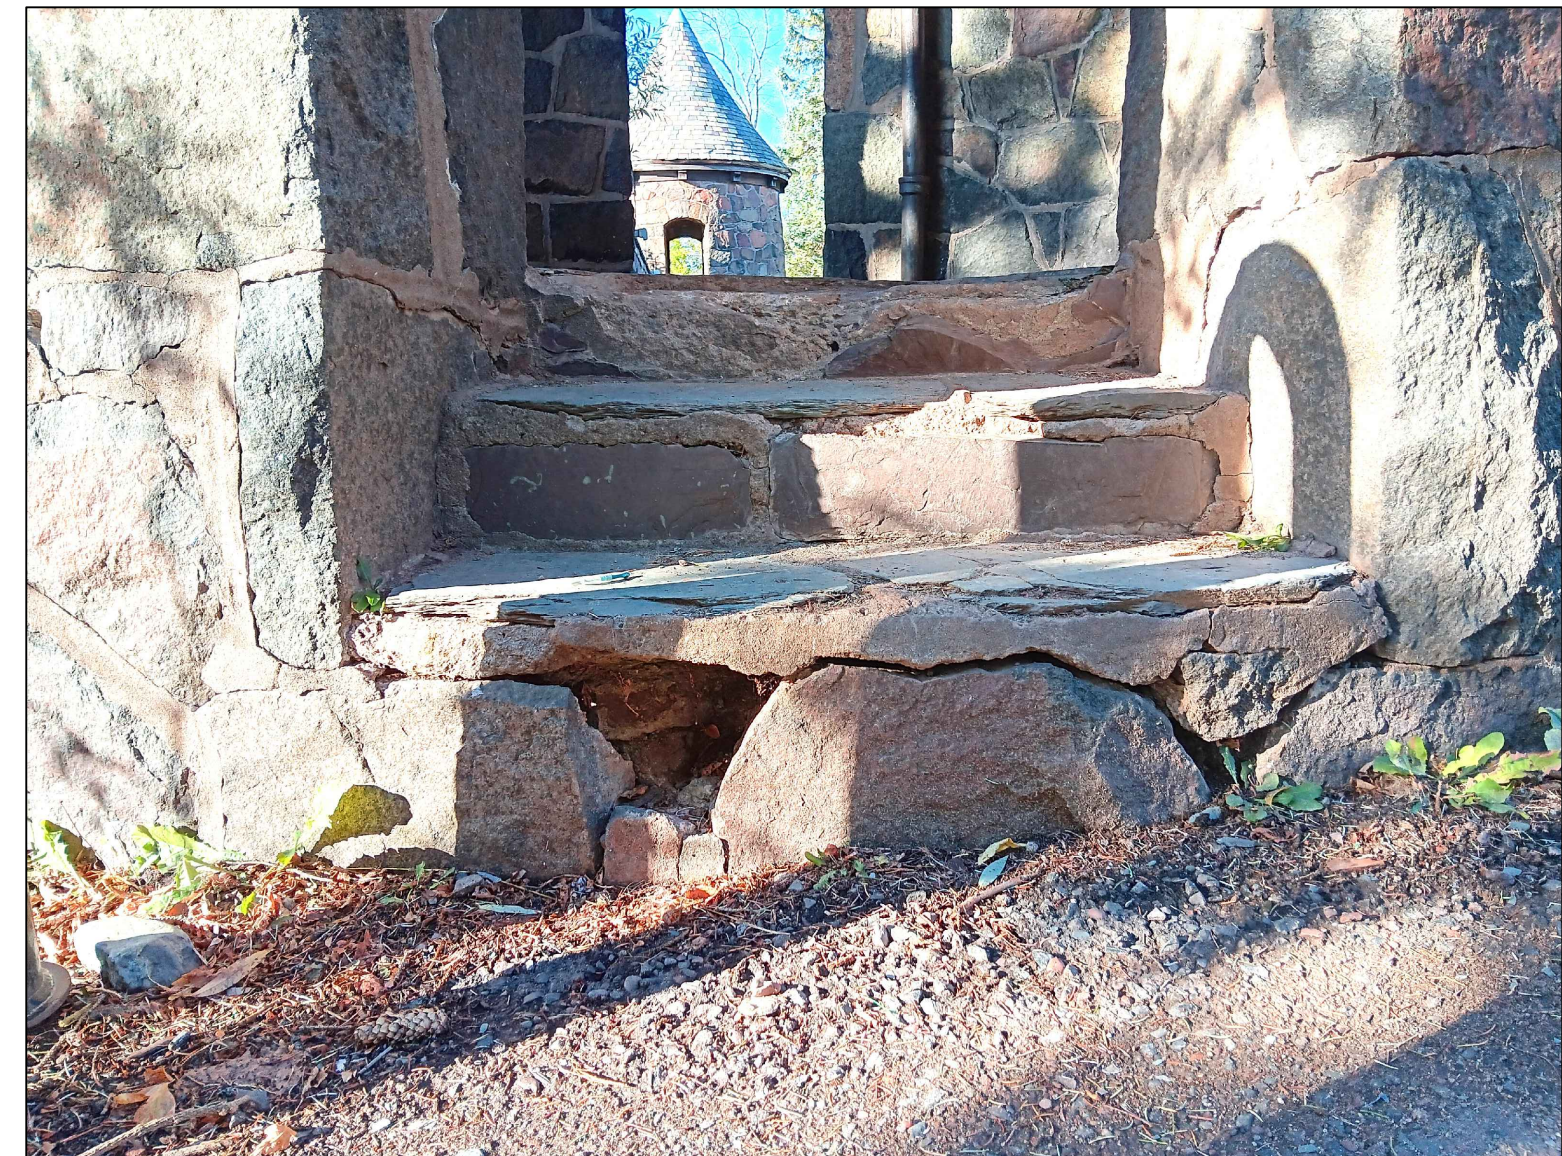
EXISTING EAST TOWER DETERIORATED ENTRY STEP

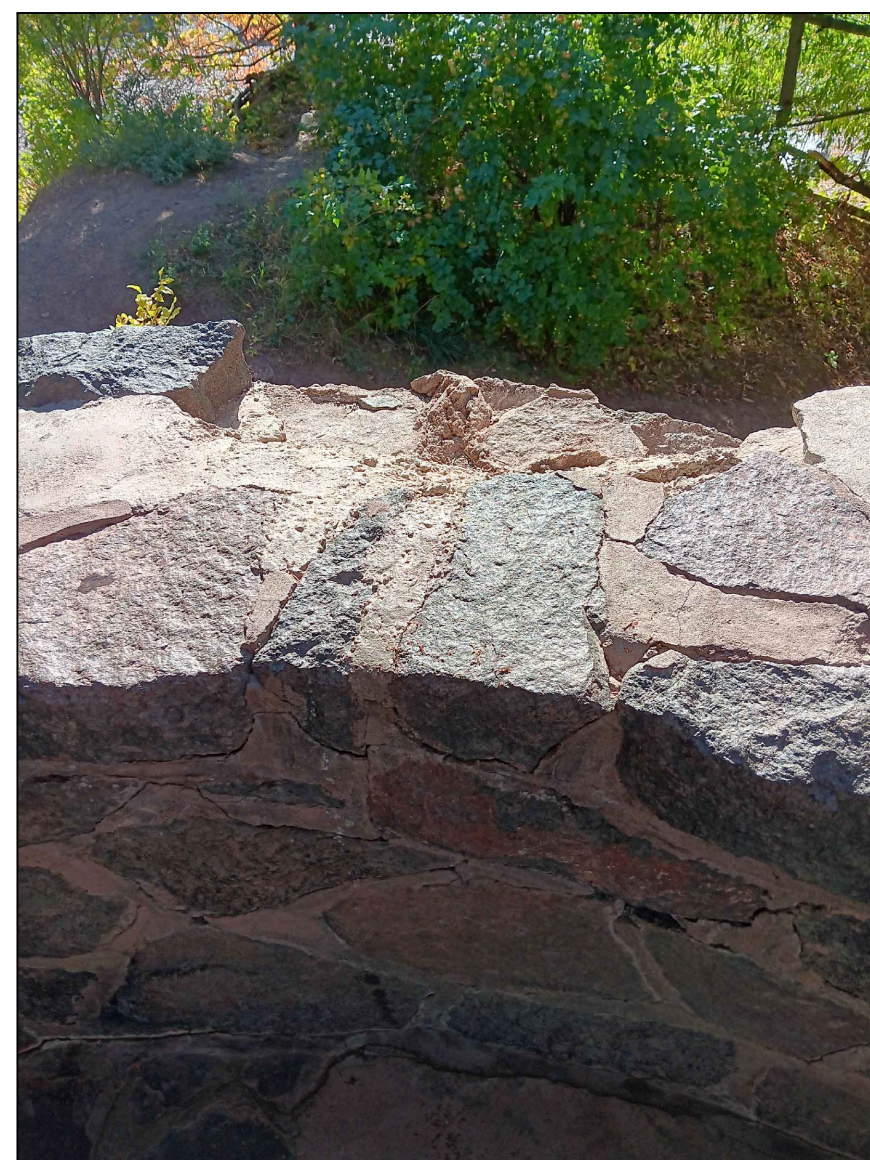
EAST TOWER DETERIORATED WINDOW SILL

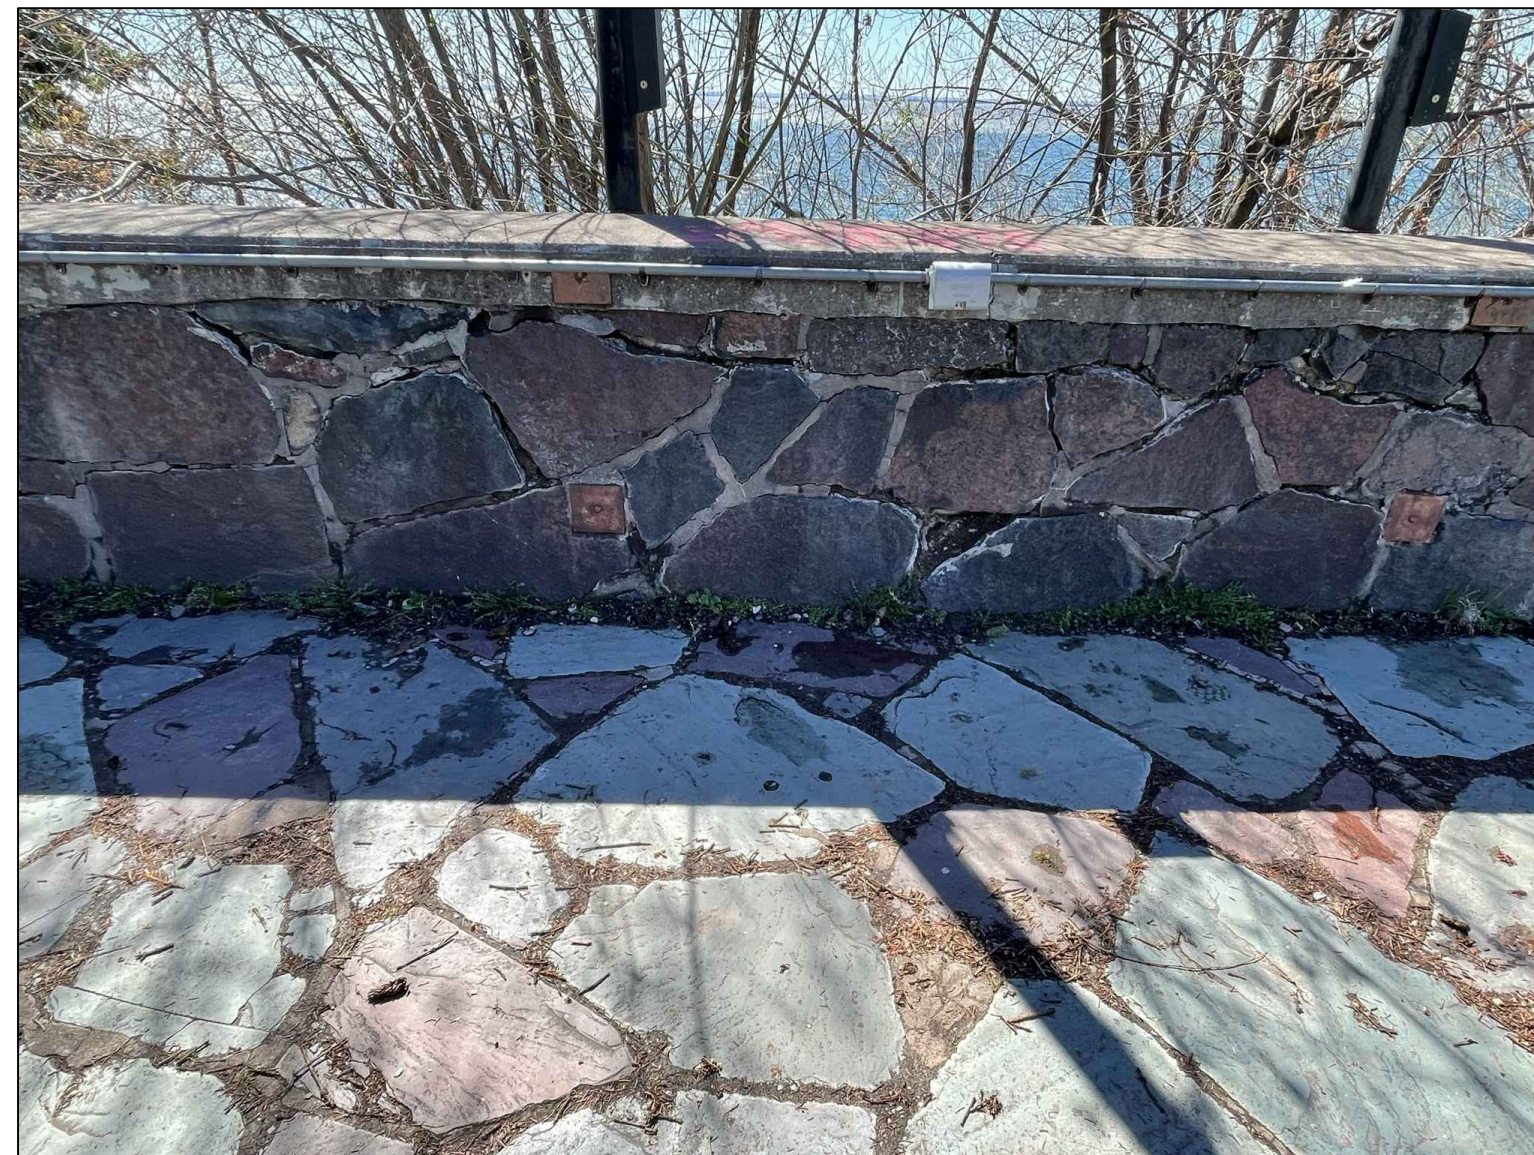
FRONT VIEW OF BACK STAGE WALL DETERIORATED MORTAR JOINTS

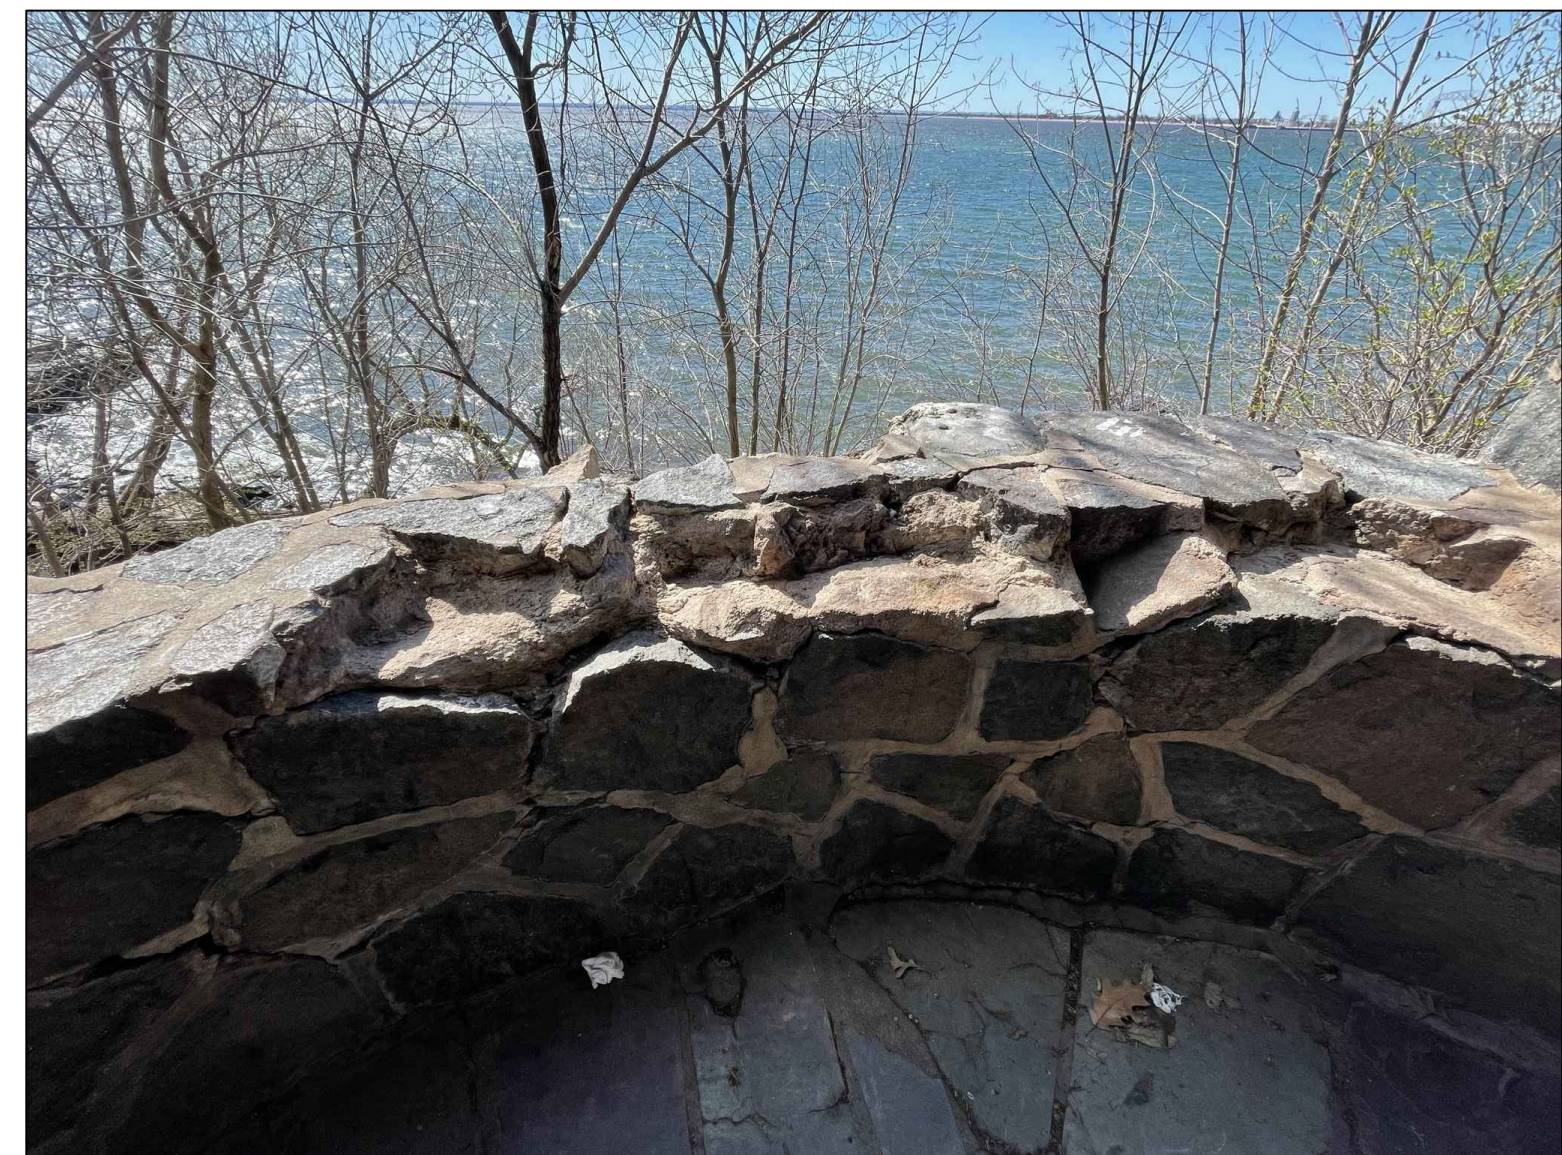
WEST TOWER DETERIORATED WINDOW SILL

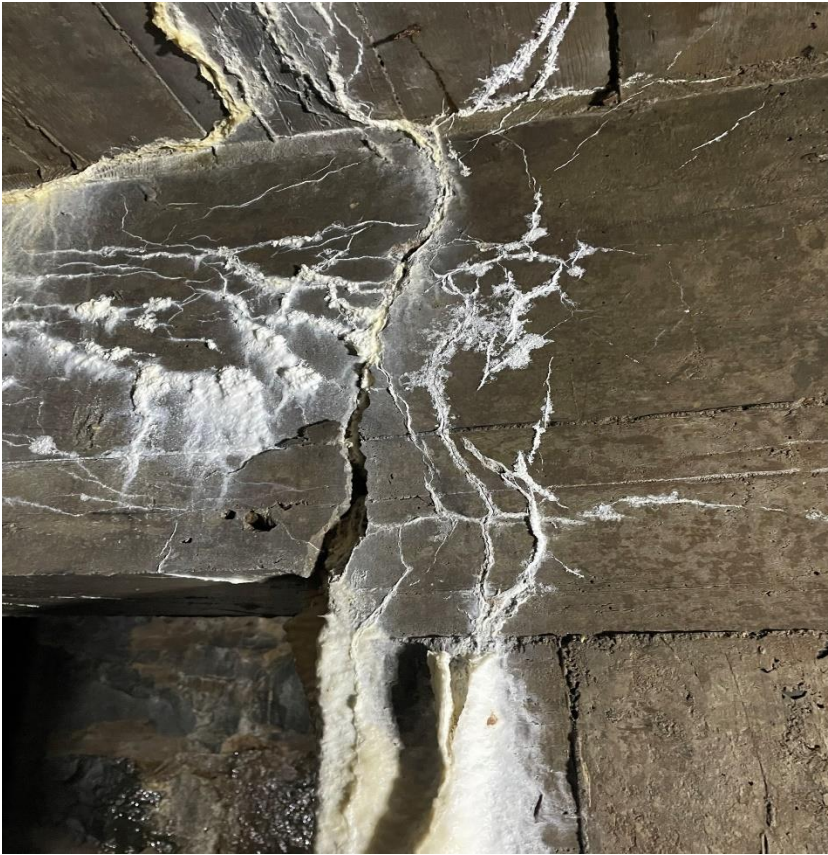
Photo 5: Vertical crack in concrete beam below the stage.

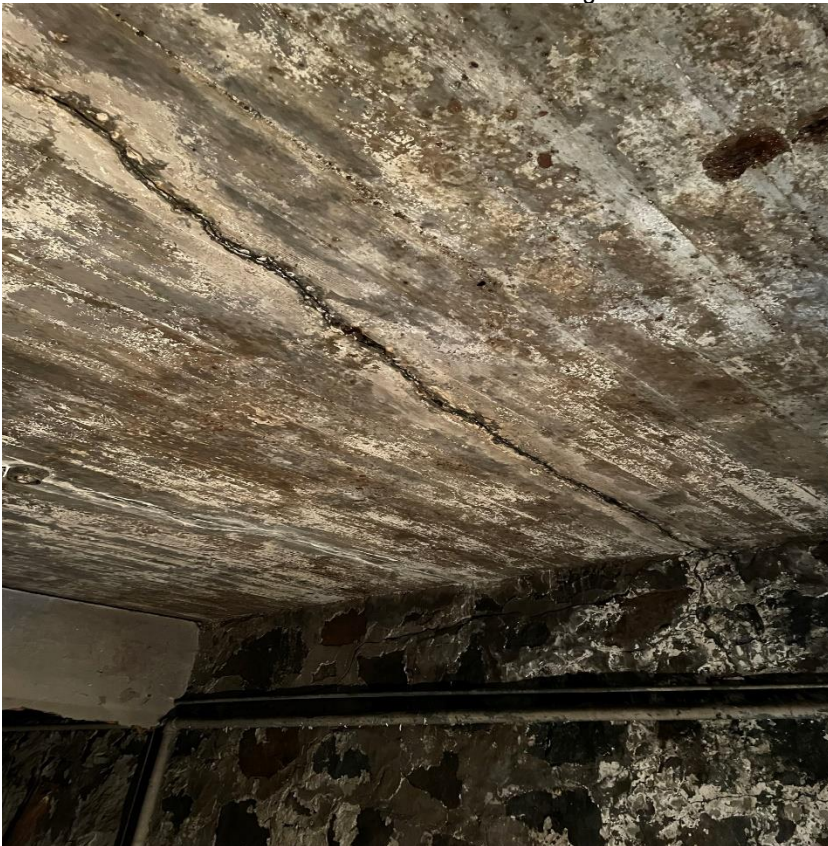
Photo 6: Crack in stage slab from below. This does allow water to leak into the basement area.

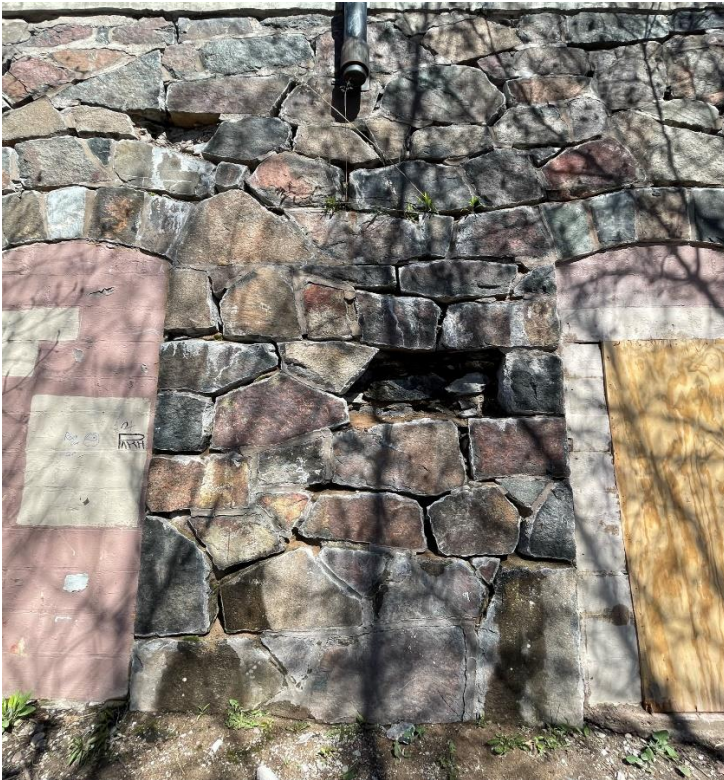
Photo 7: Exterior face of south stone wall. Note missing stones and decayed mortar joints present.

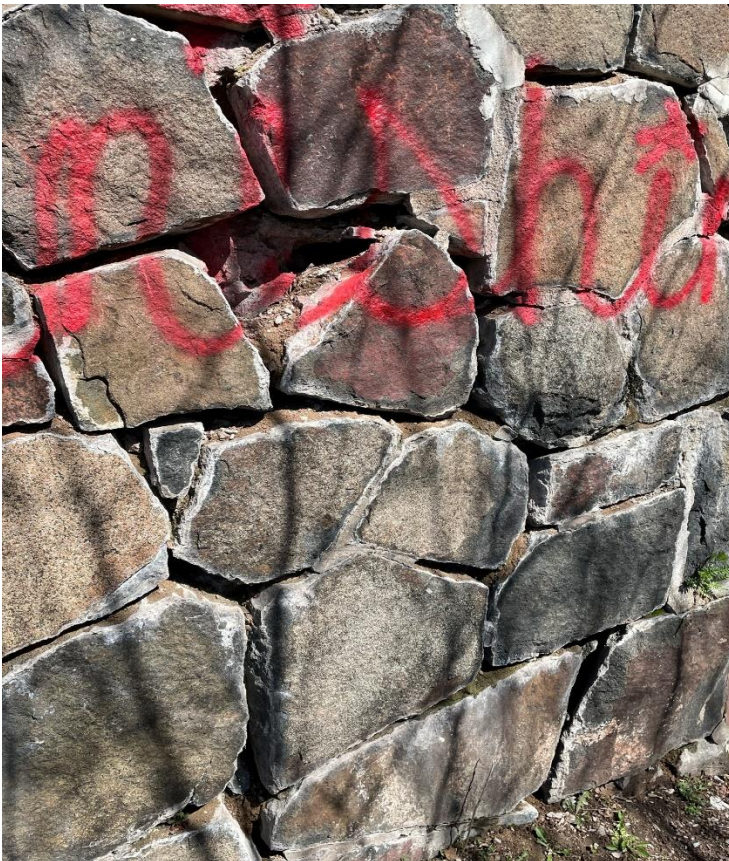
Photo 8: Example of missing stones/void spaces present in the stone walls, photo on south wall face.

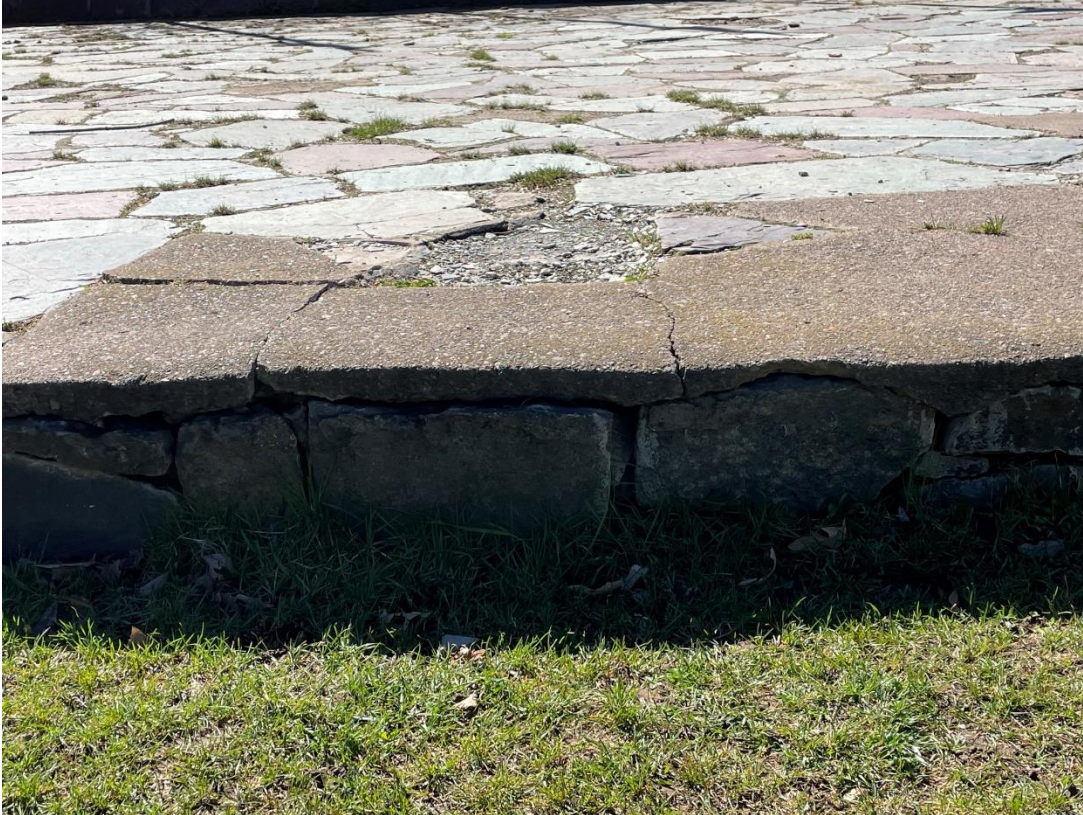
Photo 9: Example of the displaced/loose stones evident on the stage north stone wall.

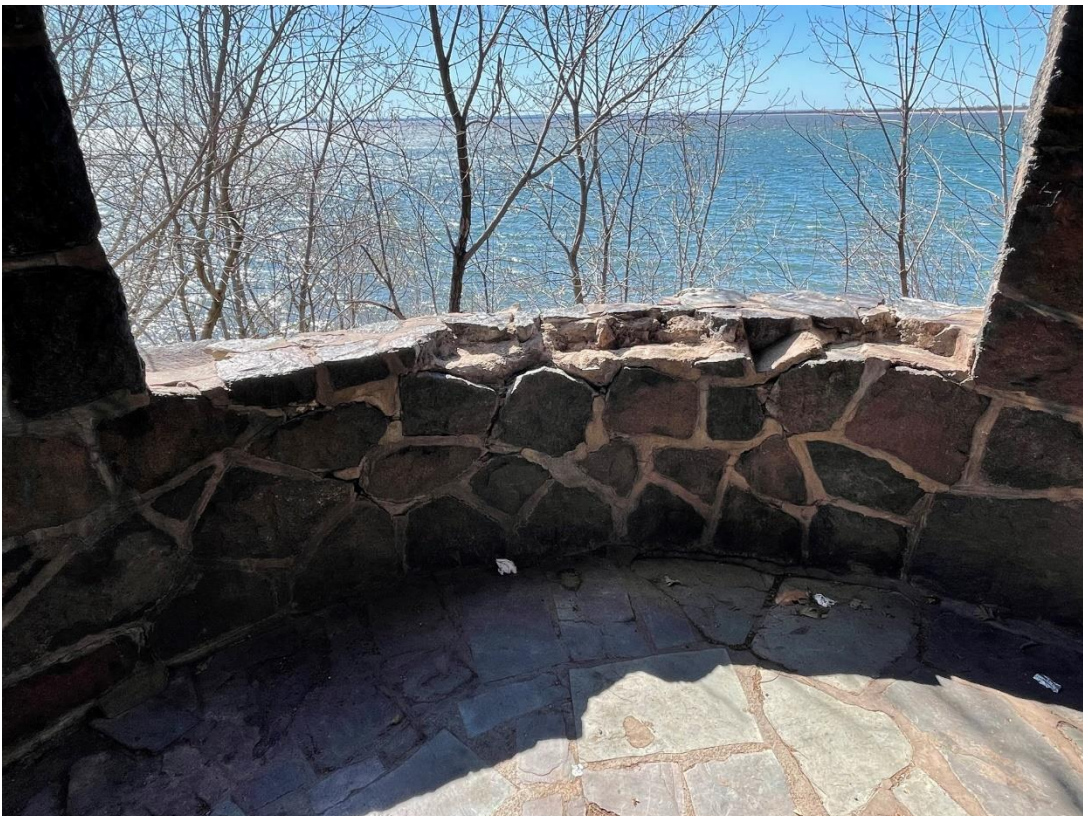
Photo 10: View of missing stones on the sill of West tower wall opening.
