Purchasing Division
Finance Department
Room 120
411 West First Street
Duluth, Minnesota 55802

218-730-5340
purchasing@duluthmn.gov

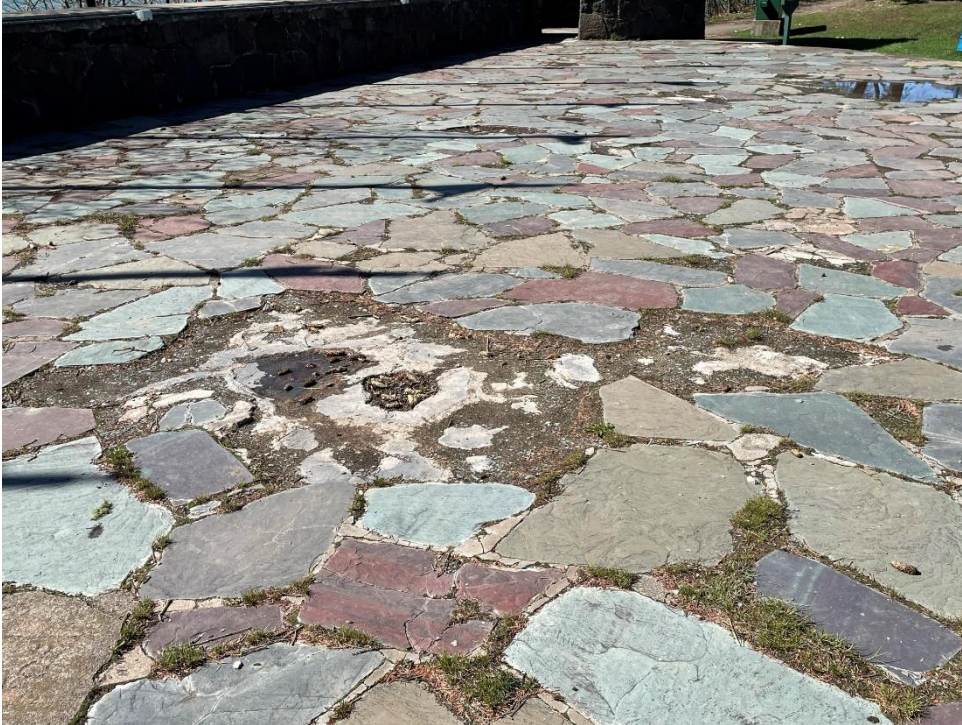
Photo 11: View of missing field stones and ponding water on the stage surface.

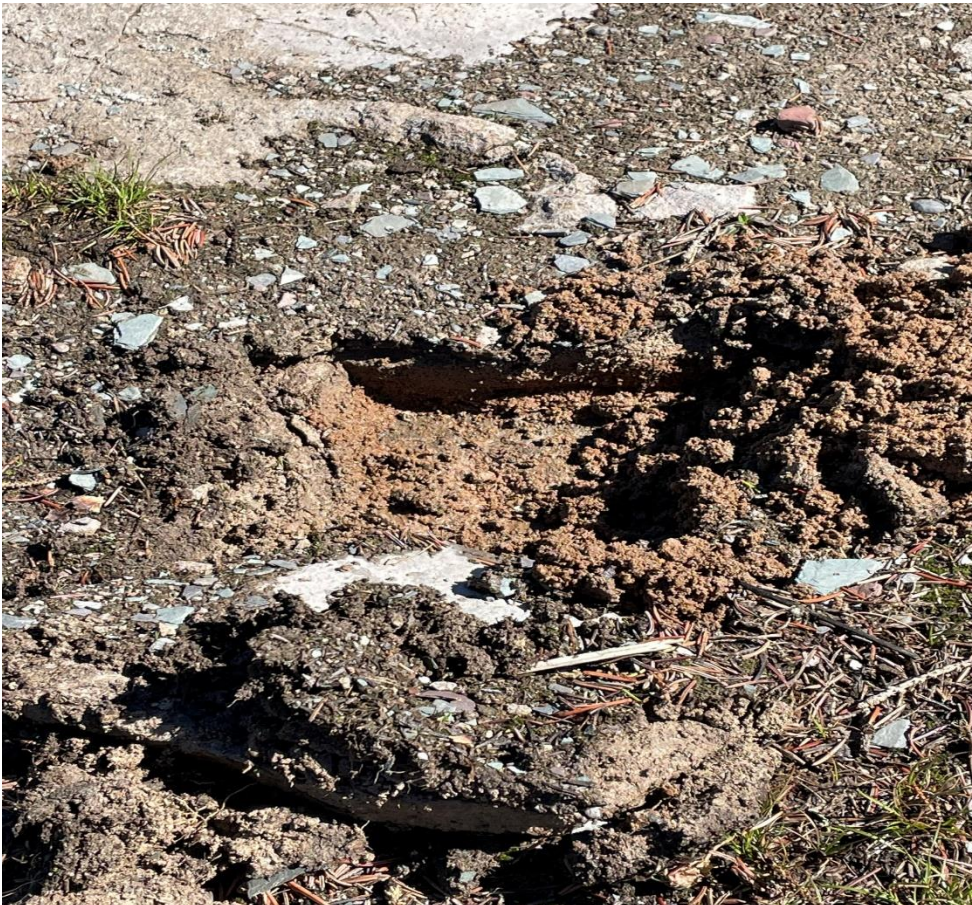
Photo 12: Example of dirt and debris (mud) building up on top of the concrete structural slab due to missing field stone.
