# Pastoret Terrace Assessment: Terrace, Kozy Bar, and Ballroom

June 17, 2016

# Pastoret Terrace – 11-01-2020 Fire Initial Assessment

November 20, 2020

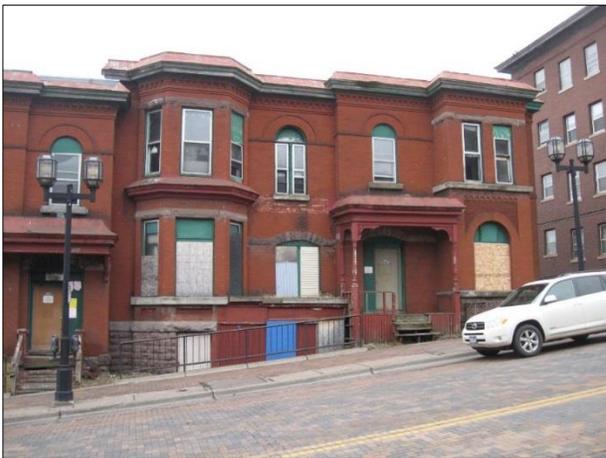
*Figure 1 Avenue Façade near alley*

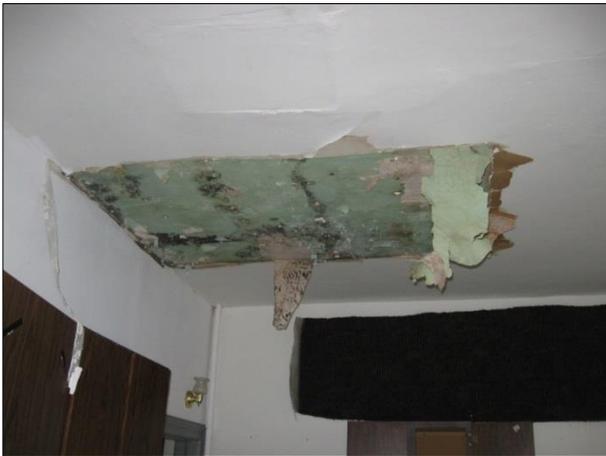
Figure 9 Typical interior of upper level ceilings showing sporadic water damage

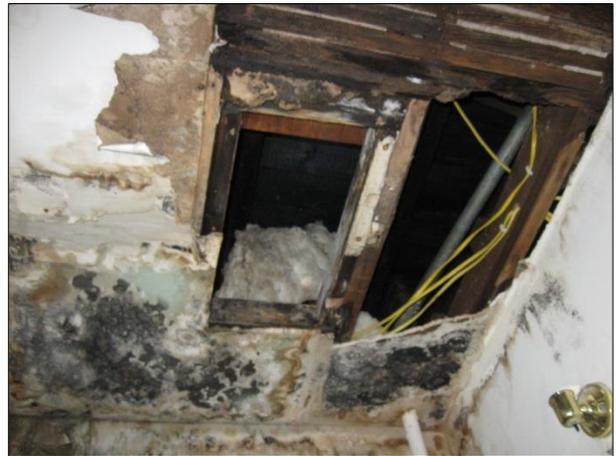
Figure 10 Roof leak and mold condition

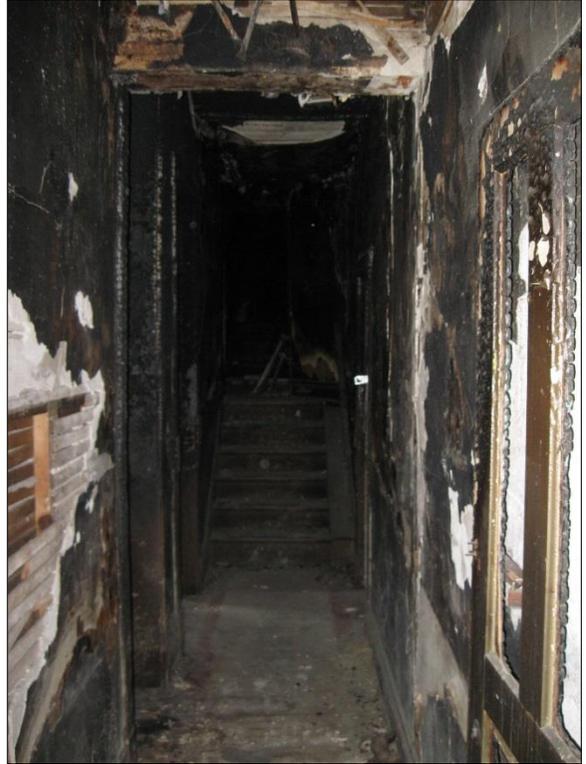
Figure 12 Corridor leading up the hill to serve inside units. Fire and smoke damage from front end fire

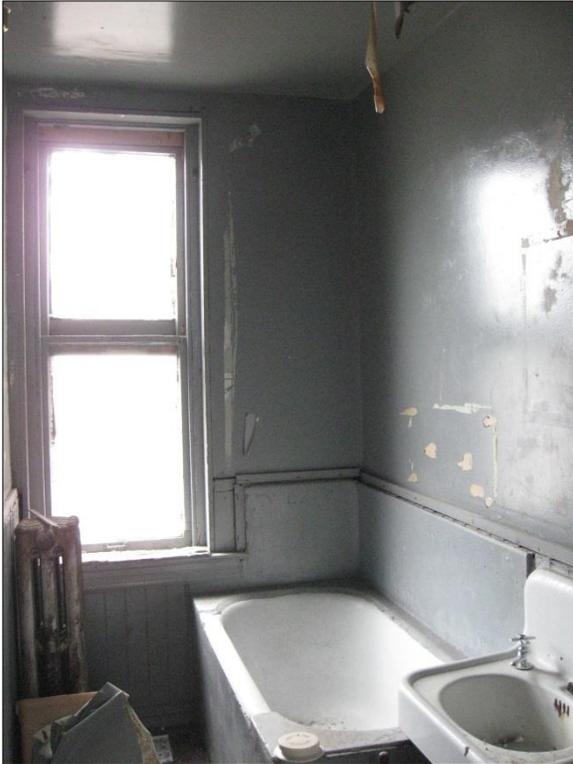
Figure 13 Typical unit bathroom condition

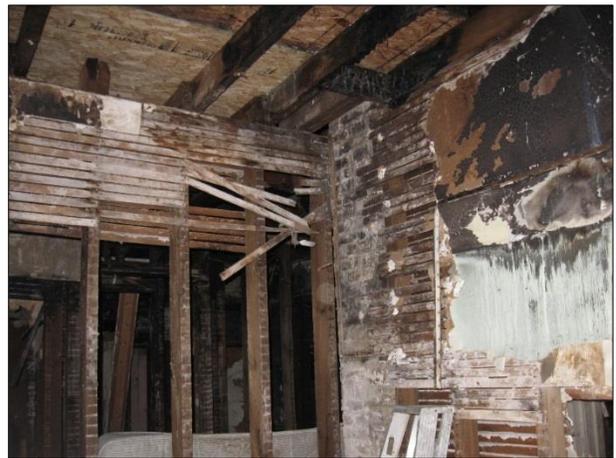
Figure 14 Stripped out and burn condition on Street side front

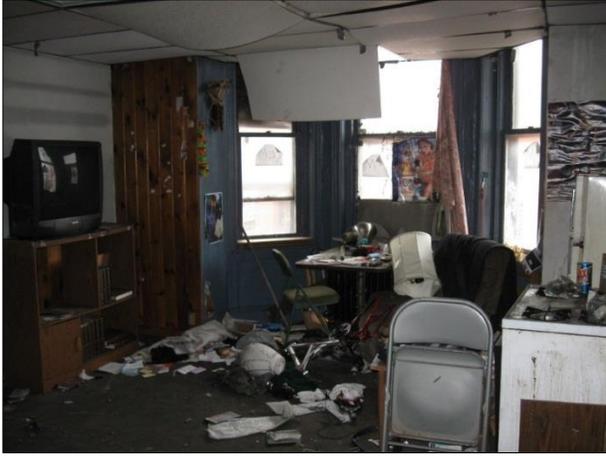
Figure 15 Typical Pastoret Terrace interior showing occupant debris and general condition of unit

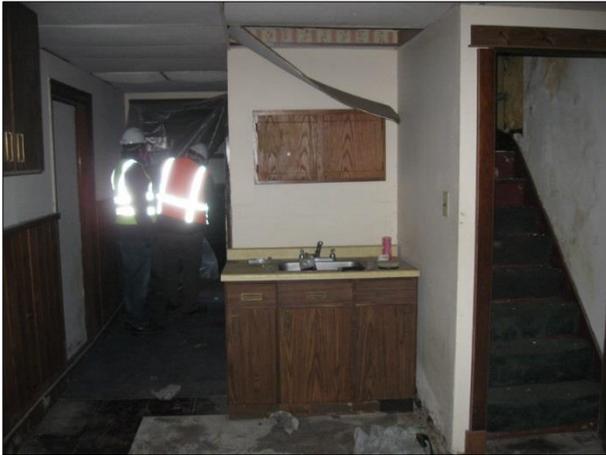
Figure 17 Ballroom first level showing water damage

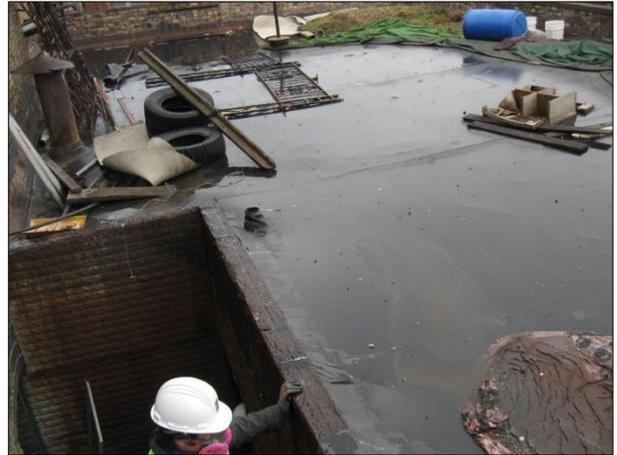
- The Ballroom building roof is comprised of EPDM adhered or loose laid membrane evidencing shrinkage and stress. The roof area is covered with much debris and plant material, including a hot tub. There is one roof drain for the main area and no provisions for overflow should this plug up. The brick parapets above the membrane are exposed and in bad condition. Evidence of leakage was observed from below. No insulation was observed for the roof.

Figure 18 EPDM roof over Ballroom area. Note growth in corner and debris.

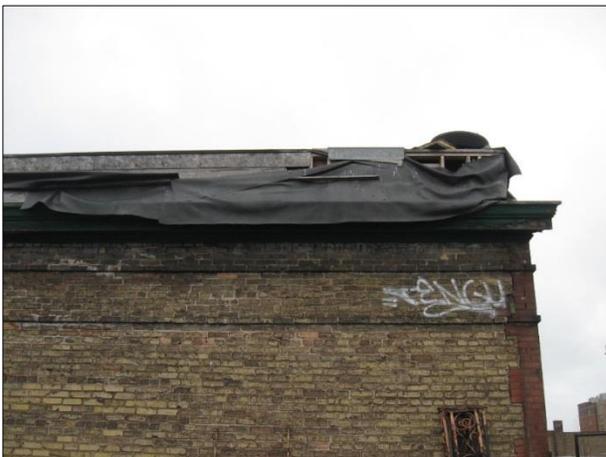
Figure 19 Southwest corner of Pastoret Terrace showing deteriorated temporary roof over burn areas

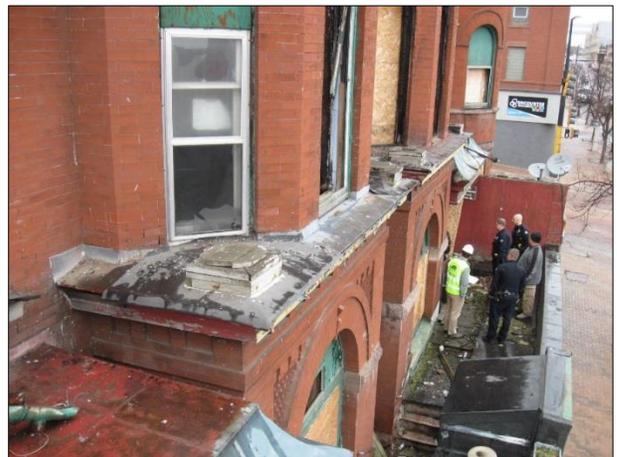
Figure 20 Street elevation close up showing metal capped façade features and EPDM membrane condition on Kozy extension below where Police are standing. Note various window conditions. No salvageable windows found.

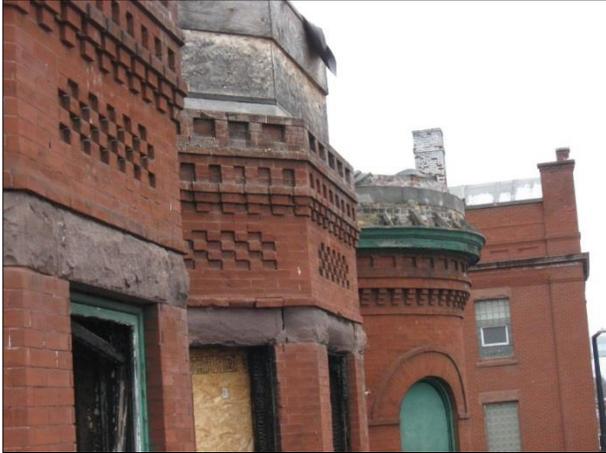
Figure 21 Note exposed Parapet wood work and brick back up on Street side

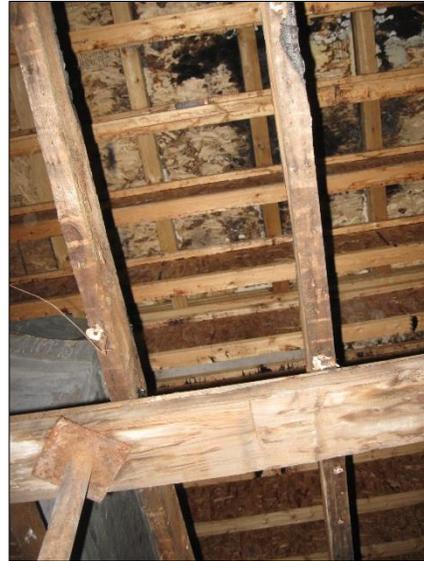
Figure 22 Black areas of temporary roof framing showing water intrusion and rot above burn area on Street side

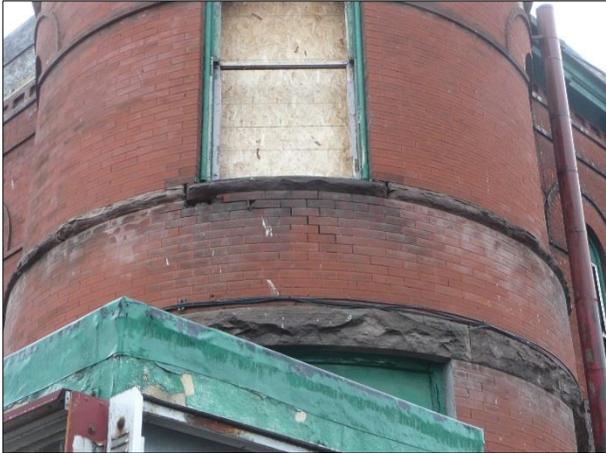
Figure 23 Loose Sandstone band, stair step crack, brick needs to be tuck-pointed

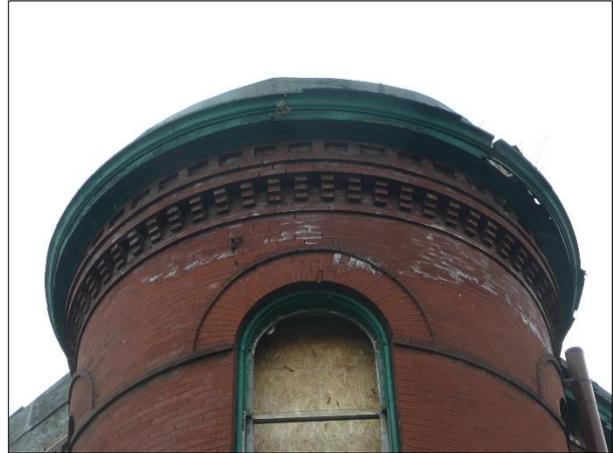
Figure 24 Loose brick at window arch, brick needs to be tuck-pointed

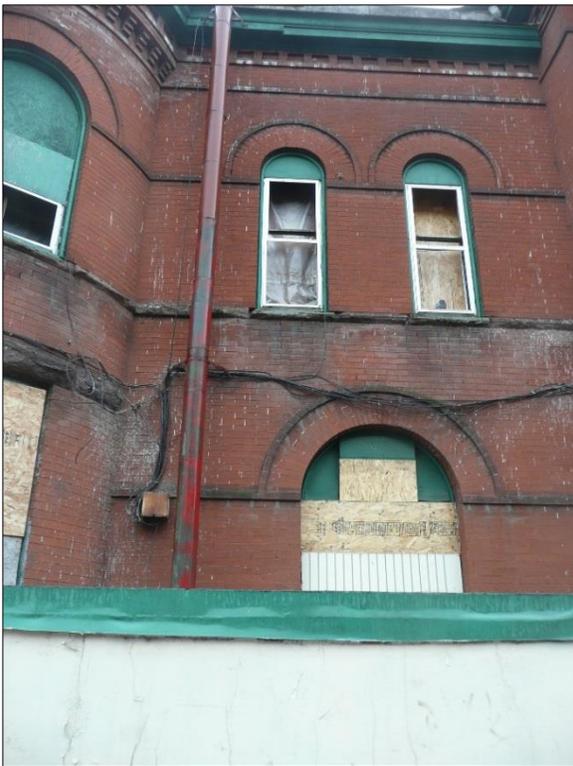
Figure 25 Loose Sandstone band, brick needs to be tuck-pointed

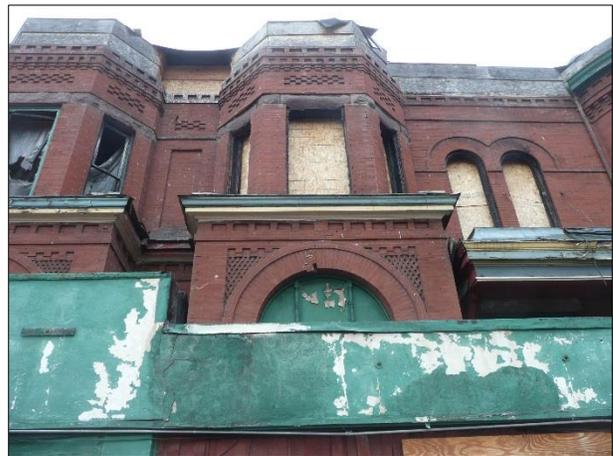
Figure 26 Loose brick at window arch, brick needs to be tuck-pointed

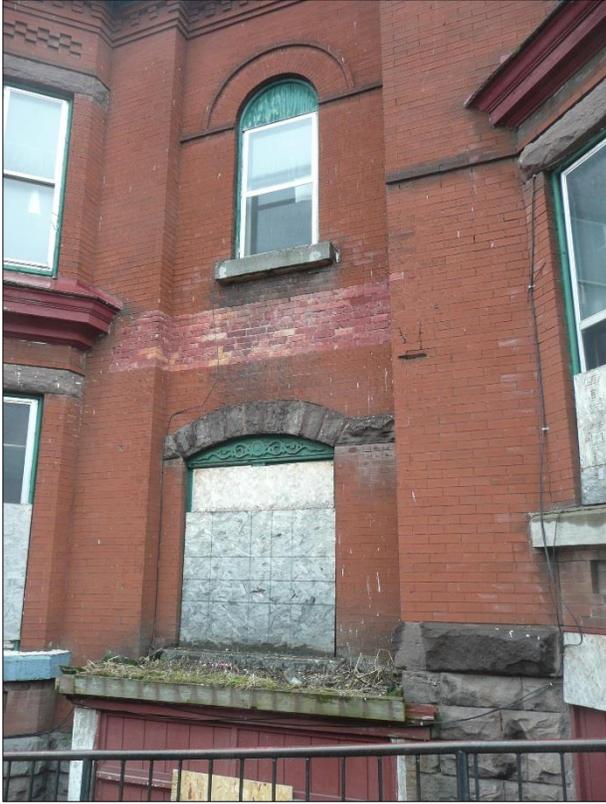
*Figure 27 Mismatched brick, existing brick needs to be tuck-pointed*

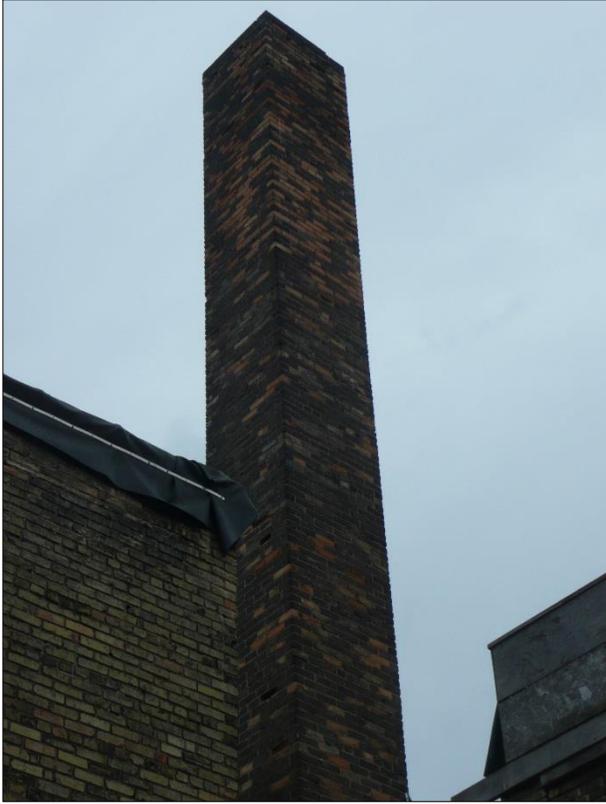
Figure 29 Brick chimney needs to be tuck-pointed

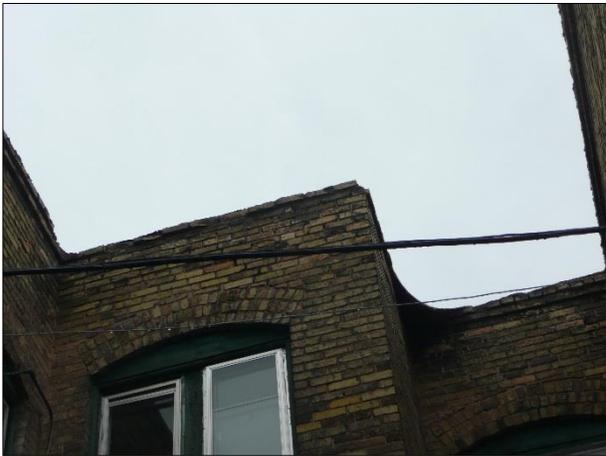
Figure 31 Brick parapet on rear of building in need of repair

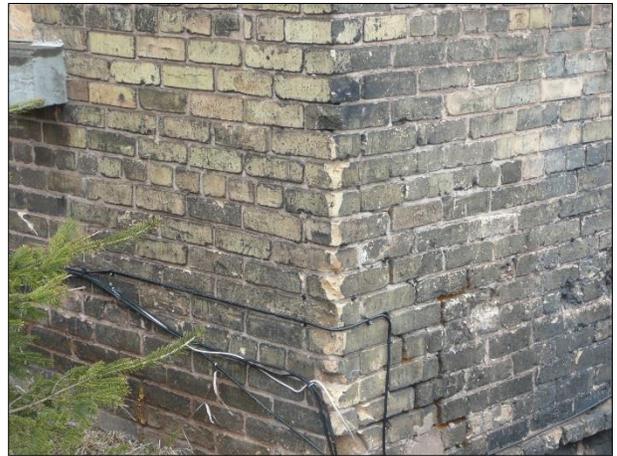
Figure 32 Damaged brick on rear of Pastoret building, brick needs to be tuck-pointed

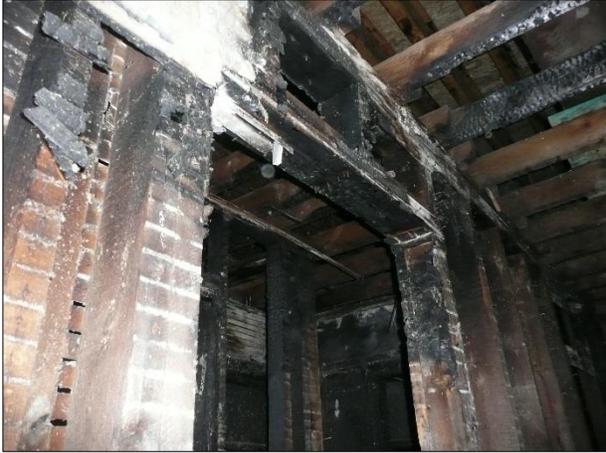
*Figure 33 Fire damaged ceiling joists and wall framing*

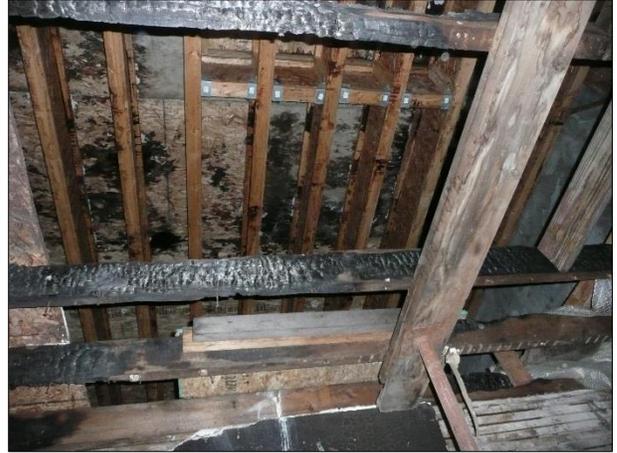
*Figure 34 Fire damaged ceiling joists, temporary wood I-joint roof over fire damaged portion of the building*

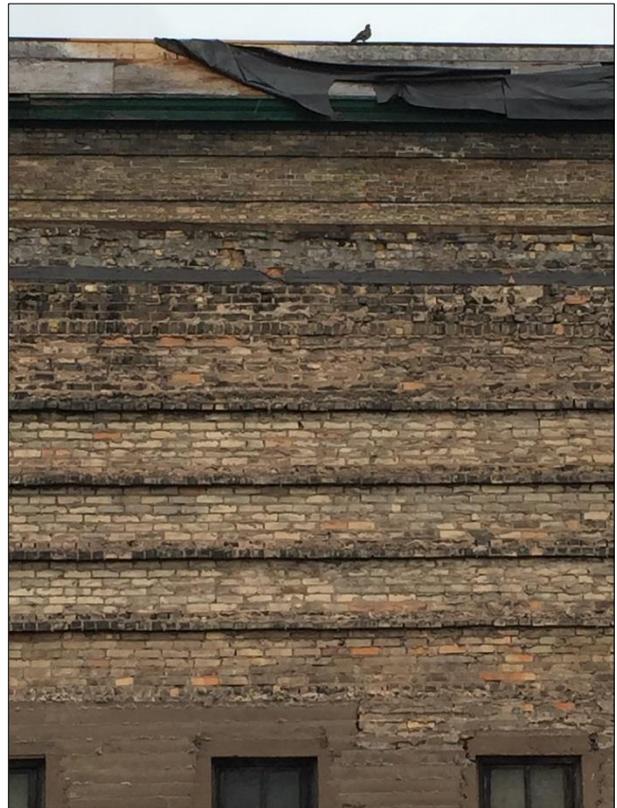
*Figure 36 Side of Paul Robeson Ballroom, Damaged brick, brick needs to be tuck-pointed, parapet needs to be repaired*

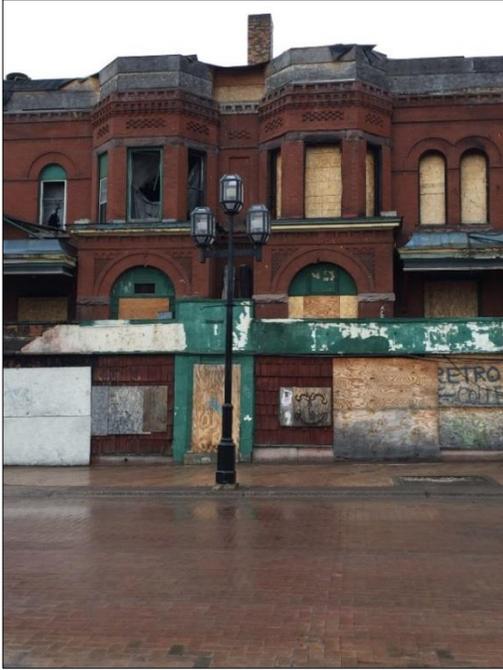
*Figure 37 Kozy Bar addition, temporary roof parapet over fire damaged portion of original Pastoret building*

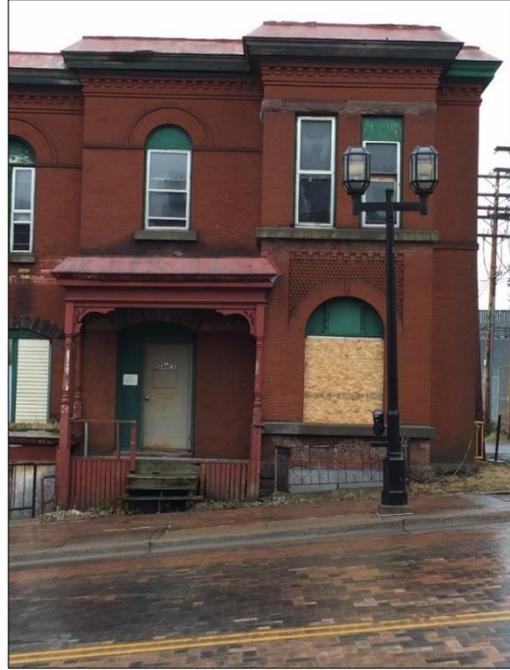
*Figure 38 Entry stairs need to be replaced. Wrought iron railing needs to be repaired or replaced.*

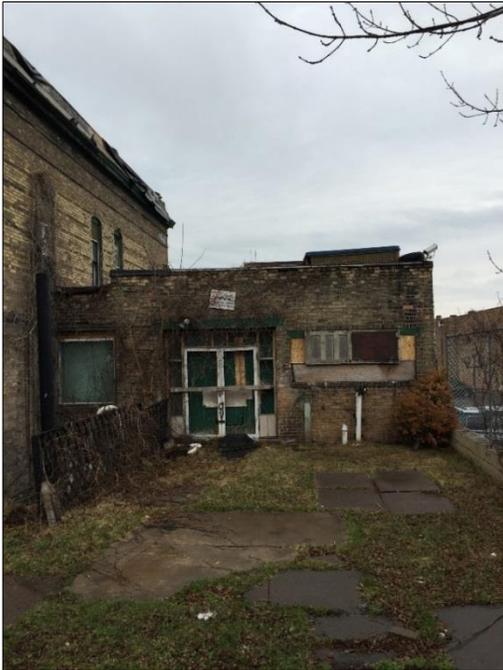
*Figure 39 Rear of Paul Robeson Ballroom, Brick needs to be tuck-pointed, parapets need to be repaired*

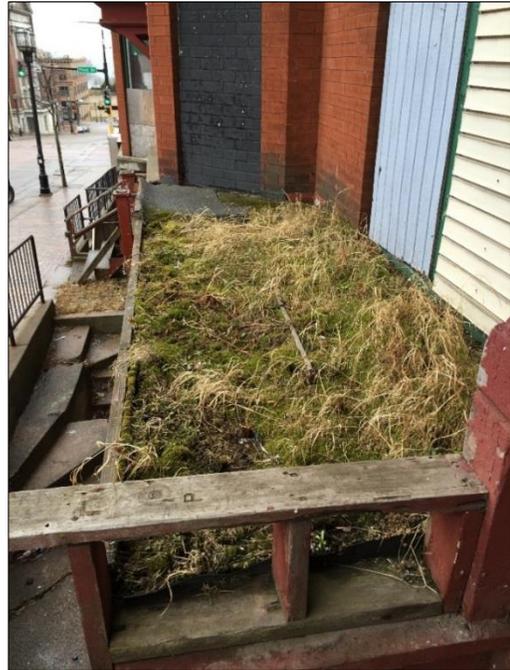
*Figure 40 Vegetation growing on low roof, deteriorated roof structure below*

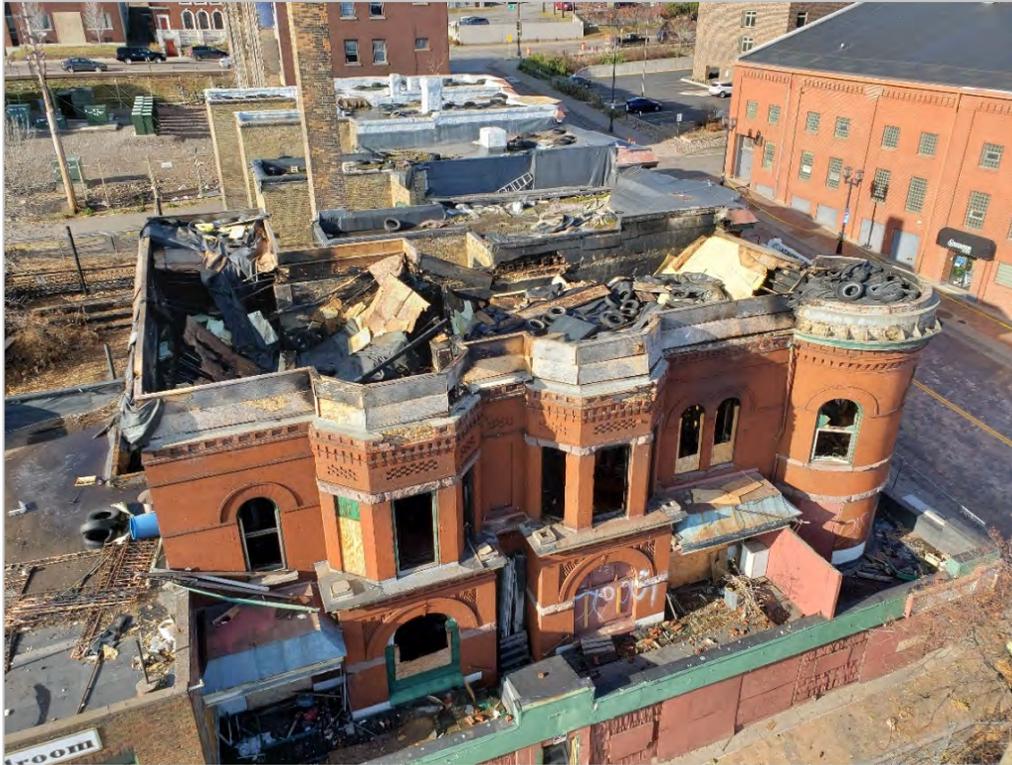
*Photo 1: Southerly (1<sup>st</sup> Street) Elevation of Pastoret Building. Westerly module is on left and easterly module is on right. Roof region and majority of window openings on both modules are open to the elements.*

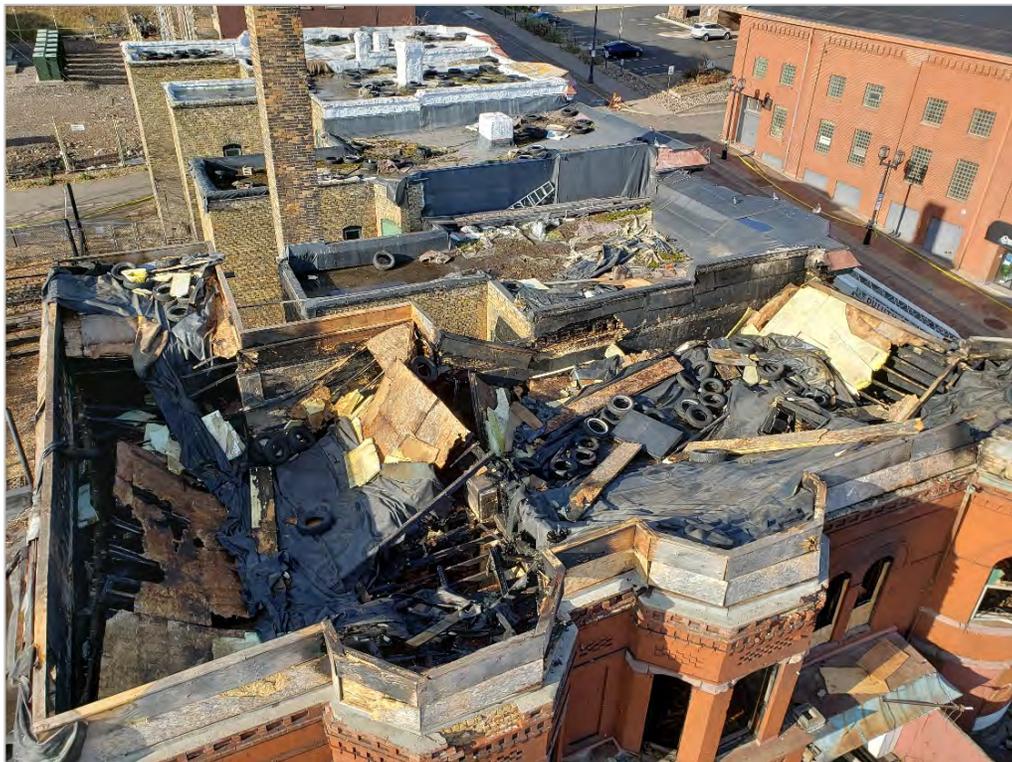
*Photo 2: Fire destroyed and collapsed roof systems of Pastoret Building westerly (left side) and easterly (right side) modules.*

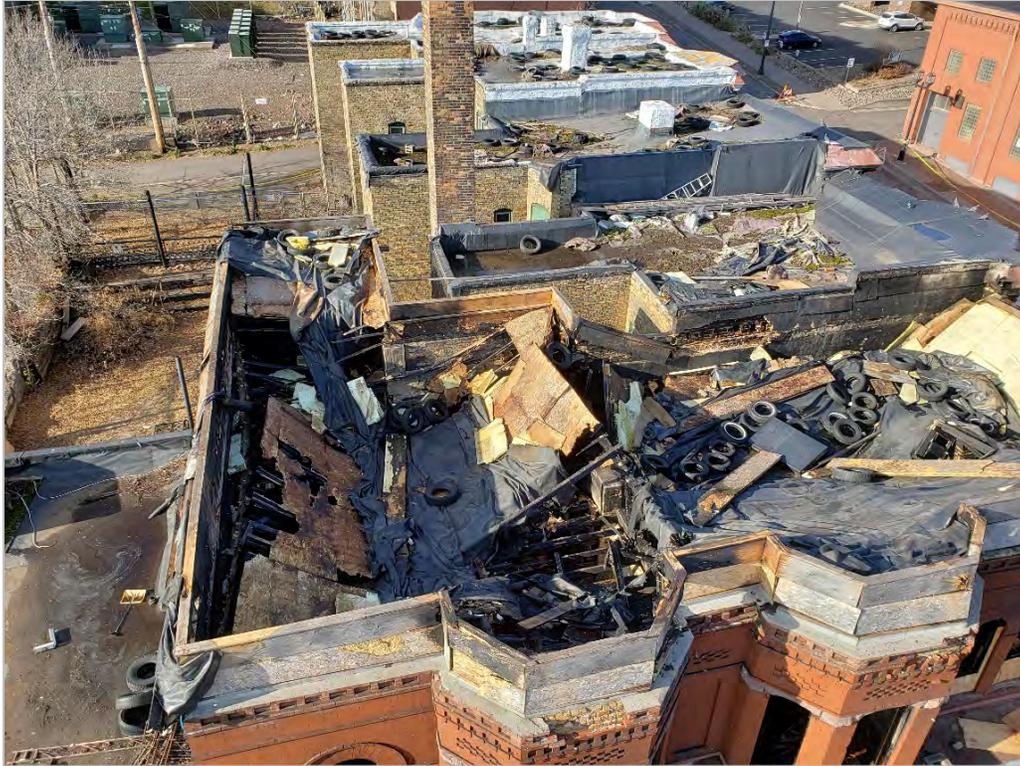
*Photo 3: Fire destroyed and collapsed roof system of Pastoret Building westerly module.*

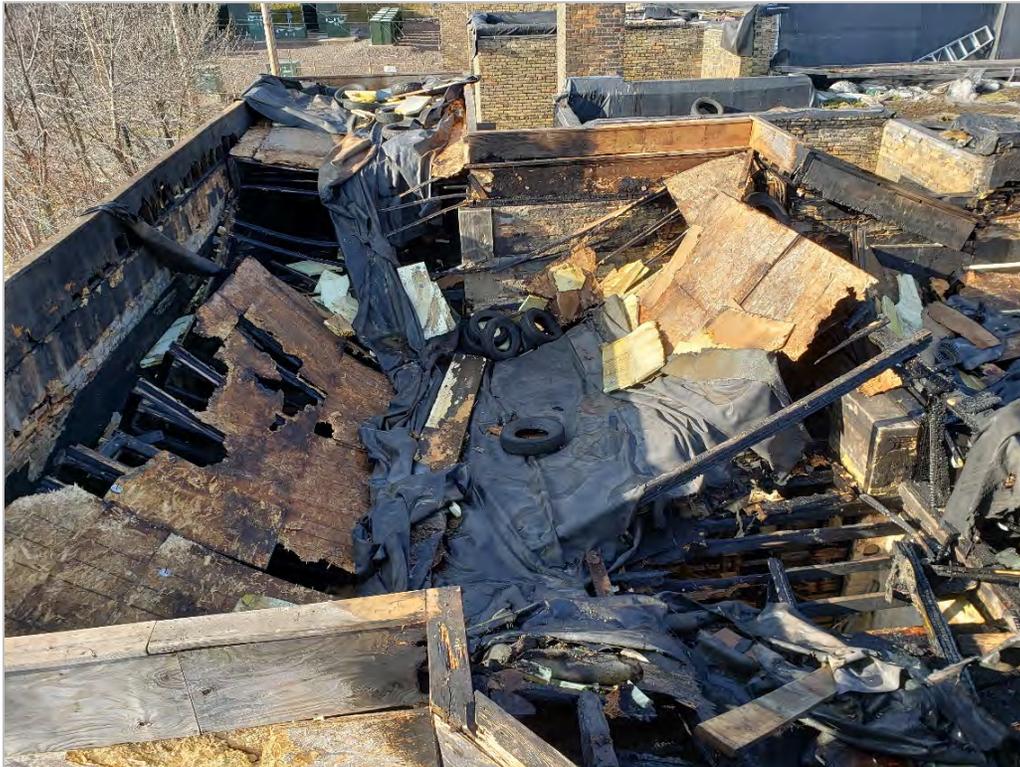
*Photo 4: Close up view of fire destroyed and collapsed roof system of Pastoret Building westerly module.*

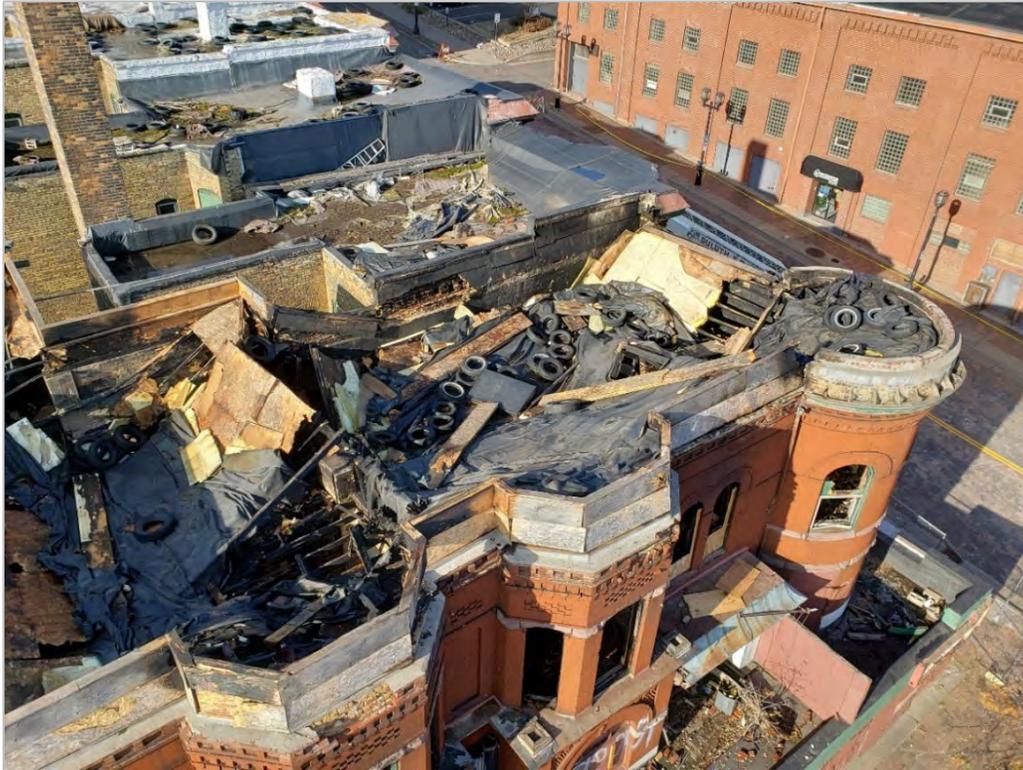
*Photo 5: Fire destroyed and collapsed roof system of Pastoret Building easterly module.*

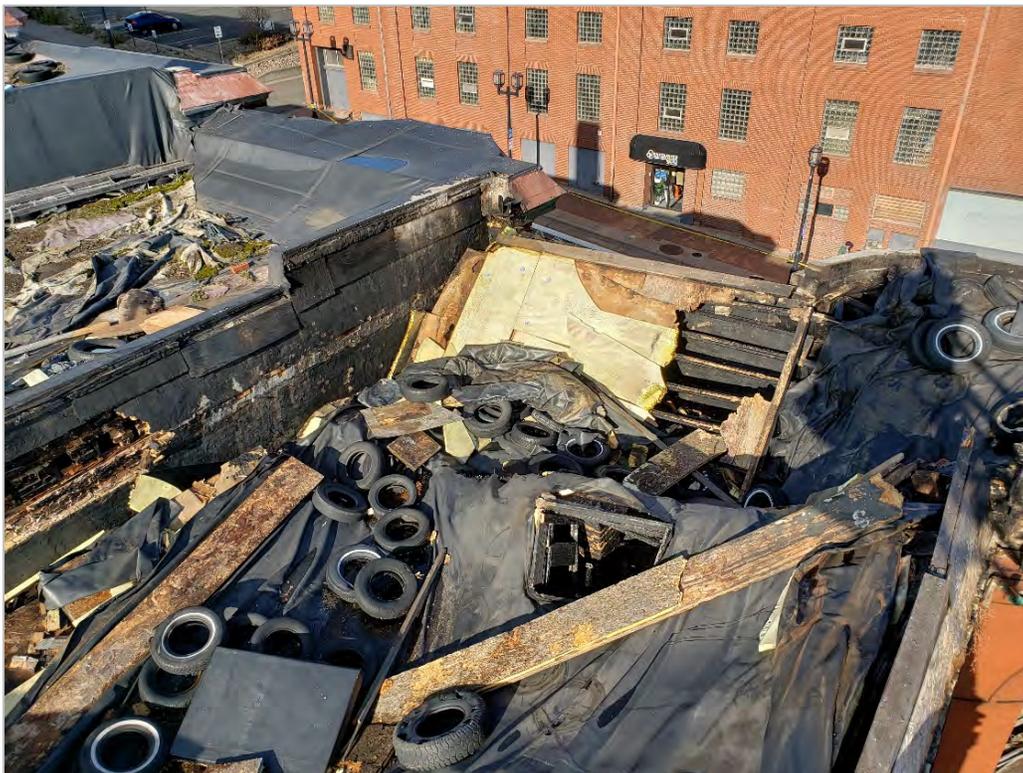
*Photo 6: Close up view of fire destroyed and collapsed roof system of Pastoret Building easterly module.*

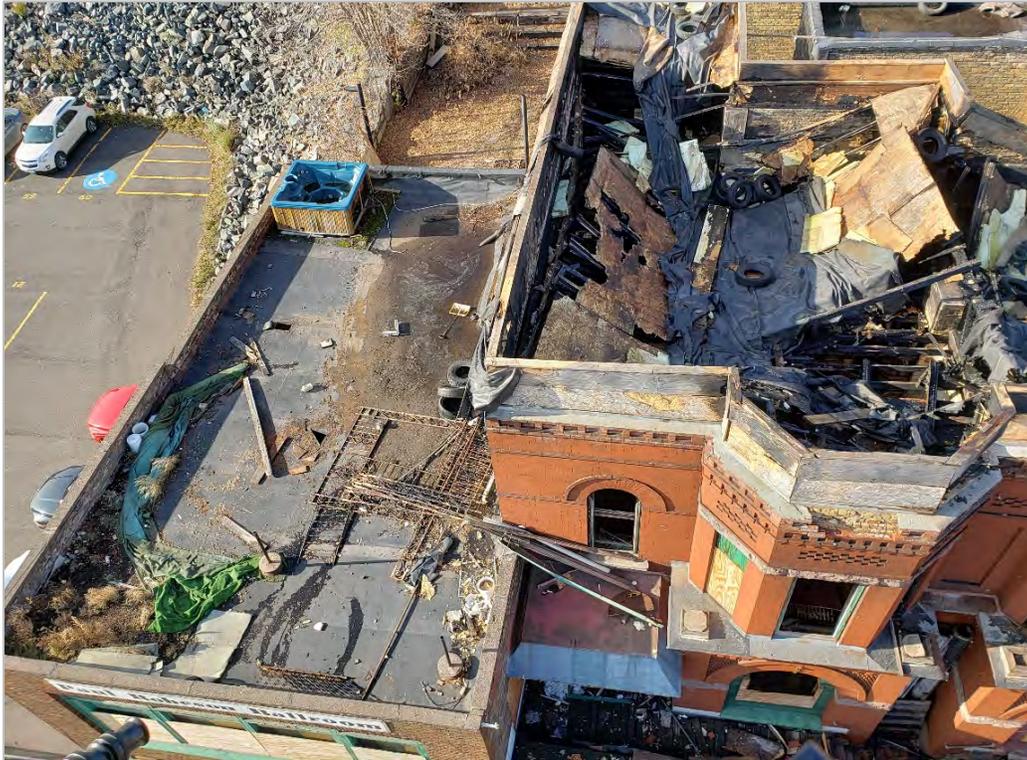
*Photo 7: Robeson Building roof (left side of photo). Initial assessment indicates fire damage from recent fire may be confined to region directly adjacent to Pastoret Building west wall, but water saturation was identified throughout interior.*

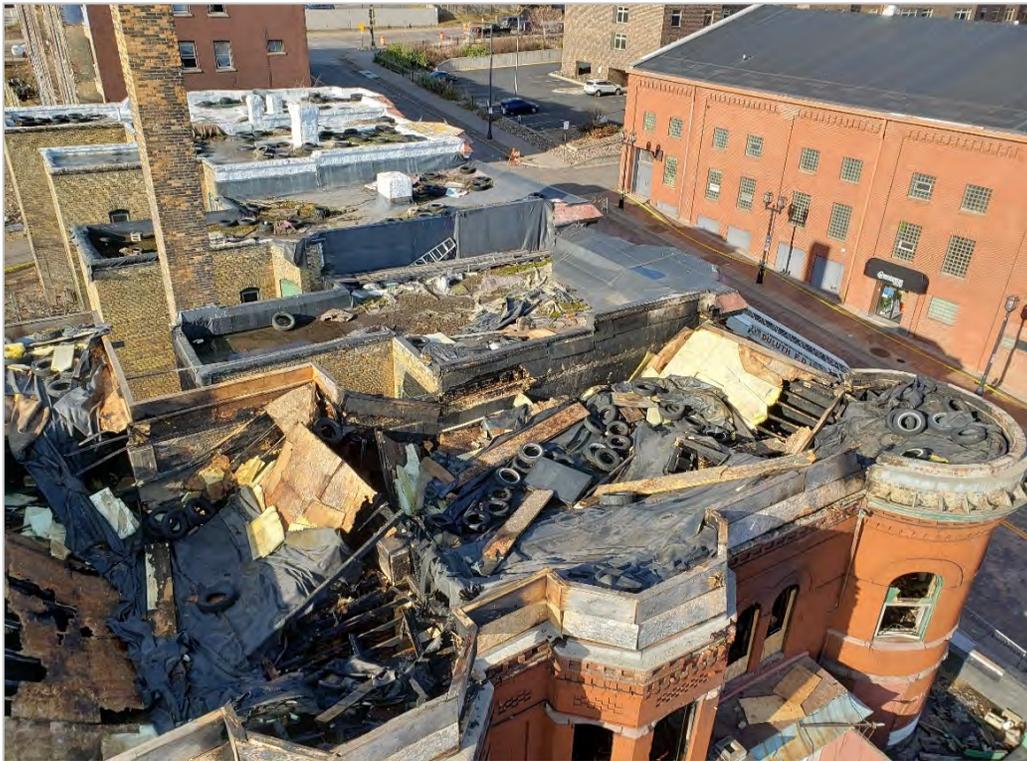
*Photo 8: Collapsed fire damaged roofs of Pastoret Building westerly and easterly modules in foreground and roofs of modules bordering/running up 2<sup>nd</sup> Avenue East beyond.*

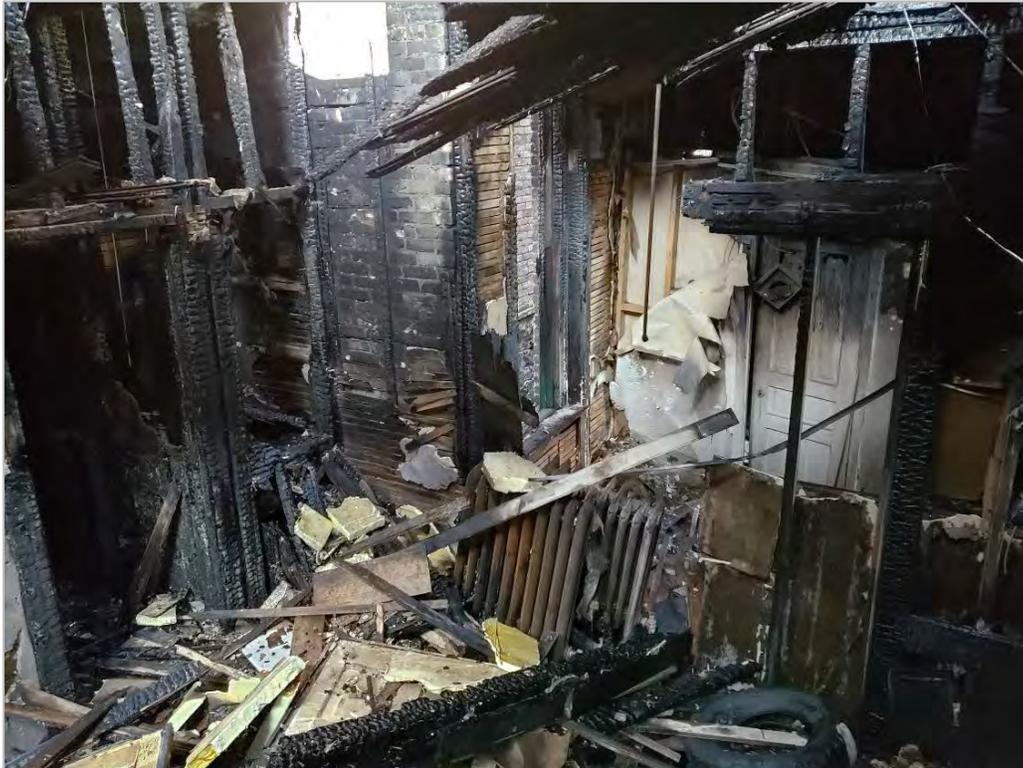
*Photo 9: Looking into Level 2 of Pastoret Building westerly module from northeast corner region of 2<sup>nd</sup> floor level of Robeson Building. Interior walls and framing are entirely compromised. Heating radiators are presently unsupported/ collapsing through floor.*

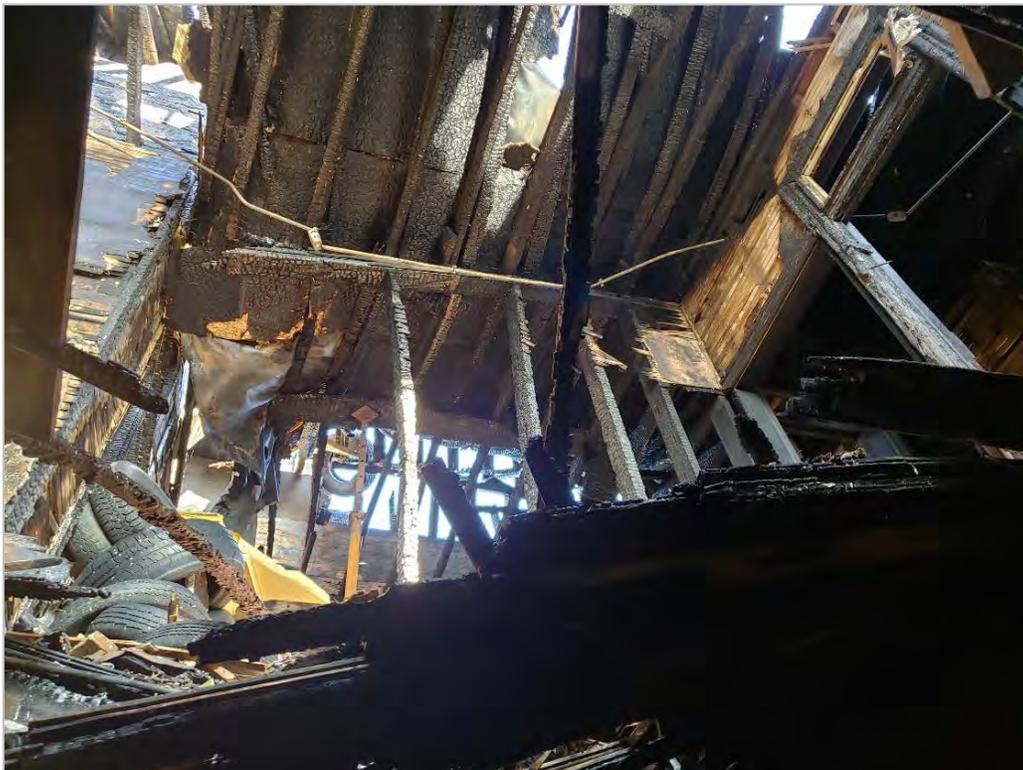
*Photo 10: Looking Easterly from location shown in Photo 9 (Level 2, Pastoret Building westerly module). Ceiling above is burnt out/ collapsing onto Level 3 floor beneath. Large openings through collapsed roof which has fallen onto Level 3 can be seen.*

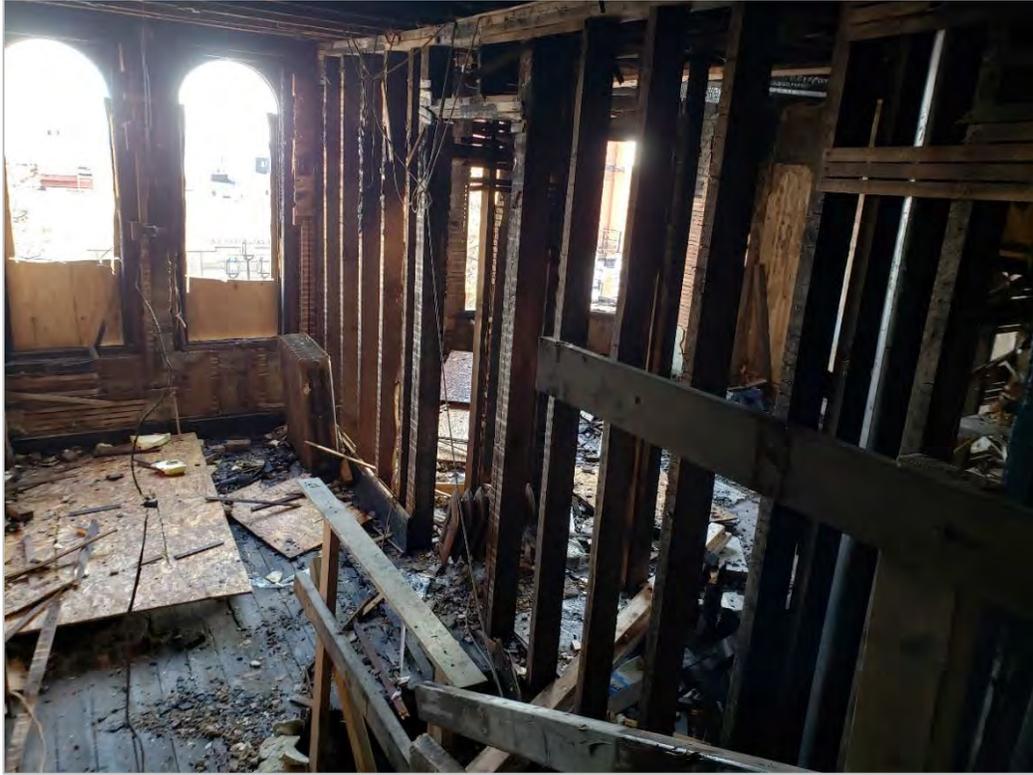
*Photo 11: Pastoret Building easterly module, Level 2 looking south. Random direct fire damage this level and extensive water infiltration.*

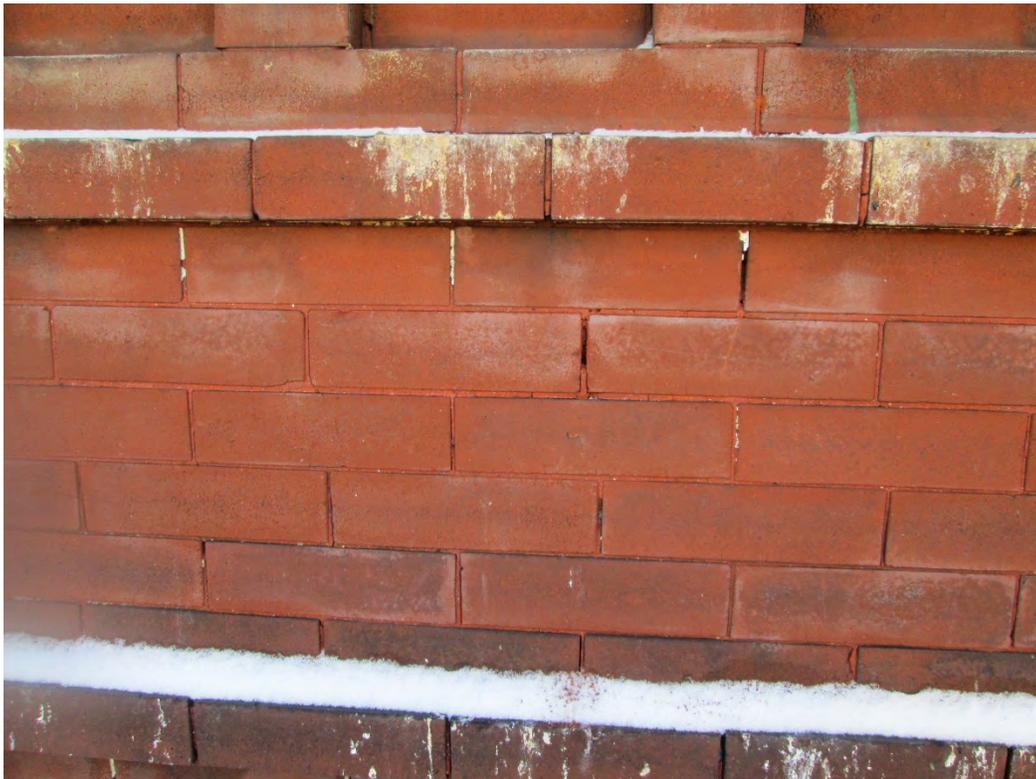
*Photo 12: Typical exterior brick masonry wall pointing mortar condition at mid-wall regions, southern elevation shown.*

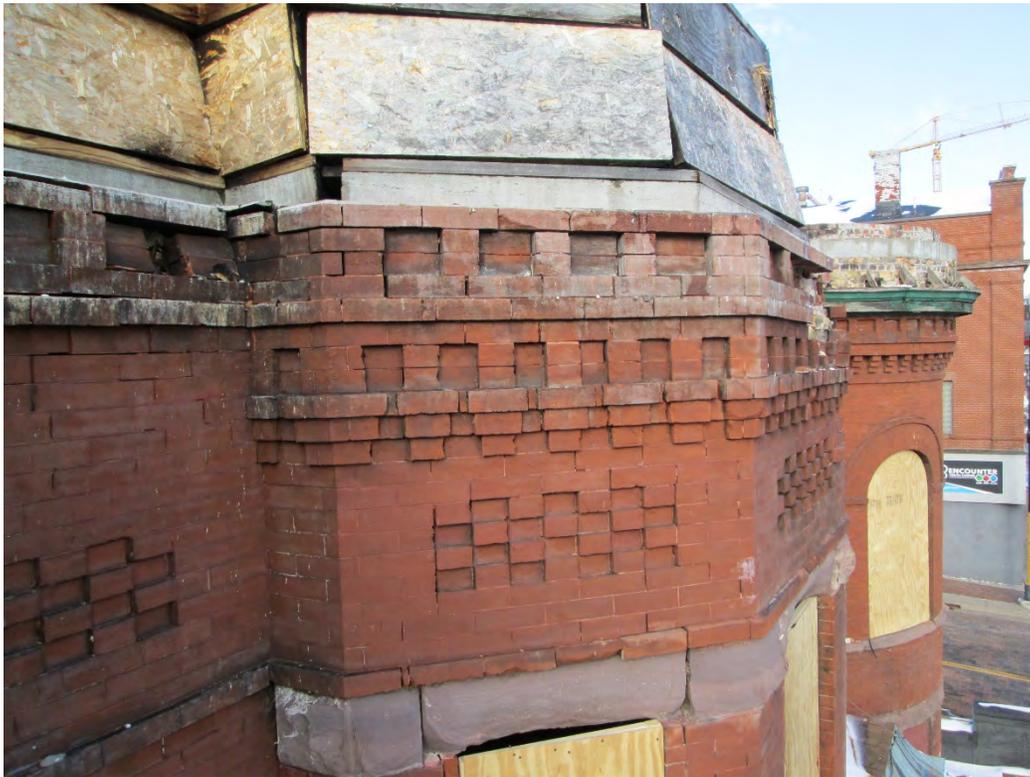
*Photo 13: Looking east, upper exterior brick masonry region, south elevation.*

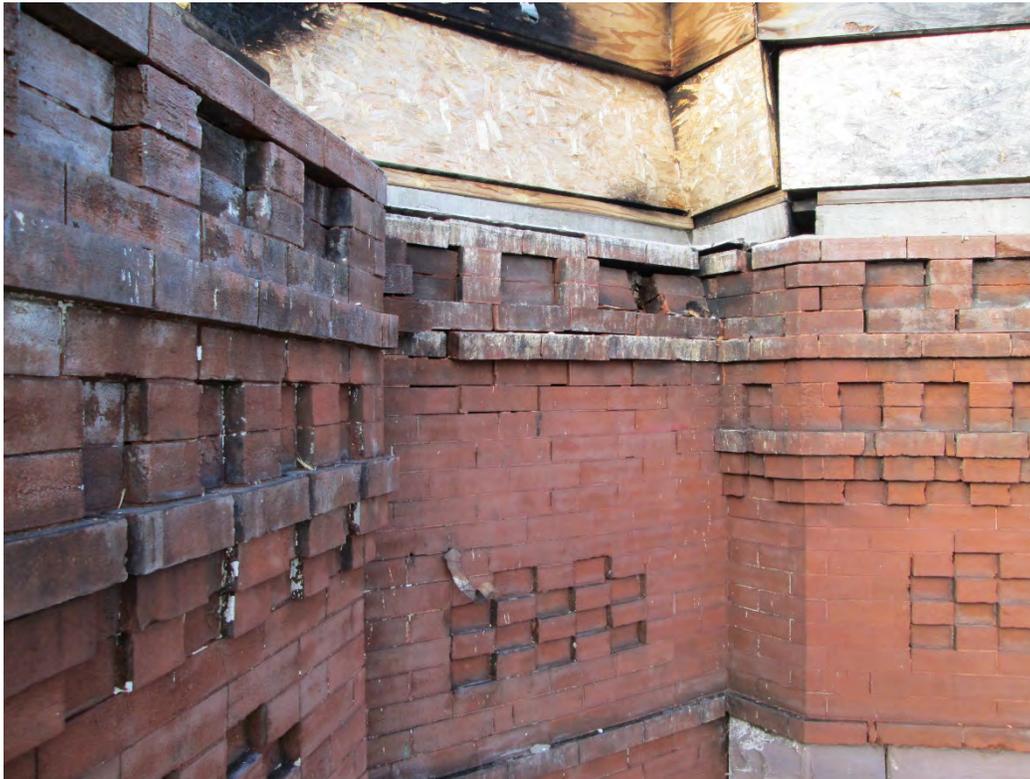
*Photo 14: Closer view from previous photo. Looking east, upper region, brick displacement/loose brick, significant efflorescence and loss of pointing mortar.*

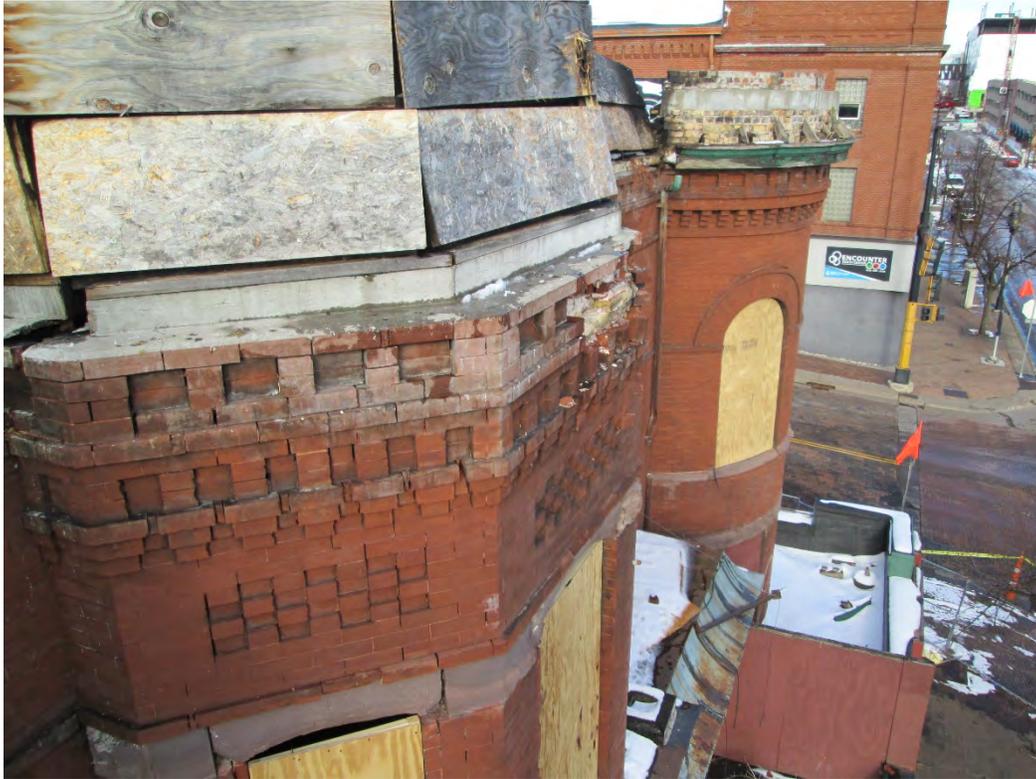
*Photo 15: Looking east, upper region, south elevation, brick displacement/loose brick, significant efflorescence and loss of pointing mortar.*

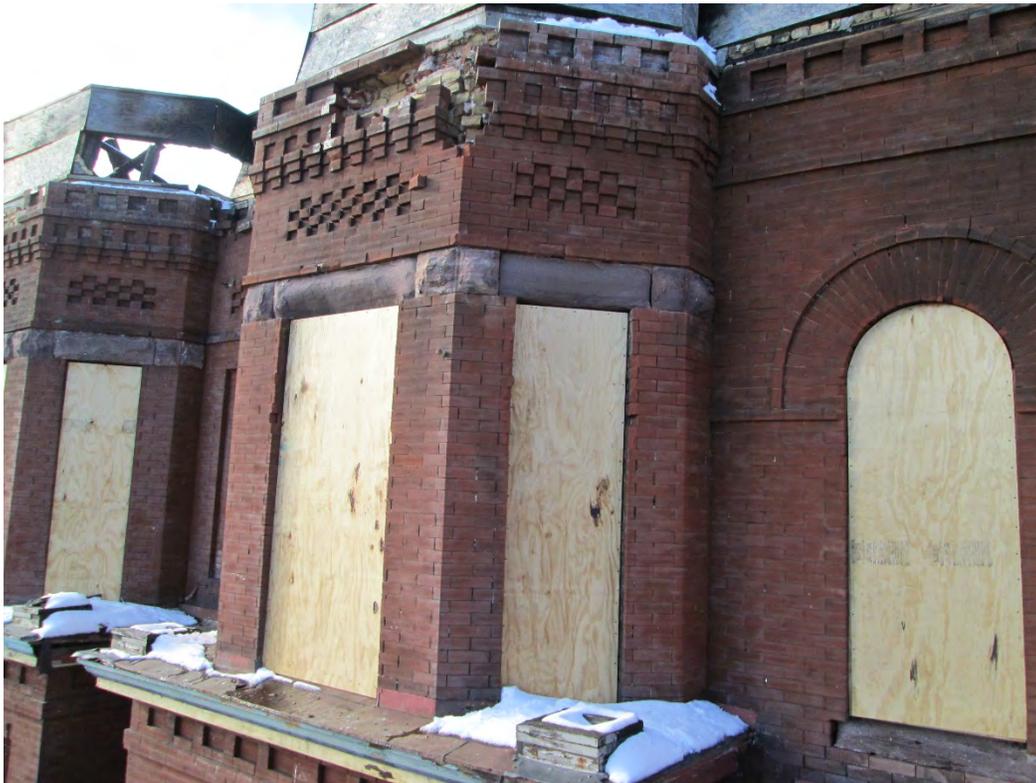
*Photo 16: Looking slight west, upper region, south elevation. Substantial brick loss, loose bricks/displaced bricks.*
