# Pastoret Terrace Assessment: Terrace, Kozy Bar, and Ballroom

June 17, 2016

# Pastoret Terrace – 11-01-2020 Fire Initial Assessment

November 20, 2020

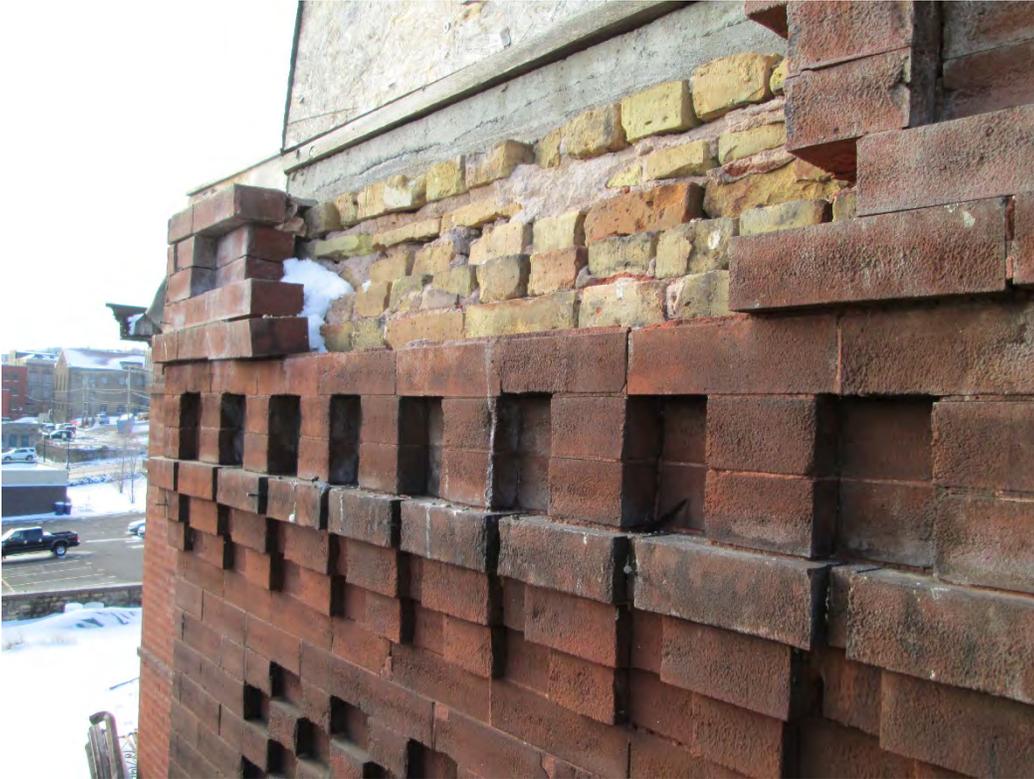
*Photo 17: Close up of voided brick area from previous photo. Numerous loose bricks remain and present a hazard to below.*

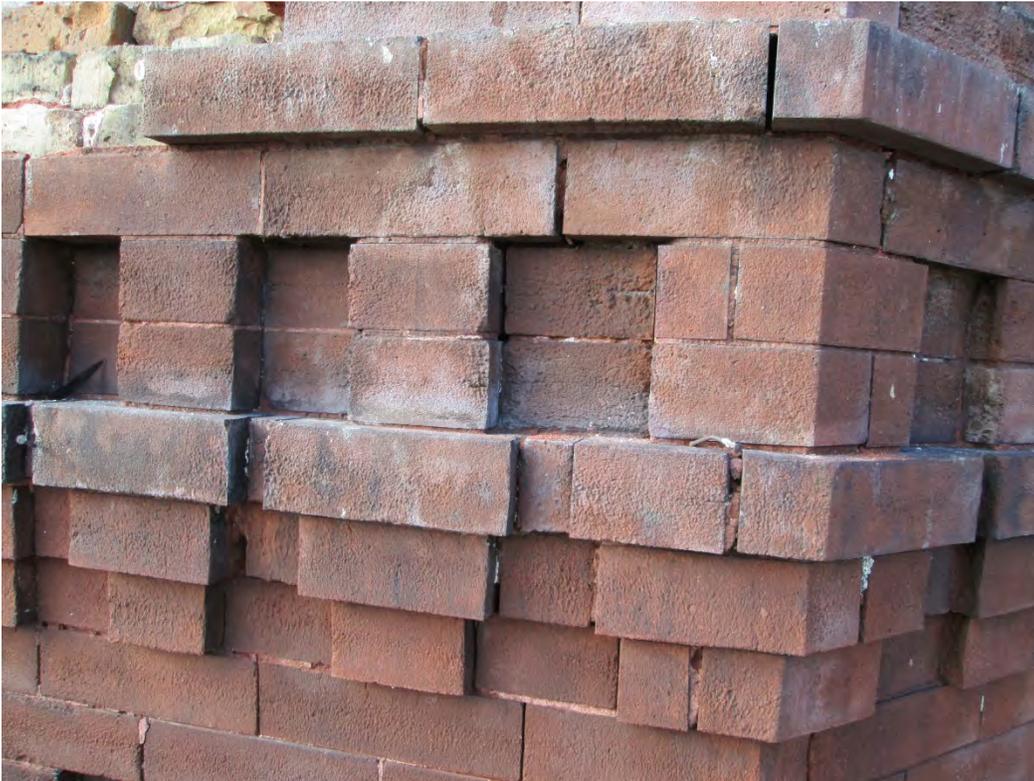
*Photo 18: Close up, right end of previous photo (upper wall, south elevation). Note substantial efflorescence, face pitting in brick (potentially fire damage) and deteriorated pointing mortar.*

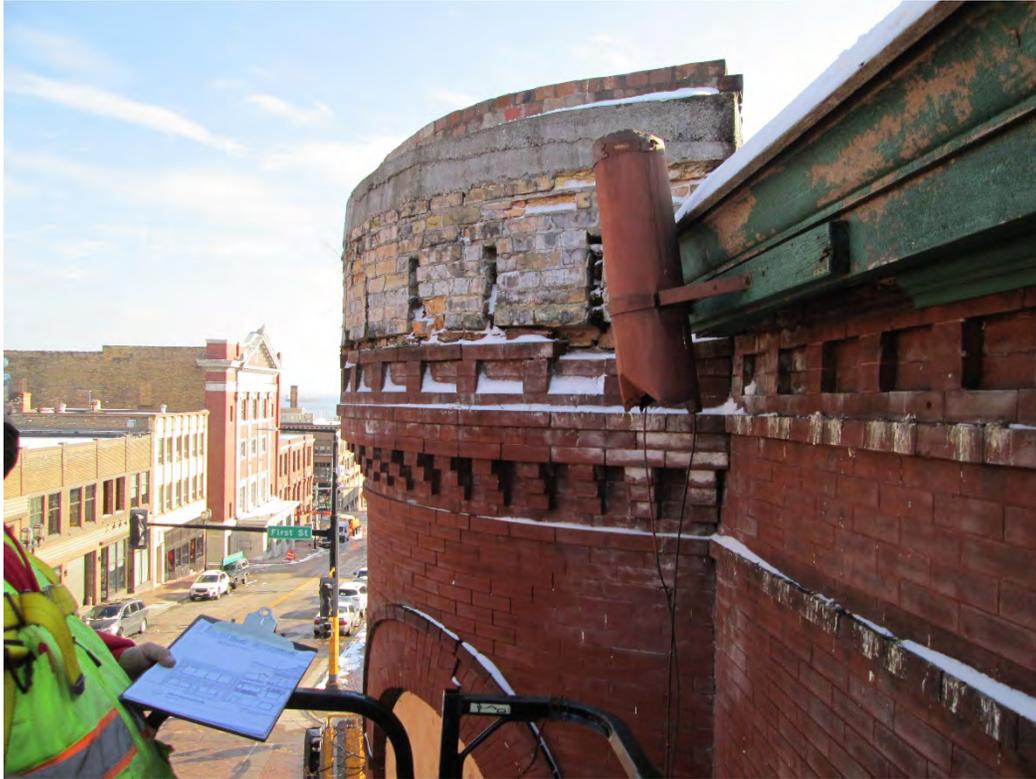
*Photo 19: Upper wall region, east elevation looking south. Substantial efflorescence, loss of pointing mortar and loose bricks.*

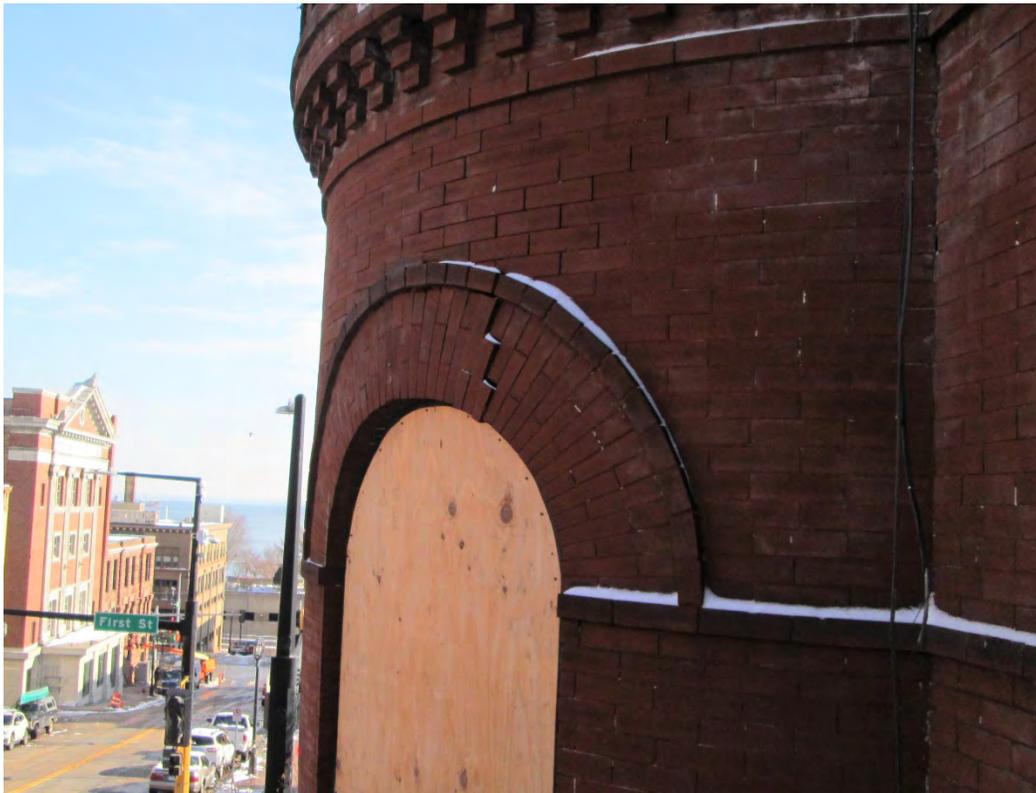
*Photo 20: Southeast corner turret, looking south. Widened brick end joints and failing brick in window header arch may indicate larger movement/instability.*

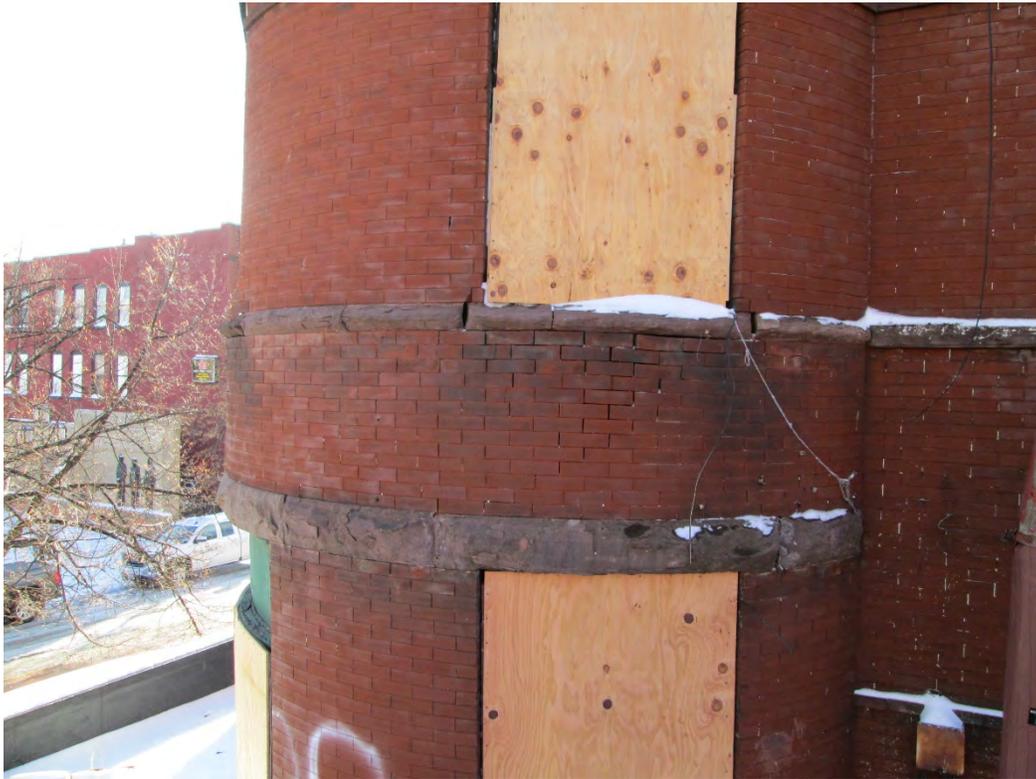
*Photo 21: Region towards base of window in previous photo. Widened brick end gaps here also indicate potential global movement in circumference brick.*

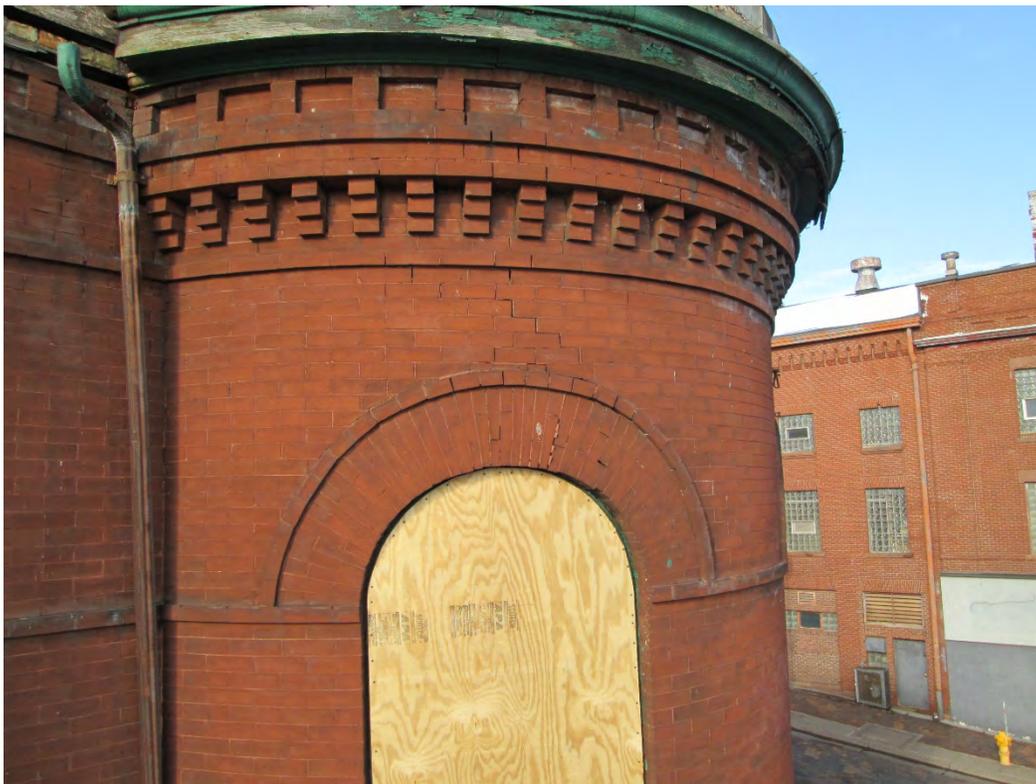
*Photo 22: Southeast corner turret., south face. Joint cracking and brick end gap openings above window indicate potential global movement in wall circumference brick.*

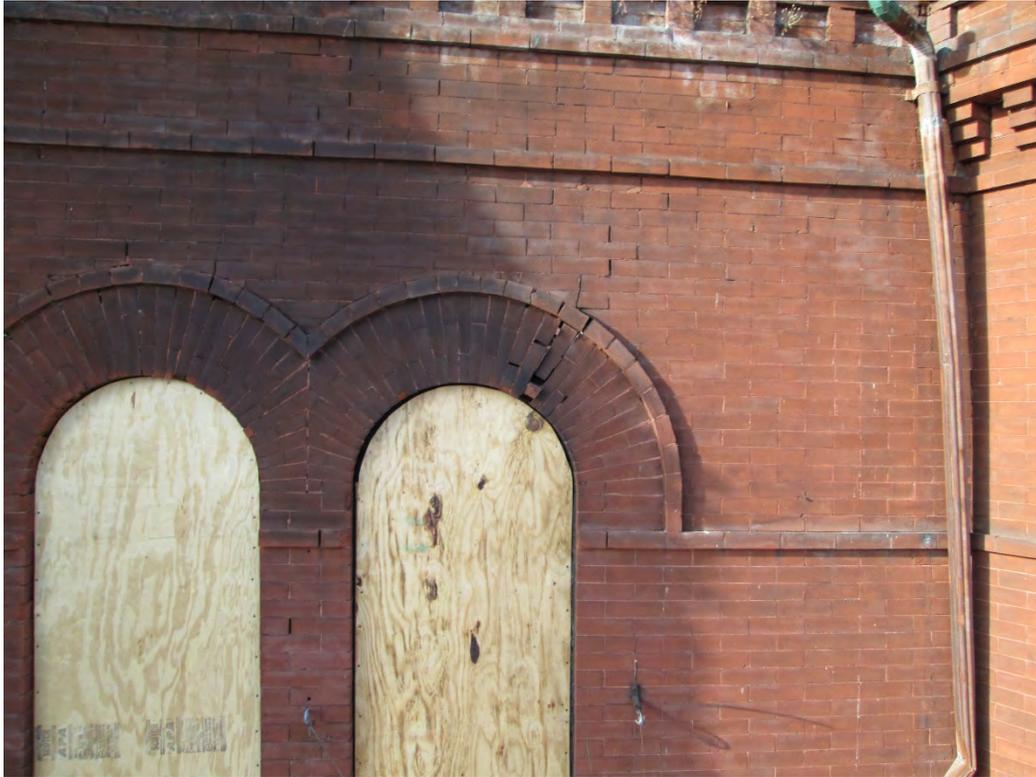
*Photo 23: Typical brick displacement/failure at arched window headers. Level 3, south elevation, easterly module adjacent to southeast corner turret.*

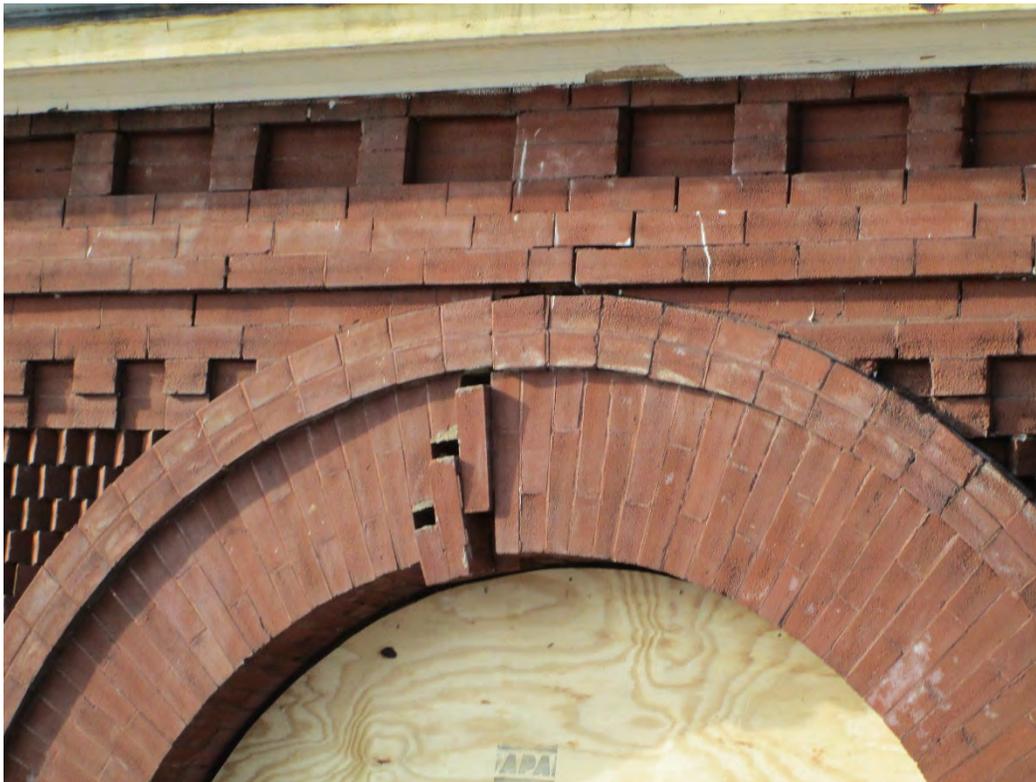
*Photo 24: Typical brick displacement/failure at arched window header, Level 2, south elevation (easterly module shown, westerly module similar).*

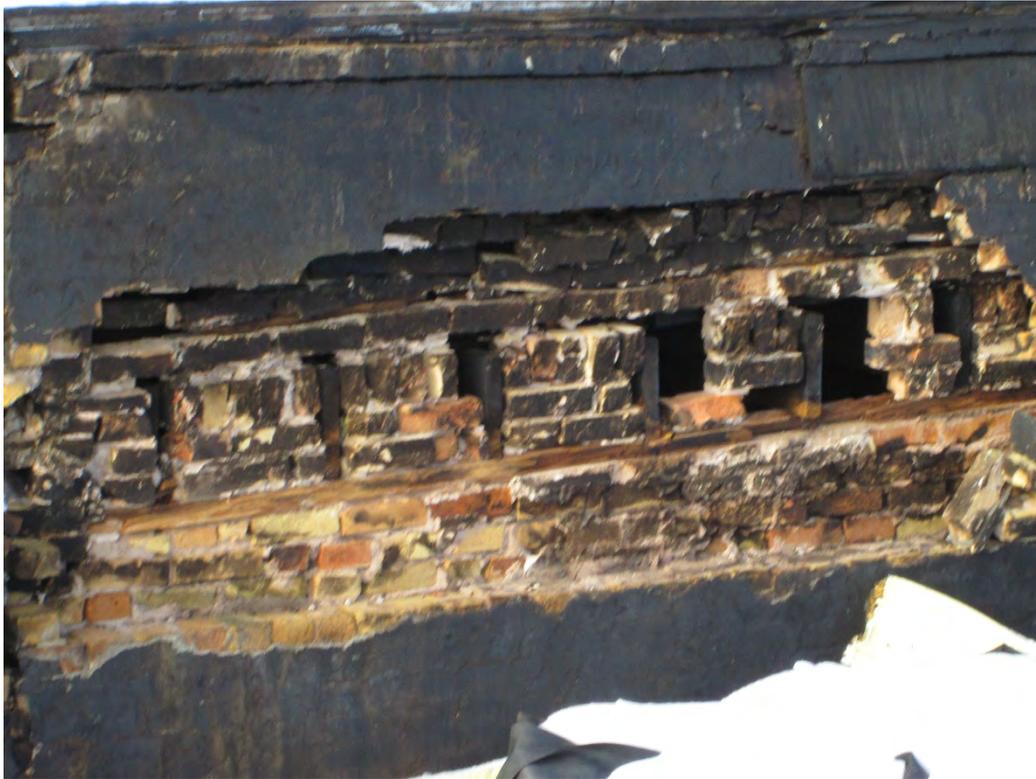
*Photo 25: Party wall between east southerly Pastoret module and module to north. Some apparent fire damage to north module roof joist ends. Unknown (due to access limitations) if joists have suffered fire damage which is compromising structural stability of north module roof.*
