Duluth Spirit Mountain Tourism Industry Infrastructure

Predesign Report Spirit Mountain Recreation Area City of Duluth, MN

TKDA No. 18185.000 October 15, 2021

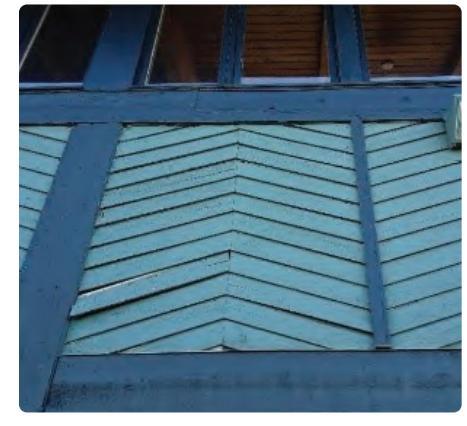
Rationale for Condition Rating: Wood exterior is generally, in poor condition. There are areas of water damage, completely rotted trim, and large areas of peeling paint. Some wood panels are missing; many wood panels are warped and pulling away from building. Some wall areas on the Bear Paw Chalet addition (that faces the parking/drop off) are in good condition, but generally, all of the siding is past its useful life. The CMU stair tower enclosures are cracking in multiple areas (see structural comments) and show water damage. In some areas, daylight is visible through the cracking.

Area of loose wood siding

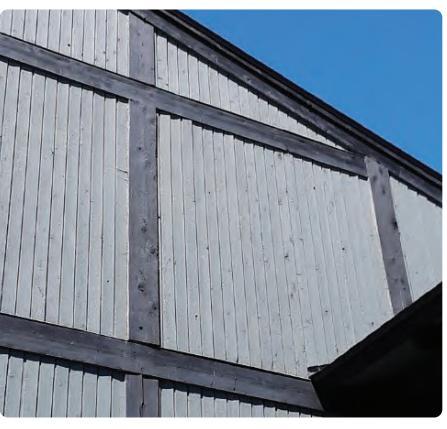
Vertical siding boards are warping

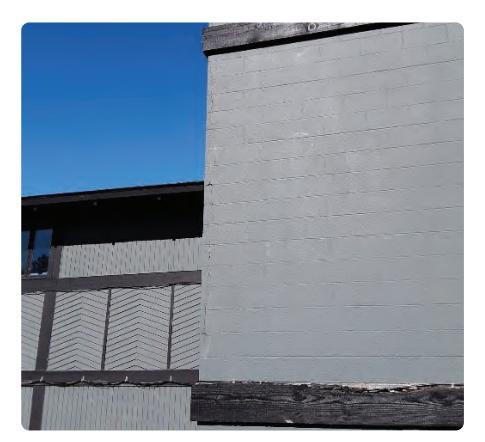
- Structural members that have been exposed to weather need replacement or removal.
- A portion of the exterior deck needs immediate removal and replacement.
- The original CMU stair towers have significant wall cracking that are structural in nature and allow water penetration into the shaft.

Cracking at outside corner of CMU wall at stair towers

The original CMU stair towers should be replaced in kind or with cast-in-place concrete walls. We do not recommend attempts to repair the existing walls.

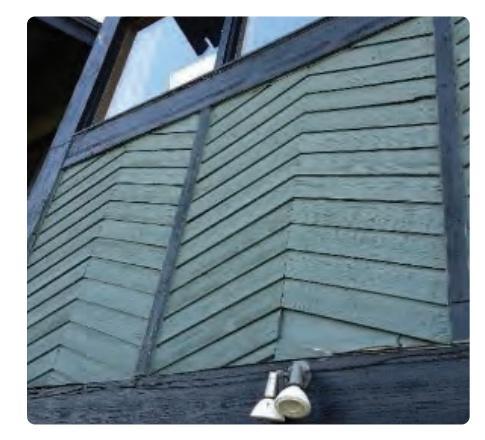
Area of missing wood siding

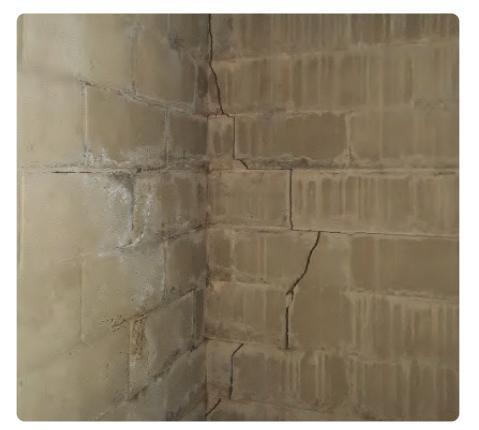
Cracking at corners of CMU stair tower enclosure

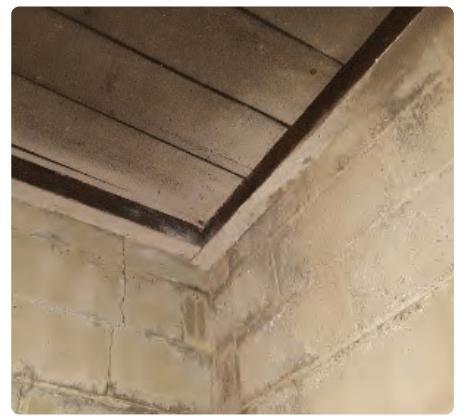
Cracking and signs of moisture infiltration at exterior stair walls

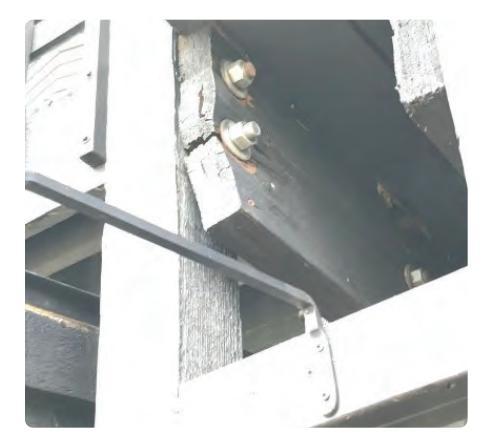
Delaminated beam at deck support

Members damaged by weather should be removed or replaced.

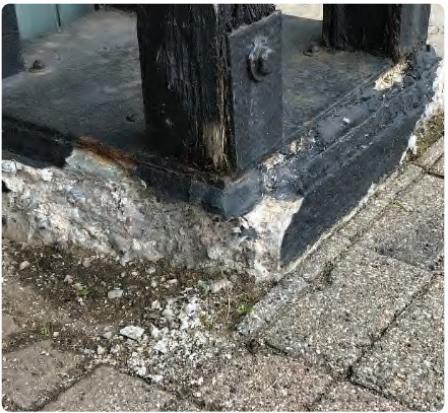
Damaged concrete pier cap and rotted wood column base footing cap

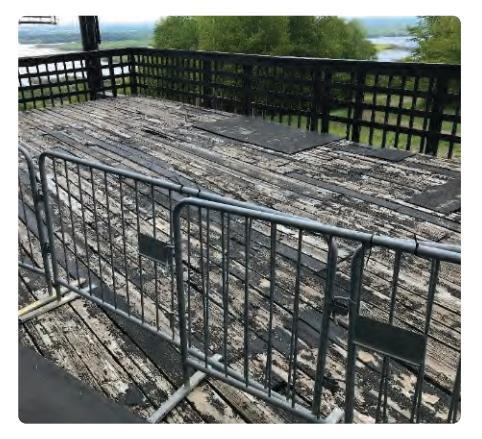
Area of deck without structural support below

The portion of exterior decking that has failed structurally is currently only restrained from occupancy by a movable barrier. This deck represents a life safety hazard to the building occupants and staff, as well as a large potential liability risk to Spirit Mountain Recreational Area. It should be demolished and removed immediately.

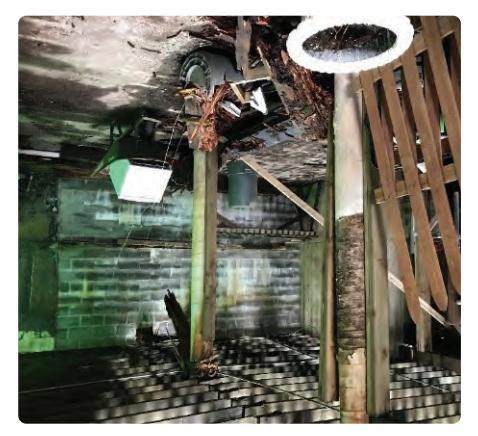
View of area below deck; primary deck support beam is missing

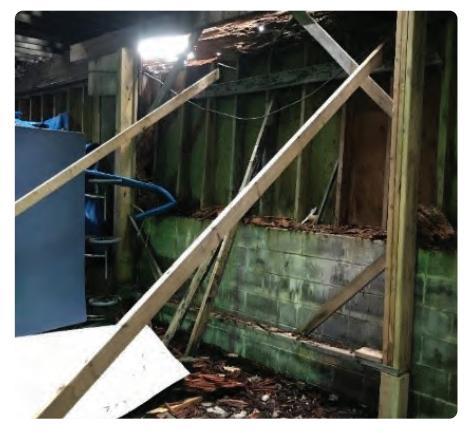
Missing area of rim board and structure at deck edge

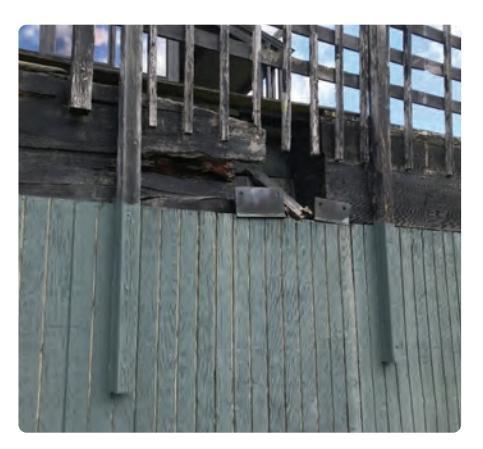
Missing area of rim board and structure at deck edge

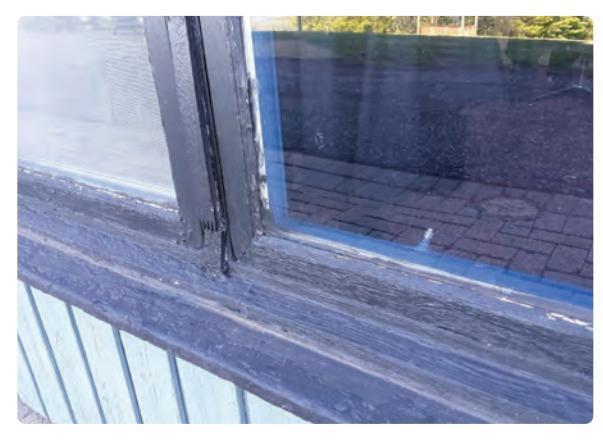
Wood window frame delamination

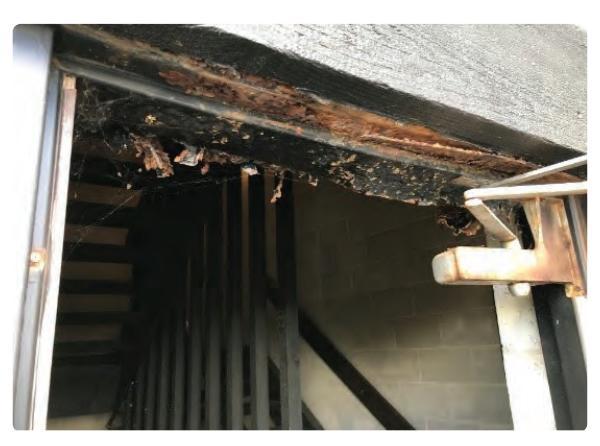
Rationale for Condition Rating: All of the hollow metal doors appear to be original to the construction. These doors range from fair to very poor condition, showing signs of rust and damage from use/abuse, and some are missing portions of the door and seals so daylight is visible.

Lintel at door head and hollow metal door frame rusted through

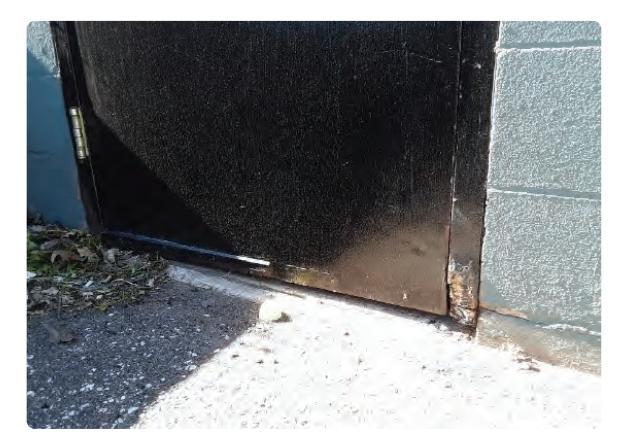
Hollow metal doorframe rusted through

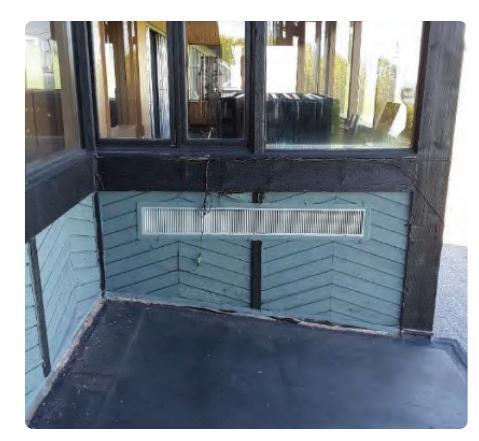
Flashing at roof to wall intersection is compromised

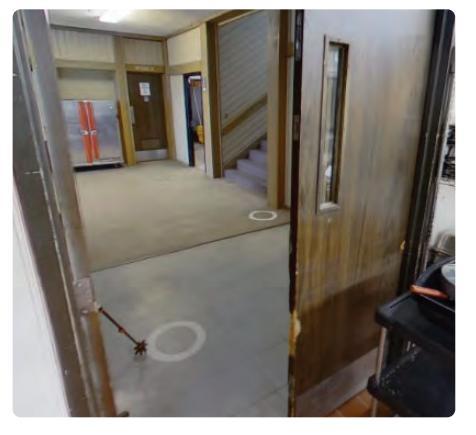
Rationale for Condition Rating: Solid wood doors have had hardware modified and doors and frames show wear and damage appropriate to age. Most doors should be replaced, especially on lower levels. Door hardware is functioning, but is at the end of its expected useful life.

Doors damaged from use

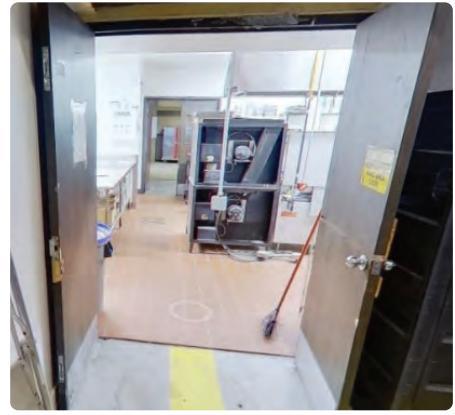
Doors damaged from use

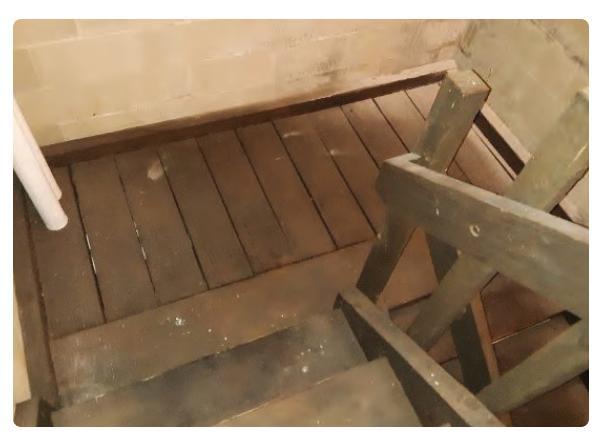
Regarding the stair system, the guard railings and open risers are not compliant with current code. In addition, some of the boards that make up the stair landing surface are loose and the landing floor surface is uneven where individual floor planks meet.

Typical stair landing and guardrail

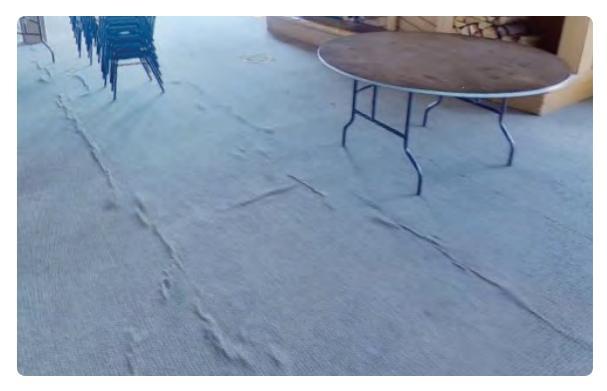
Rationale for Condition Rating: Approximately 90% of the carpet is worn, bubbled, and/or completely attached to substrate in areas. The carpet is at the end of its useful life.

Carpet in Moosehead Saloon seating

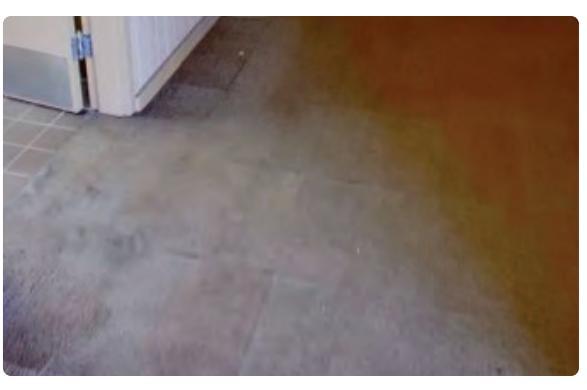
Worn and stained carpet in Moosehead Saloon, level 3

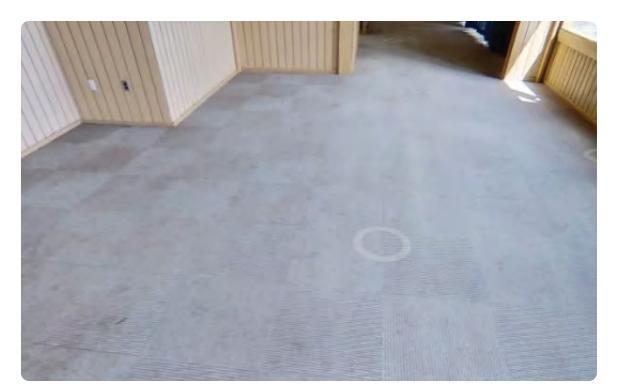
Worn carpet in Bear Paw seating area

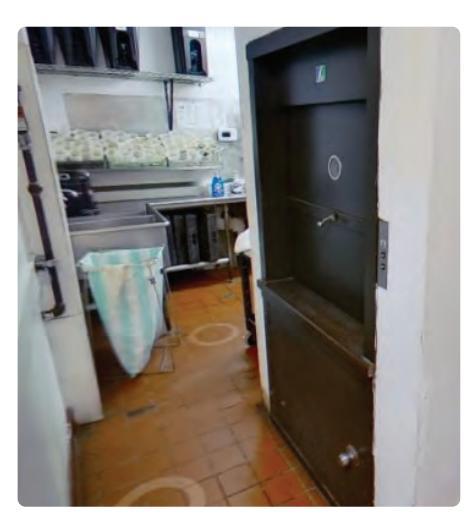
Rationale for Condition Rating: Unit is no longer working. When it was working, it was not an efficient way to move food from kitchen to table. Food cools too quickly and capacity of lift is limited.

Dumbwaiter at level 2 kitchen

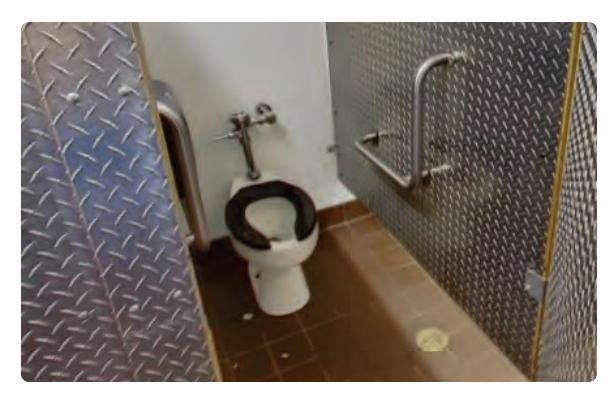
Rationale for condition rating: Fixtures no longer operate as intended and create continuous maintenance for staff while offering visitors a poor quality of use.

Kitchen staff toilet room

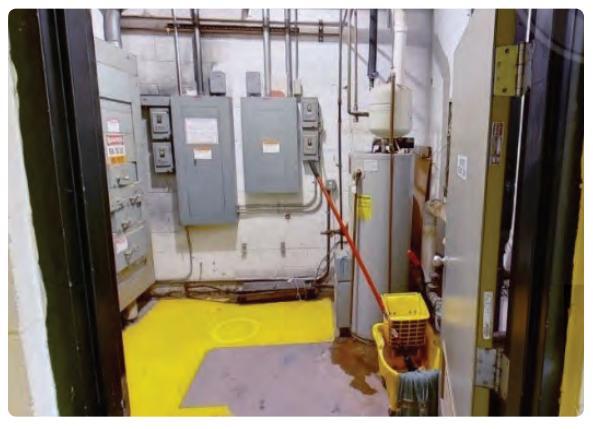
Rationale for Condition Rating: These water heaters work but have reached the end of their useful life, (with less than 5 years remaining).

Residential-grade domestic hot water heater serving Bear Paw area

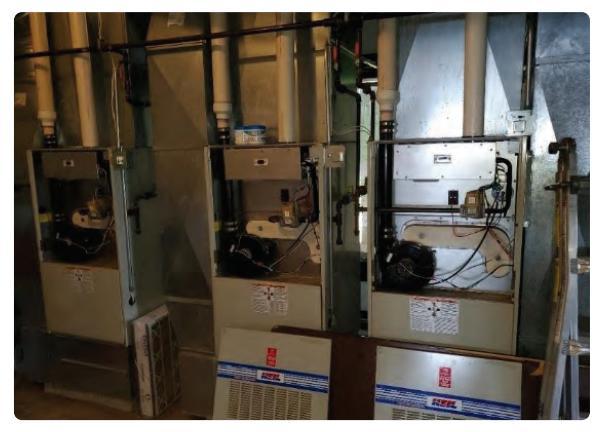
Rationale for Condition Rating: Age of system. Boiler still works but is nearing the end of its expected useful life. (Lifespan: less than 5 years remaining). System is inefficient and hard to maintain. Temperature control is poor. Does not incorporate heating of outside air that would be required in a remodel effort.

Residential-grade furnaces with DX split system cooling

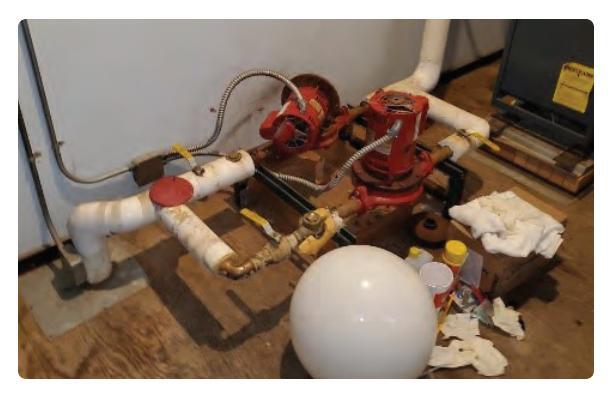
Rationale for Condition Rating: Age of system, tied to poor quality units, No centralized system. No control of outside air percentages.

Hot water distribution pumps

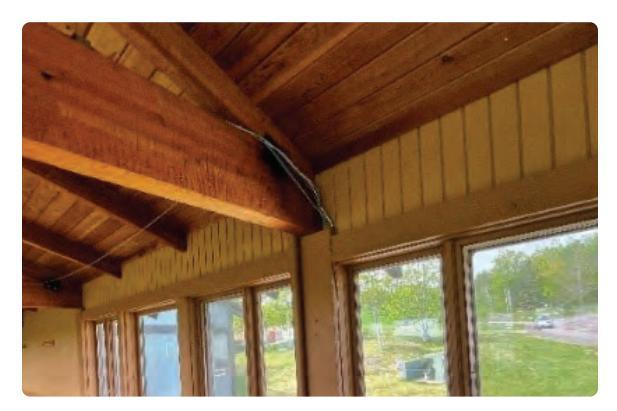
Exposed cabling at link

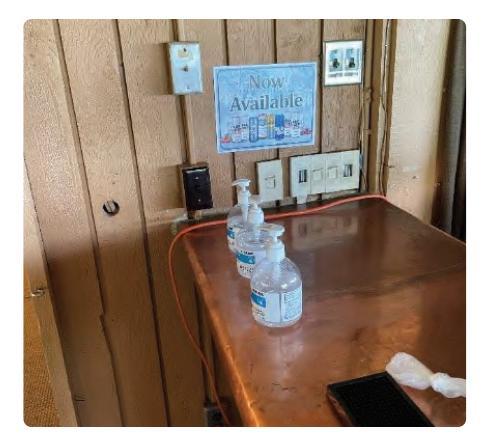
Rationale for Condition Rating: Age of equipment, showing wear consistent with age. Expected useful life of cabinets is 25 years. Service counters are in areas that are not ADA compliant.

Extension cords exposed at counter to serve bar power requirements

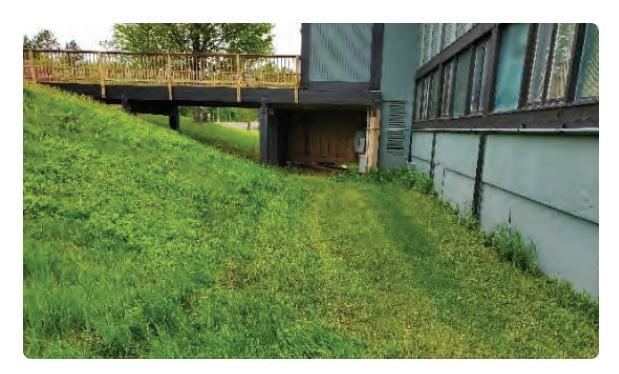
Rationale for Condition Rating: Slopes around the building are problematic and contribute to water infiltration to the building. The ADA parking area has drainage issues causing ice build-up in ADA walkways and parking areas. Most drainage grates are handmade, failing, and not based on any standards. Stormwater leaks into the sanitary system during spring thaw and causes backups into the building, which require yearly maintenance.

Steep slope into ponding area

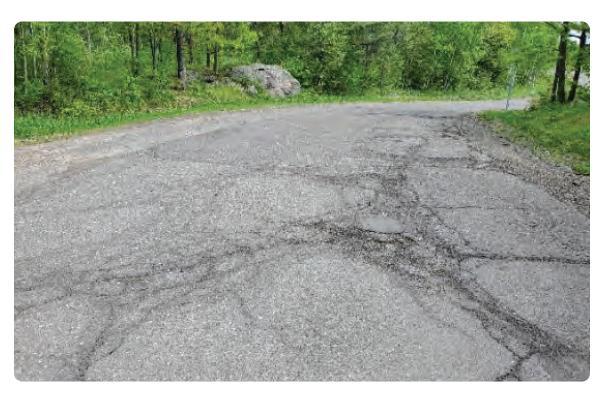
Rationale for Condition Rating: Age of system (lifespan: Approximately 45 years, useful lifespan of equipment is normally 30 years).

Major cracking and patching at parking loop

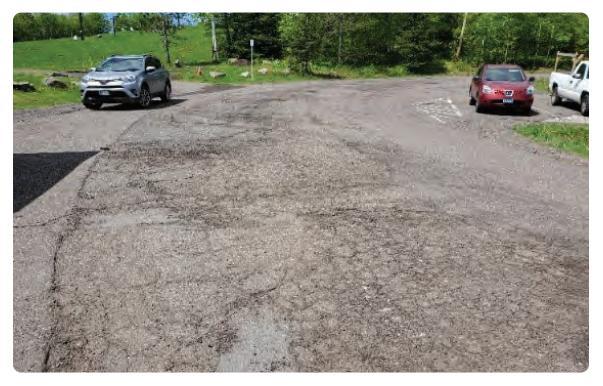
Major cracking and patching at driving lanes

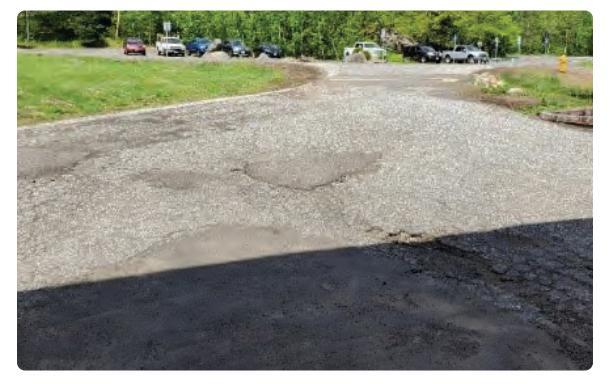
Major cracking and patching at building

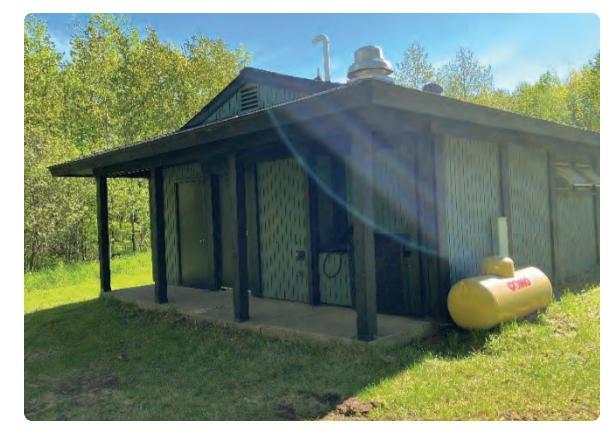
Restroom building

The campground toilet and shower facilities need amenity upgrades, ADA accessibility upgrades, and stall and shower counts appropriate for number of campsites. There is a failing concrete slab and column support in one location, which need repair or replacement.

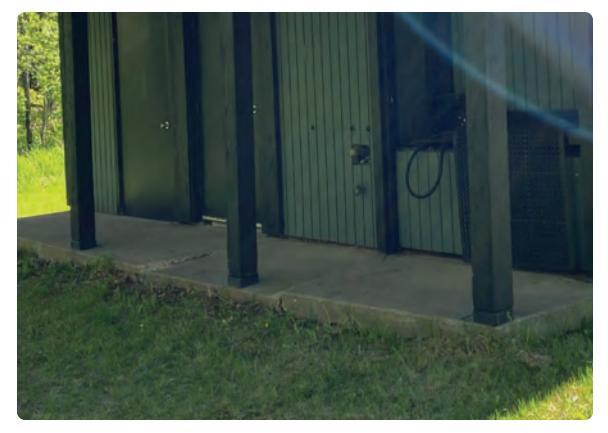
Failed slab to be replaced
