#### Addendum # File # 17-0108 Project: Park Point Beach House North Wall Replacement

November 23, 2015

# Re: Park Point Beach House Water Damage NCE Job No. 15-640

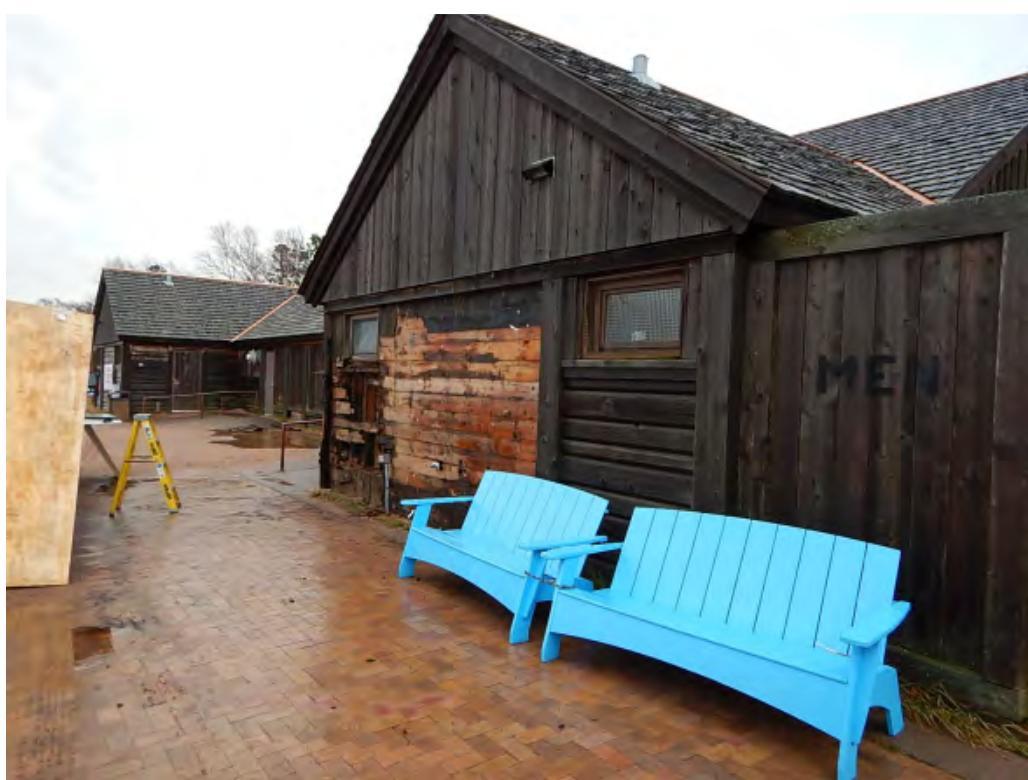
1. Reviewed section on lifeguard area on east side of building.

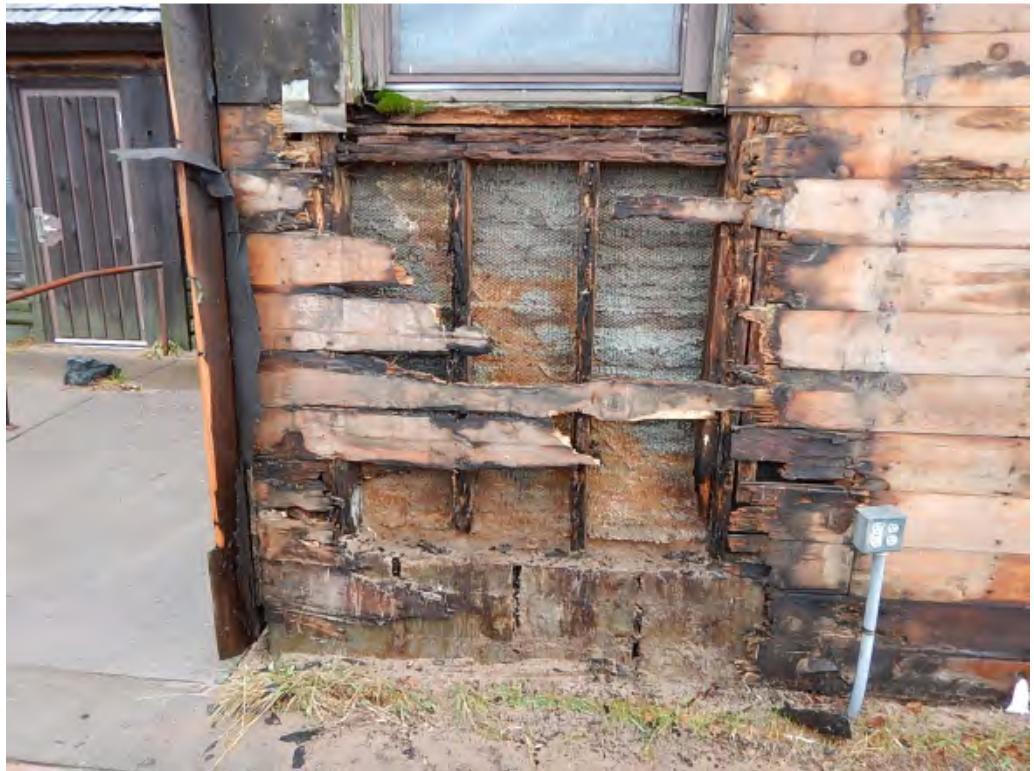
2. Conditions found below window following removal of siding.

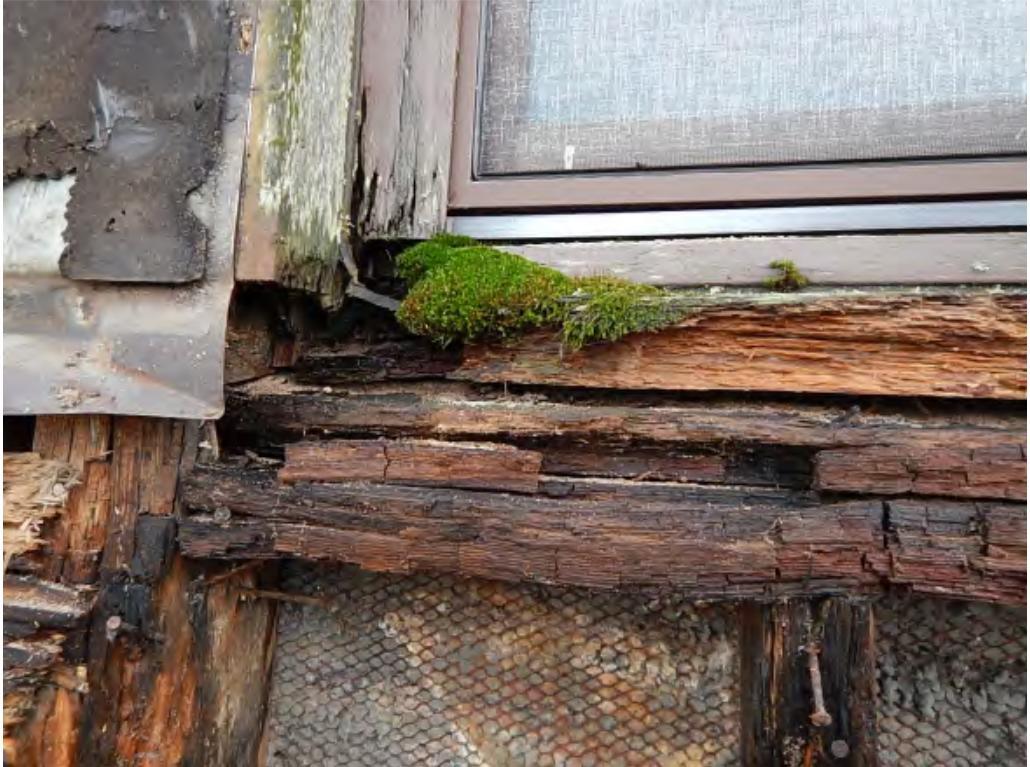
3. Decayed window frame, sill and studs.

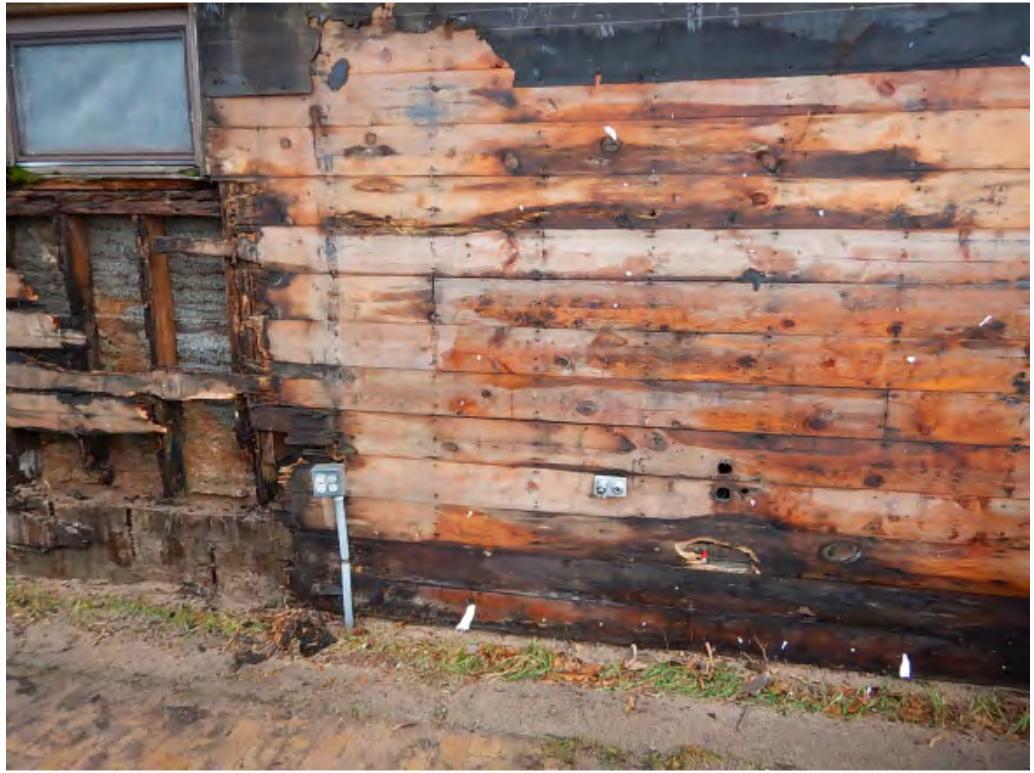
4. Plank sheathing wet with minor decay.

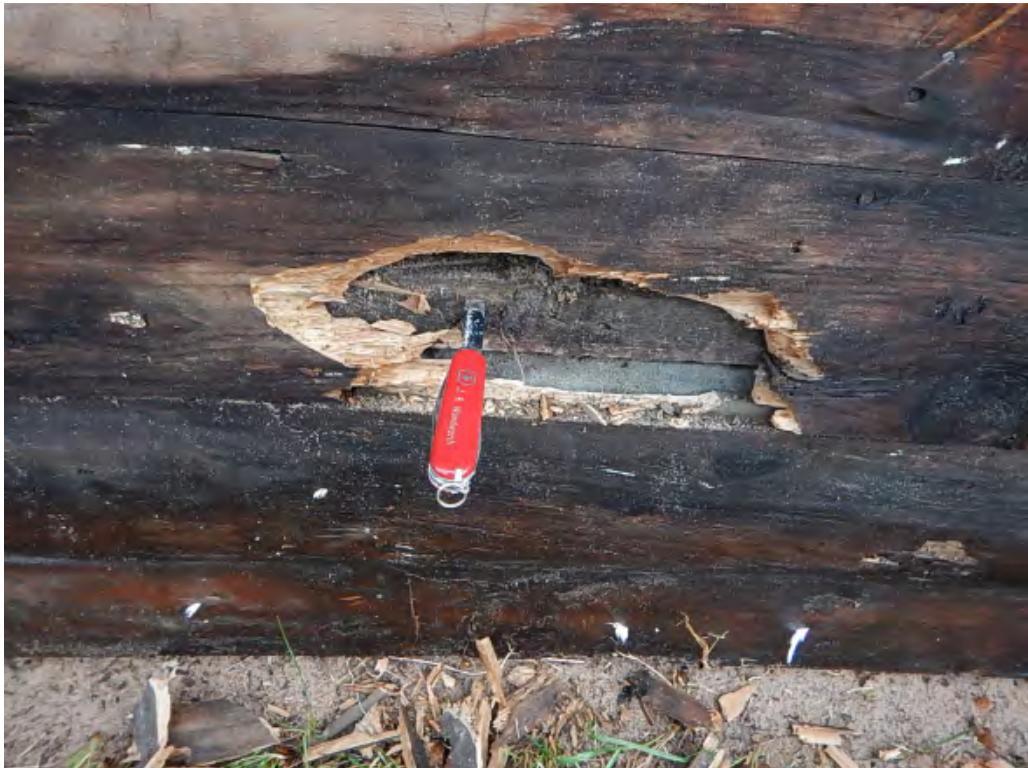
5. Sheathing decayed near foundation and sill plate. Plate is soft but not entirely decayed.

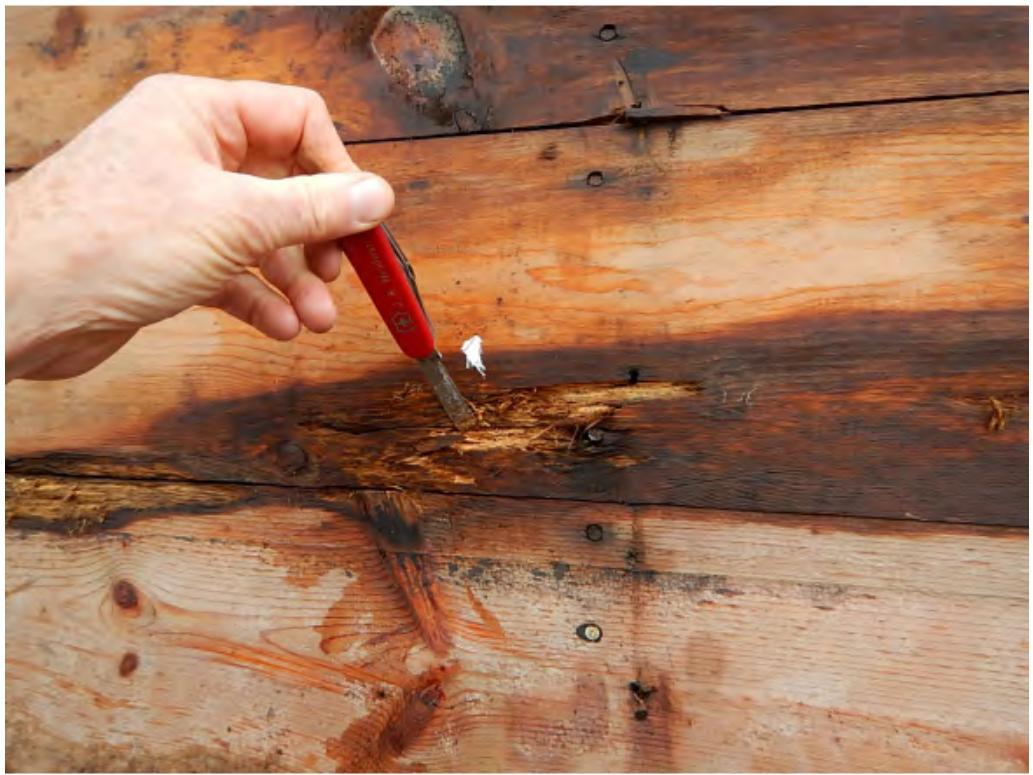
6. Decayed board sheathing in wet area.

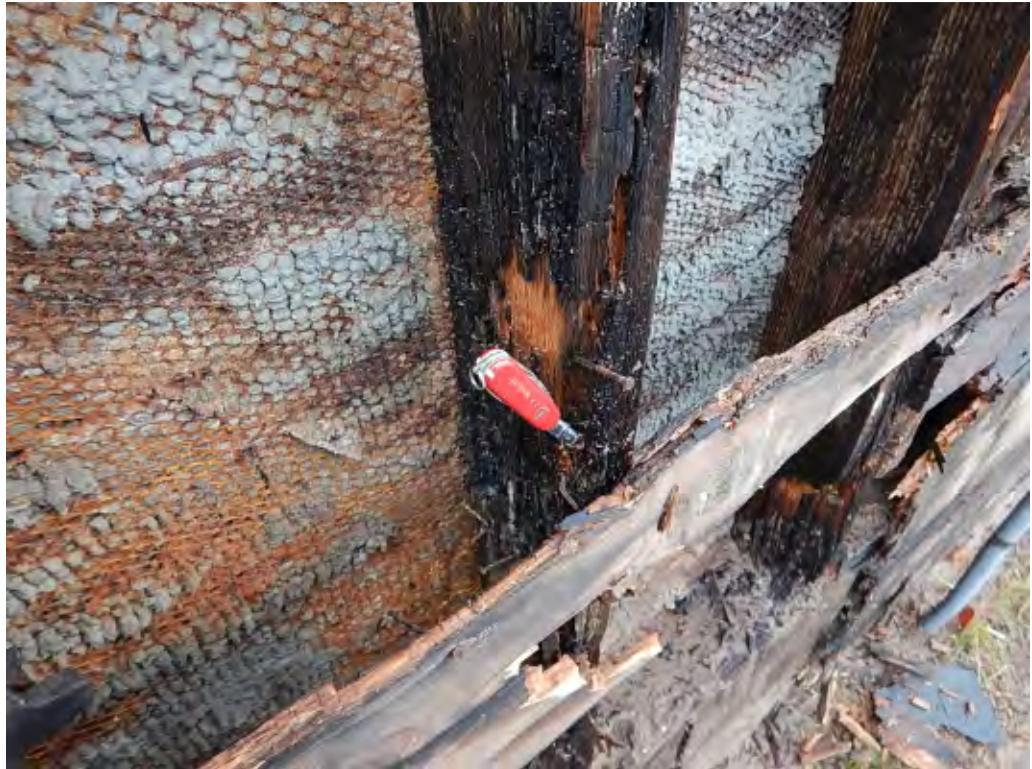
7. Studs beneath window are decayed.

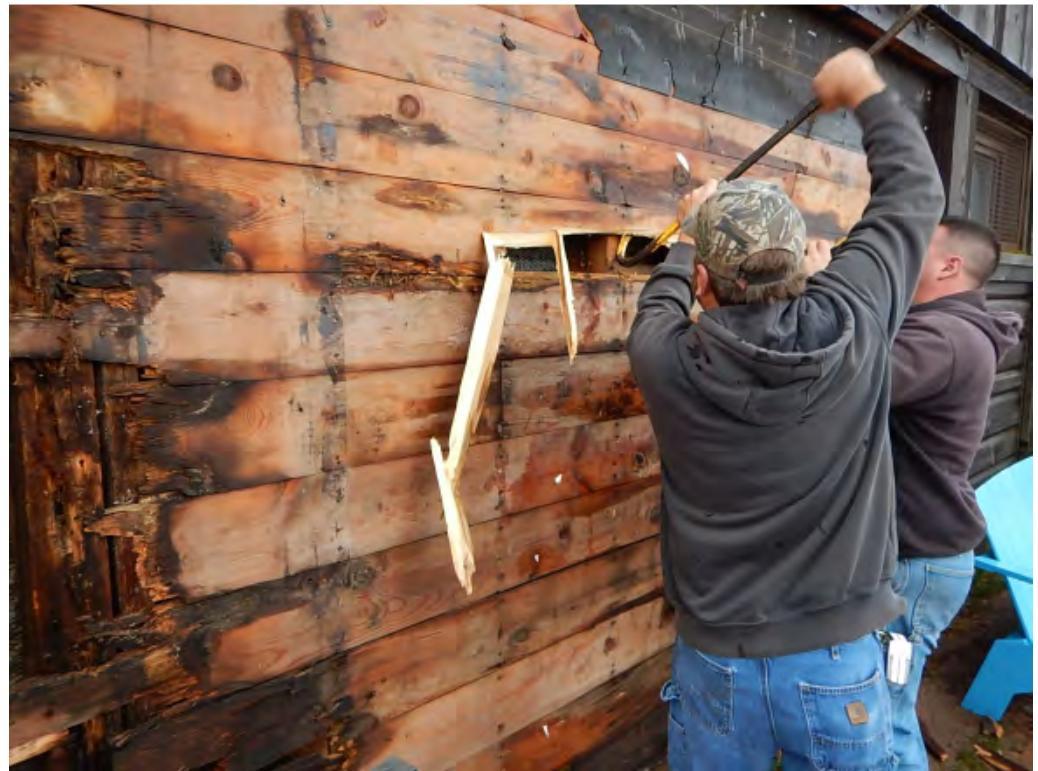
8. Removal of sheathing adjacent to window in life guard area.

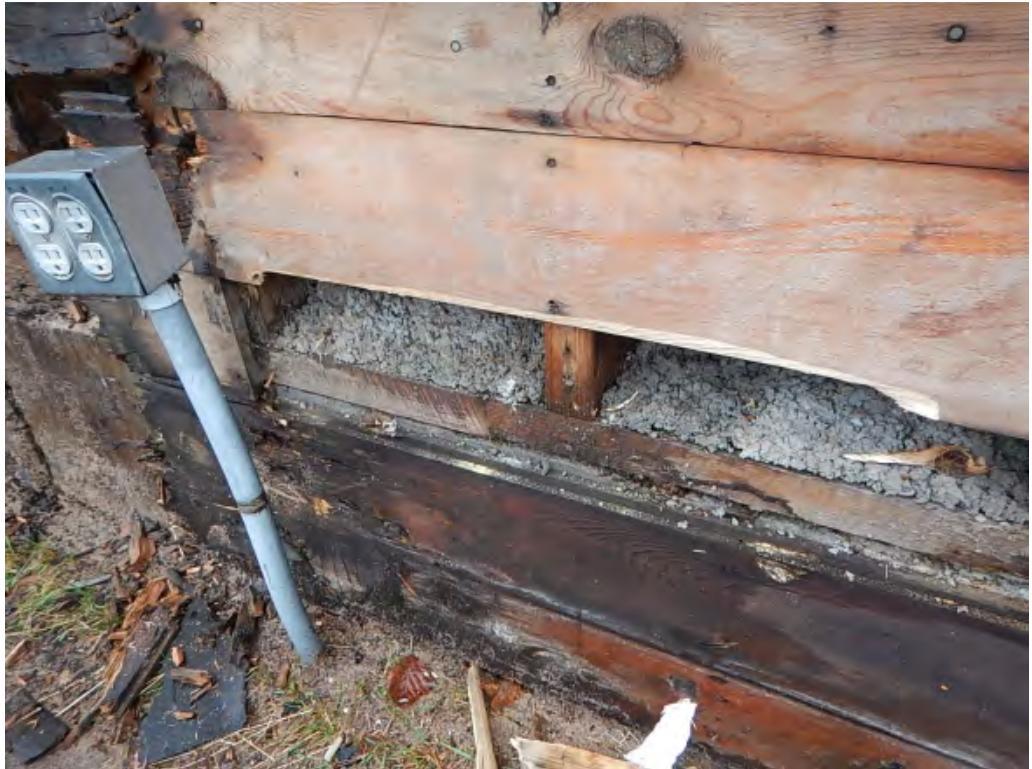
9. Sill plate west but not decayed.

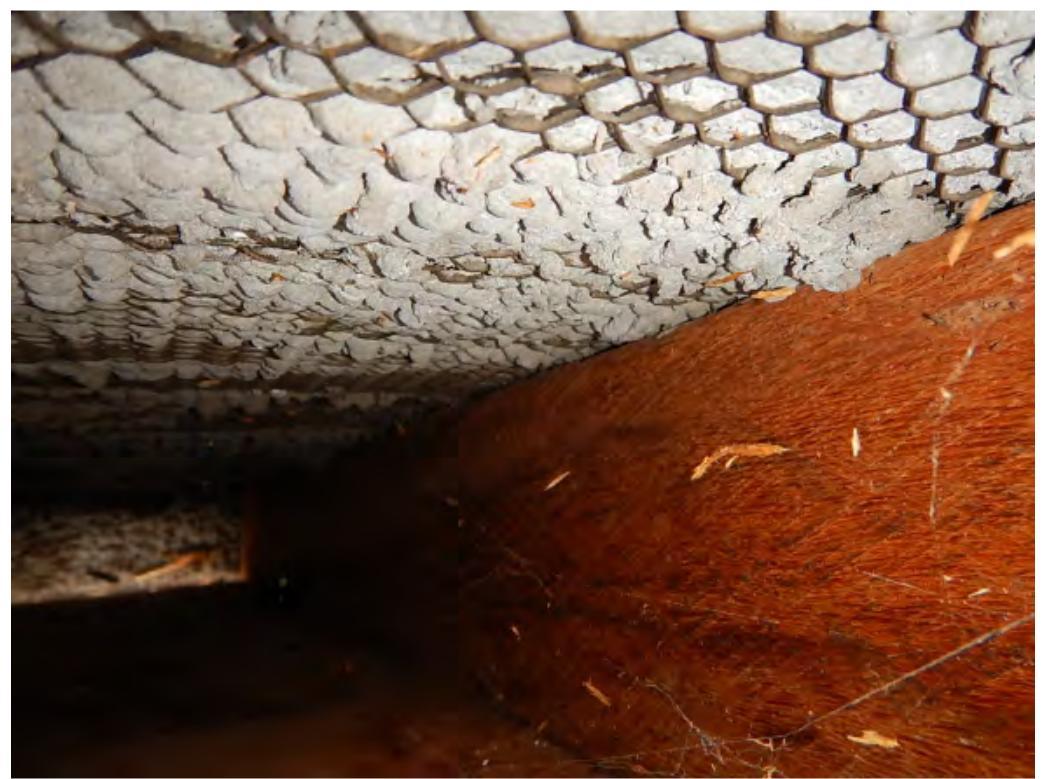
10. Interior of wall cavity is reasonably dry, studs appear good.

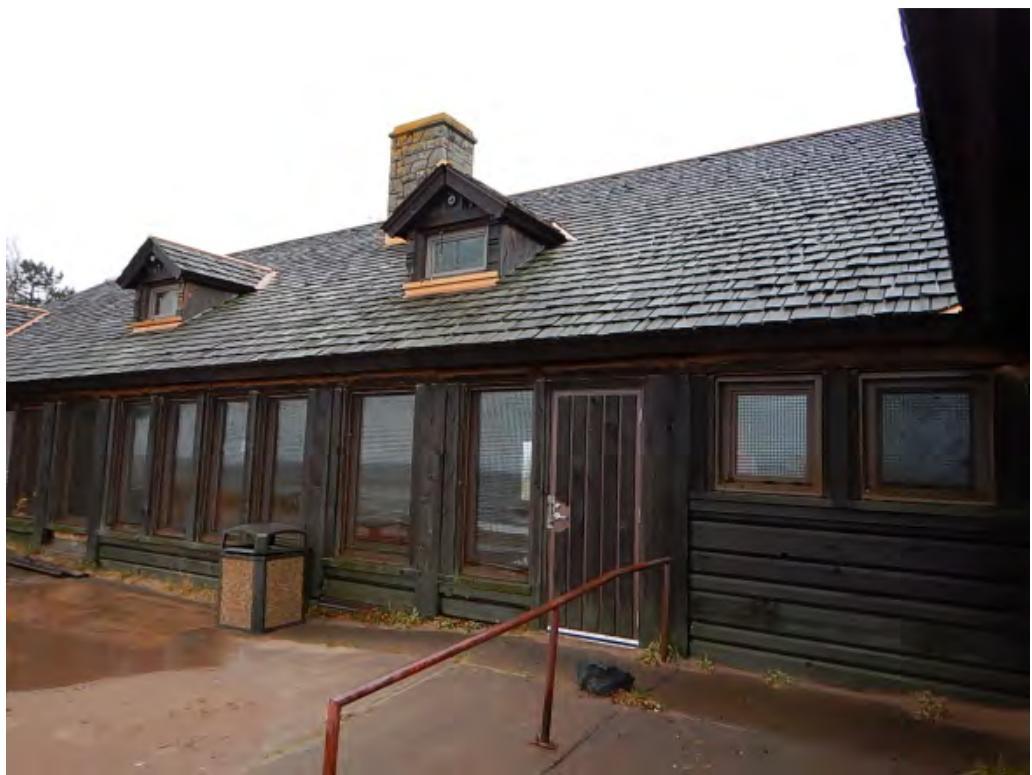
11. Center section of building with near full height window wall.

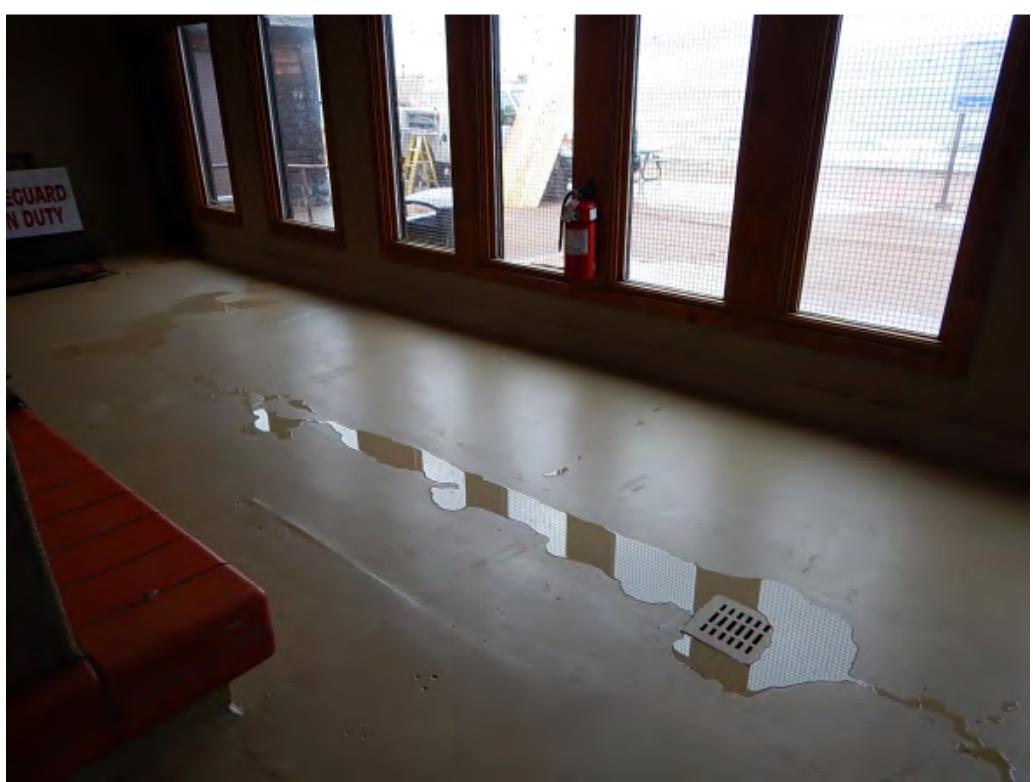
12. Leakage through window wall from rains of previous two days.

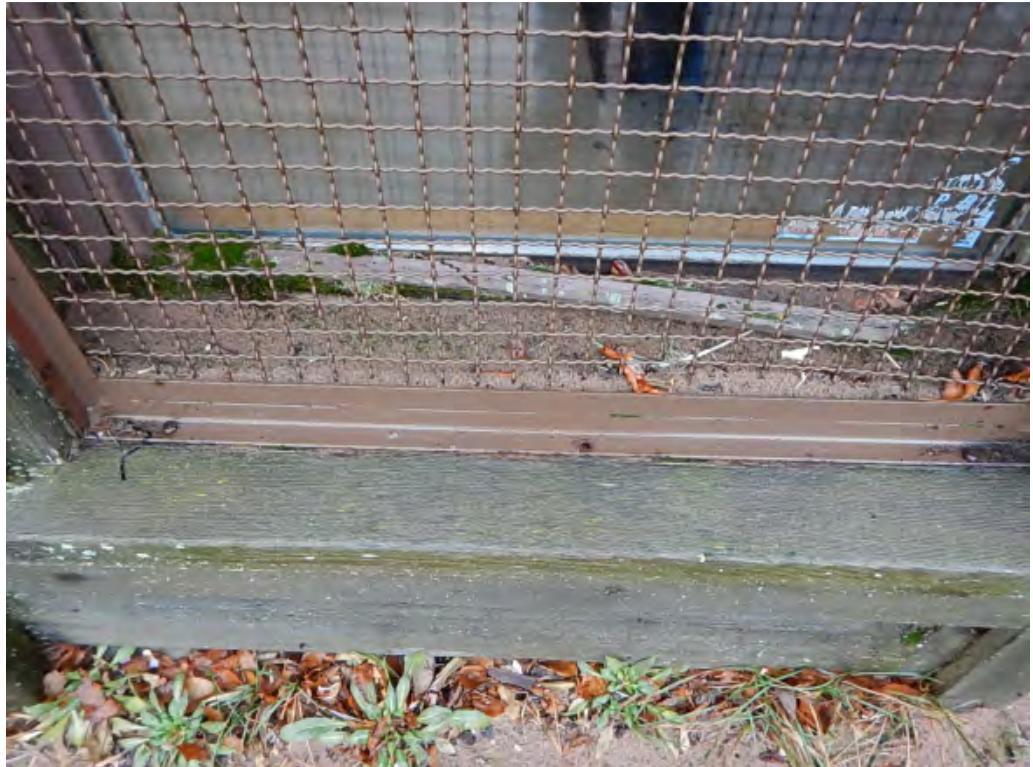
13. Note vegetation growth on window sill. Also sand held in by screens that trap, hole water.

- 6. If screen mesh is utilized on the new windows then it should not extend to the sill so that debris will not be captured and trapped on the sill.
- 7. Replacement of the existing siding with a similar material that is resistant to severe water exposure.

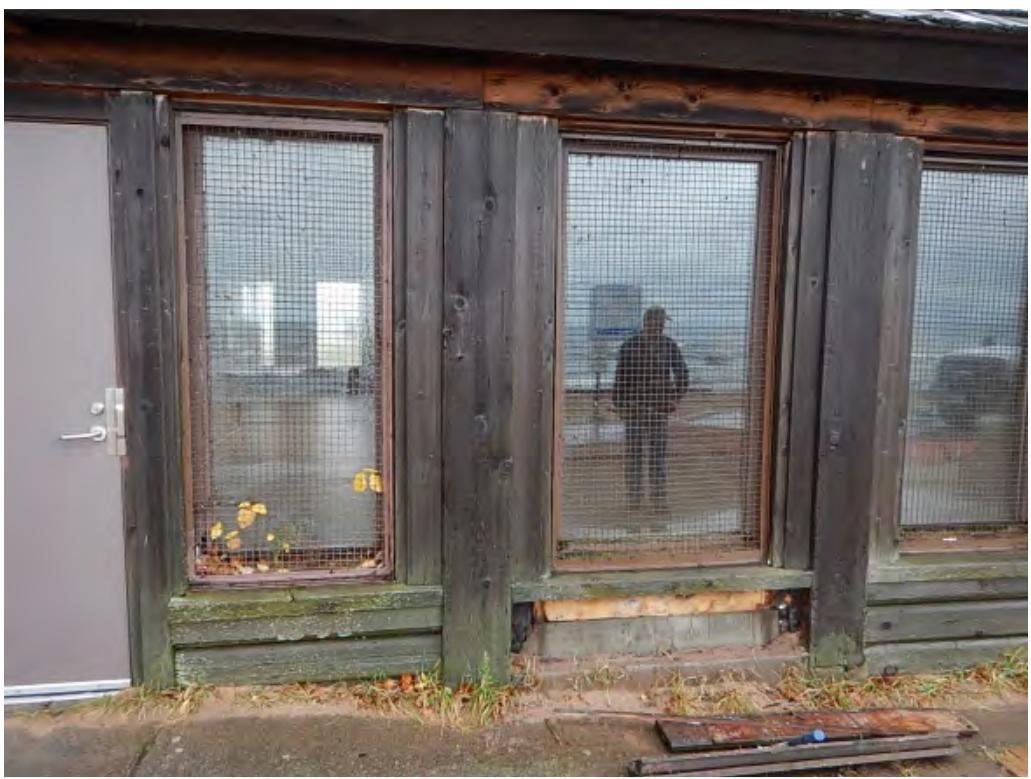
14. Exposed area beneath window in window wall.

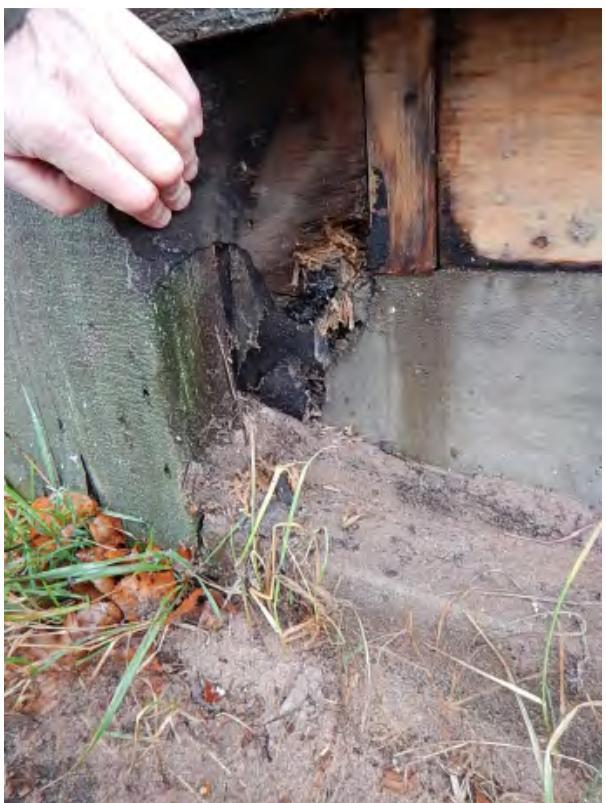
15. Decayed sheathing beneath corner of window.

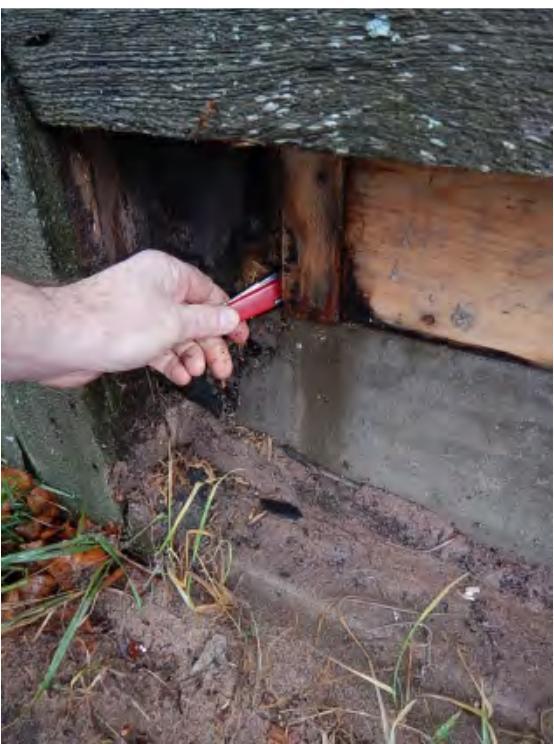
16. Hole in sheathing penetrates into wall cavity. Stud is wet and partially decayed.

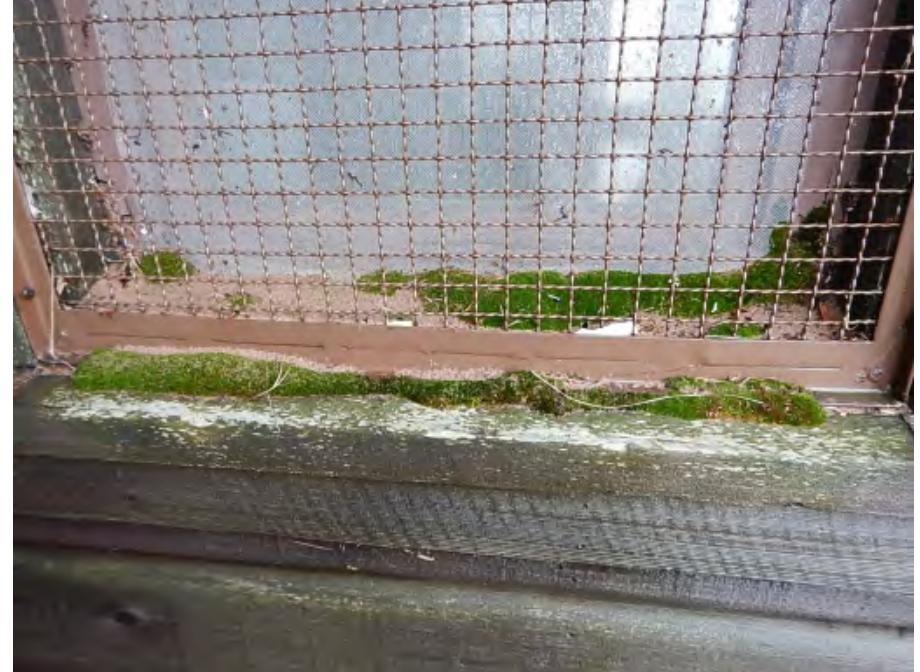
17. Note sand and vegetation in sill of window adjacent and to the south of window wall area.

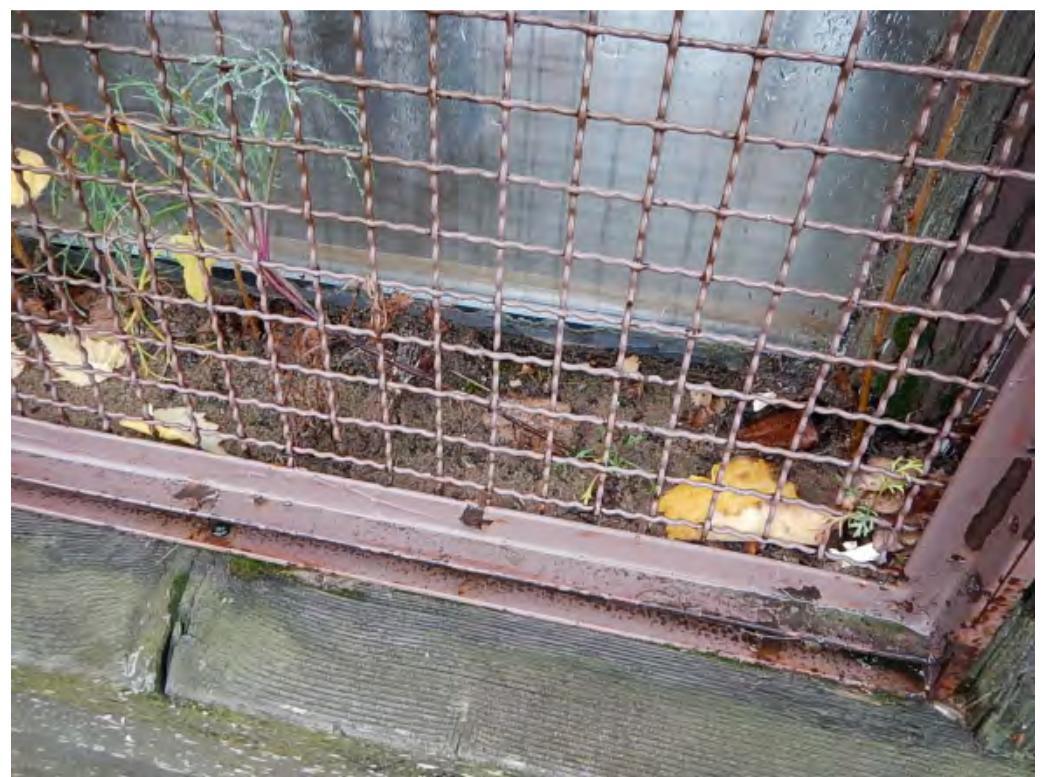
1. Note vegetation and sand, window to the west of window wall area.

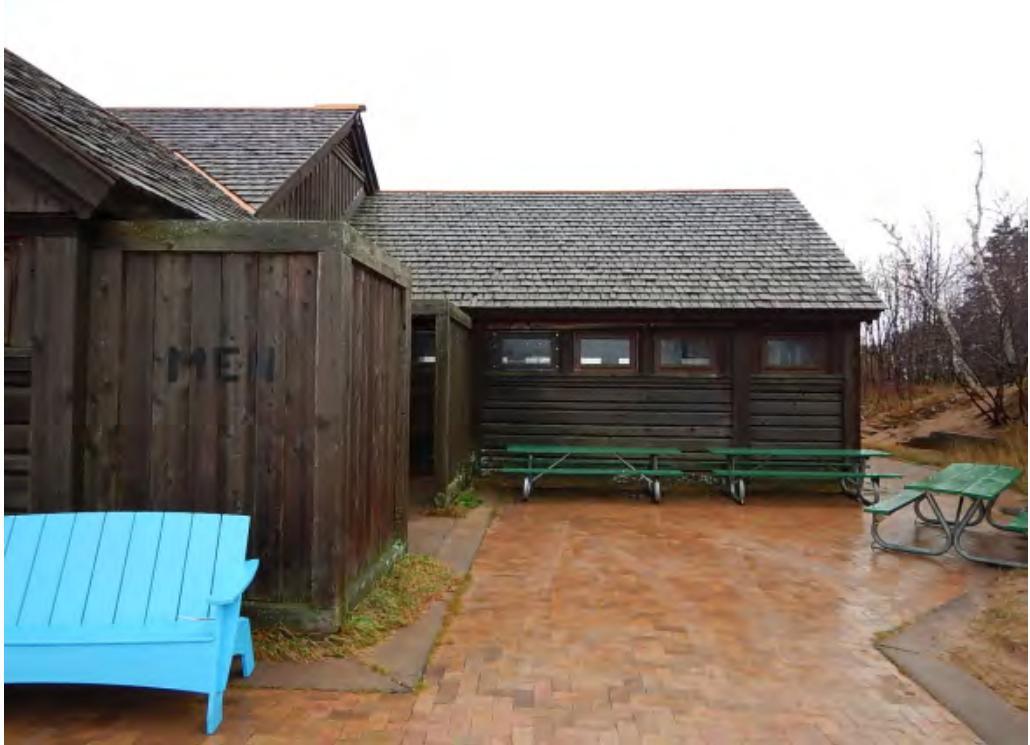
2. Extension at north end of building.

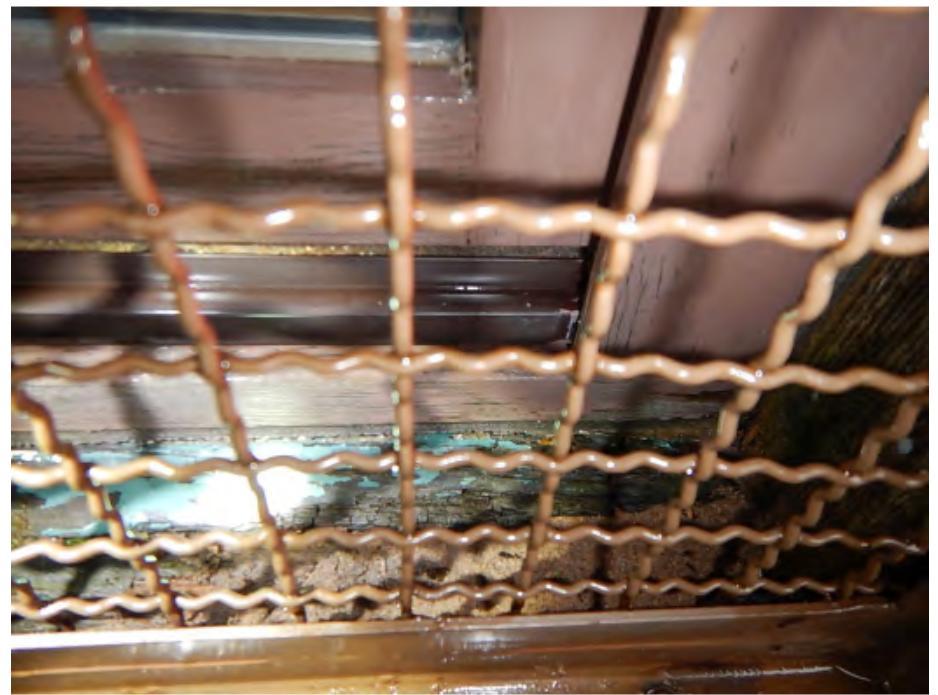
20. Frame in north extension. Note decay frame and sill. This was a common condition on all the windows in this area.

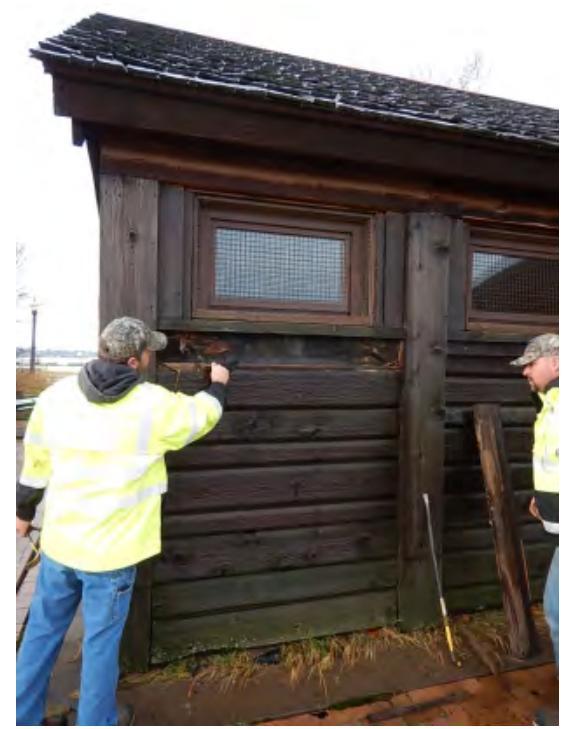
21. Removal of siding at south end of building.

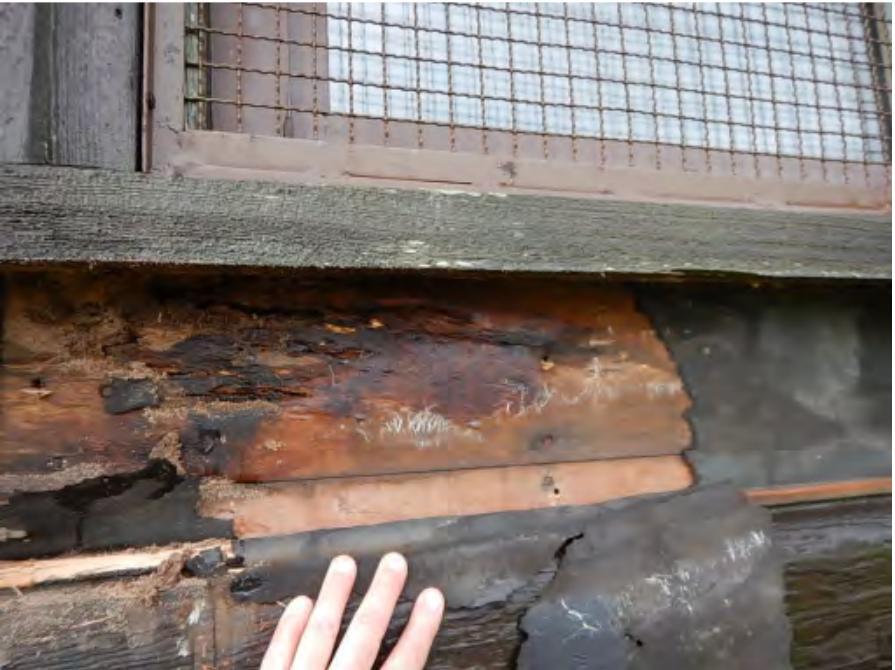
### 22. Sheathing wet and partially decayed.

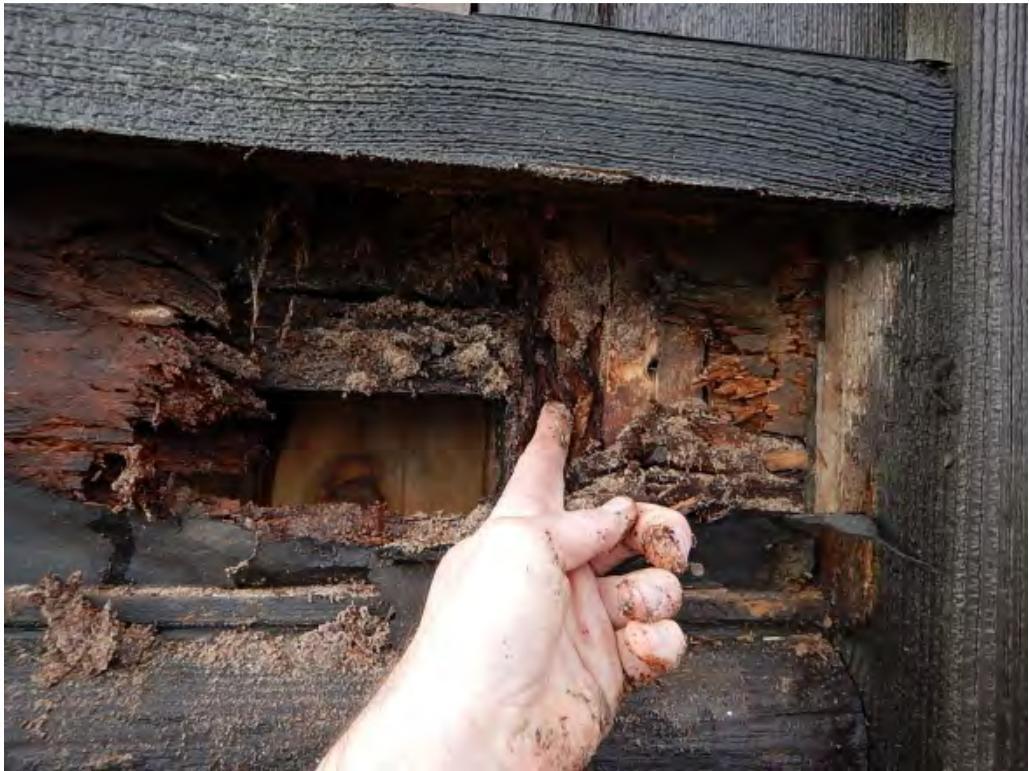
23. Sill and stud beneath window corner decayed.

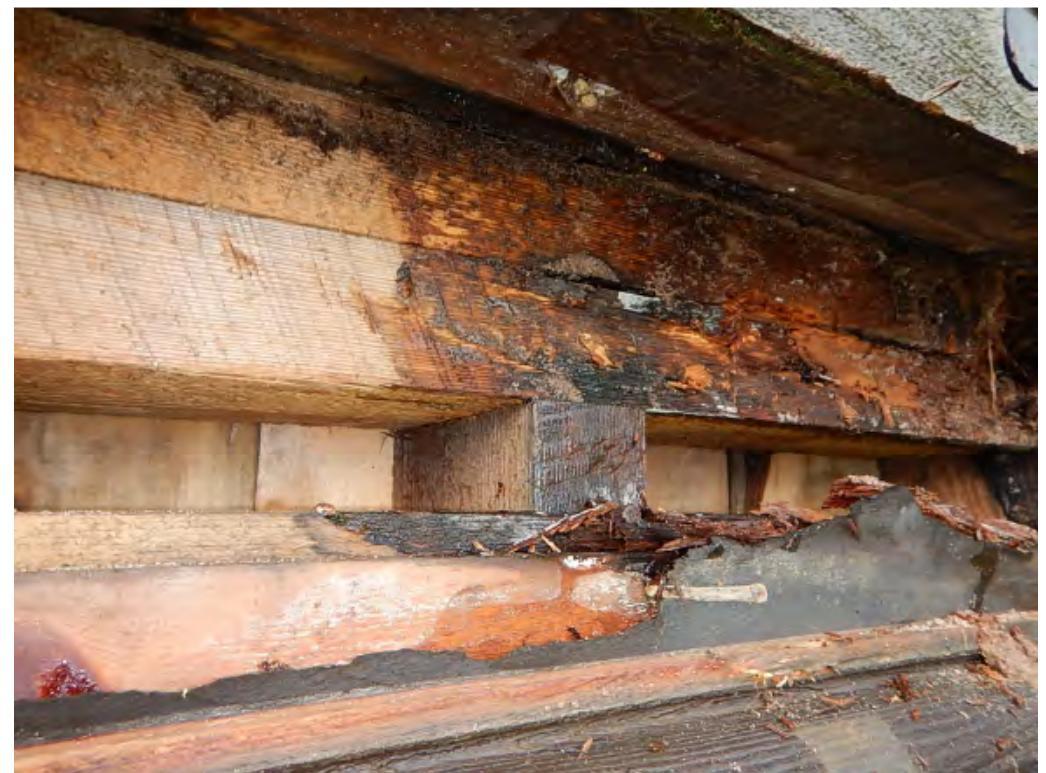
24. Away from corner the sill plate and studs were wet but still reasonably hard.

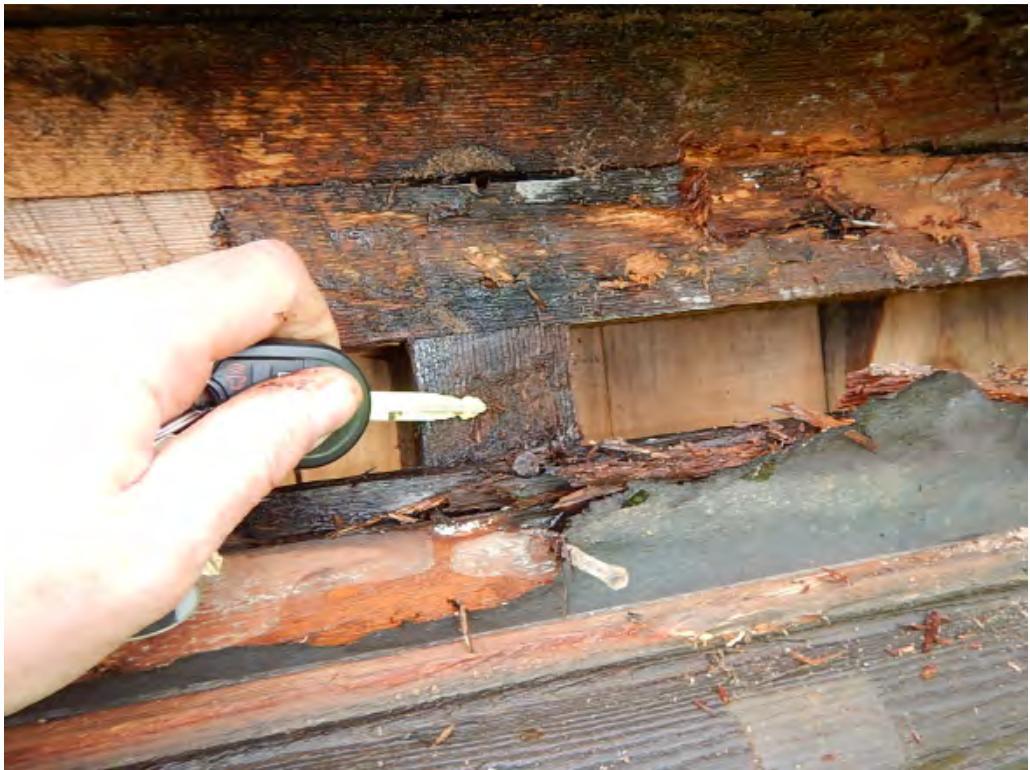
25. Close up of stud and sill plates away from corner.

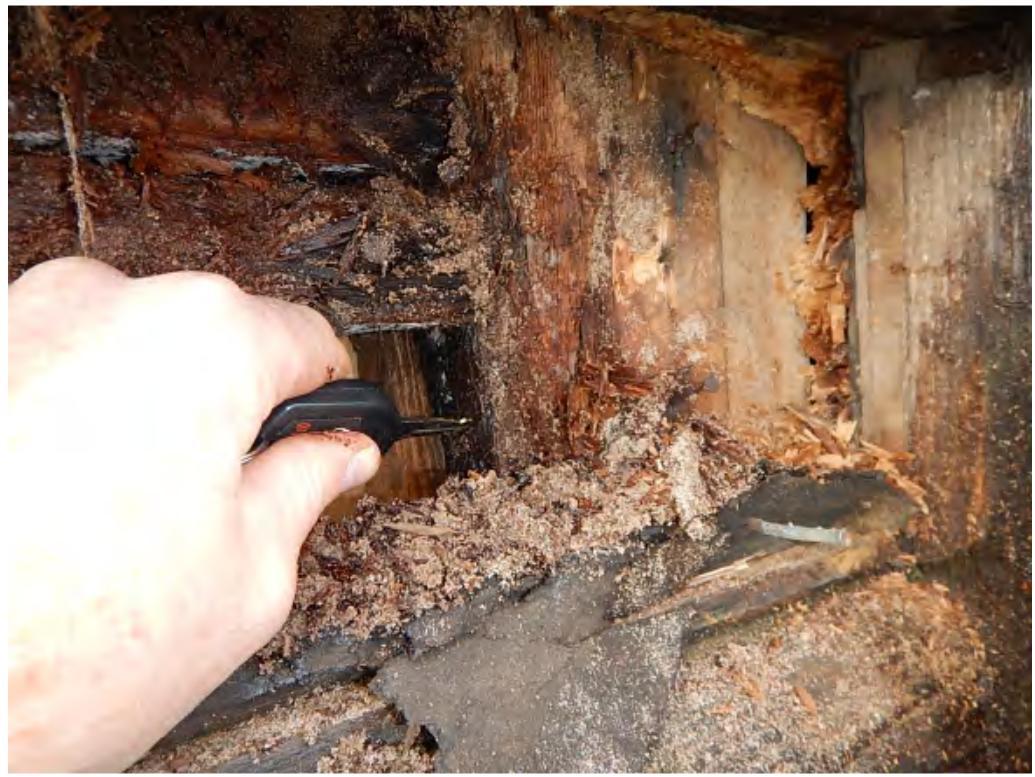
26. Close up of stud and sill beneath window corner.

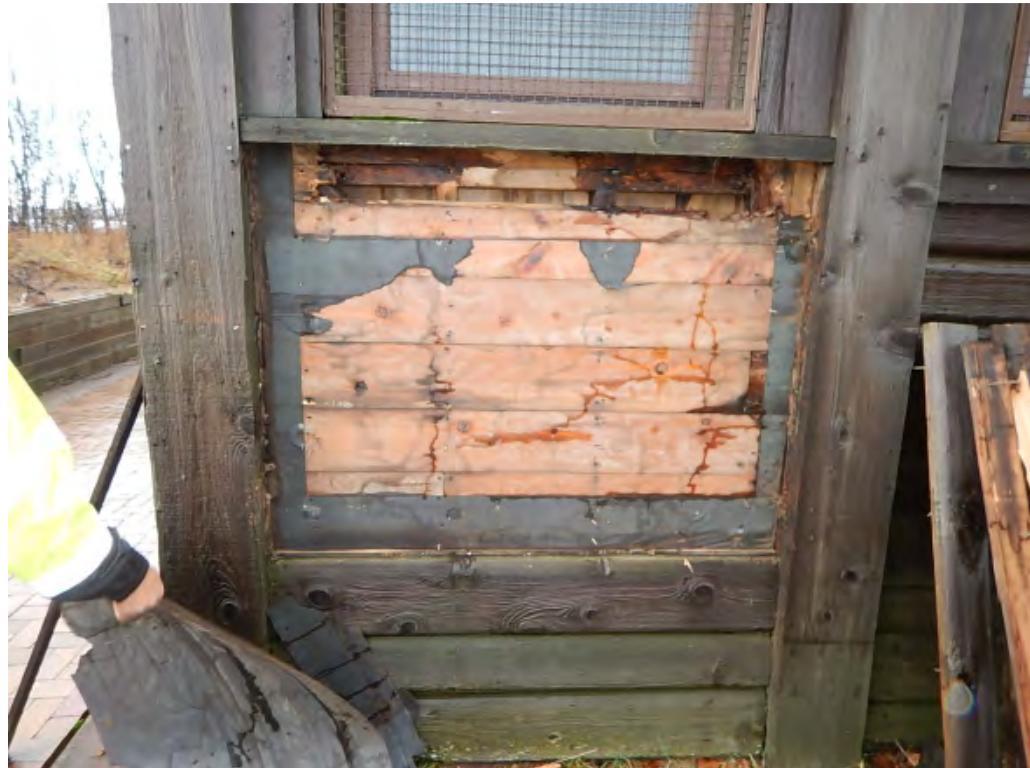
27. Building paper removed. Sheathing is good with localized wet areas.

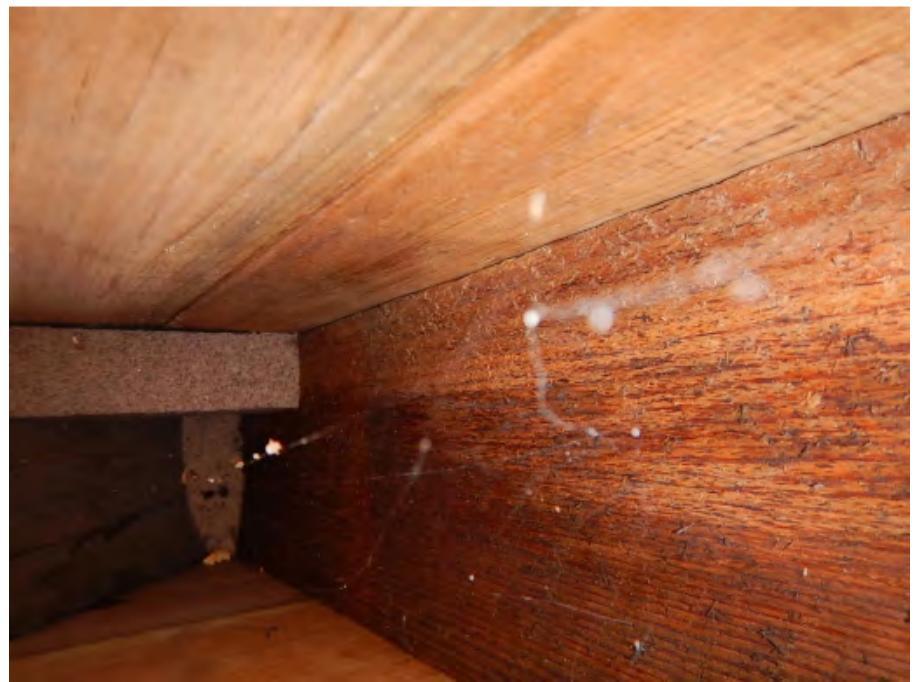
28. Cavity beneath center of window. Conditions dry.

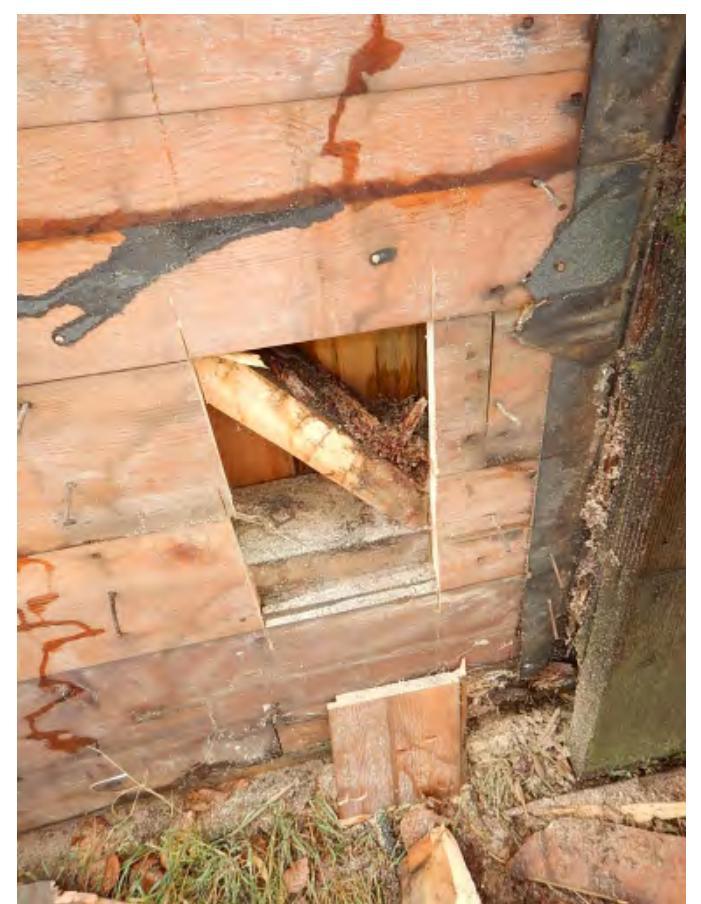
29. Corner brace with wall cavity is partially decayed, west, sand covered.

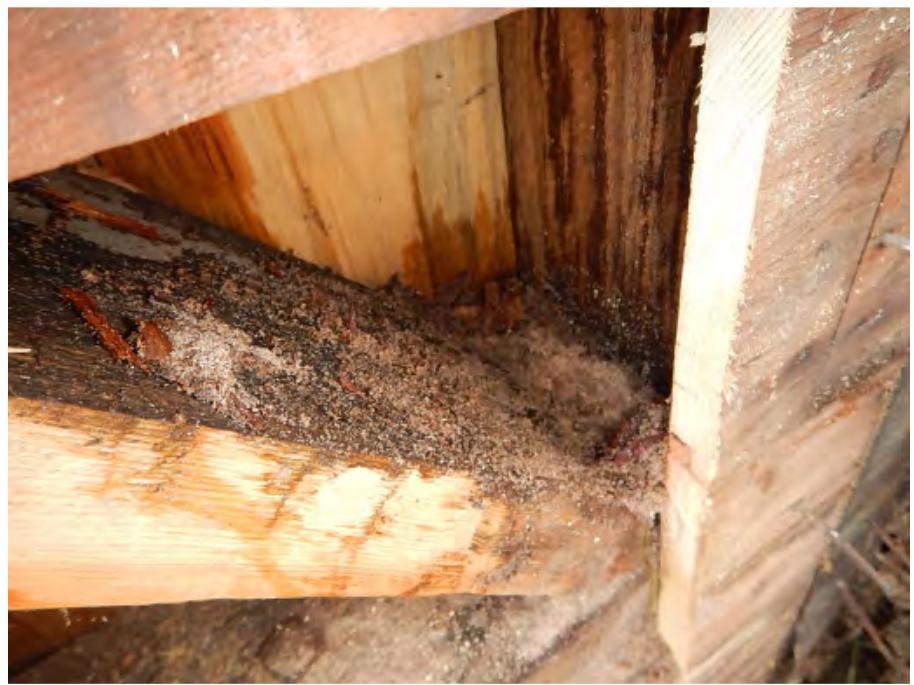
30. Close up of corner brace. Location is beneath northerly corner of window.

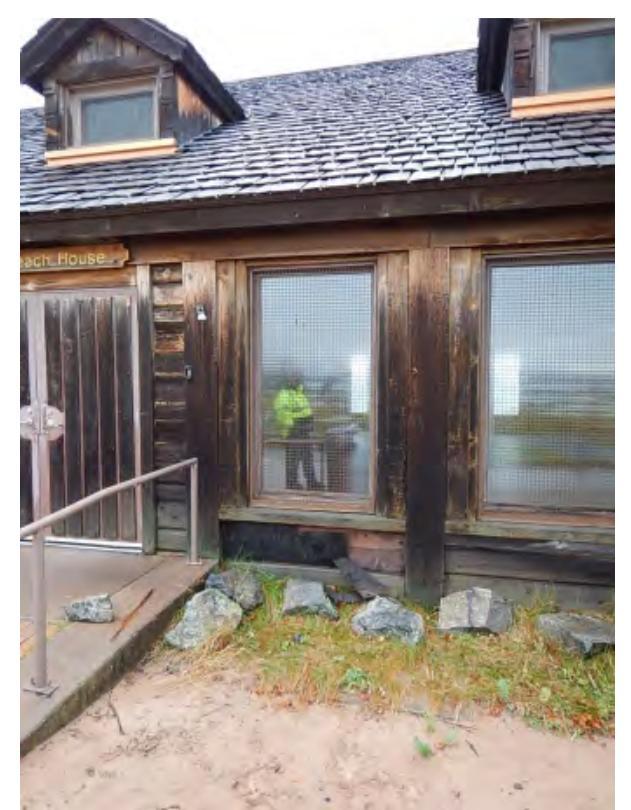
31. Exposed area on west side in window wall next to main entrance.
