#### Addendum # File # 17-0108 Project: Park Point Beach House North Wall Replacement

November 23, 2015

# Re: Park Point Beach House Water Damage NCE Job No. 15-640

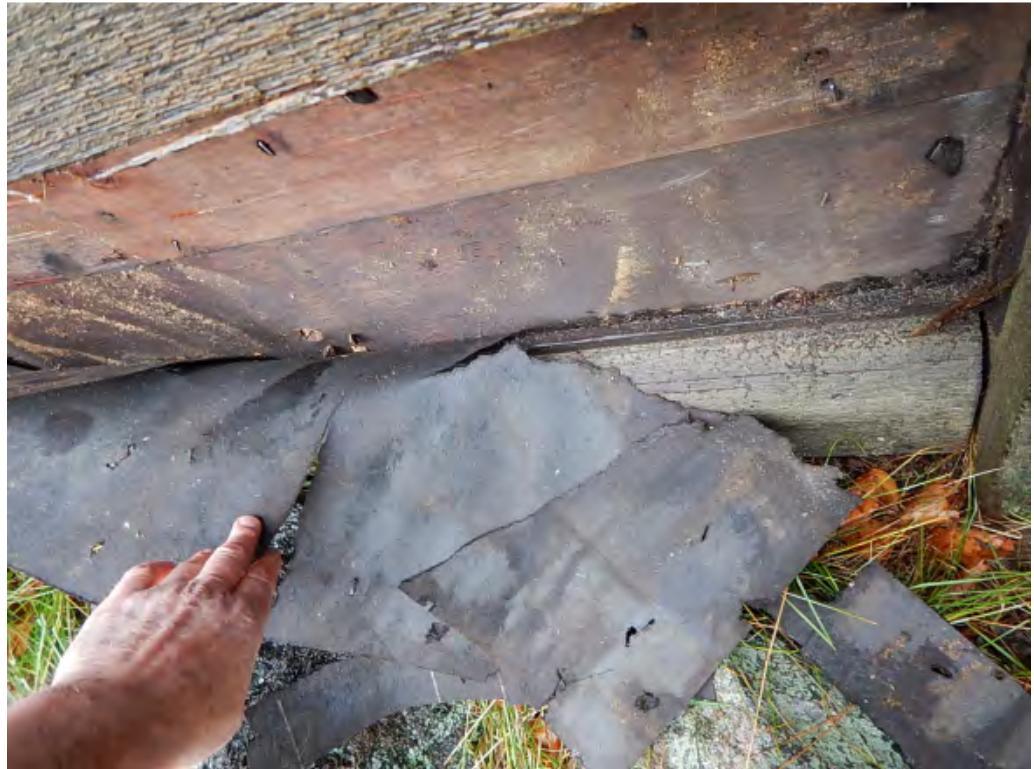
32. Building paper removed. Siding is dry without evidence of significant decay.
