U.S.S. MASSACHUSETTS

Tow Plan & Trip-in-Tow Survey

Purpose of survey: Tow Plan & Trip-In-Tow Survey

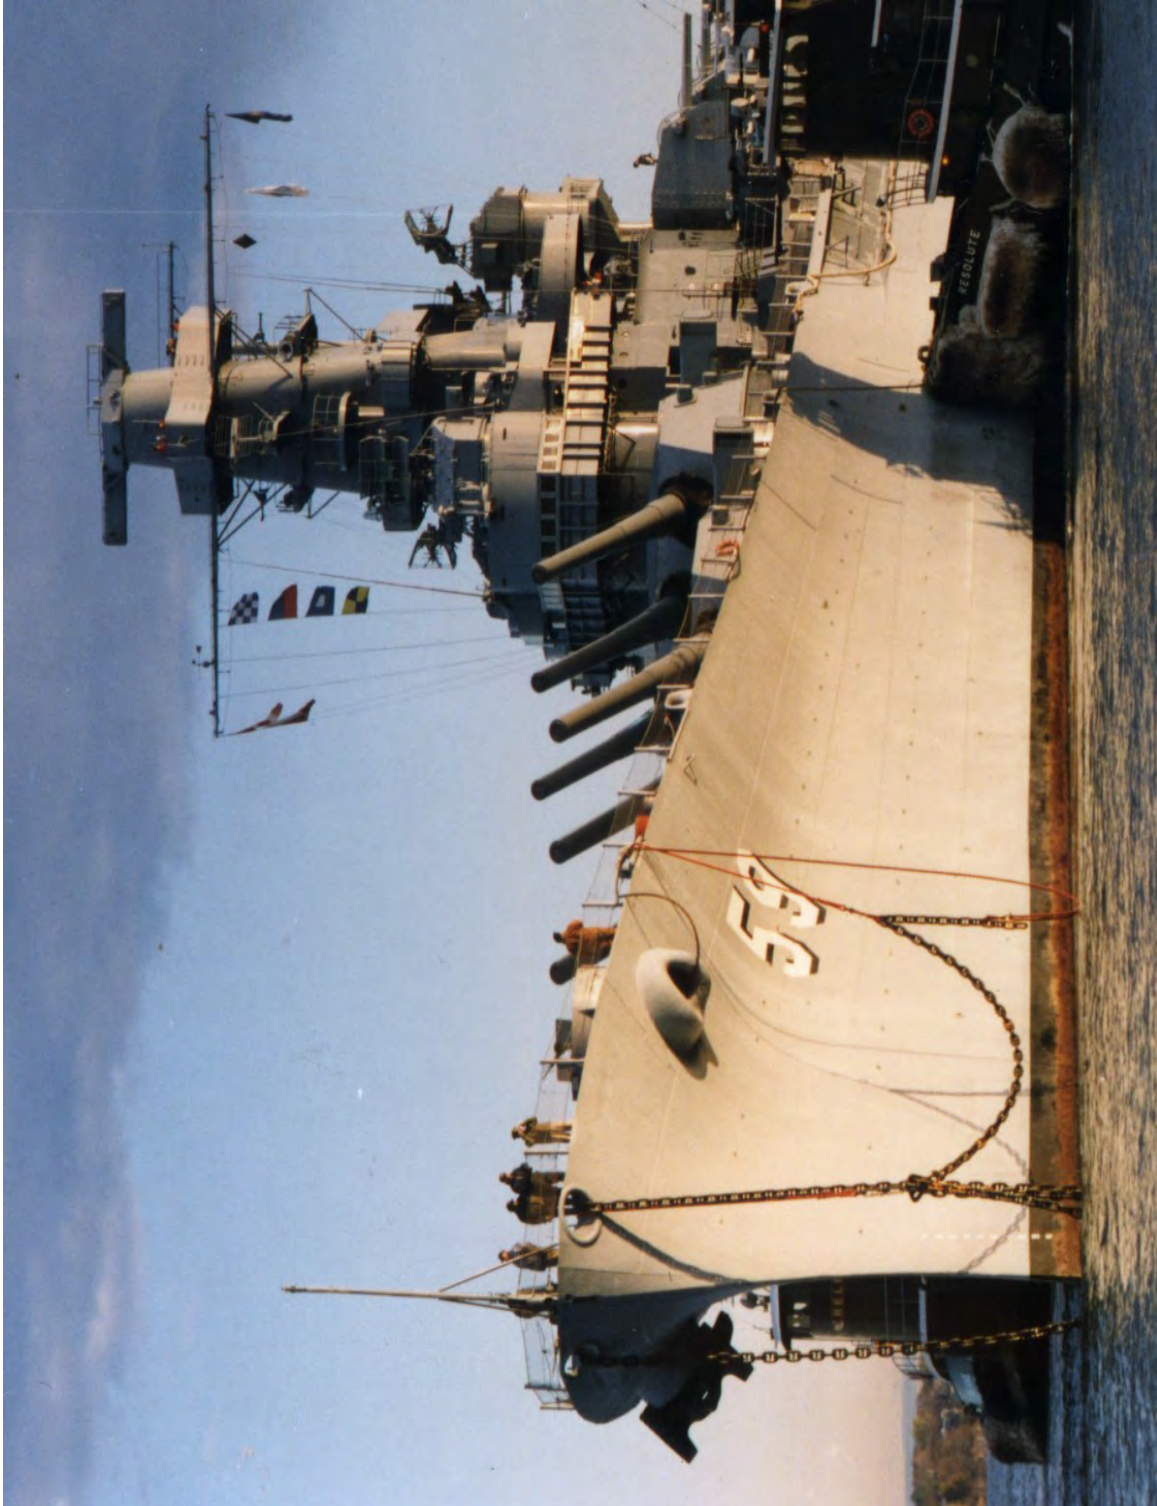
Ship is turned around in the Taunton River with towing bridle and retrieval lines depicted. Notice towing diamond day shape in rigging.

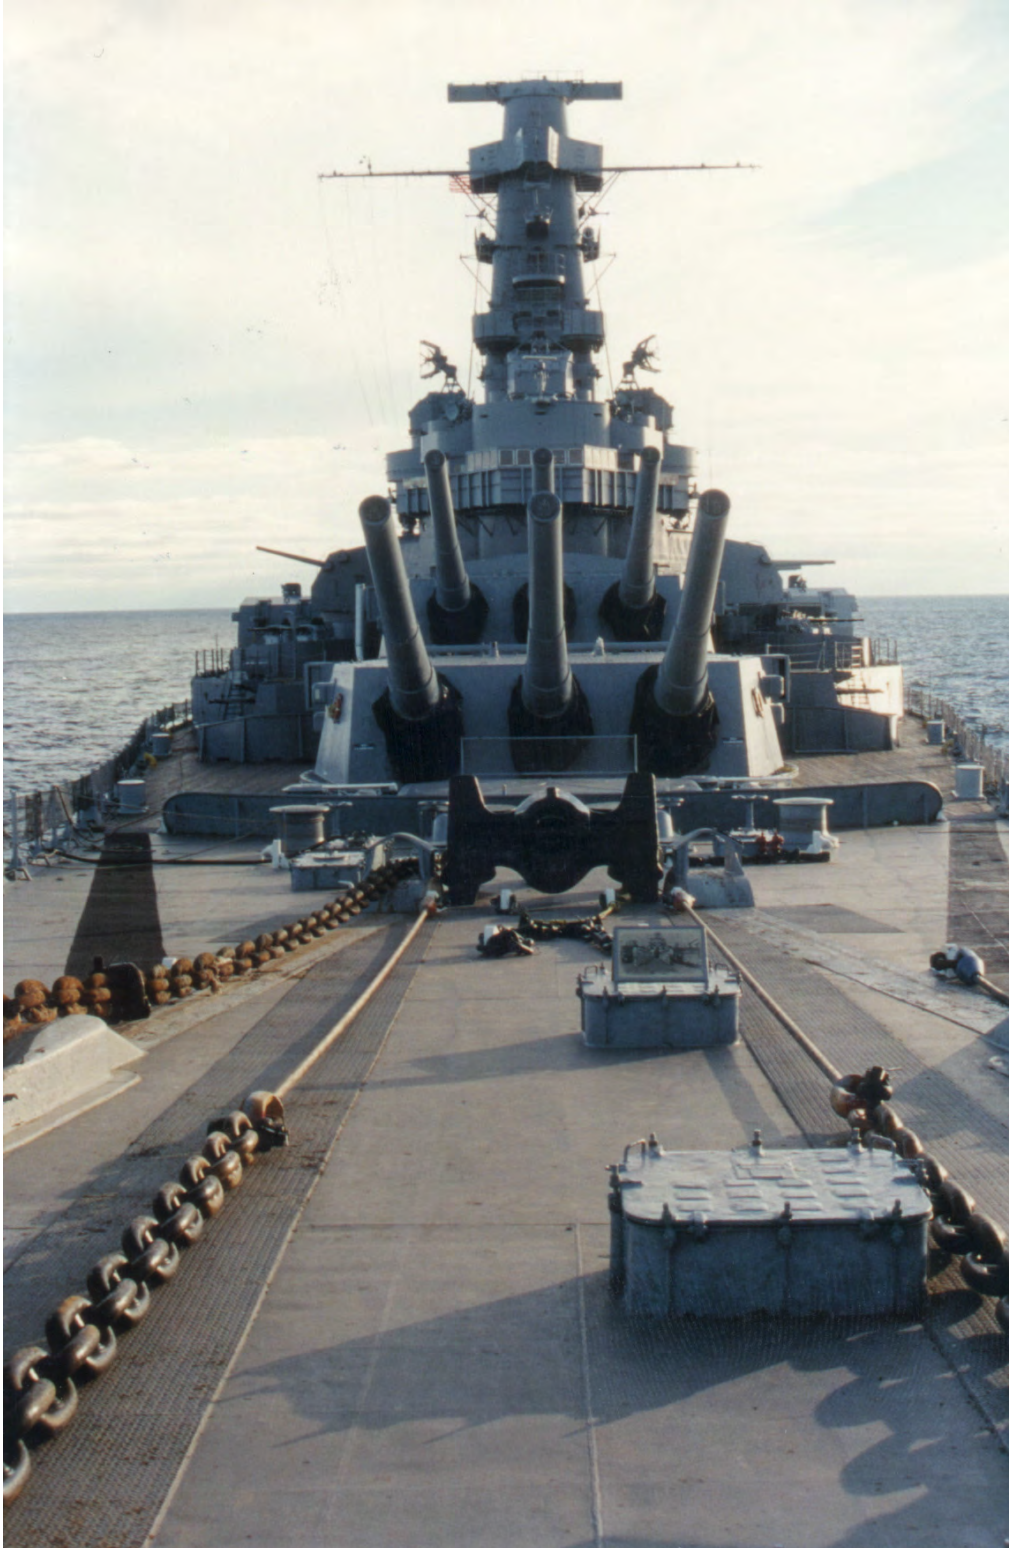
Both legs of towing bridle inboard can be seen on foredeck with wire shackled to towing eyes and chain bridle.

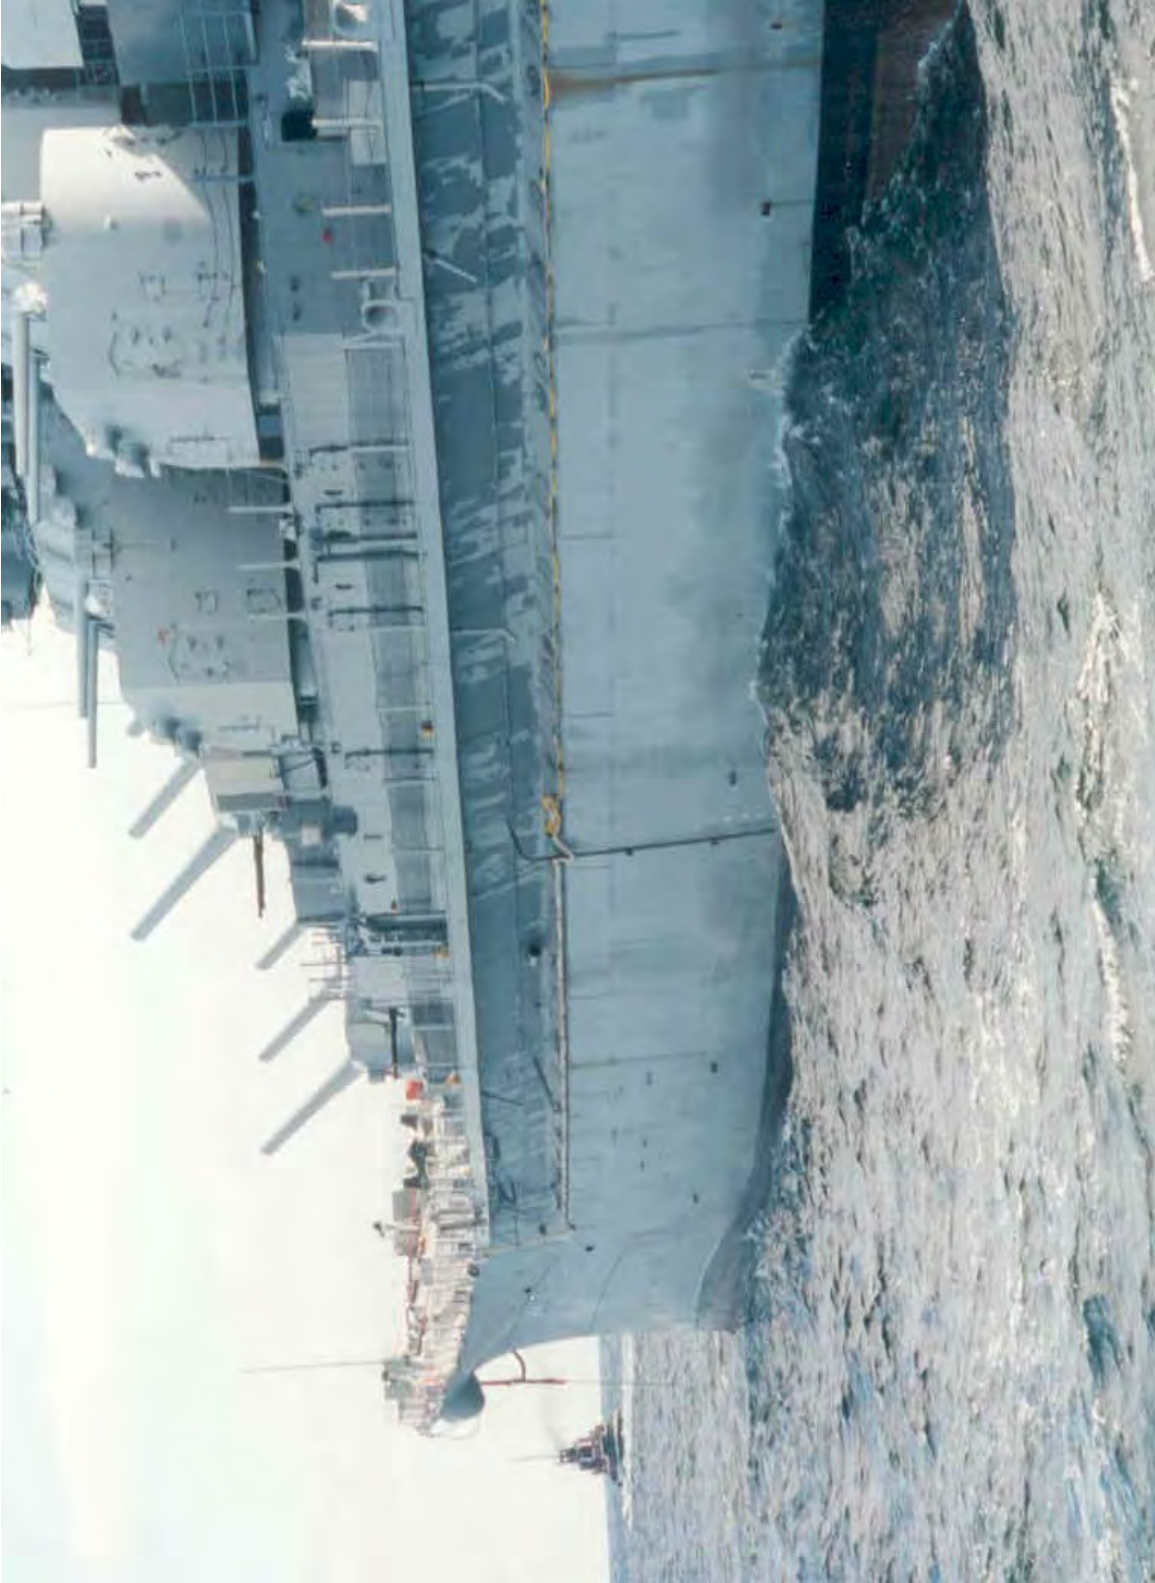
In the sea lanes around Nantucket showing the emergency tow wire strapped to the port side of MASSACHUSETTS.

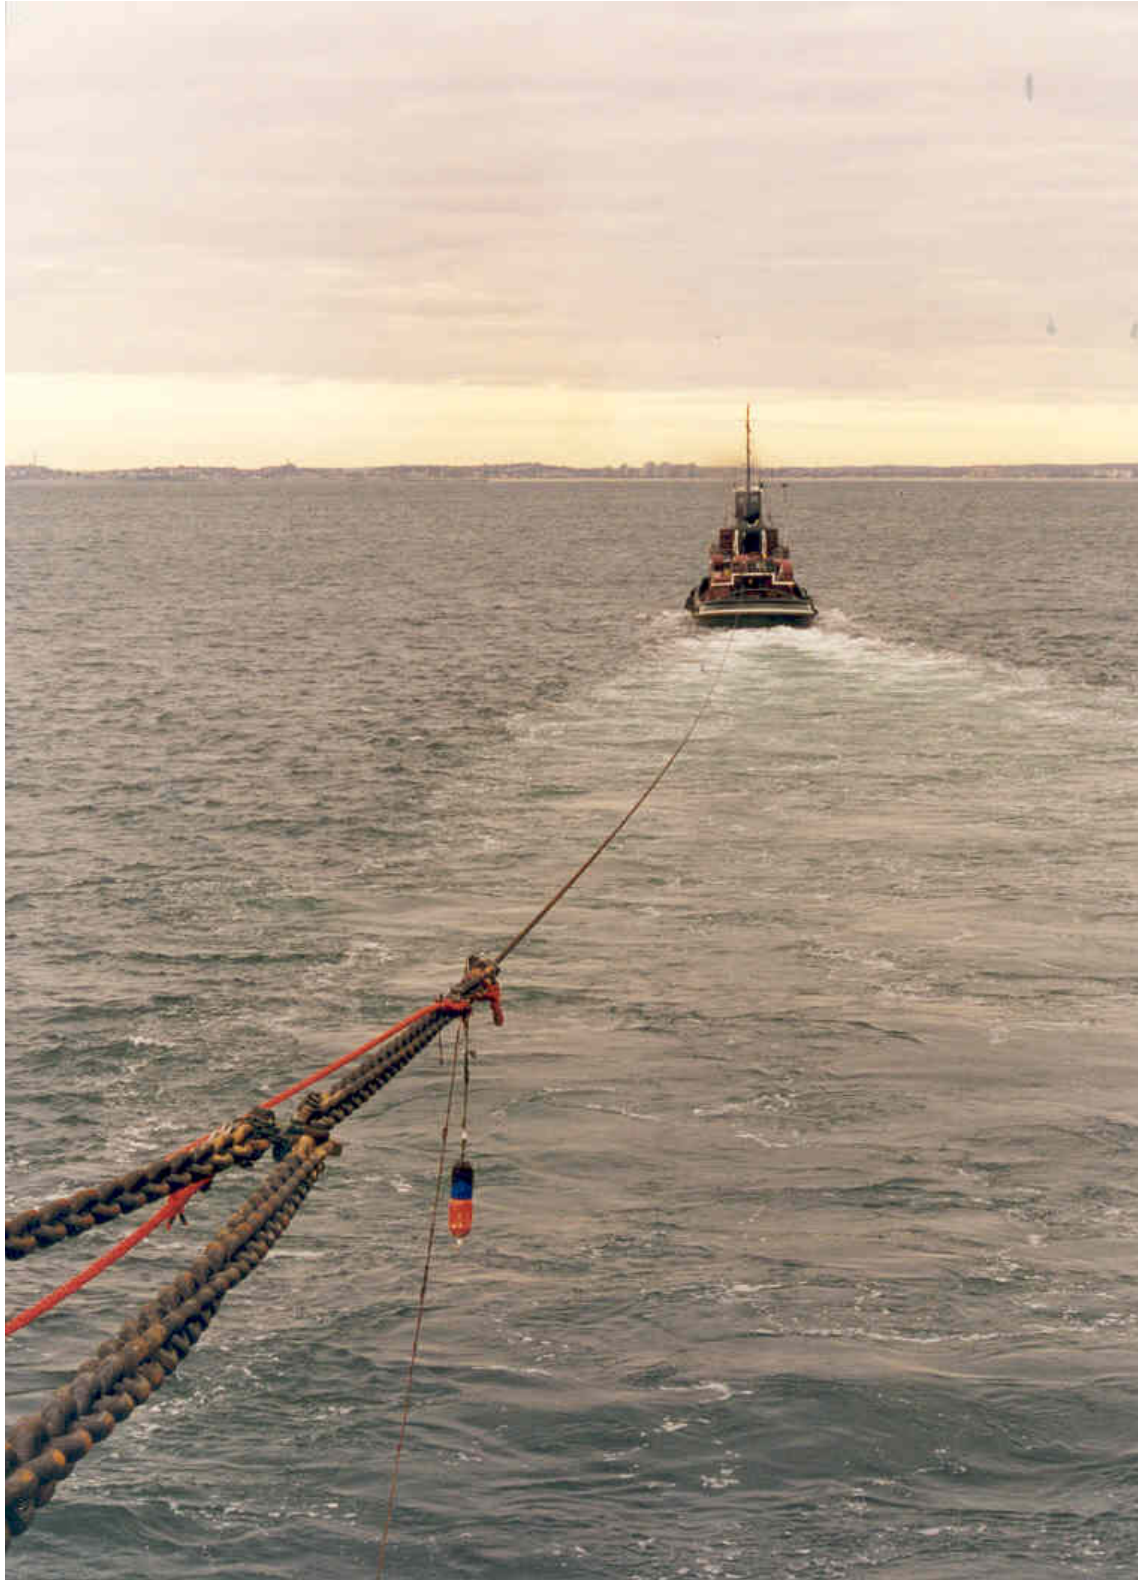
**Excellent view of tow chain bridle and retrieval lines as tug
'ESTER MORAN' commences shortening wire entering Boston Harbor.**
