ENVIRONMENTAL ASSESSMENT WORKSHEET

1. Project title: Pastoret Terrace Building Potential Demolition

2. Proposer: Duluth Economic Development Authority

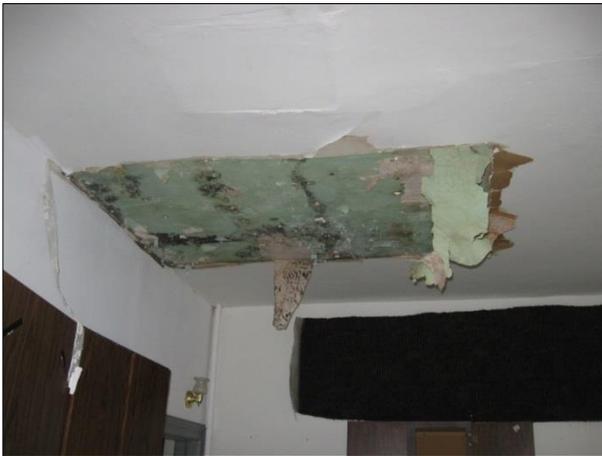
Figure 9 Typical interior of upper level ceilings showing sporadic water damage

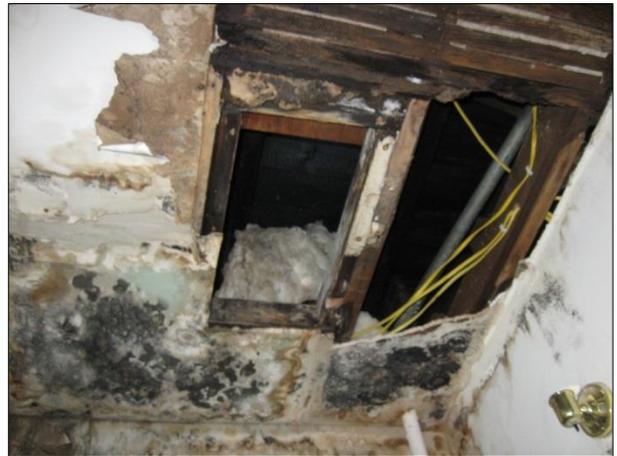
Figure 10 Roof leak and mold condition

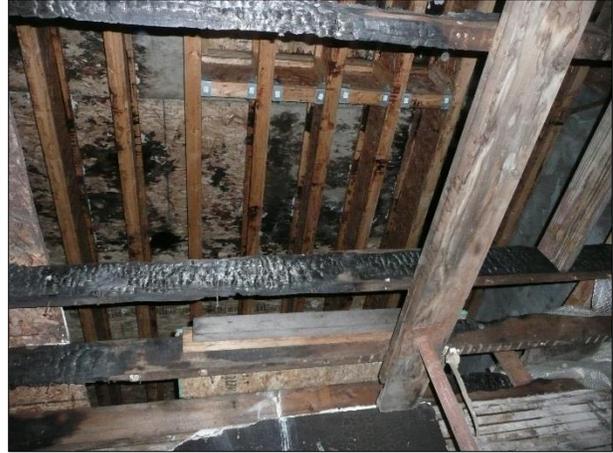
Figure 34 Fire damaged ceiling joists, temporary wood I-joint roof over fire damaged portion of the building

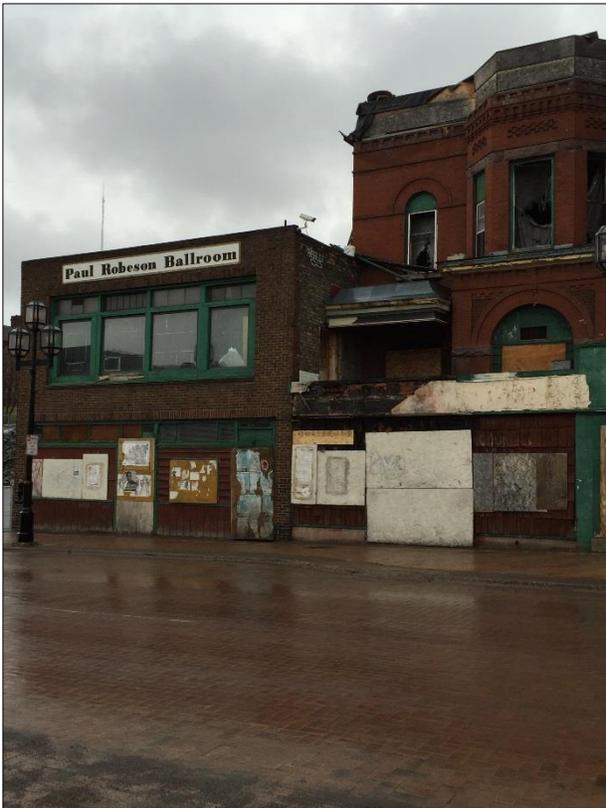
Figure 35 Front of Paul Robeson Ballroom, brick in good condition

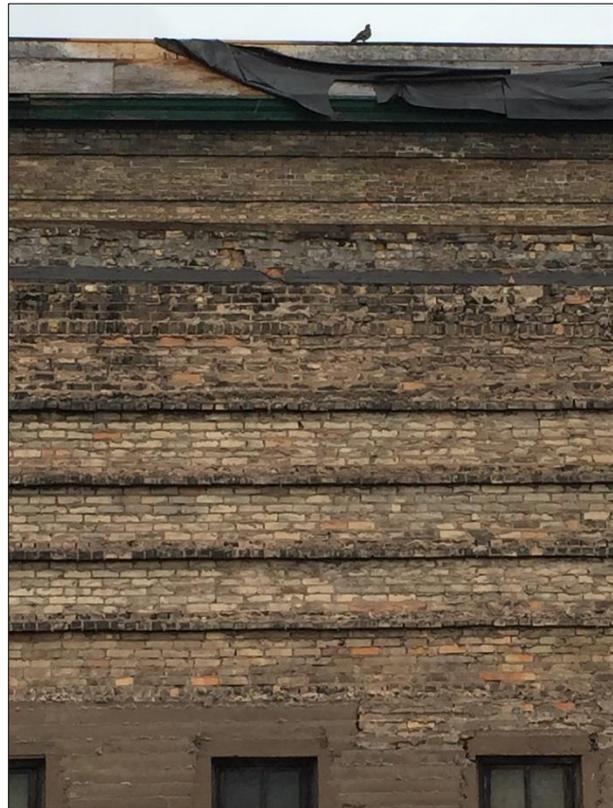
- The Ballroom building masonry has deteriorated at the parapet on both sides and should be repaired

Figure 36 Side of Paul Robeson Ballroom, Damaged brick, brick needs to be tuck-pointed, parapet needs to be repaired
