# City of Duluth

## Meeting Agenda

### Heritage Preservation Commission.

RE: Review of Historic Construction/Demolition Permit for a Temporary Roof Replacement on the Duluth Public Library Heritage Preservation Landmark (PL 23-025)

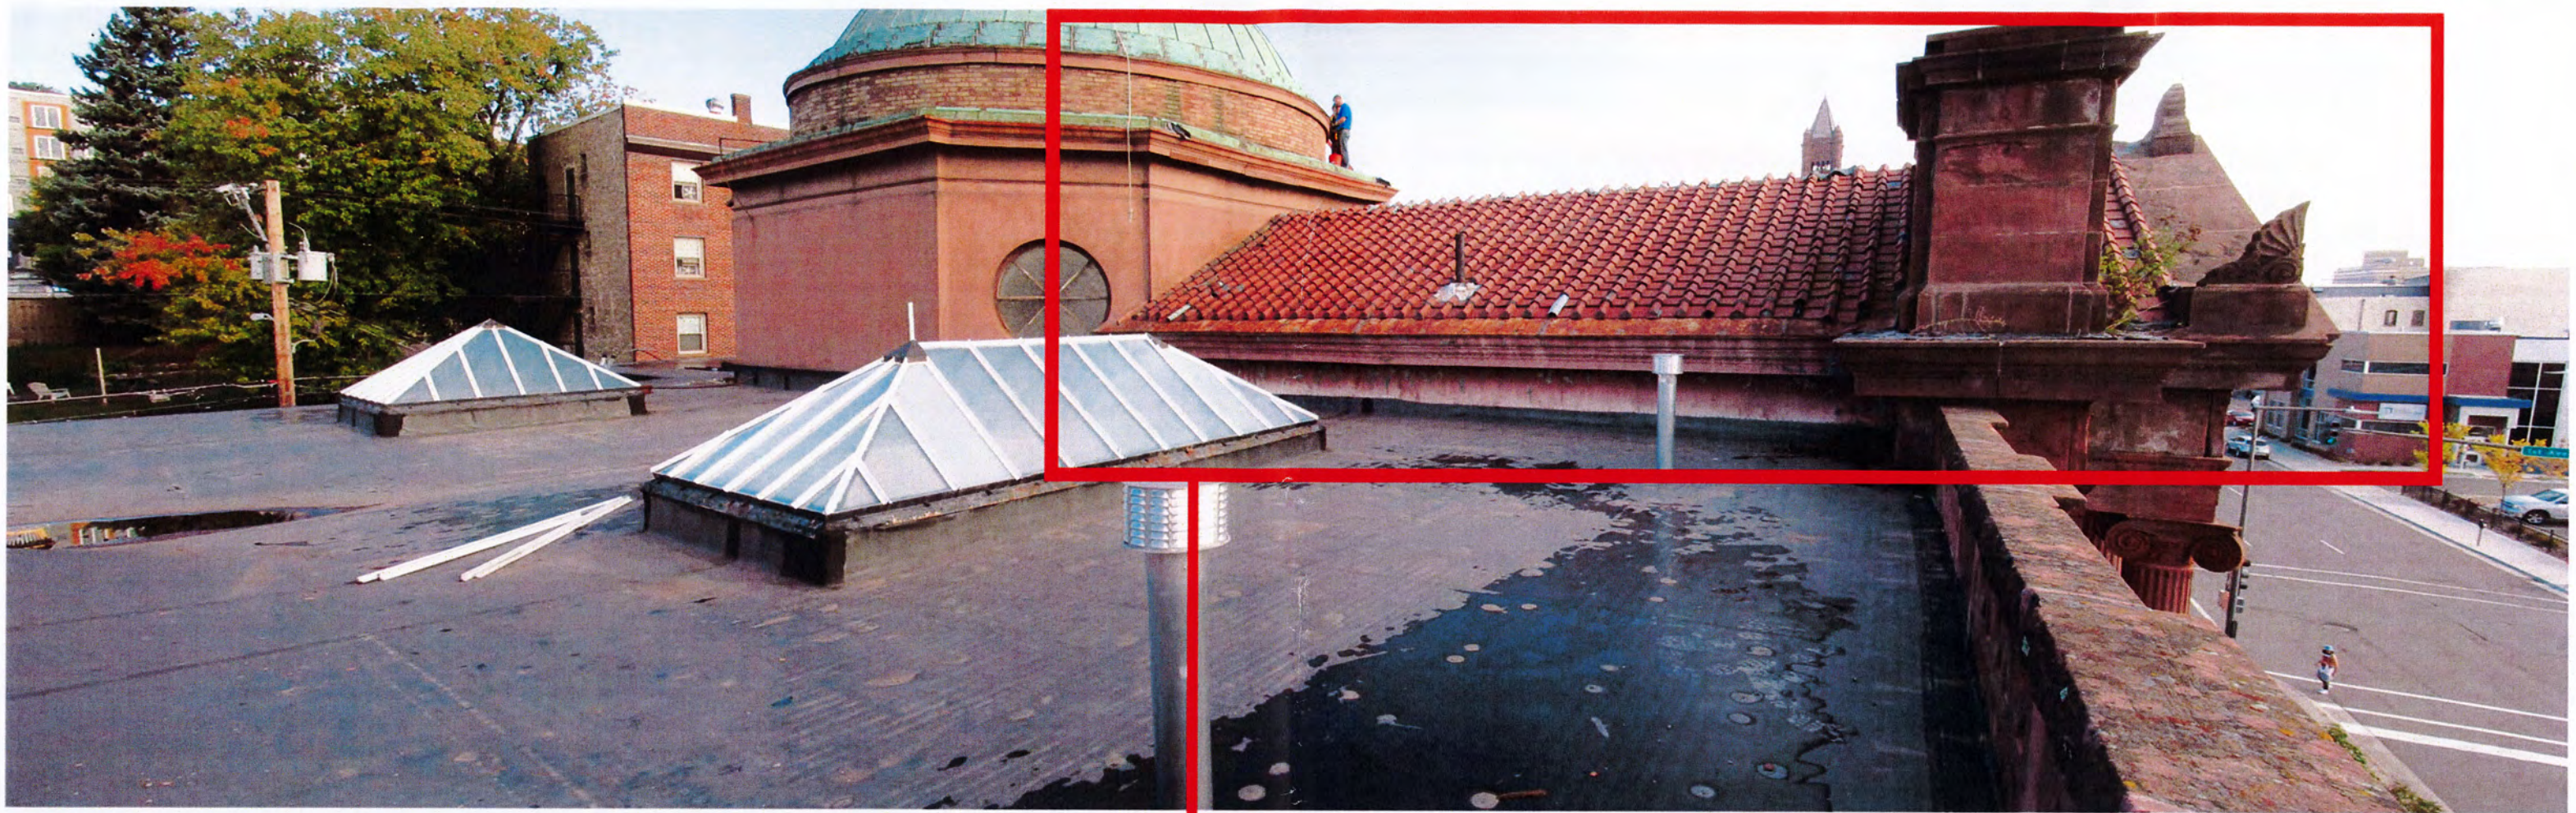
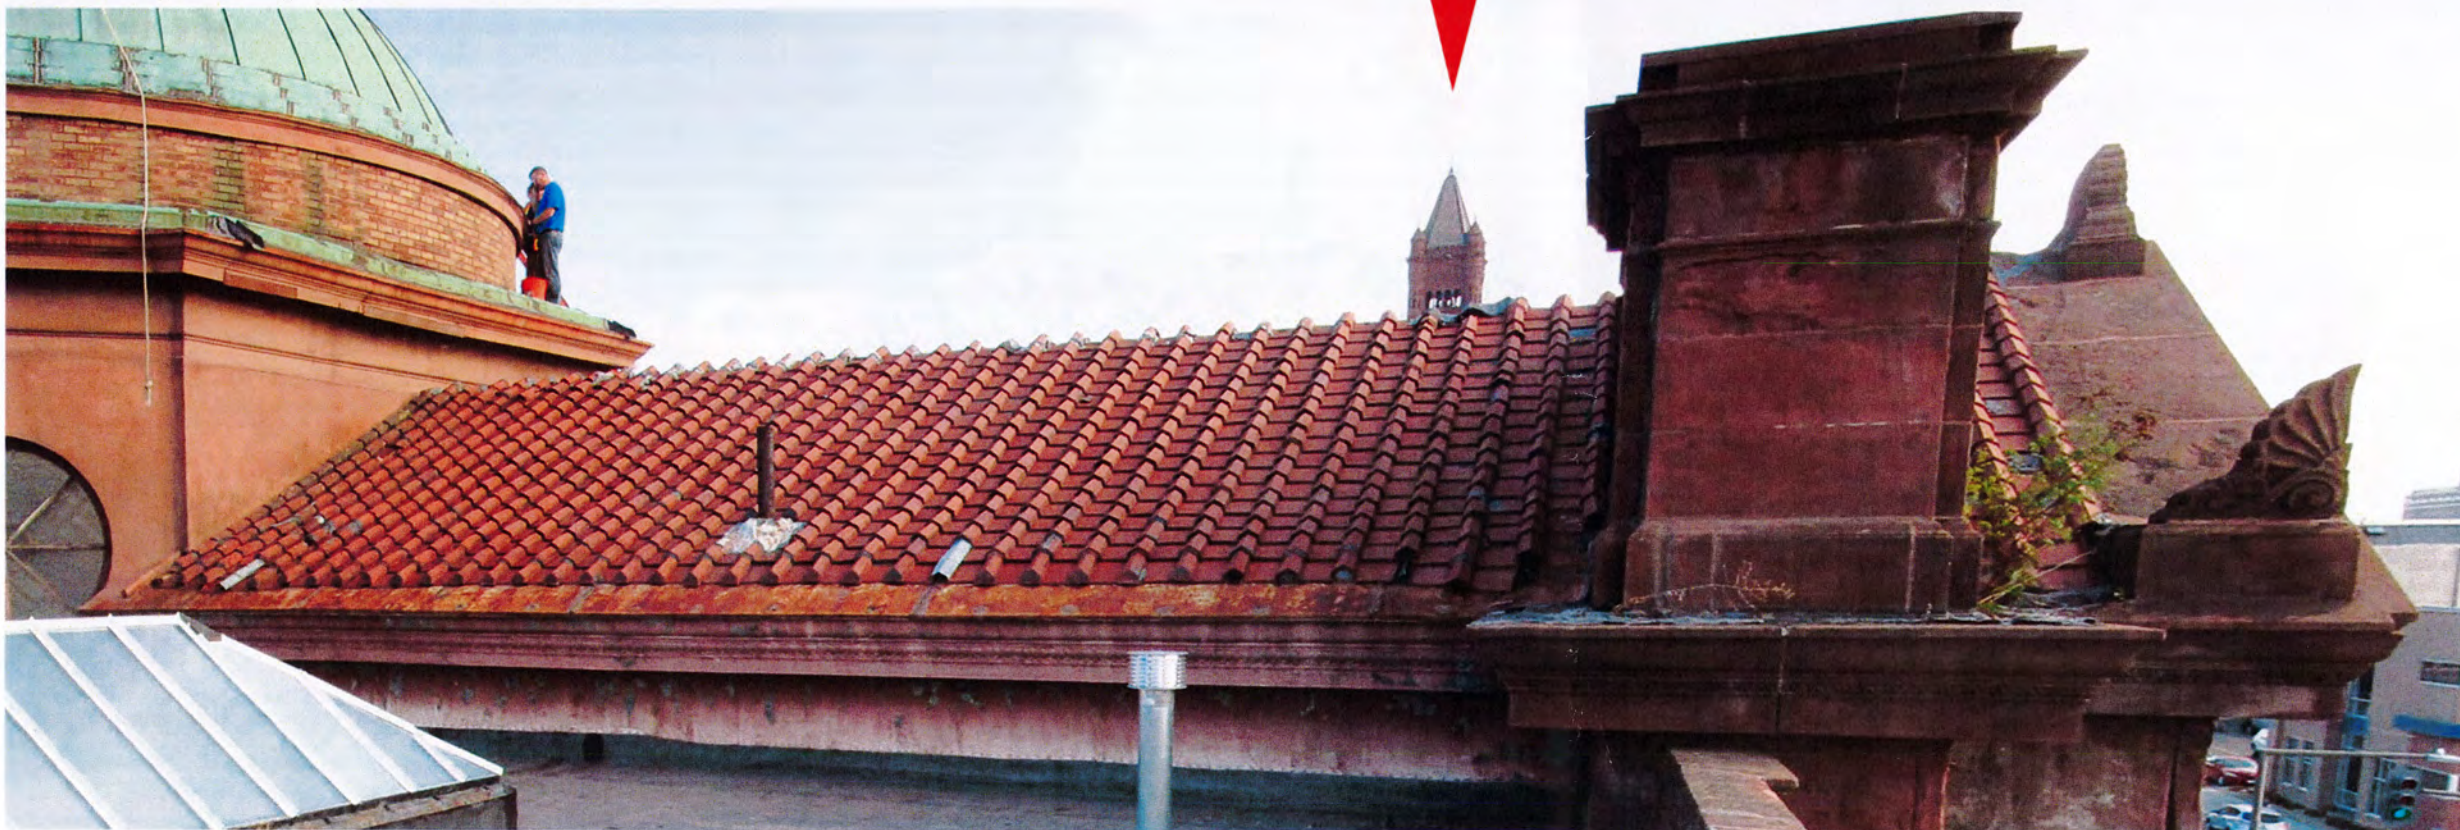
- Existing clay tile sections are in poor to fair condition with many broken tiles, missing tiles, and tiles damaged from sealants and mastics of previous repairs. Approximately 30% of tiles cannot be reused.
- Nail attachments to wood sleepers have failed in many cases due to rotted sleepers or deterioration to the point that tiles are loose and sliding down slope of roof exposing underlayments.
- Wood sleepers are rotted from exposure to water over many years.
- Asphalt underlayment and top surface of concrete deck is not watertight and has areas where concrete is loose and deteriorated.
- Concrete roof deck condition was reviewed by Jon Aamodt, Northland Consulting Engineers – Duluth, and was found to be sufficient to continue to support the roof load and new roof anchorage.

West Roof Slope Prior to Demolition  
and Temporary Covering

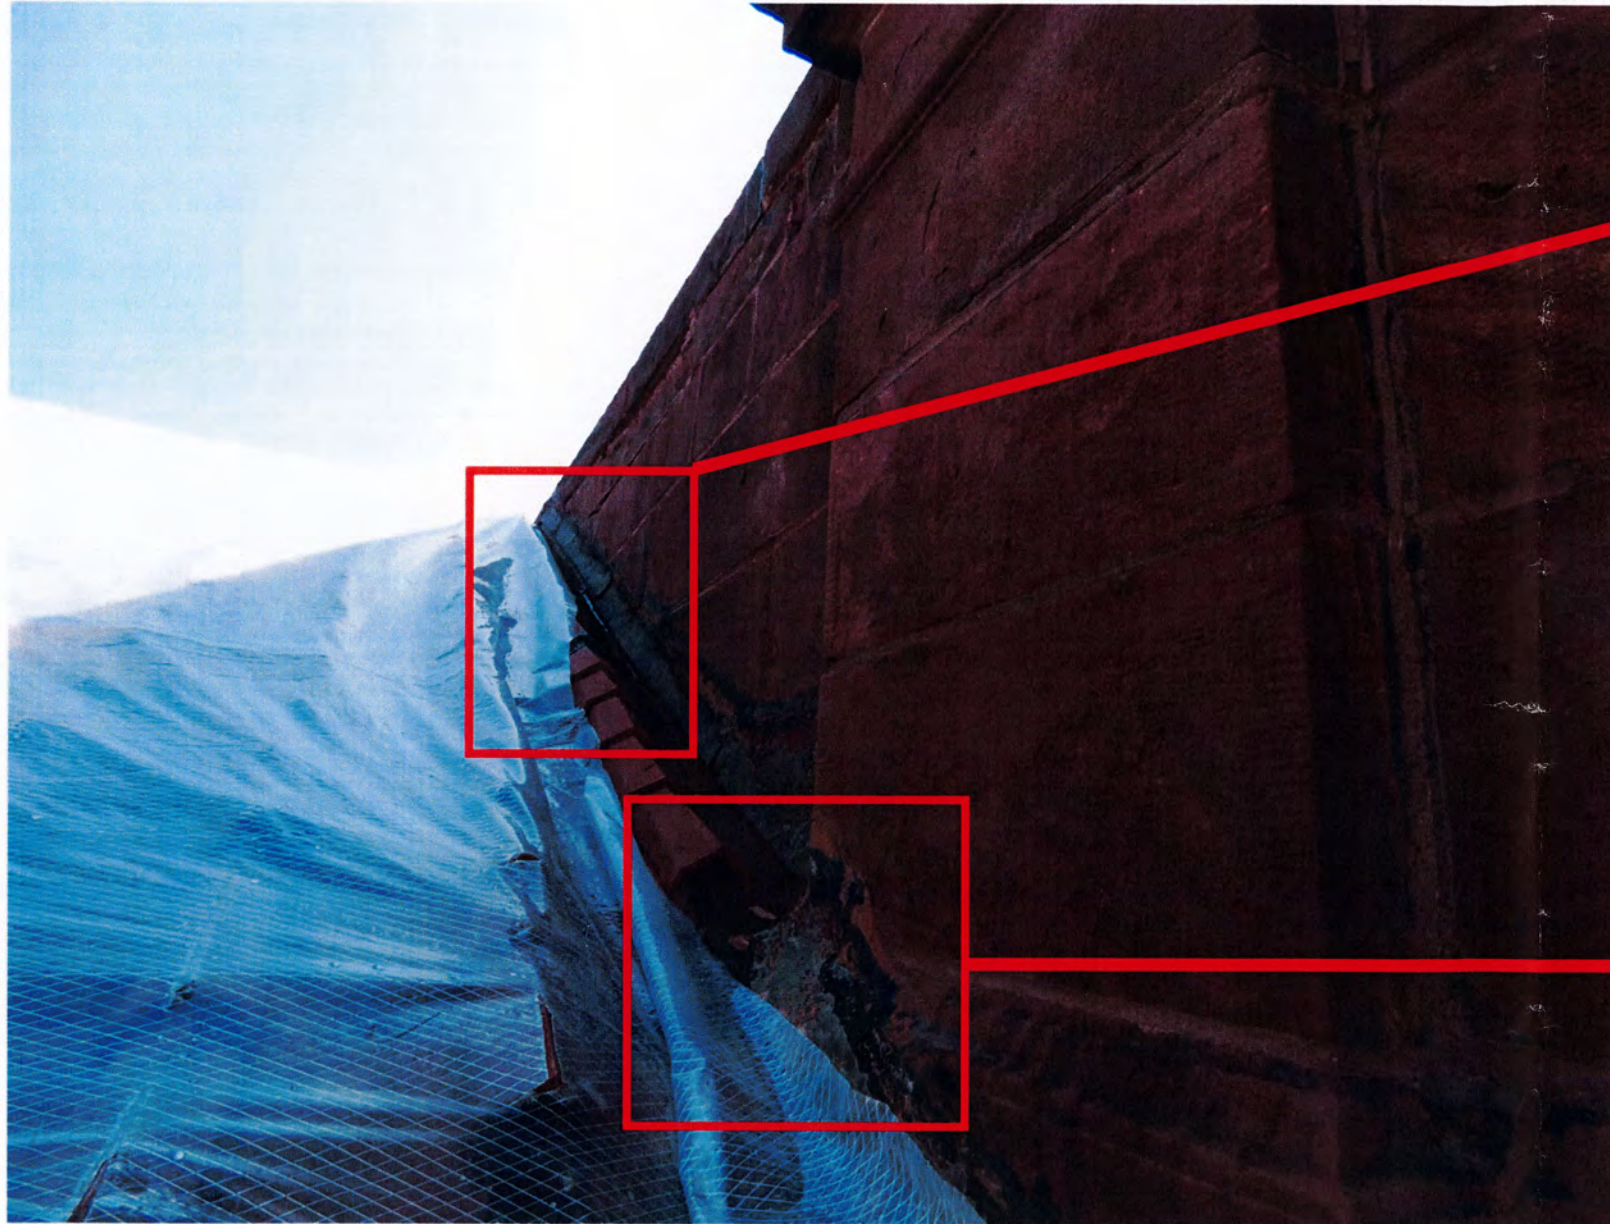
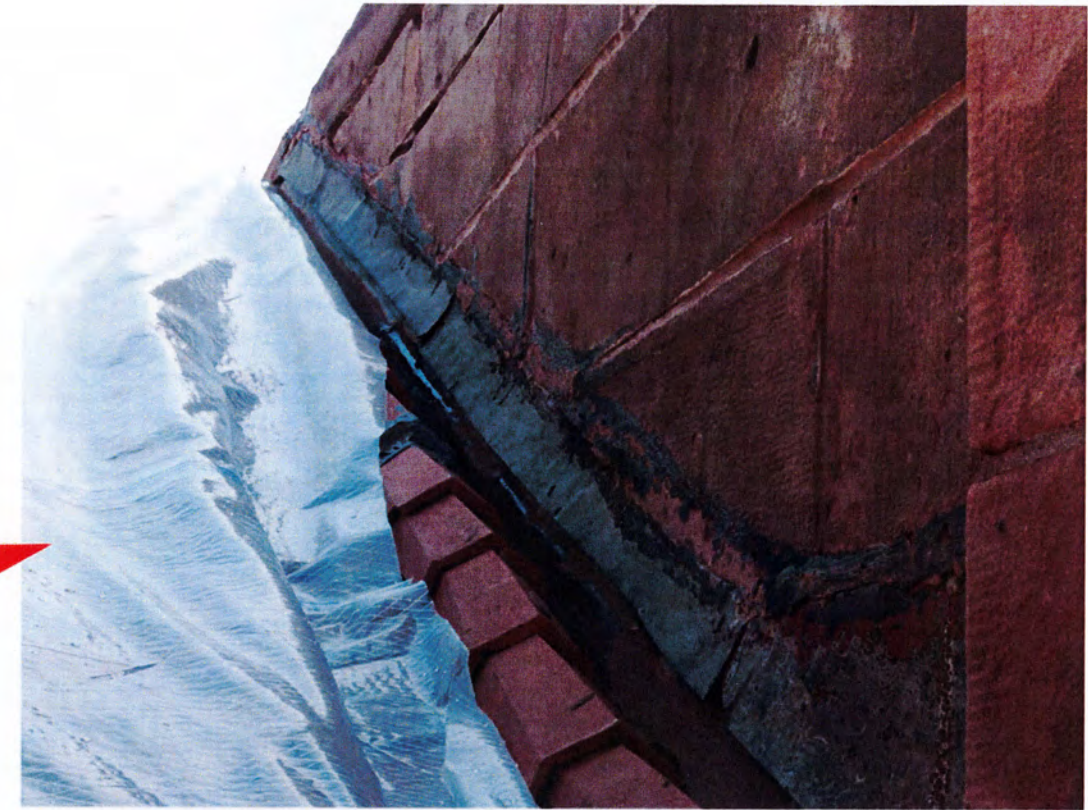
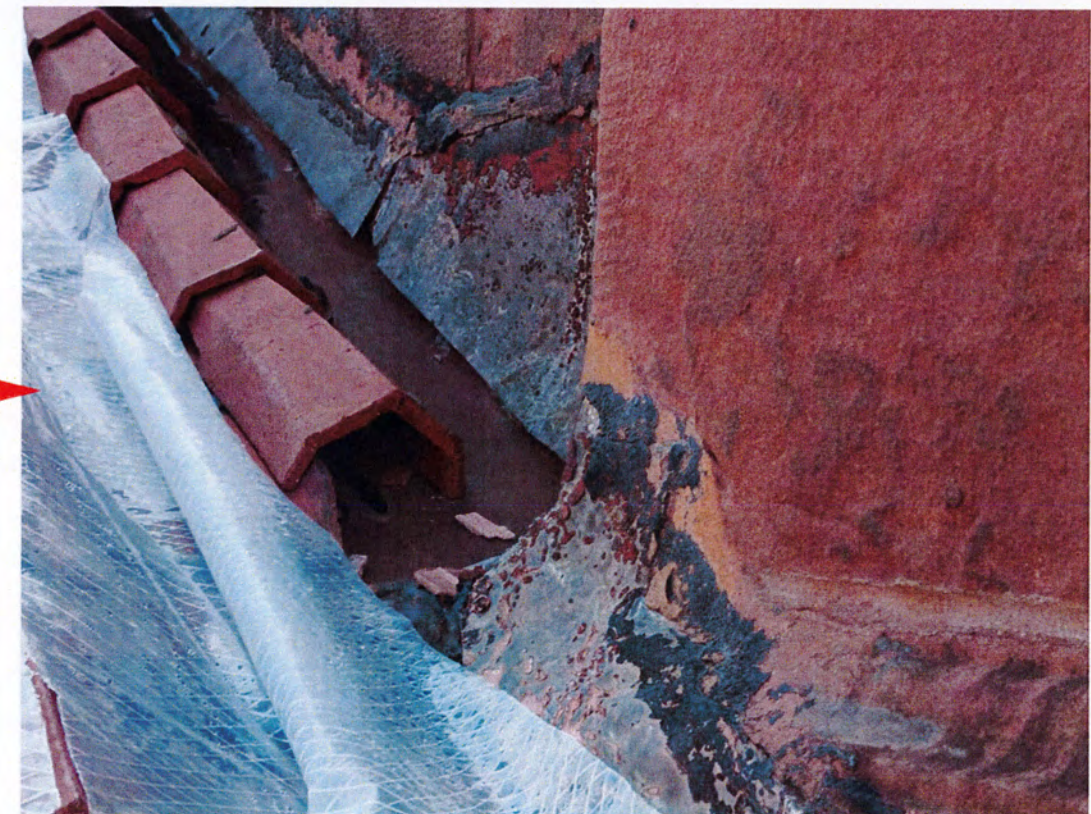
- Edge flashing condition is unknown due to inability to adequately see wall connections (stucco replacement at drum section below dome and multiple coatings with mastic). It is believed that the edge flashings have failed due to the amount of water leaking into the building.

- Bottom drip flashing is significantly deteriorated and must be replaced.
- Stamped metal fascia is in relatively good shape with minor sections requiring restoration. Paint over galvanized surfaces is peeling and will require stripping in restoration project.

West Slope Edge Flashing

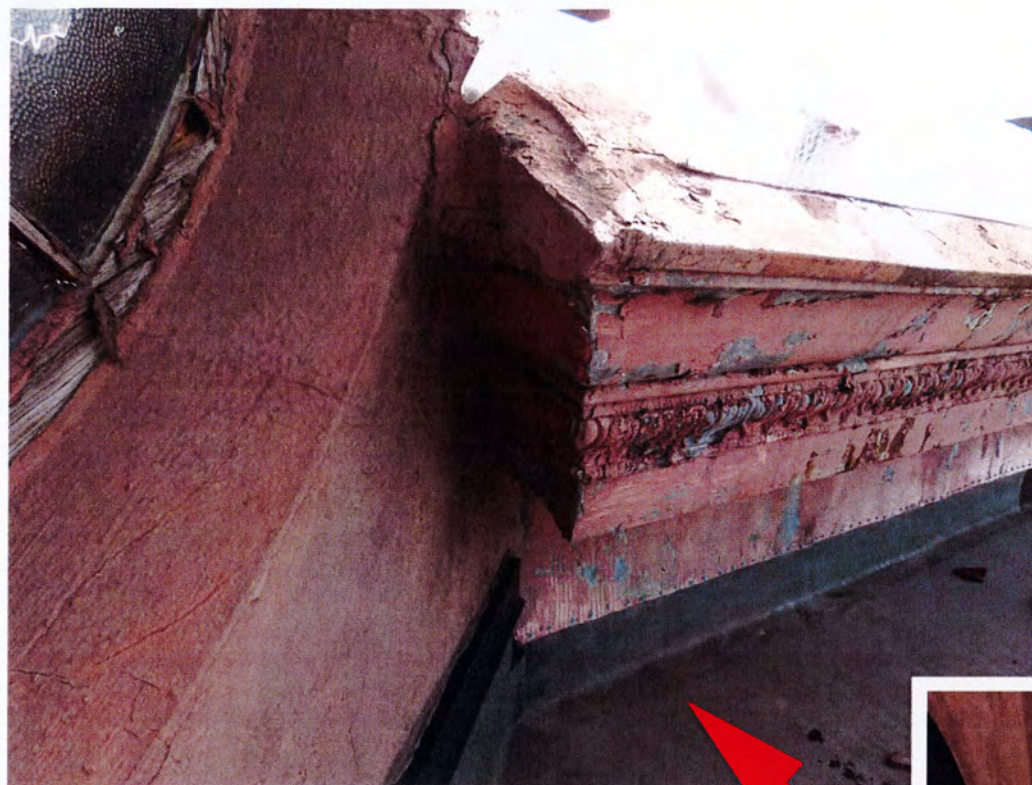
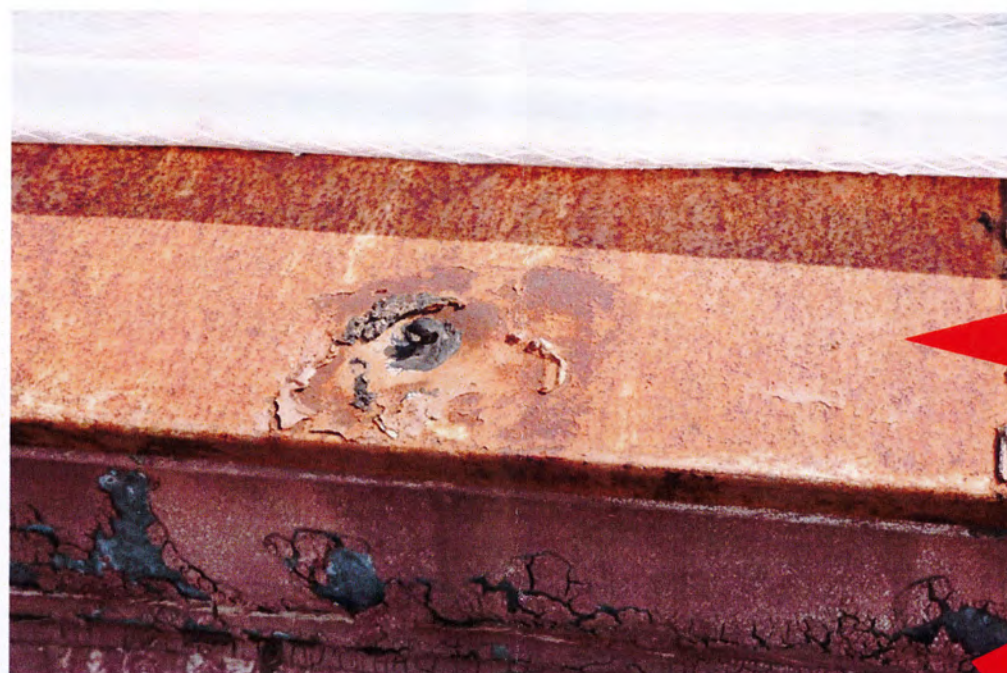
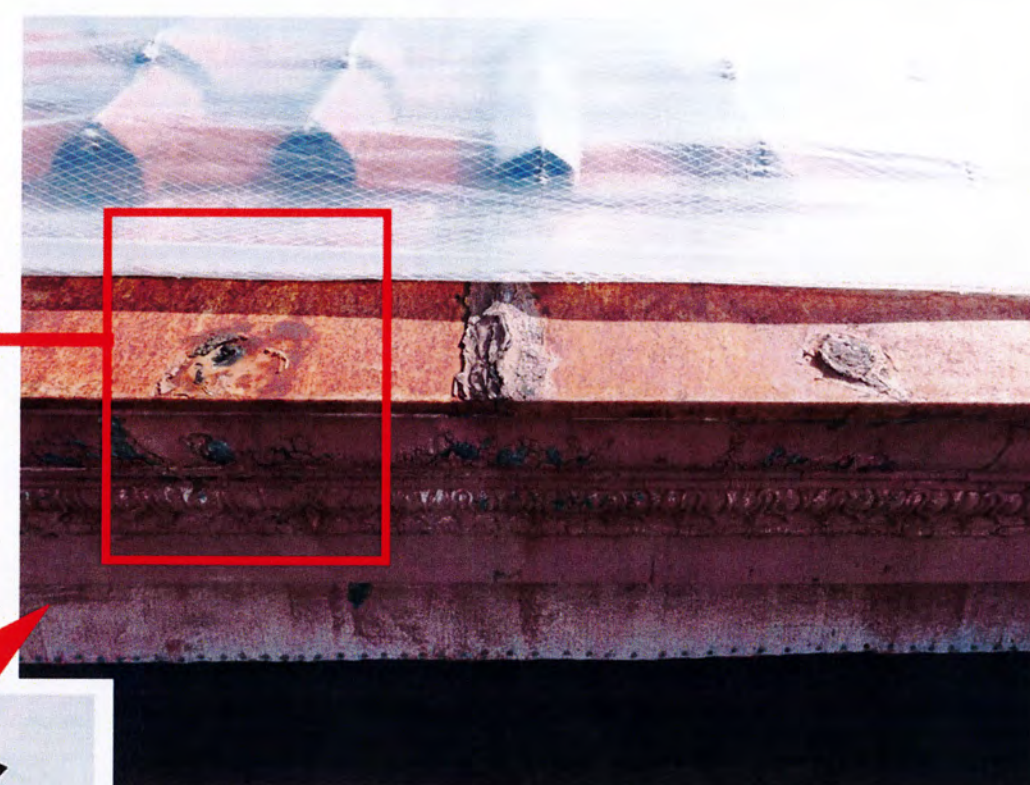
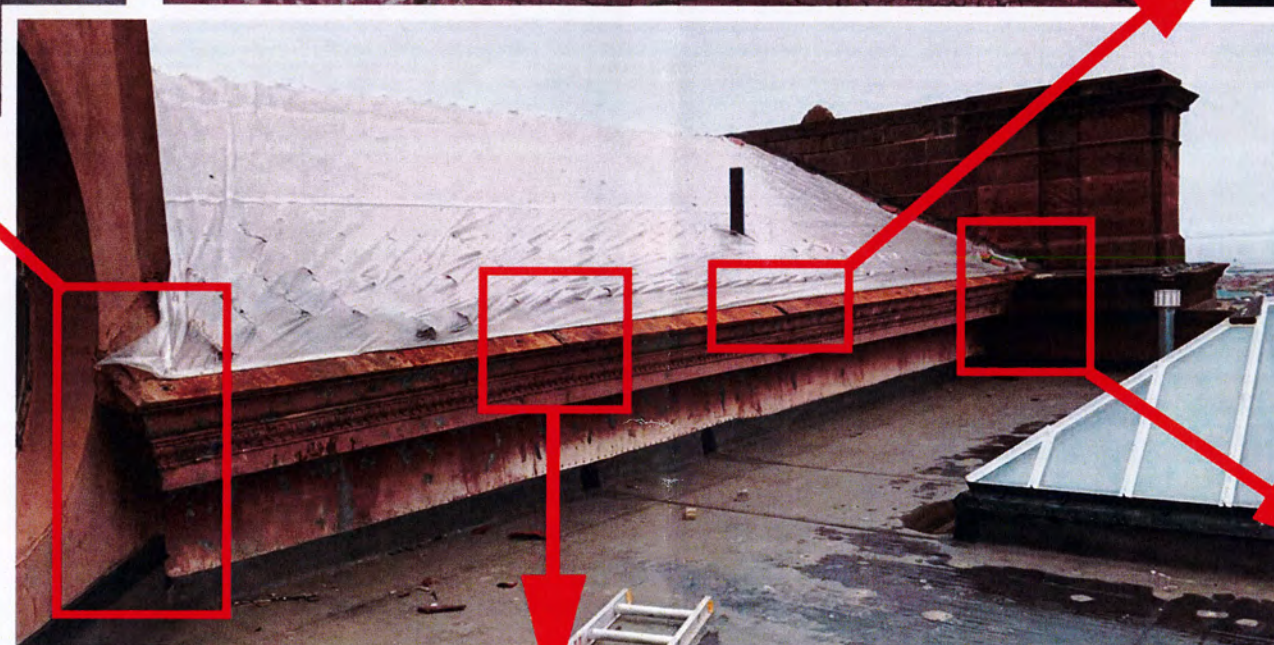
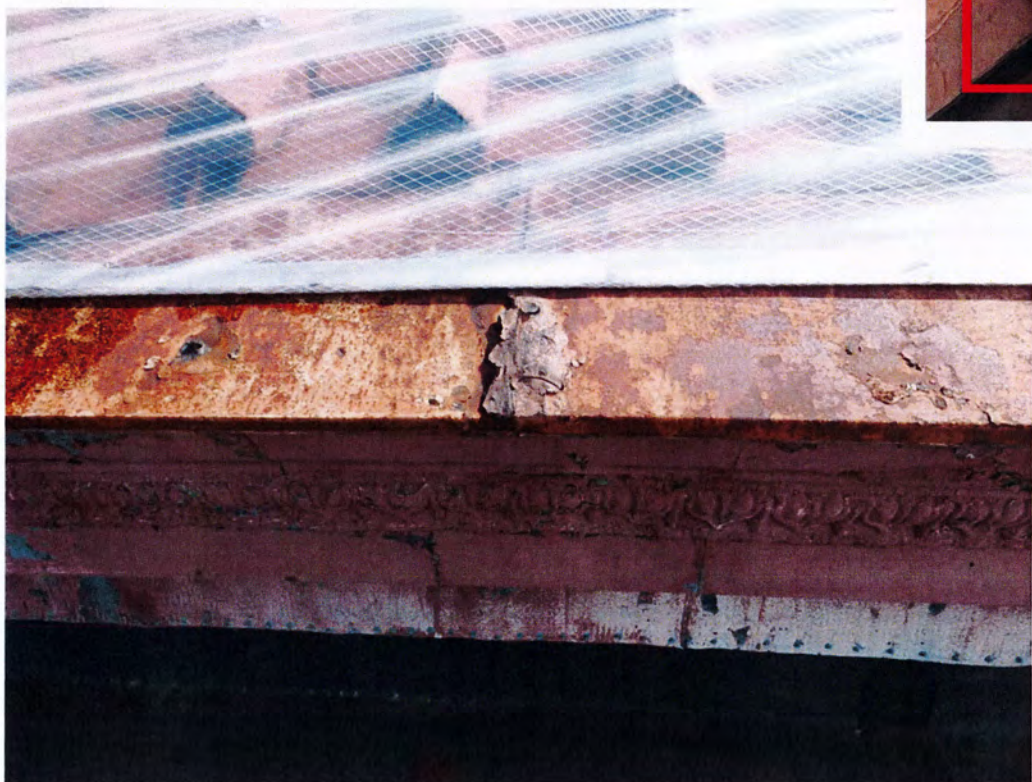
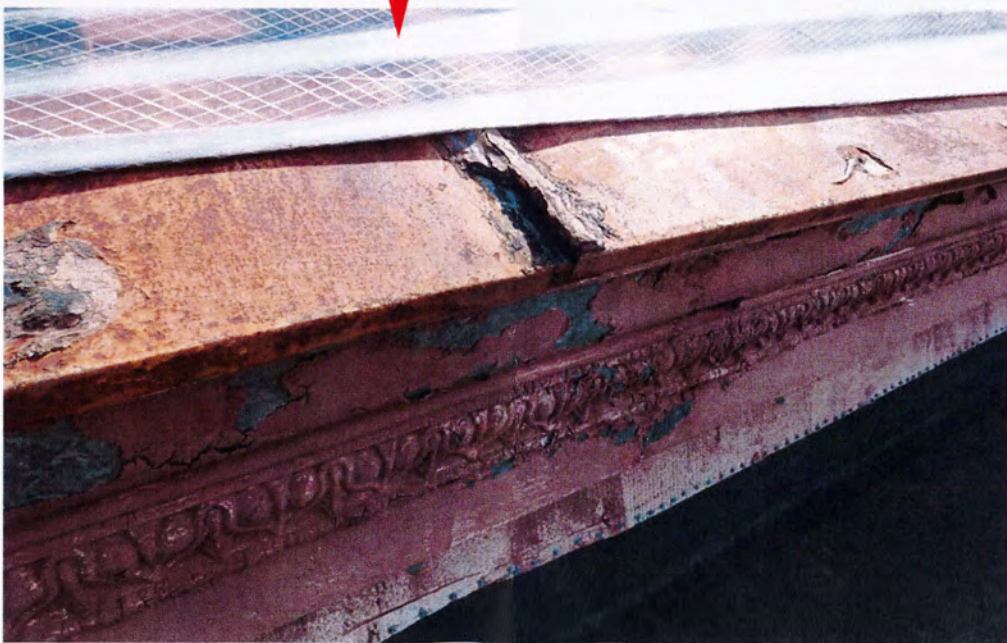
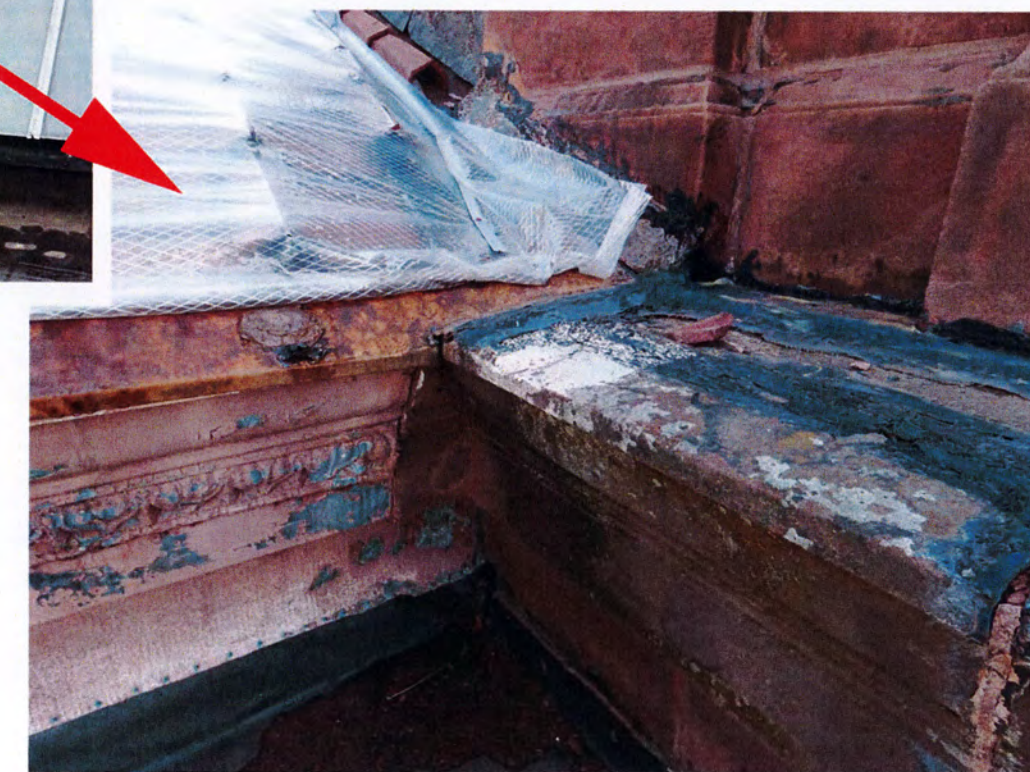
West Slope Cornice

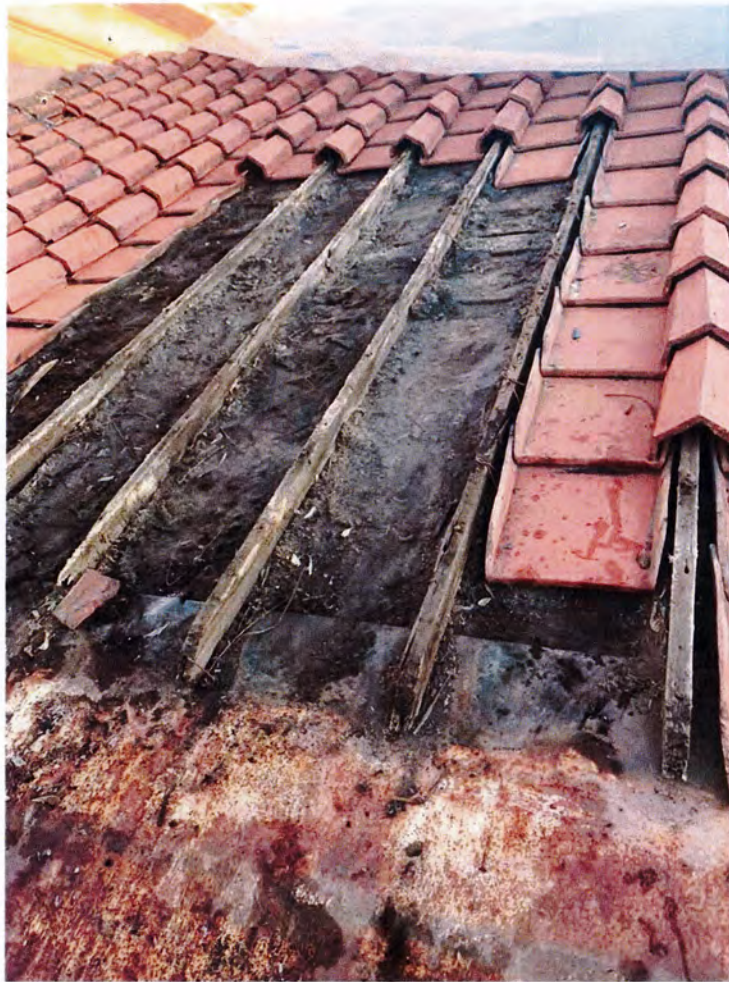
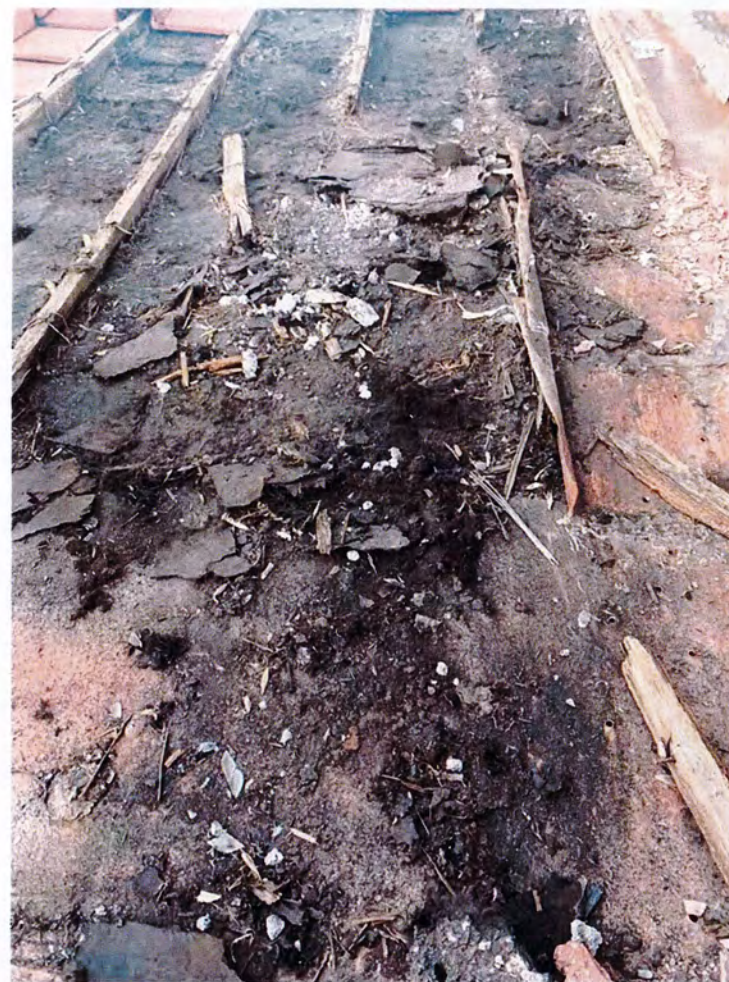
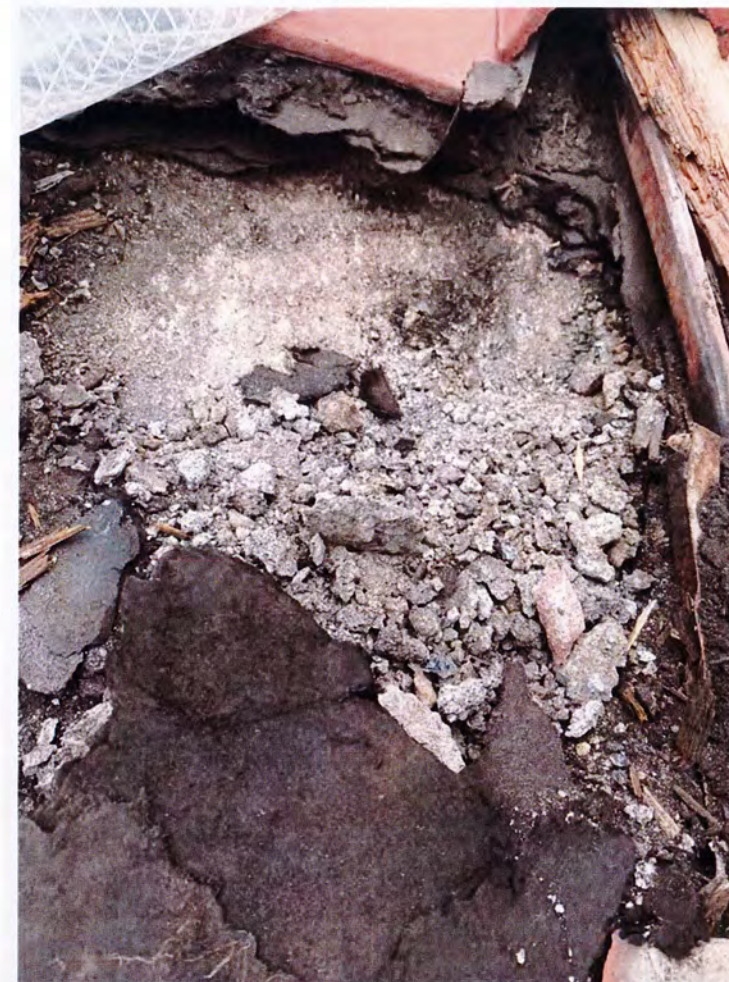
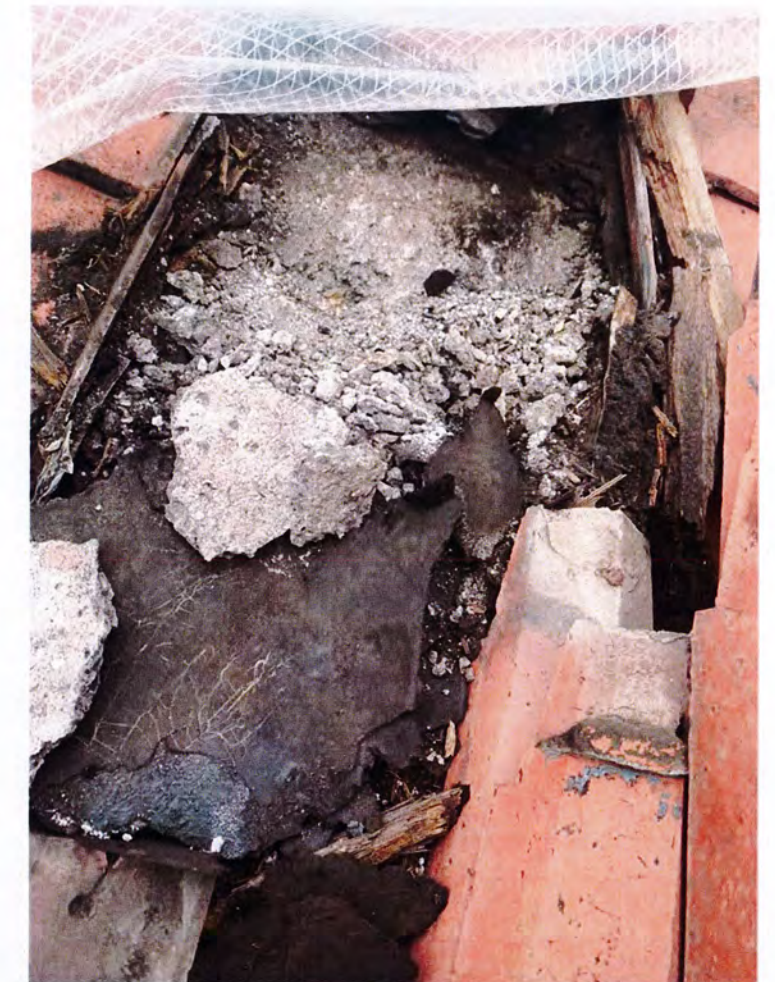
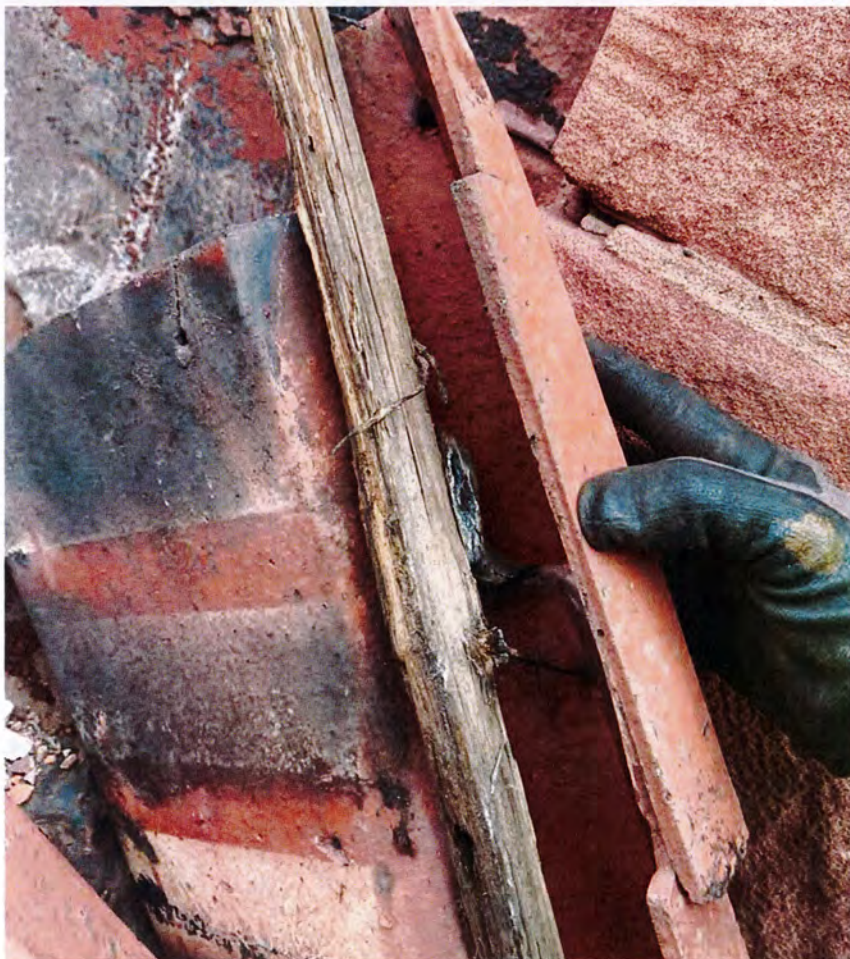
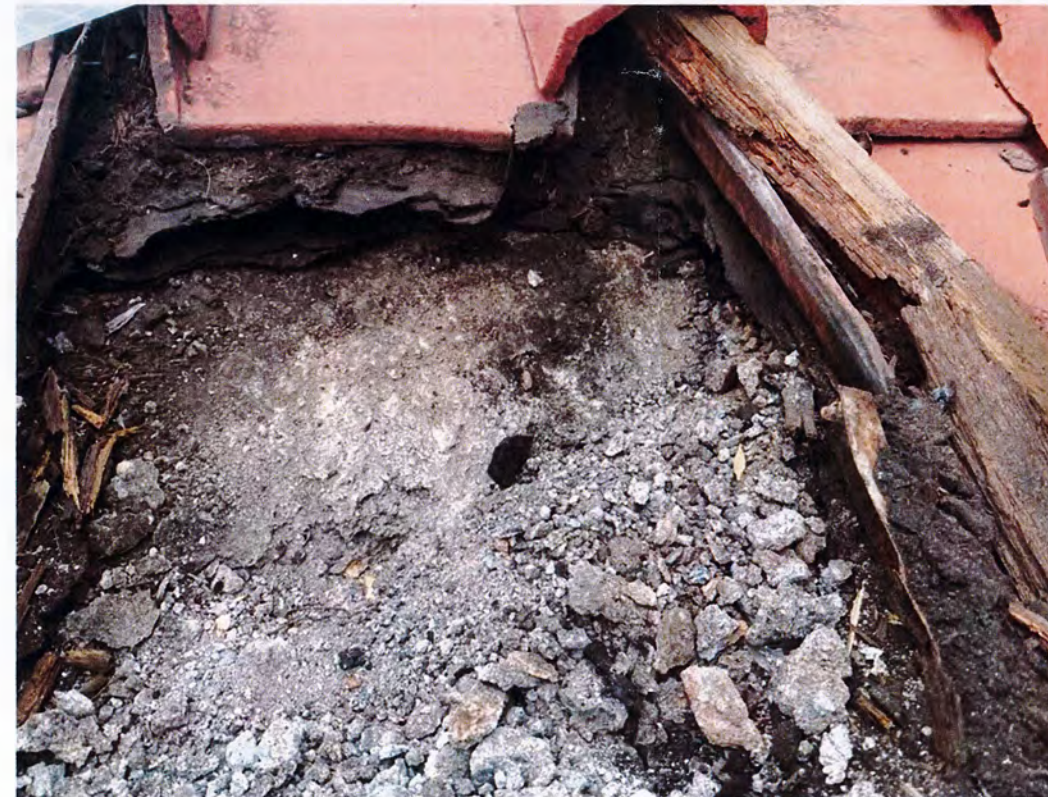
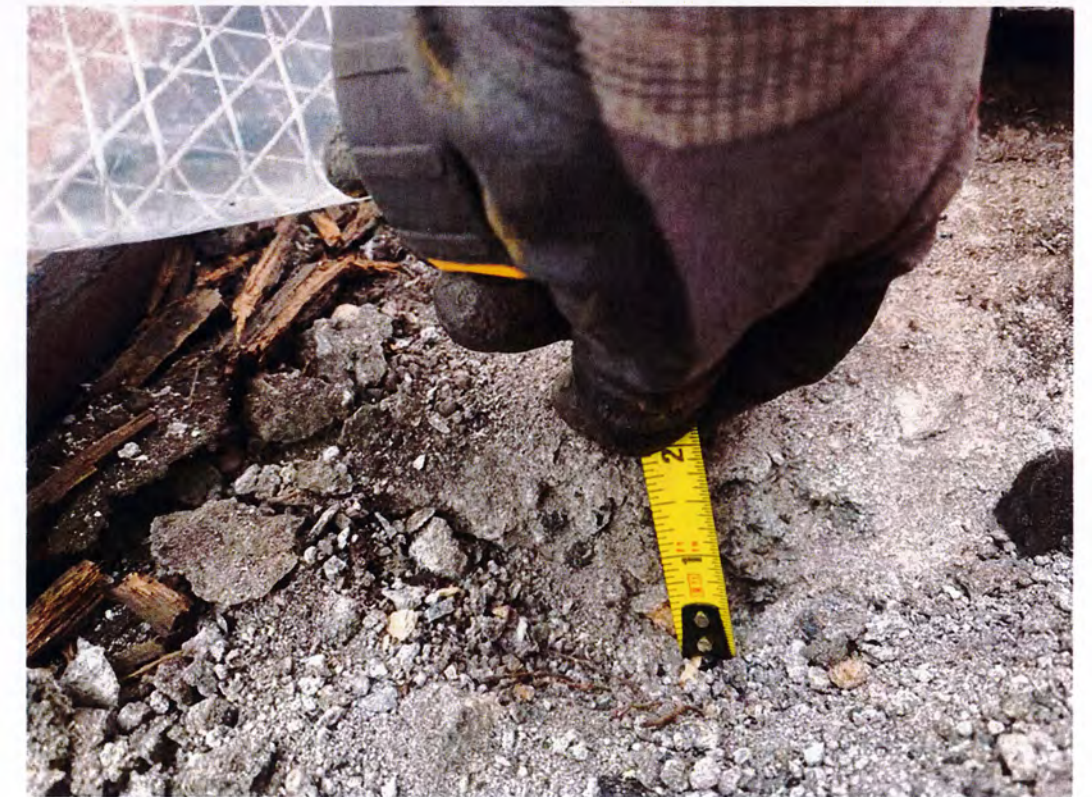
5. The concrete appears to be a lightweight concrete with a large amount of slag aggregate to reduce weight. The top surface appears rough and porous, and is deteriorated, likely due to roof deterioration, combined with freeze thaw cycles.

West Slope Demolition Showing Deterioration  
and Spalled Concrete Roof Deck

- A) In my professional opinion, the concrete deck appears to be sufficient to continue to support load for 16" between steel plate supports and sufficient to accept anchorage.
- B) Therefore we recommend that a layer of ¾" treated plywood be fastened to the surface to both provide a flat surface for membrane attachment and to provide structural integrity to the system of resisting gravity loads.
