# City of Duluth

## Meeting Agenda

### Heritage Preservation Commission.

RE: Review of Historic Construction/Demolition Permit for a Temporary Roof Replacement on the Duluth Public Library Heritage Preservation Landmark (PL 23-025)

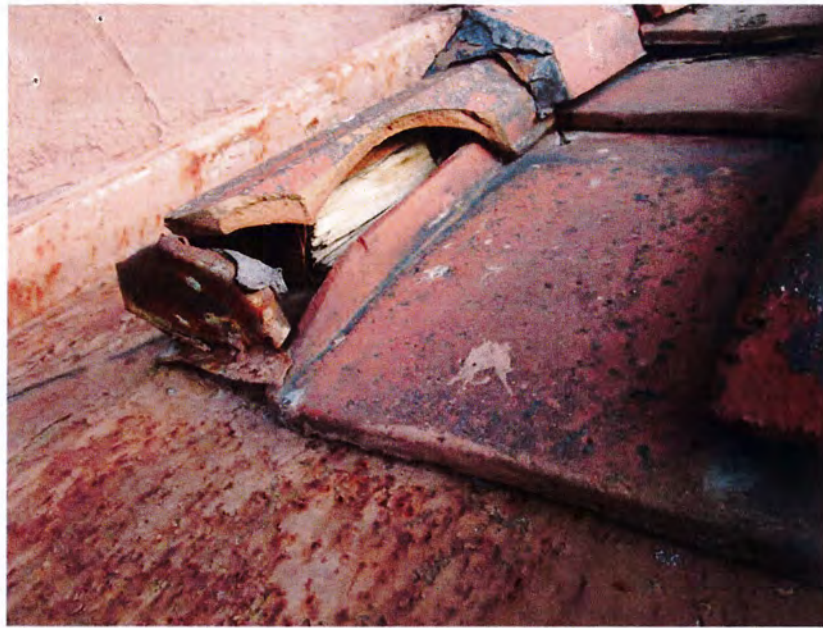
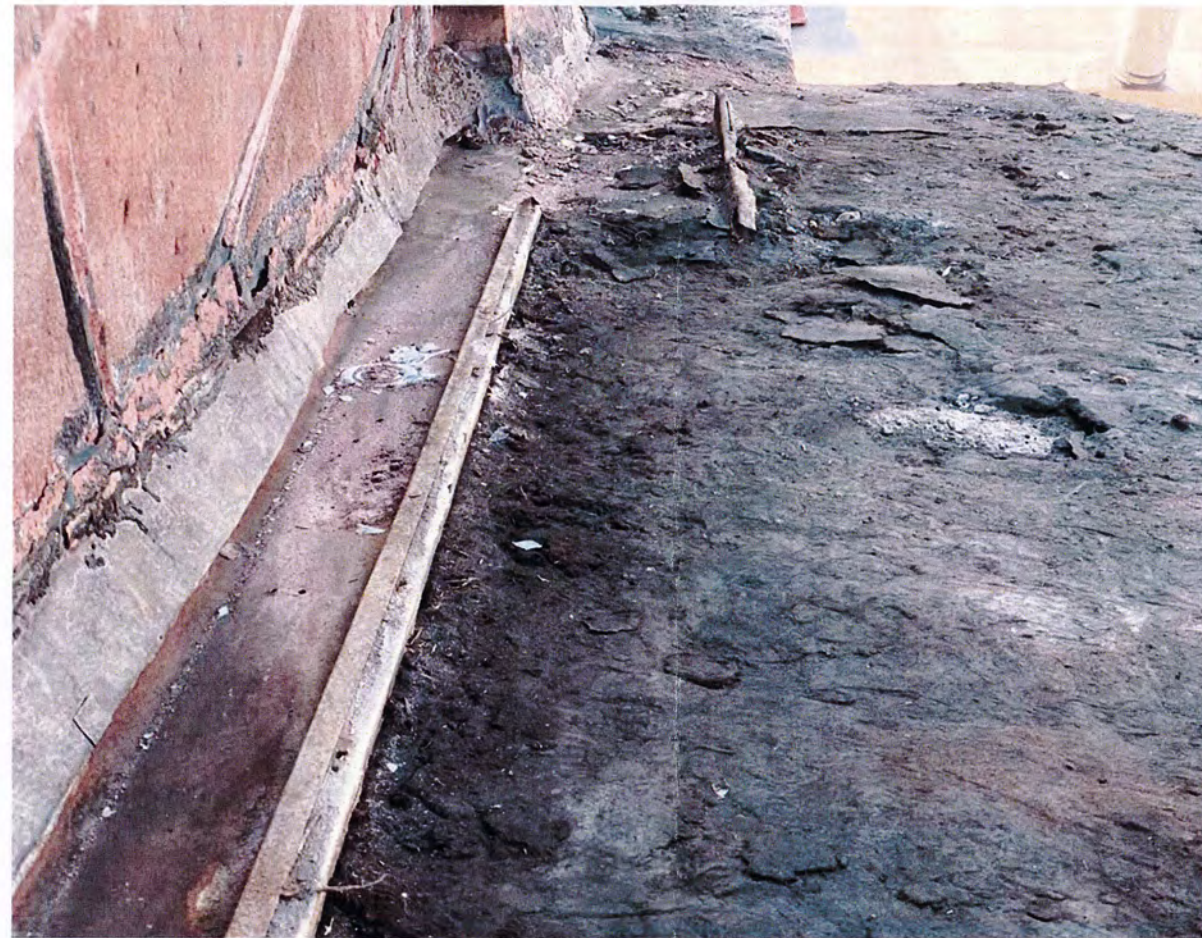
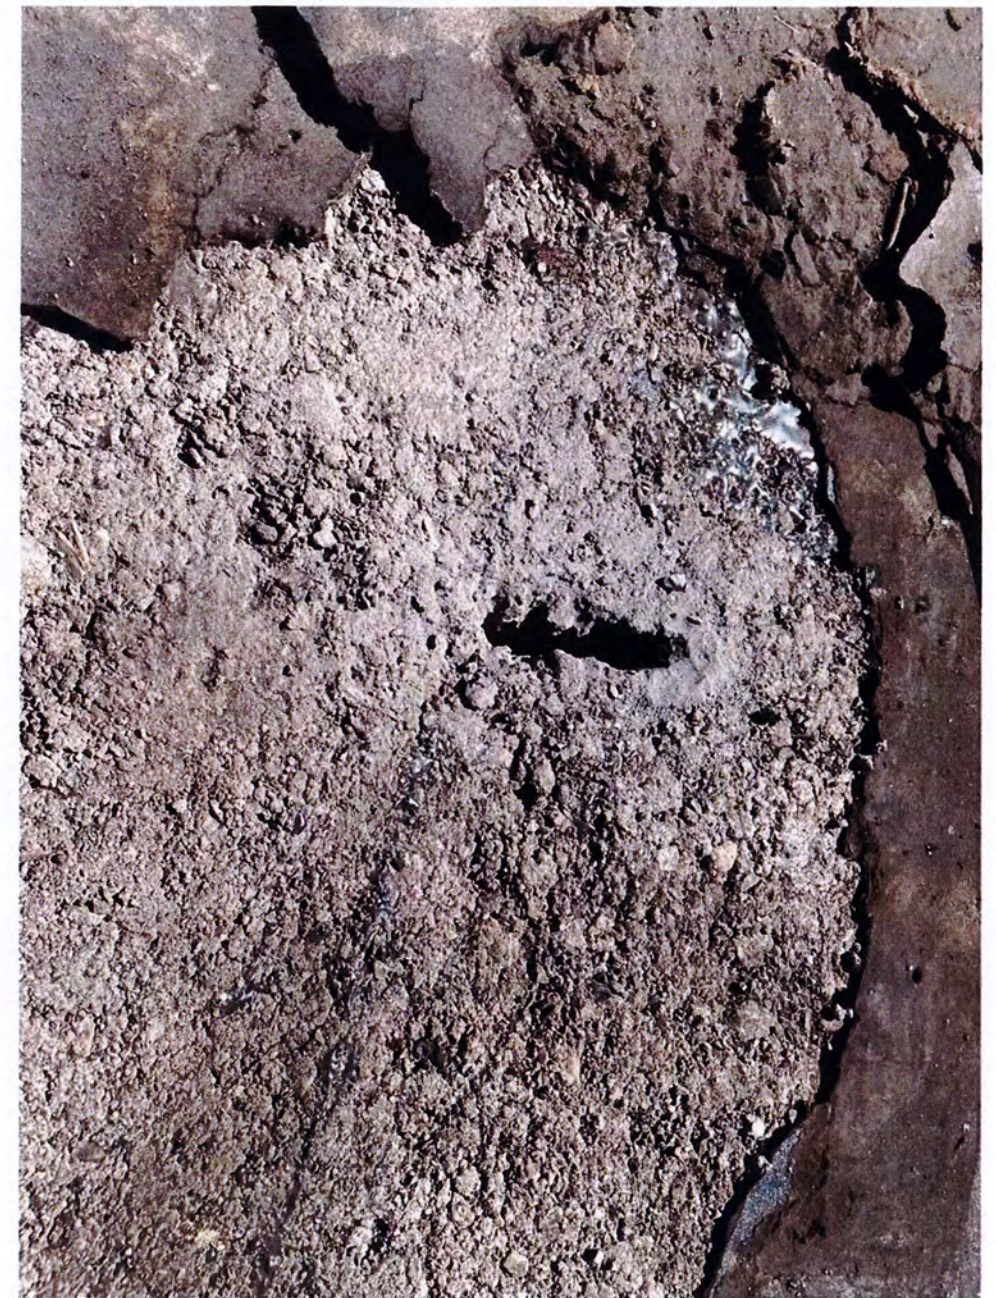
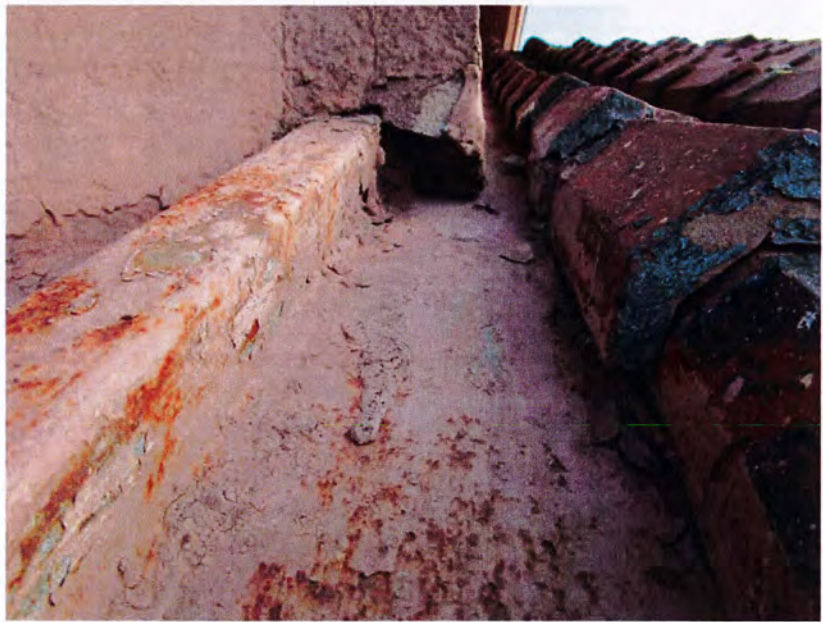
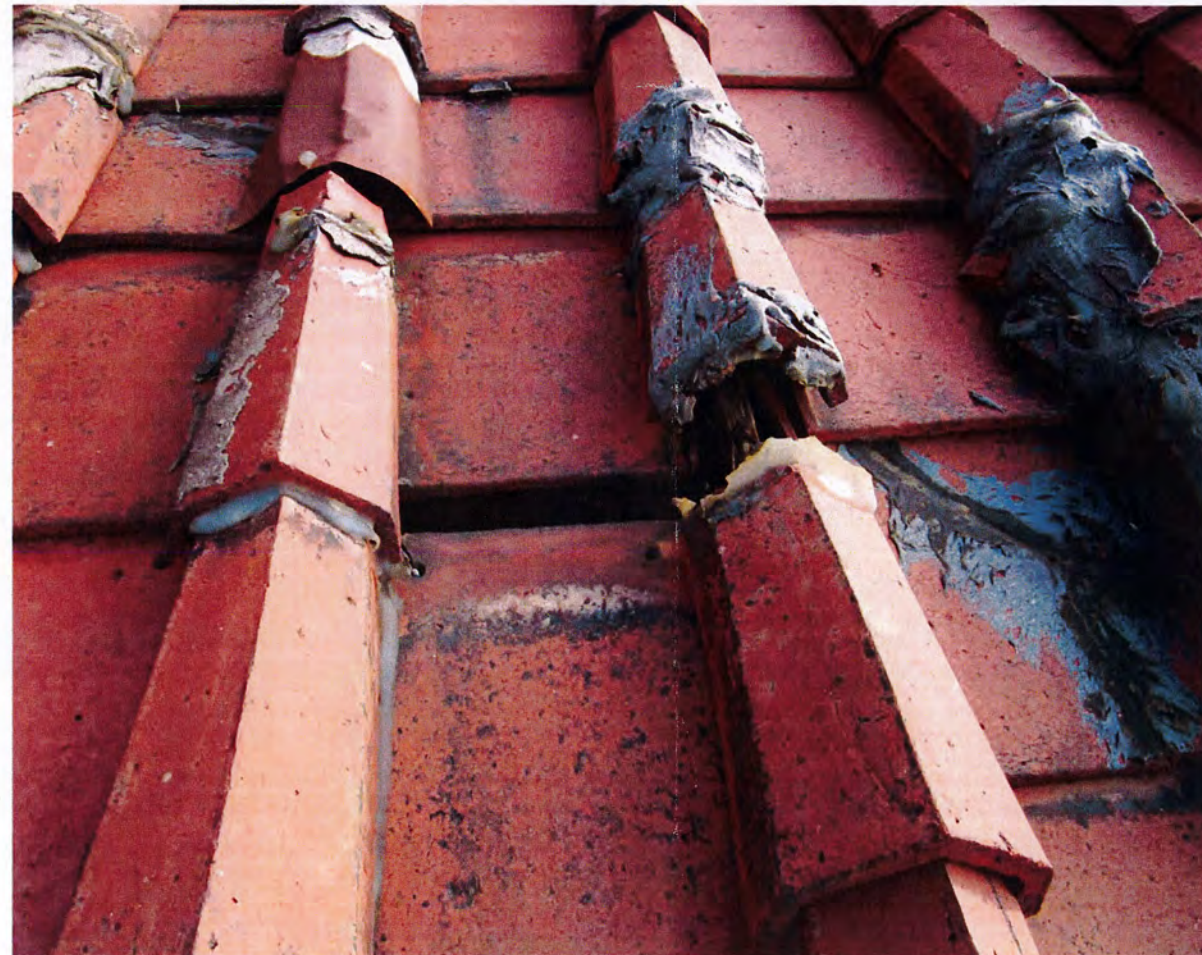
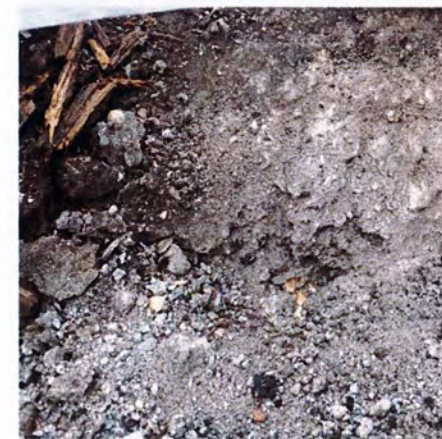
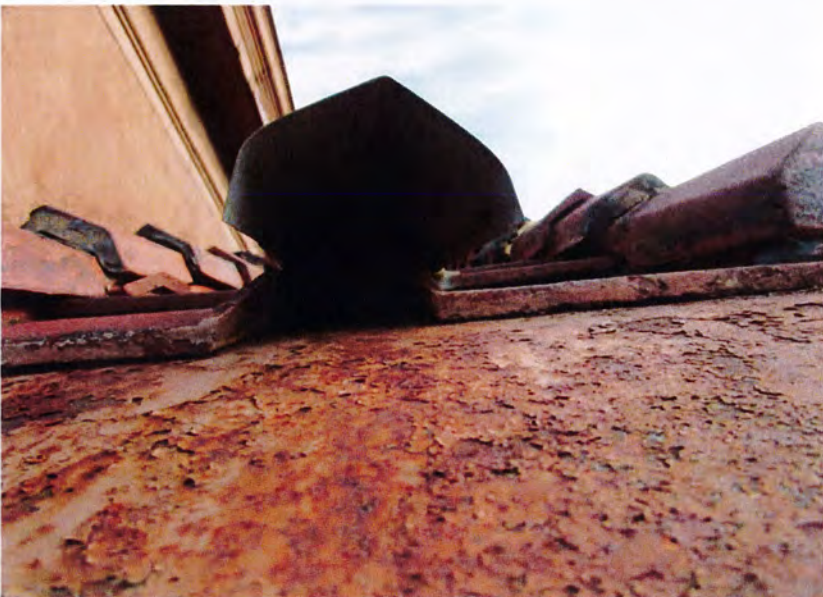
West Slope Demolition  
and Roof Deterioration

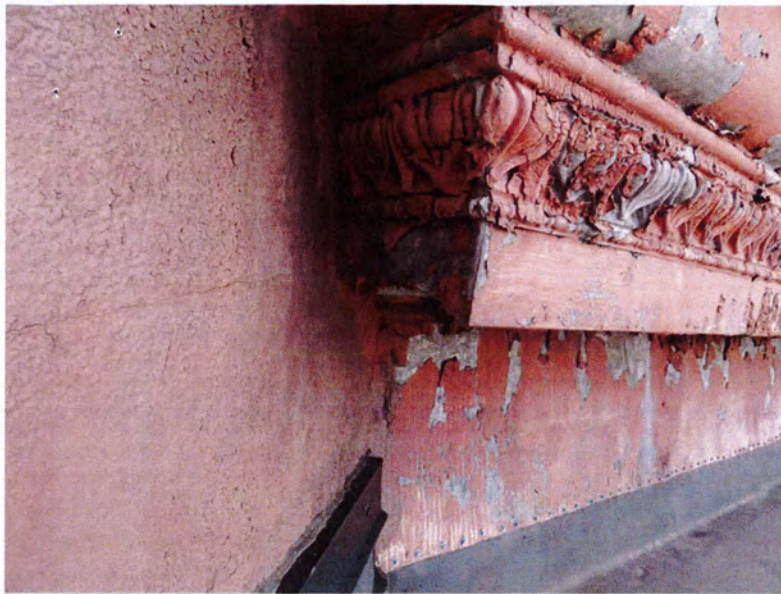
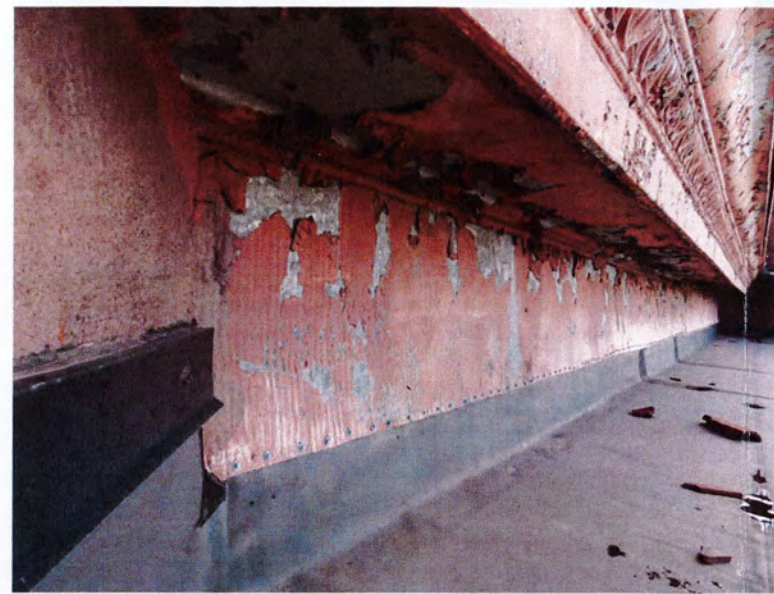
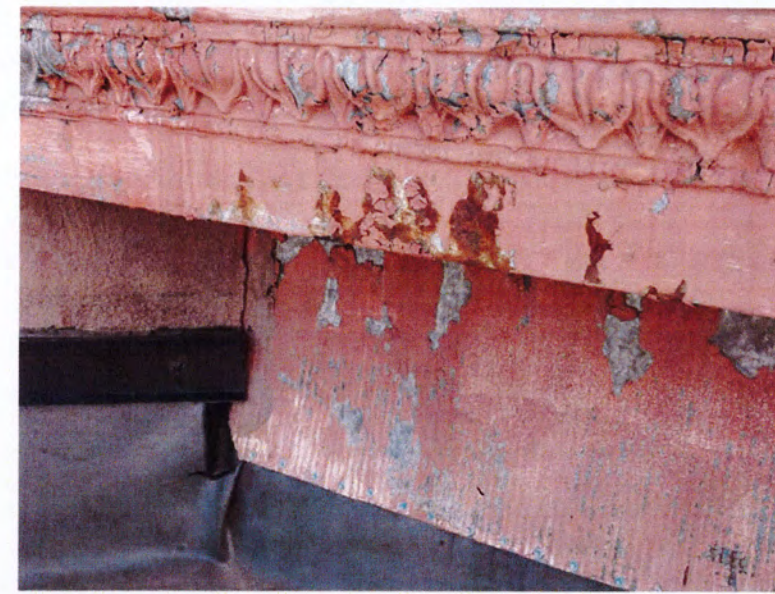
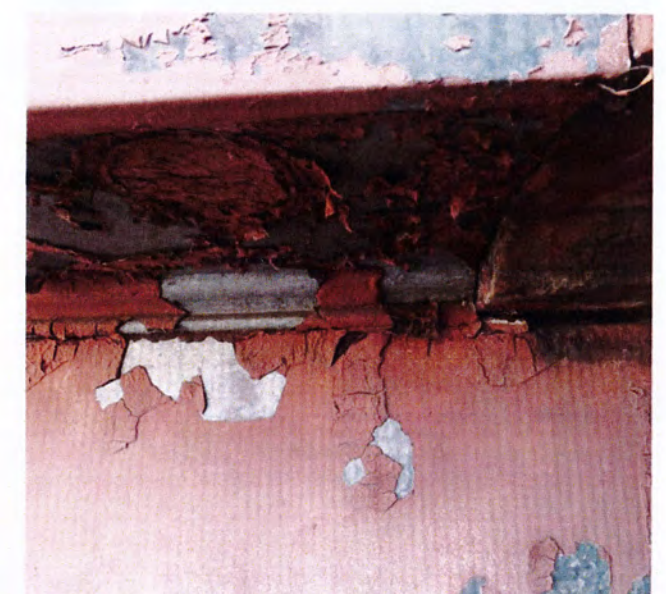
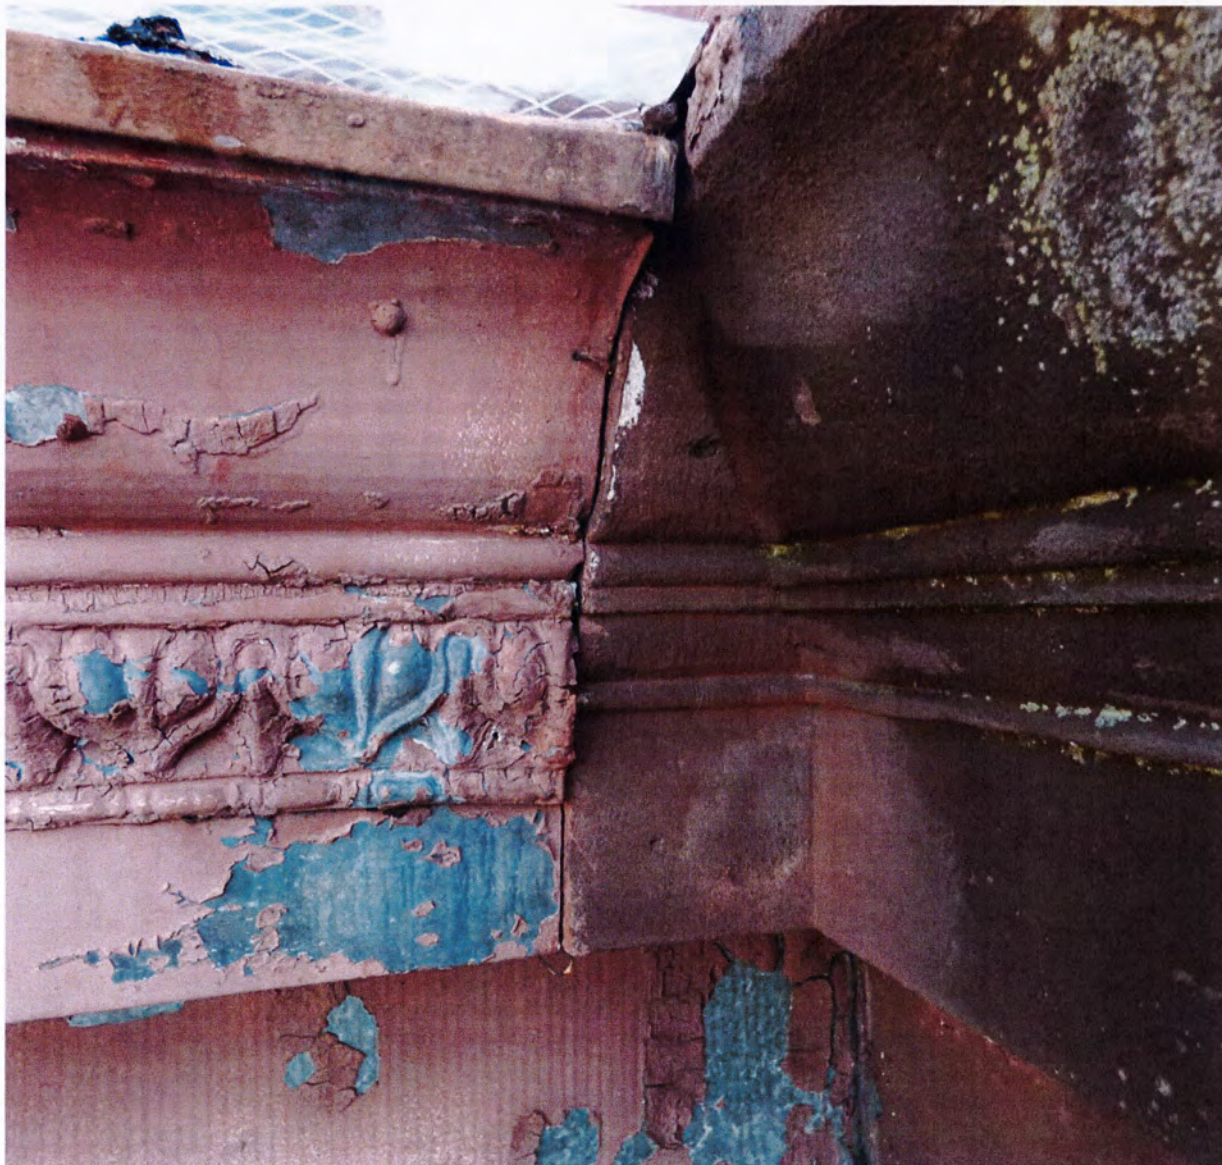
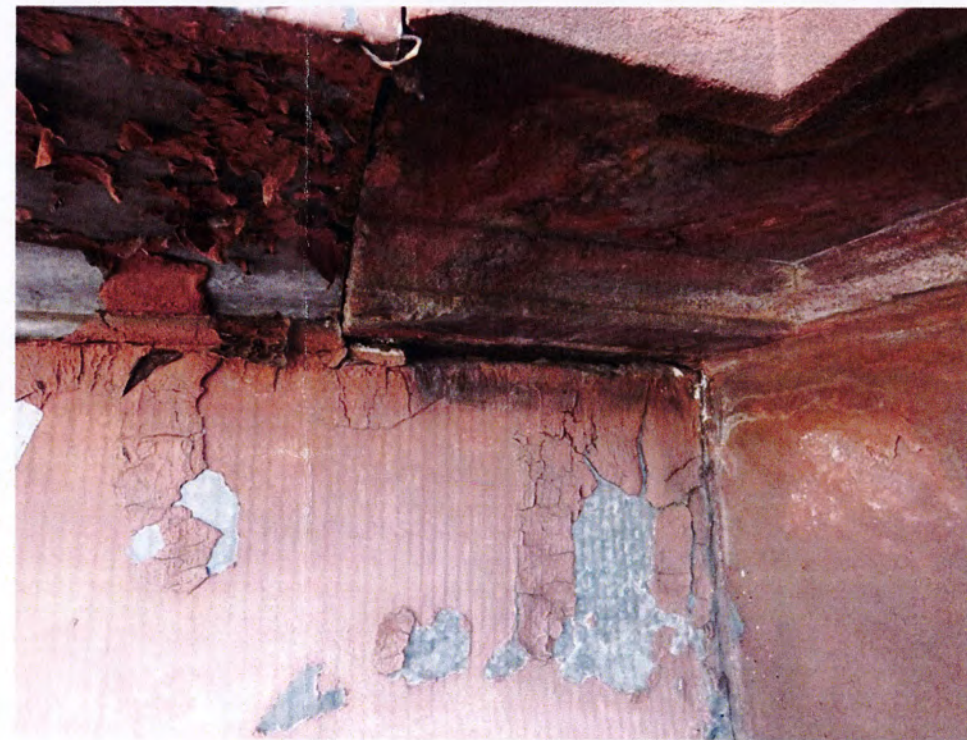
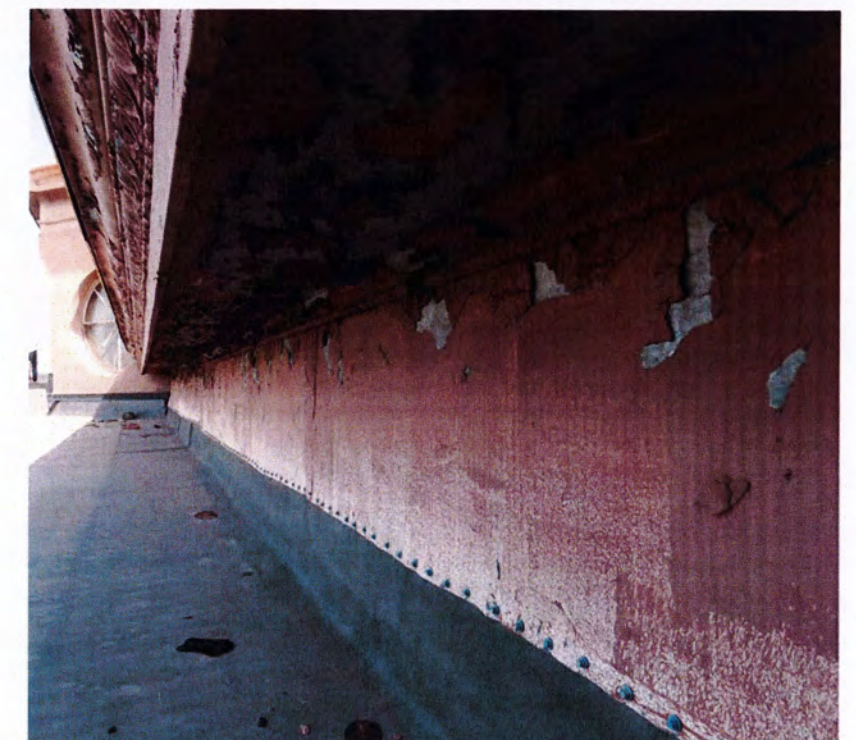
- Bottom drip flashing is significantly deteriorated and must be replaced.
- Stamped metal fascia is in relatively good shape with minor sections requiring restoration. Paint over galvanized surfaces is peeling and will require stripping in restoration project.

- Galvanized, corrugated vertical metal wall panel is in fair to poor condition. Bottom edge was cut during other reroofing projects, bent out from wall for membrane to run behind, and re-anchored with screws at 4" to 6" on center. Paint is peeling. Unknown if these panels were original to building or not.

West Slope Cornice, Fascia, Soffit and Vertical Metal Wall Panel  
East Slope Same Condition

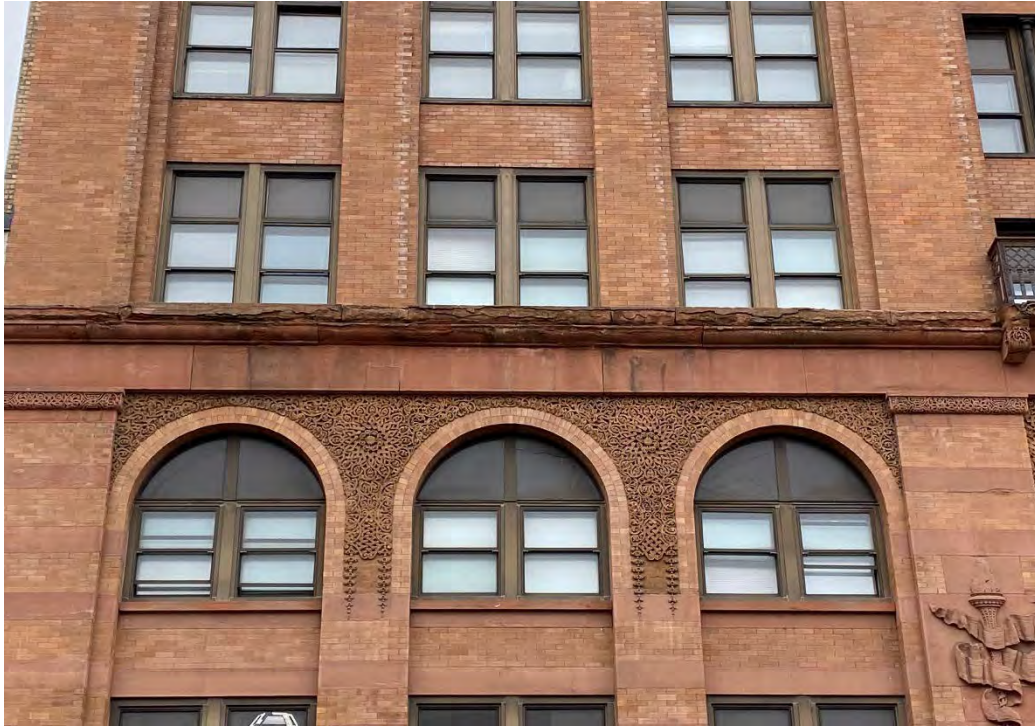
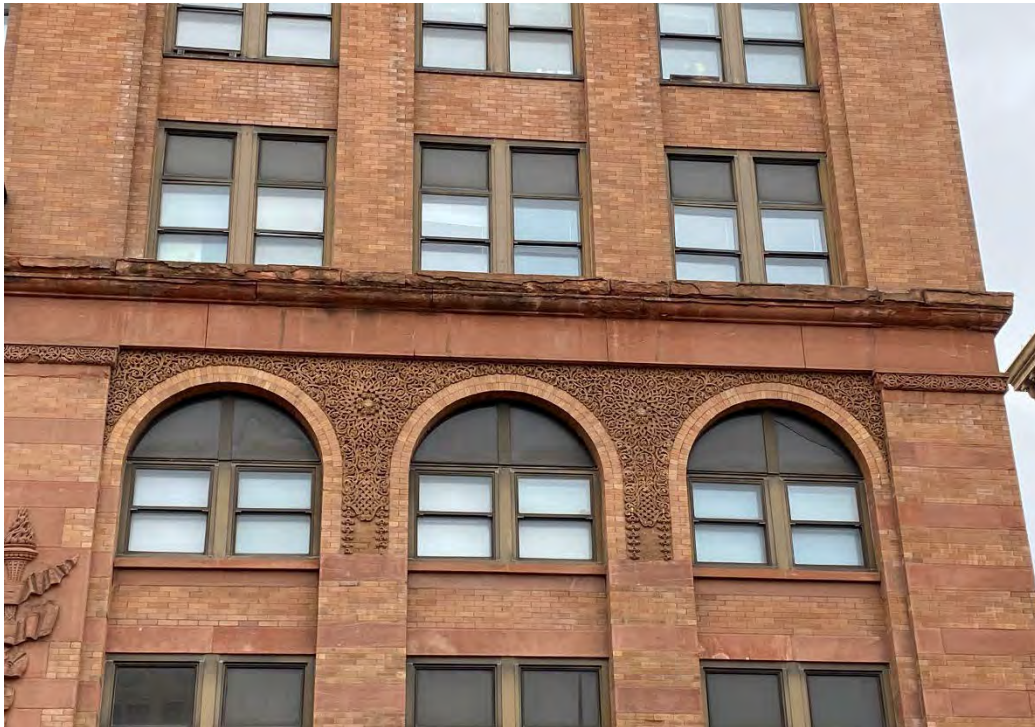
E.47 View of masonry at the south façade of the Board of Trade building, looking north. September, 2022.

E.48 View of masonry at the south façade of the Board of Trade building, looking north. September, 2022.

- Localized areas of cast stone in poor condition will be addressed on the south façade. The masonry work proposed at this time will address spalled, damaged, and missing stone at window sills, water tables, and belt courses. Spalled or otherwise damaged and missing cast stone will be replaced to match the existing adjacent historic stone. Existing damaged stone will carefully be removed with chisels and power saws, with care being taken to not damage the surrounding stone to remain.

- Repointing mortar will match the color, texture, strength, and tooling of the existing mortar joints.
- After all masonry repair work is complete, a final cleaning of the repaired areas of exterior masonry will be completed using the gentlest means possible without damaging the surface of the masonry. Cleaning will include removing dust and debris associated with the repair work with water and synthetic bristle brushes. Chemical cleaning of any sort will not be pursued.

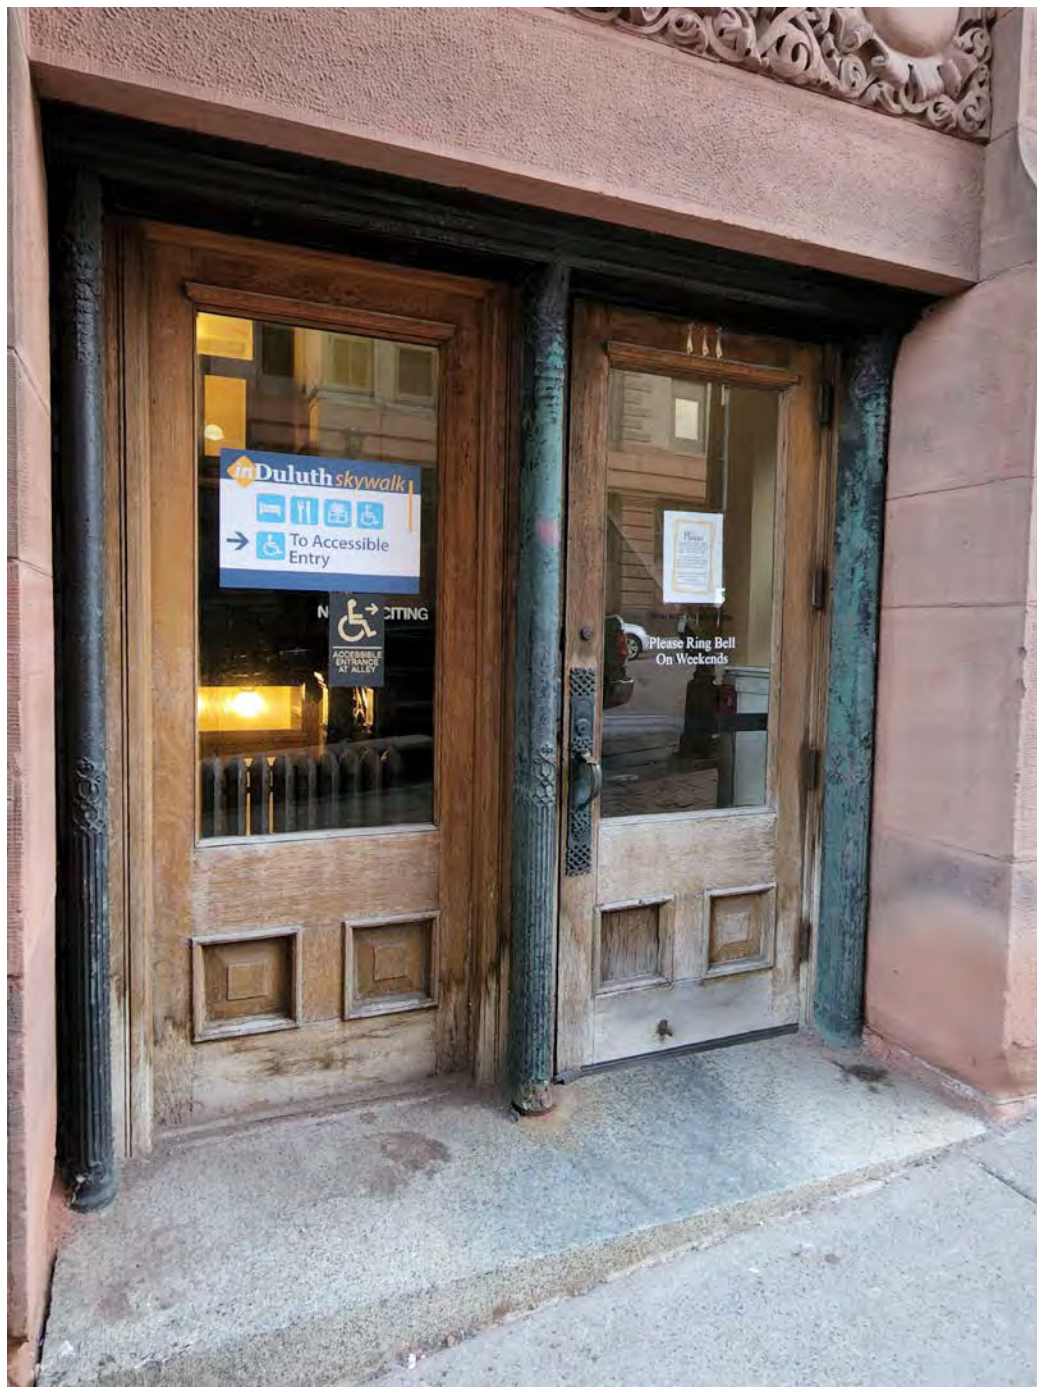
E.59 East façade, southernmost pair of entry doors. September, 2022.

- The southernmost pair of doors on the east façade will be refinished. The existing finish will be removed by hand sanding or chemical stripper if necessary. Stain and varnish will be applied to match the previous finish.
