RIVERSIDE RECREATION AREA

Summary and Overview

FIGURE 2.13 RIVERSIDE PARK MINI-MASTER PLAN CONCEPT

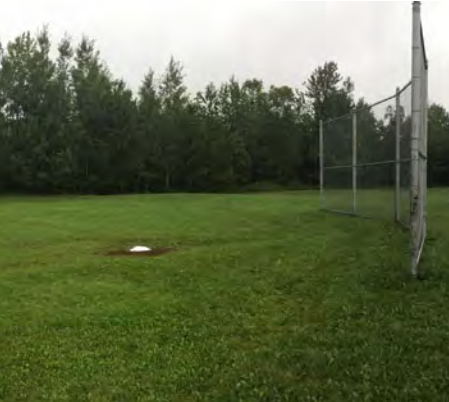
The existing ballfield

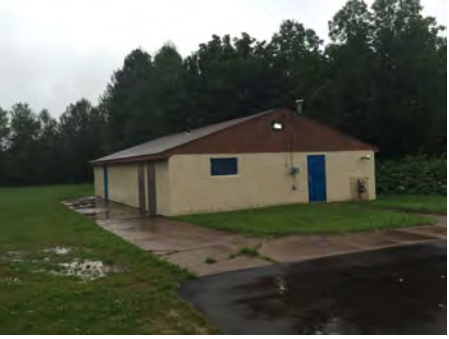
The existing building is no longer utilized

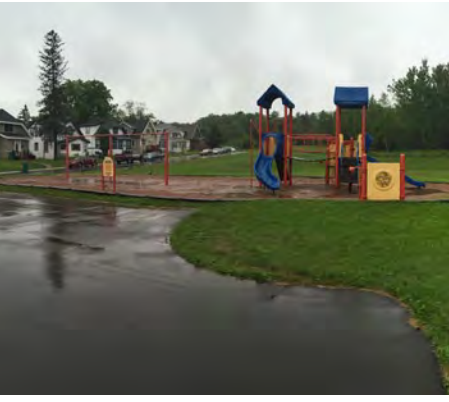
The existing playground is in fair condition

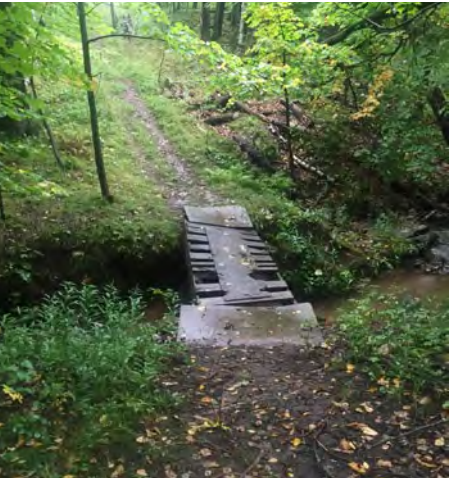
The existing crossing of 85th Avenue W Creek
