COASTAL INFRASTRUCTURE RESILIENCE RESEARCH AND DEVELOPMENT

SHORELINE MITIGATION FEASIBILITY STUDY

DULUTH, MINNESOTA

April 2023

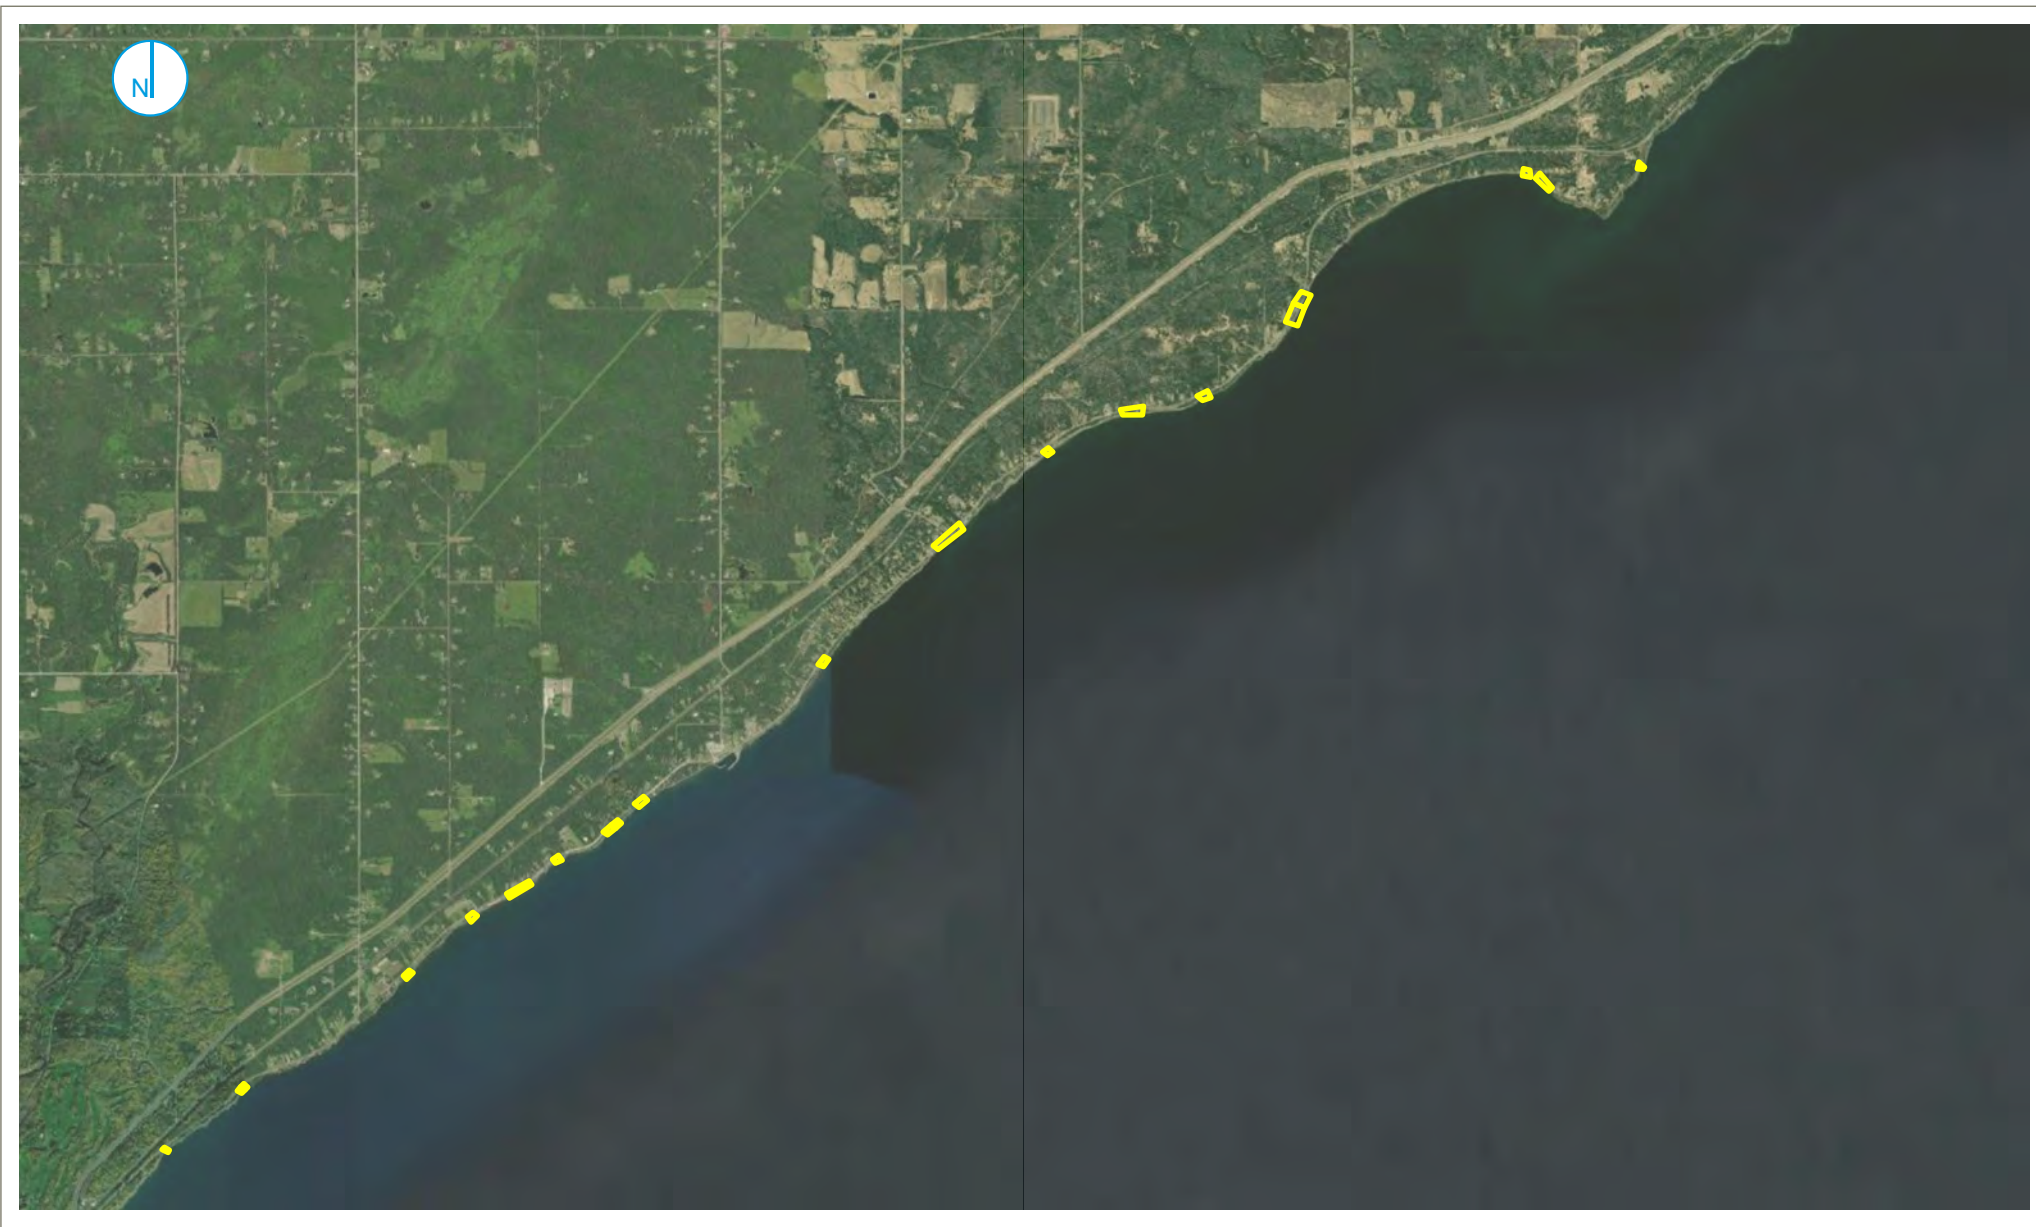
North Shore Primary Locations

A total of 20 locations (approximately 2.0 miles total) had a shoreline prioritization score of 8 or 9. The location of these high-priority areas are provided in Figure 2. Photographs of all 20 high priority locations along with changes between 2021 and 2022 are provided in Appendix A.

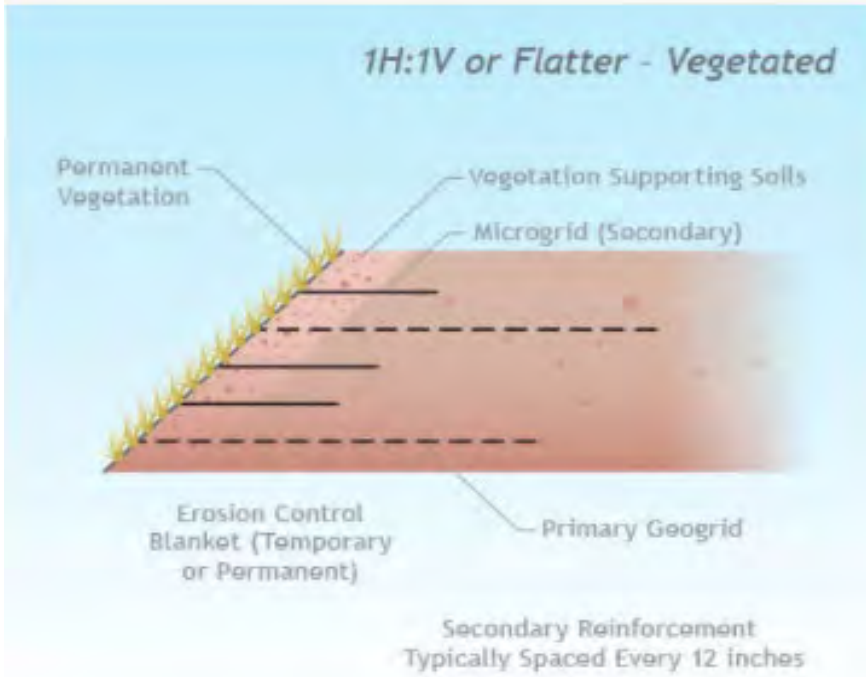
<p>Case Study: Milwaukee County Coastal Resources Inventory</p>
Geogrid reinforced steepened slope (GRSS)	Can be used in areas where banks cannot be regraded to a shallower slope, can be used in areas that are severely eroded. Geogrid layers act as a soil reinforcement. The geogrid has resistance to tensile and shear stresses that occur within the soil fill, thus reinforcing slip planes in the soil mass.	Need space to reconstruct slope and install geogrid horizontally back into bank and compact soil in lifts over primary and secondary geogrid. Will need to be combined with toe protection.	Steep banks and areas that cannot be regraded to a shallow slope.

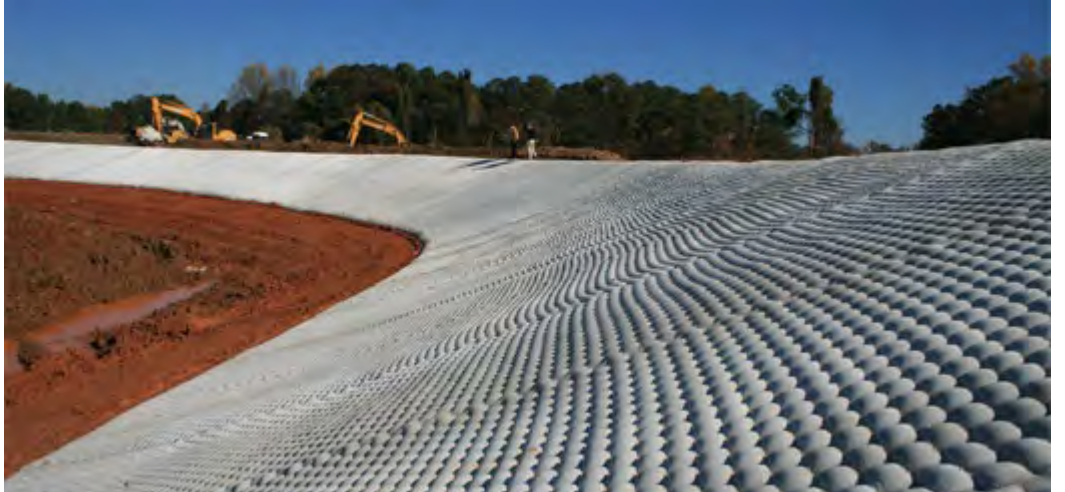
<p>Articulated concrete block (ACB)</p>	<p>Large waves, long fetch length, open coast sites</p>	<p>Shoreline width, slope. Requires smooth, uniform surfaces to avoid erosion and differential settling.</p>	<p>All shorelines</p>

- Articulated Concrete Blocks (ACBs) are made of a matrix of individual concrete blocks placed together to form an erosion-resistant overlay with specific hydraulic performance characteristics. The system includes a filter underlay that allows infiltration and exfiltration to occur while providing particle retention of the soil subgrade. The filter layer may be comprised of a geotextile or properly graded aggregate or both. The blocks within the matrix must be dense and durable while providing a matrix that is flexible and porous.

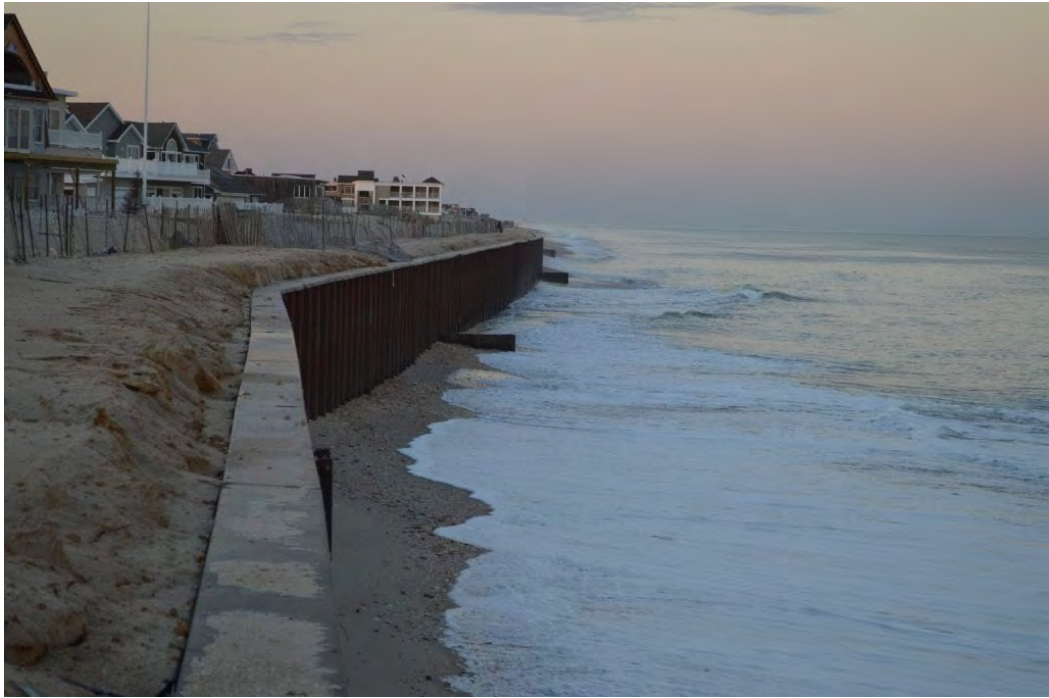
Alternative	Applicability	Constraints	Shoreline Classification	Example
Retaining walls	Retaining walls are also parallel to the shoreline and are vertical walls intended to hold soil in place and allow for a stable shoreline. Harbors, marinas, other working waterfronts, areas without room for a rock revetment	Disrupt sediment transport, high up-front cost, prevents upland from being a source of sediment to the system, can be damaged from overtopping oceanfront storm waves. Expanding ice sheets can damage vertical walls.	Bluffs, areas highly vulnerable to storm surge and wave forces. Areas adjacent to critical infrastructure. High wave energy settings.

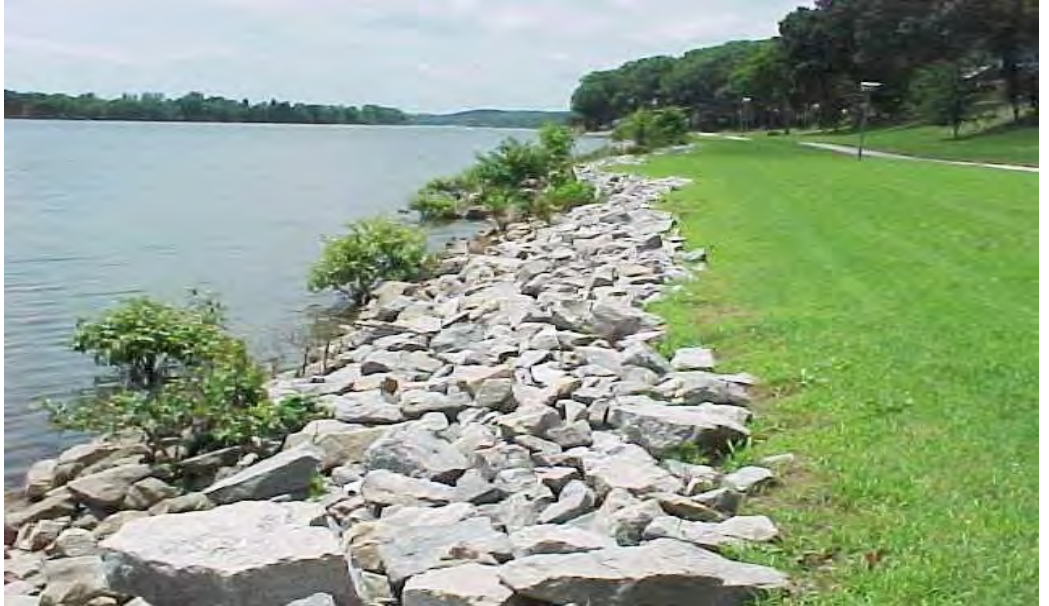
Riprap rock revetment	Revetments are hardened areas that lay over a slope of a shoreline to project from erosion and waves. Large waves, long fetch length, open coast sites. Benefits include mitigates wave energy, little maintenance, and indefinite life span	Loss of intertidal and coastal habitat, requires more land area, potential erosion of adjacent unreinforced sites, prevents upland from being a sediment source to the system.	All shorelines, including bluffs, are experiencing toe erosion. Sites with pre-existing hardened shoreline structures.

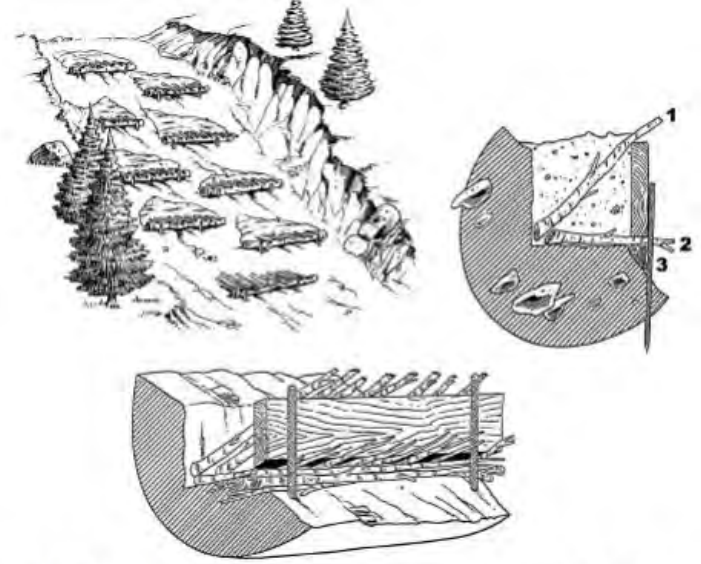
Duluth North Shoreline				
Shoreline Management Alternative Matrix				
Alternative	Applicability	Constraints	Shoreline Classification	Example
Biostabilization - terracing-modified brush layer	A modified brush layer is using a small log or board to support a brush layer along steep gravelly slopes. The board creates a terrace that can serve to catch materials (rocks/soil) rolling down the slope. It also creates terraces where vegetation can more easily establish. Effective on sites too dry for wattle fences.	Needs to be paired with toe protection if shoreline lake erosion is also contributing to bluff erosion. Does not include infiltration systems/swales.	Bluffs and slopes

<p>Figure 3.2.2-1. Modified brush layers should be staggered across the slope (left). Boards or logs can be used for support. Three different positions for placement of cuttings are shown in the diagram on the right. On mesic sites, modified brush layers should be built with the cuttings above the board or log ("1"). On dry sites, the cuttings should go below the board or log (2), while on very moist sites a small wattle fence can be installed below the board or log (3) to provide drainage. Modified brush layers are perfect for ravelling gravel slopes (from Polster, 2001).</p>

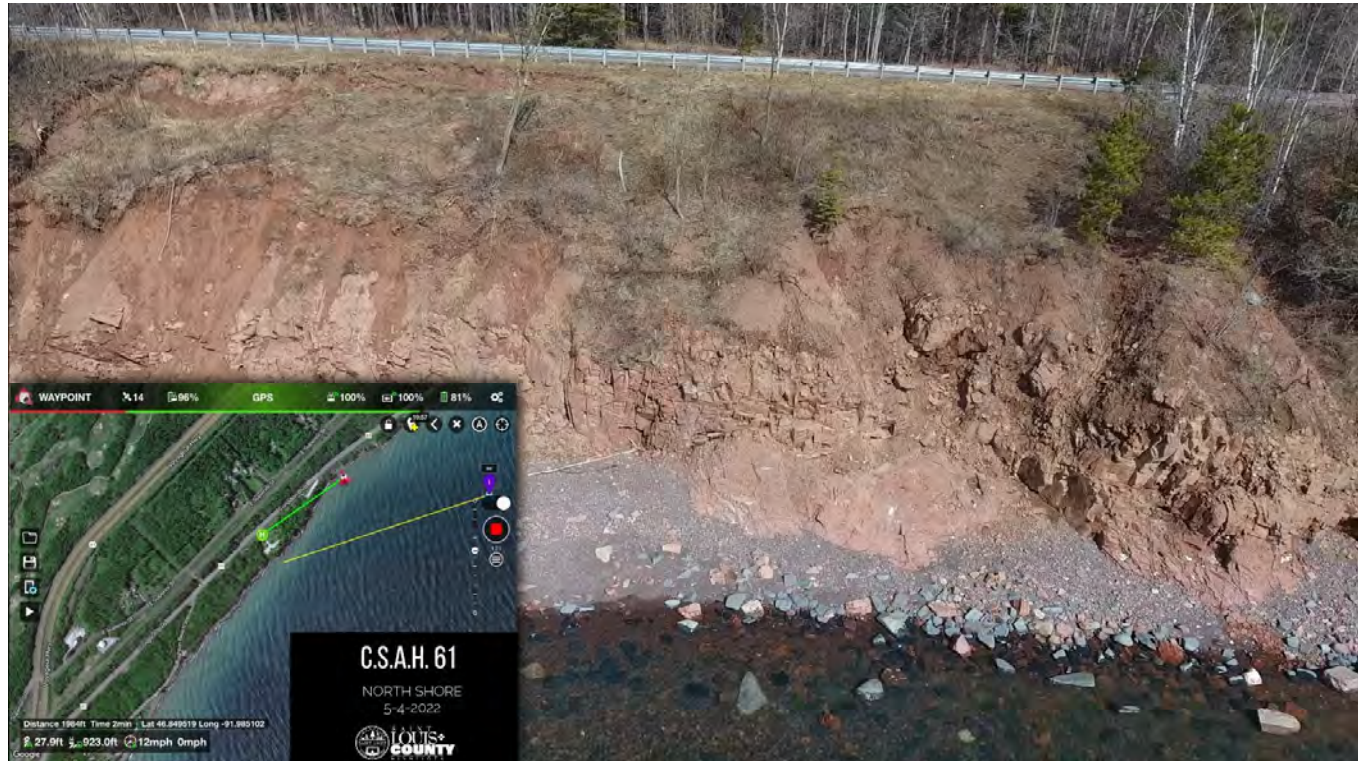
Location 0.5

Bank Height (Feet)	Length (Feet)
60	130

Recommended Option

Toe protection with geotextile and stone to 20' Geogrid/Vegetation above with upland water management

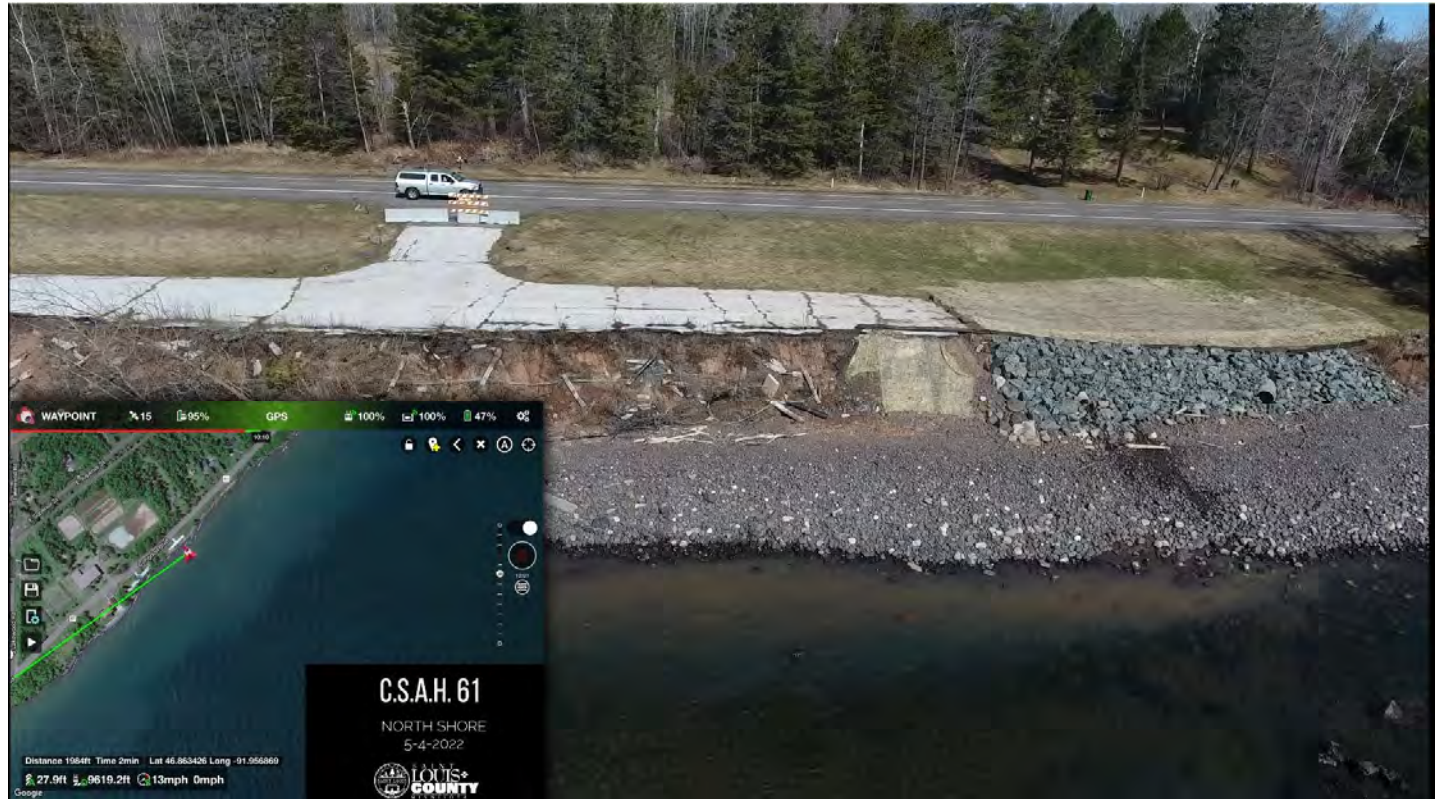
Location 2.9

Bank Height (Feet)	Length (Feet)
10	400

Recommended Option	Estimated Cost
Retreat turnout, revegetate the slope, add watermanagment.	\$1,430,000

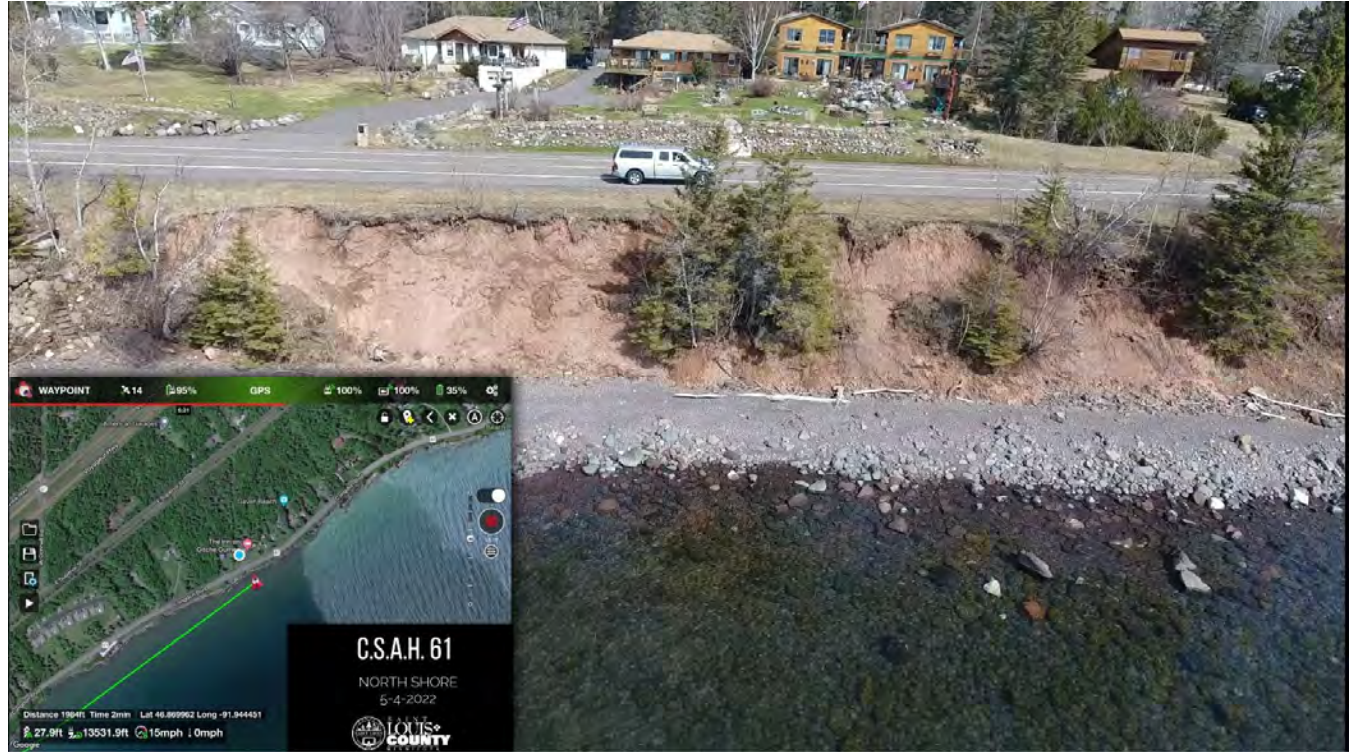
Location 3.9

Bank Height (Feet)	Length (Feet)
20	1285

Recommended Option	Estimated Cost
Regrade add reinforced stone 10 ft up slope – reinforced vegetation above with water management.	\$1,530,000

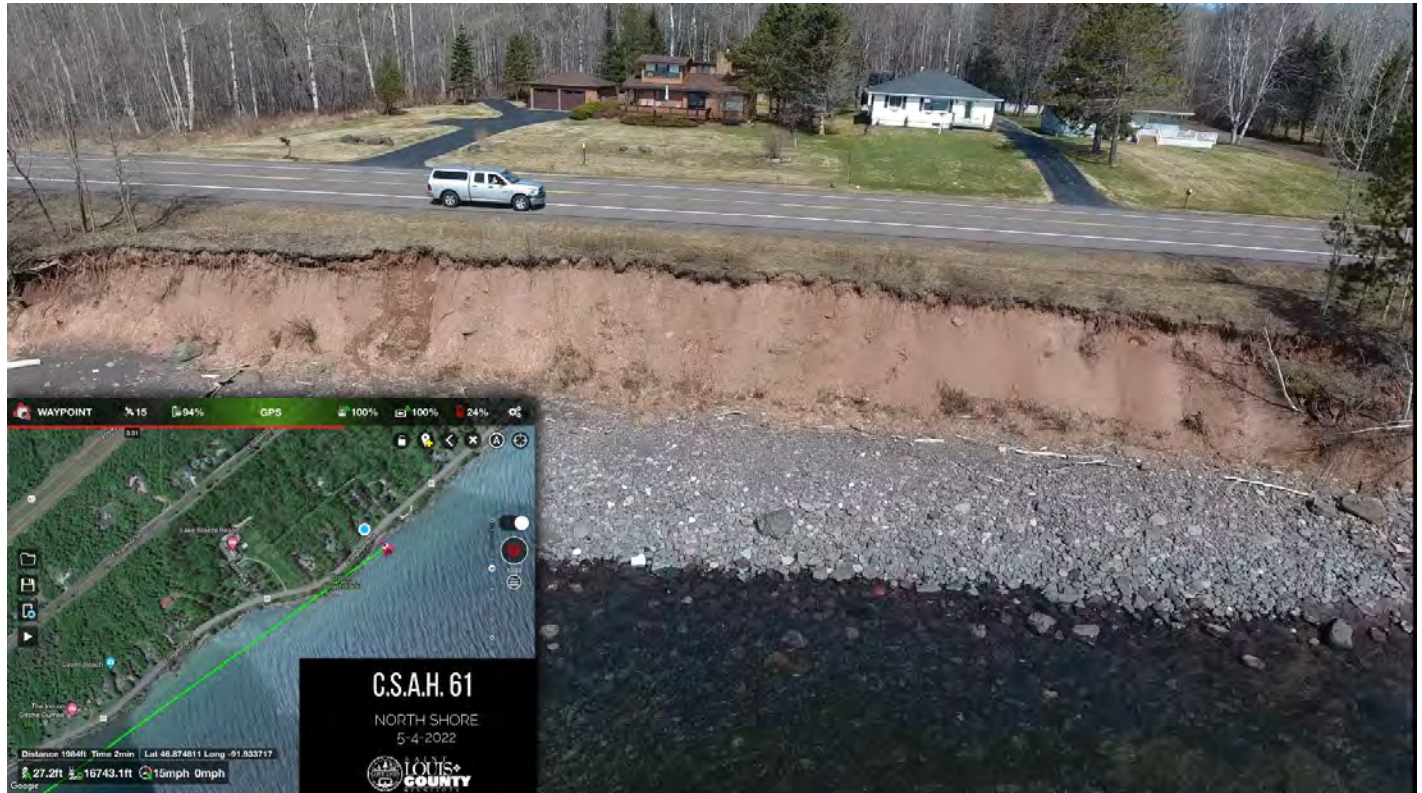
Location 4.9

Bank Height (Feet)	Length (Feet)
15	450

Recommended Option	Estimated Cost
Reshape, geogrid reinforced vegetation above and toe protection with management of surface water	\$1,100,000

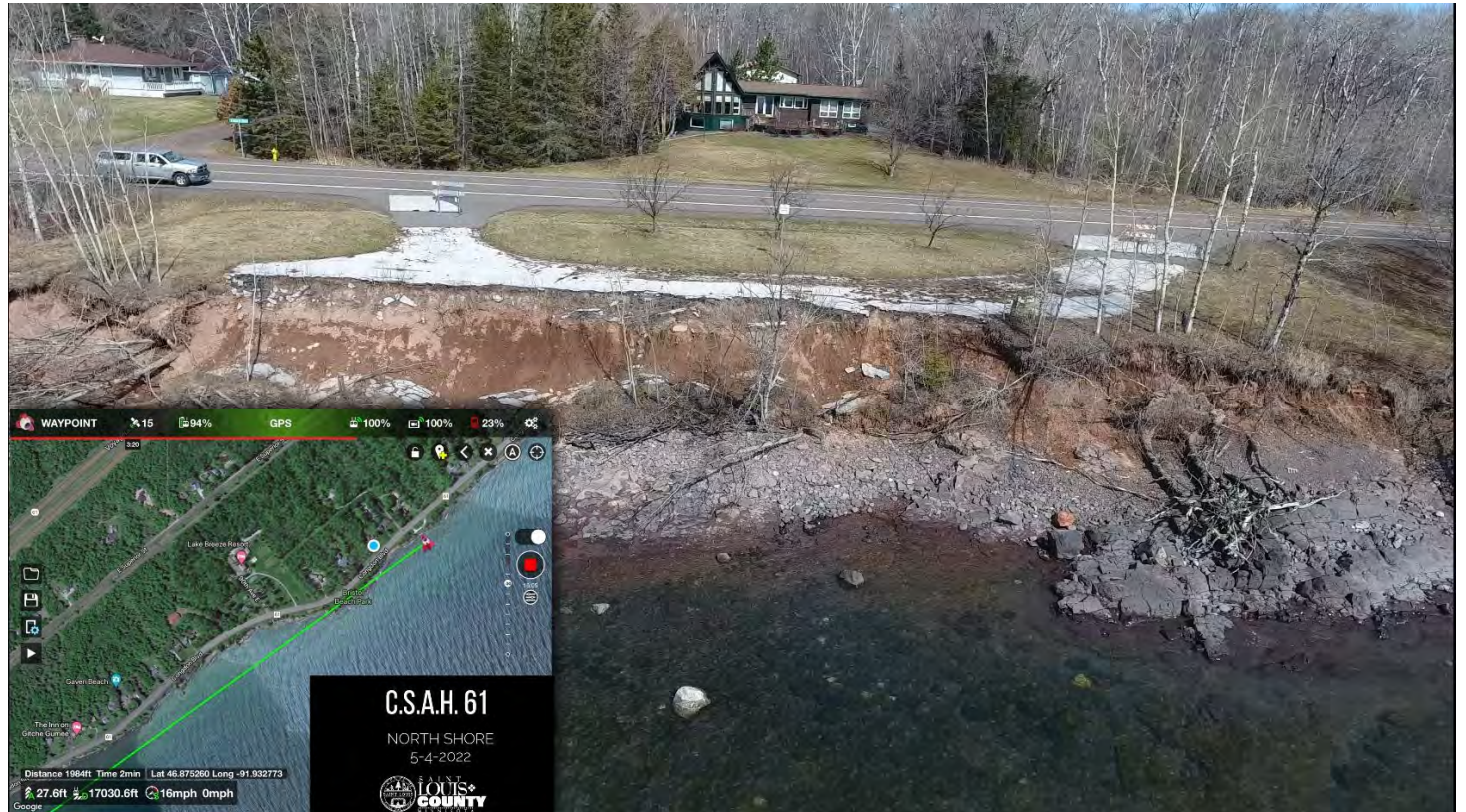
Location 5.0

Bank Height (Feet)	Length (Feet)
10	325

Recommended Option	Estimated Cost
Retreat turnout to roadway, reshape with geogrid vegetation and toe protection	\$1,160,000

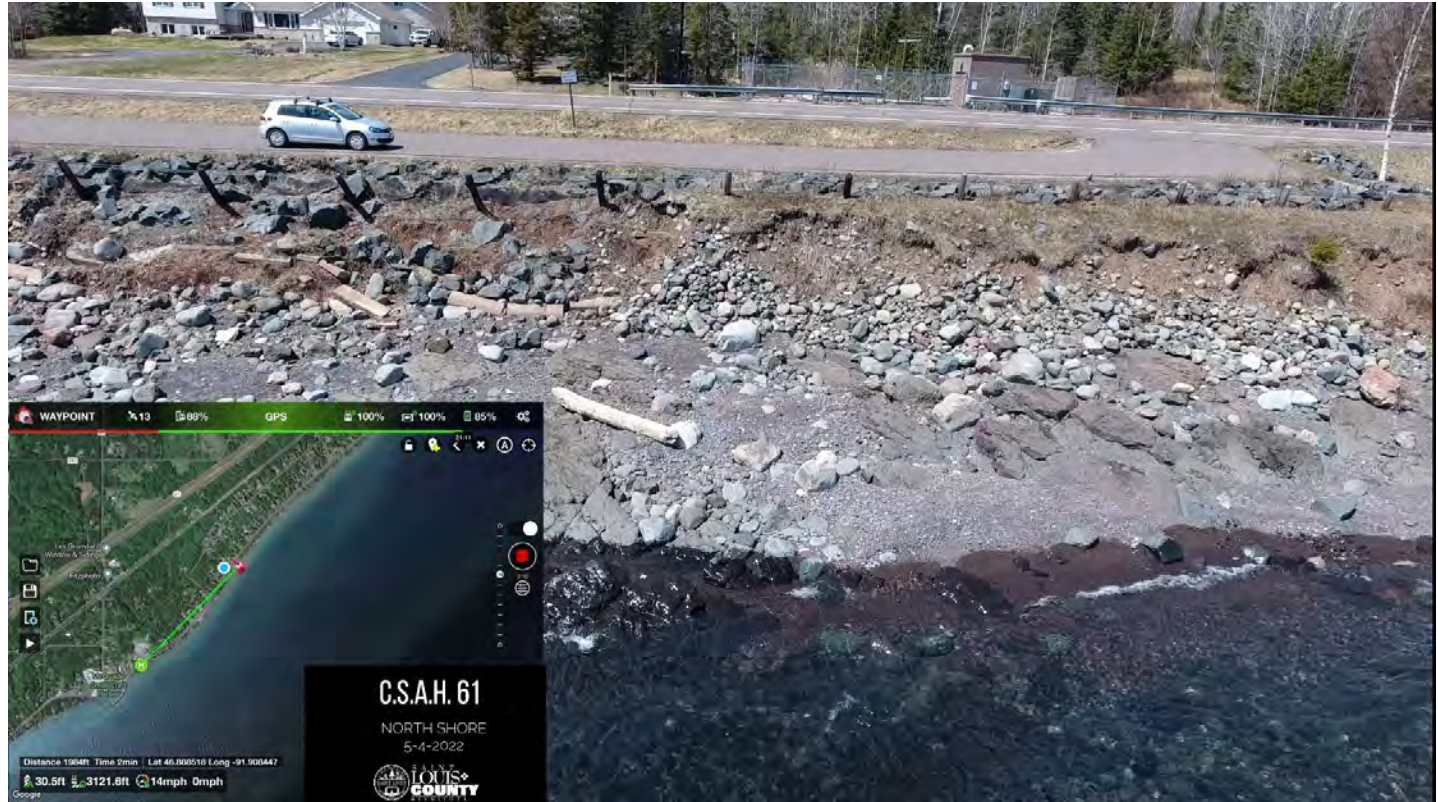
Location 7.1

Bank Height (Feet)	Length (Feet)
6	400

Recommended Option	Estimated Cost
Retreat to roadway, reshape with vegetation above and reinforced toe stone.	\$1,630,000

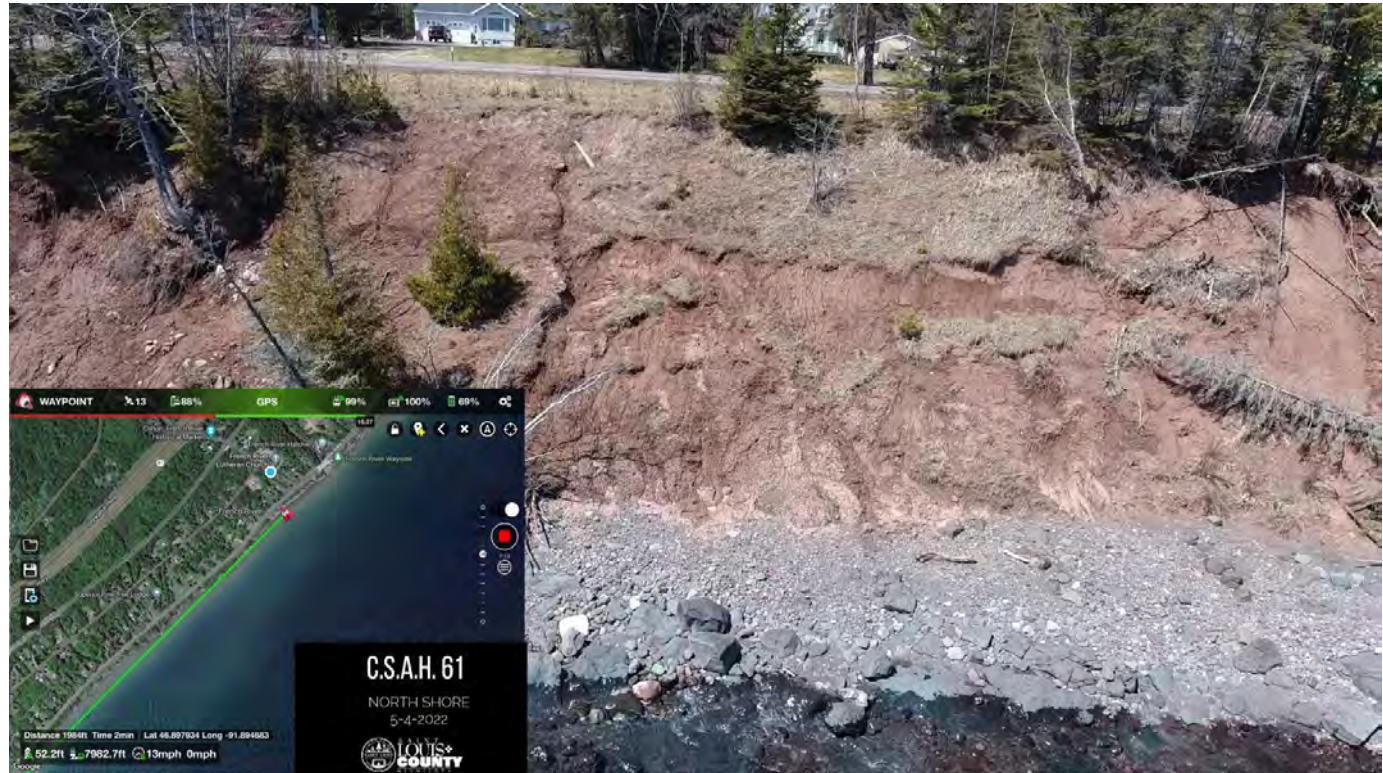
Location 8.5

Bank Height (Feet)	Length (Feet)
50	1730

Recommended Option	Estimated Cost
Reshape with reinforced stone to 20 feet vegetation above with toe protection and water management.	\$5,100,000

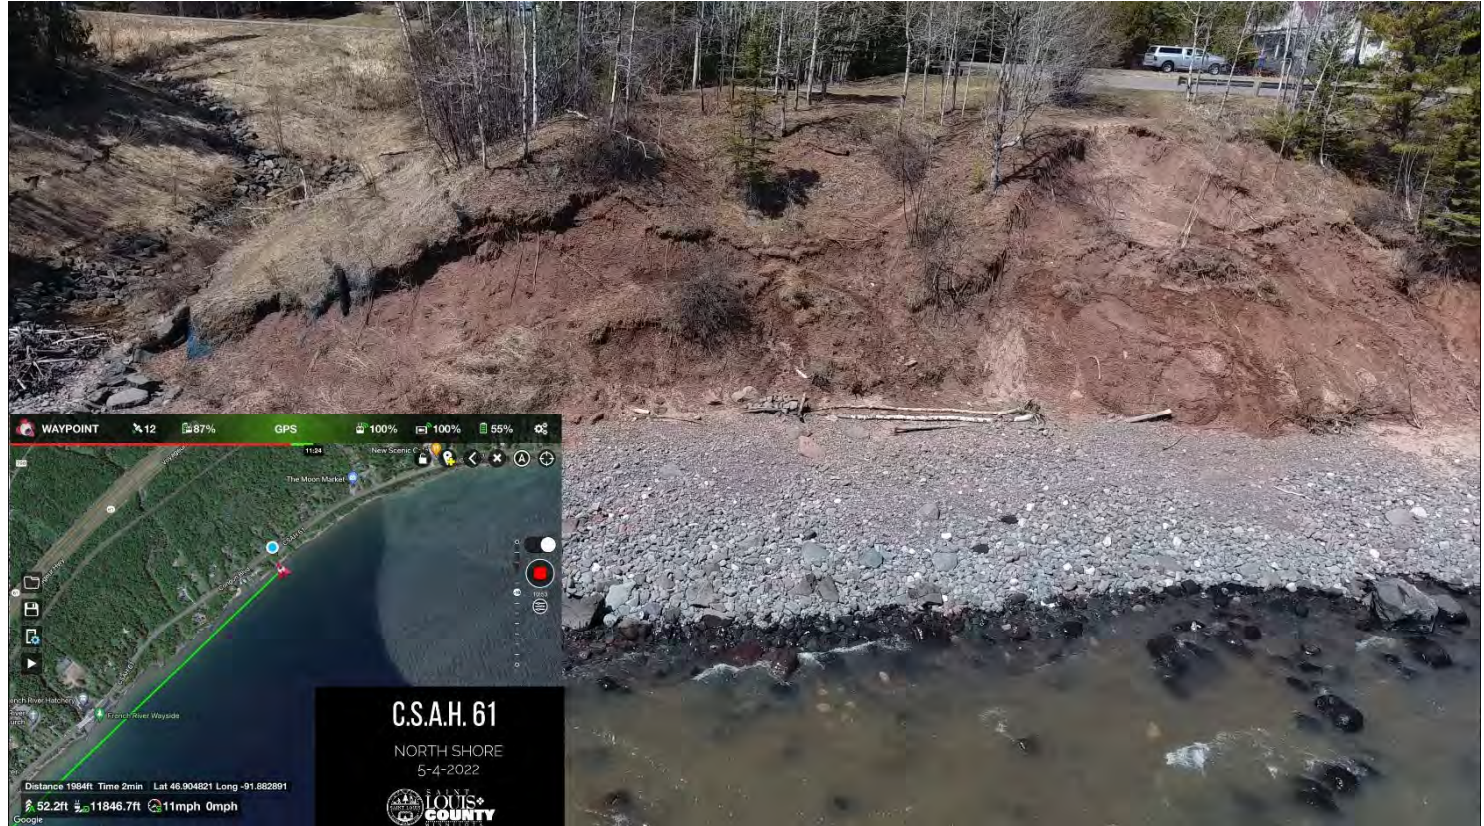
Location 9.6

Bank Height (Feet)	Length (Feet)
40	270

Recommended Option	Estimated Cost
Reshape – Stone to 15 feet – vegetation above – redirect surface water	\$690,000

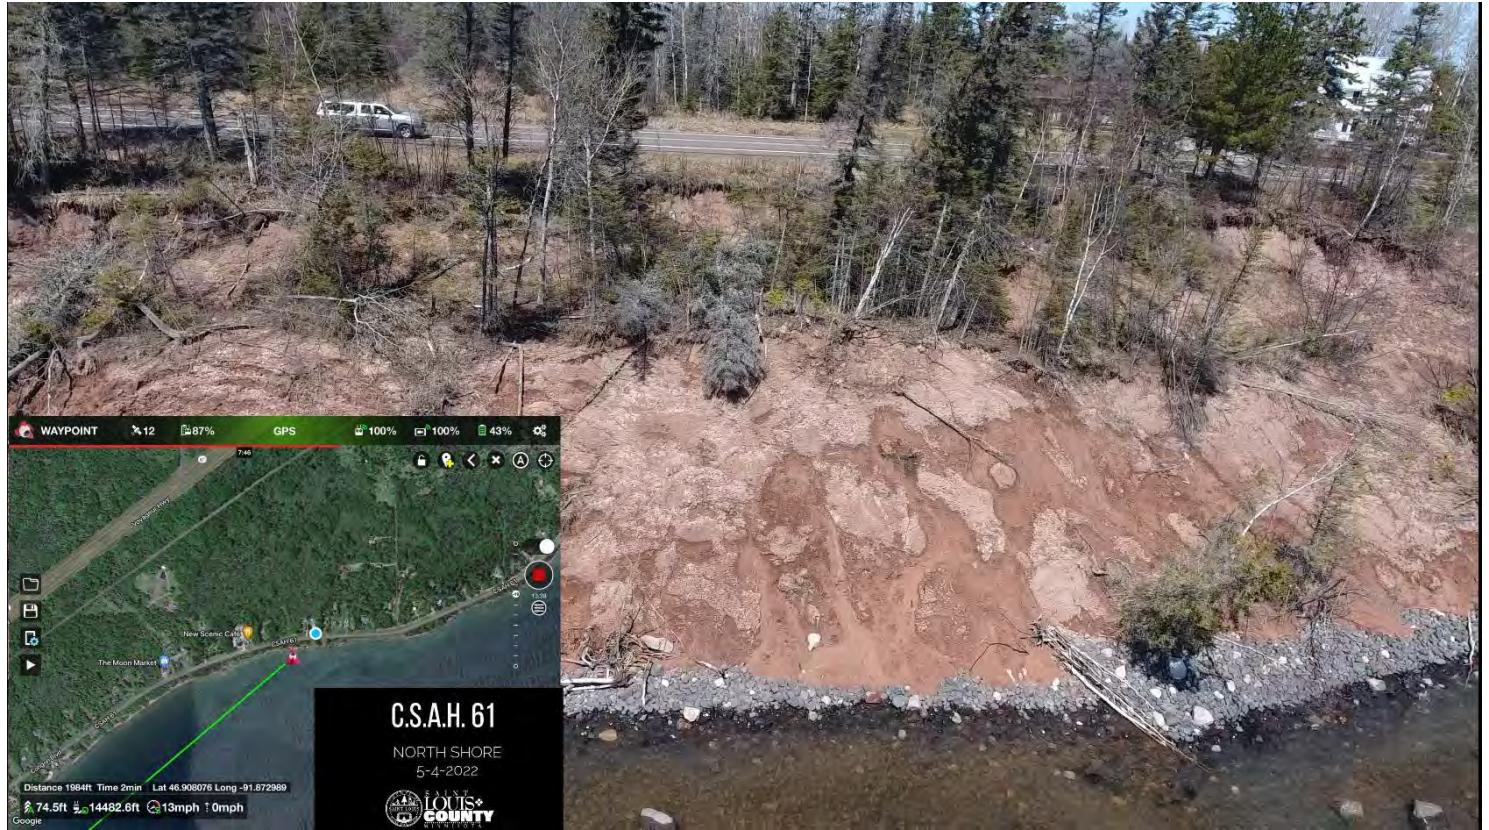
Location 10.3

Bank Height (Feet)	Length (Feet)
50	1485

Recommended Option	Estimated Cost
Reshape with stone to 20 feet, geogrid with vegetation above, toe protection and water management.	\$4,450,000

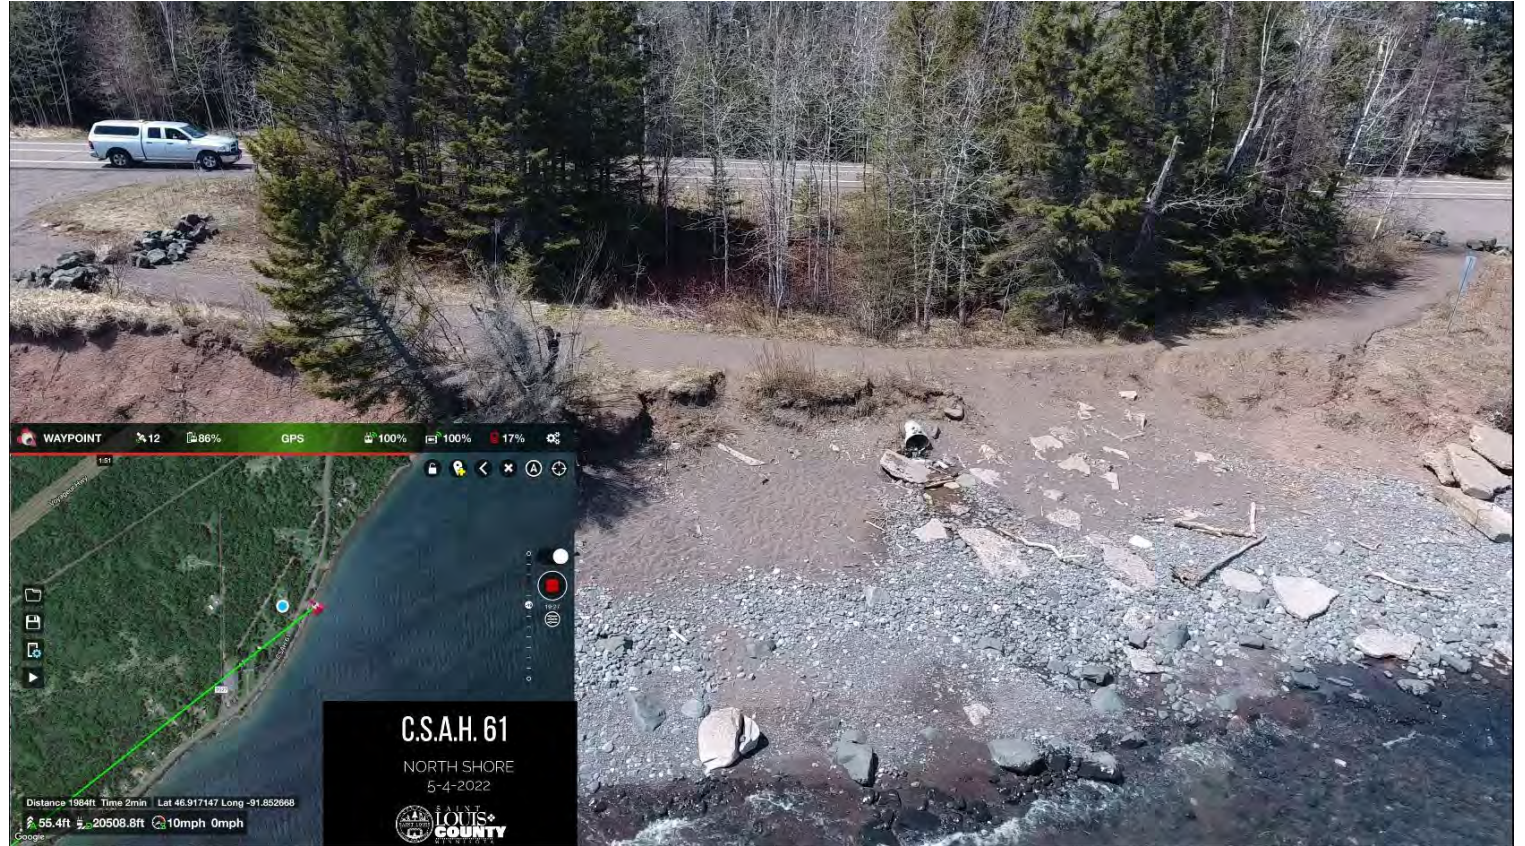
Location 12.0

Bank Height (Feet)	Length (Feet)
5	590

Recommended Option

Abandon loop, retreat / rebuild turnout, repair outfall, reshape slope, reinforced stone with vegetation above.

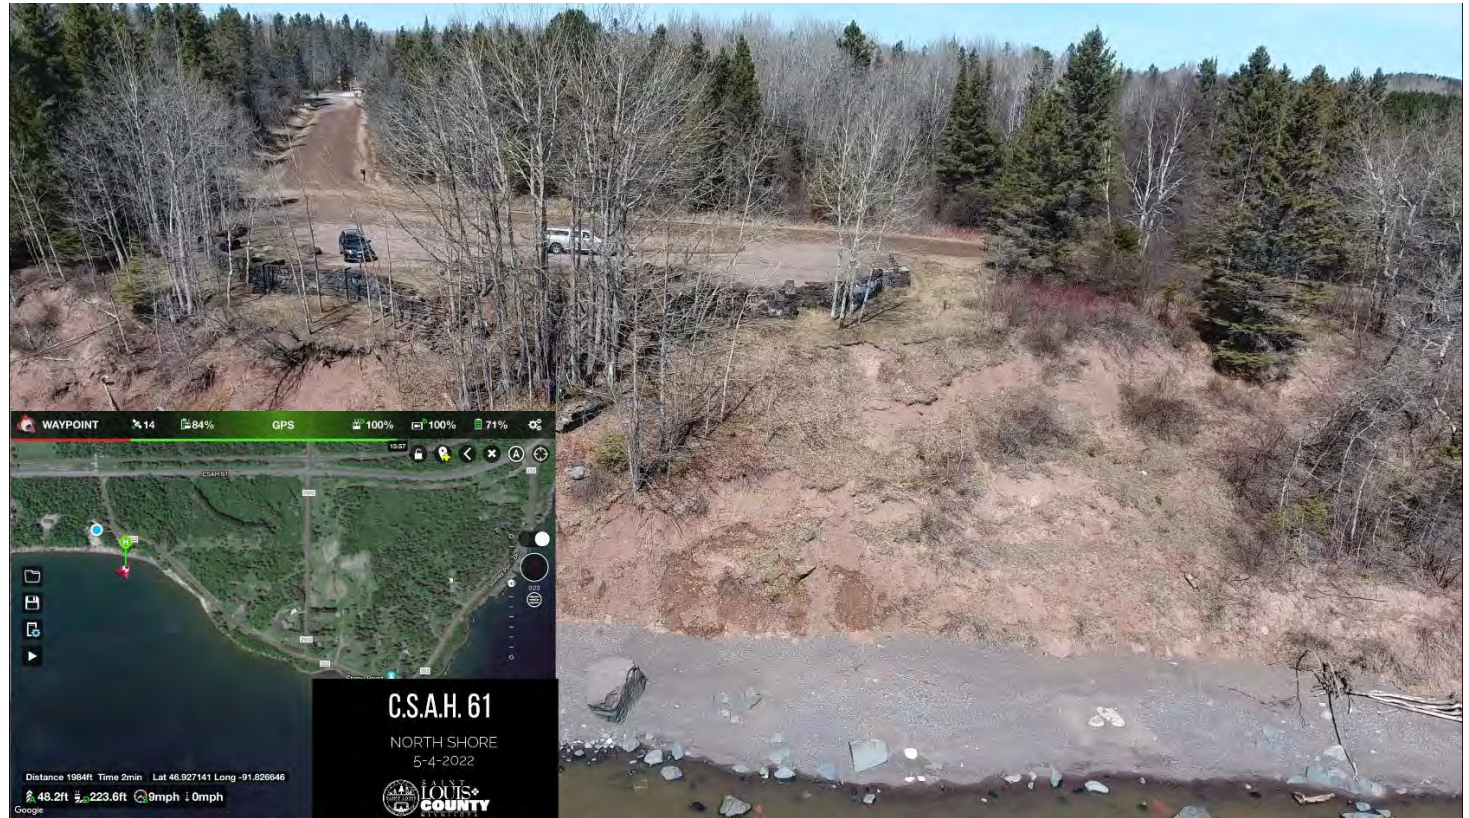
Location 14.1

Bank Height (Feet)	Length (Feet)
45	330

Recommended Option	Estimated Cost
Design and Repair existing wall structure, reshape, add reinforced vegetation	\$800,000

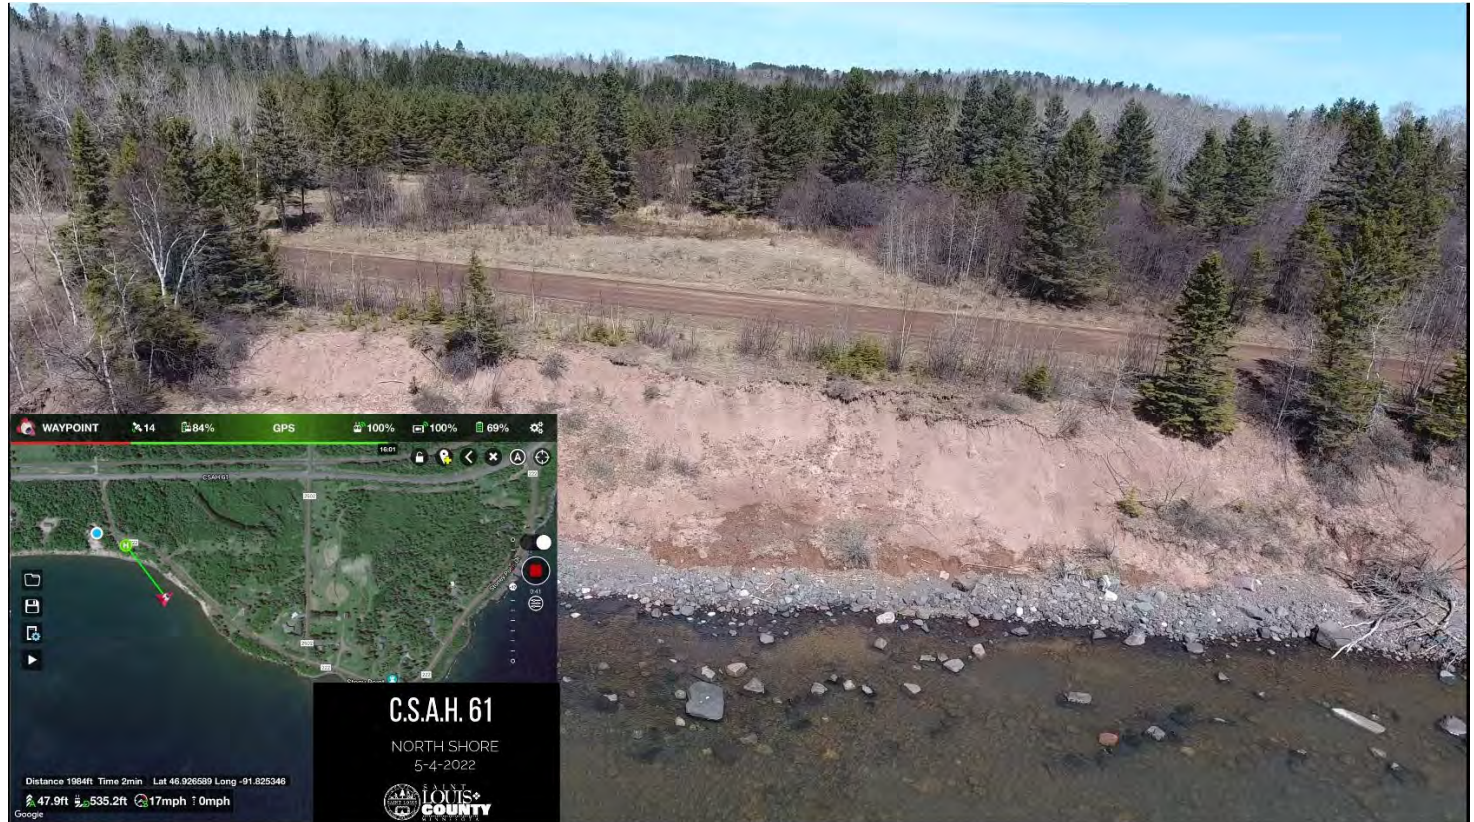
Location 14.3

Bank Height (Feet)	Length (Feet)
25	2900

Recommended Option	Estimated Cost
Reshape – Geogrid with vegetation and toe protection to 15 feet with Vegetation above.	\$3,400,000

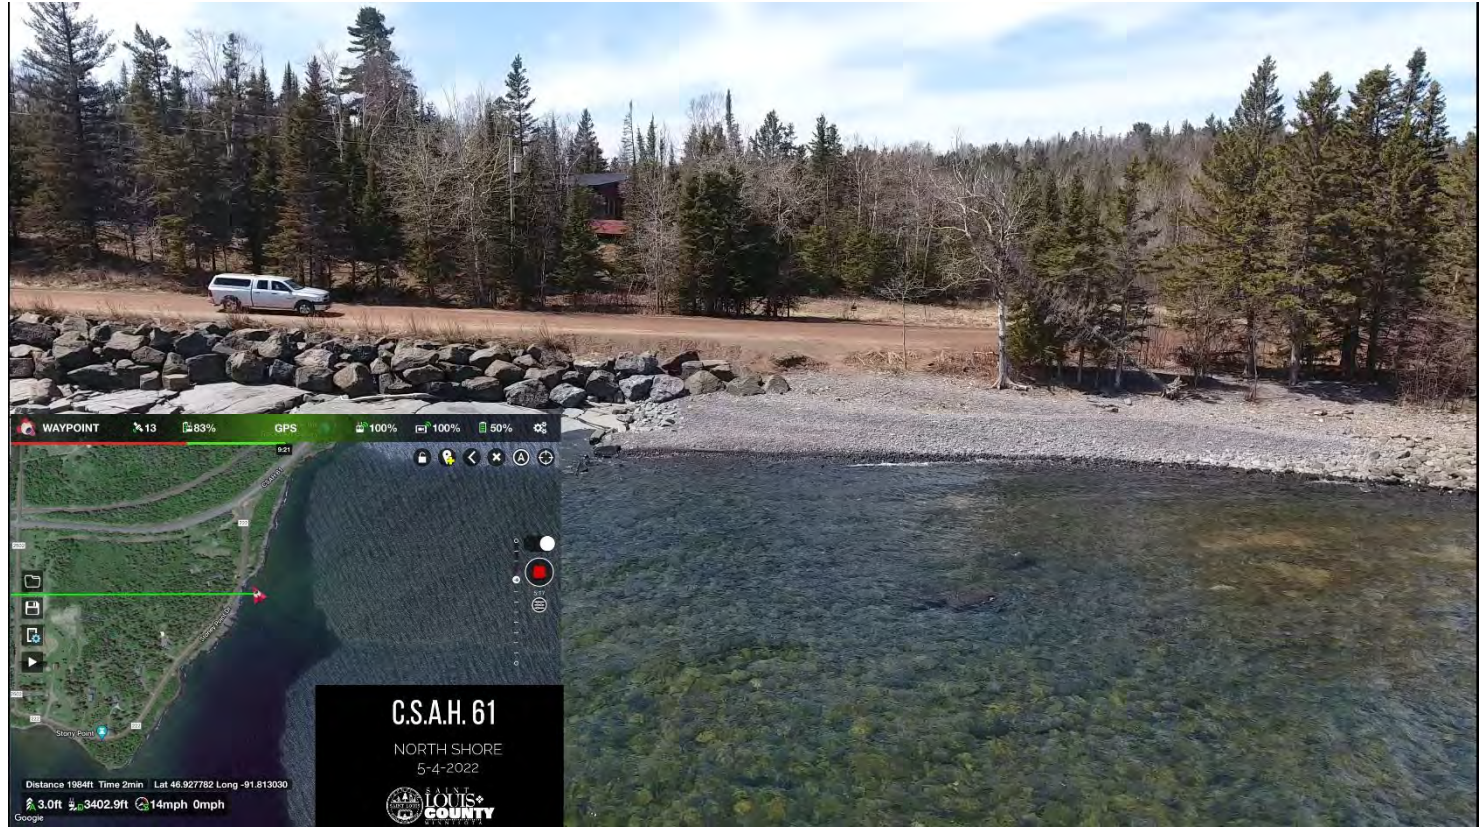
Location 15.2

Bank Height (Feet)	Length (Feet)
5	145

Recommended Option

Riprap to tie in to existing with vegetation above.
