MEETING AGENDA

**Heritage Preservation Commission
Monday, November 13, 2023 – 12:00pm
City Council Chambers, Third Floor City Hall, 411 W. First Street**

COA for a chiller outside St Louis County building.

ST. LOUIS COUNTY COURTHOUSE CHILLER

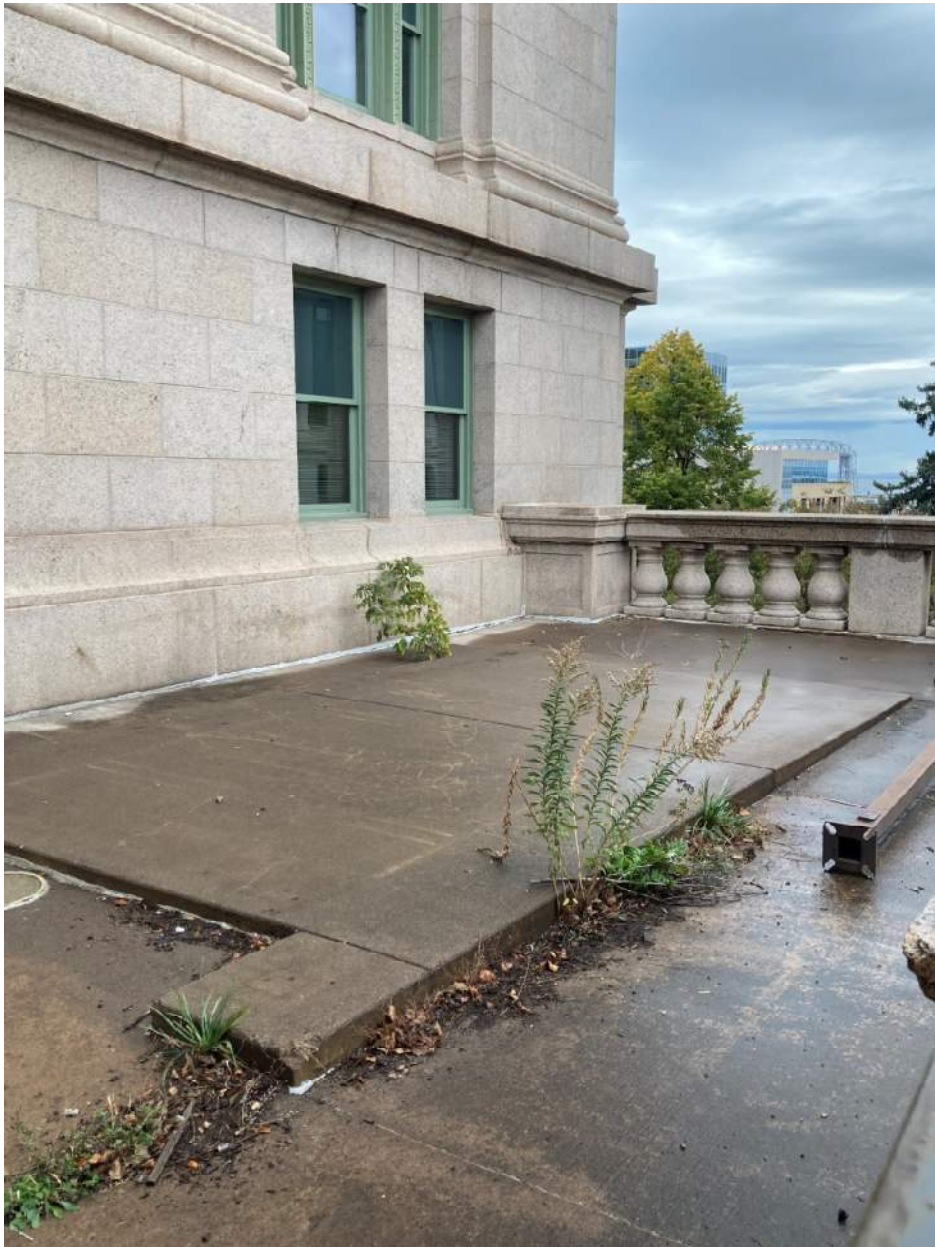
PICTURE #3

View where (2) new chillers will be placed and mechanical louver wall will be built

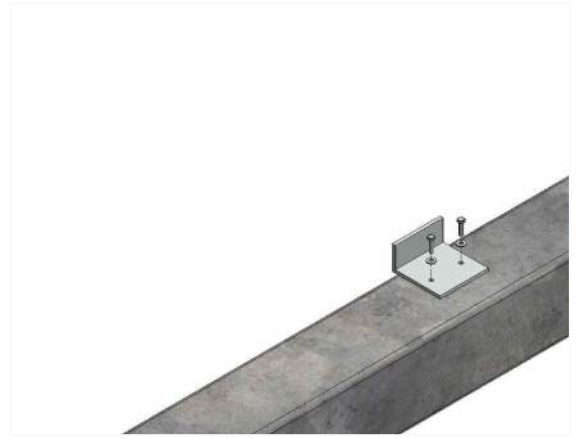
-The following tasks shall be done along each horizontal support. Ensure that the upper and lower clips are installed plumb.

- A. Mark location of all clip angles per the Industrial Louvers prepared shop drawings.
- B. Install a clip angle on each end of the equipment screen run.
- C. Place a string line between the two outer clip angles. This will locate the intermediate clip angles in/out.
- D. Install all intermediate clip angles using the string line as a reference.

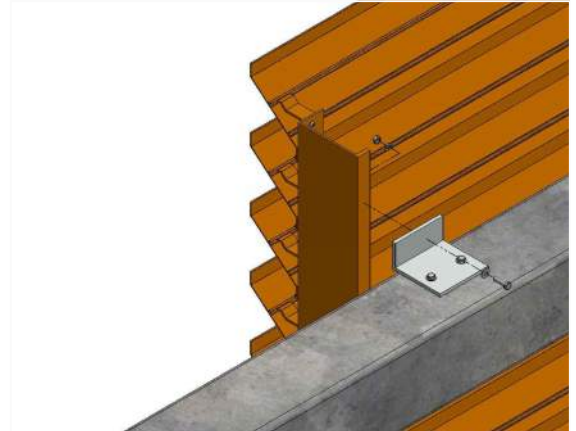
**Step 2: Installing the First Unit**

-Begin by installing a corner unit. Work away from the corner to allow for variations in unit sizes and/or steel support measurements.

- A. Clamp vertical supports to clip angles.
- B. Verify that equipment screen blades are running level and at the correct elevation. Unclamp vertical supports and adjust if necessary.
- C. Drill clearance hole through clip angle and rear flange of vertical support.
- D. Install bolt through clip angle and rear flange.
- E. Repeat steps 2C and 2D for each anchor point of the first unit.

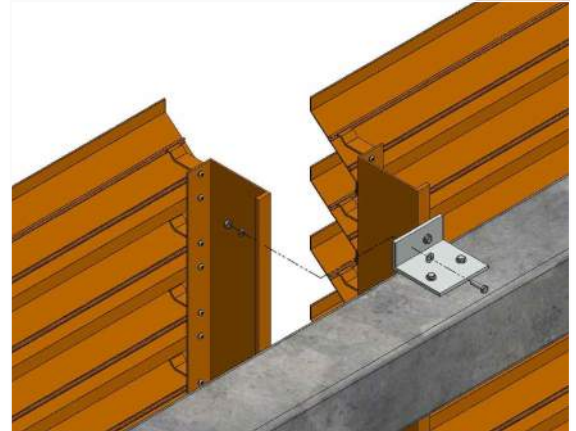
**Step 3: Installing the Remaining Units**

-The following tasks shall be completed for each remaining unit.

- A. Clamp vertical supports to clip angles.
- B. Verify that equipment screen blades are running level and at the correct elevation. Unclamp vertical supports and adjust if necessary.
- C. Drill clearance hole through clip angle and rear flange of vertical support.
- D. Install bolt through clip angle and rear flange.
- E. Repeat steps 3C and 3D for each anchor point.

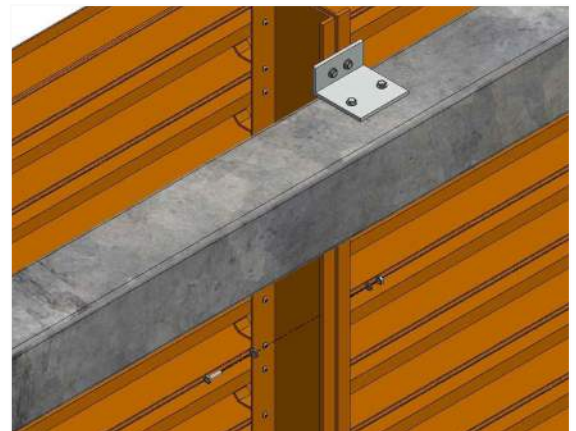
**Step 4: Vertical Support Bracing**

-The following tasks shall be completed only after all units have been bolted to clip angles. Note: vertical support bracing may not be required, see shop drawings for requirements.

- A. Mark location of all through bolts for vertical support bracing purposes per the Industrial Louvers prepared shop drawings.
- B. Drill clearance hole through both vertical supports at each location marked in step 4A.
- C. Install bolts through vertical supports.

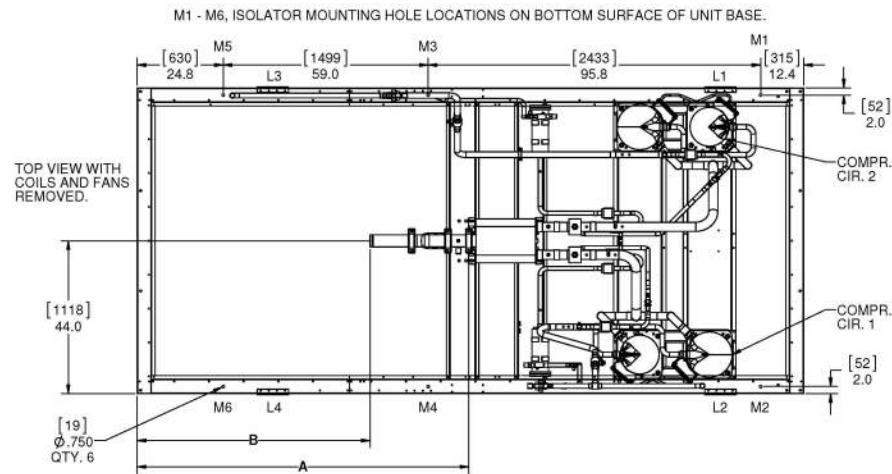
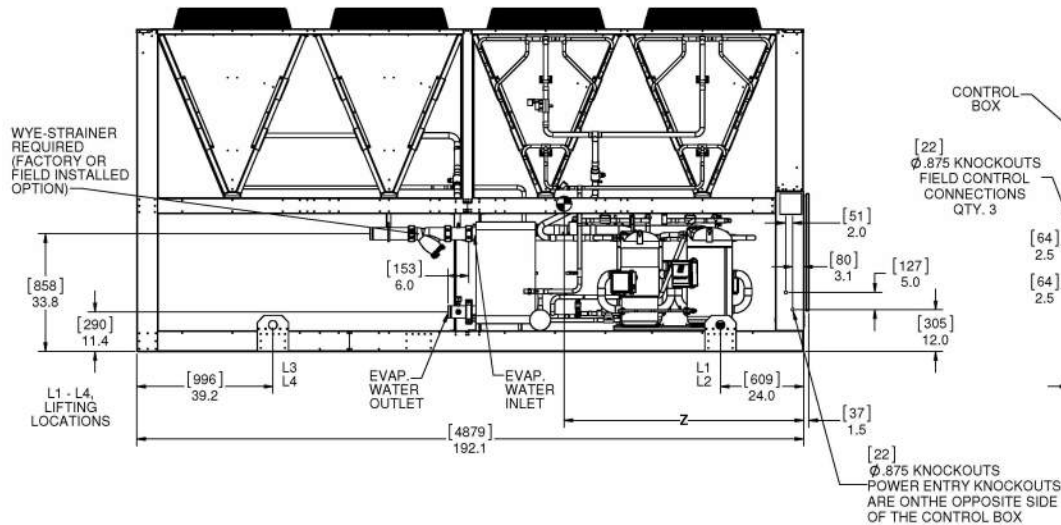
Unit Dimensions

Unit Weight Data												
Units	Weight		Lifting Weight				Mounting Weight					
	Shipping	Operating	L1	L2	L3	L4	M1	M2	M3	M4	M5	M6
lb	5792	5903	1941	1863	1015	974	1575	1511	920	883	517	496
kg	2627	2678	880	845	460	442	714	685	417	401	235	225

Unit and Center of Gravity Dimensions						
Units	A (No Strainer)	B (With Strainer)	Connection Size (Victaulic)	Center of Gravity		
				X	Y	Z
in	92.0	65.5	3.0	43.1	41.0	68.3
mm	2337	1664	76	1095	1041	1735

NOTE
IT IS RECOMMENDED THAT THE SIDE LOCATIONS BE USED FOR POWER ENTRY WIRE SIZES LARGER THAN 350 MCM.

NOTE
A water strainer must be installed at the inlet of the evaporator to protect it from damage. Please refer to the IOM for additional details.

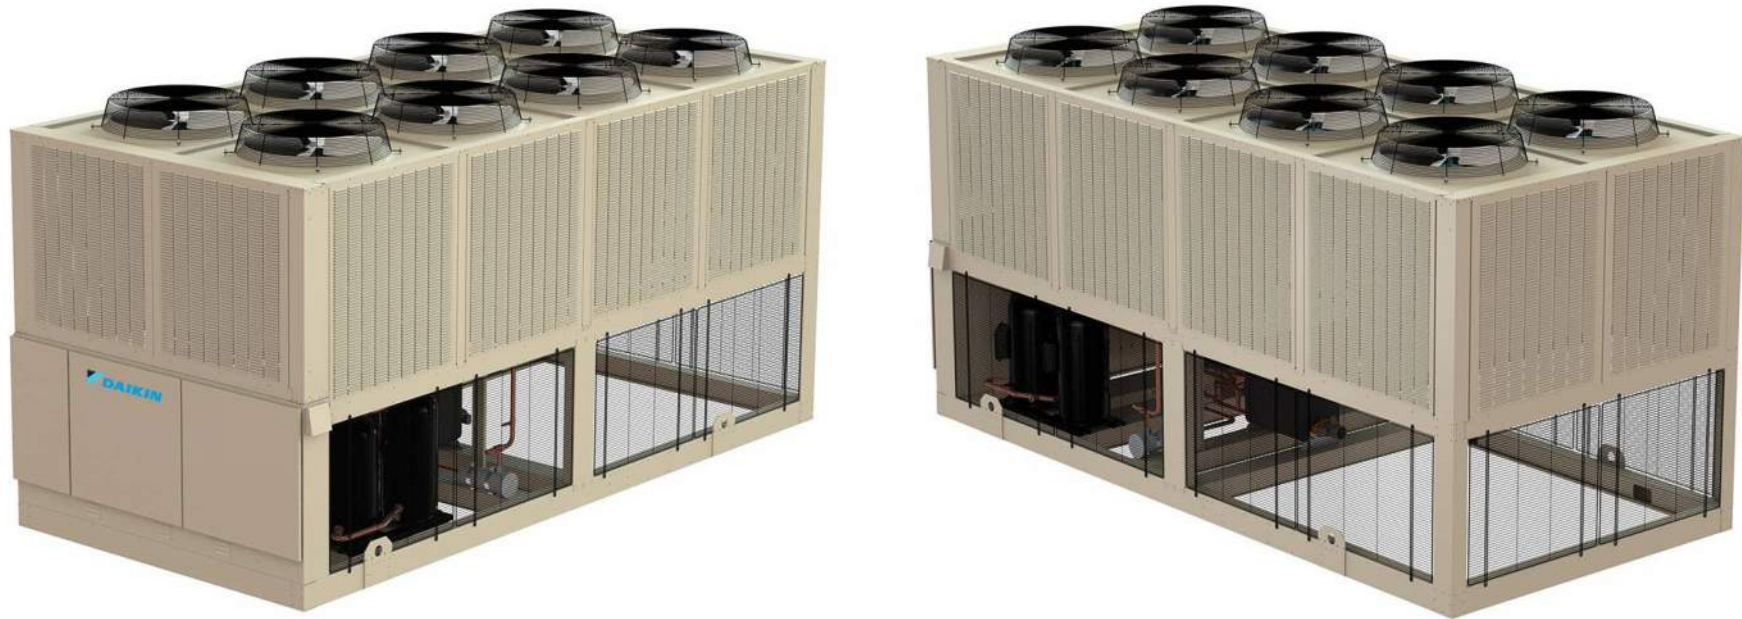
AGZ110-130E_GndLuv_BsGrI_PntBs_Drawing

Diagram Notes
 Diagram simulates wrap, grille and louver options as selected only. Refrigeration components may vary depending on selected options.

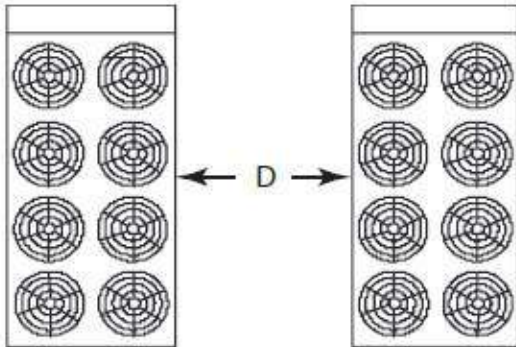
Two Units, Side-by-Side

For models 030-180, there must be a minimum of 4 feet between two units placed side-by-side; however, performance may be affected at this distance. For models 191-241, the minimum is 6 feet as closing spacing may cause air recirculation and elevated condenser pressure. Assuming the requirement of one side having at least 8 feet of service clearance is met, Case 2 figures show performance adjustments as the distance between two units increases.

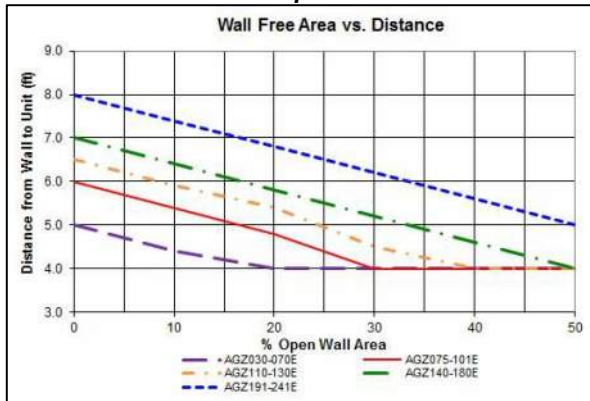
Case 4 - Allowable Wall Open Area

Decorative screening walls are often used to help conceal a unit either on grade or on a rooftop. When possible, design these walls such that the combination of their open area and distance from the unit (see chart below) do not require performance adjustment. If the wall opening percentage is less than recommended for the distance to the unit, it should be considered as a solid wall. It is assumed that the wall height is equal to or less than the unit height when mounted on its base support. If the wall height is greater than the unit height, see Case 5: Pit Installation for performance adjustment factors. The distance from the sides of the unit to the side walls must be sufficient for service, such as opening control panel doors. For uneven wall spacing, the distance from the unit to each wall can be averaged providing no distance is less than 4 feet. Values are based on walls on all four sides.

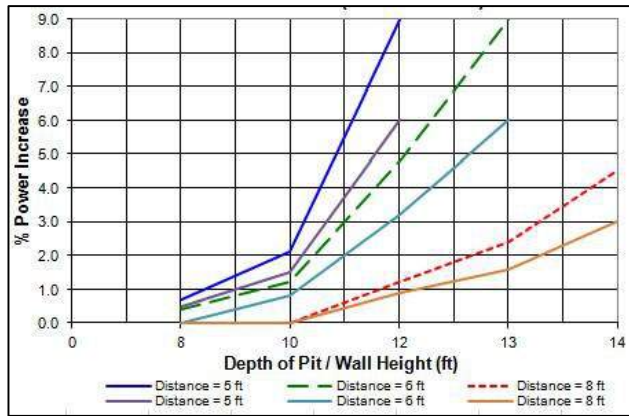
Case 5 - Full Load Capacity Reduction and Power Increase (AGZ075-130E)

The Case 5 figures for models AGZ075-130E show adjustment factors for pit/wall heights of 5 feet, 6 feet, and 8 feet.

KEY:
 - - - - - : Power Increase
 _____ : Capacity Reduction

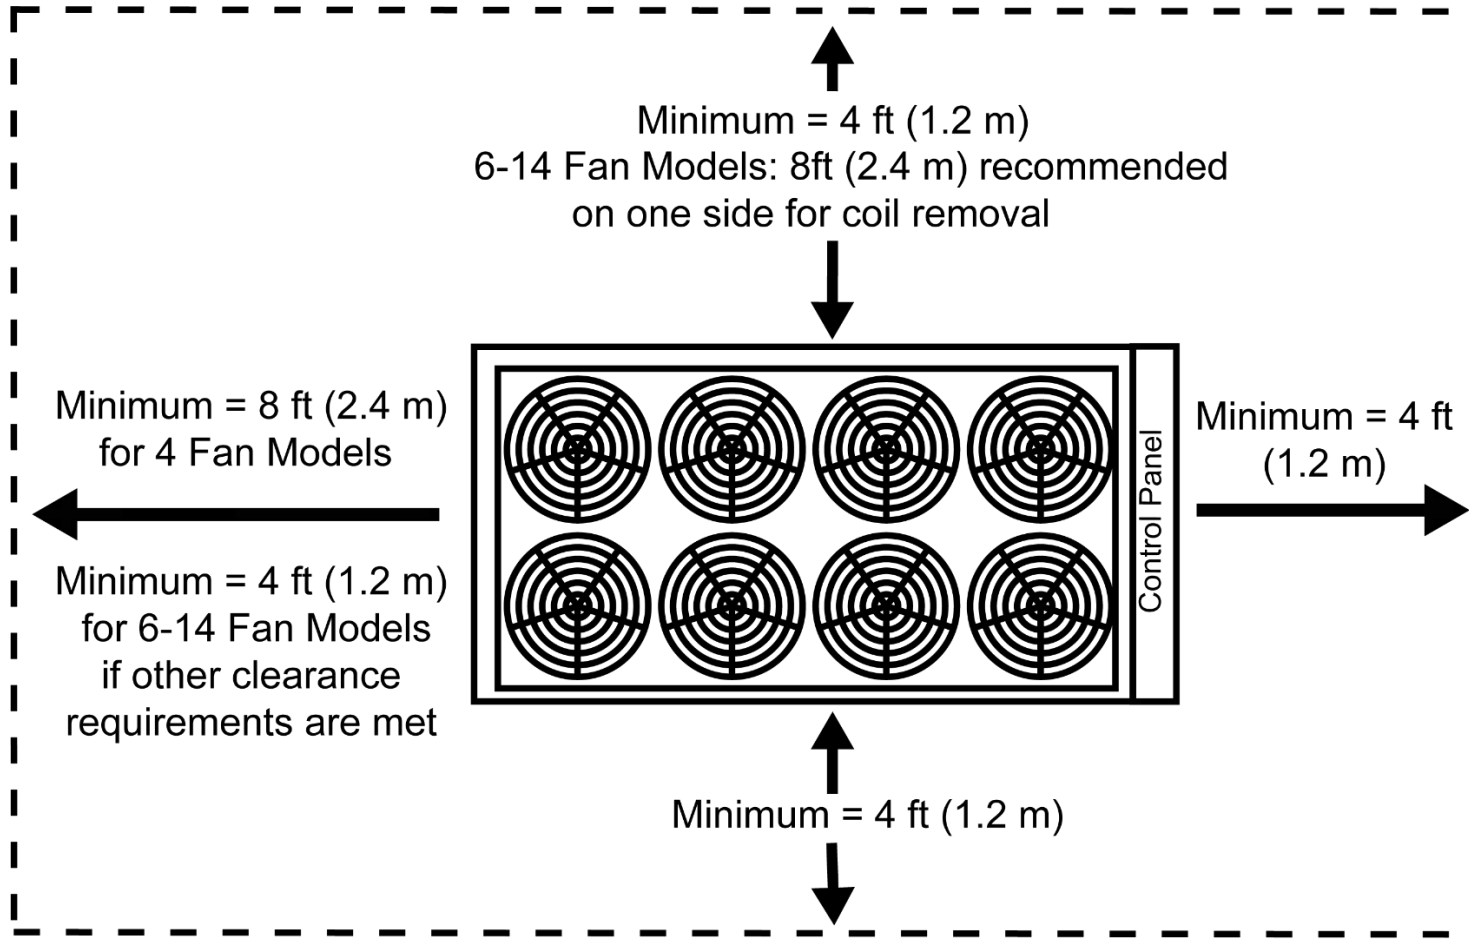
AGZ-E Service Clearance

• NOTE: Additional clearance may be required for proper airflow. Please consult Close Spacing drawings and IOM for additional details.

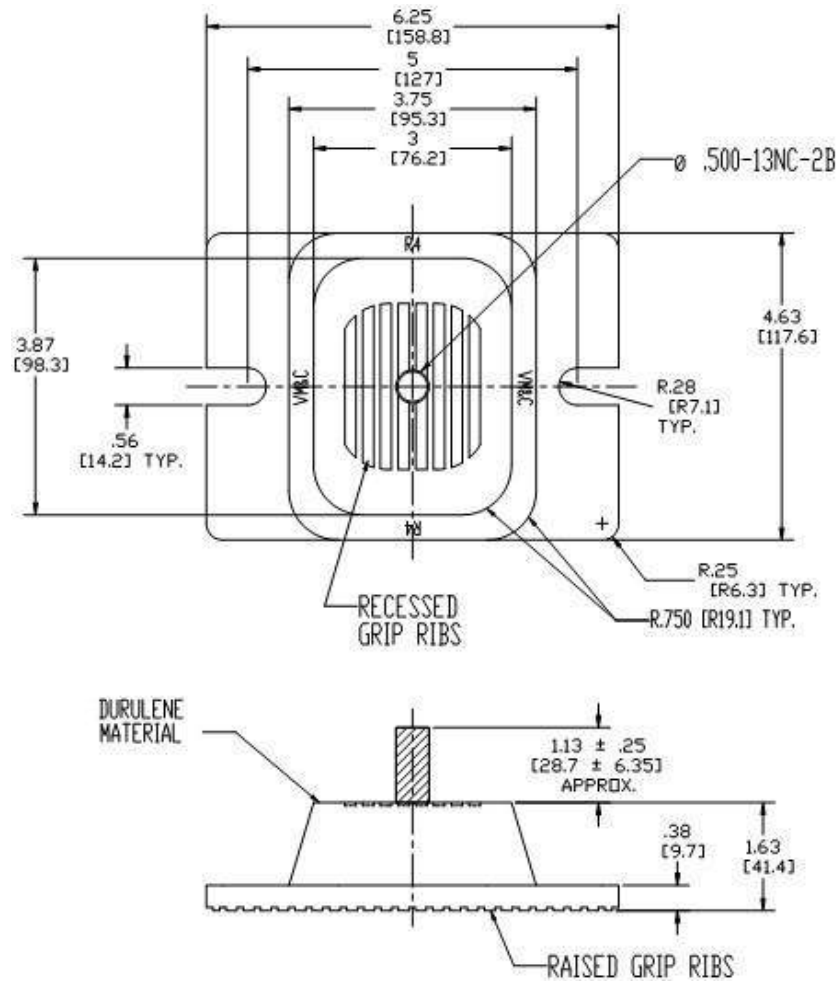
Dimensions and Placement

Mounting Location					
M1	M2	M3	M4	M5	M6
Red	Red	Brown	Brown	Brown	Brown

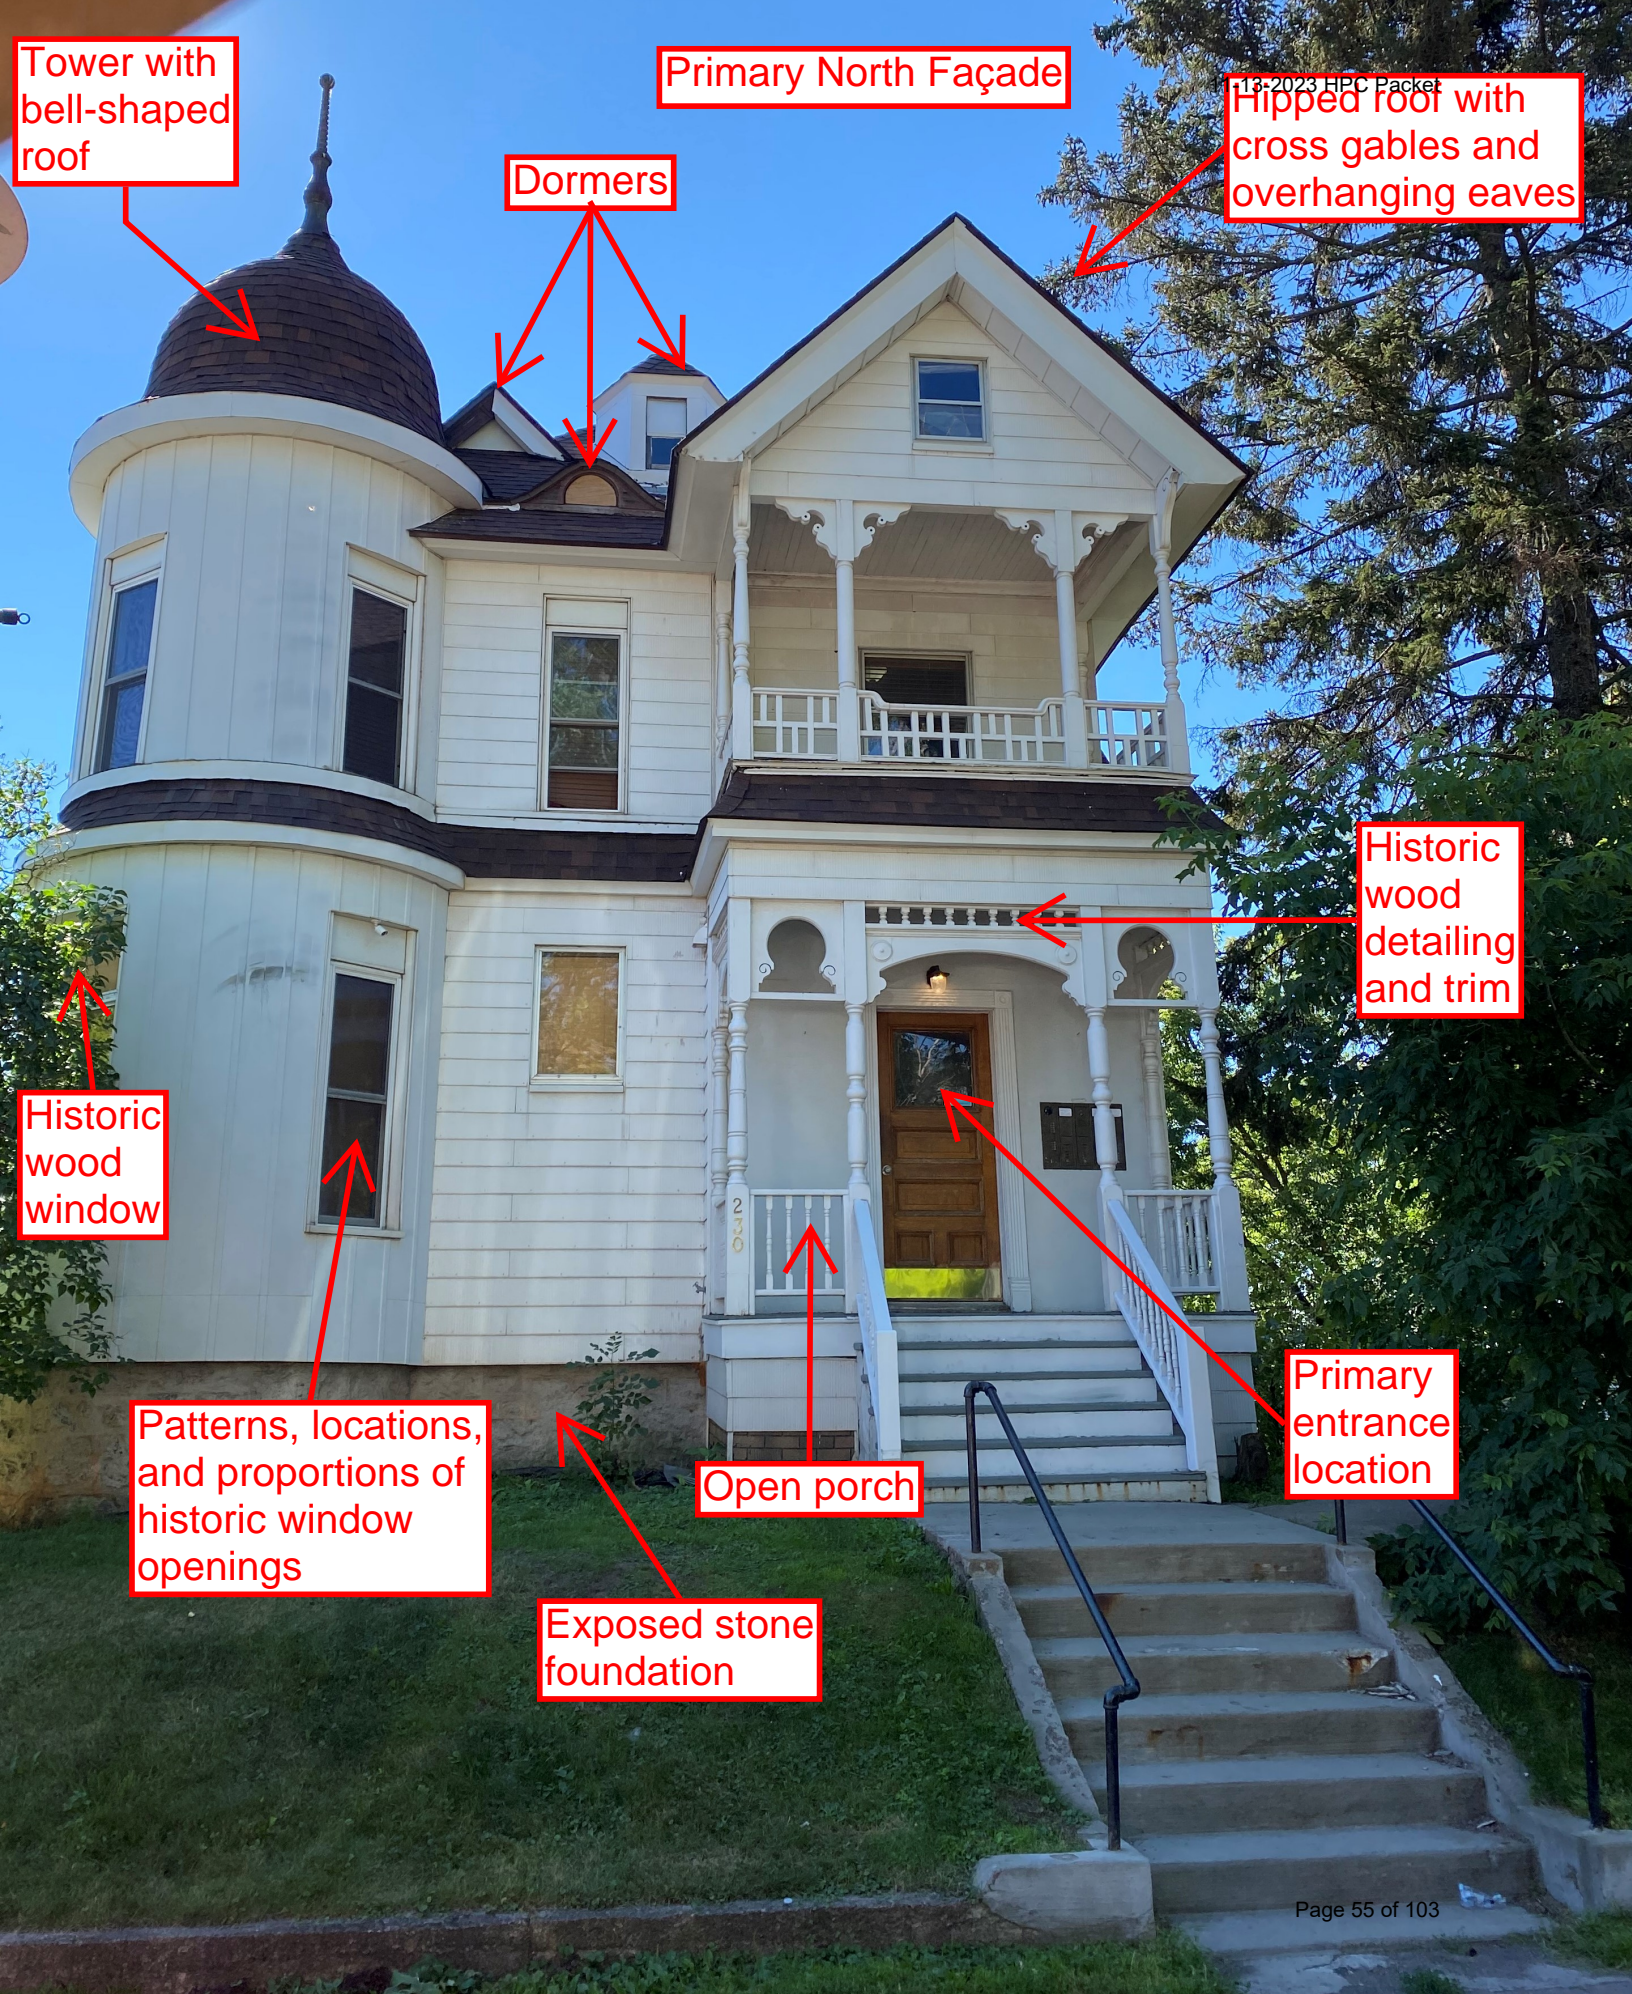
Primary North Façade

13-2023 HPC Packet
Hipped roof with cross gables and overhanging eaves

Exposed stone foundation

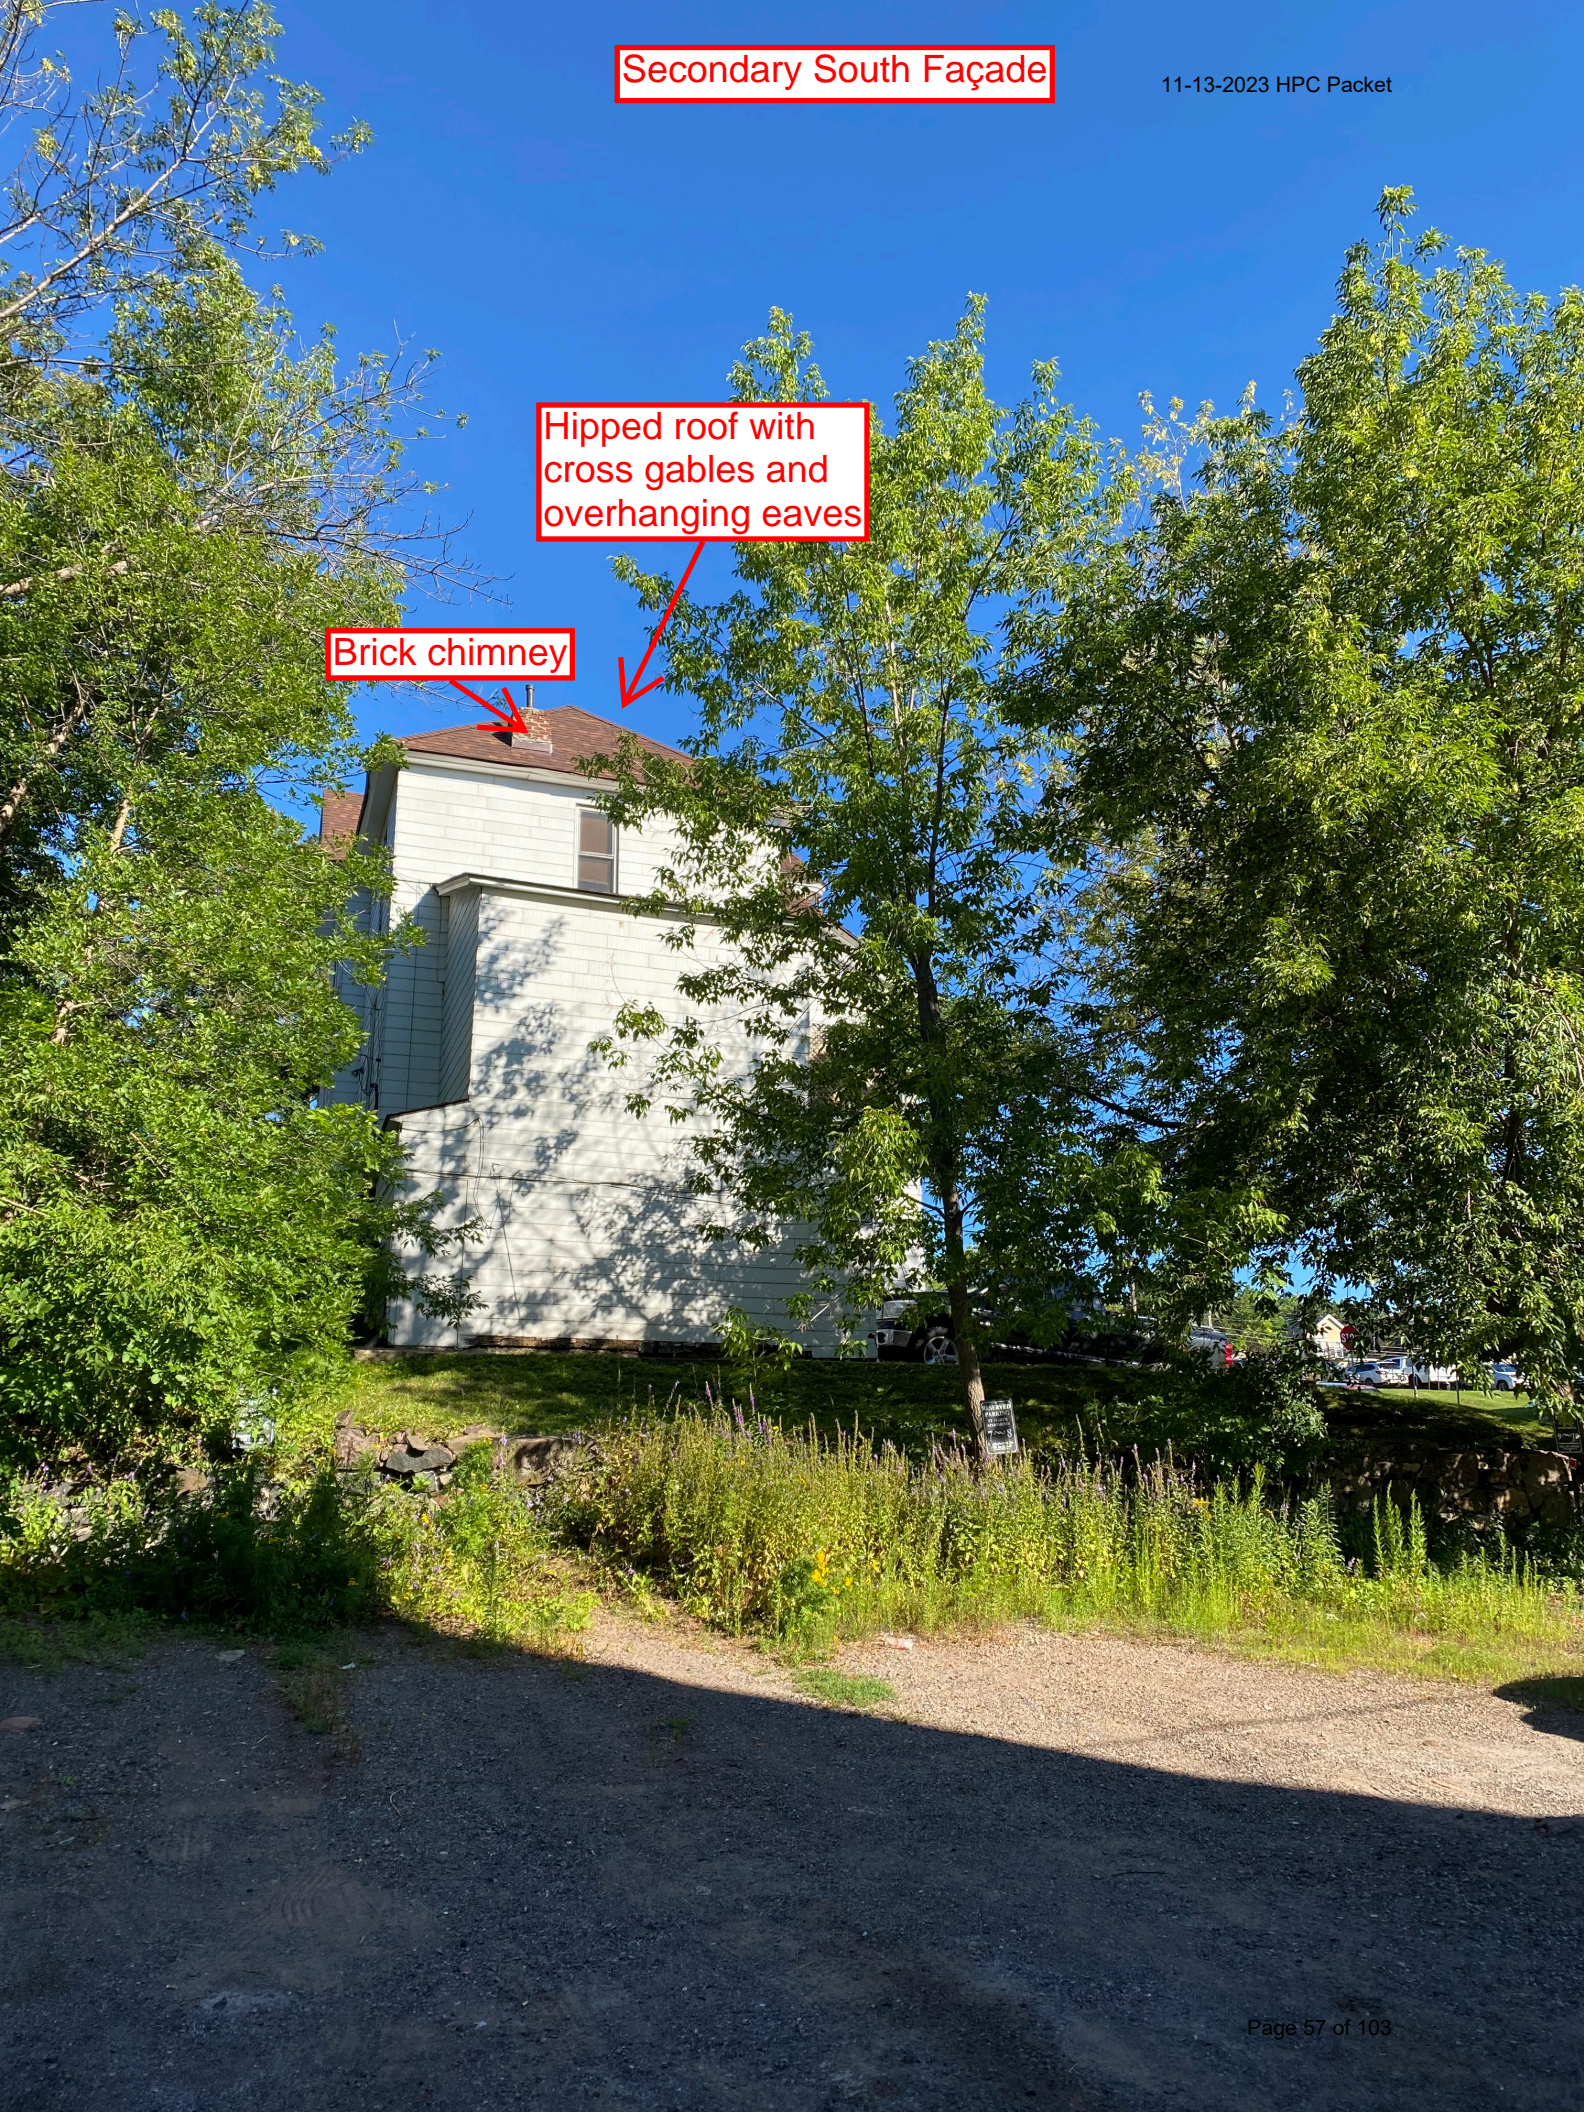
Hipped roof with cross gables and overhanging eaves

Brick chimney

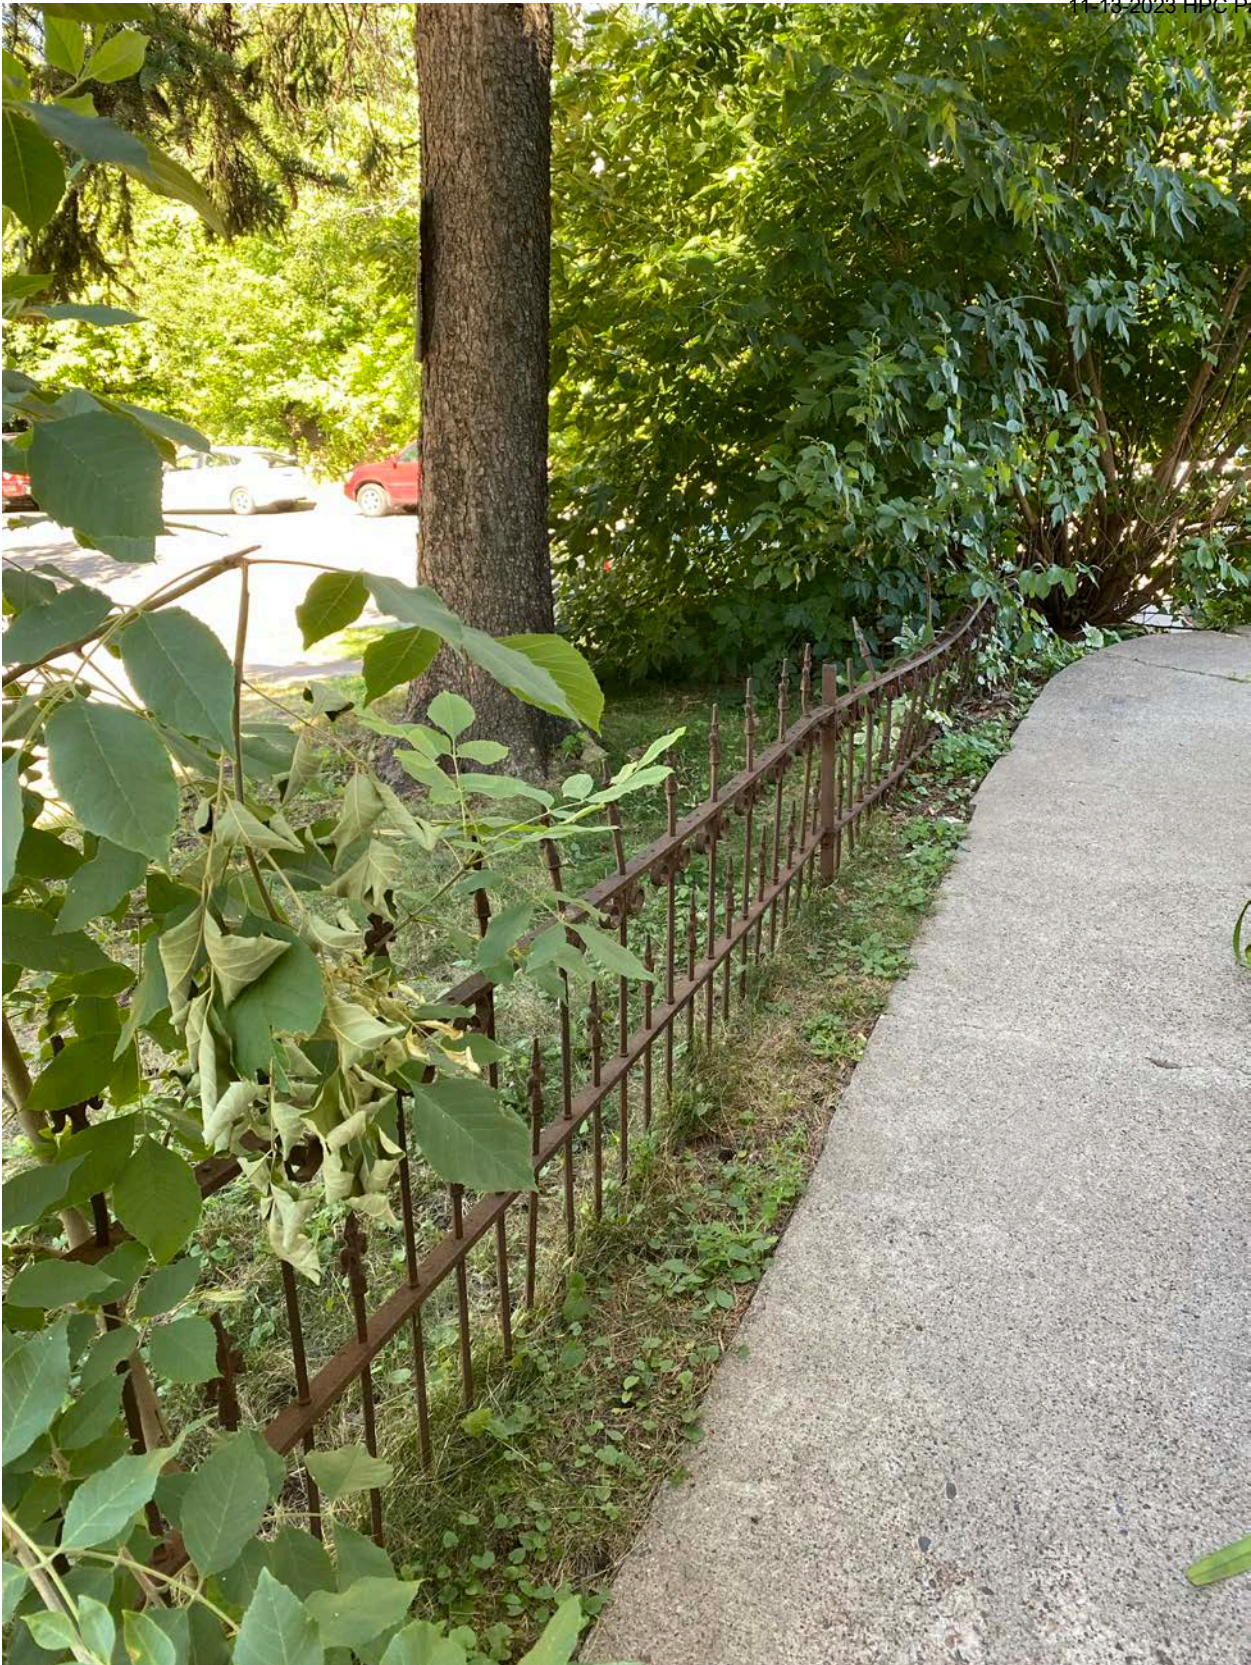
Photo 0010: View of metal fence at west elevation, looking north.

- The metal fence remnant should be retained and may be repaired. Modifications to the fence for safety reasons will be considered.

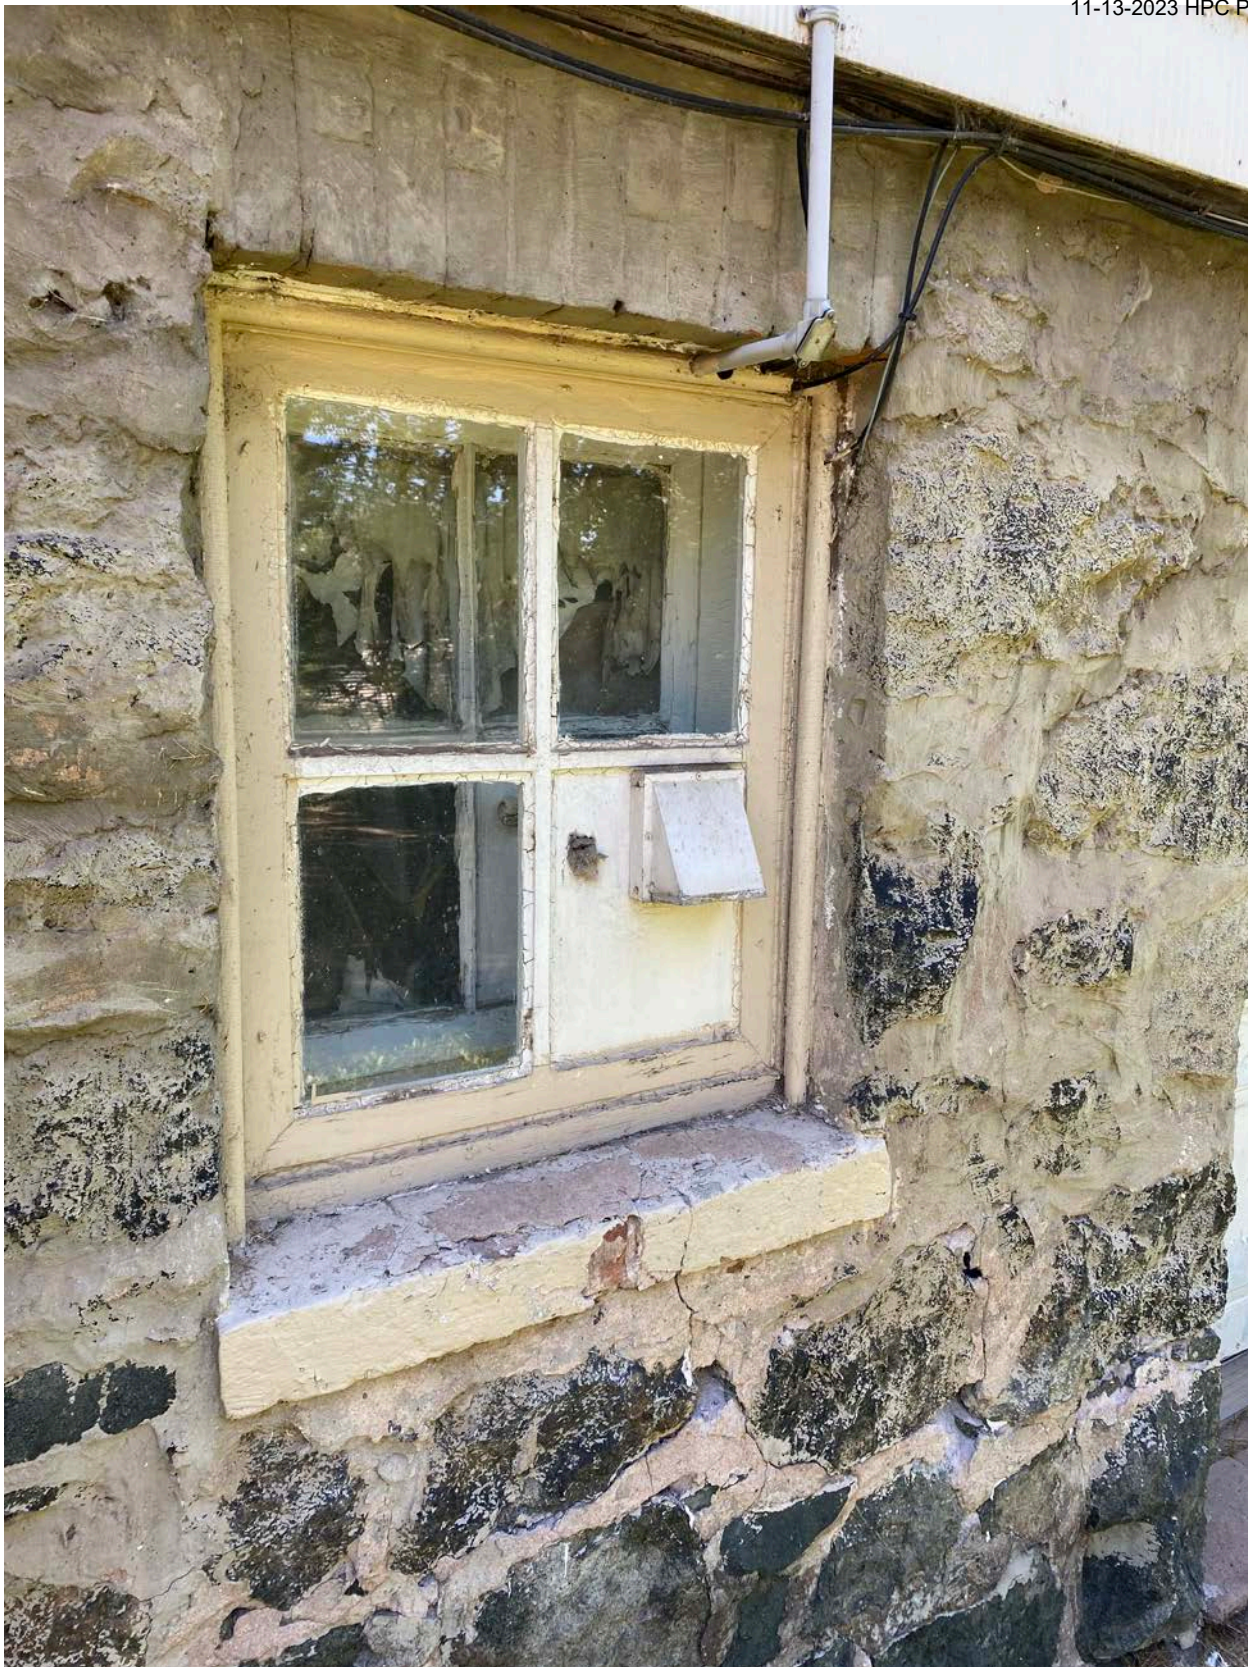
Photo 0011: View of wood window and stone foundation at west elevation, looking southeast.

- Exposed stone foundation
- Masonry window sills and headers at lower-level window openings
- Historic wood detailing and trim, including at the north porch, east dormer, and west secondary entrance
