## **PHASE I ENVIRONMENTAL SITE ASSESSMENT**

**Lester Park Redevelopment  
1860 Lester River Rd  
Duluth, Minnesota 55804**

**BAY WEST PROJECT NO. J220163**

**June 2022**

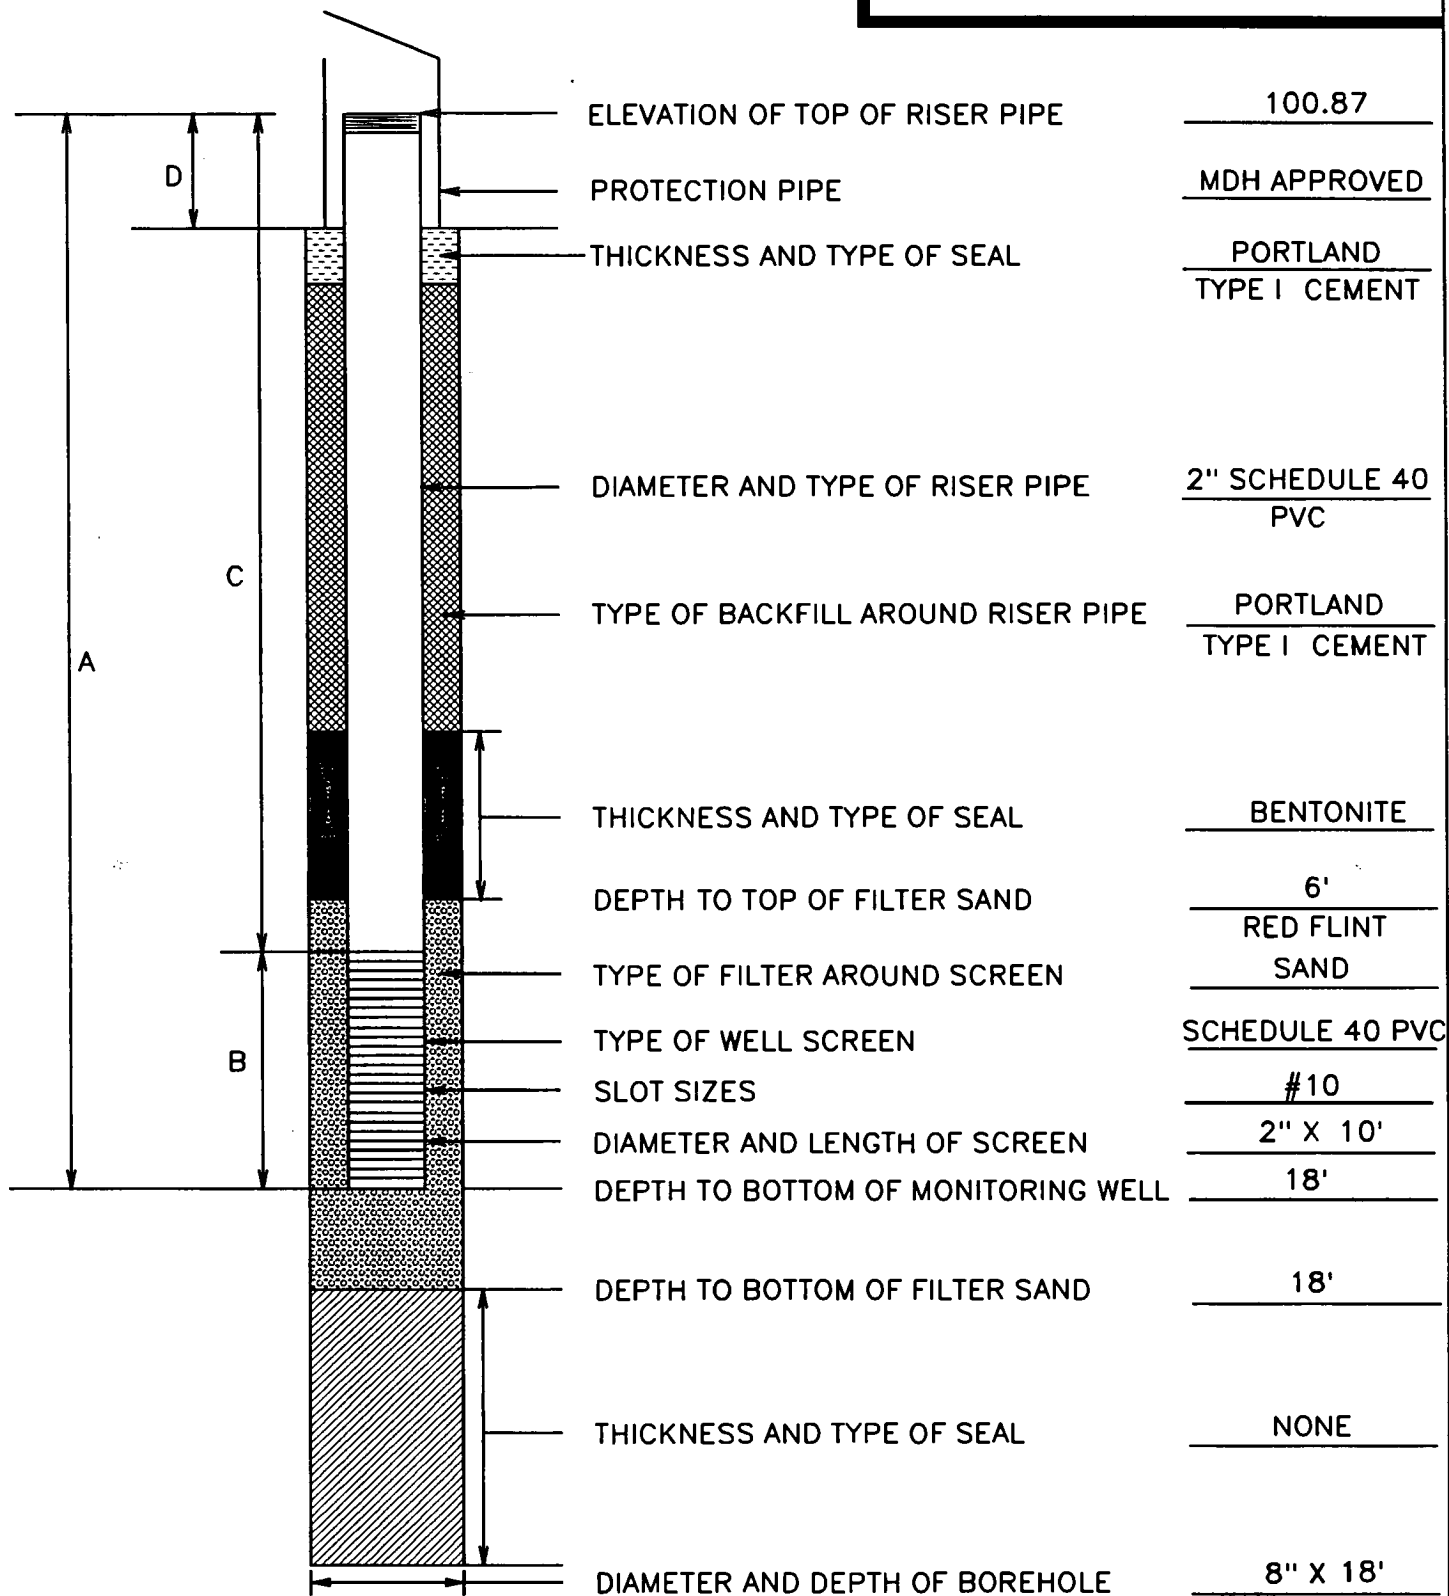
SITE NAME LESTER PARK GOLF COURSE  
 MINNESOTA UNIQUE WELL NO. 559216  
 A = total length of well 20'  
 B = length of well screen 10'  
 C = length of riser pipe 10'  
 D = stick-up at surface 1.5'

MONITORING WELL MW-1  
 DATE INSTALLED 3/27/95  
 DRILLER/RIG HSA  
 GROUND SURFACE ELEV. 99.31  
 WATER LEVELS  
 static: \_\_\_\_\_

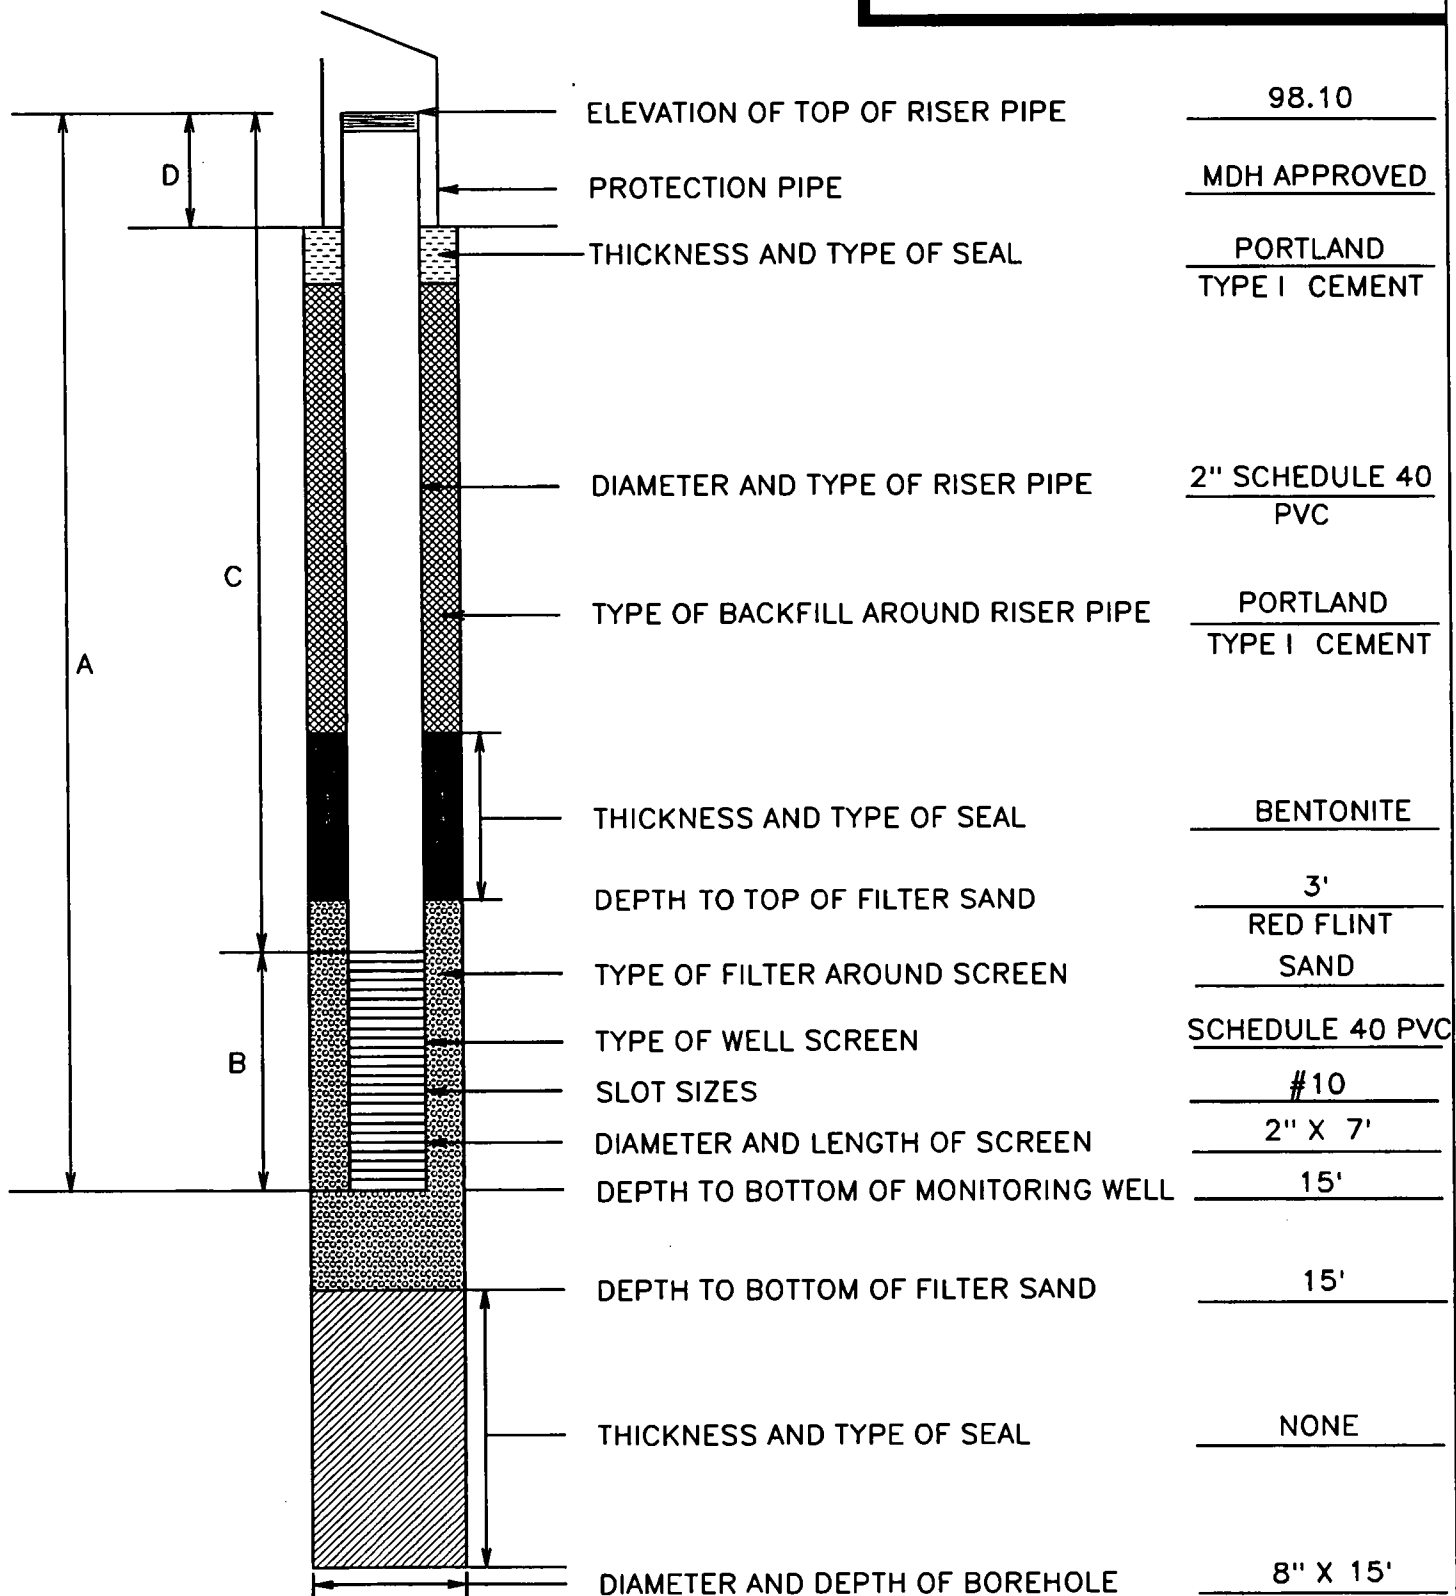
SITE NAME LESTER PARK GOLF COURSE  
 MINNESOTA UNIQUE WELL NO. 559217  
 A = total length of well 17'  
 B = length of well screen 7'  
 C = length of riser pipe 10'  
 D = stick-up at surface 2'

MONITORING WELL MW-2  
 DATE INSTALLED 3/28/95  
 DRILLER/RIG HSA  
 GROUND SURFACE ELEV. 95.96  
 WATER LEVELS  
 static: \_\_\_\_\_

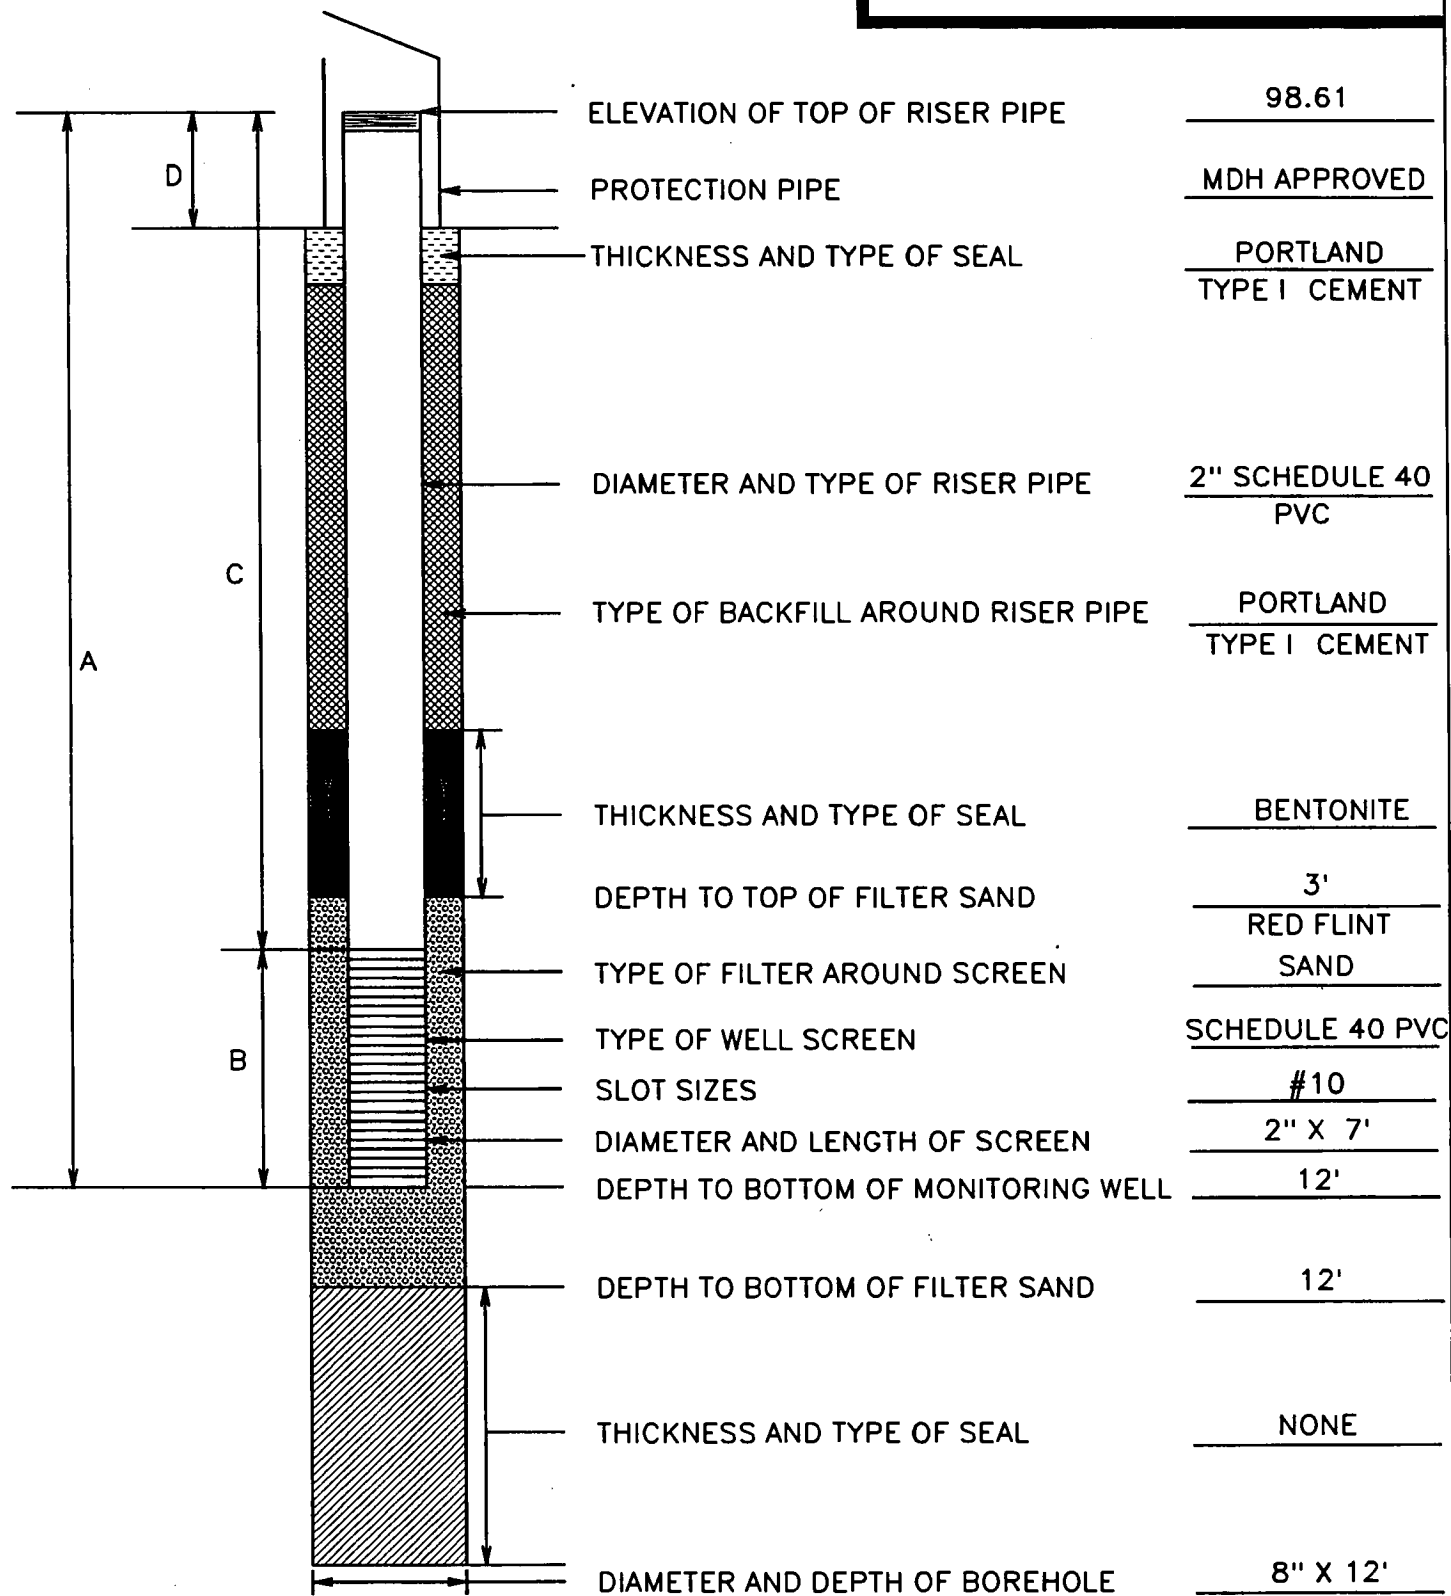
SITE NAME LESTER PARK GOLF COURSE  
 MINNESOTA UNIQUE WELL NO. 559218  
 A = total length of well 14'  
 B = length of well screen 7'  
 C = length of riser pipe 7'  
 D = stick-up at surface 2'

MONITORING WELL MW-3  
 DATE INSTALLED 3/28/95  
 DRILLER/RIG HSA  
 GROUND SURFACE ELEV. 96.34'  
 WATER LEVELS  
 static: \_\_\_\_\_

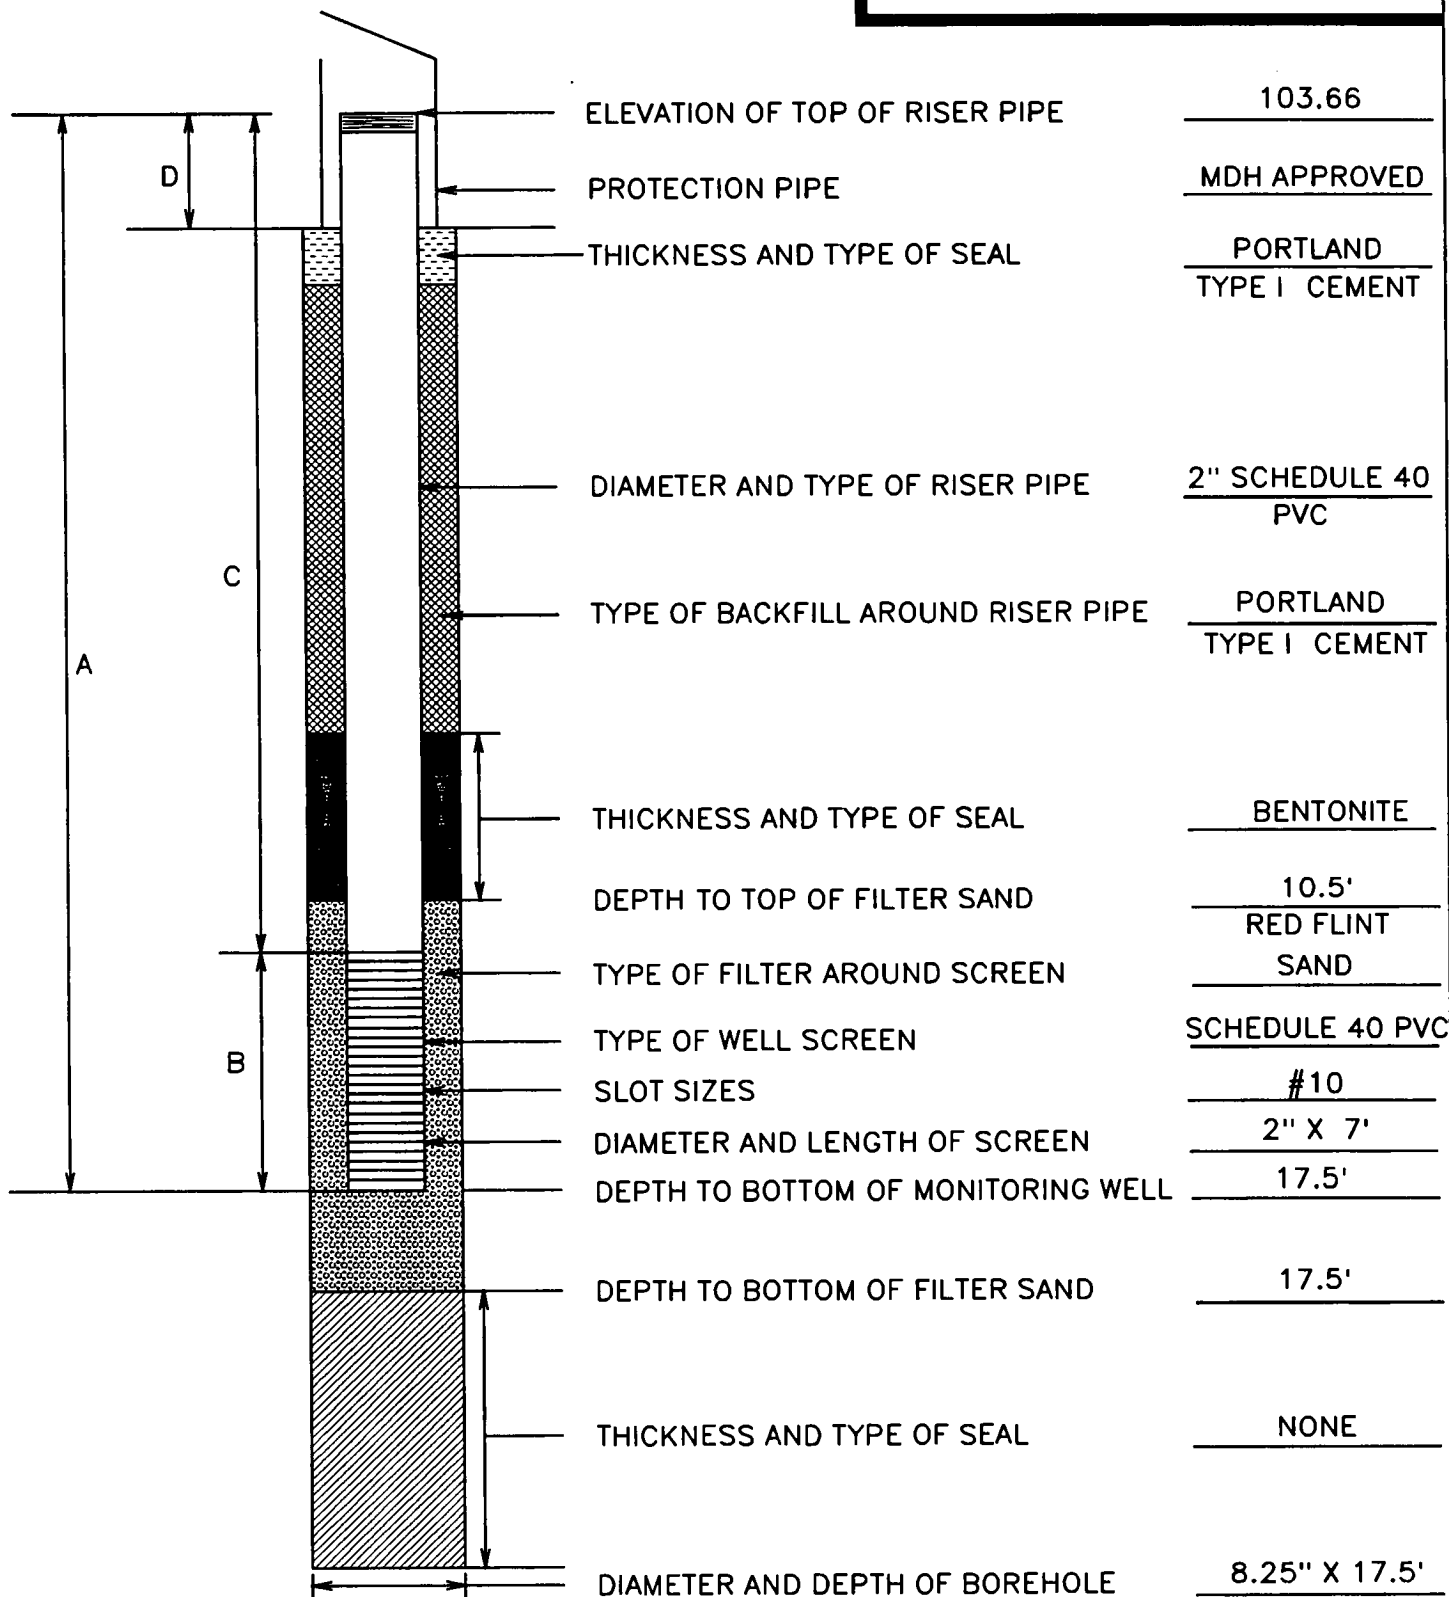
SITE NAME LESTER PARK GOLF COURSE  
 MINNESOTA UNIQUE WELL NO. 567885  
 A = total length of well 20'  
 B = length of well screen 5'  
 C = length of riser pipe 15'  
 D = stick-up at surface 2.5'

MONITORING WELL MW-4  
 DATE INSTALLED 4/29/96  
 DRILLER/RIG HSA  
 GROUND SURFACE ELEV. 100.88  
 WATER LEVELS  
 static: \_\_\_\_\_

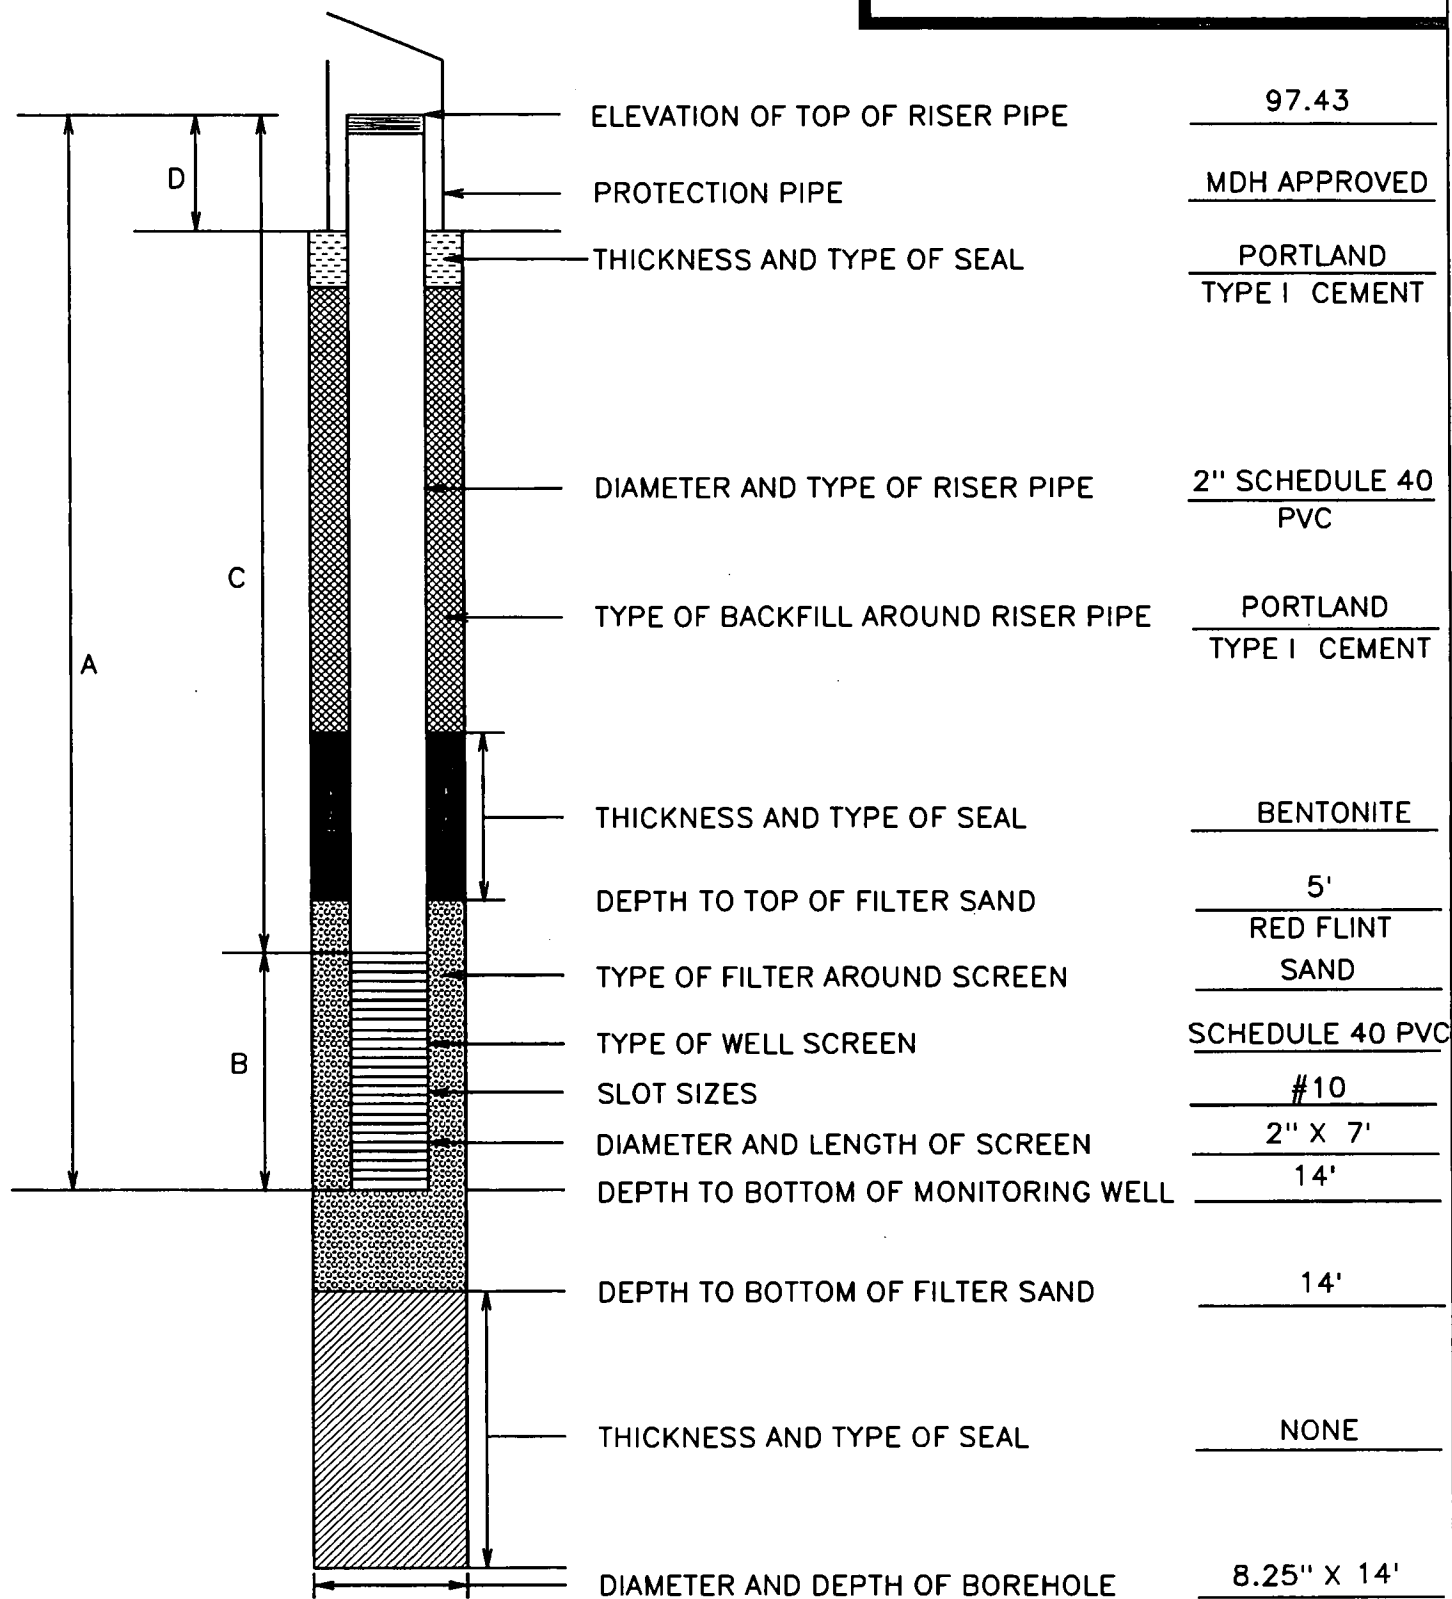
SITE NAME LESTER PARK GOLF COURSE  
 MINNESOTA UNIQUE WELL NO. 567886  
 A = total length of well 17'  
 B = length of well screen 7'  
 C = length of riser pipe 10'  
 D = stick-up at surface 3'

MONITORING WELL MW-5  
 DATE INSTALLED 4/29/96  
 DRILLER/RIG HSA  
 GROUND SURFACE ELEV. 94.25  
 WATER LEVELS  
 static: \_\_\_\_\_
