**Central Hillside Community Center**  
 Ext. Door & Window Replacement  
 12 East 4th Street

**CONSTRUCTION DOCUMENTS**

**DOOR & WINDOW DETAILS**

**A511**  
 15245.001

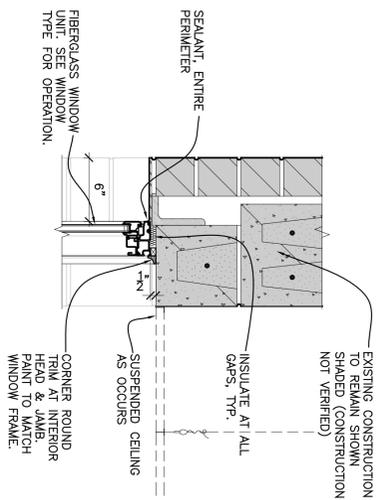
18 WDW - HEAD CONDITION AT FACE BRICK/CMU WALL  
 1/1/2" = 1'-0"

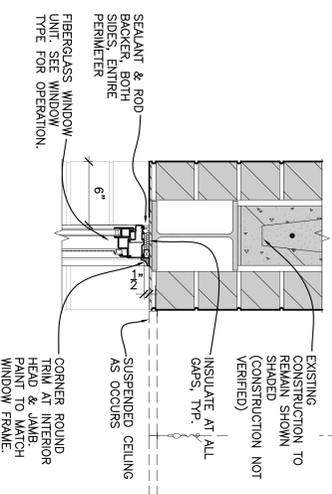
17 WDW - HEAD CONDITION AT BRICK/CMU/BRICK WALL  
 1/1/2" = 1'-0"

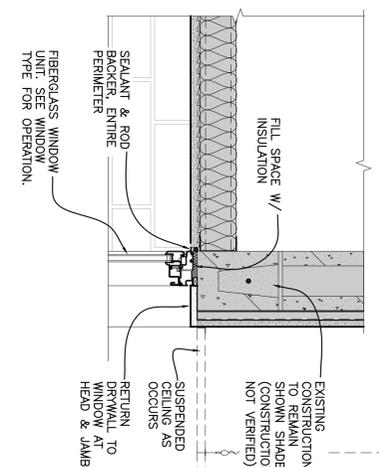
16 HEAD CONDITION AT BRICK/DRYWALL  
 1/1/2" = 1'-0"

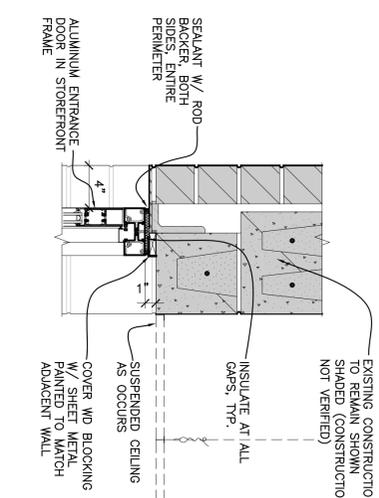
15 HEAD CONDITION AT ALUMINUM ENTRANCE DOOR  
 1/1/2" = 1'-0"

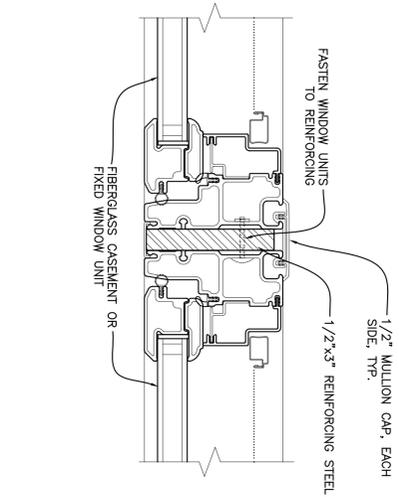
14 FIELD ASSEMBLED REINFORCED MULL  
 1" = 1'-0"

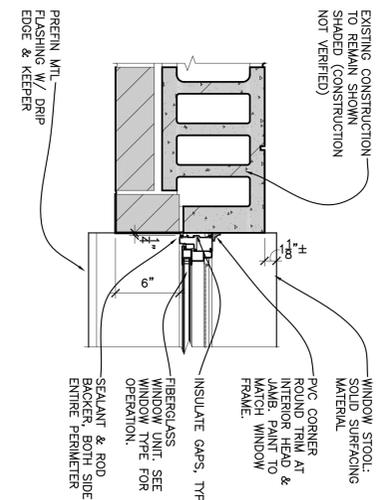
13 WDW - JAMB CONDITION AT FACE BRICK/CMU WALL  
 1/1/2" = 1'-0"

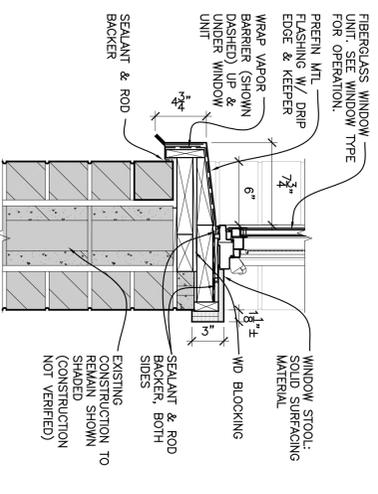
12 WDW - SILL CONDITION AT BRICK/CMU/BRICK WALL  
 1/1/2" = 1'-0"

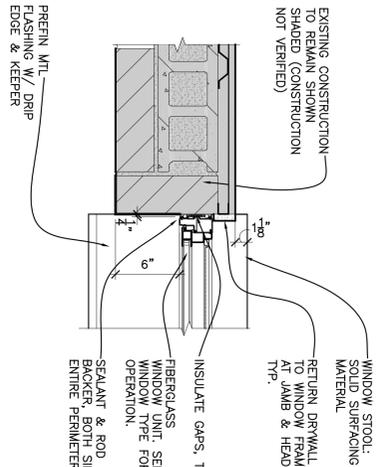
11 JAMB CONDITION AT BRICK/DRYWALL  
 1/1/2" = 1'-0"

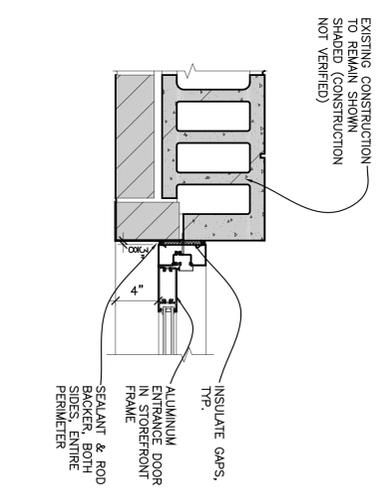
10 JAMB CONDITION AT ALUMINUM ENTRANCE DOOR  
 1/1/2" = 1'-0"

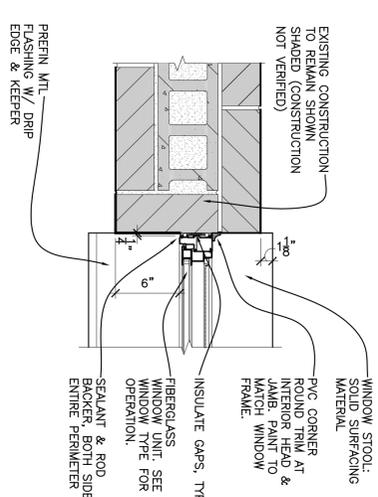
9 JAMB CONDITION AT BRICK/CMU/BRICK  
 1/1/2" = 1'-0"

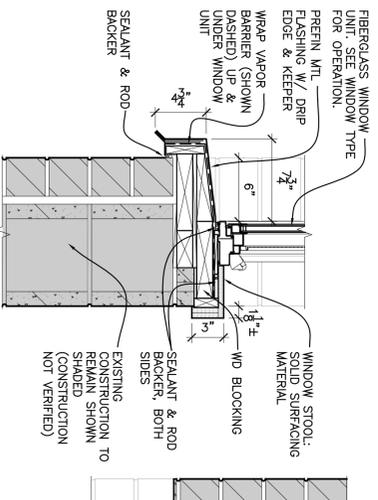
8 WDW - SILL CONDITION AT FACE BRICK/CMU WALL  
 1/1/2" = 1'-0"

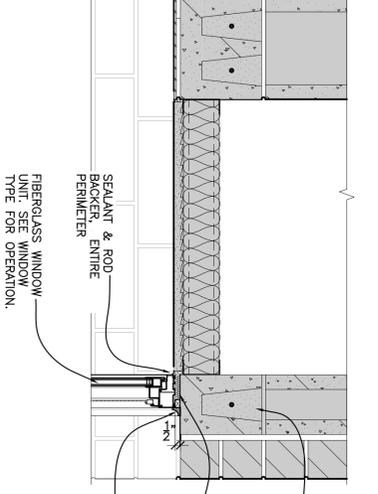
7 HEAD CONDITION AT RECESSED WINDOWS  
 1/1/2" = 1'-0"

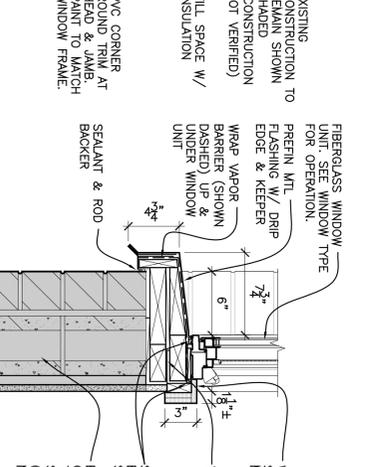
6 WDW - SILL CONDITION AT BRICK/DRYWALL  
 1/1/2" = 1'-0"

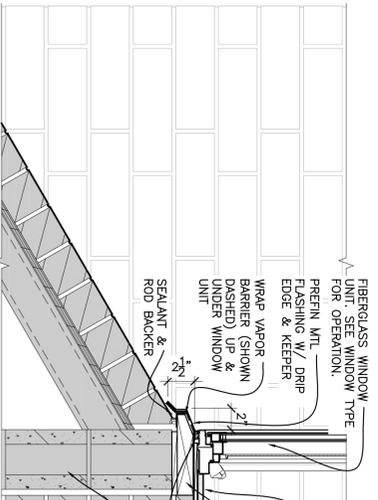
4 SILL CONDITION AT RECESSED WINDOWS  
 1/1/2" = 1'-0"

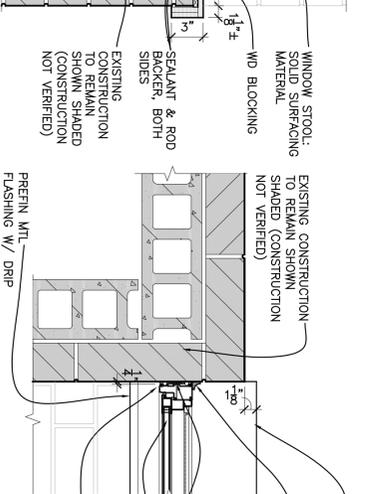
3 JAMB CONDITION AT RECESSED WINDOWS  
 1/1/2" = 1'-0"
