Keen Creek

Activities / Amenities

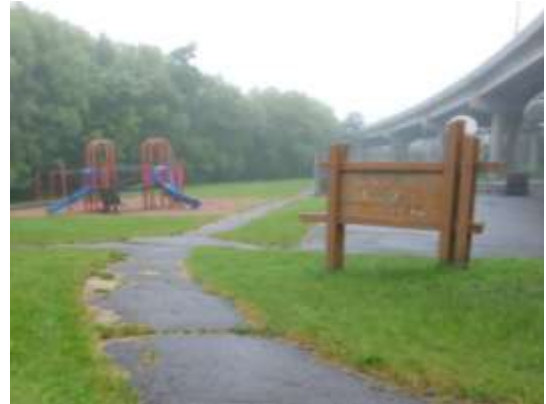
- Playground
- Skate Park
- Dog Park
- Basketball
- Tennis (abandoned)
- Parking (2)

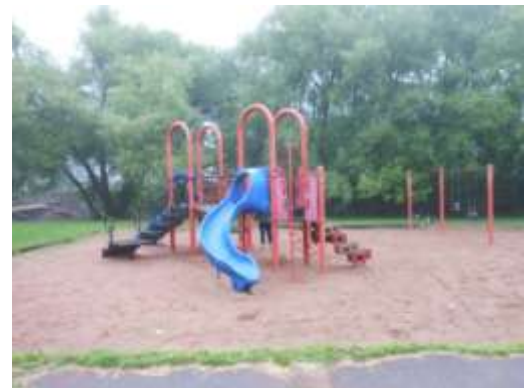
Defined Play Area

The defined play area includes 1 composite play structure, to-fro swings (2 strap style, 2 bucket style) and digger. An adequate quantity of ground level components have been provided. *This is a good example of accessibility.*

Loose fill sand is used throughout the defined play area.

Priority 2- Replace the loose fill sand with a surface material with a type that complies with ASTM 1292 for impact attenuation and ASTM 1951 for accessibility. *ADA 206.2.17*

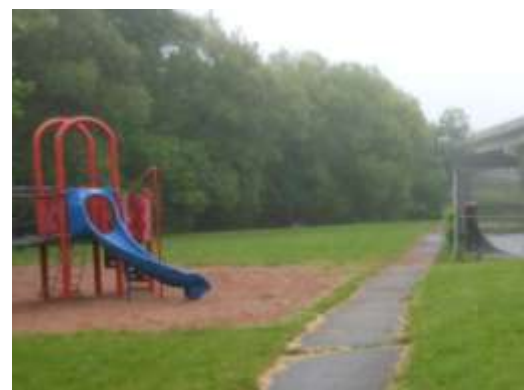
The defined play area is located adjacent to the accessible route. The plant material is currently overgrown, creating a barrier between the accessible route and the defined play area.

Priority 2- Remove the plant material to create an accessible route into the defined play area. *ADA 206.2.2*

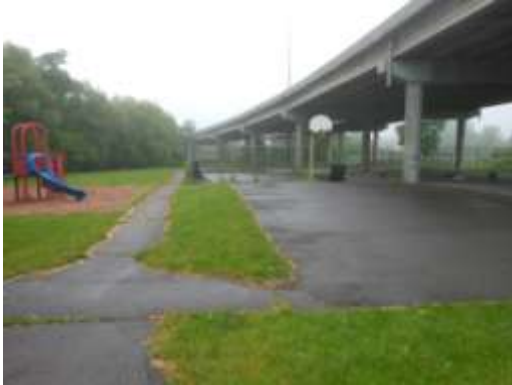
Basketball

An accessible route is currently provided from the east parking lot to the basketball court. *This is a good example of accessibility.*

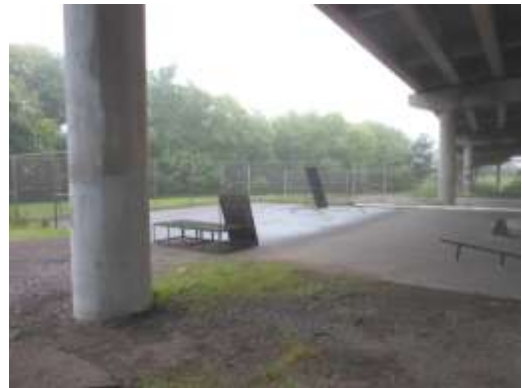
An accessible route is not currently provided to the boundary skate park.

Priority 3- Create an accessible route to the skate park. (Approximately 20'). ADA 206.2.2

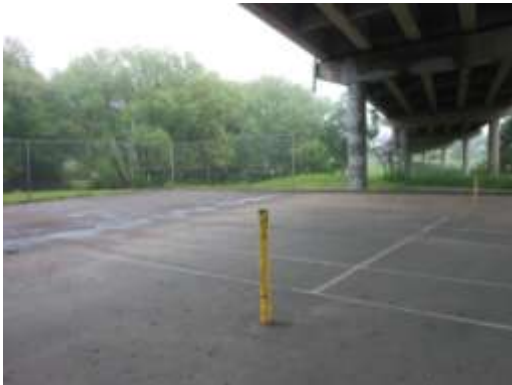
Tennis

An accessible route is not currently provided to the tennis court. It appears that the tennis court is currently abandoned.

Priority 3- If the tennis courts are used, create an accessible route. ADA 206.2.2

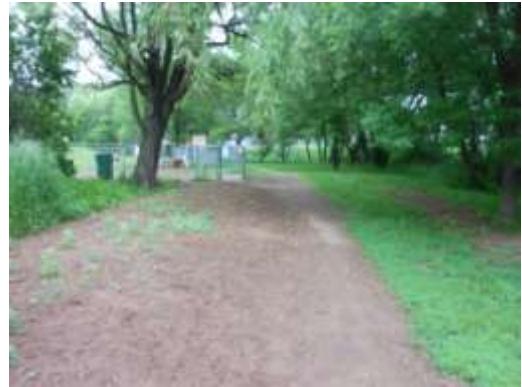
A hard surface accessible route is provided to the entry gate of the dog park. The route is currently covered with sand and dirt.

Priority 2- Clear the sand and dirt to create an accessible route to the dog park entry from the west parking lot. *ADA 206.2.2, 302.1*

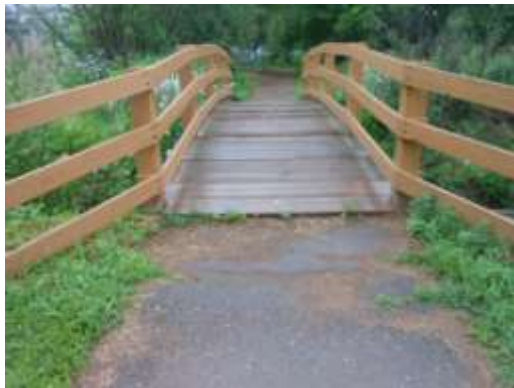
Bridge

There is a bridge over the Keen Creek that connects the east and west sides of the park. There is currently a 1" rise where the asphalt meets the wood surface.

Priority 3- Replace the boards of the bridge so the space does not exceed 1/2". *ADA 302.3*

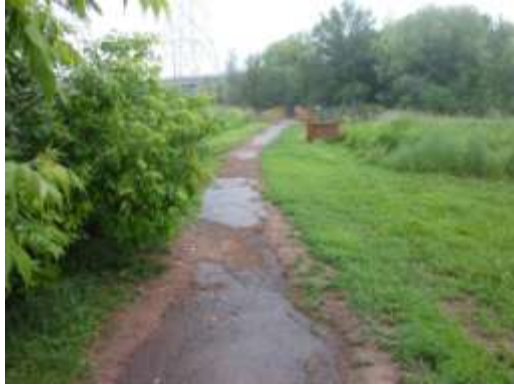
The spacing between the boards of the bridge is currently as much as 1".

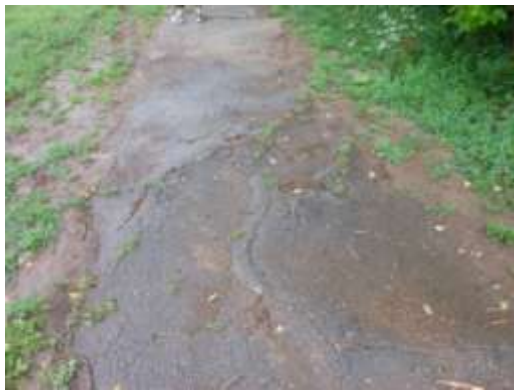
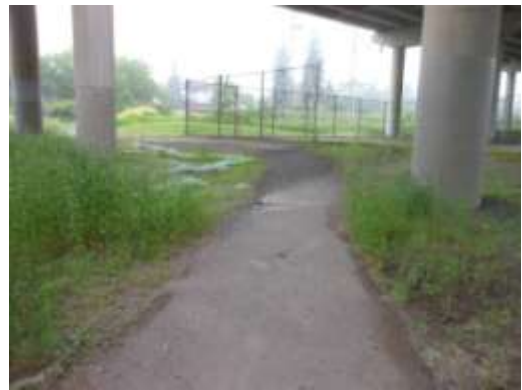
The route throughout the park is currently showing signs of damage and deterioration. There are rises exceeding 1/2" where tree roots have grown below the accessible route and washed-out segments.

Priority 2- Patch and repair the hard surface route.
ADA 303, 302.1

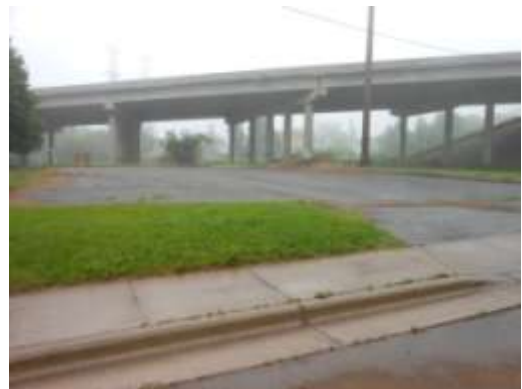
The parking lot on the east side of the park (near the playground) has room for approximately 20 vehicles (there is no striping). There is not currently any designated accessible parking.

Priority 2- Designate 1 accessible parking space.
ADA 208.2

Priority 2- Stripe the accessible parking spaces to provide an 8' wide minimum space with an 8' wide minimum aisle. MN1341 502.4.2

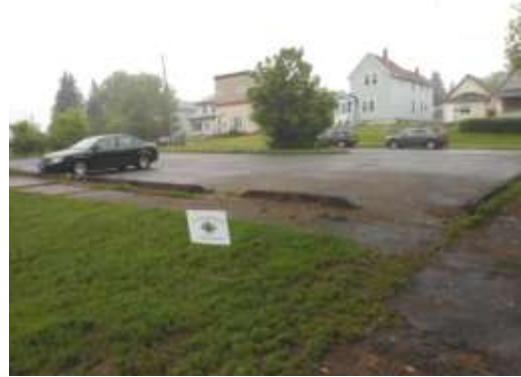
The parking lot on the west side of the park (near the dog park) has room for approximately 20 vehicles (there is no striping). There is not currently any designated accessible parking.

Priority 2- Designate 1 accessible parking space.
ADA 208.2

Priority 2- Stripe the accessible parking spaces to provide an 8' wide minimum space with an 8' wide minimum aisle. *MN1341 502.4.2*
