Duluth Streams Bacterial Source Identification Study Final Report

City of Duluth, Public Works and Utilities

**Duluth Streams Bacterial Source Identification Study
Project No. 118320**

8/19/2020

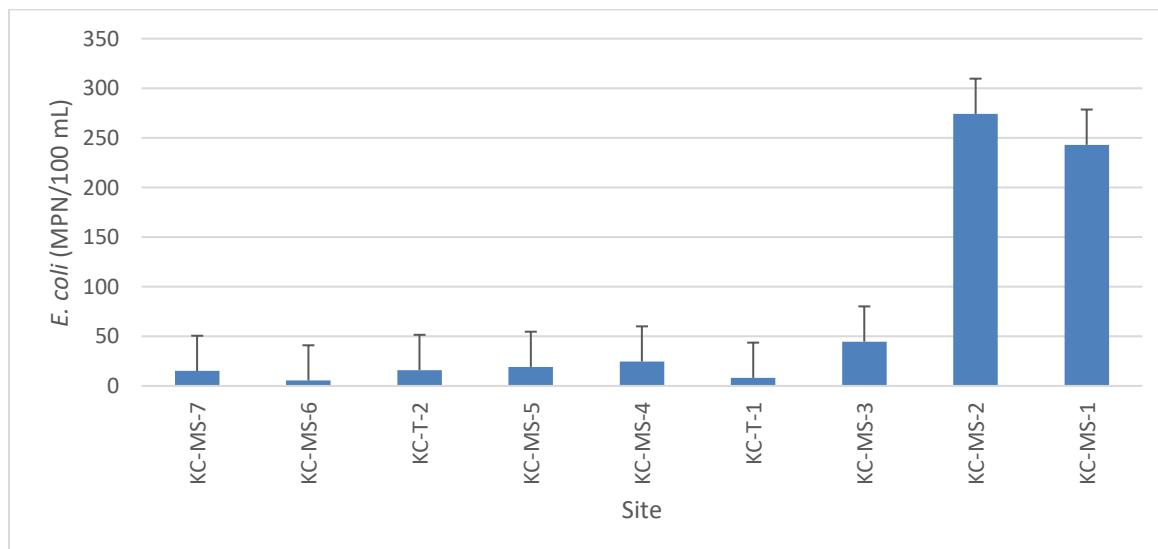
Figure 3-1: *E. coli* Geometric Mean Concentrations (+1 SE) at Keene Creek Monitoring Sites

Mean concentrations from samples collected over the course of the dry weather monitoring varied little and were low between Sites KC-MS-7 (upper-most portion of the Study Area) and KC-MS-3 (Keene Creek Dog Park). All individual samples except one were less than 100 MPN/100 mL at these sites and the geometric means were less than 50 MPN/100 mL. In contrast, geometric mean concentrations were much greater at the two sites at the bottom of the Keene Creek Study Area at Sites KC-MS-2 and KC-MS-1, which had geometric mean concentrations of 274.2 and 243.1 MPN/100 mL, respectively.

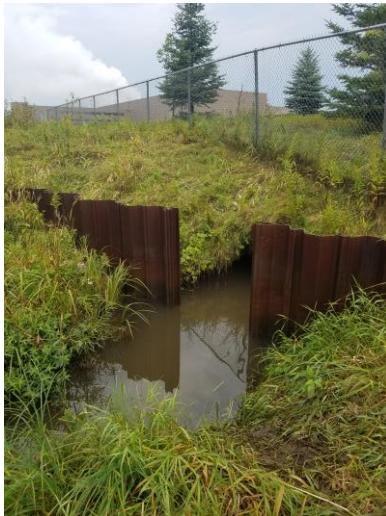
- **Paper mill tributary (MS-1 reach)** – A tributary originating from the paper mill property that lies to the north of the mouth of Keene Creek discharges to the creek (left bank) approximately 100 feet above the historical MS-1 monitoring site (S004-968). Water quality appeared to be very poor in this discharge water, which had a thick, oily sheen on the surface and very loose, anoxic streambed sediments.

Inlet from paper plant at MS-1

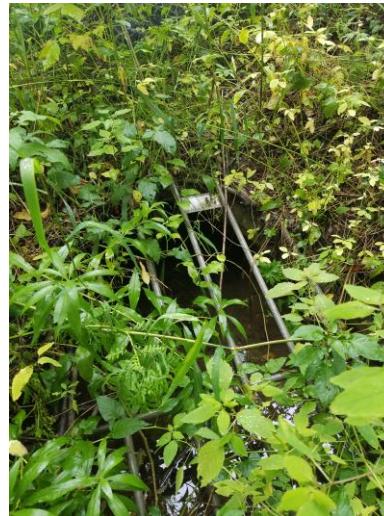
- **Wetland discharge (MS-1 reach)** – Approximately 350 feet upstream of Site S004-968, is an outfall on the left bank of Keene Creek that drains water from a wetland on the opposite side of the bike path that parallels the creek. The wetland contained large amounts of ponded water with decaying organic debris and degraded habitat that can serve as a source of *E. coli* via bacterial regrowth. The outfall had a minor but persistent flow from the wetland to the creek during the sanitary survey.

Inlet from wetland at MS-1

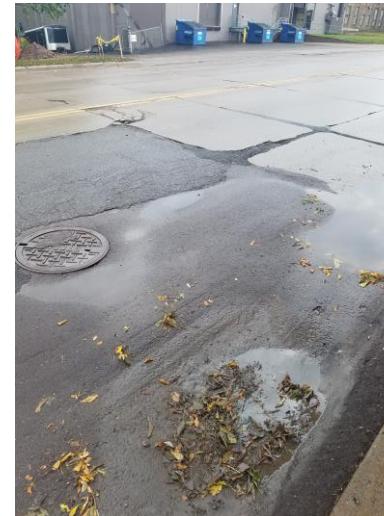
Decaying plant material in the catch basin inlets was a frequent observation in reaches MS-1 and MS-2 of Keene Creek. Leaf litter and sediment clogged catch basin inlets were observed where Keene crosses South Central Avenue, South 57th Avenue West, and South 59th Avenue West. Flow from these catch basins discharges directly to the creek. Similar observations of excessive street debris were noted at Waseca Industrial Road (near South Central Avenue, reach MS-1), the end of South 56th Avenue (right bank, reach MS-2), and North 61st Avenue West and Roosevelt Street (reach MS-4).

Clogged catch basin at MS-1

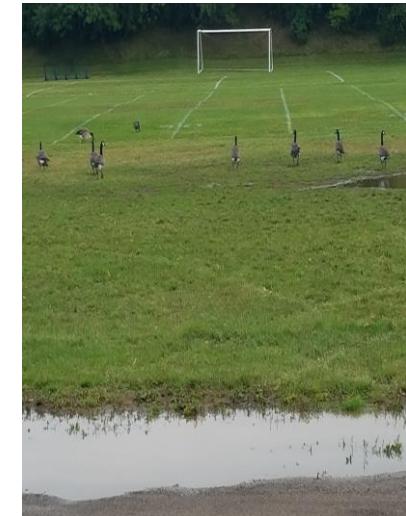
A variety of songbirds and crows were observed in the Study Area, but sightings were relatively minimal. A population of Canadian geese was observed consistently at Irving Park (MS-2 reach) and large amounts of goose waste were observed in the soccer field and adjacent park area. There is a small detention basin to the west of the soccer field with a catch basin inlet for overflow water and goose waste was observed in and around the basin. There is also a small catch basin inlet on the south side of the soccer field. It is unclear how these catch basins drain to Keene Creek, but there is a small six-inch PVC line directly on the other side of the riparian buffer from the southern catch basin that discharges directly to the creek. Minimal flow was emanating from the pipe during the sanitary survey (and subsequent observations) and the storm drain appeared to be flooded. The drain may be partially clogged, but when flowing, would represent a pathway for *E. coli* associated with the goose waste from the soccer field, park, and detention basin to enter Keene Creek. Approximately 300 feet downstream from this discharge is another six-inch blue PVC pipe that appears to also originate from the soccer field. The pipe was not flowing during any of the observation days and no catch basin inlet could be found in the soccer field or adjacent area. No other wildlife (including other birds) were observed in large numbers anywhere in the Study Area.

Geese in Irving Park at top of MS-1

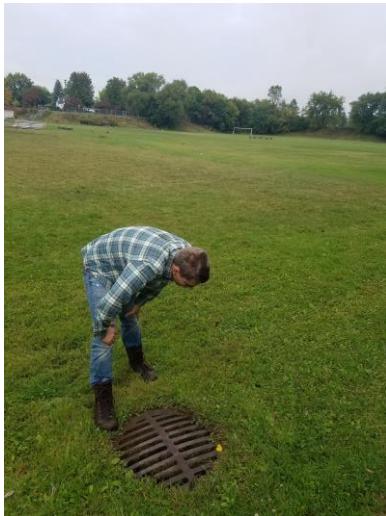
Catch basin at soccer field

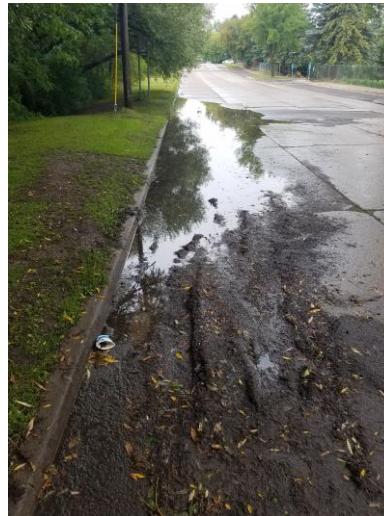
Clogged inlet at MS-2

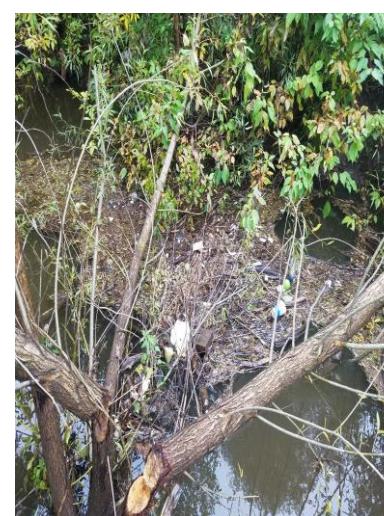
- **Degraded habitat (MS-2 reach)** – The lower portion of reach MS-2 (from South 57th Avenue West to South 59th Avenue West) is severely degraded. This portion of the reach flows directly under two transmission line towers whose foundation impede flow and trap sediment. The streambanks are severely eroded in several places and decaying vegetation has filled the stream. Several storm drain outfalls discharge directly to this part of the MS-2 reach and it is characterized by fine-grained sediment in the streambed, sluggish flow, and very turbid water.

Degraded habitat at MS-2

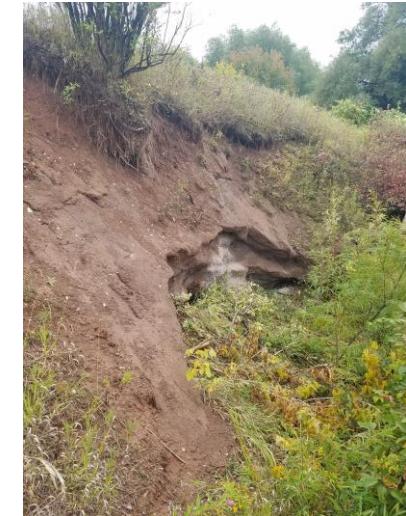
- **Severe erosion (MS-2 reach)** – At the top of reach MS-2, just downstream of Grand Avenue is an abandoned railroad line. The area where the railroad crosses Keene Creek is characterized by severe erosion on the upstream side of the crossing (Particularly the left bank) and decaying vegetation has filled the stream in several areas.

Bank erosion at top of MS-2

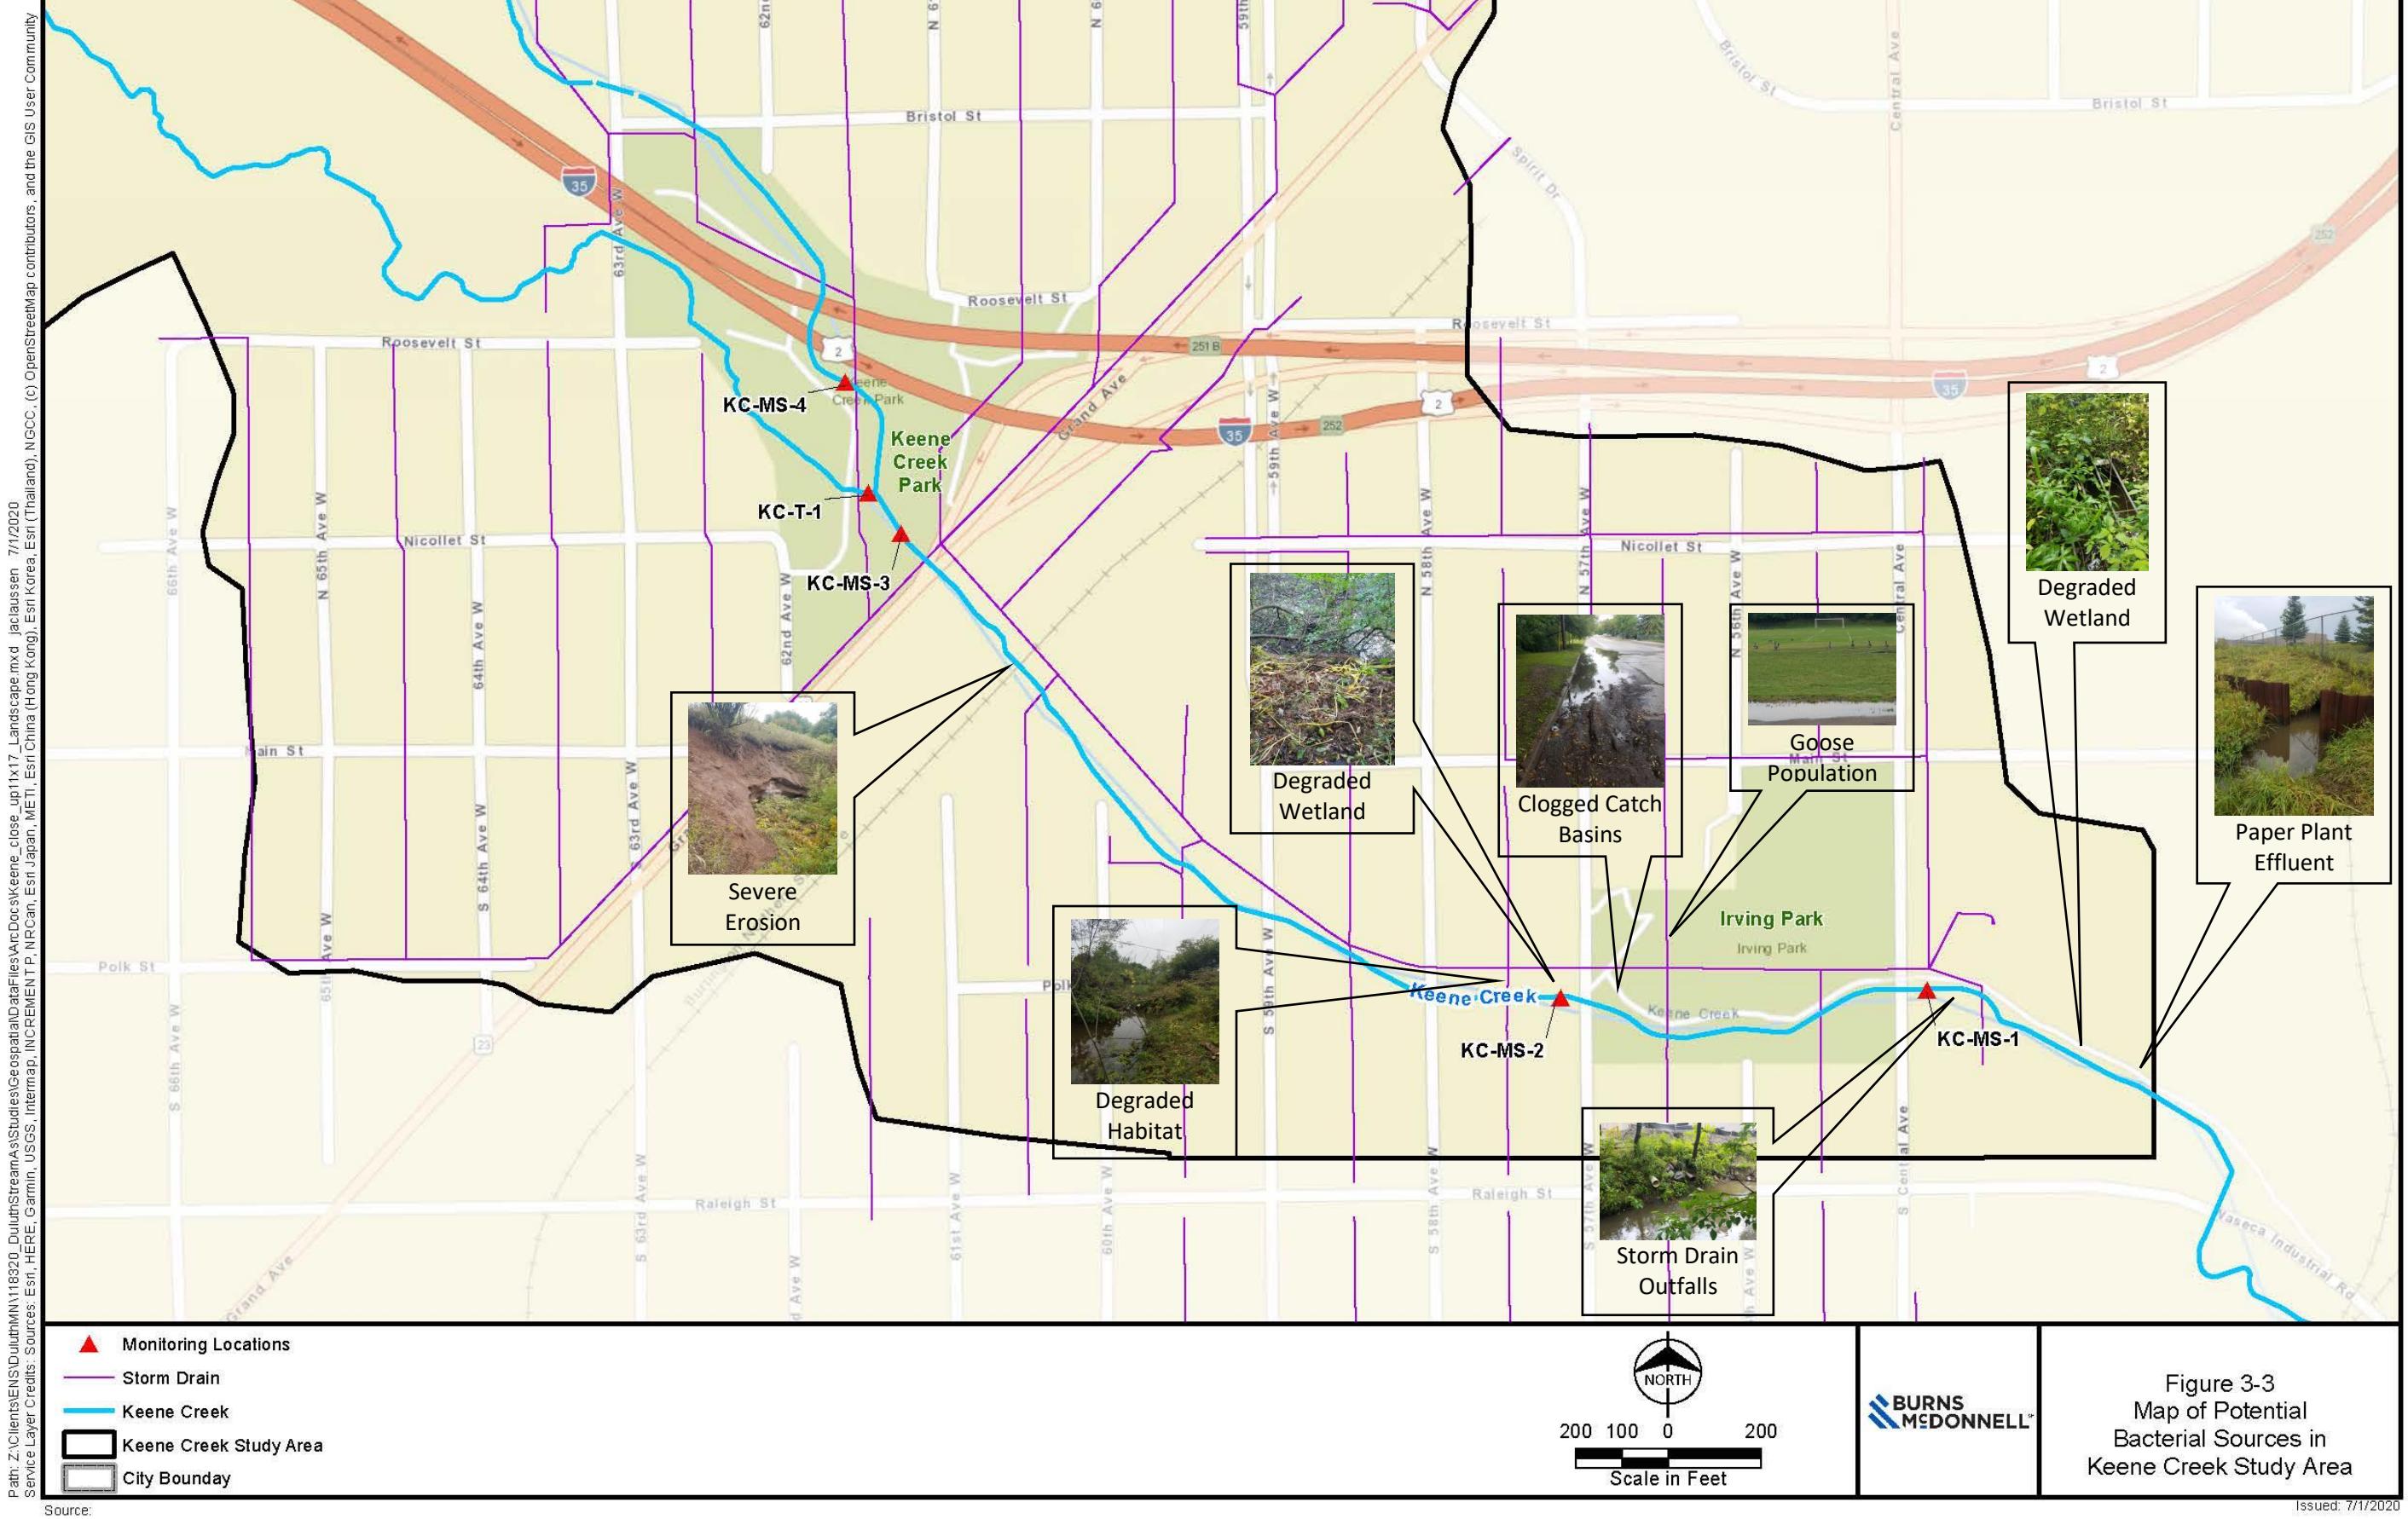
A map of the potential sources of *E. coli* identified in the Keene Creek Study Area is shown on Figure 3-3.

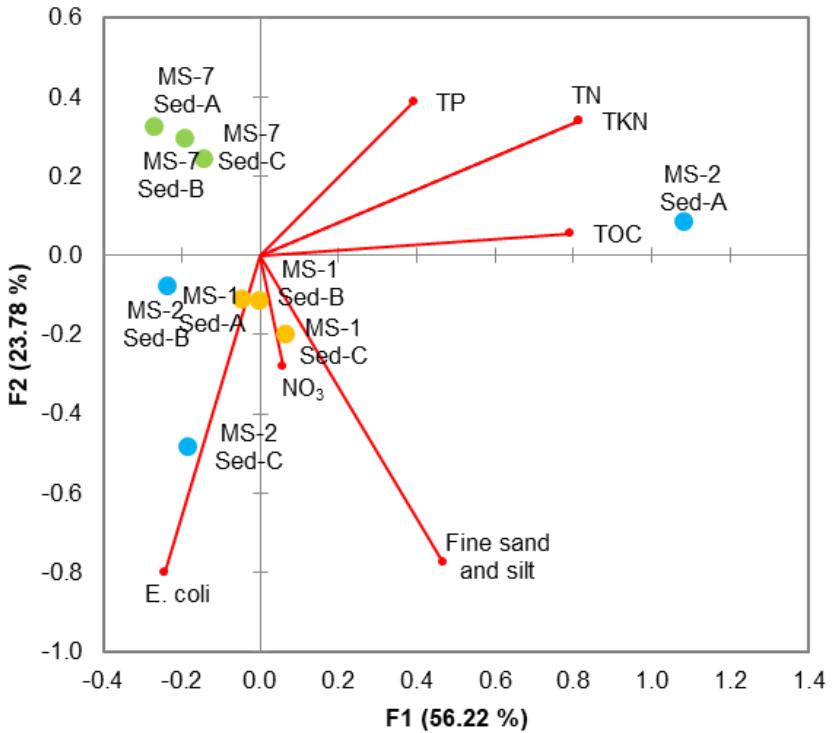
Figure 3-5: Keene Creek Canonical Correspondence Analysis Results for Sediment Samples

Sediment samples also tended to cluster by site. In streambed sediment, MS-1 and MS-2 samples tended to be associated with elevated concentrations of *E. coli*, and NO₃, as well as higher percentages of fine-grained sediment (fine sand and silt).

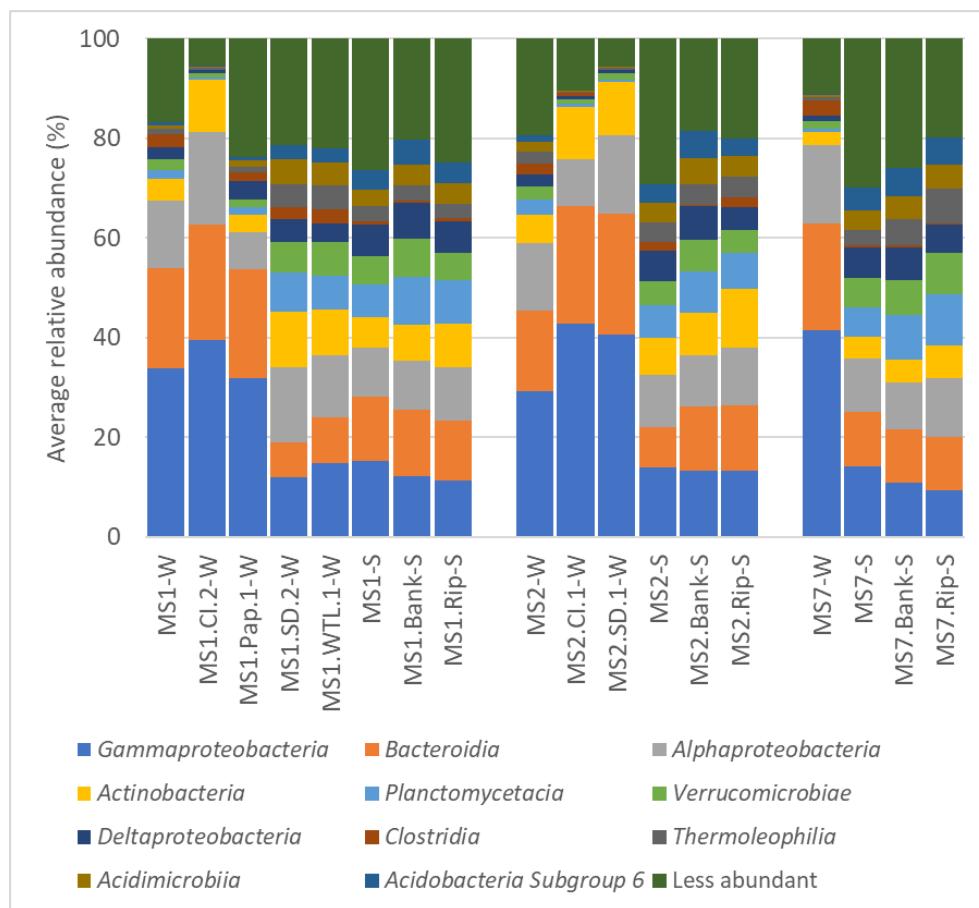
Figure 3-6: Keene Creek Bacterial Community Composition (Class Level)

The results of the bacterial community composition analysis are presented on Figure 3-6. Bacterial communities in water and sediment samples mostly consisted of members of the classes *Gammaproteobacteria*, *Bacteroidia*, *Alphaproteobacteria* and *Actinobacteria*. In general, water samples harbored a greater relative abundance of *Gammaproteobacteria*, whereas sediment samples were enriched with *Planctomycetacia*, *Verrucomicrobiae*, *Deltaproteobacteria*, *Thermoleophila*, *Acidimicrobiia*, and *Acidobacteria Subgroup 6*. The genus *Escherichia-Shigella* was detected in water samples from catch basin inlets and storm drains in both MS-1 and MS-2 reaches (data not shown). Microbial community patterns were generally similar for receiving water samples collected from MS-1 (MS-1-W), MS-2 (MS-2-W), and MS-7 (MS-7-W), although the MS-7 water samples tended to be slightly less diverse than the urbanized sites. Similarly, sediment samples tended to have similar microbial communities regardless of the reach from which it was collected. The exception to this was water samples collected from MS-1-SD-2 (storm drain) and MS-1-WTL-1 (wetland), both of which had microbial communities similar to those observed in sediment samples.

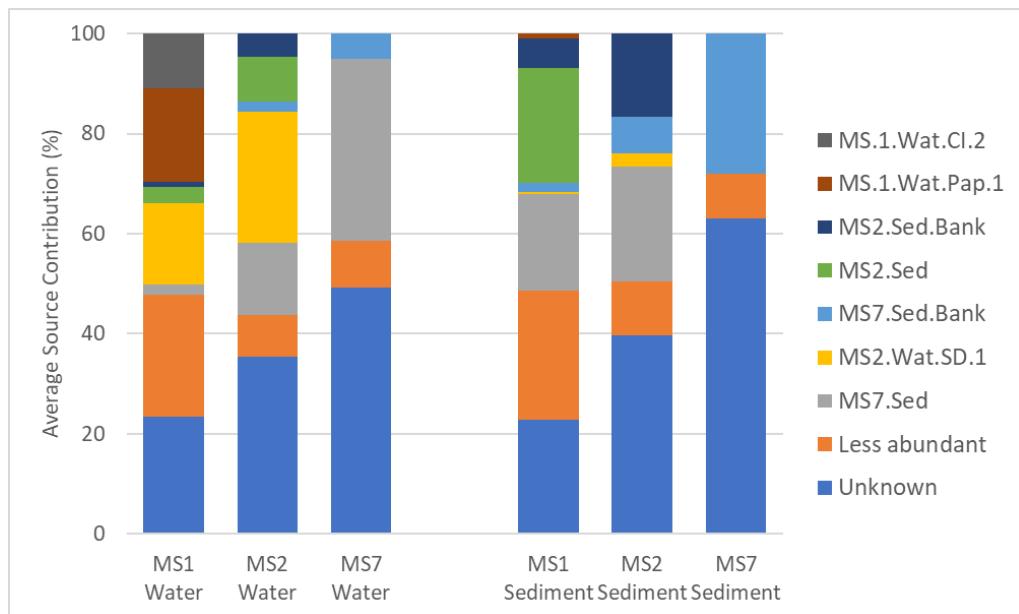
Figure 3-7: Graphic of Mean Percentage of Source Contributions to Keene Creek

The major sources of all sediment sinks originated from sediment sources. For example, the major sources of bacteria to Keene Creek streambed sediment in the MS-1 reach were streambed sediments collected from MS-2 (23.1 percent) and MS-7 (19.3 percent). For MS-2 streambed sediment, the major sources were identified as streambed sediment form MS-7 (23.1 percent) and bank sediment from MS-2 (16.6 percent). For MS-7 streambed sediment, the major identified source was MS-7 bank sediment (28 percent), with a large proportion of unknown sources. Contributions from suspected water sources to streambed sediment were small at all three sites.

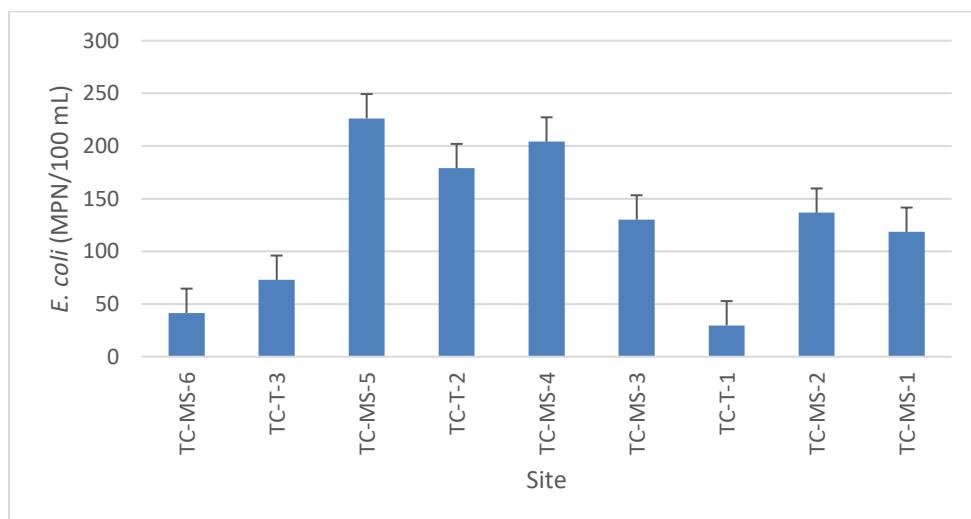
Figure 3-8: *E. coli* Geometric Mean Concentrations (+1 SE) at Tischer Creek Monitoring Sites

Mean concentrations from samples collected over the course of the dry weather monitoring at Tischer Creek were lowest at the upper-most mainstem site in the Study Area (Site TC-MS-6) and tributary sites TC-T-1 and TC-T-3. Over the course of the baseline monitoring at these three sites, concentrations from individual samples were less than 100 MPN/100 mL except for one sample collected at TC-T-3 (which had a value of 102 MPN/100 mL). The greatest mean concentrations were observed at mainstem sites TC-MS-5, TC-MS-4 (just downstream of TC-MS-5) and tributary site TC-T-2. Geometric mean values for these sites were 222.6 MPN/100 mL, 204 MPN/100 mL, and 178.9 MPN/100 mL, respectively. The remaining sites had generally lower concentrations.

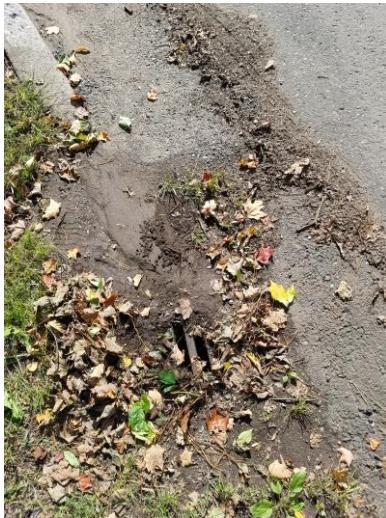
Clogged catch basin at MS-5

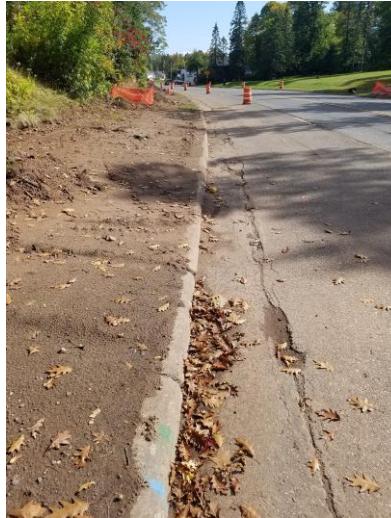
Construction sediment at MS-5

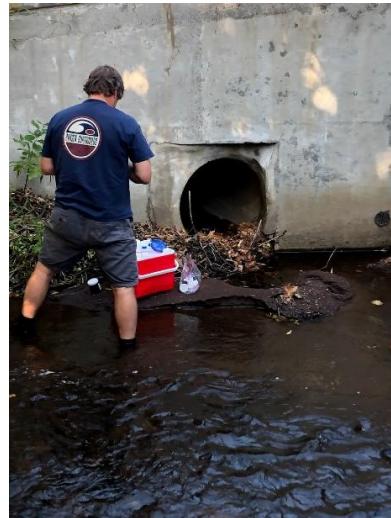
Storm drain outfall at MS-5

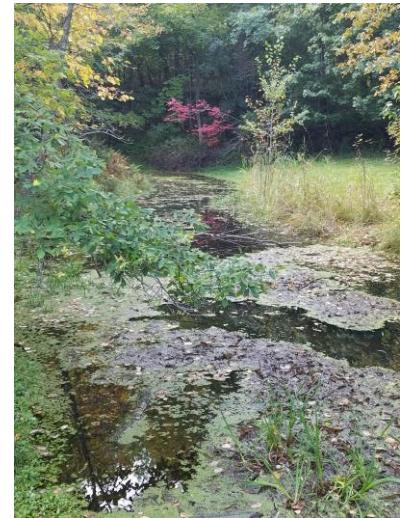
Wetland bog at upper MS-5

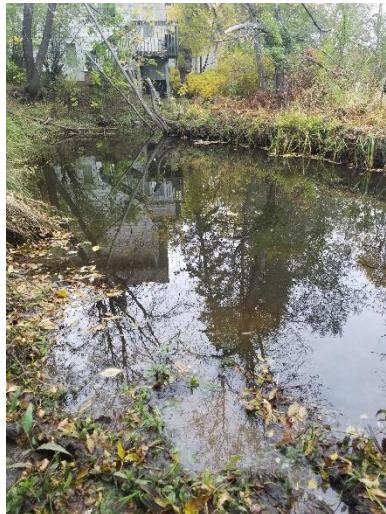
Degraded pond at T-2

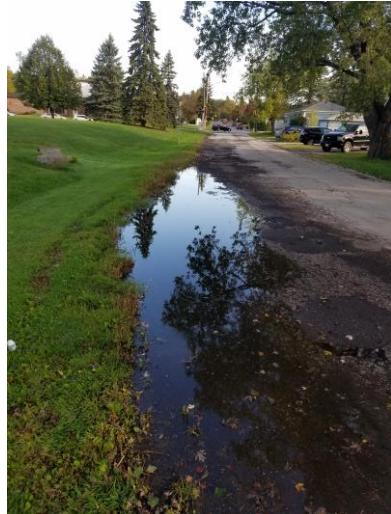
Ponded water that drains to T-2

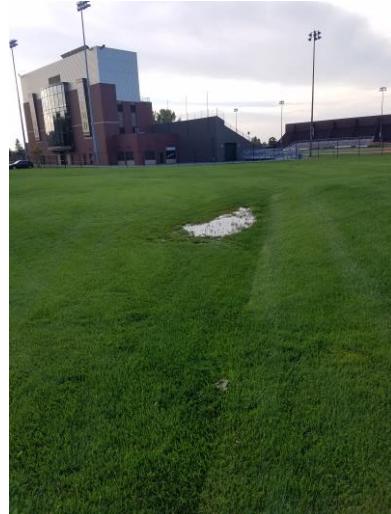
Grassy swale at T-2

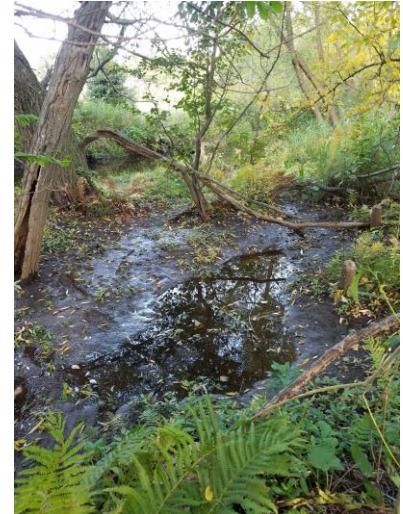
Wetland bog at T-2

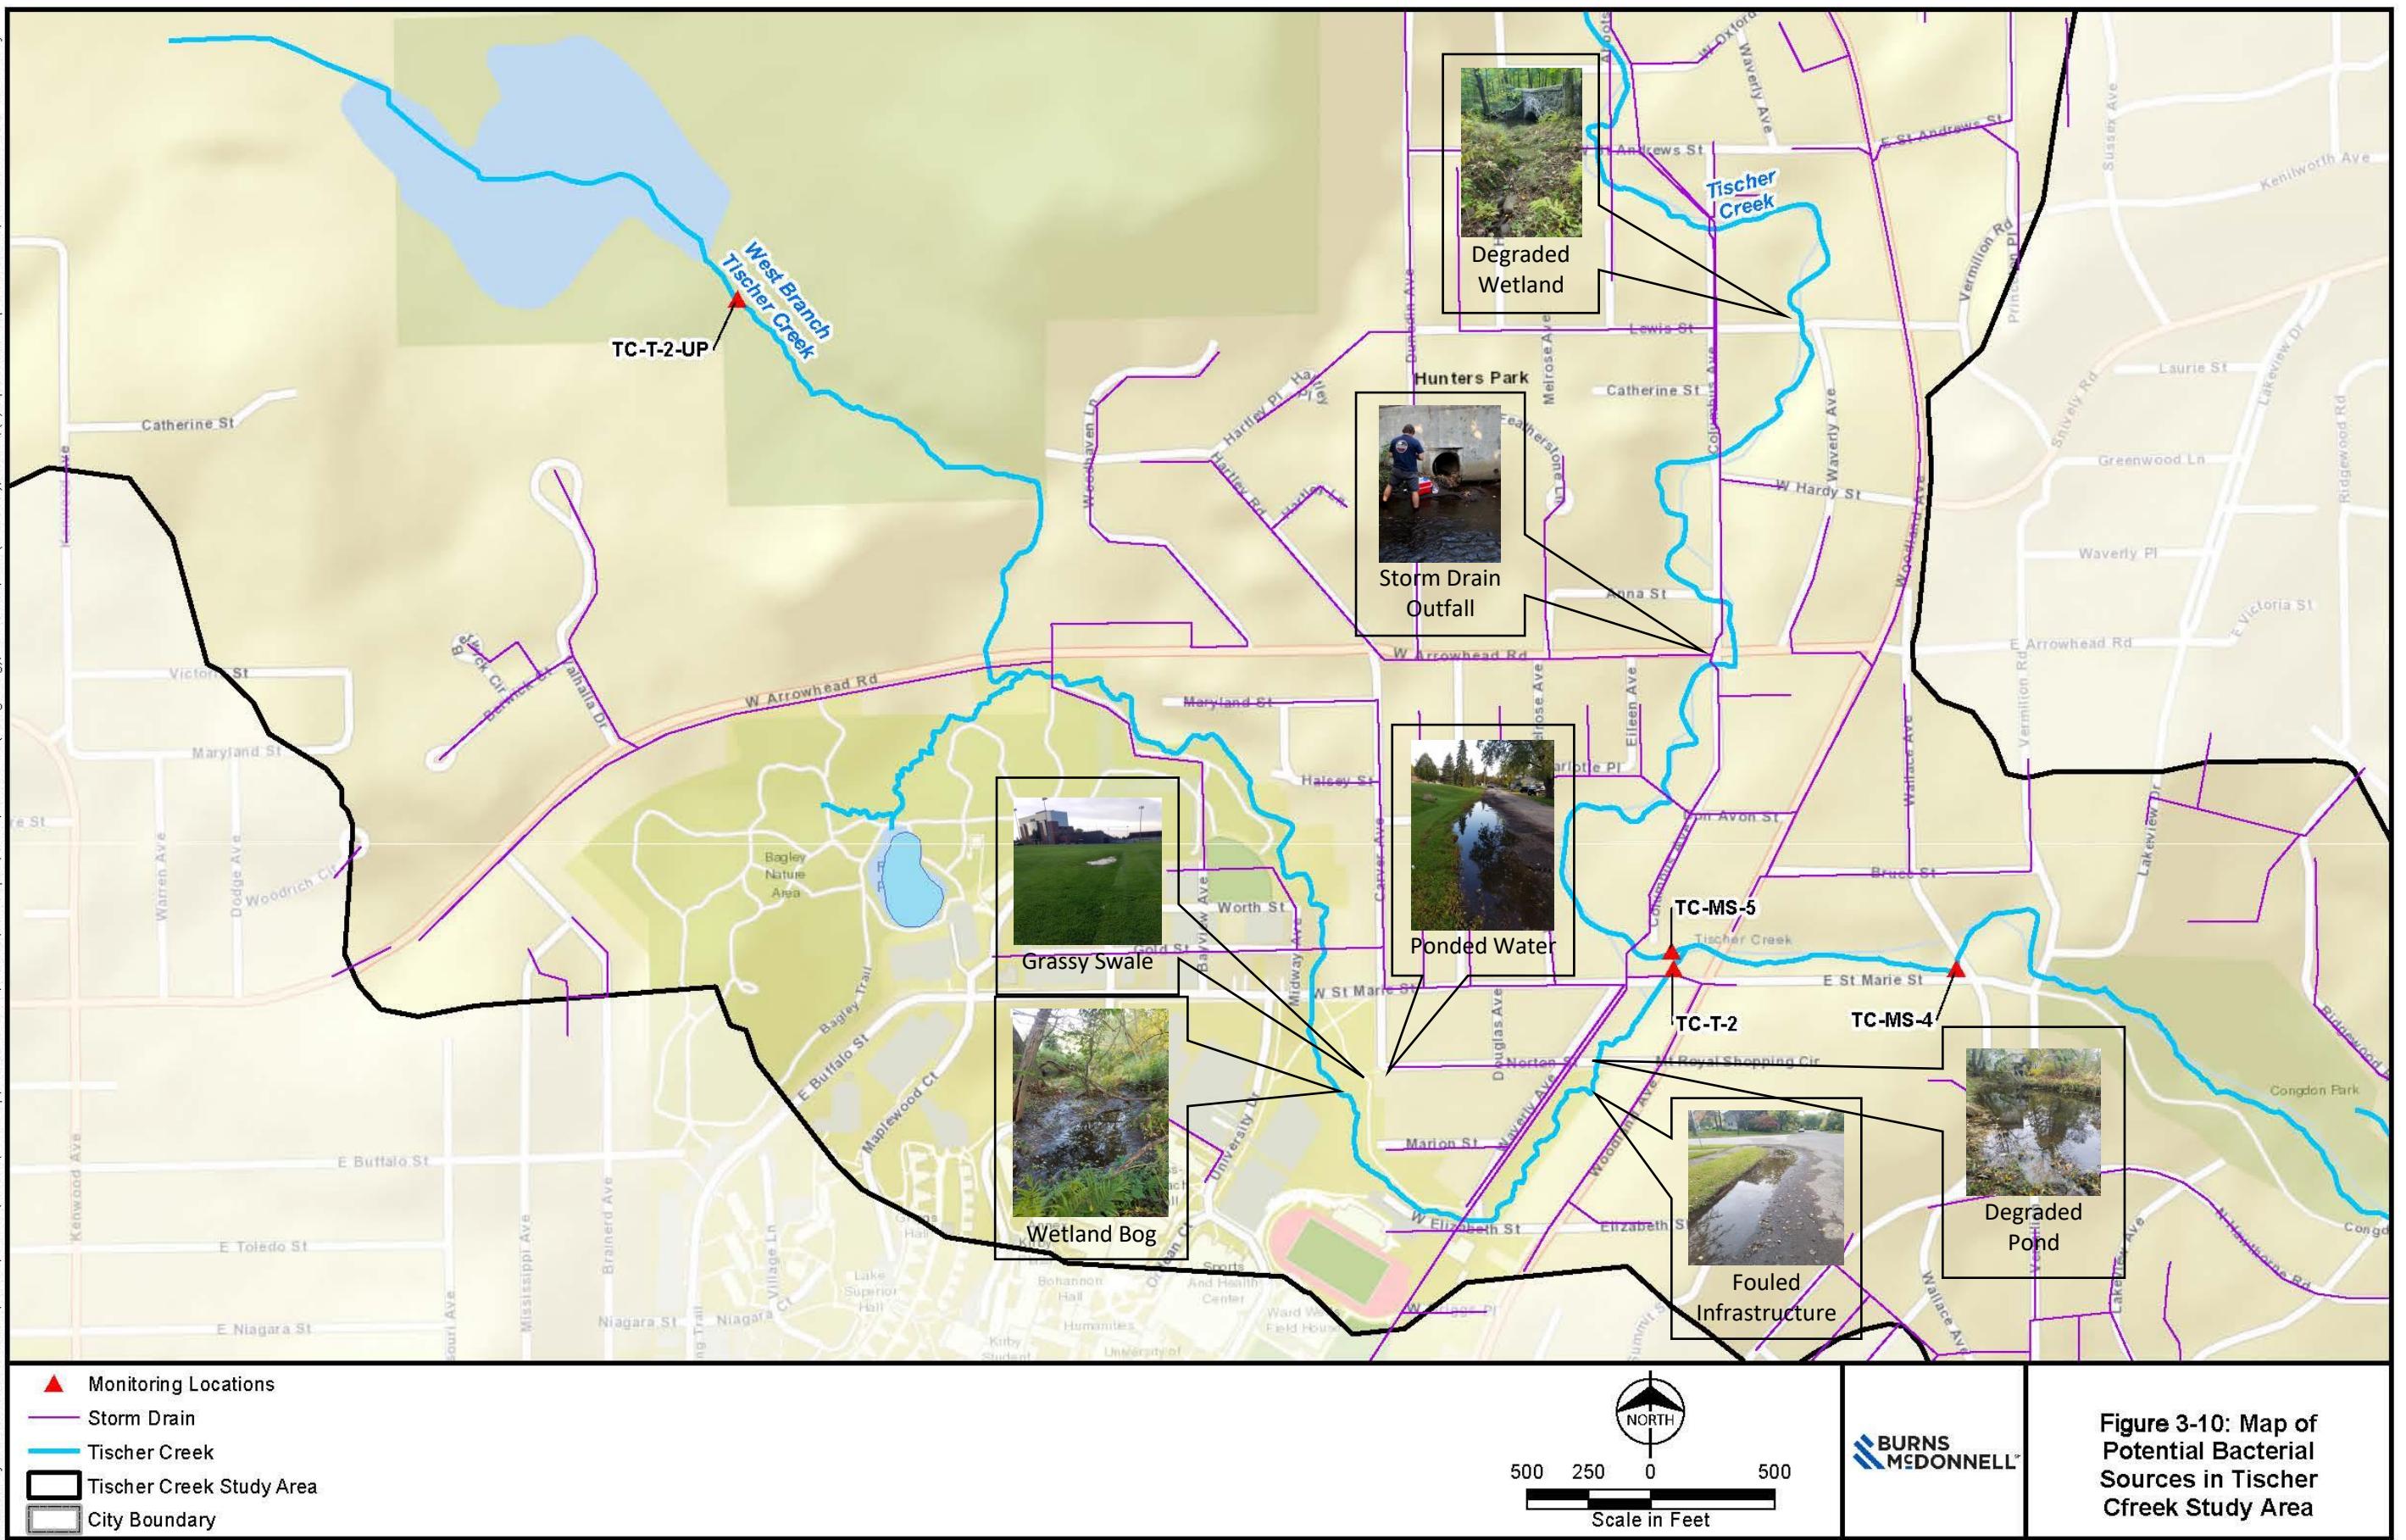
A map of the potential sources of *E. coli* in the Tischer Creek Study Area is shown on Figure 3-10.

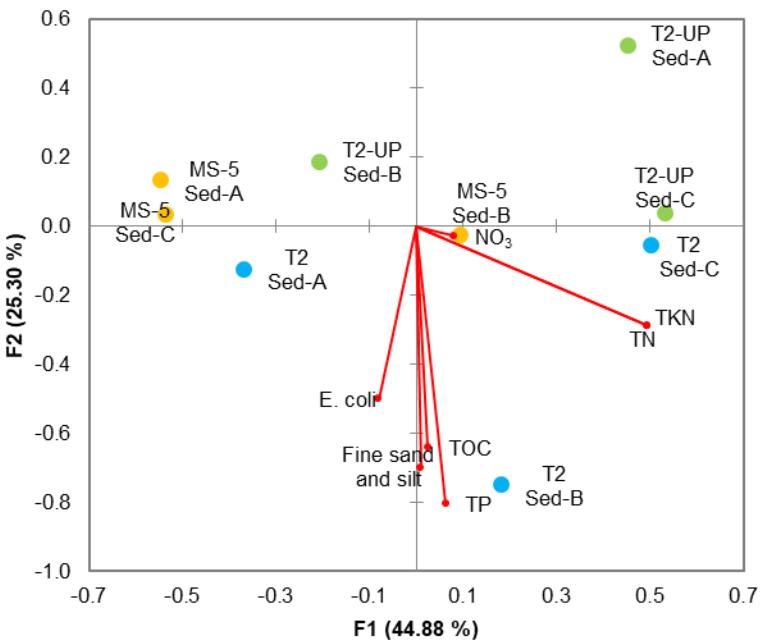
Figure 3-12: Tischer Creek Canonical Correspondence Analysis Results for Sediment Samples

Tischer Creek sediment samples also tended to cluster by site, although more loosely than the clusters seen for water. In streambed sediment, Sample T-2-Sed-B tended to be associated with elevated concentrations of *E. coli*, TP, TOC, as well as higher percentages of fine-grained sediment (fine sand and silt). Sample T-2-Sed-B was collected from the badly degraded pond (see Figure 3-9) upstream of the mouth of the T-2 tributary with the Tischer Creek at Norton Street. Sediments in the pond appeared to have large amounts of decaying organic material, a very fine grain size, and had a hydrogen sulfide odor.

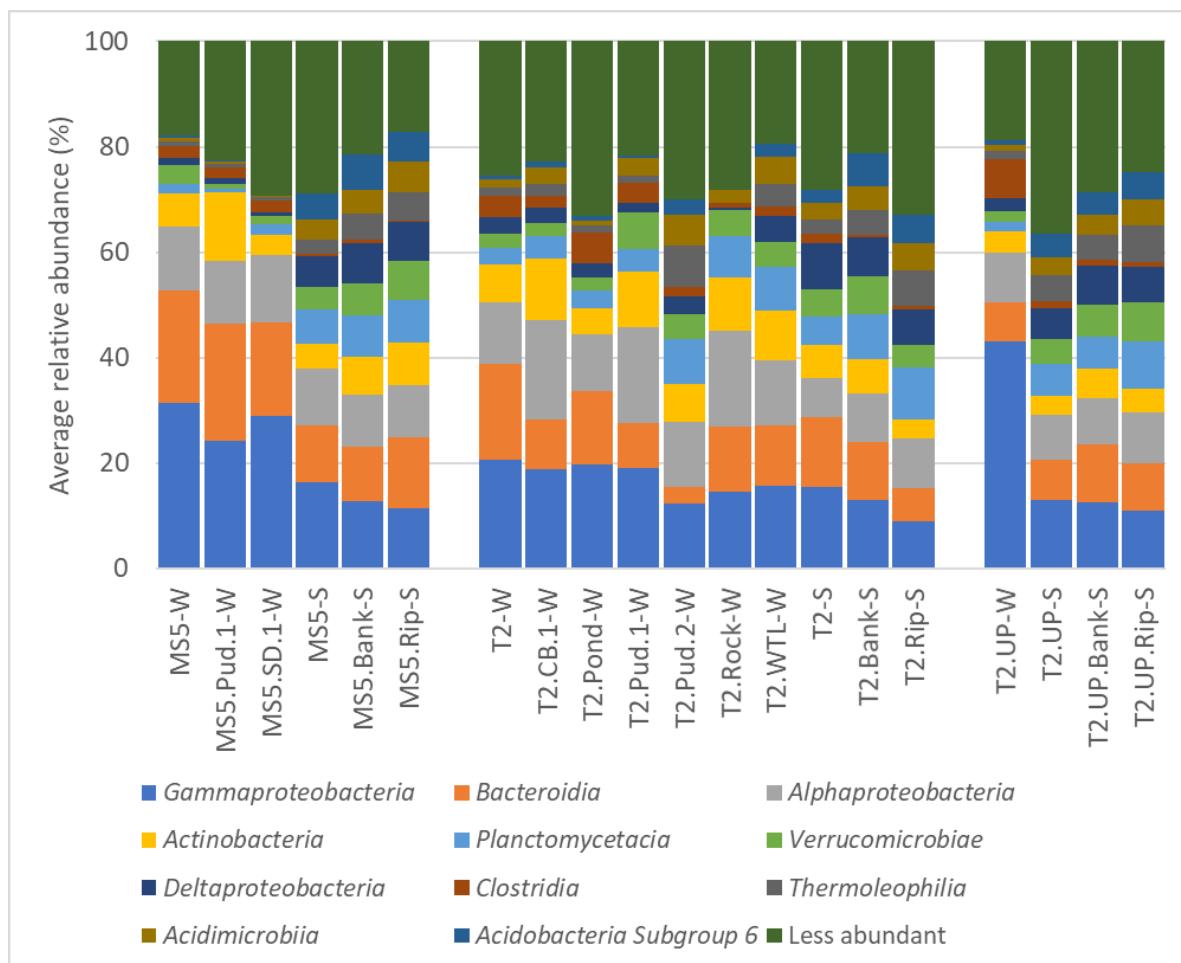
Figure 3-13: Tischer Creek Bacterial Community Composition (Class Level)

The results of the bacterial community composition analysis are presented on Figure 3-13. Bacterial communities in water and sediment samples mostly consisted of members of the classes *Gammaproteobacteria*, *Bacteroidia*, *Alphaproteobacteria* and *Actinobacteria* (as well as the less abundant class-level taxa, represented as a mix of other class-level taxa on Figure 3-13). These results are very similar to those observed in Keene Creek.

Microbial community patterns in sediment were generally similar across all sites (MS-5, T-2, and T-2-UP) (Figure 3-13). Microbial community patterns in water also were similar among sites with a generally lower proportion of *Gammaproteobacteria* and *Bacteroidia* than was found in sediment samples and a larger proportion of more diverse taxa. The exception to that was reach T-2, where little difference was observed in microbial community structure between water and sediment samples.

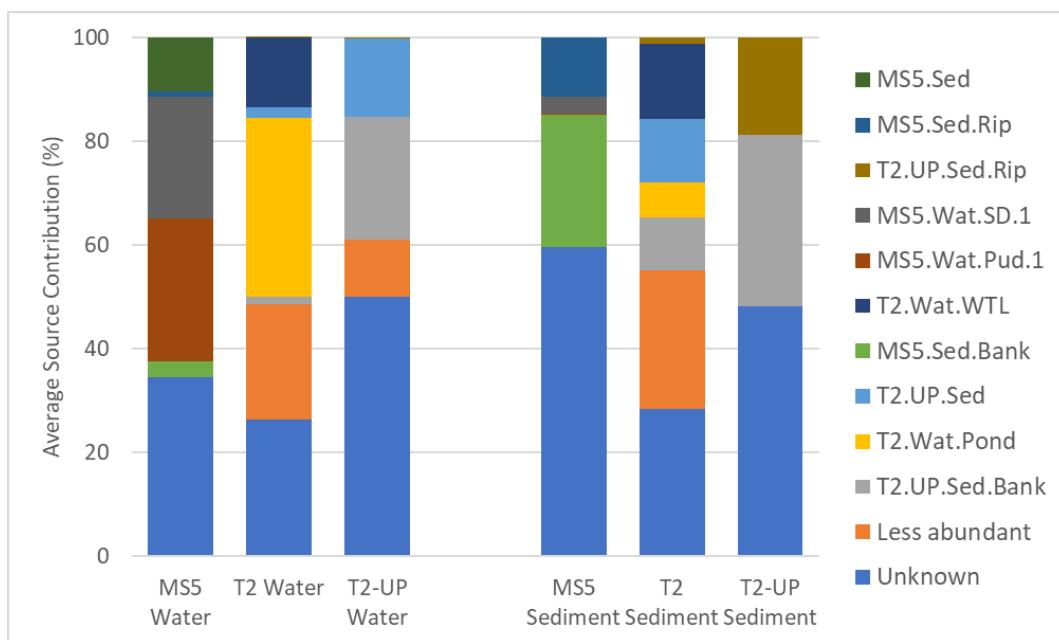
Figure 3-14: Graphic of Mean Percentage of Source Contributions to Tischer Creek

The results of the SourceTracker analysis of water and samples collected from Tischer Creek are presented graphically on Figure 3-14 and numerically in Table 3-14. SourceTracker software was used to determine which sources of bacteria (from samples collected from a variety of suspected sources in MS-5, T-2, and T-2-Up reaches) were the major source contributors for a given “sink”, where sink is defined as either Tischer Creek surface water at sites MS-5, T-2, or T-2-Up or as sediment at sites MS-5, T-2, or T-2-Up. Colors in the stacked bar chart on Figure 3-14 and values in Table 3-14 represent the mean percent contribution of each suspected source for a given sink. The means were derived from three samples collected from each suspected source. For each sink, the two identified sources with the highest percent contribution are highlighted in red text.

SourceTracker analysis revealed that the major sources of bacteria to Tischer Creek surface waters in the MS-5 reach were water from samples collected within the reach from ponded water at the southern end of Columbus Avenue (27.7 percent) and storm drain effluent from the storm drain outfall at West Arrowhead Road (23.3 percent) (Table 3-14). The major sources to receiving water collected in the T-2 reach were ponded water at Norton Street and Waverly Avenue (34.4 percent) and the wetland adjacent to the creek off Carver Avenue (13.5 percent). The major identified sources to receiving water collected at T-2-Up was T-2-Up bank sediment (23.7 percent) and T-2-Up streambed sediment (15.1 percent), but the largest proportion at this site was from unknown sources (50.1 percent).

Similar to the Keene Creek sediment results, the major sources of most sediment sinks in Tischer Creek originated from sediment sources. For example, the major sources of bacteria to Tischer Creek streambed sediment at the bottom of the MS-5 reach was streambank and riparian sediment at MS-5 (25.5 and 11.5 percent, respectively) (Table 3-14). For T-2 streambed sediment in Tischer Creek, the major sources were identified as the water from the wetland adjacent to the T-2 tributary off North Street (14.5 percent) and streambed sediment from T-2-Up (12.3 percent). For streambed sediment at the T-2-Up reference site, the major sources were the bank and riparian sediments at T-2-Up (33.2 and 18.7 percent, respectively).
