## **Harrison Community Club**

Accessibility Review

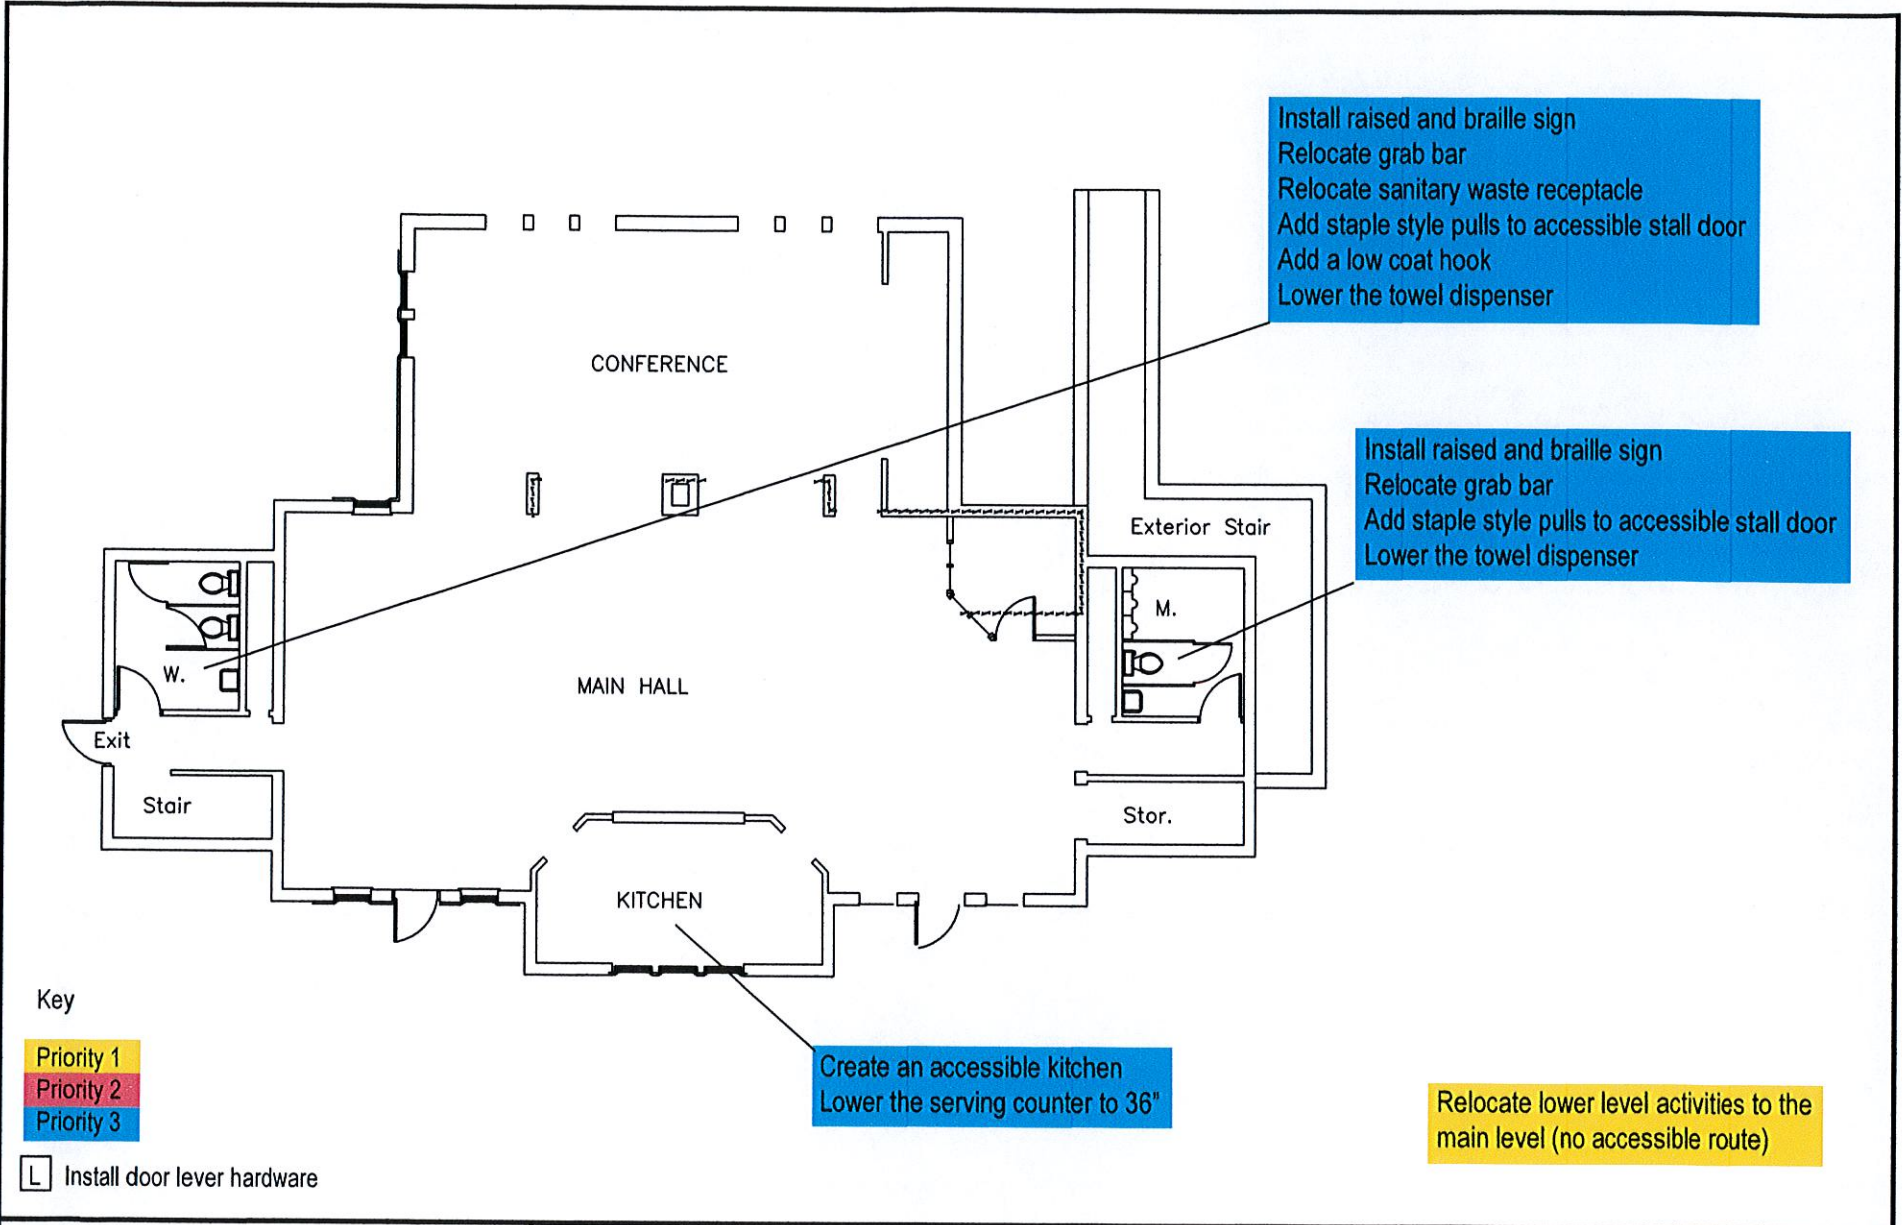
**Photo 6:** View of lower level. The lower level is currently abandoned and used only for storage. There is not an accessible route to the lower level.

Location JQP # / Item #	Solution / Comments	Qty	Unit Cost	Total Cost	Priority	Estimated Compl. Date	Person Responsible	Actual Compl. Date	Actual Cost
<b>Lower Level</b>									
14D2 16155	Relocate program as necessary to an accessible location to provide program access. MN 1341 1104.4 <i>There is not currently an accessible route to the lower level (interior and exterior stairs). The lower level appears to be abandoned at this time and used only for storage. Photo 6.</i>	1	\$0	\$0	1				
				<b>Priority # 1 Total</b>	<b>\$0</b>
