Case No. C-8884  
Condition Survey

June 12, 2018

### **Museum S.S. William A. Irvin**

REPORT OF INSPECTION made by the undersigned surveyor of North American Marine, Inc., on June 6 & 7, 2018, at the request of the, City of Duluth, Duluth, Minnesota, on the Museum Steamship William A. Irvin, 8,240 gross registered tons, 237395 Official Number, 6,072 net tons, the City of Duluth, Duluth, Minnesota, Owners, while lying afloat port side to the dock at the Minnesota Slip, Duluth, Minnesota, in order to ascertain the general condition of the vessel.

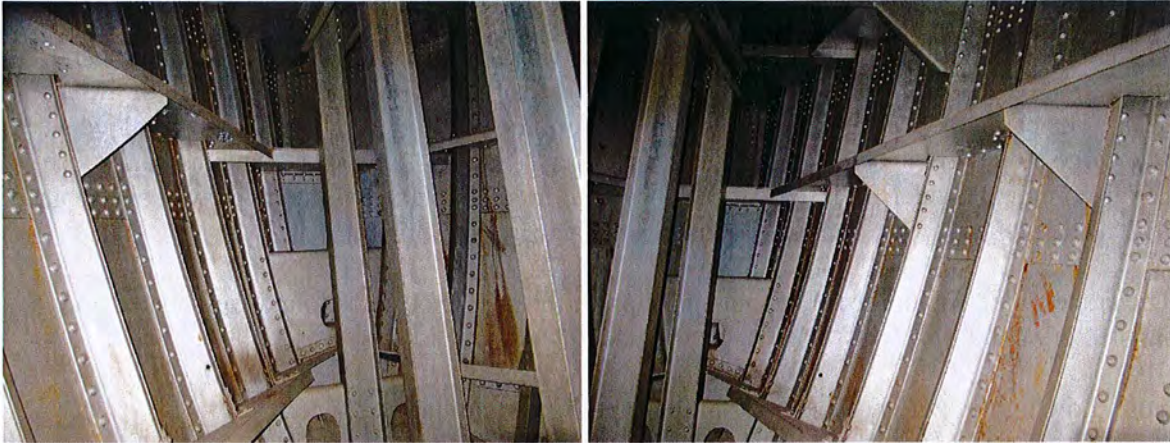
Looking forward

Forepeak stiffened with cant channel shell frames. Shell plate framing found in satisfactory condition. All structure very well coated with the exception of the lower 12" of the collision bulkhead.

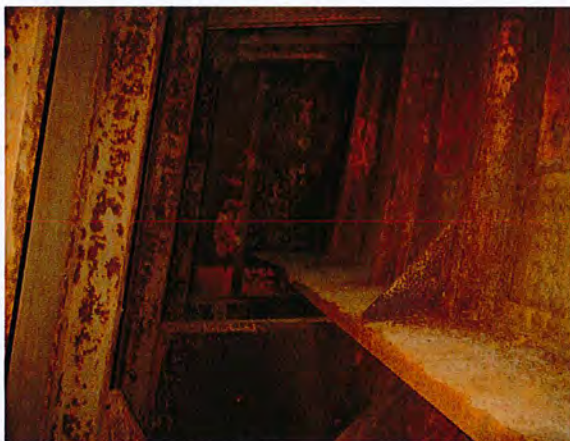
Looking forward

Access was gained from a man hole at the top of the tank from the main deck storm tunnel. Number one starboard ballast tank was found with two web frames and ten intermediate channel frames on 3'0" centers all of which were connected to the shell plate with rivets. Web frames were spaced every 12'00". There was no damage sighted to the frames. There is 8" x 3" x 21.4 lbs. channel stringers extending from the side shell framing to the cargo slope stiffeners. The channel stringers were found in fair condition. The side shell frames were connected to 5'06" high floors. The floors were attached to the bottom shell plating with rivets. The floors have either 22" diameter round or 20" x 30" oblong lightning holes. The lightning holes were found with square edges. Main deck beam flanges found square. Forward bulkhead found in satisfactory condition with the exception of a rough cut 24" x 24" access hole approximately 8" below the main deck. Aft bulkhead found in satisfactory condition with the exception of a rough cut 16" x 16" access hole just below approximately 8" below the main deck. The tank is not considered watertight.

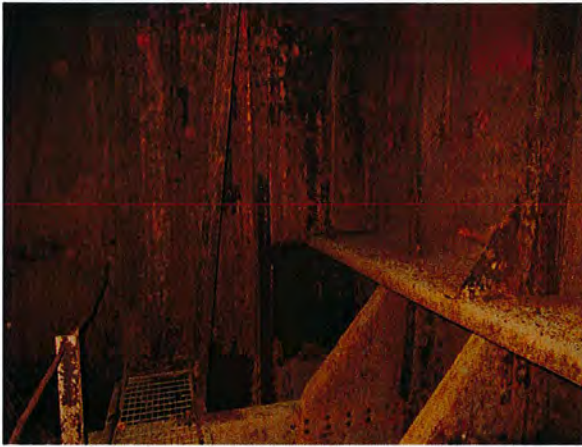
Access was gained from a man hole at the top of the tank from the main deck storm tunnel. Number two starboard ballast tank was found with five web frames and eighteen intermediate channel frames on 3'0" centers all of which were connected to the shell plate with rivets. Web frames were spaced every 12'00". There was no damage sighted to the frames. There is 8" x 3" x 21.4 lbs. channel stringers extending from the side shell framing to the cargo slope stiffeners. The channel stringers were found in fair condition. The side shell frames were connected to 5'06" high floors. The floors were attached to the bottom shell plating with rivets. The floors have either 22" diameter round or 20" x 30" oblong lightning holes. The lightning holes were found with square edges. Main deck beam flanges found square. Forward bulkhead found in satisfactory condition with the exception of a rough cut 16" x 16" access hole approximately 8" below the main deck. Aft bulkhead found in satisfactory condition with the exception of a rough cut 24" x 24" access hole approximately 8" below the main deck. Tank considered non-water tight.

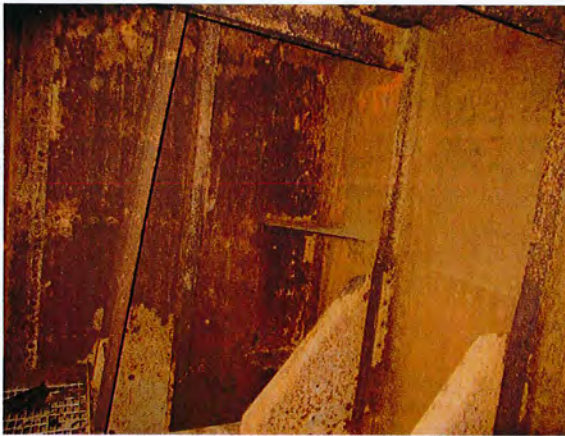
Access was gained from a man hole at the top of the tank from the main deck storm tunnel. Number three starboard ballast tank was found with five web frames and eighteen intermediate channel frames on 3'0" centers all of which were connected to the shell plate with rivets. Web frames were spaced every 12'00". There was no damage sighted to the frames. There is 8" x 3" x 21.4 lbs. channel stringers extending from the side shell framing to the cargo slope stiffeners. The channel stringers were found in fair condition. The side shell frames were connected to 5'06" high floors. The floors were attached to the bottom shell plating with rivets. The floors have either 22" diameter round or 20" x 30" oblong lightning holes. The lightning holes were found with square edges. Main deck beam flanges found lightly tapered. Forward bulkhead found in satisfactory condition with the exception of a rough cut 24" x 24" access hole approximately 8" below the main deck. Aft bulkhead found in satisfactory condition with the exception of a rough cut 24" x 24" access hole approximately 8" below the main deck. Tank considered non-water tight.

Forward bulkhead to side shell

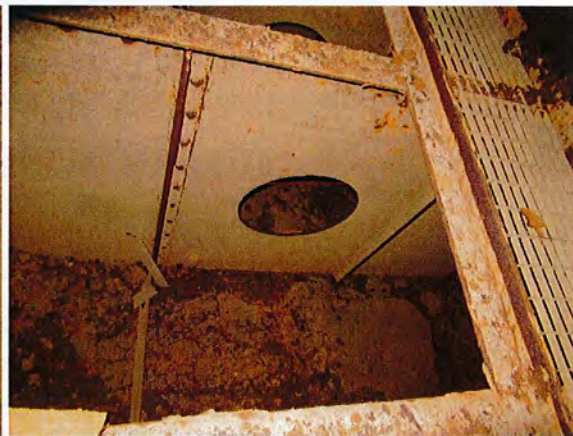
Floor with 22" diameter lightning hole

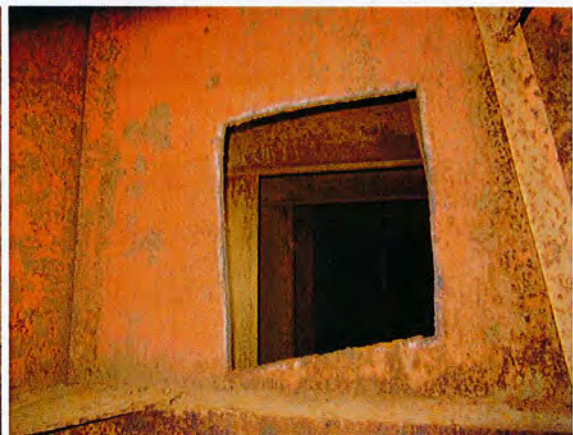
Access hole in aft bulkhead

1. Above lightship water line hull penetrations to be sealed.
2. Ballast tank tween tank bulkheads and cargo slopes to be made watertight and or sealed.
3. Mooring winches to be overhauled and made serviceable.
4. Steel cable mooring lines to be replaced where found parted and establish an annual documented examination schedule.
5. Tailshaft to be drawn out and stern tube to be blanked off.
6. Detailed fire plan to be developed for "Haunted House" cargo hold.
7. Vessel to be dry-docked in order to sandblast hull down to white metal from lightship waterline to lightship water line and painted with marine grade two-part epoxy paint.

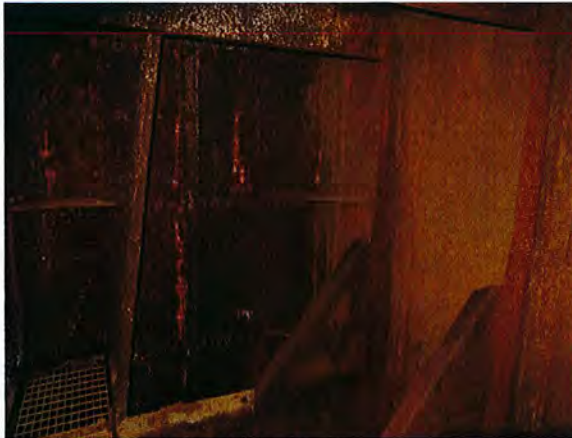
Access was gained from a man hole at the top of the tank from the main deck storm tunnel. Number four starboard ballast tank was found with five web frames and eighteen intermediate channel frames on 3'0" centers all of which were connected to the shell plate with rivets. Web frames were spaced every 12'00". There was no damage sighted to the frames. There is 8" x 3" x 21.4 lbs. channel stringers extending from the side shell framing to the cargo slope stiffeners. The channel stringers were found in fair condition. The side shell frames were connected to 5'06" high floors. The floors were attached to the bottom shell plating with rivets. The floors have either 22" diameter round or 20" x 30" oblong lightning holes. The lightning holes were found with square edges. Main deck beam flanges found lightly square. Forward bulkhead found in satisfactory condition with the exception of a rough cut 24" x 24" access hole just below approximately 8" below the main deck. Aft bulkhead found in satisfactory condition with the exception of a rough cut 10" x 10" access hole just below approximately 8" below the main deck. It should be noted that the main deck storm tunnel has been converted to men/women's restrooms for the gift shop that is located at midship. That being said there is water supply and sewage piping penetrating the main deck and flowing aft into number 5 ballast tank. There was 0-1" of accumulated water in the aft end of number four ballast tank. It is unknown whether the water is from the restroom plumbing or a shell plate leak. Tank considered non-water tight.

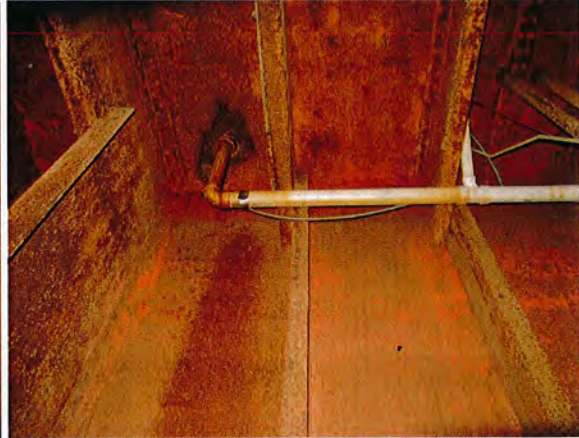
Restroom plumbing

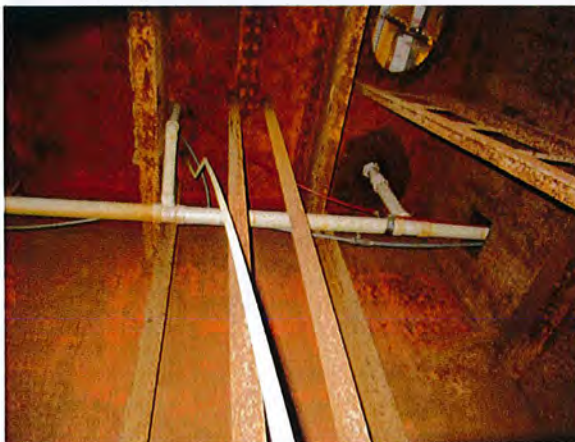
Restroom plumbing and access hole

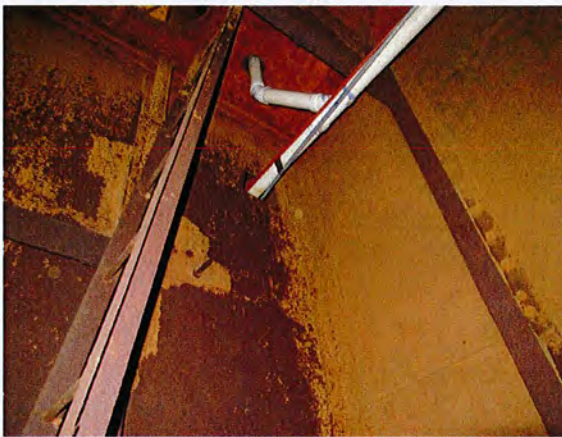
Forward Bulkhead

Access was gained from a man hole at the top of the tank from the main deck storm tunnel. Number five starboard ballast tank was found with five web frames and eighteen intermediate channel frames on 3'0" centers all of which were connected to the shell plate with rivets. Web frames were spaced every 12'00". There was no damage sighted to the frames. There is 8" x 3" x 21.4 lbs. channel stringers extending from the side shell framing to the cargo slope stiffeners. The channel stringers were found in fair condition. The side shell frames were connected to 5'06" high floors. The floors were attached to the bottom shell plating with rivets. The floors have either 22" diameter round or 20" x 30" oblong lightning holes. The lightning holes were found with square edges. Main deck beam flanges found lightly tapered. Forward bulkhead found in satisfactory condition with the exception of a rough cut 10" x 10" access hole just below approximately 8" below the main deck. Water supply and sewage drain passing through bulkhead access hole. Second access hole, 8" x 8", cut into cargo slope. Aft bulkhead found in satisfactory condition. Tank considered non-water tight.

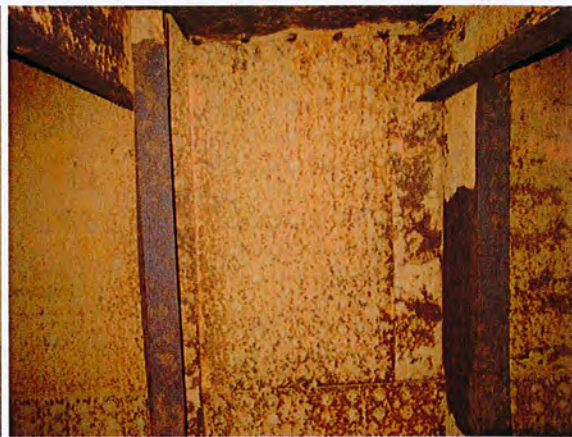
Side shell plating and framing

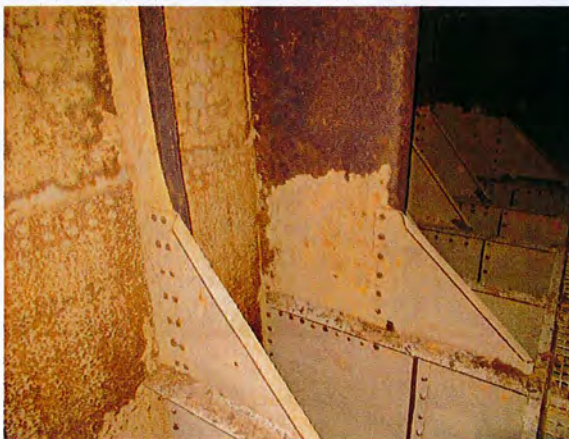
Side shell plating and framing

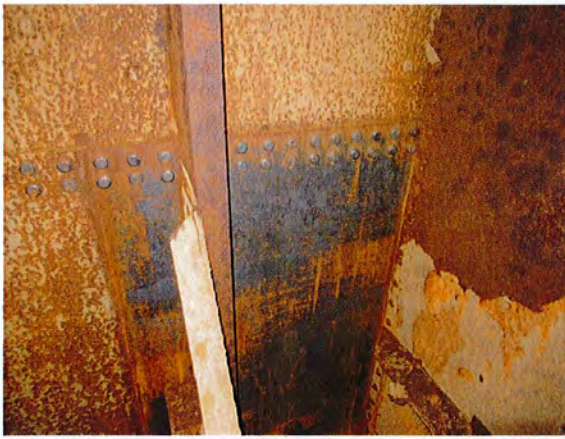
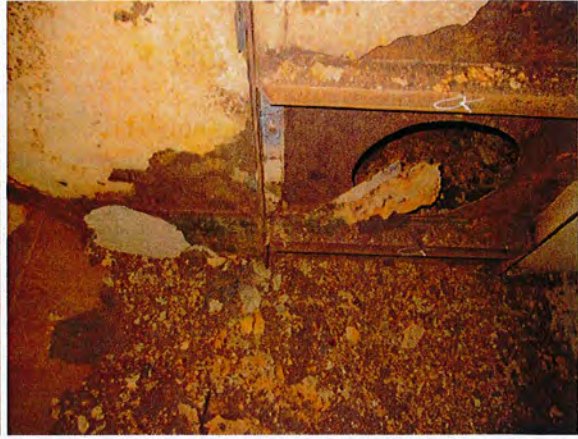
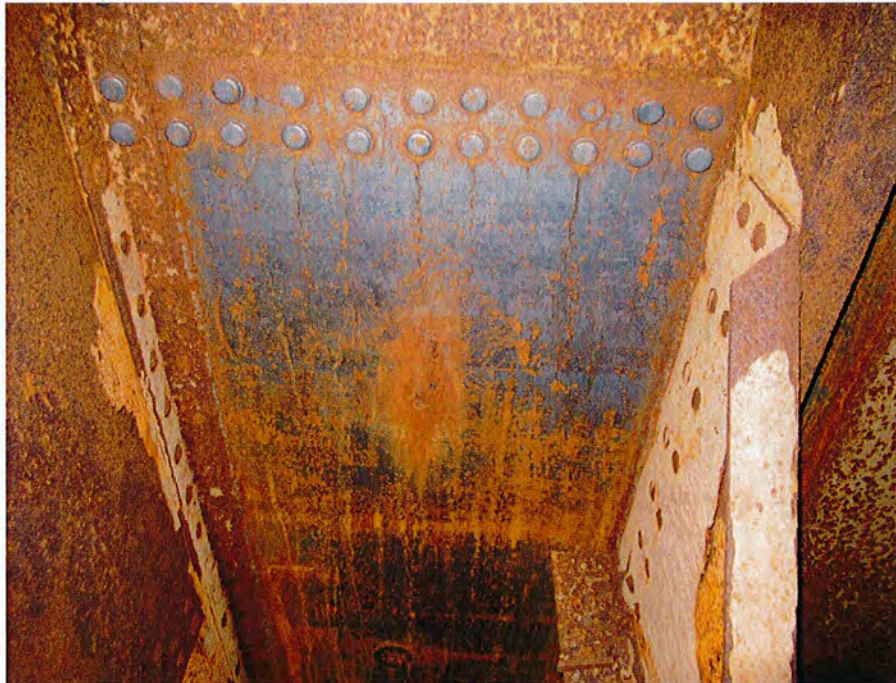
Commencing at frame 143 (ninth frame from forward) continuing aft through the bulkhead there is a bilge repair. This repair appears to have been made just prior to the end of the sailing career of the vessel. The repair is partially welded repair.

Please note that the steel is still mill blue, which is indicative of very little deterioration since the vessel has been out of service.

Upper bilge roll (flushed butt)

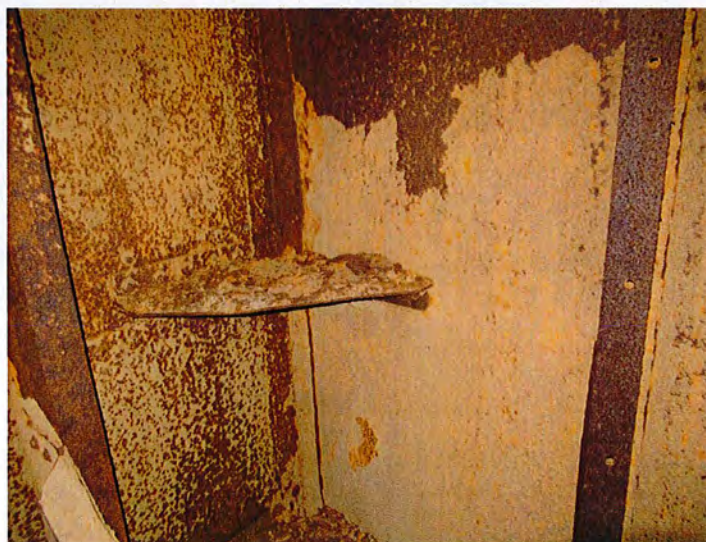
Access was gained from a man hole at the top of the tank from the main deck storm tunnel. Number six starboard ballast tank was found with five web frames and eighteen intermediate channel frames on 3'0" centers all of which were connected to the shell plate with rivets. Web frames were spaced every 12'00". There was no damage sighted to the frames. There is 8" x 3" x 21.4 lbs. channel stringers extending from the side shell framing to the cargo slope stiffeners. The channel stringers were found in fair condition. The side shell frames were connected to 5'06" high floors. The floors were attached to the bottom shell plating with rivets. The floors have either 22" diameter round or 20" x 30" oblong lightning holes. The lightning holes were found with square edges. Main deck beam flanges found square. Forward bulkhead found in satisfactory condition. Aft bulkhead found in satisfactory condition.

Aft Bulkhead to side shell connection

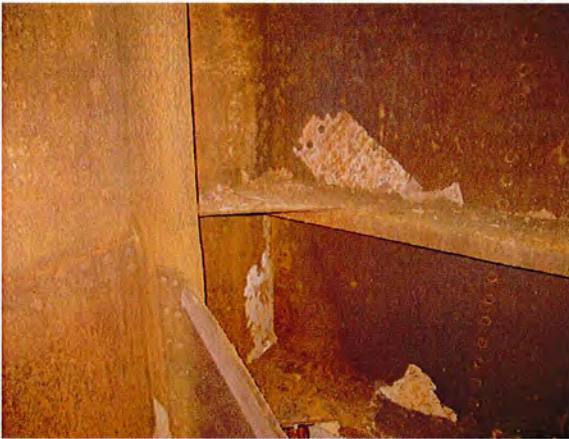
Forward Bulkhead

Access was gained from a man hole at the top of the tank from the main deck storm tunnel. Number seven starboard ballast tank was found with two web frames and ten intermediate channel frames on 3'0" centers all of which were connected to the shell plate with rivets. Web frames were spaced every 12'00". There was no damage sighted to the frames. There is 8" x 3" x 21.4 lbs. channel stringers extending from the side shell framing to the cargo slope stiffeners. The channel stringers were found in fair condition. The side shell frames were connected to 5'06" high floors. The floors are attached to the bottom shell plating with rivets. The floors have either 22" diameter round or 20" x 30" oblong lightning holes. The lightning holes were found with square edges. Main deck beam flanges found square. Forward bulkhead found in satisfactory condition. Aft bulkhead found in satisfactory condition. Bilge plating repair continues through the tank ending at frame 177.

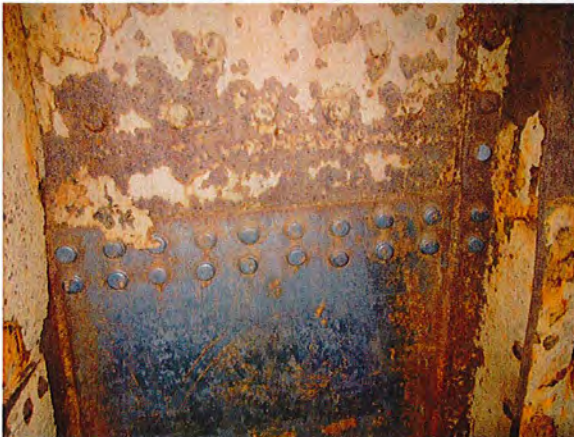
Upper bilge roll (flushed butt)

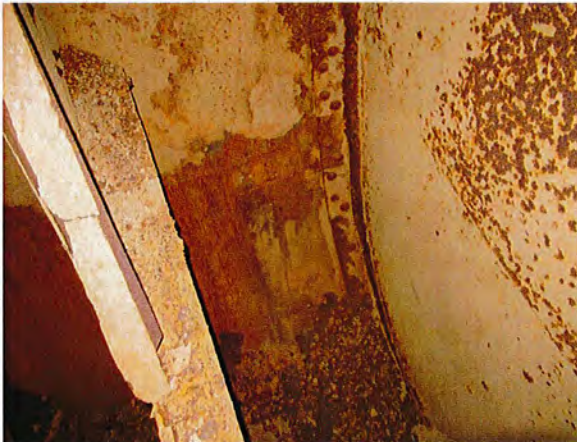
Bilge roll at aft bulkhead

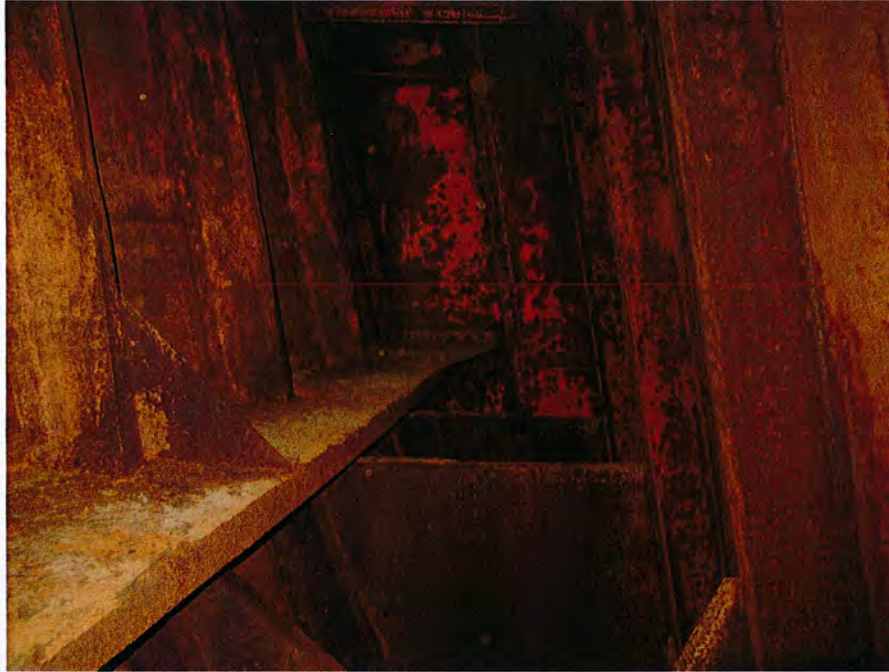
Looking forward

Access was gained from a man hole at the top of the tank from the main deck storm tunnel. Number one port ballast tank was found with two web frames and ten intermediate channel frames on 3'0" centers all of which were connected to the shell plate with rivets. Web frames were spaced every 12'00". There was no damage sighted to the frames. There is 8" x 3" x 21.4 lbs. channel stringers extending from the side shell framing to the cargo slope stiffeners. The channel stringers were found in fair condition. The side shell frames were connected to 5'06" high floors. The floors were attached to the bottom shell plating with rivets. The floors have either 22" diameter round or 20" x 30" oblong lightning holes. The lightning holes were found with square edges. Main deck beam flanges found square. Forward bulkhead found in satisfactory condition. Aft bulkhead found in satisfactory condition. Sounding pipes in fair condition.

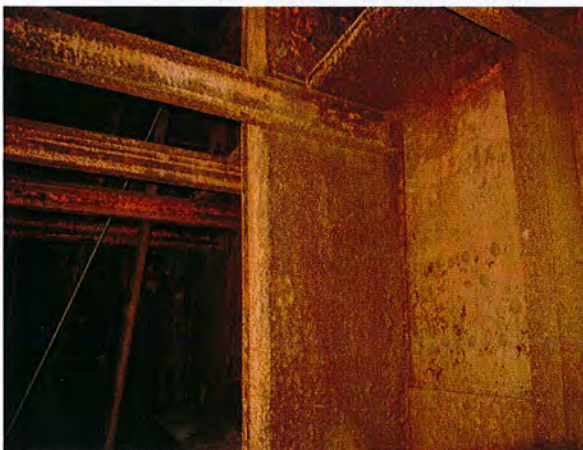
Web frame and channel stringer

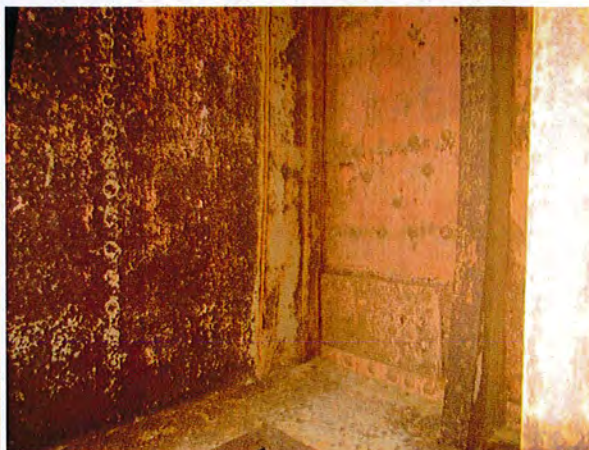
Aft bulkhead to side shell connection

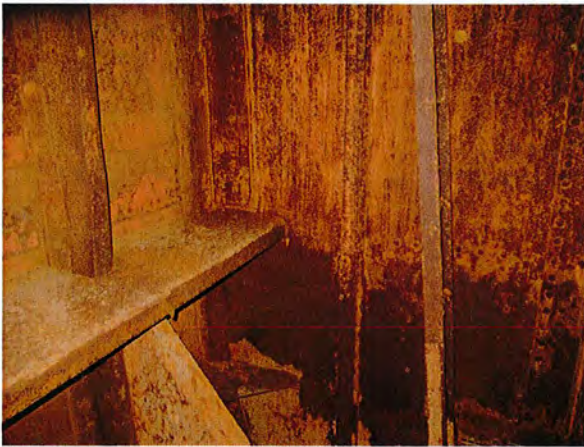
Forward Bulkhead

Access was gained from a man hole at the top of the tank from the main deck storm tunnel. Number two Port ballast tank was found with five web frames and eighteen intermediate channel frames on 3'0" centers all of which were connected to the shell plate with rivets. Web frames were spaced every 12'00". There was no damage sighted to the frames. There is 8" x 3" x 21.4 lbs. channel stringers extending from the side shell framing to the cargo slope stiffeners. The channel stringers were found in fair condition. The side shell frames were connected to 5'06" high floors. The floors were attached to the bottom shell plating with rivets. The floors have either 22" diameter round or 20" x 30" oblong lightning holes. The lightning holes were found with square edges. Main deck beam flanges found square. Forward bulkhead found in satisfactory condition. Aft bulkhead found in satisfactory condition.

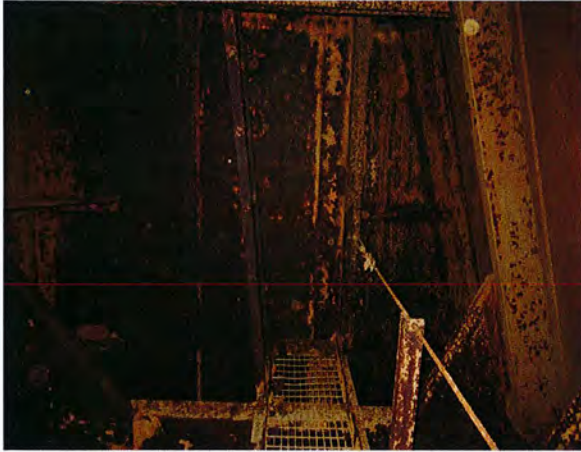
Access was gained from a man hole at the top of the tank from the main deck storm tunnel. Number port starboard ballast tank was found with five web frames and eighteen intermediate channel frames on 3'0" centers all of which were connected to the shell plate with rivets. Web frames were spaced every 12'00". There was no damage sighted to the frames. There is 8" x 3" x 21.4 lbs. channel stringers extending from the side shell framing to the cargo slope stiffeners. The channel stringers were found in fair condition. The side shell frames were connected to 5'06" high floors. The floors were attached to the bottom shell plating with rivets. The floors have either 22" diameter round or 20" x 30" oblong lightning holes. The lightning holes were found with square edges. Main deck beam flanges found lightly square. Forward bulkhead found in satisfactory condition. Aft bulkhead found in satisfactory condition. Sounding pipes intact.

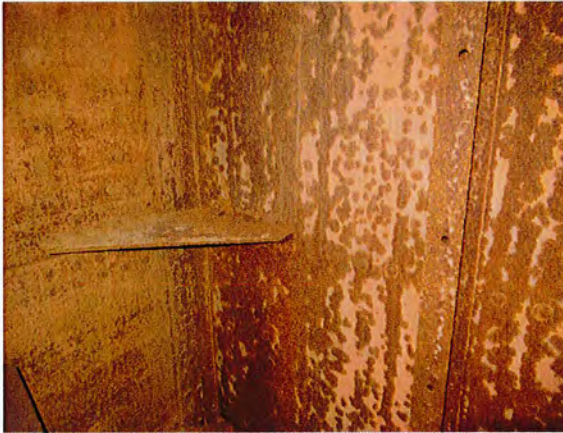
Access was gained from a man hole at the top of the tank from the main deck storm tunnel. Number four port ballast tank was found with five web frames and eighteen intermediate channel frames on 3'0" centers all of which were connected to the shell plate with rivets. Web frames were spaced every 12'00". There was no damage sighted to the frames. There is 8" x 3" x 21.4 lbs. channel stringers extending from the side shell framing to the cargo slope stiffeners. The channel stringers were found in fair condition. The side shell frames were connected to 5'06" high floors. The floors were attached to the bottom shell plating with rivets. The floors have either 22" diameter round or 20" x 30" oblong lightning holes. The lightning holes were found with square edges. Main deck beam flanges found lightly square. Forward bulkhead found in satisfactory condition. Aft bulkhead found in satisfactory condition. Sounding pipes intact.

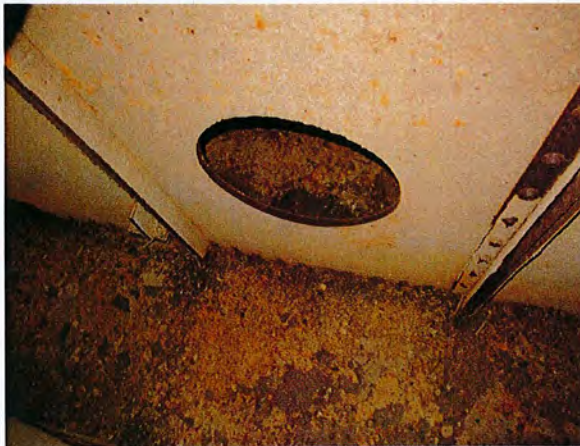
Floor – Lightning hole
