*Appendix D*

*MPCA File Review Information and  
Previous Investigation Reports*

*Leak # 2094 MPCA File Excerpts*

Re: Limited Phase I Site Assessment  
(Historical Records Review)  
Bayfront Property  
Duluth, Minnesota

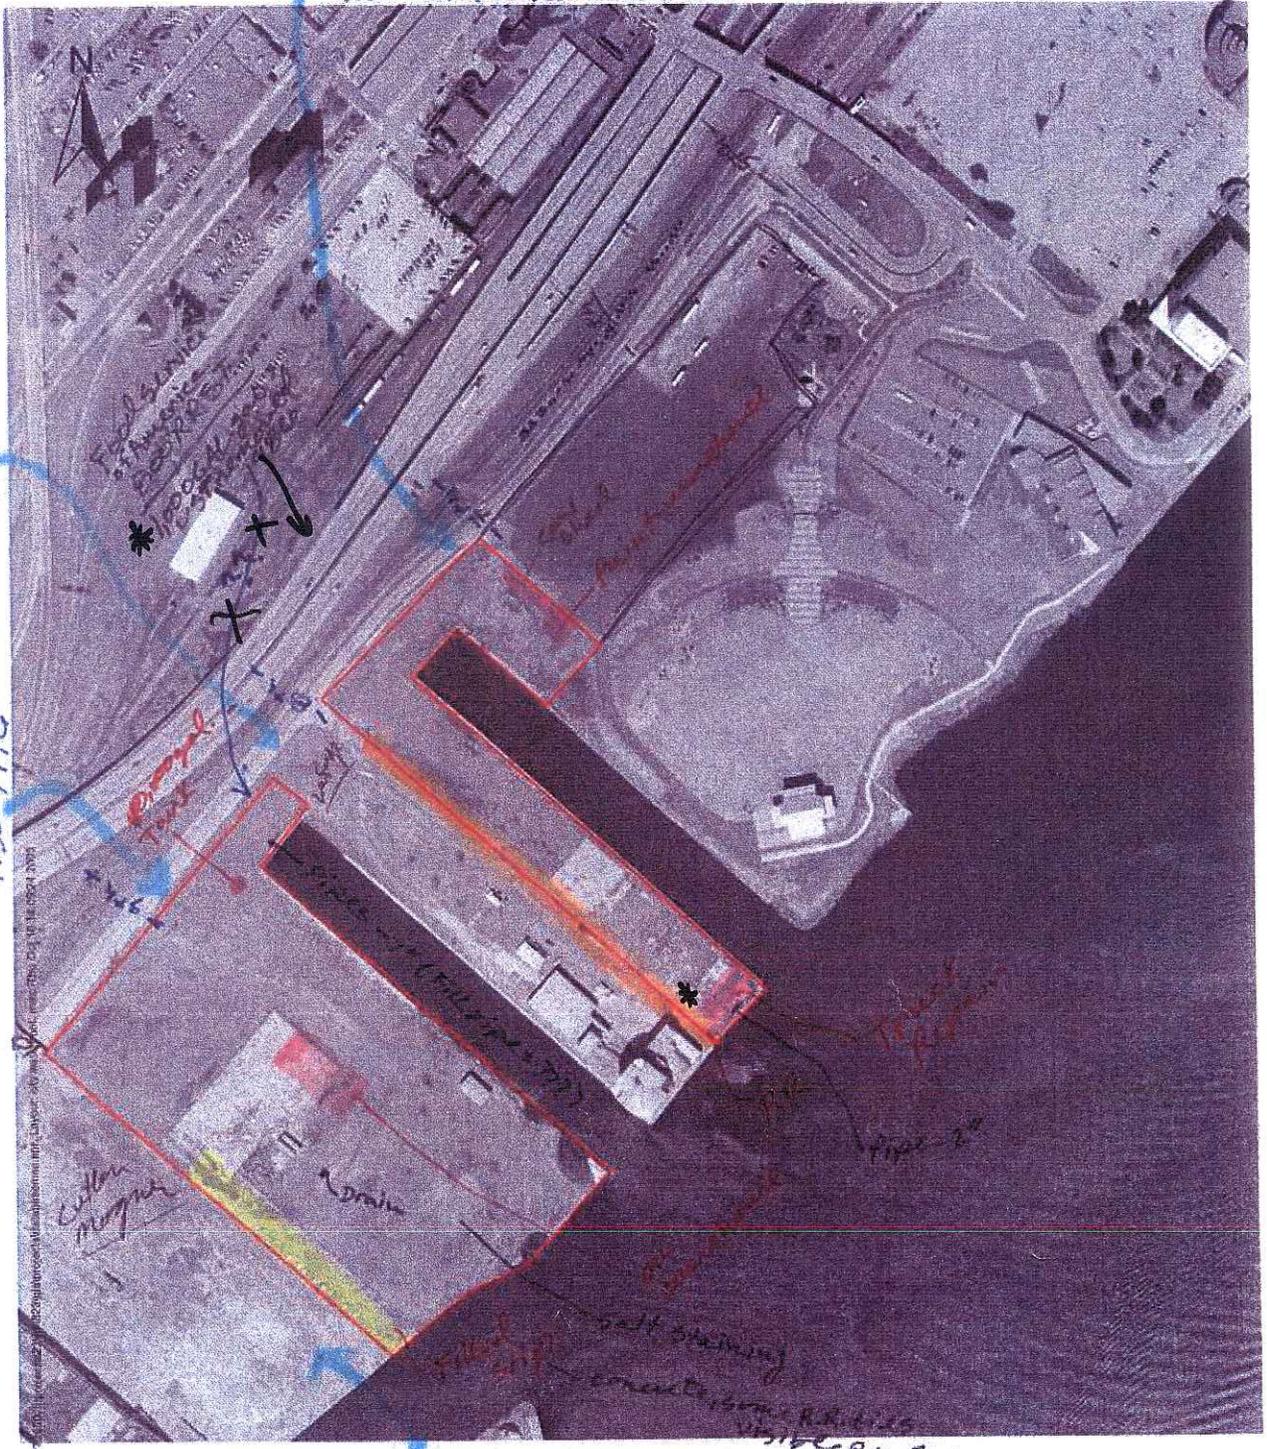
Duluth  
Brownfields Study Area  
CITY WATERFRONT PROPERTY

802 Northern Scrap Iron + Metal - 1930-75

824-902 - includes Pritzer (Non-ignom) 1930-1996

202 - Valvoline Oil 1946-1964  
Viscosity Oil 1930-1956  
Sherwin Williams Paint 1935-1940

1002 - Sintered Svc. - Trucking 1961-76  
Cophon State Oil - 1950-61  
Phil. A Nelson Co. Oil + Greases 1946-1951

golf stadium  
concrete from building  
visible @ surface

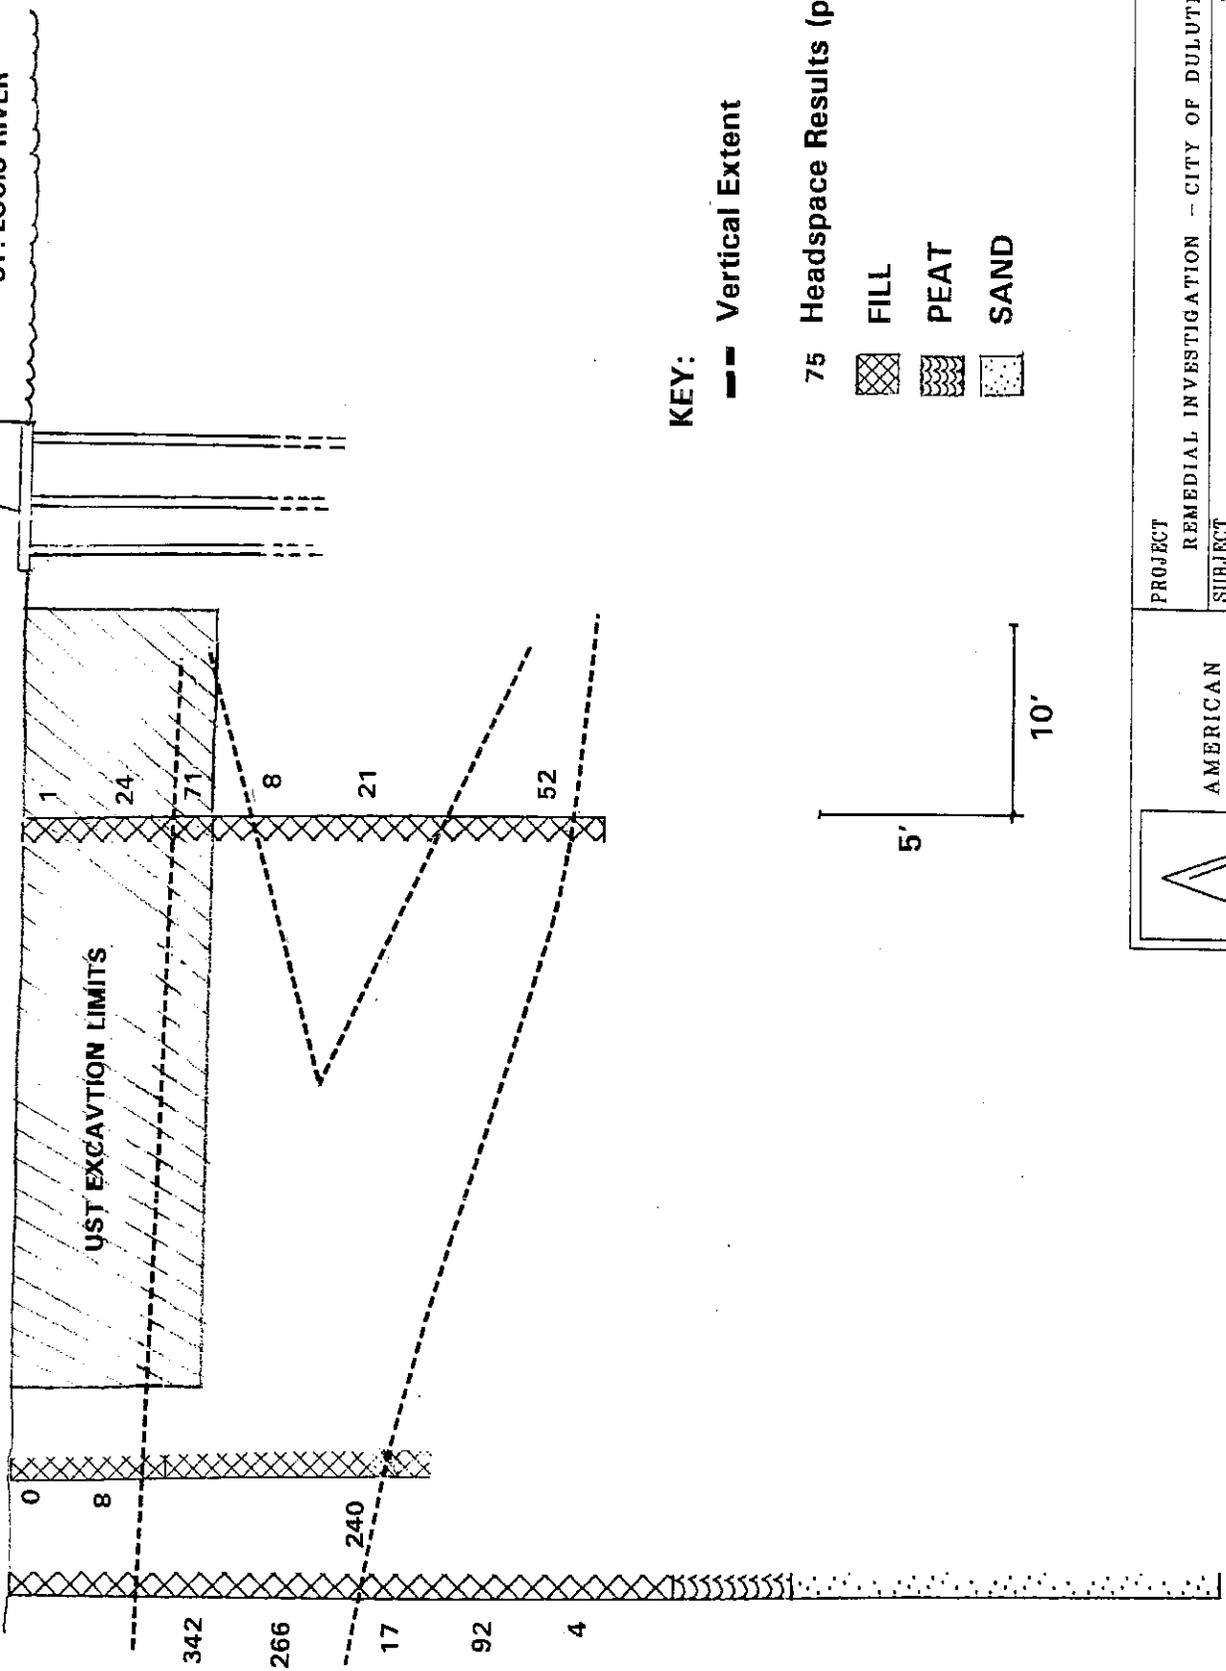
SB-1

93-25 SB-4

KEY: --- Vertical Extent

75 Headspace Results (ppm)
