Arlington Soccer

Activities / Amenities

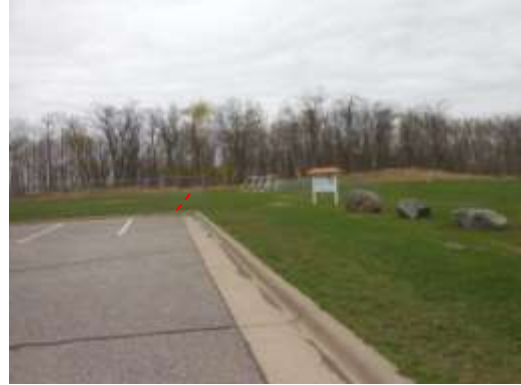
Route- Paul Antonich Field

There is not currently an accessible route to the boundary of Paul Antonich Field.

Priority 3- Create an accessible route to the boundary of the soccer field. (Approximately 160' from the driveway apron; a shorter route may be created directly from the parking lot.) *ADA 206.2.2*
