# Enger Tower

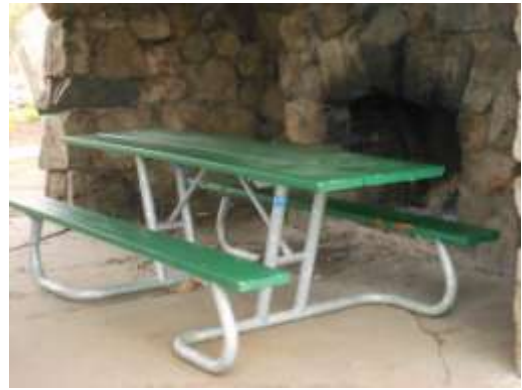
### **Picnic Shelter**

There is a picnic shelter associated with the toilet room building. At the time of site visit there were 3 tables, including 1 with knee and toe clearance. This picnic area will be eliminated as part of the planned expansion and remodel of the toilet rooms.

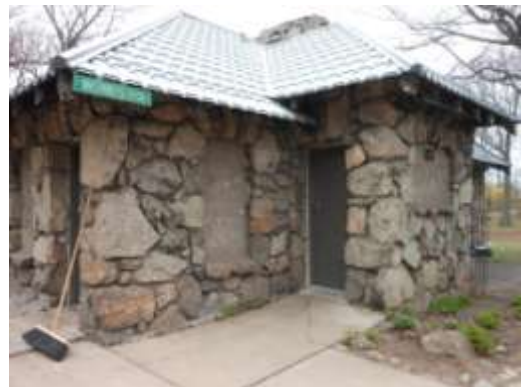
### View of Toilet Building

The toilet building was evaluated and included in the facilities report. JQP, Inc. conducted a plan review of the proposed enlargement and remodel of this location.

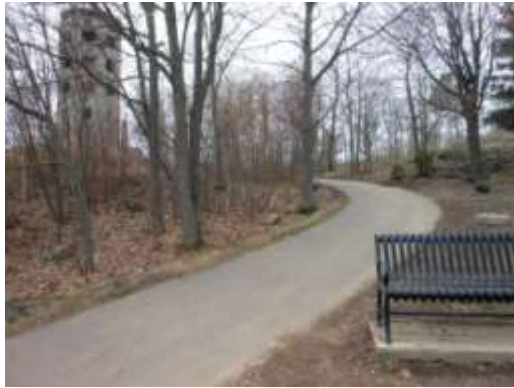
### Route

The tower is located on the top of a hill, located to the west of the parking lot. The route from the bathroom building to the entry to the tower is currently as steep as 15.8%.
