Park Point

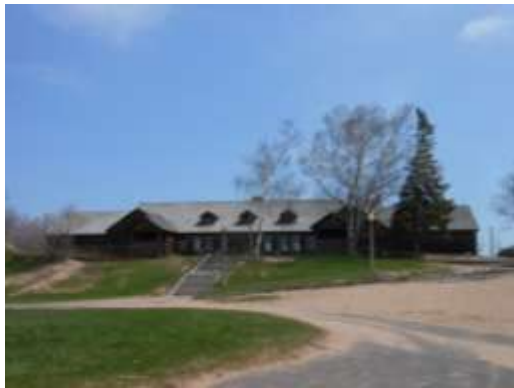
JQP, Inc. prepared a detailed report of the Beach House building, it has been included in the facilities report.
