-PL 21-013, Historic Construction Permit and Certificate of Appropriateness, Redevelopment of Historic Old Central High School (With SHPO Comments as of 2/11/21)

ZENITH - DULUTH CENTRAL HIGH SCHOOL - HPC & PART II 02.10.2021

200-298 N 1st Ave. E, Duluth, MN 55805

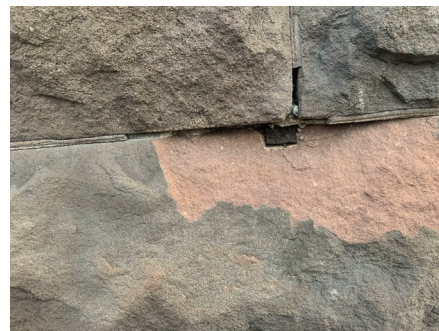
DETERIORATING STEEL CAUSING DAMAGE

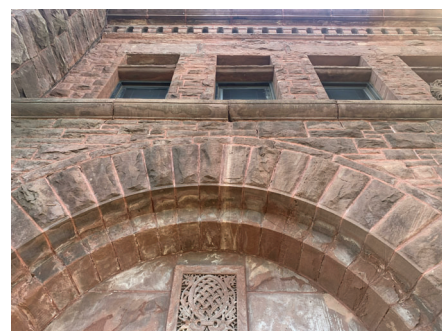
EFFLORESCENCE AND SPALLING AT ARCH. DEFLECTING STONES AND FAILED MORTAR JOINTS AT WASH PANEL ABOVE.

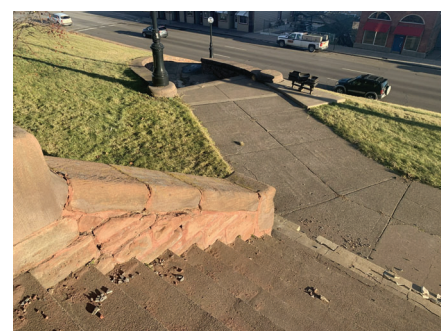
BALUSTRADE AND CONC. STAIRS IN POOR CONDITION, SIMILAR BEYOND AT CURVED STAIR AND BALUSTRADE.

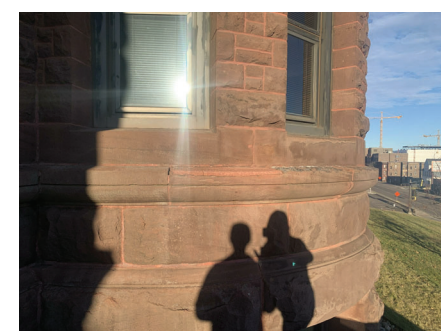
IMPROPER MORTAR PATCHING ON WASH PANEL

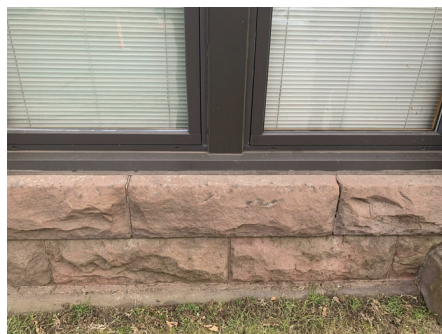
FAILED MORTAR JOINTS

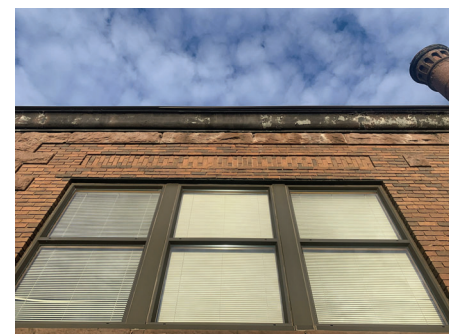
EFFLORESCENCE AT CORNICE LIKELY DUE TO ROOF LEAKAGE AND TYPICAL BRICK FACADE

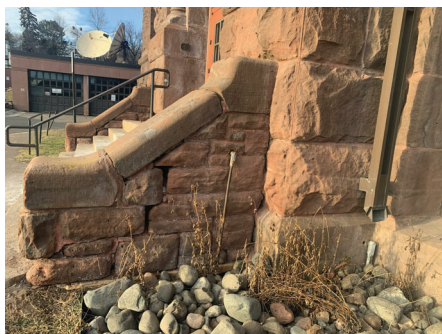
BALUSTRADE IN POOR CONDITION

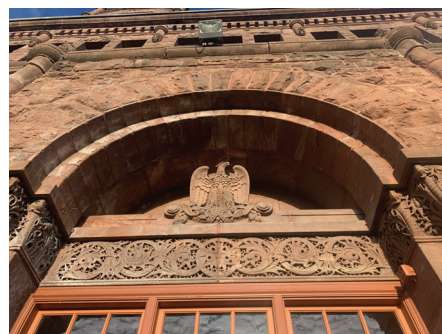
EFFLORESCENCE AND SPALLING AT ARCH. DEFLECTING STONES AND FAILED MORTAR JOINTS AT WASH PANEL ABOVE.

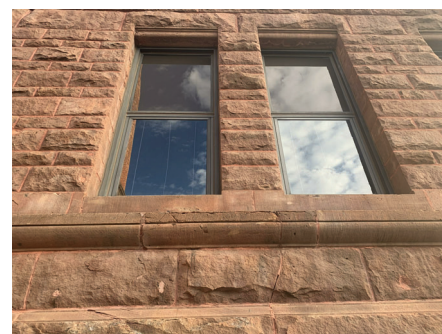
CRACKING AND SPALLING AT WASH LEDGE

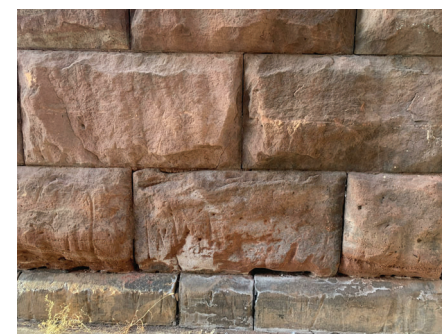
BASE OF CHIMNEY, EVIDENCE OF WATER INFILTRATION, FAILED MORTAR JOINTS, AND DAMAGED STONE.

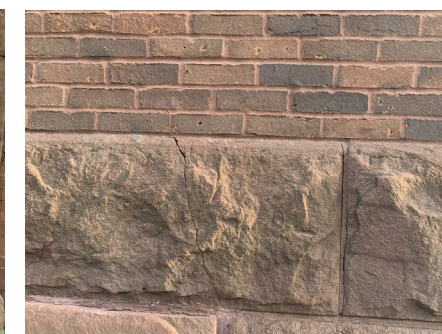
RUNNING CRACK AND FAILED MORTAR JOINTS AT BOILER HOUSE

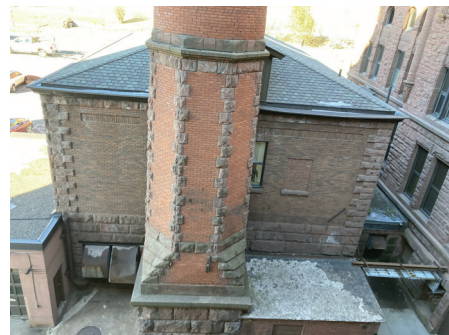
BOILER CHIMNEY - DETERIORATED MORTAR JOINTS ESPECIALLY ON THE HORIZONTAL SURFACES OF THE WASH PANEL

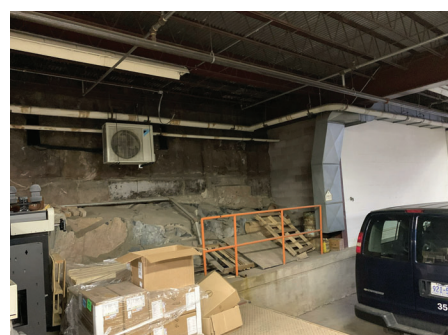
FOUNDATION WALL UNDER GYMNASIUM ON BEDROCK IN EAST DOCK

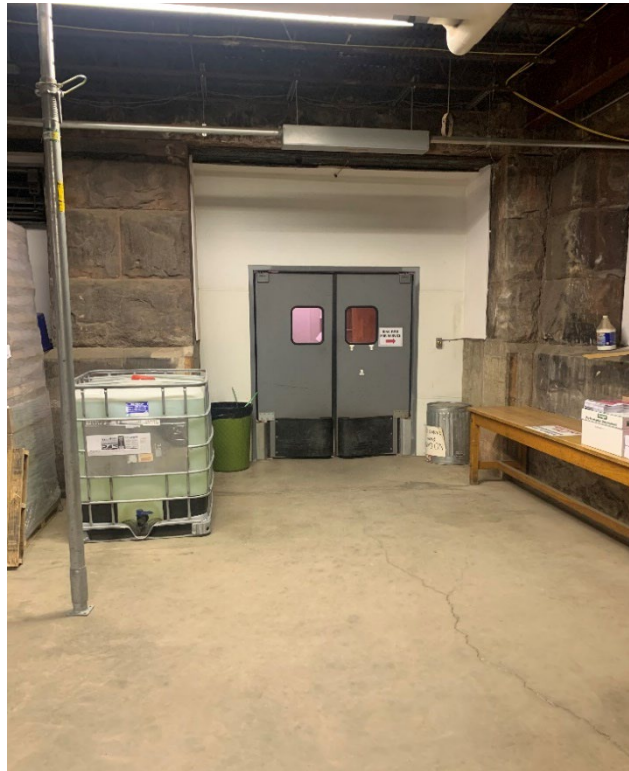
E.1 - Exterior Photo 1: View from N looking S in loading dock area

The existing loading dock and adjacent structure will be partially removed and replaced or reinforced to accommodate new program and code-required drifted and sliding snow (from the existing pitched high roof).

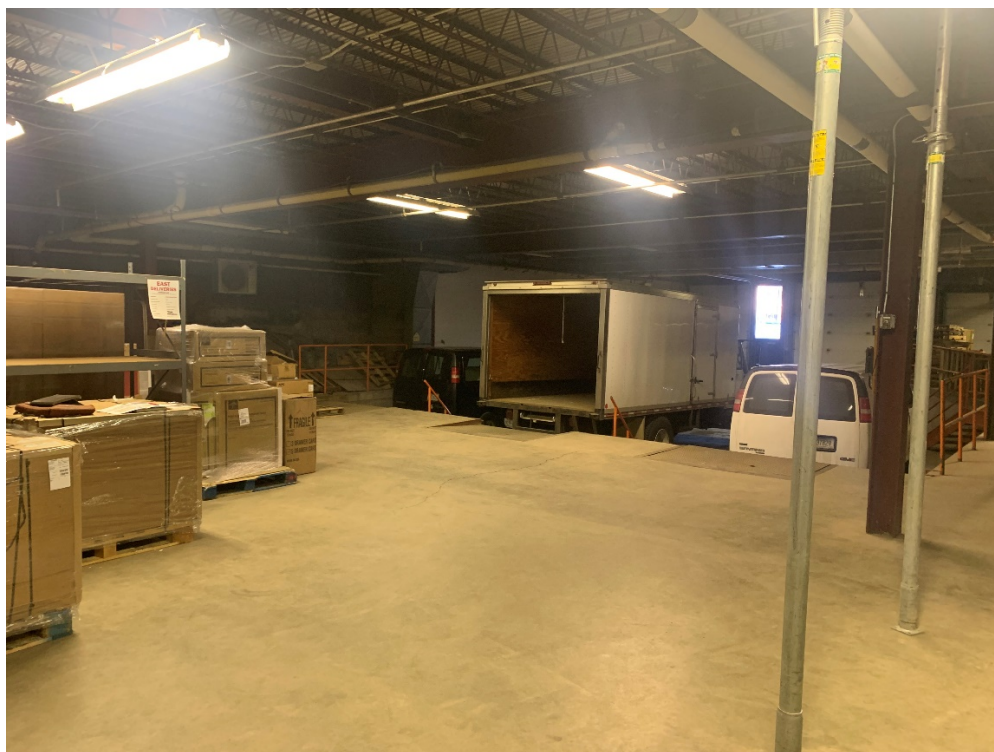
E.2 - Exterior Photo 2: View from SW looking NE in loading dock area

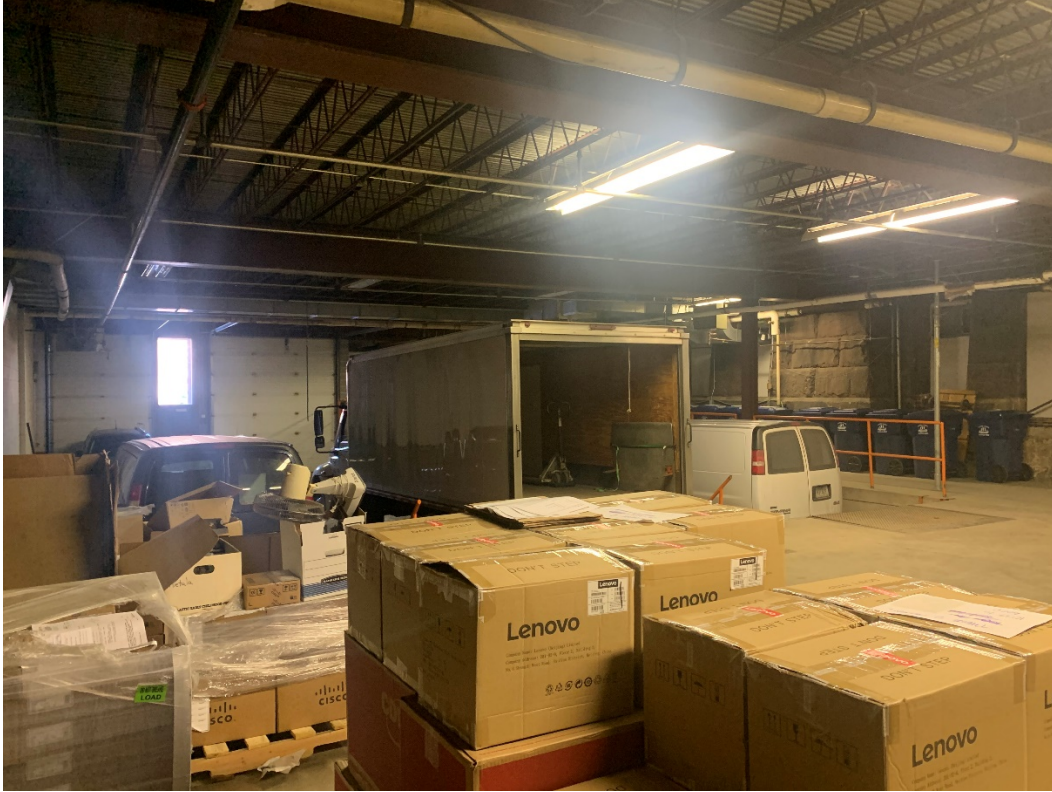
E.3 - Exterior Photo 3: View from NW looking SE in loading dock area
