22-5504 Request for Proposals

Historic Restoration Pastoret Terrace

Duluth, Minnesota

Pastoret Terrace Assessment: Terrace, Kozy Bar, and Ballroom

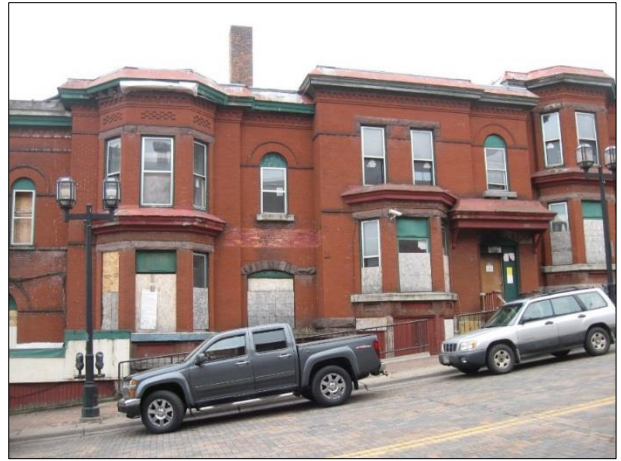
Figure 2 Middle of Avenue side. Note 10% sidewalk slope and stepped units.

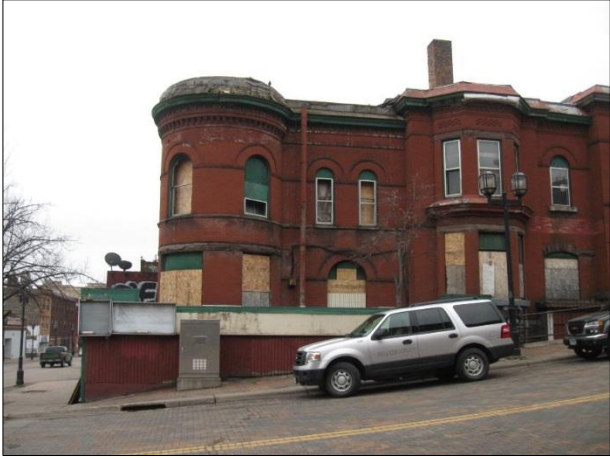
Figure 3 Avenue corner showing wrapping of Kozy bar addition

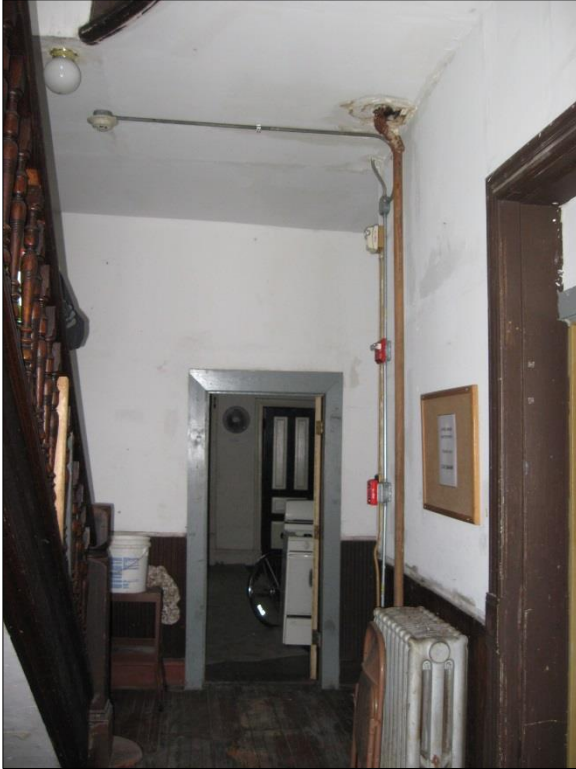
Figure 7 Interior of stair and corridor

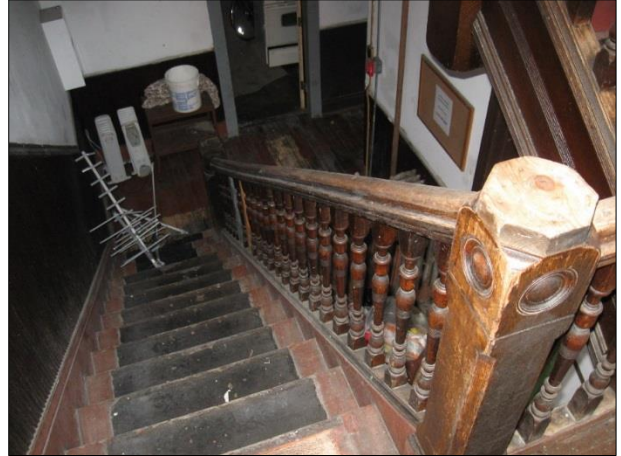
Figure 8 Example of interior wood stairs that can be retained serving second floor

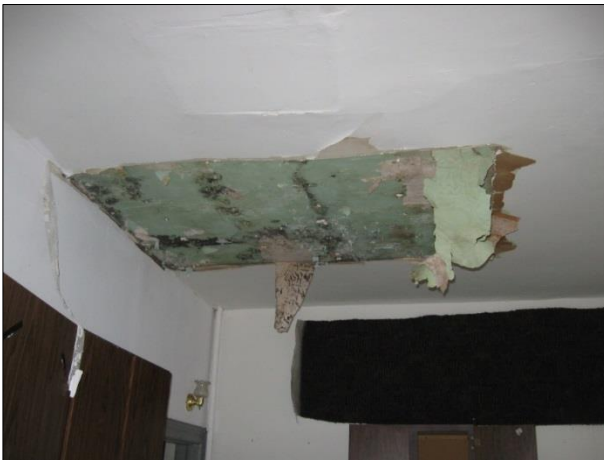
Figure 9 Typical interior of upper level ceilings showing sporadic water damage

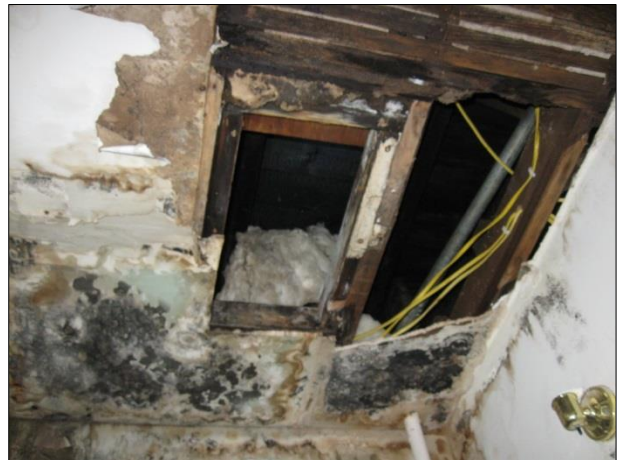
Figure 10 Roof leak and mold condition

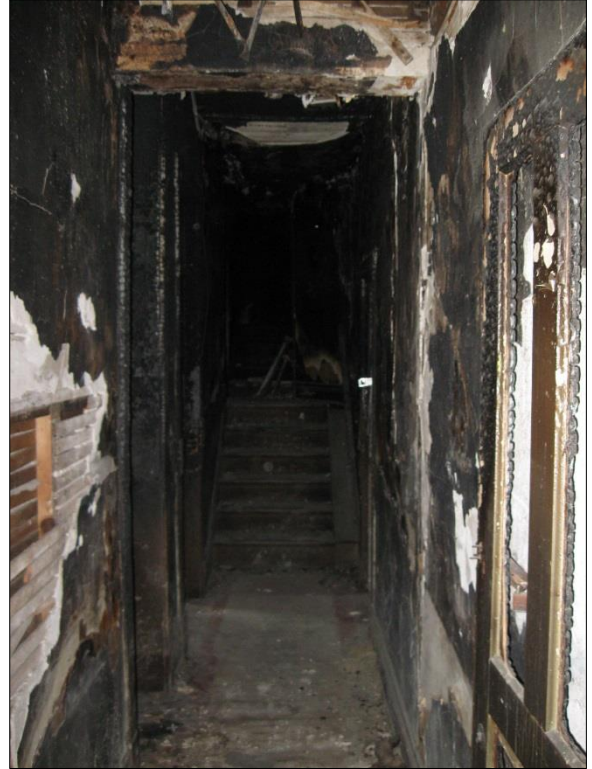
Figure 12 Corridor leading up the hill to serve inside units. Fire and smoke damage from front end fire

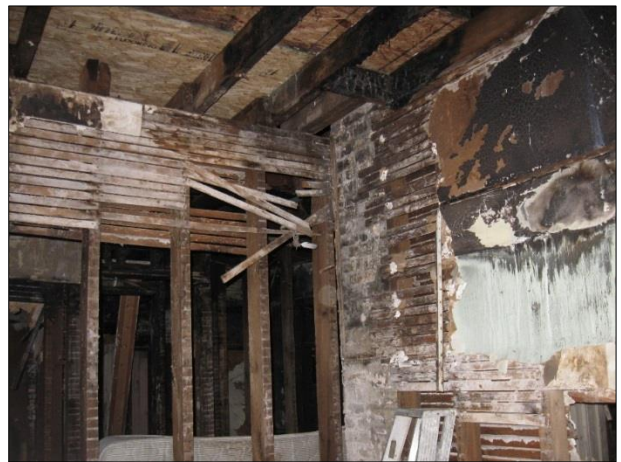
Figure 14 Stripped out and burn condition on Street side front

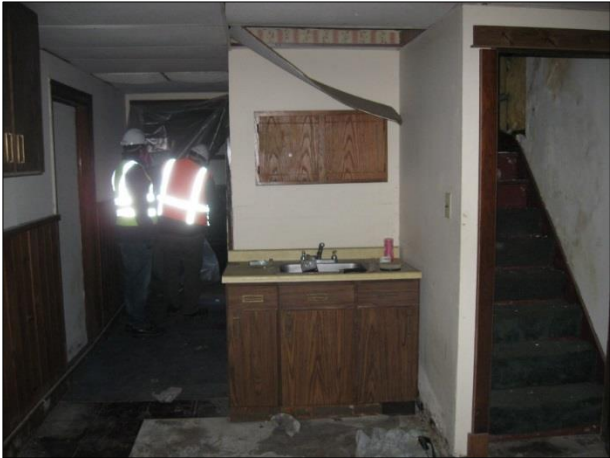
Figure 17 Ballroom first level showing water damage

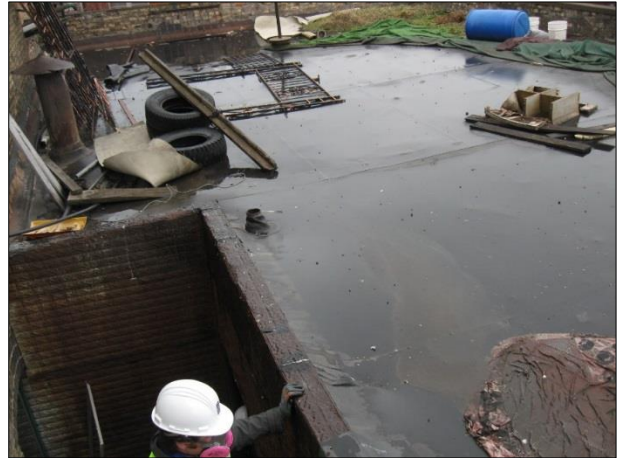
Figure 18 EPDM roof over Ballroom area. Note growth in corner and debris.

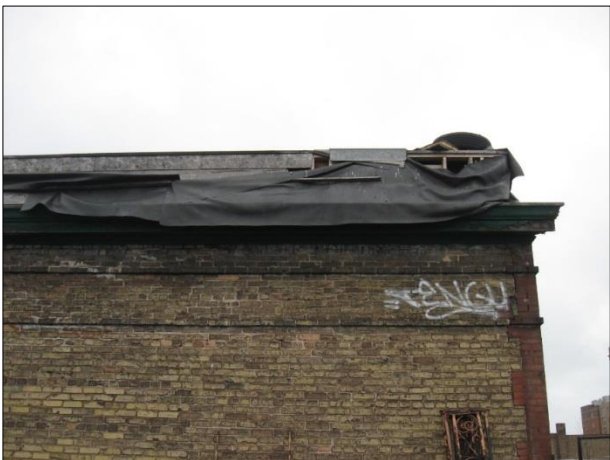
Figure 19 Southwest corner of Pastoret Terrace showing deteriorated temporary roof over burn areas

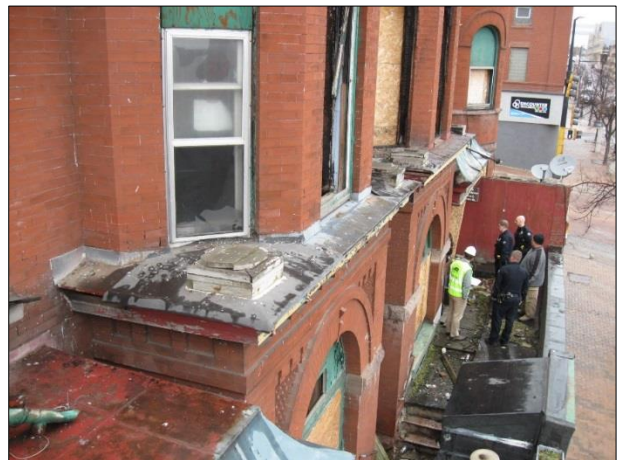
Figure 20 Street elevation close up showing metal capped façade features and EPDM membrane condition on Kozy extension below where Police are standing. Note various window conditions. No salvageable windows found.

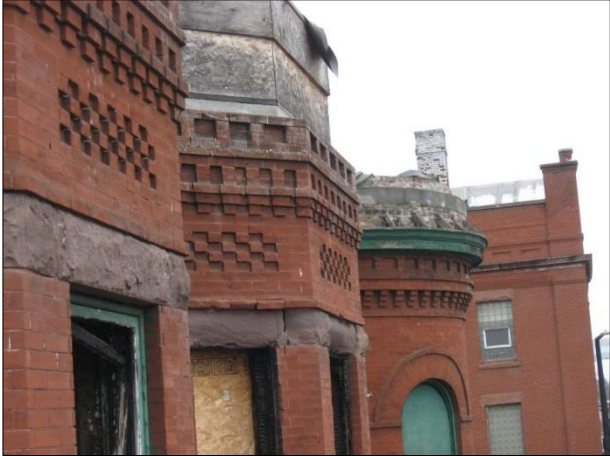
Figure 21 Note exposed Parapet wood work and brick back up on Street side

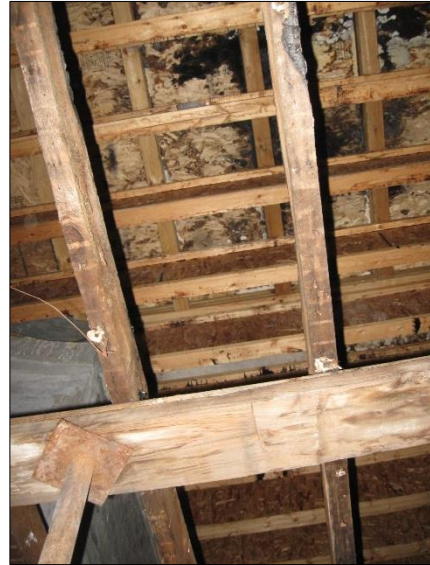
Figure 22 Black areas of temporary roof framing showing water intrusion and rot above burn area on Street side

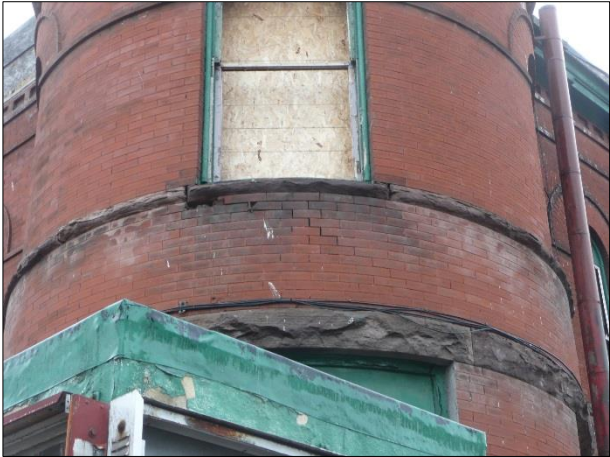
Figure 23 Loose Sandstone band, stair step crack, brick needs to be tuck-pointed

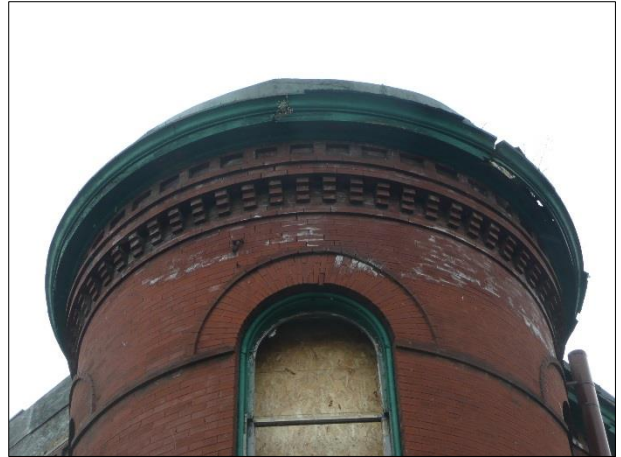
Figure 24 Loose brick at window arch, brick needs to be tuck-pointed

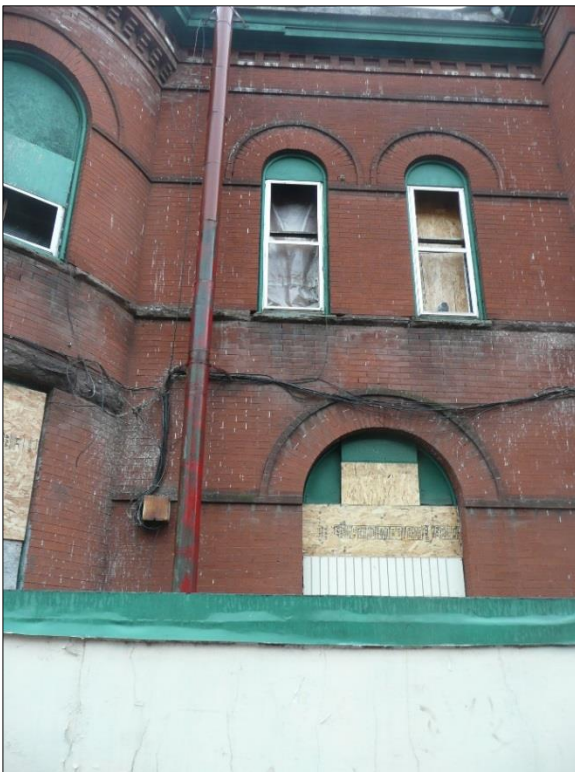
Figure 25 Loose Sandstone band, brick needs to be tuck-pointed

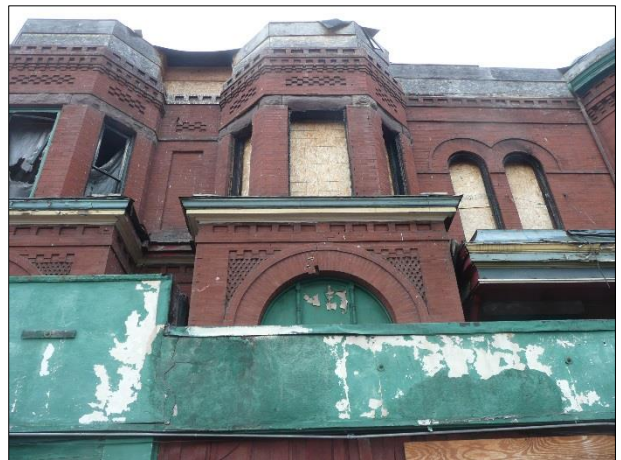
Figure 26 Loose brick at window arch, brick needs to be tuck-pointed

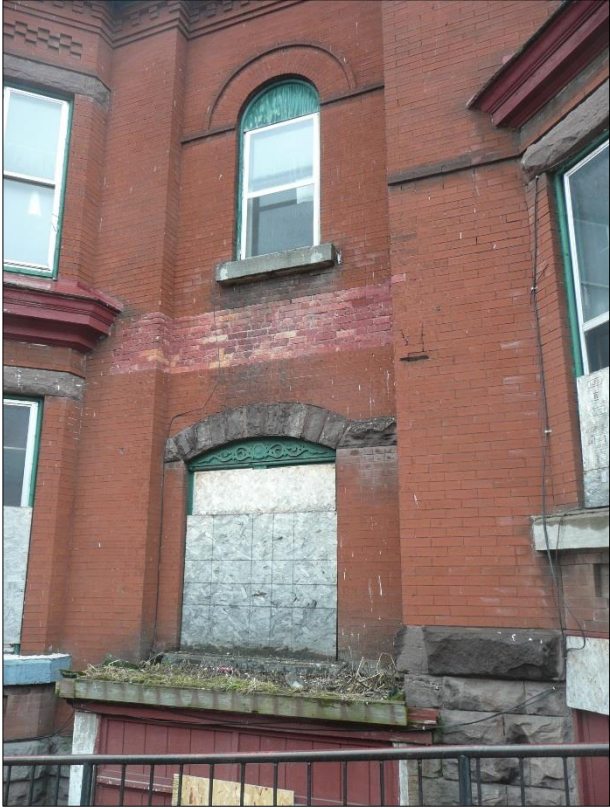
Figure 27 Mismatched brick, existing brick needs to be tuck-pointed

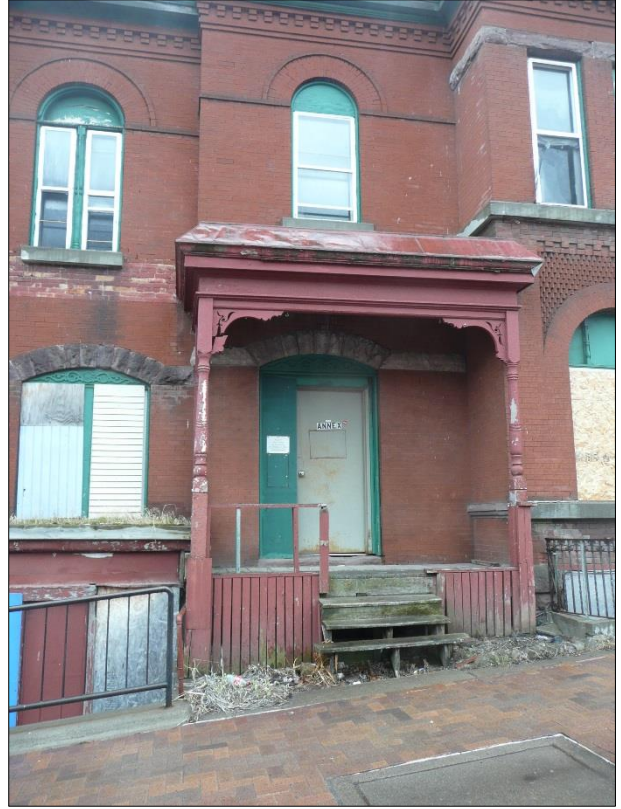
Figure 28 Typical entry porch Roof.

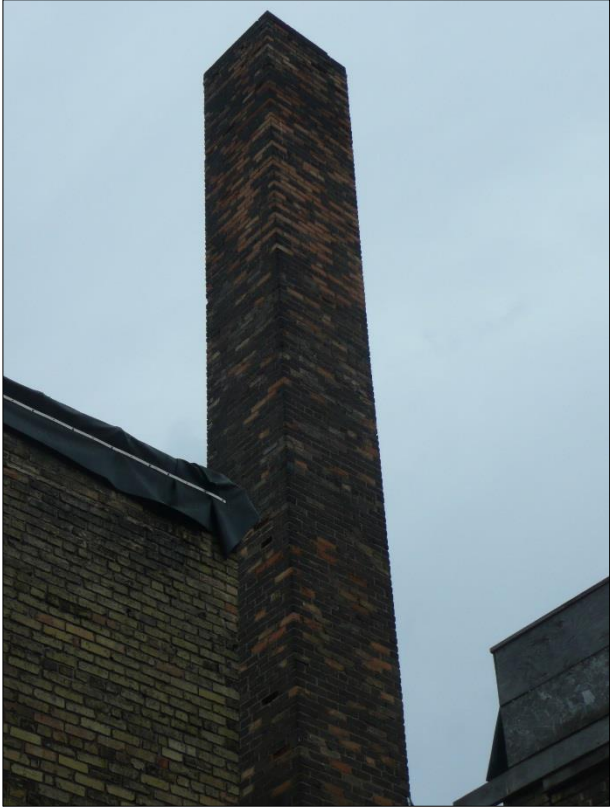
Figure 29 Brick chimney needs to be tuck-pointed

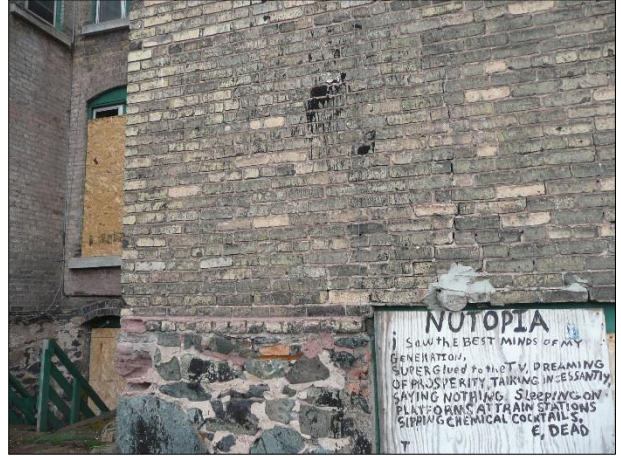
Figure 30 Brick on rear of Pastoret building needs to be tuck-pointed

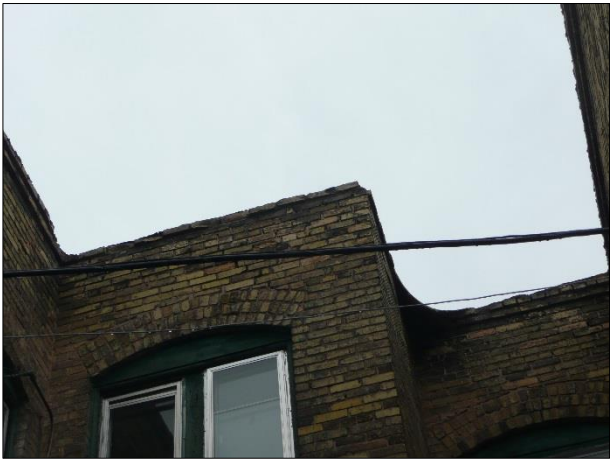
Figure 31 Brick parapet on rear of building in need of repair

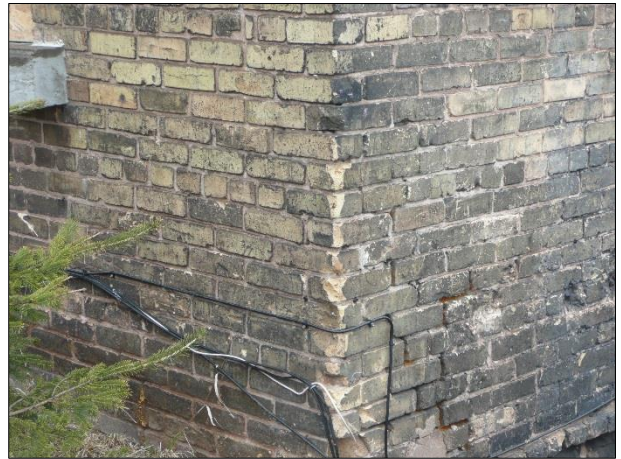
Figure 32 Damaged brick on rear of Pastoret building, brick needs to be tuck-pointed

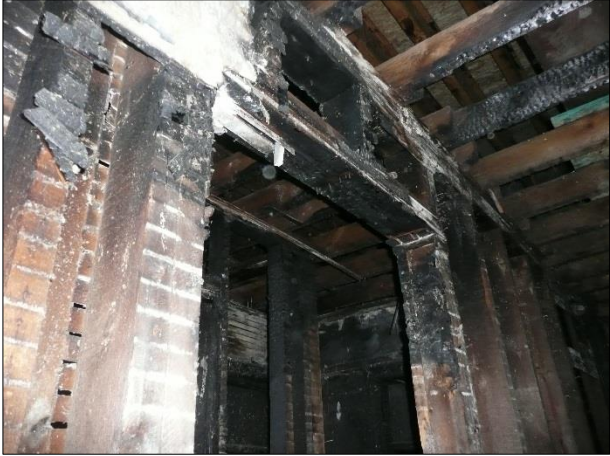
Figure 33 Fire damaged ceiling joists and wall framing

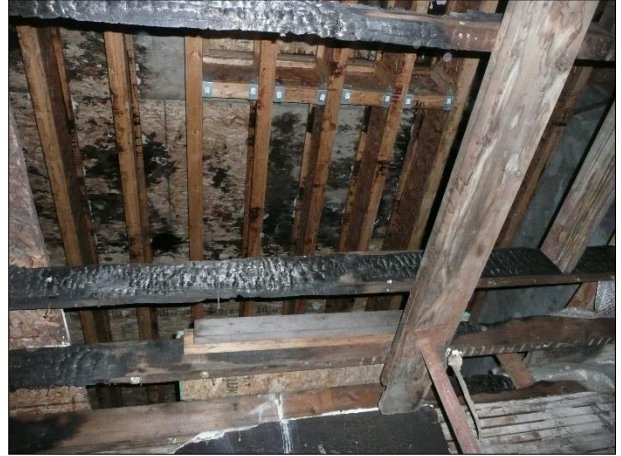
Figure 34 Fire damaged ceiling joists, temporary wood I-joist roof over fire damaged portion of the building

Most of the wood floor and roof structure was not visible. However, with the exception of the fire damaged area, which is limited to the areas above the Kozy Bar on East 1st Street side of the building, what was visible appears to be in good condition. The wood structure in the fire damaged area of the building will need to be 100% replaced but otherwise we would expect there to be very limited areas that may be compromised due to water infiltration. Generally, we would expect this be limited to the wood roof sheathing or the sub floor. The super structure, wood floor and roof joists below, should generally be in good condition. Exterior wood stairs and porches will probably need to be replaced but with the exception of the 1st street facade most of the porch roofs appear to be structurally in good condition.

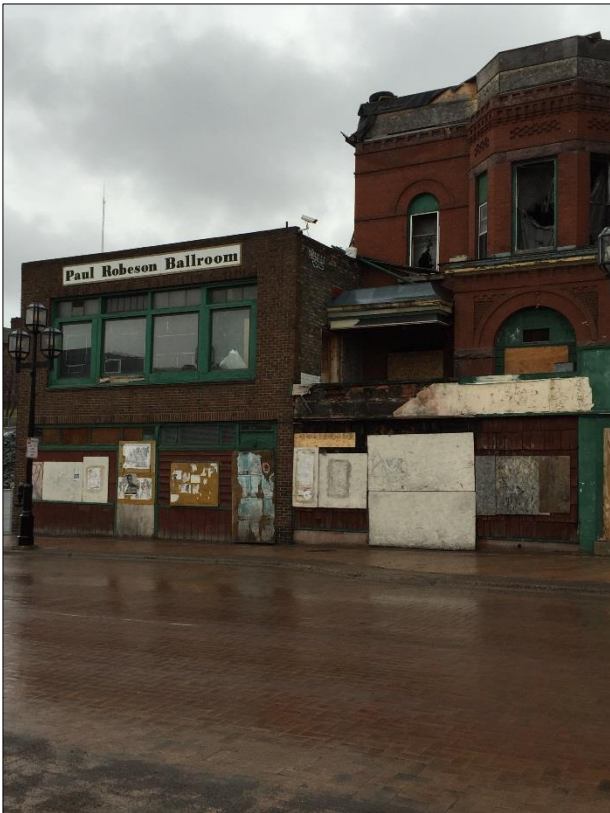
Figure 35 Front of Paul Robeson Ballroom, brick in good condition

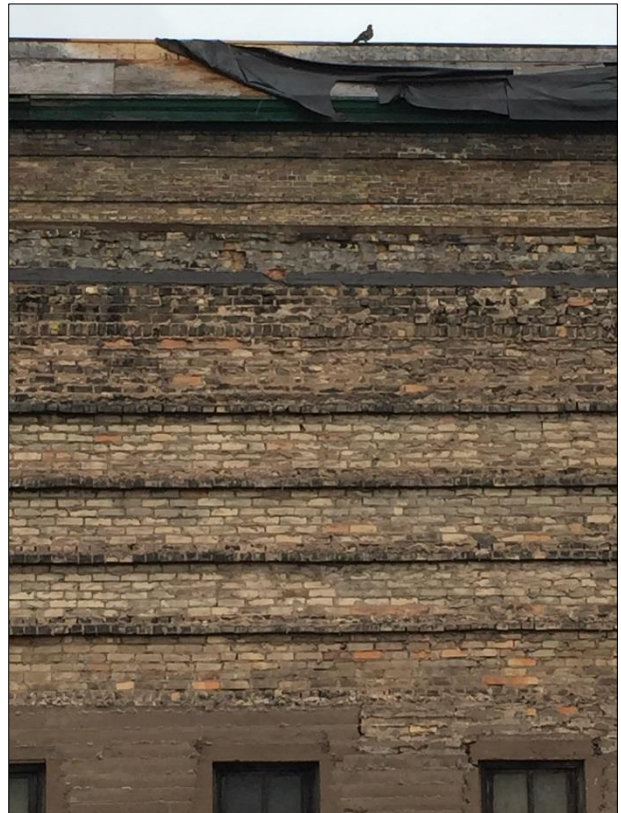
Figure 36 Side of Paul Robeson Ballroom, Damaged brick, brick needs to be tuck-pointed, parapet needs to be repaired

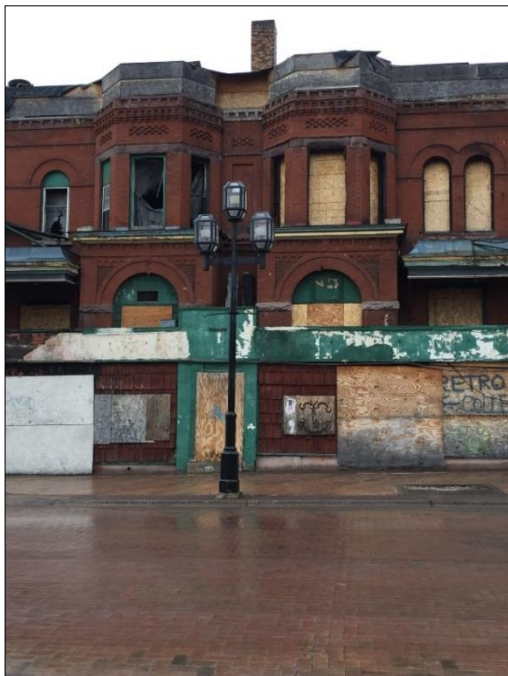
Figure 37 Kozy Bar addition, temporary roof parapet over fire damaged portion of original Pastoret building

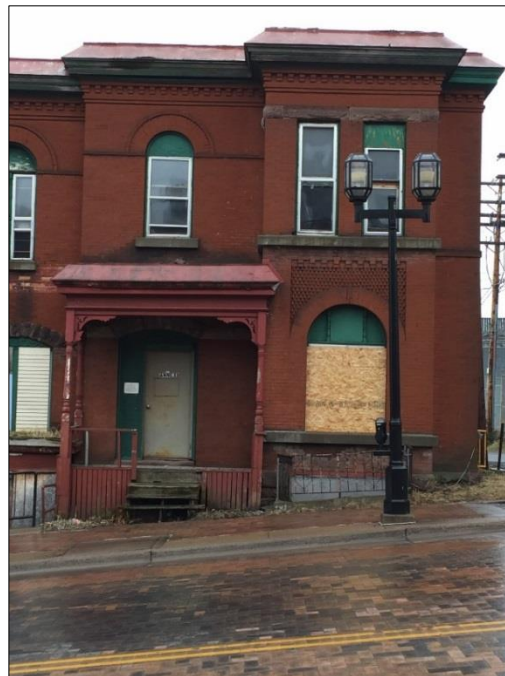
Figure 38 Entry stairs need to be replaced. Wrought iron railing needs to be repaired or replaced.

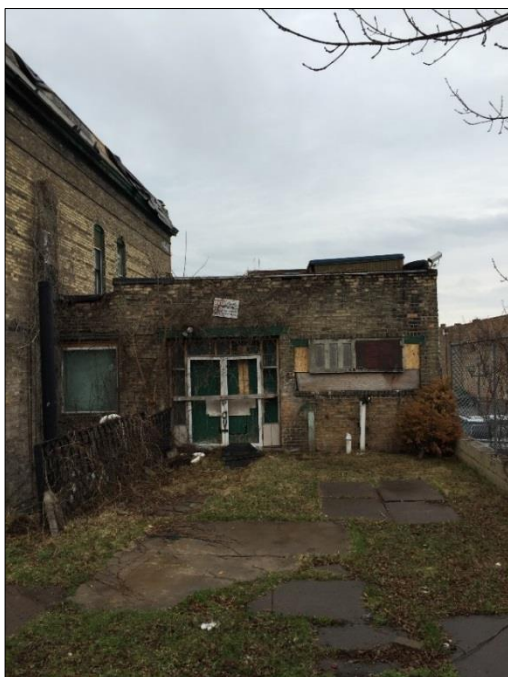
Figure 39 Rear of Paul Robeson Ballroom, Brick needs to be tuck-pointed, parapets need to be repaired

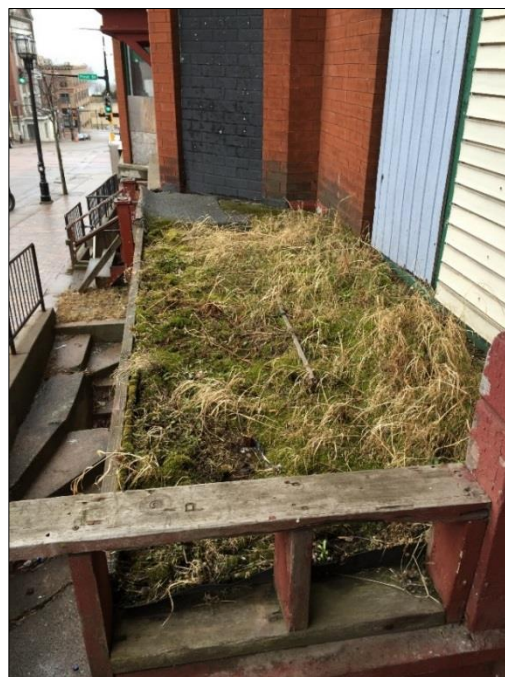
Figure 40 Vegetation growing on low roof, deteriorated roof structure below

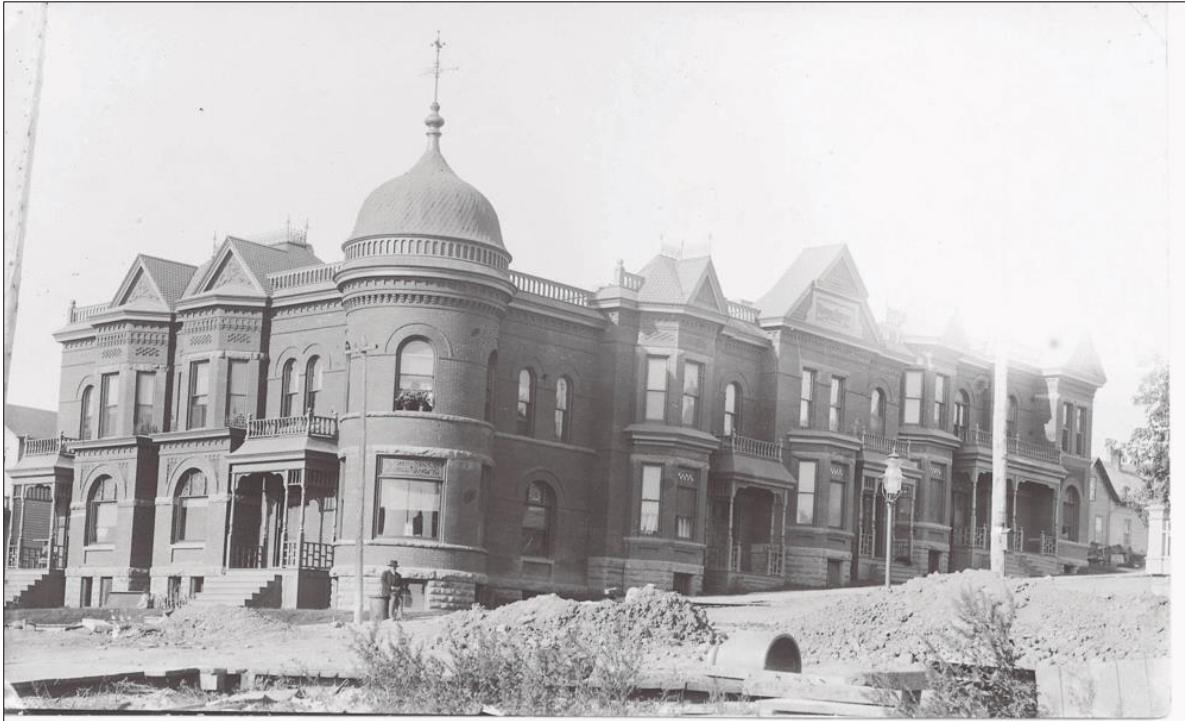
Figure 41 Historic Photo. 1883.

The design elements that have been removed over time such as wrought iron finials, domed turret roof, Gabled roofs, porches and balustrade can be reconstructed using photographic evidence. The existing windows and doors are primarily non-original and/or broken and destroyed. There may be a select few windows and exterior doors that are salvageable. It is assumed that the building will need a window and door replacement. Additionally, any rehabilitation of the building should remove the bar/restaurant structure that was placed on the East 1st Street façade and wraps around the north 2nd Avenue side.

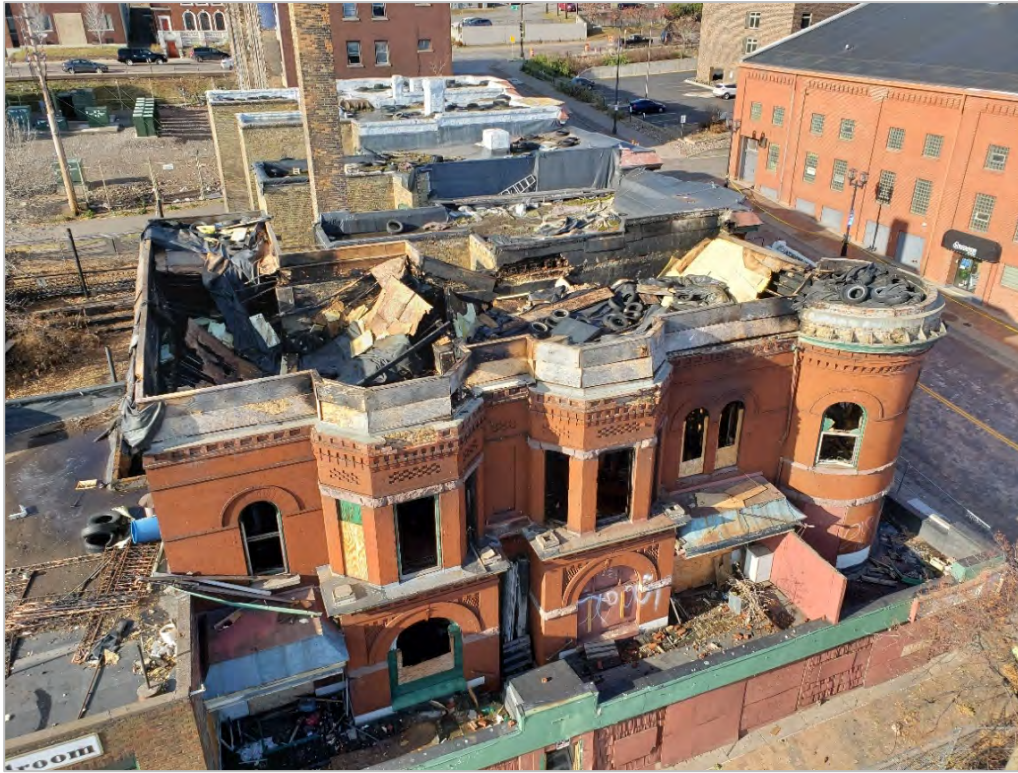
Photo 1: Southerly (1st Street) Elevation of Pastoret Building. Westerly module is on left and easterly module is on right. Roof region and majority of window openings on both modules are open to the elements.

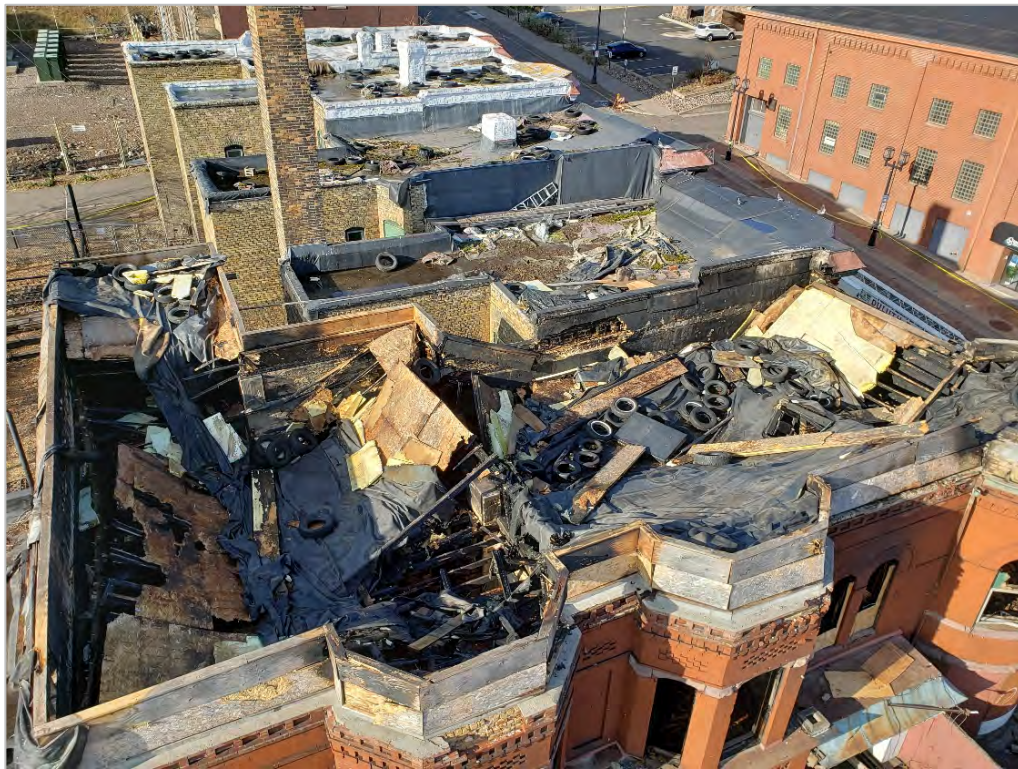
Photo 2: Fire destroyed and collapsed roof systems of Pastoret Building westerly (left side) and easterly (right side) modules.

During our observations of the collapsed Pastoret southern building roof regions, and review of the November 30, 2010 re-roofing drawings which were furnished to us by DEDA, we noted that the observed perimeter framing condition for the roof system did not appear to be constructed as indicated in the furnished drawings. The furnished drawings indicate the ends of the timber roof joists for both modules were to have extended onto the top of the exterior masonry walls. What was observed however is that the ends of the timber joists stopped short of the perimeter masonry walls and instead appear to have been secured to a timber ledger board which was anchored to the inside face of the perimeter masonry walls. It was observed that the ledger board anchors appear to have pulled free from the masonry walls thus allowing the timber joists to drop to the level below. Had the joists framed in the manner which was represented by the drawings it is possible more of them may have stayed in position since their ends would not have been able to fall unless they were sufficiently burned through or overloaded to the extent their ends were displaced off of the wall.

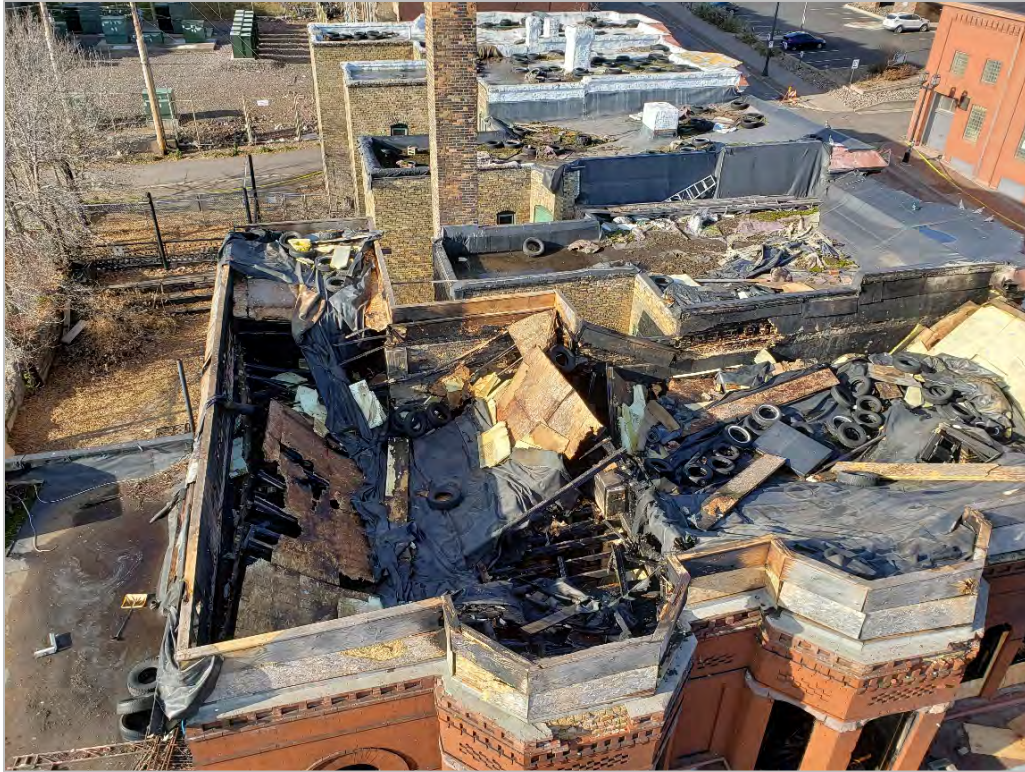
Photo 3: Fire destroyed and collapsed roof system of Pastoret Building westerly module.

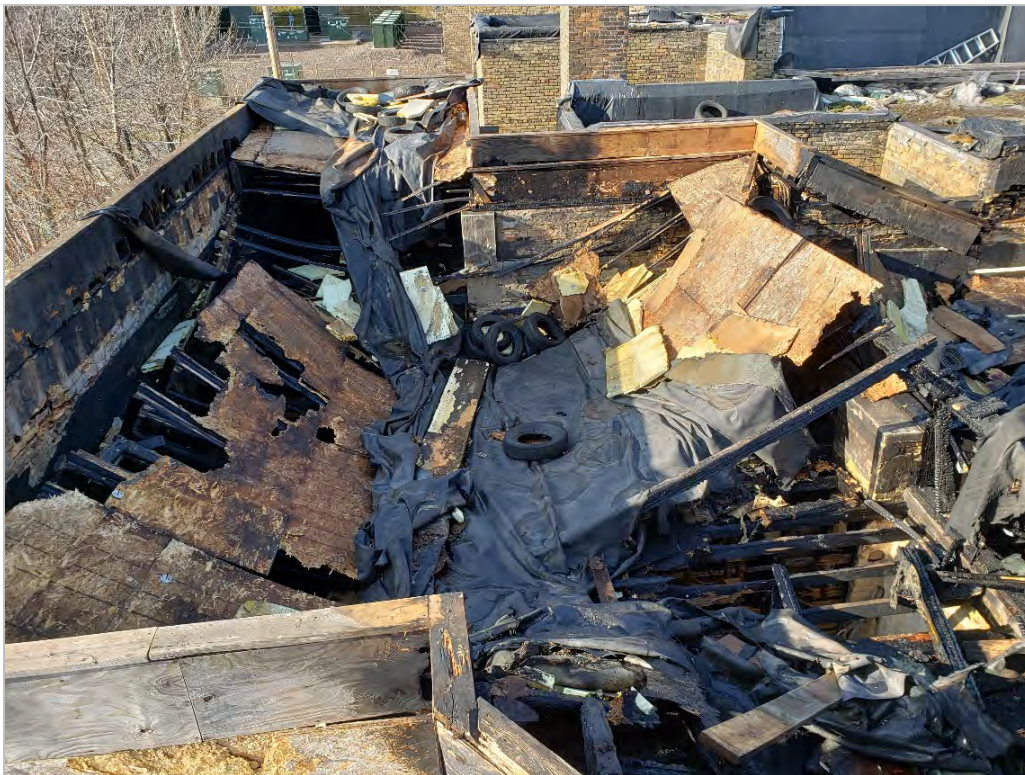
Photo 4: Close up view of fire destroyed and collapsed roof system of Pastoret Building westerly module.

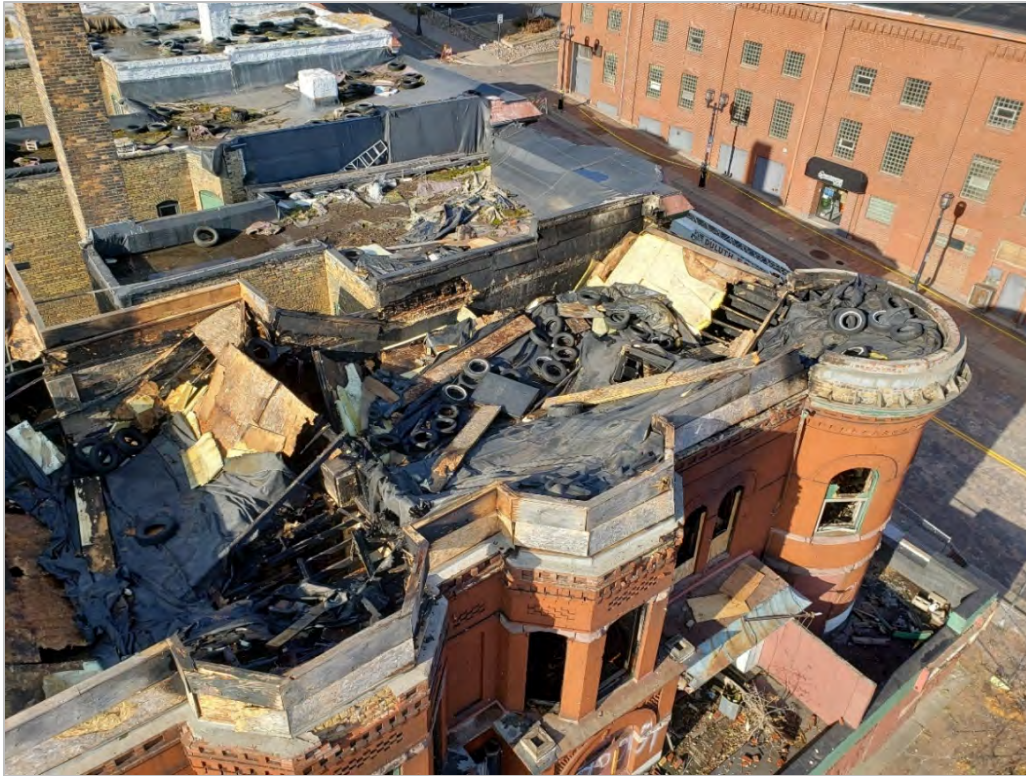
Photo 5: Fire destroyed and collapsed roof system of Pastoret Building easterly module.

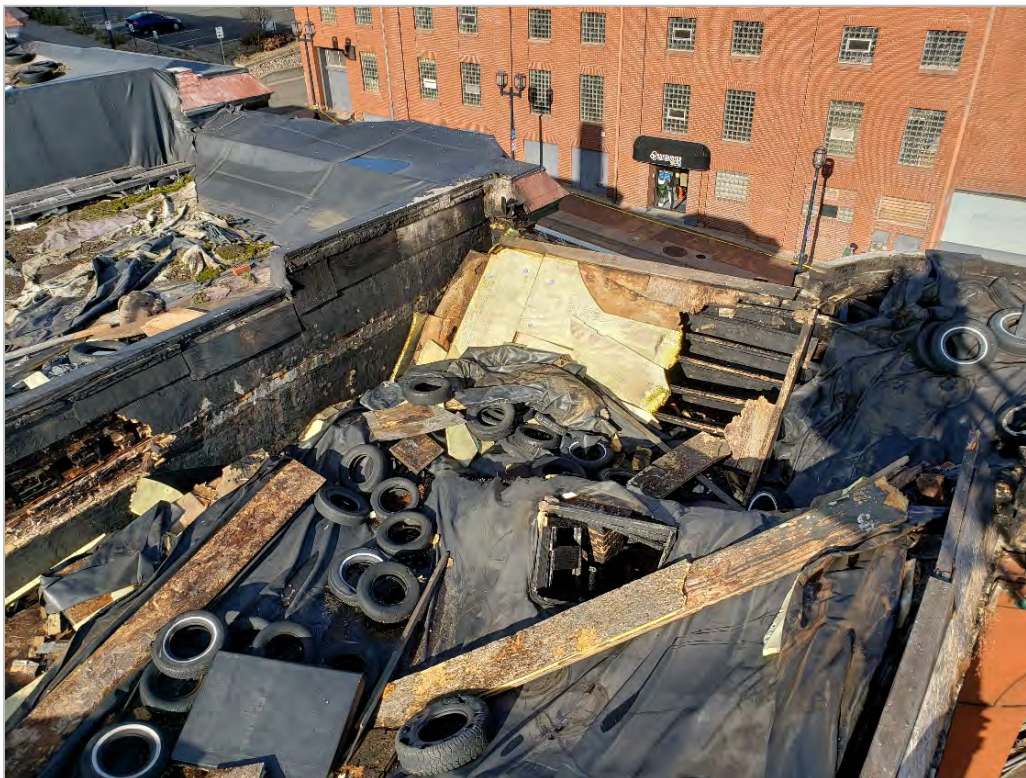
Photo 6: Close up view of fire destroyed and collapsed roof system of Pastoret Building easterly module.

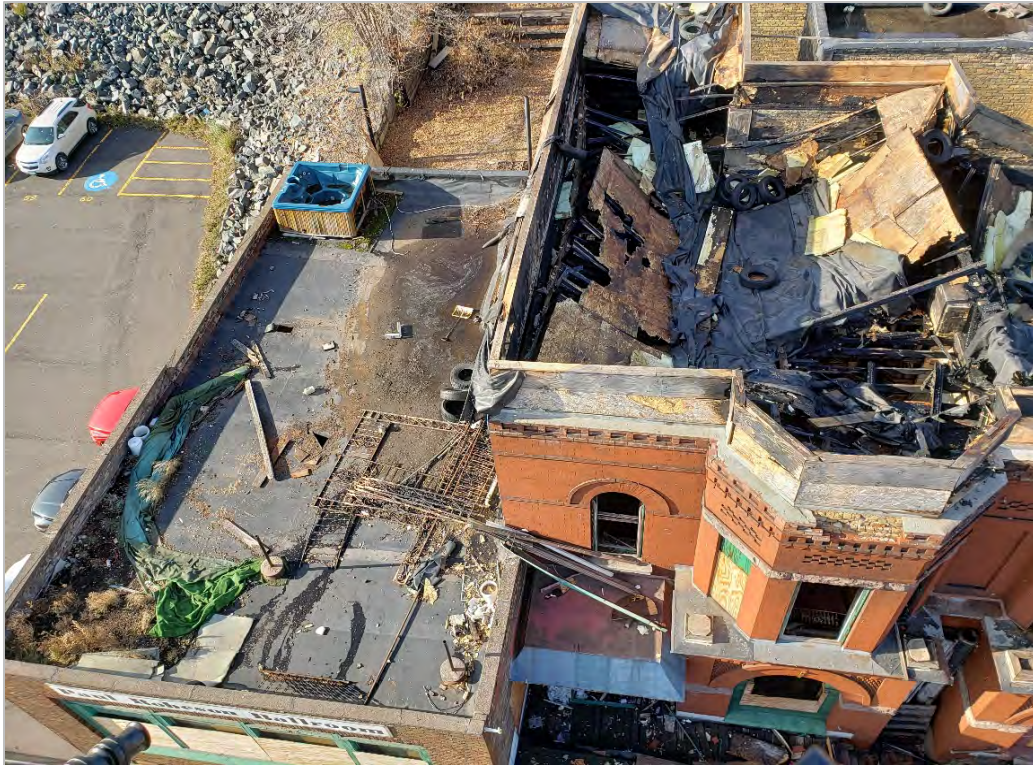
Photo 7: Robeson Building roof (left side of photo). Initial assessment indicates fire damage from recent fire may be confined to region directly adjacent to Pastoret Building west wall, but water saturation was identified throughout interior.

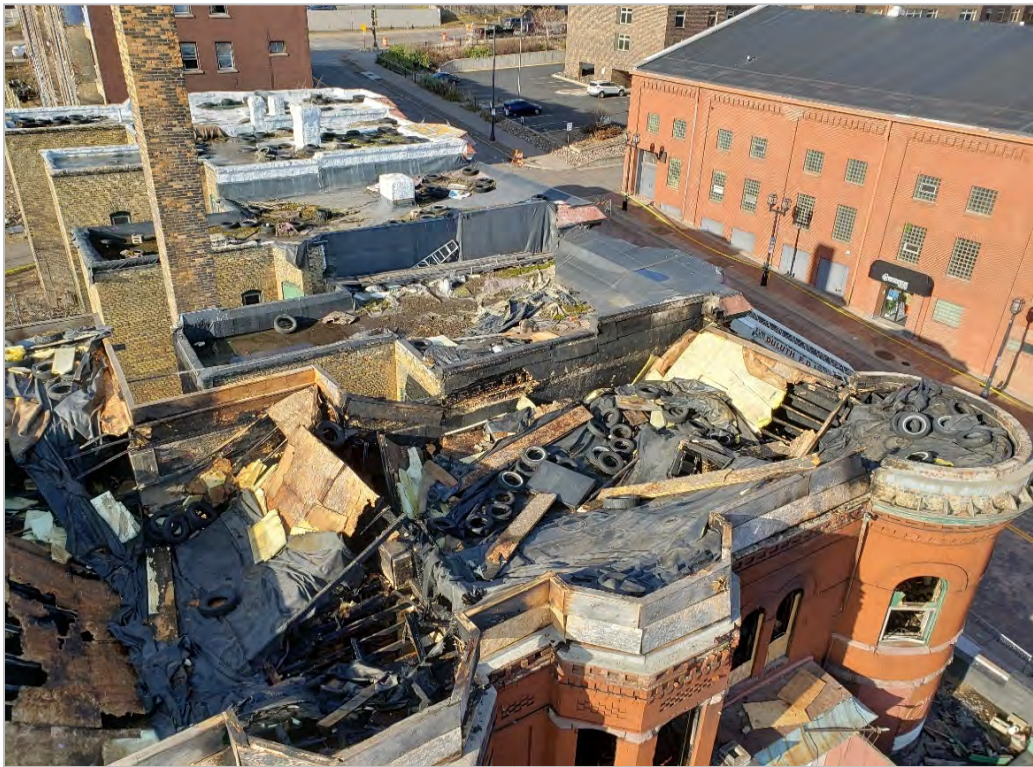
Photo 8: Collapsed fire damaged roofs of Pastoret Building westerly and easterly modules in foreground and roofs of modules bordering/running up 2nd Avenue East beyond.

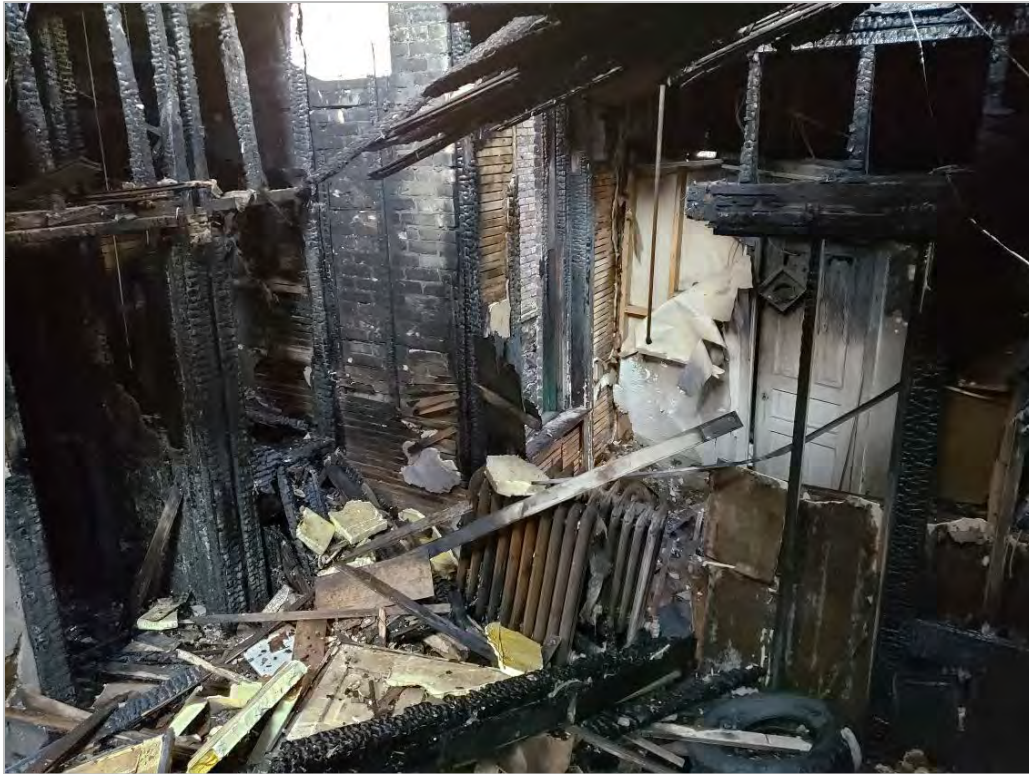
Photo 9: Looking into Level 2 of Pastoret Building westerly module from northeast corner region of 2nd floor level of Robeson Building. Interior walls and framing are entirely compromised. Heating radiators are presently unsupported/ collapsing through floor.

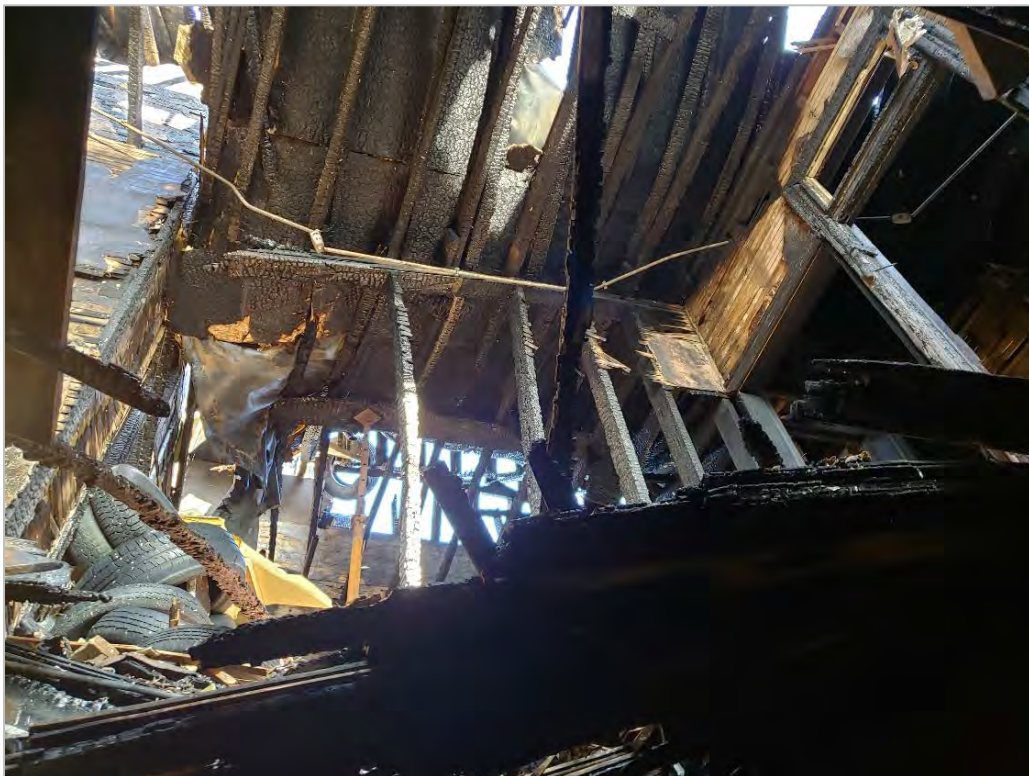
Photo 10: Looking Easterly from location shown in Photo 9 (Level 2, Pastoret Building westerly module). Ceiling above is burnt out/ collapsing onto Level 3 floor beneath. Large openings through collapsed roof which has fallen onto Level 3 can be seen.

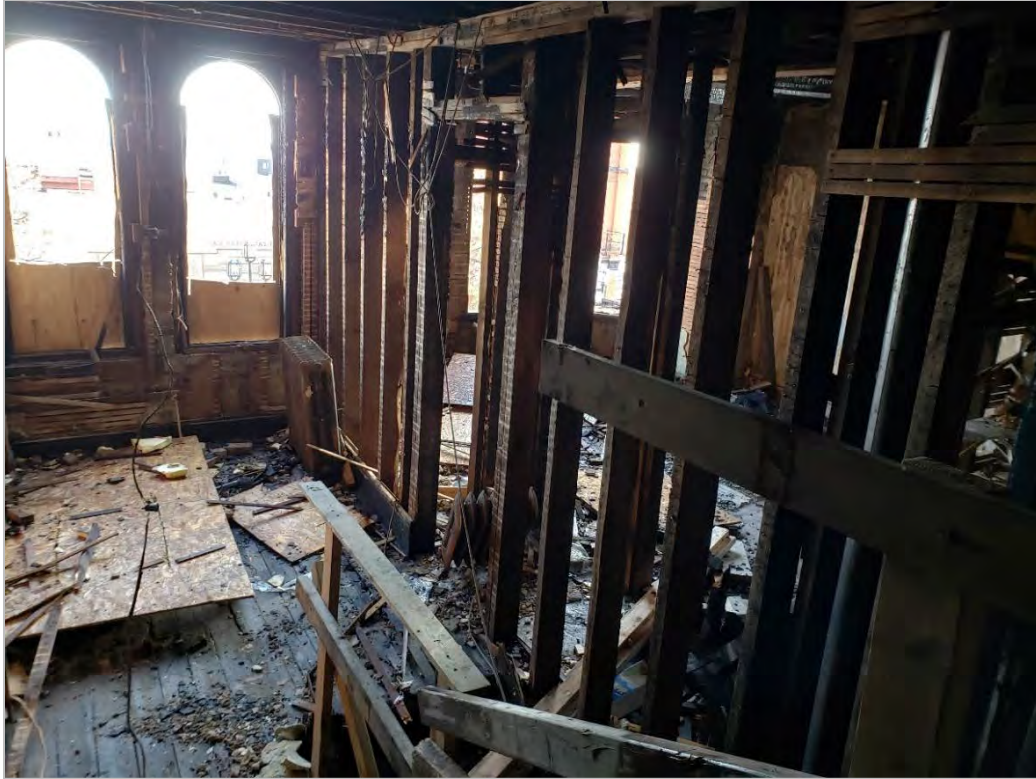
Photo 11: Pastoret Building easterly module, Level 2 looking south. Random direct fire damage this level and extensive water infiltration.

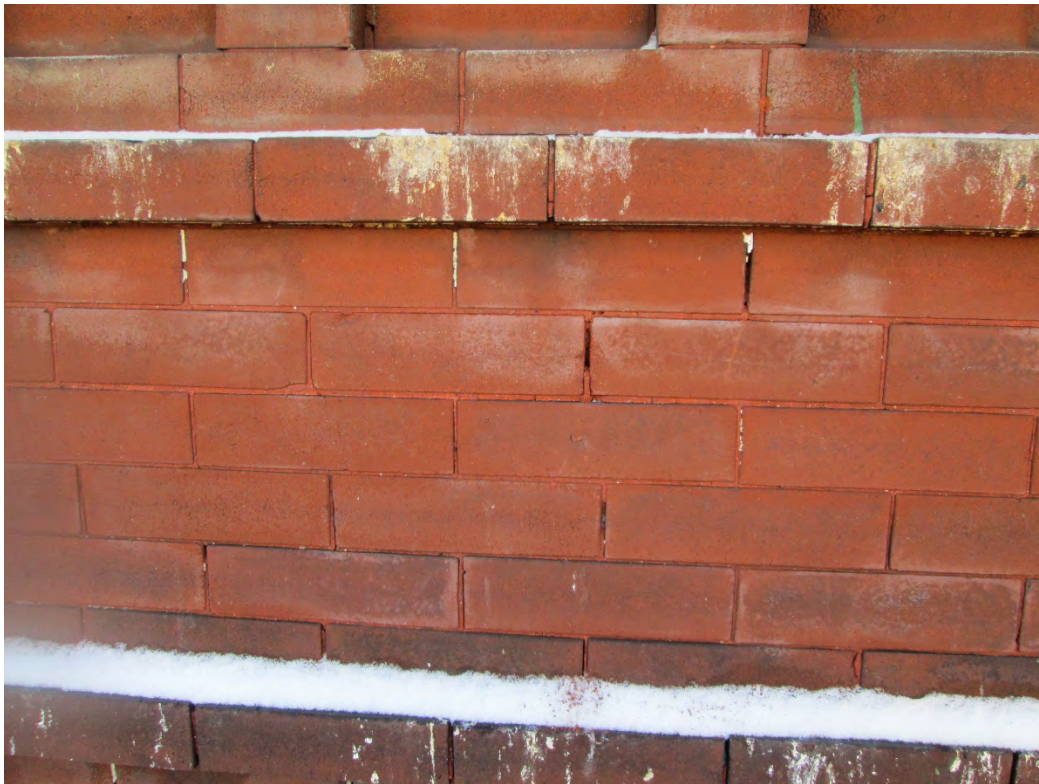
Photo 12: Typical exterior brick masonry wall pointing mortar condition at mid-wall regions, southern elevation shown.
