22-5504 Request for Proposals

Historic Restoration Pastoret Terrace

Duluth, Minnesota

Pastoret Terrace Assessment: Terrace, Kozy Bar, and Ballroom

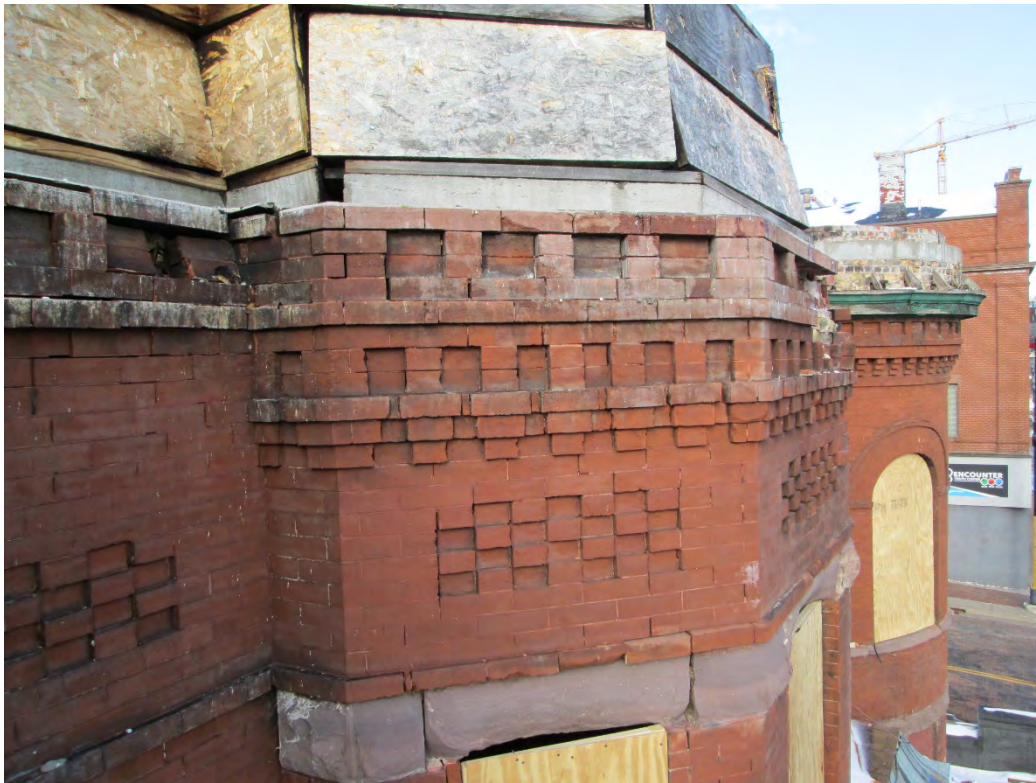
Photo 13: Looking east, upper exterior brick masonry region, south elevation.

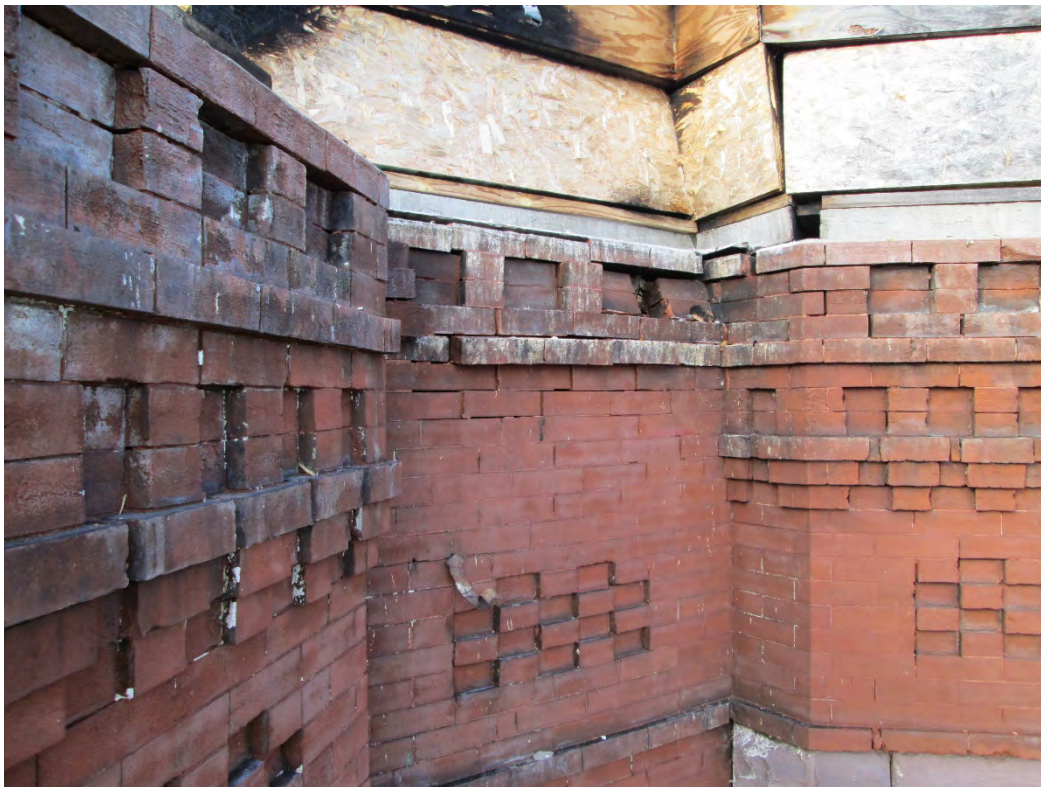
Photo 14: Closer view from previous photo. Looking east, upper region, brick displacement/loose brick, significant efflorescence and loss of pointing mortar.

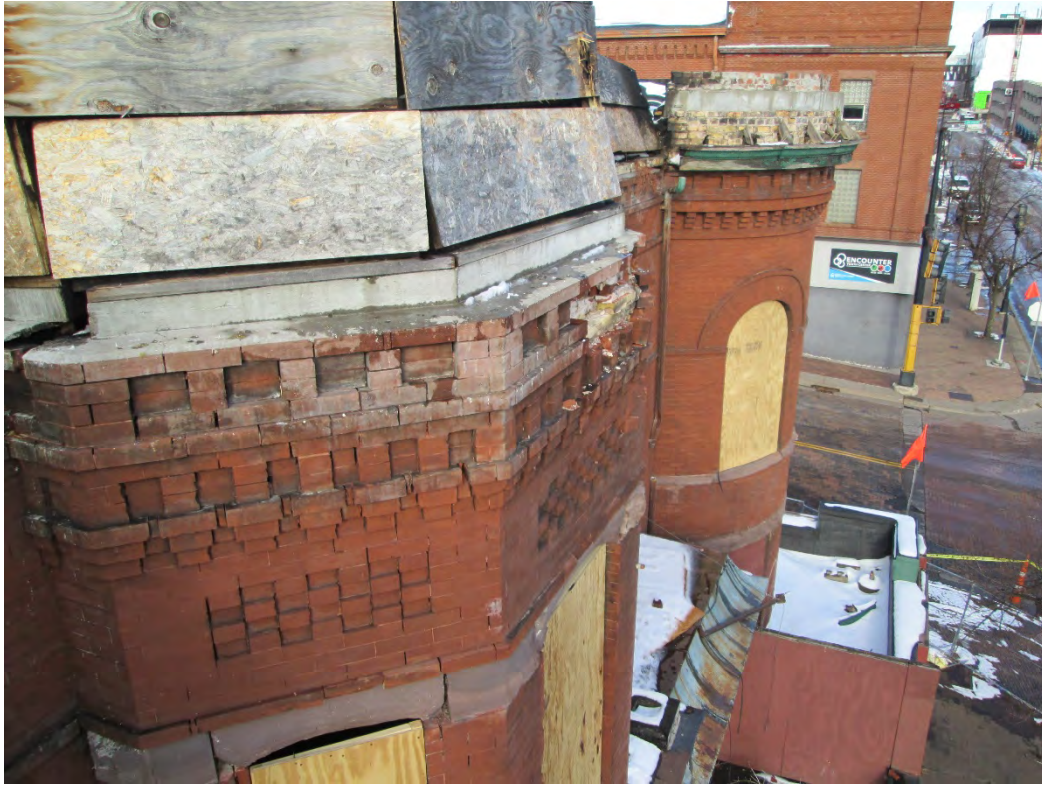
Photo 15: Looking east, upper region, south elevation, brick displacement/loose brick, significant efflorescence and loss of pointing mortar.

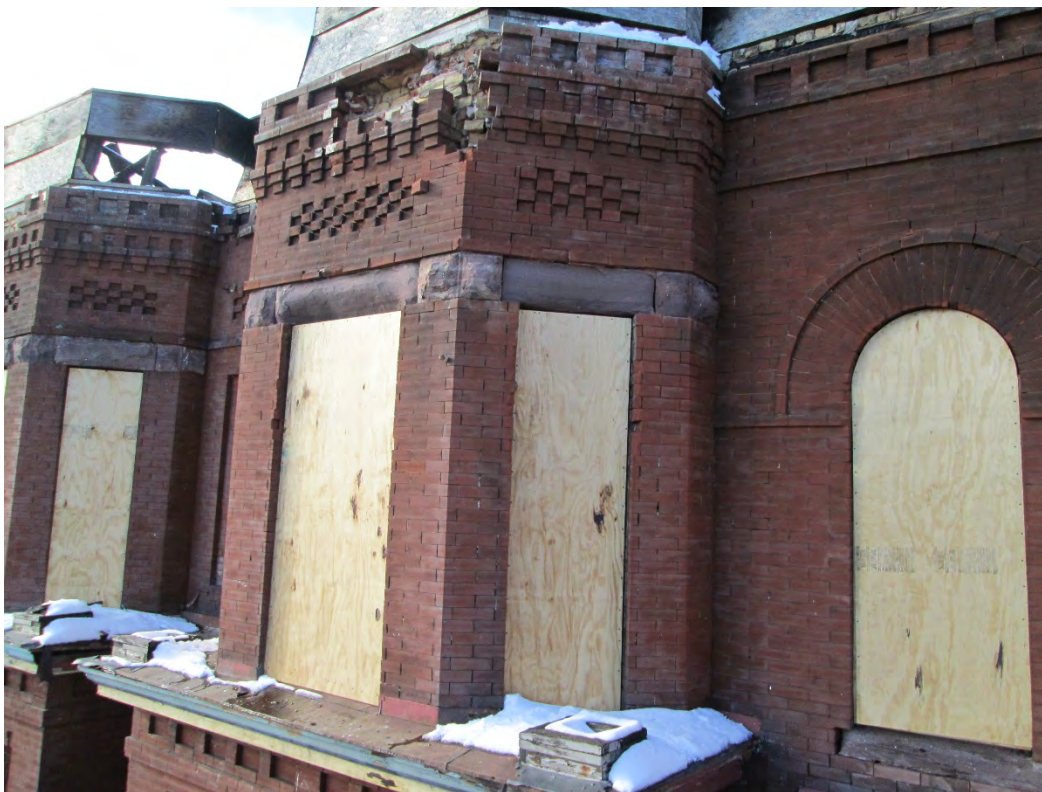
Photo 16: Looking slight west, upper region, south elevation. Substantial brick loss, loose bricks/displaced bricks.

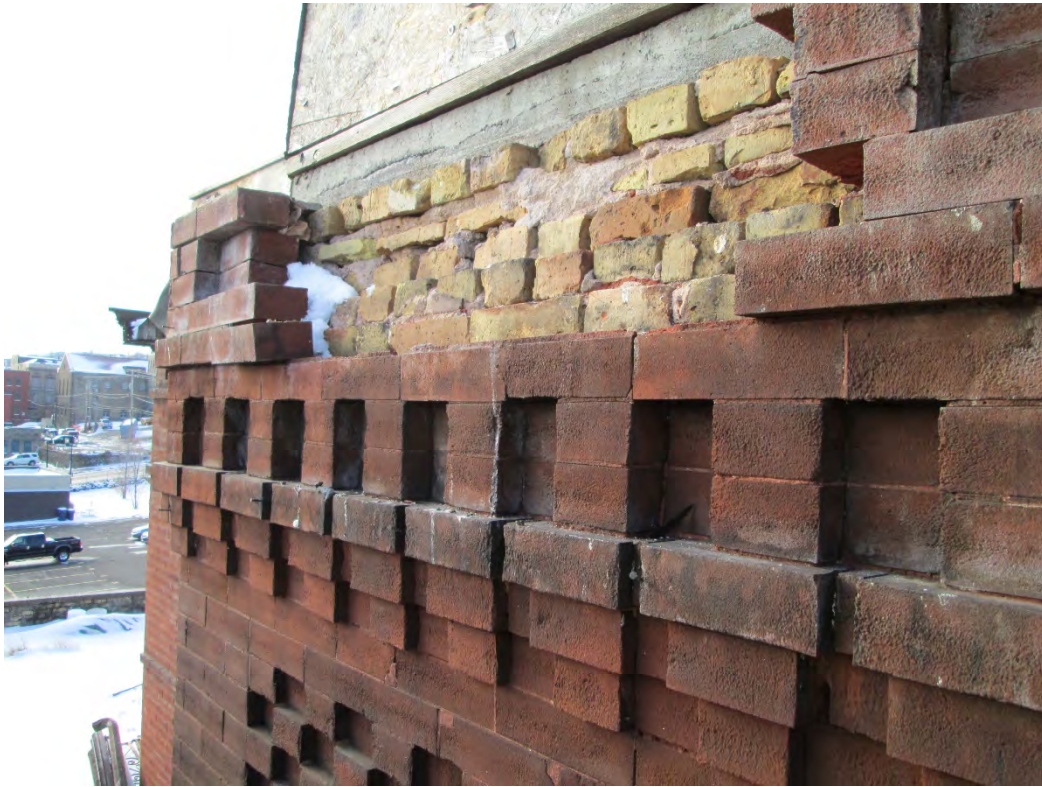
Photo 17: Close up of devoid brick area from previous photo. Numerous loose bricks remain and present a hazard to below.

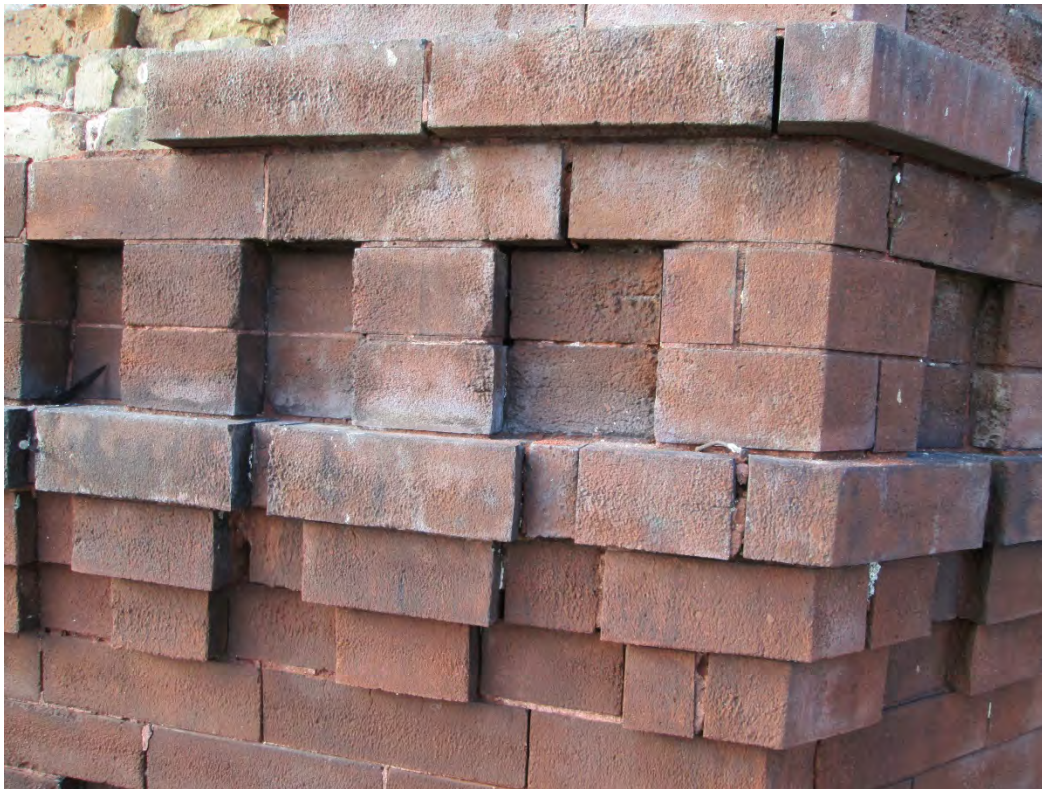
Photo 18: Close up, right end of previous photo (upper wall, south elevation). Note substantial efflorescence, face pitting in brick (potentially fire damage) and deteriorated pointing mortar.

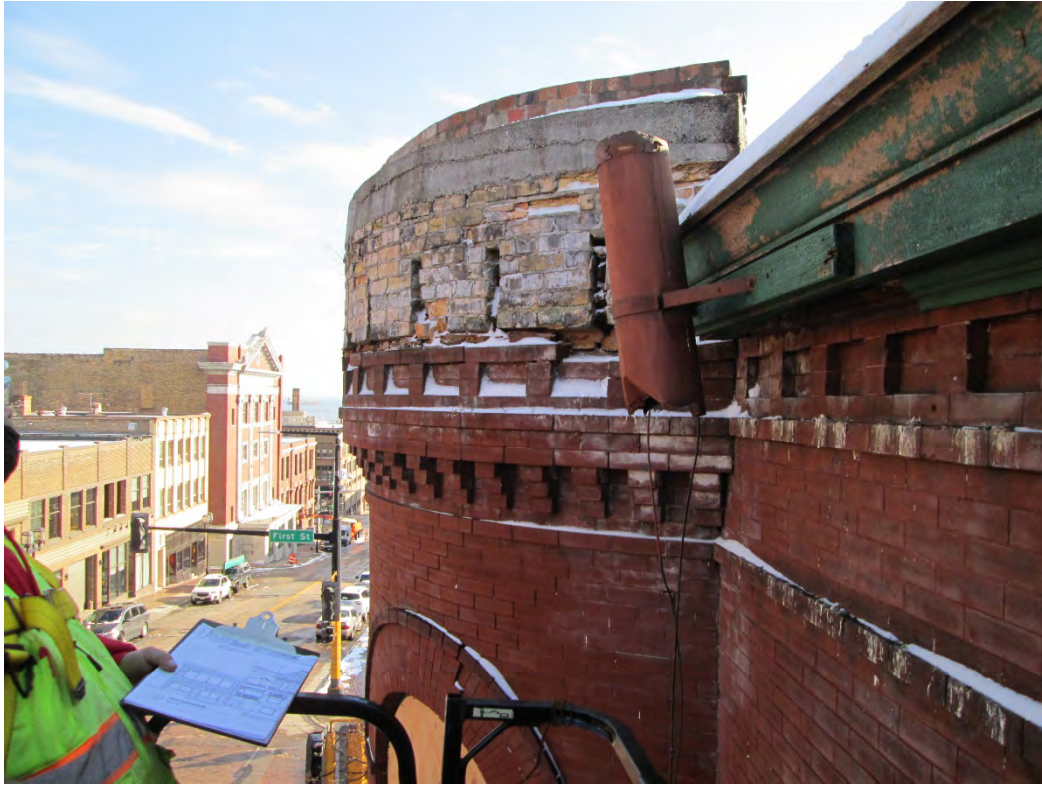
Photo 19: Upper wall region, east elevation looking south. Substantial efflorescence, loss of pointing mortar and loose bricks.

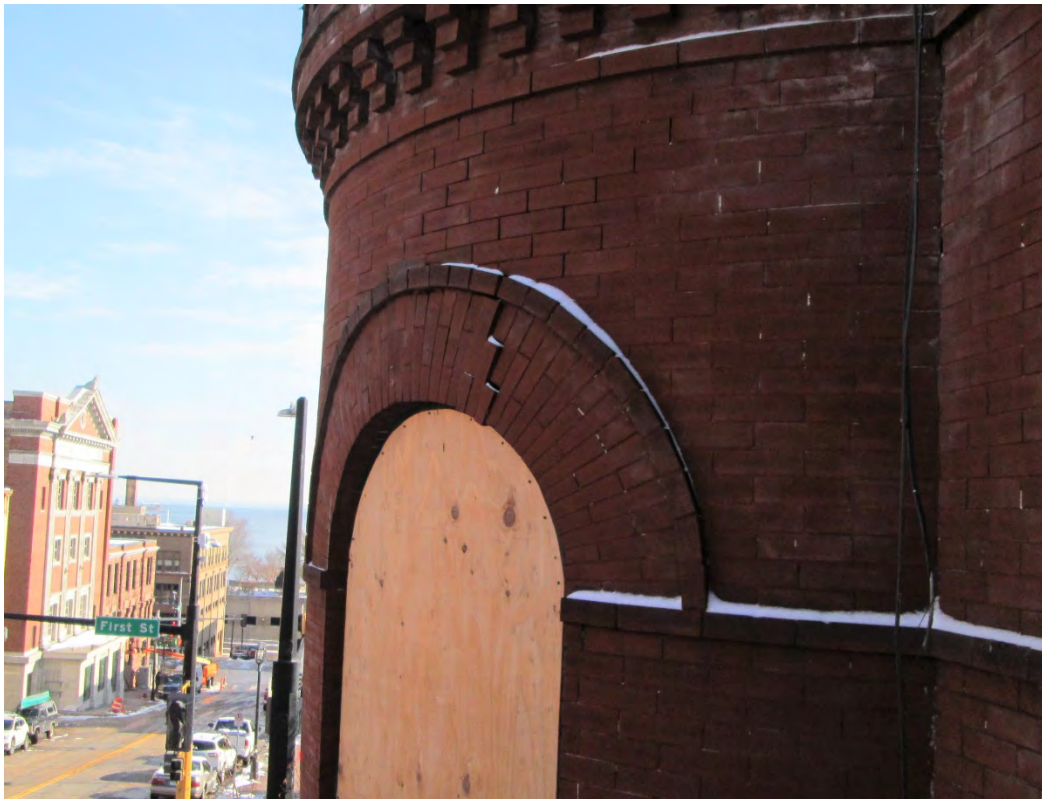
Photo 20: Southeast corner turret, looking south. Widened brick end joints and failing brick in window header arch may indicate larger movement/instability.

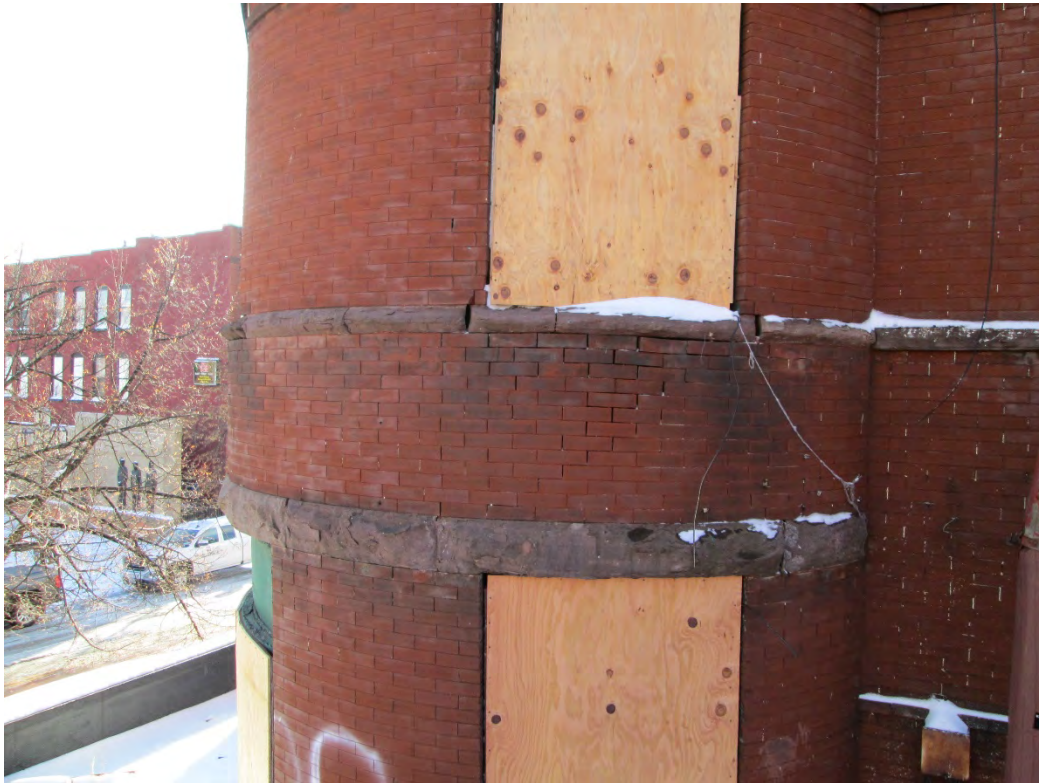
Photo 21: Region towards base of window in previous photo. Widened brick end gaps here also indicate potential global movement in circumference brick.

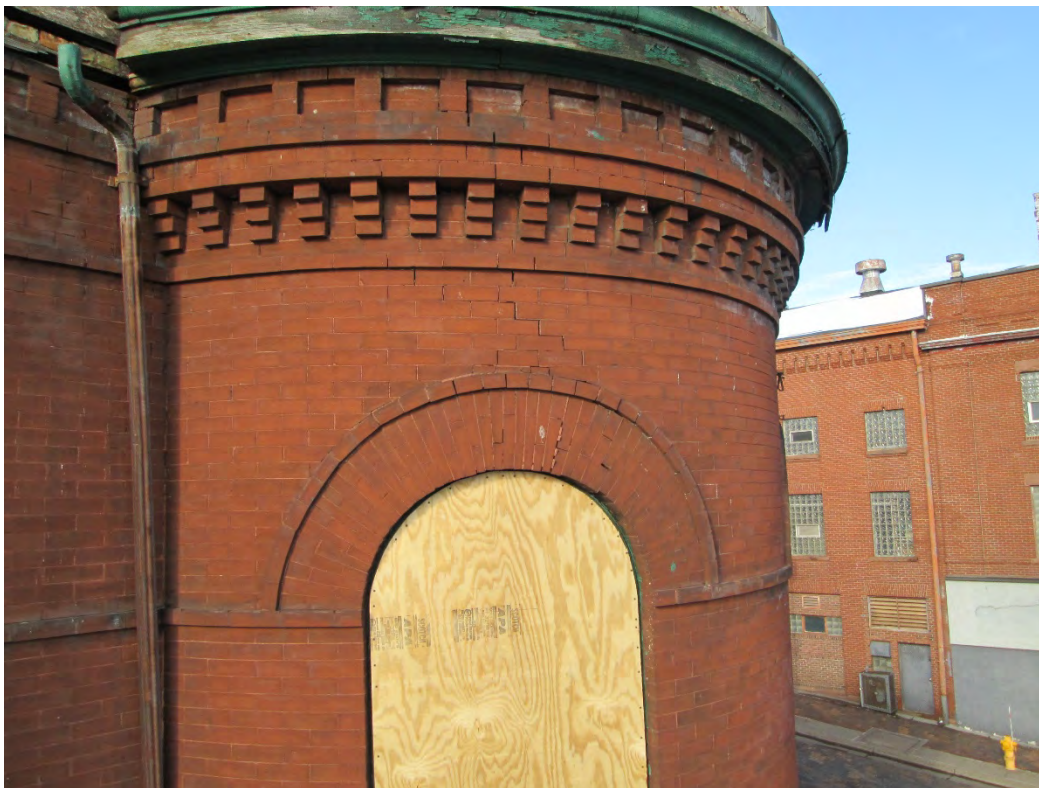
Photo 22: Southeast corner turret., south face. Joint cracking and brick end gap openings above window indicate potential global movement in wall circumference brick.

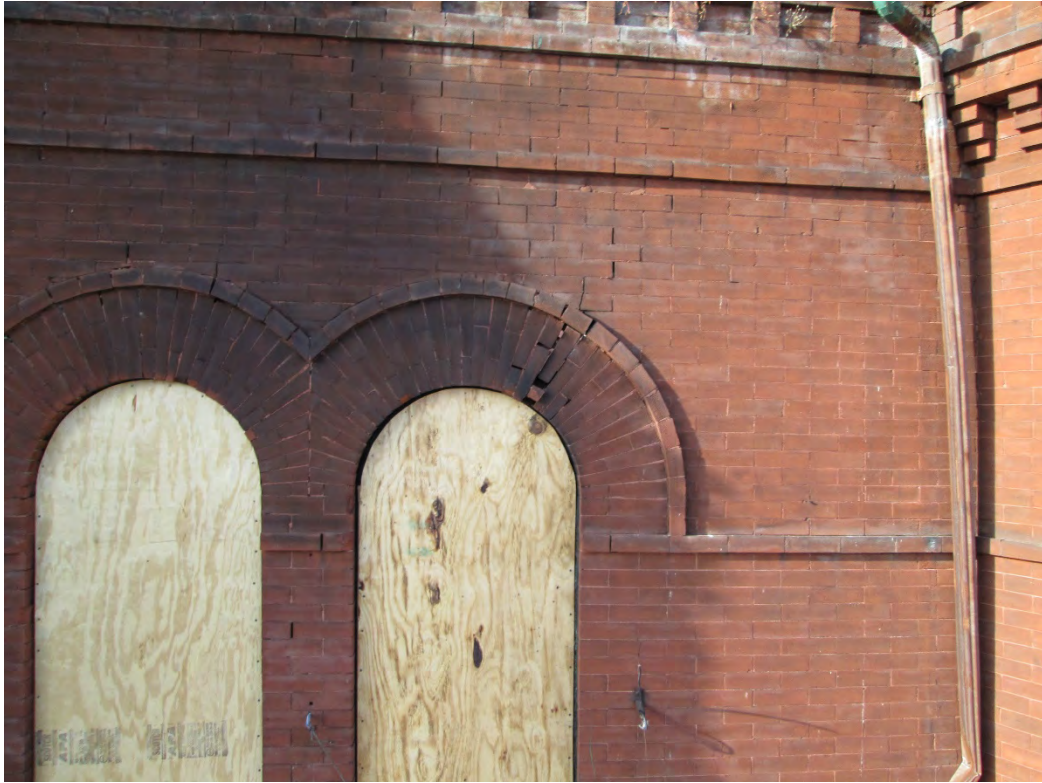
Photo 23: Typical brick displacement/failure at arched window headers. Level 3, south elevation, easterly module adjacent to southeast corner turret.

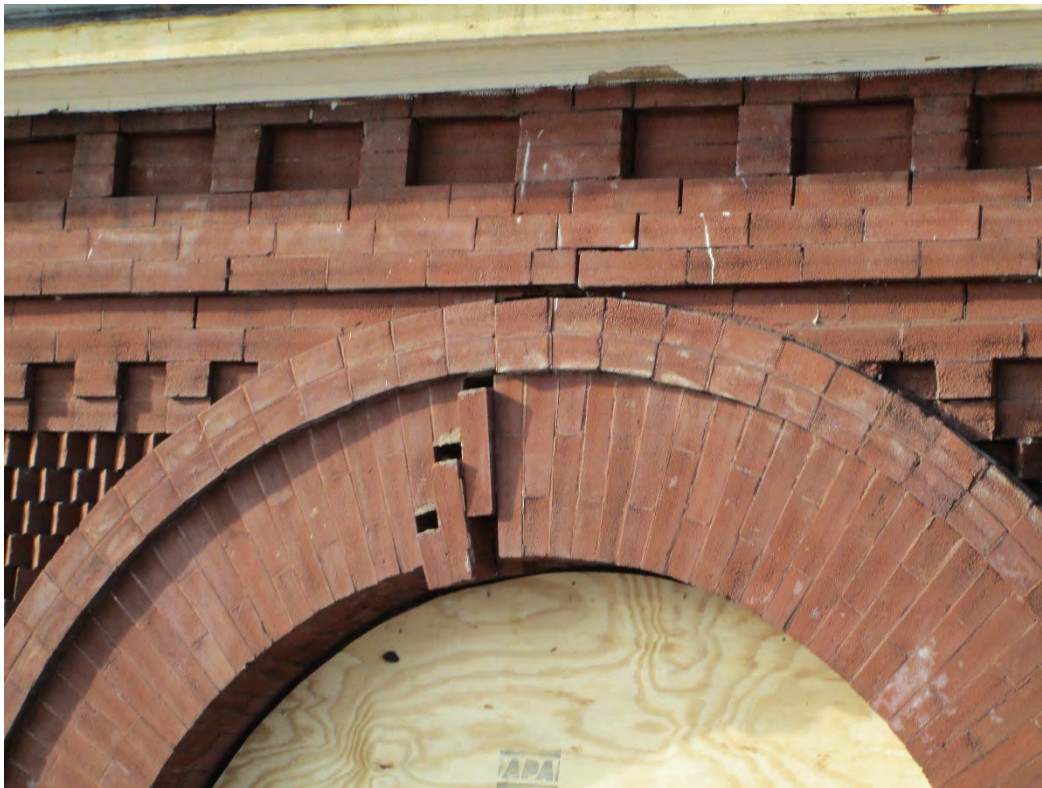
Photo 24: Typical brick displacement/failure at arched window header, Level 2, south elevation (easterly module shown, westerly module similar).

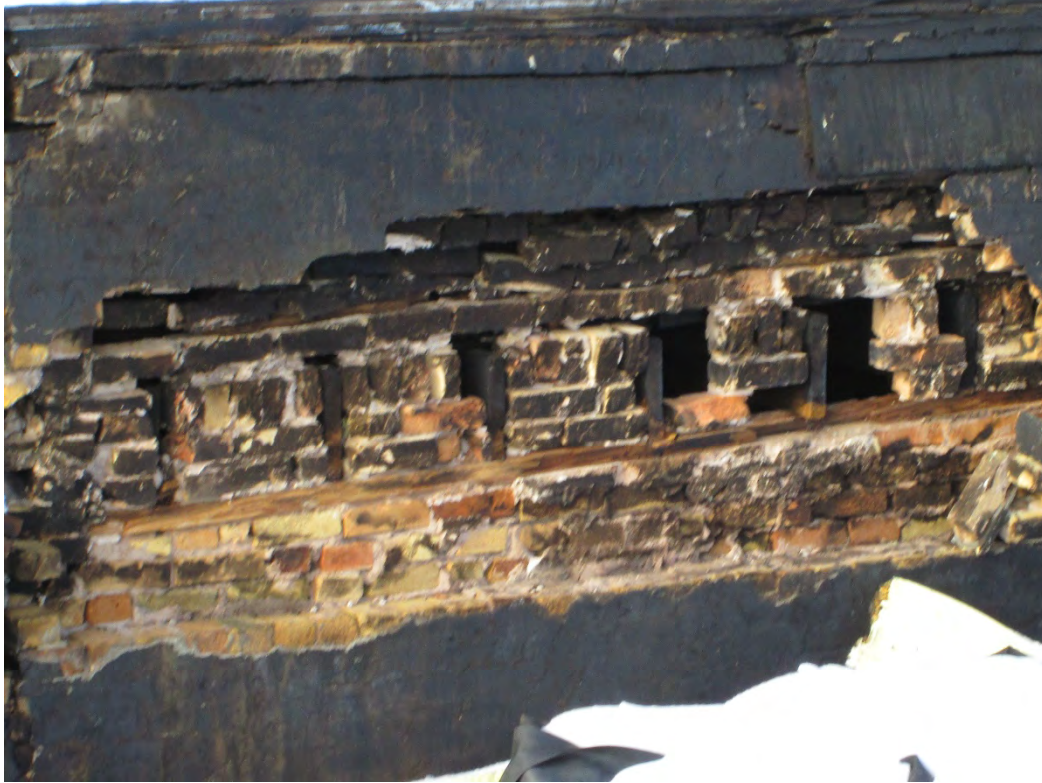
Photo 25: Party wall between east southerly Pastoret module and module to north. Some apparent fire damage to north module roof joist ends. Unknown (due to access limitations) if joists have suffered fire damage which is compromising structural stability of north module roof.

Select regions of the northerly building modules were observed. Based on the limited observations, it is believed the masonry bearing wall lying between the southern-most building modules and those to the north, primarily confined and maintained the fire from the northerly modules. It was observed however that the southerly ends of the roof joists of the northerly module (which bear onto the shared masonry wall with the southernmost easterly module) may have suffered fire damage. This condition can be seen when viewing the south face of the northerly party wall where the roof joist ends bear (see photo 25). This is a condition which will require further assessment when access to this region of the building can be gained but is pointed out as it may be a hidden condition impacting the capacity of this region of roof. Beyond the noted roof joist condition, cursory review of the northerly building module exterior roof surfaces did not seem to indicate they were significantly impacted by the fire. Some window openings within the northerly modules were observed to be open/ unbarricaded so the potential exists that those regions incurred water damage during fire fighting operations. In addition, smoke damage was observed throughout.

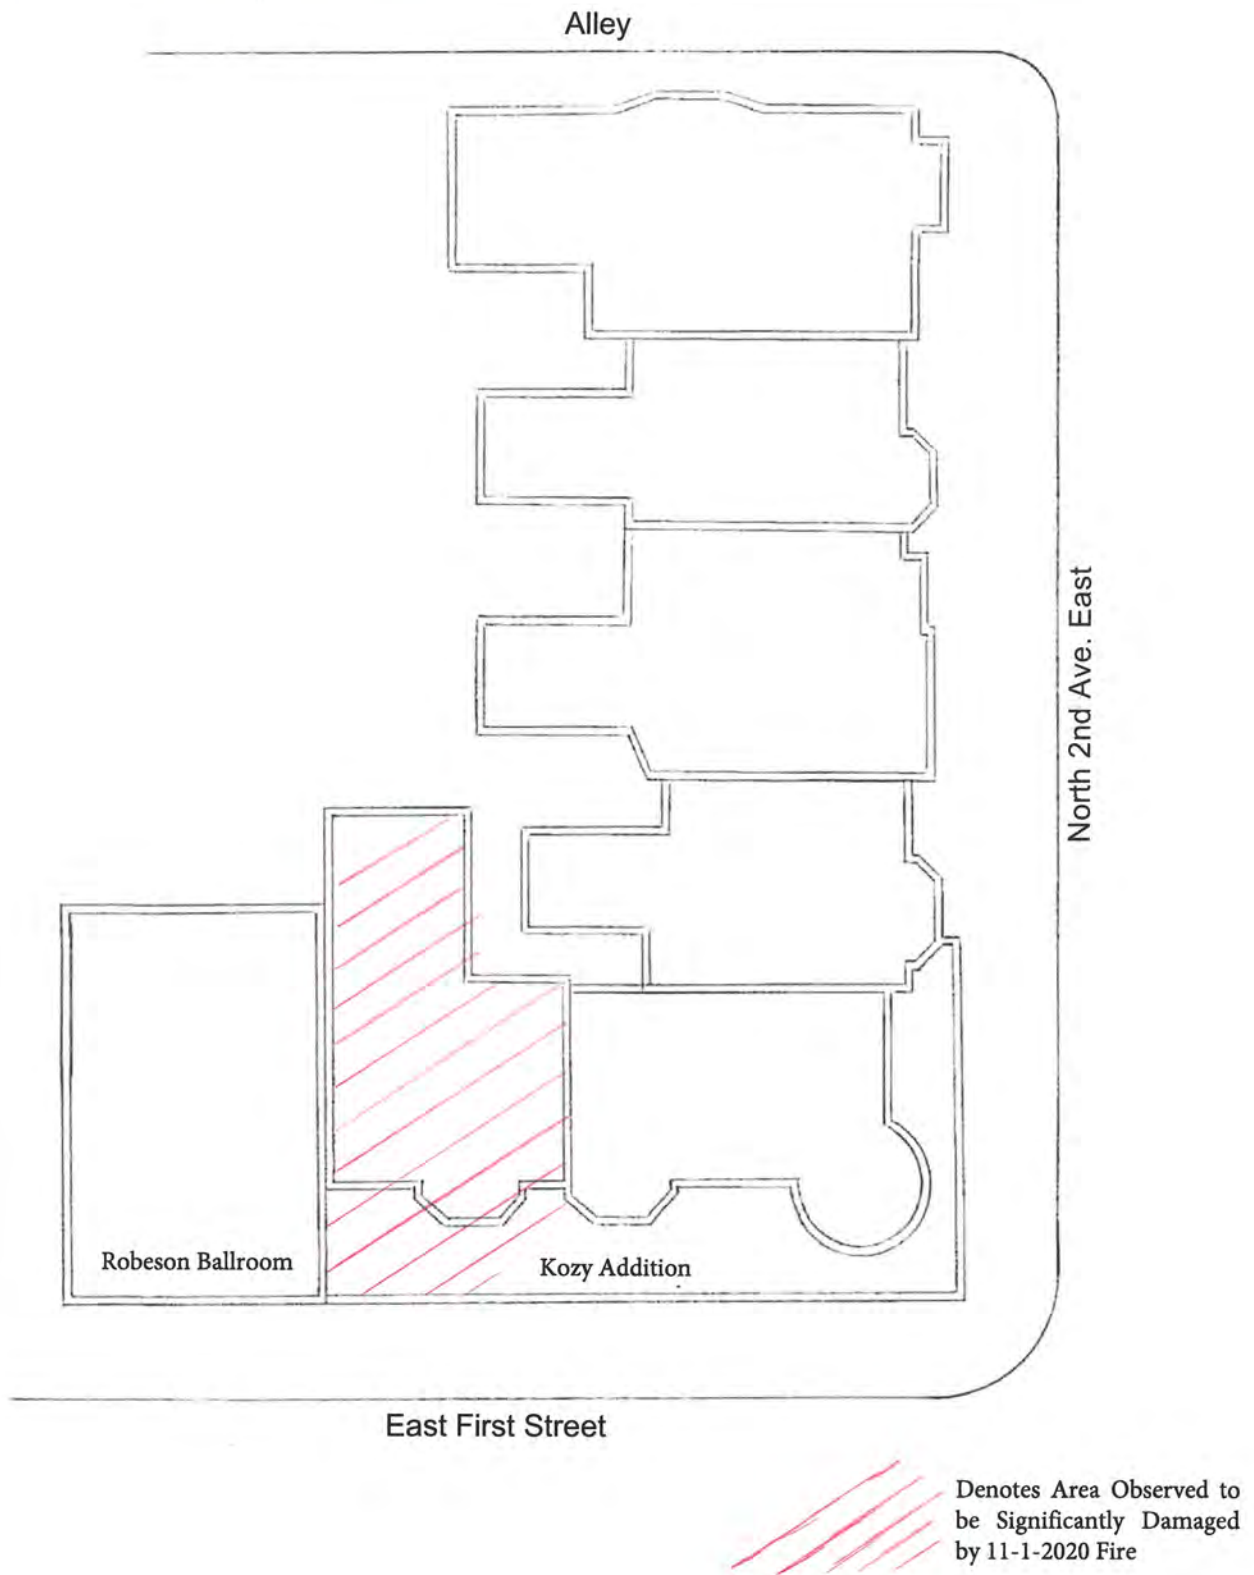
First Level (First Street Level)

Pastoret Building Diagram- Initial Noted Impact Areas from 11-1-2020 Fire

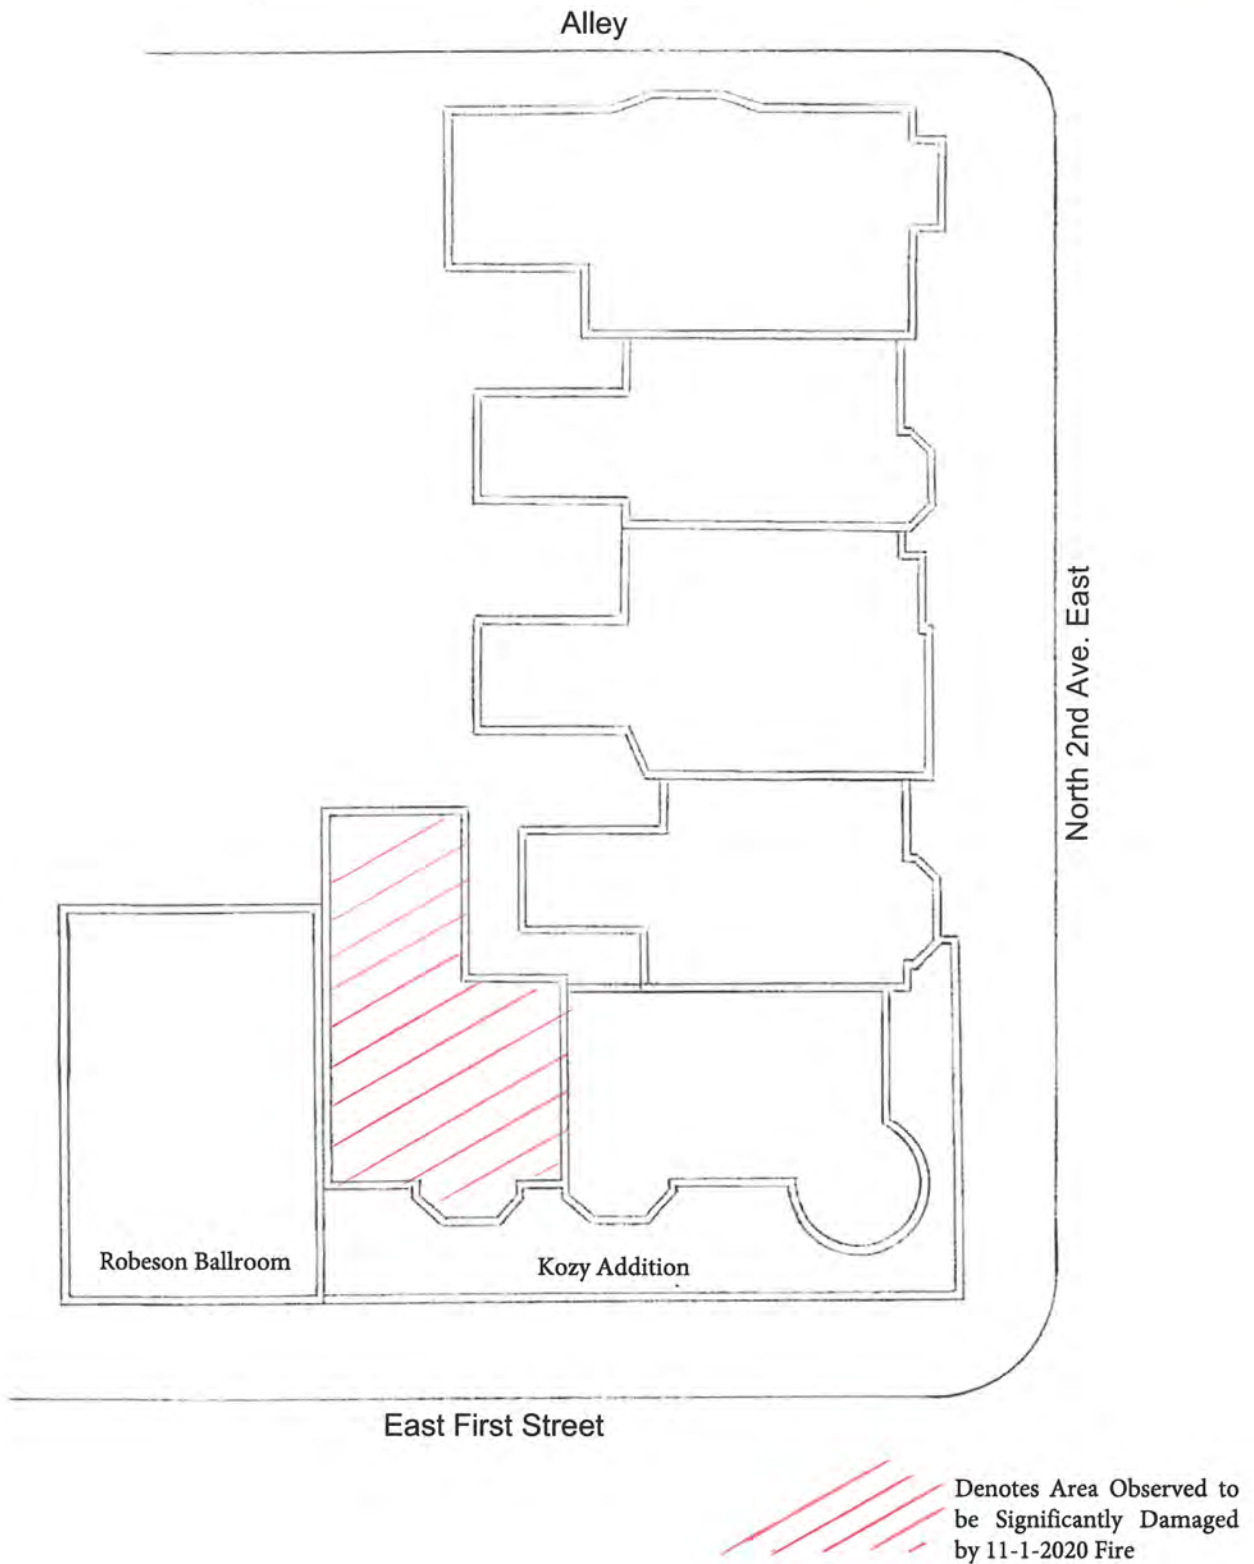
Second Level

Pastoret Building Diagram- Initial Noted Impact Areas from 11-1-2020 Fire

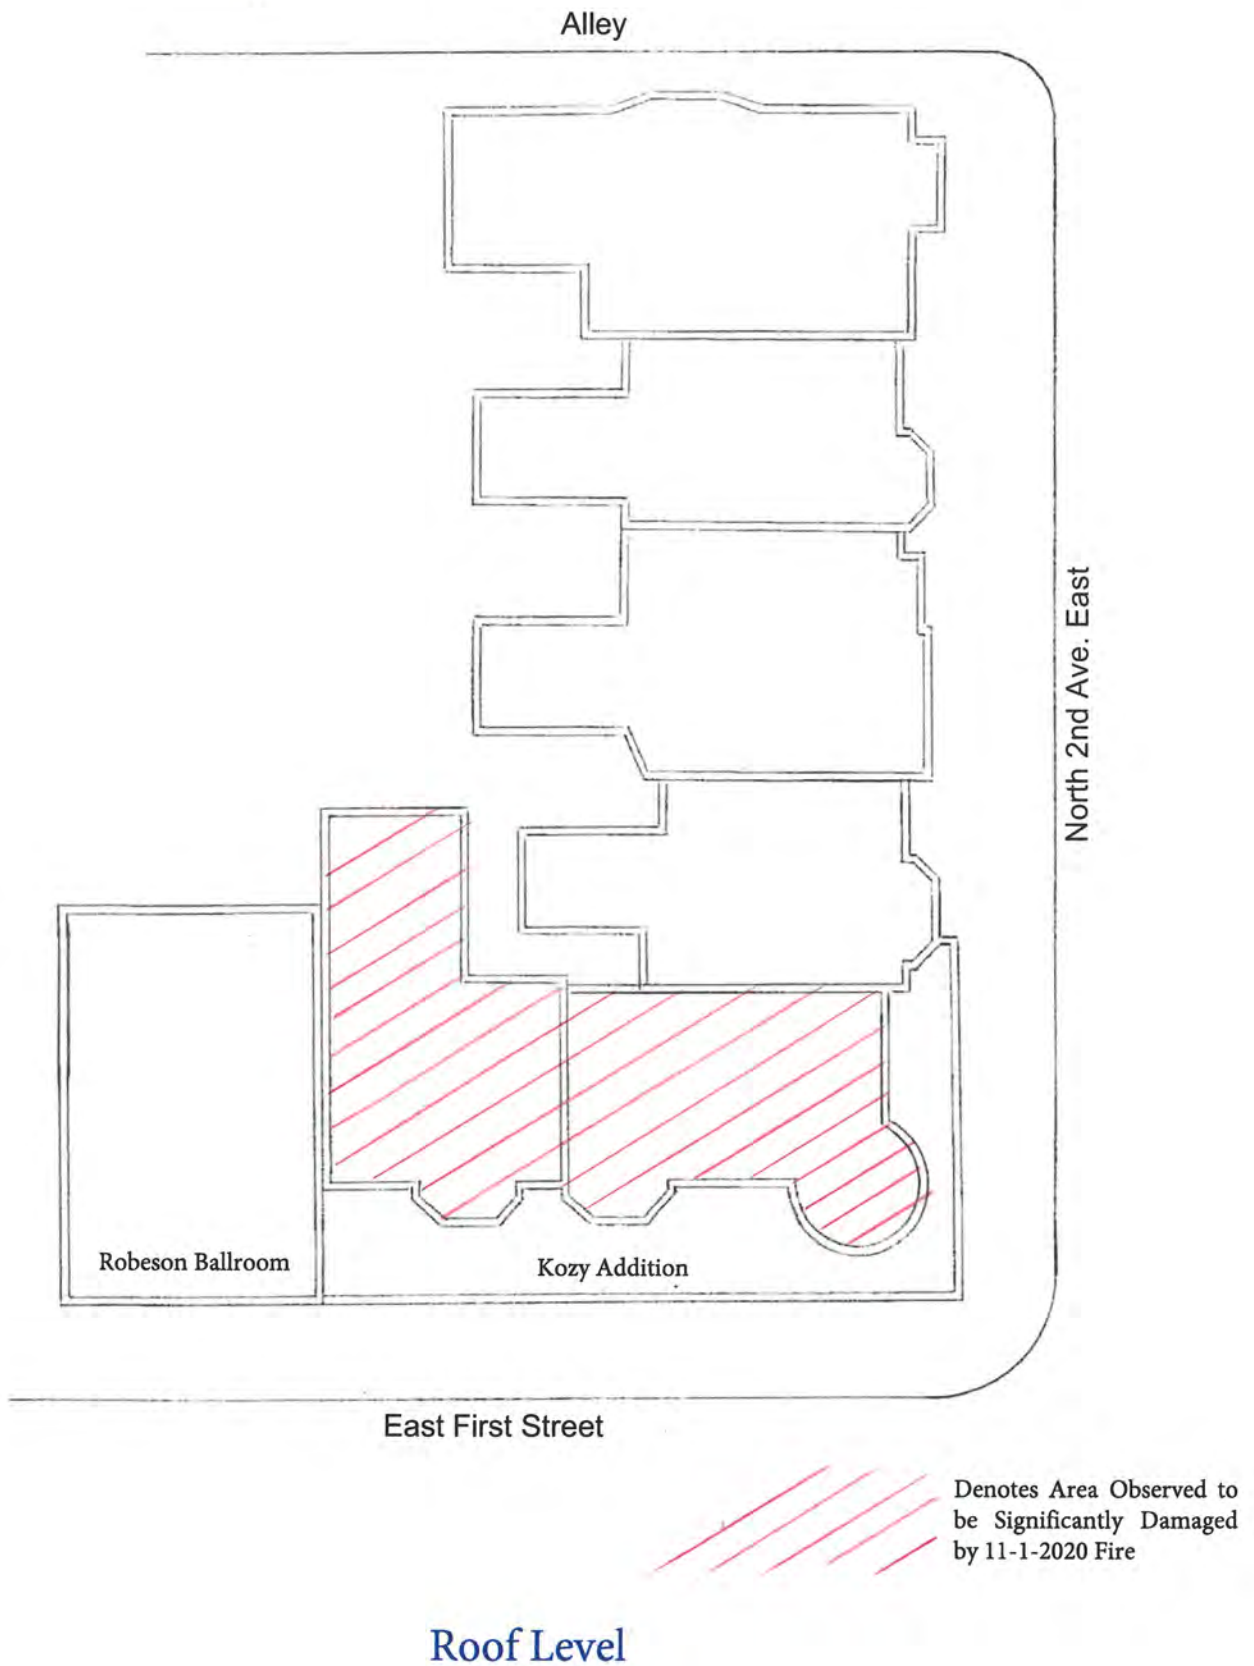
Pastoret Building Diagram- Initial Noted Impact Areas from 11-1-2020 Fire
