Wade Stadium

Activities / Amenities

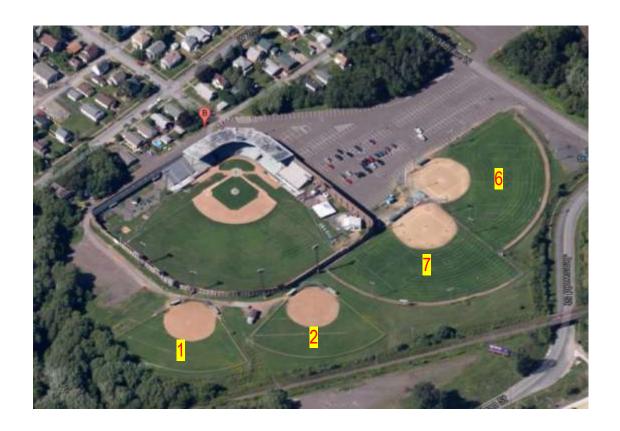
Priority 2- Stripe/mark the accessible parking spaces to provide an 8' wide minimum space with an 8' wide minimum aisle. (Note: 2 spaces can share an aisle.) *MN1341 502.4.2*
