Fire Station 8 (City Center West)

Fire Station 8 / City Center West

Accessibility Review

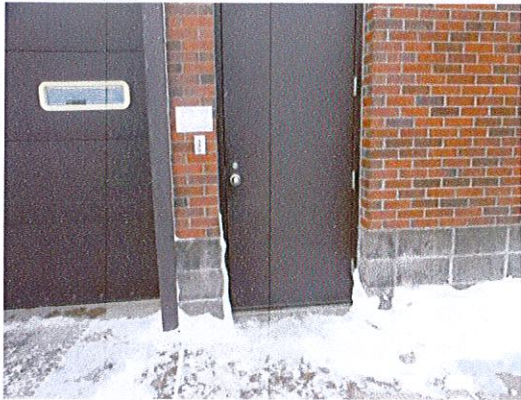
Photo 1: Service door to apparatus area. Replace the knob with a style that does not require grasping, pinching or twisting to operate (such as a lever).

<i>Location Subtotal:</i>	\$600				
Service Door- To Apparatus									
12D 15586	Provide door hardware that does not require grasping, pinching or twisting to operate, such as lever. Exterior security hardware. ICC / ANSI 404.2.6 Photo 1.	2	\$325	\$650	4

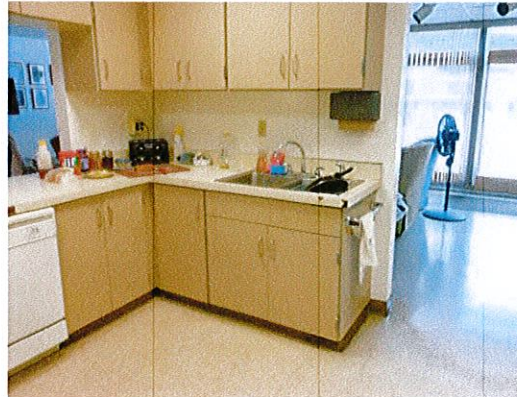
Photo 2: View of kitchen. There are currently no features of accessibility provided.

<i>Location Subtotal:</i>		\$200					
Interior Route- To Apparatus									
20B	15583	1	\$400	\$400	4				
	Re-hinge / relocate door to provide needed maneuvering clearance on the latch pull side of the door. ICC / ANSI 404.2.3, Table 404.2.3.1 <i>Currently provides 10".</i>								
Kitchen									
25J9	15564	1	\$7,000	\$7,000	4				
	Create an accessible kitchen, including: roll under work surface, roll under sink, range with front or side controls, and compliant clearances. ANSI 804 <i>Photo 2.</i>

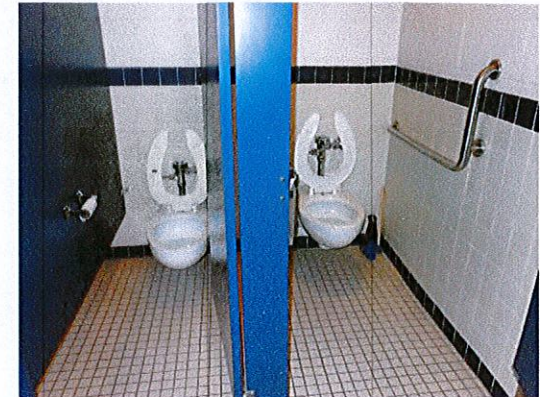
Photo 3: View of toilet room. An ambulatory accessible stall is provided, but not a stall with 60" clearance.

Location JQP # / Item #	Solution / Comments	Qty	Unit Cost	Total Cost	Priority	Estimated Compl. Date	Person Responsible	Actual Compl. Date	Actual Cost
Women's Locker Room									
22E1	15566 Enlarge to provide a fully compliant 60" minimum wide toilet stall. (Currently an alternate stall is provided), MN 1341 604.3.1 <i>Photo 3.</i>	1	\$1,350	\$1,350	4				
22K6 (MN)	15567 Remove the existing grab bar configuration and replace with a compliant grab bar configuration. MN 1341 604.5.1 ANSI 604.5.2	1	\$400	\$400	4				
22Q	15568 Insulate or otherwise protect exposed pipes at lavatory. ICC / ANSI 606.6	1	\$50	\$50	4				
22V	15569 Install a full-height mirror or provide a mirror where the bottom of the reflective surface is no higher than 40" above the floor. MN 1341 603.3 <i>Currently at 41".</i>	1	\$300	\$300	4				
24D	15570 Provide a compliant shower seat. ICC / ANSI 608.4, 610 <i>Currently provides a 36"x36" shower with a threshold. Photo 4.</i>	1	\$750	\$750	4

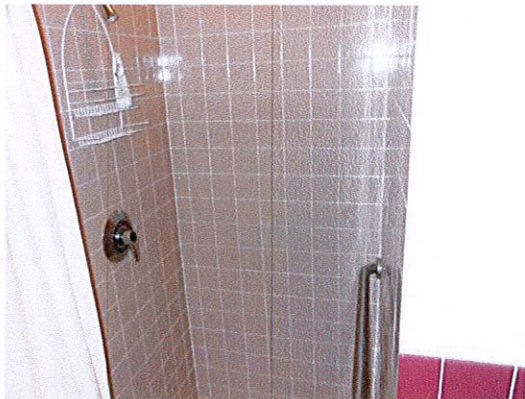
Photo 4: Add a shower seat, hand held shower wand and correct grab bars to create an accessible transfer shower.

24E	15571 Provide a compliant hand-held shower unit. ICC / ANSI 608.5, 608.6 <i>Currently provides a 36"x36" shower with a threshold. Photo 4.</i>	1	\$475	\$475	4				
24I	15572 Install compliant shower grab bars. ICC / ANSI 608.3.1 <i>Currently provides a 36"x36" shower with a threshold. Photo 4.</i>	1	\$400	\$400	4				
				<i>Location Subtotal:</i>	\$3,725				
				Priority # 4 Total	\$20,800

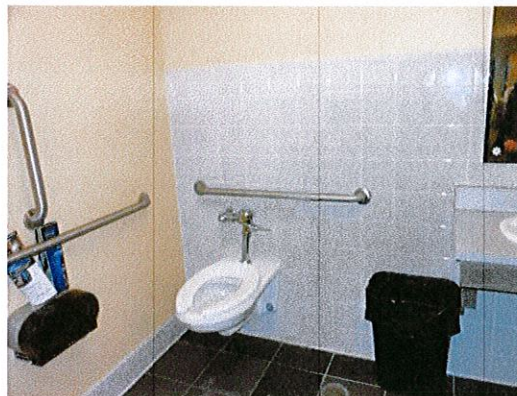
Photo 5: The attached police station provides accessible toilet and shower facilities.
